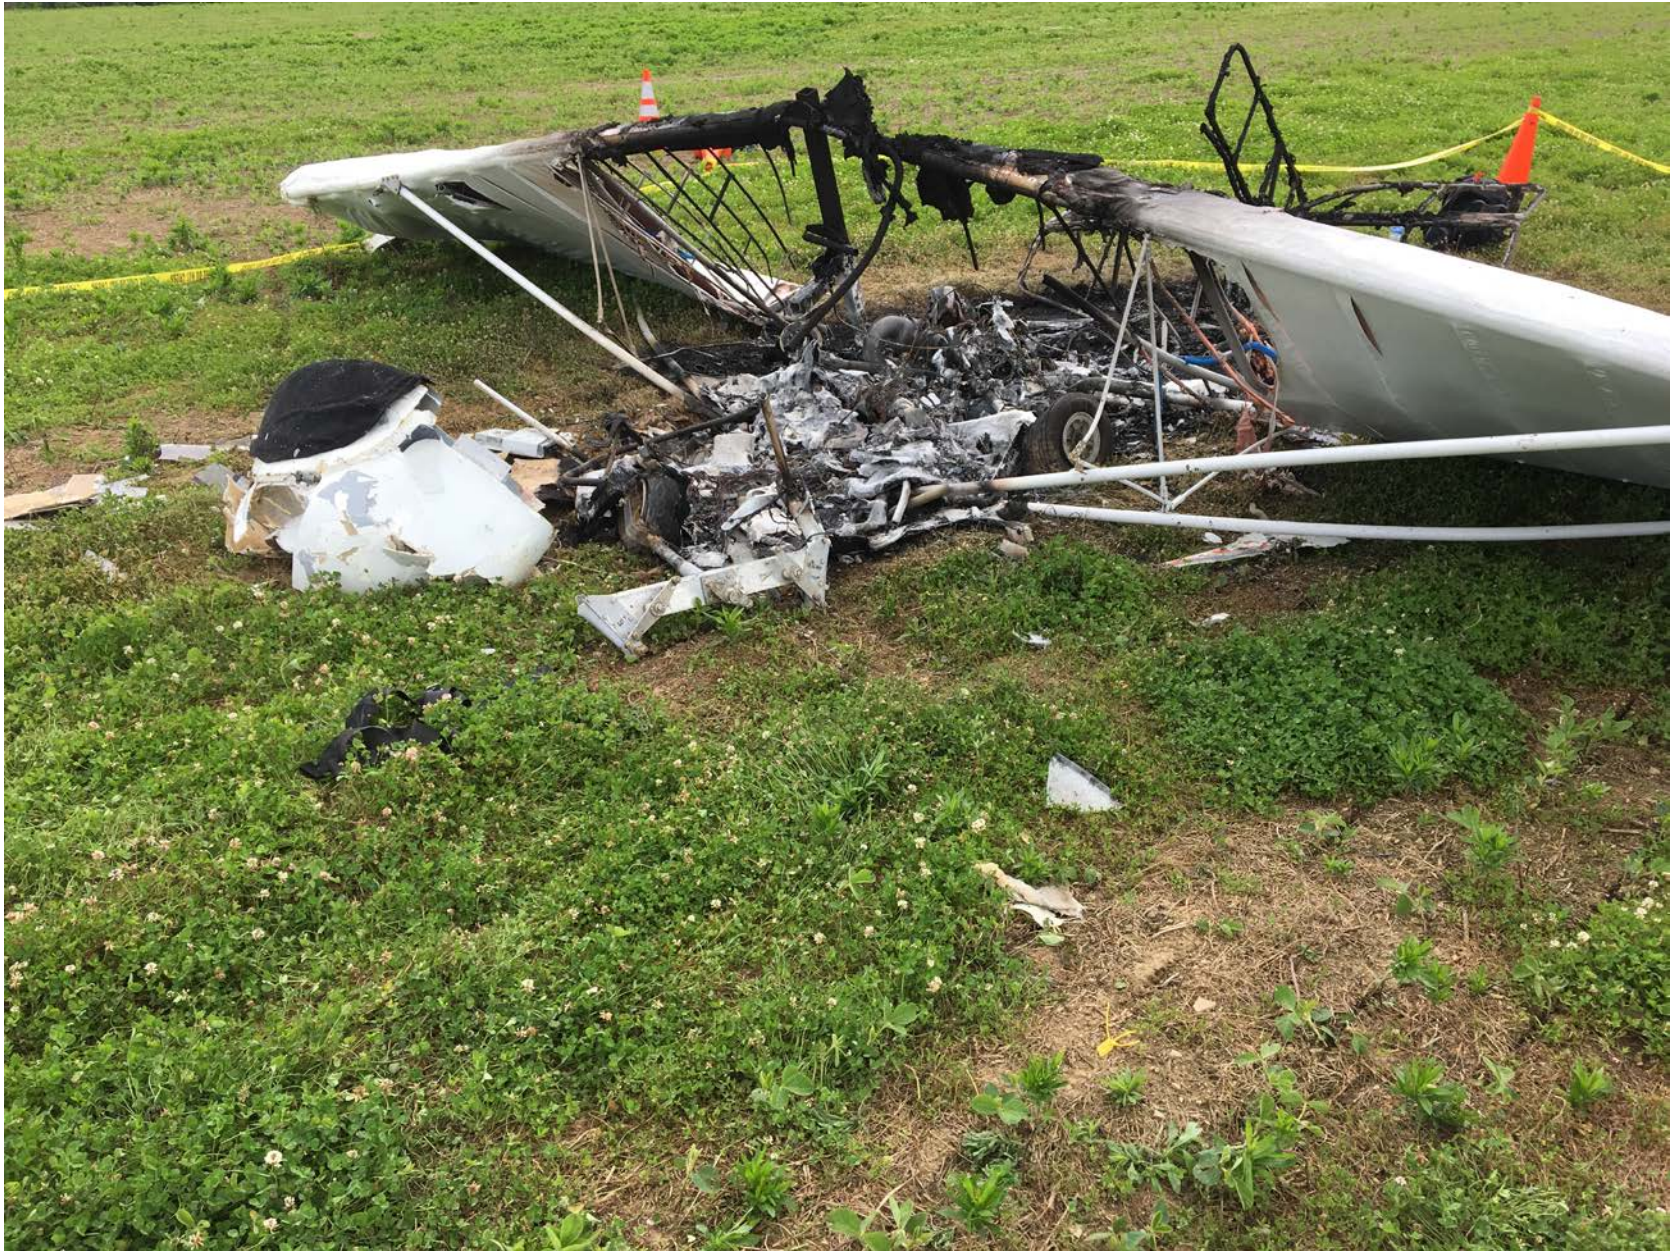
**Photo 1 – Airplane impact and fire damage looking at left front quarter.**

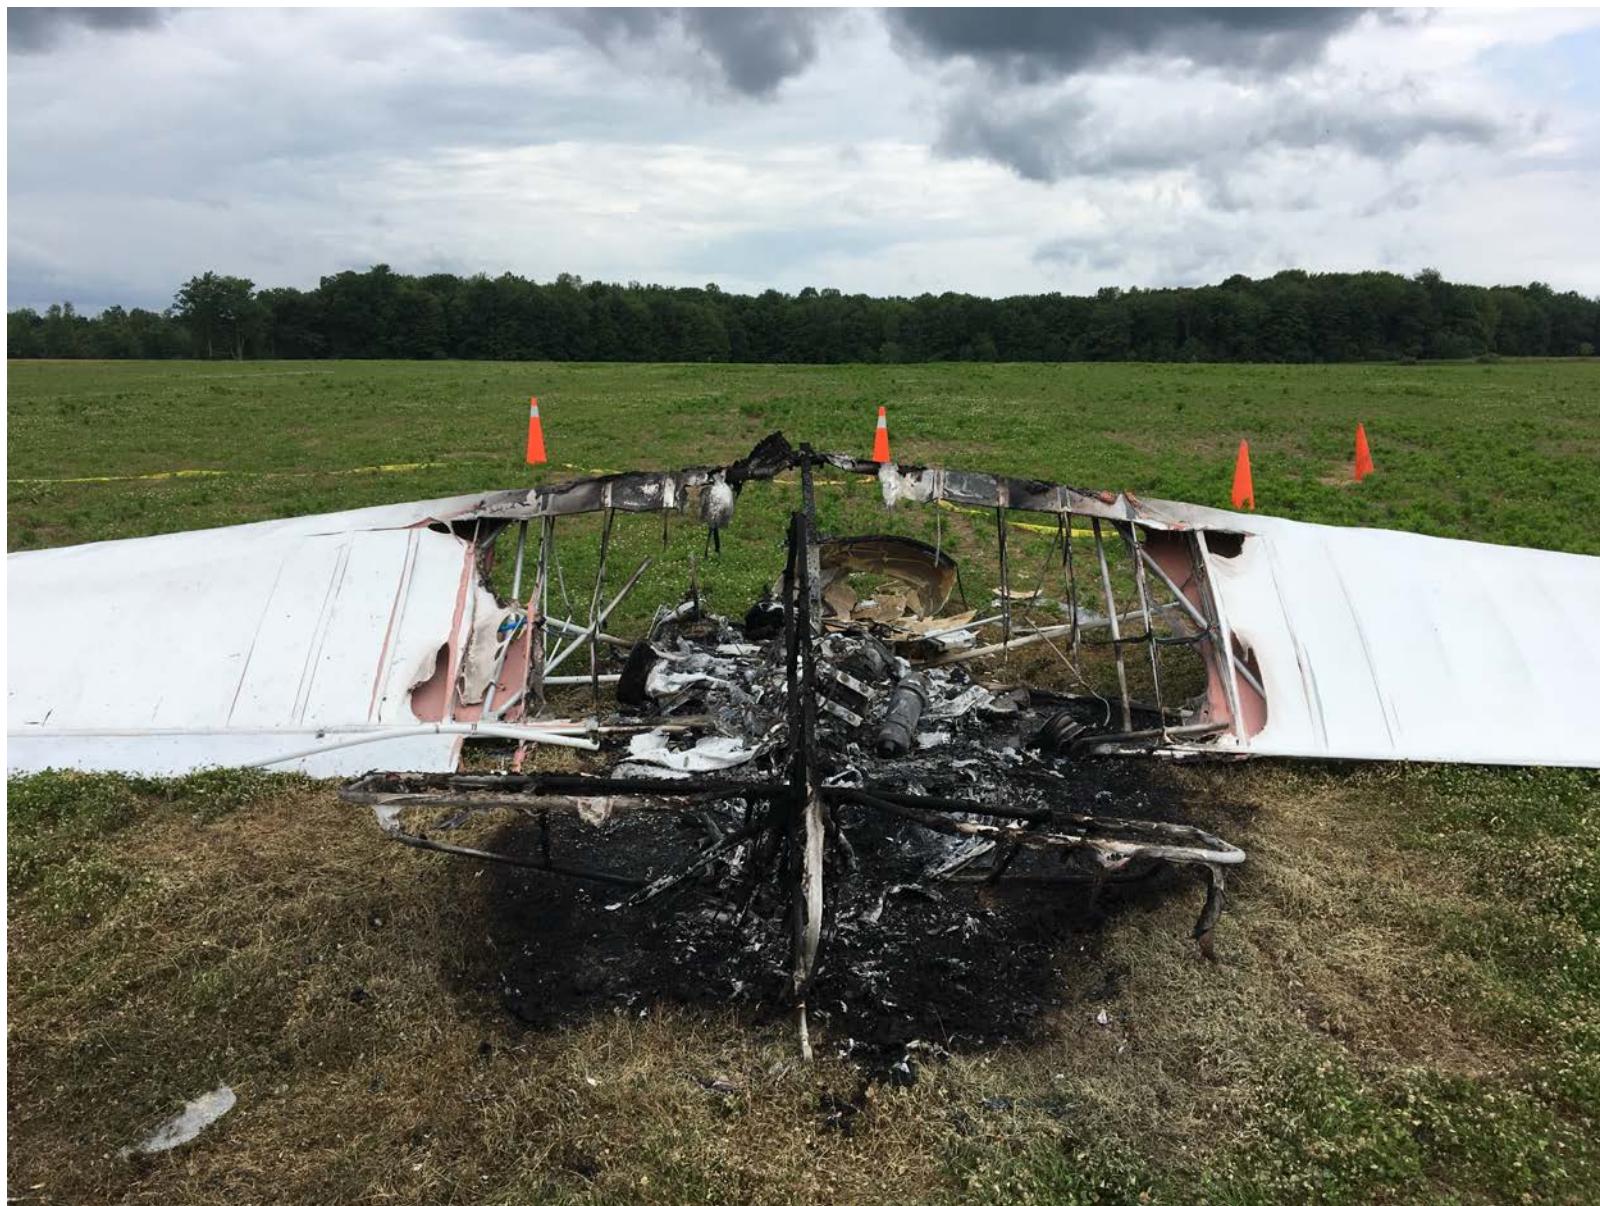
**Photo 2 – Airplane impact and fire damage looking from the tail forward.**

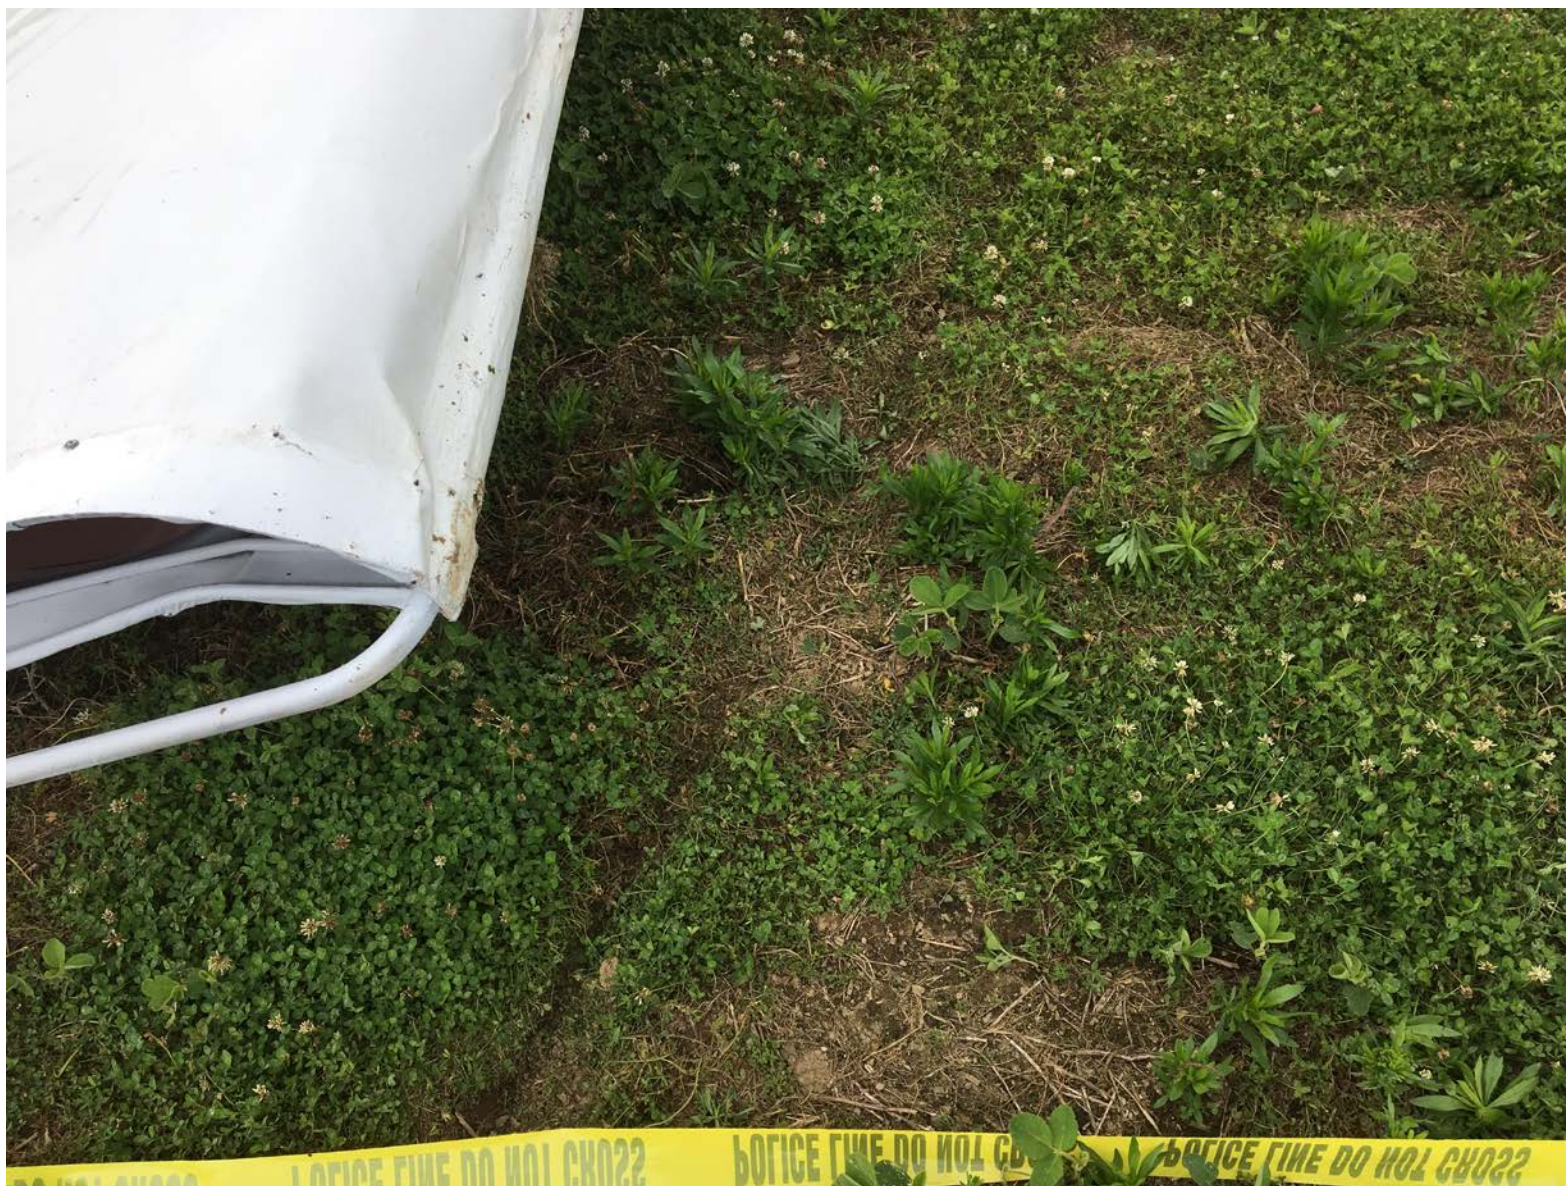
**Photo 3 – Right wing damage and ground impact mark.**

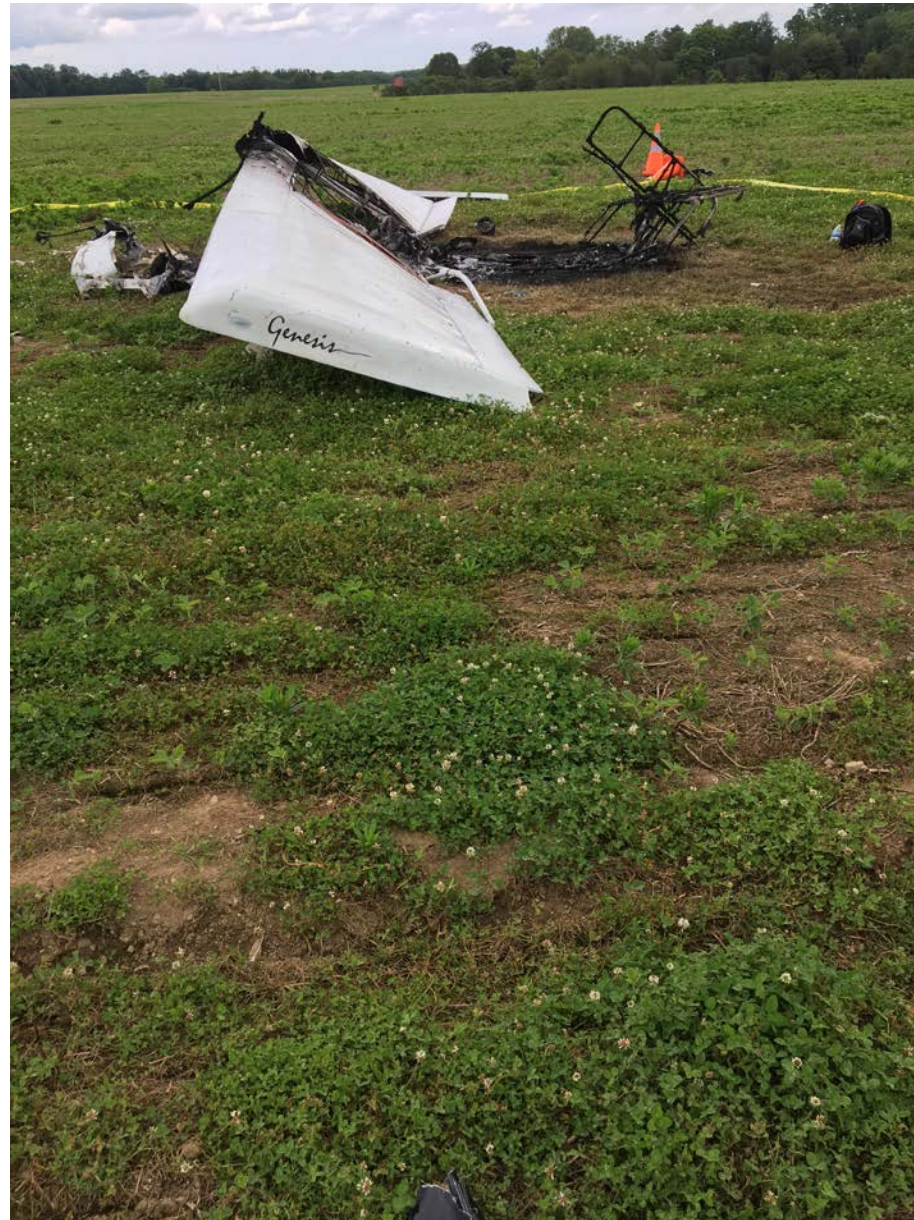
**Photo 4 – Left profile of entire airplane impact and fire damage.**

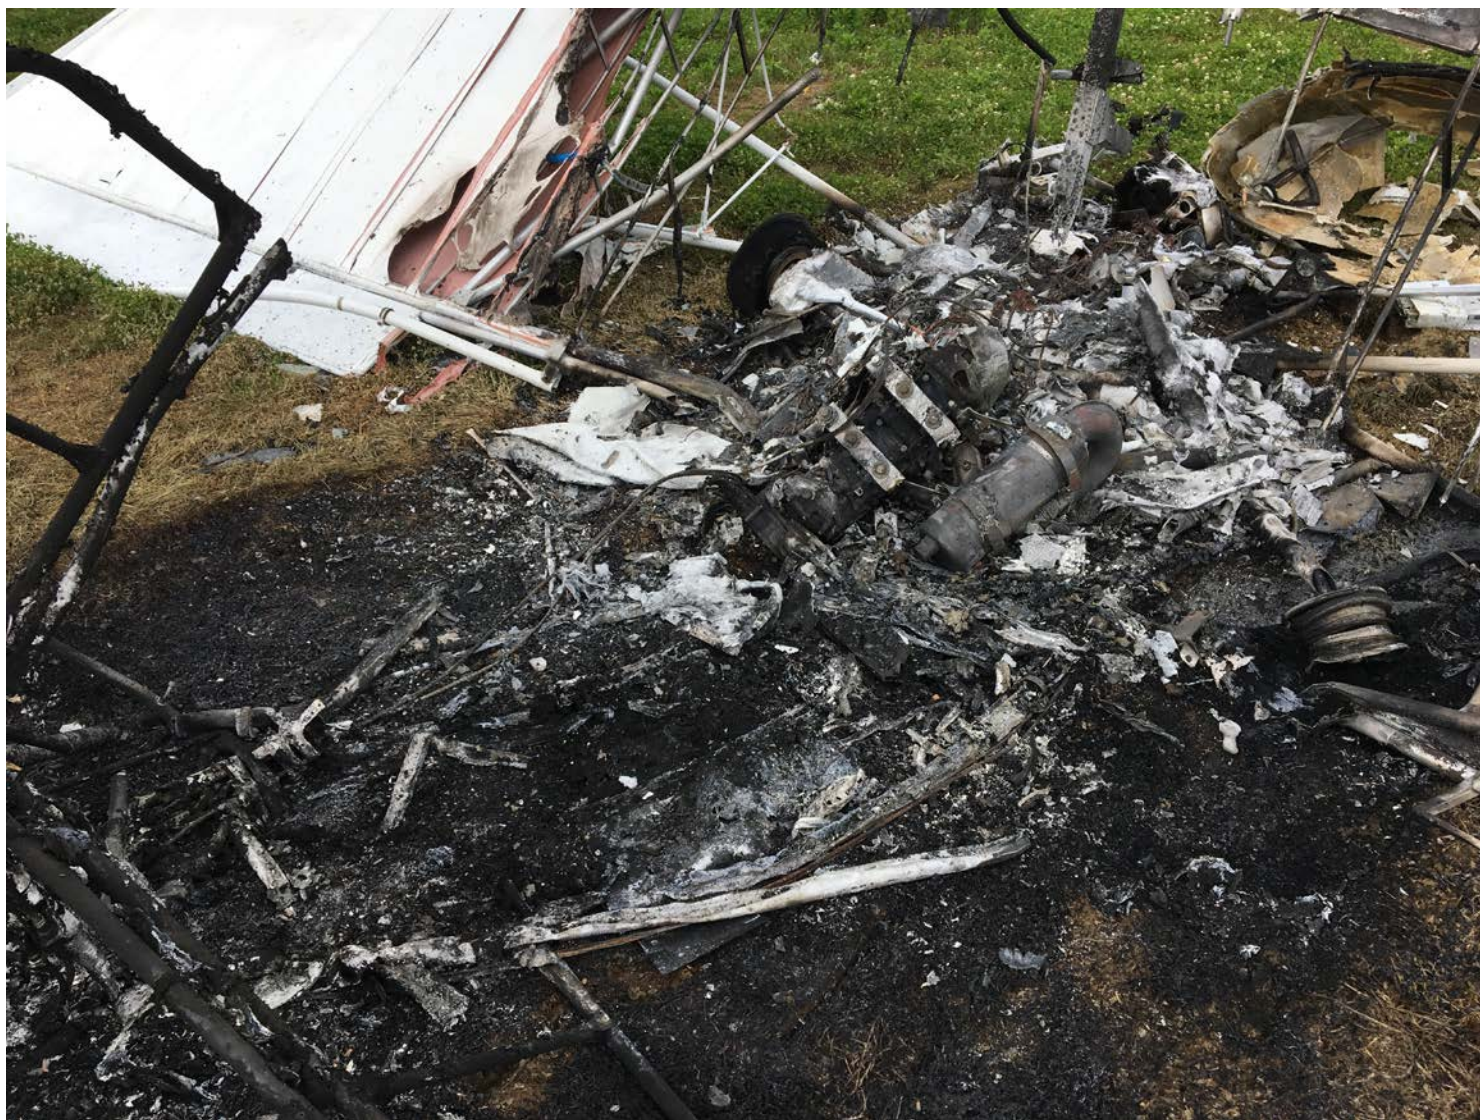
**Photo 5 – Close up of fire damage at center of fuselage. Note the engine heat damage.**

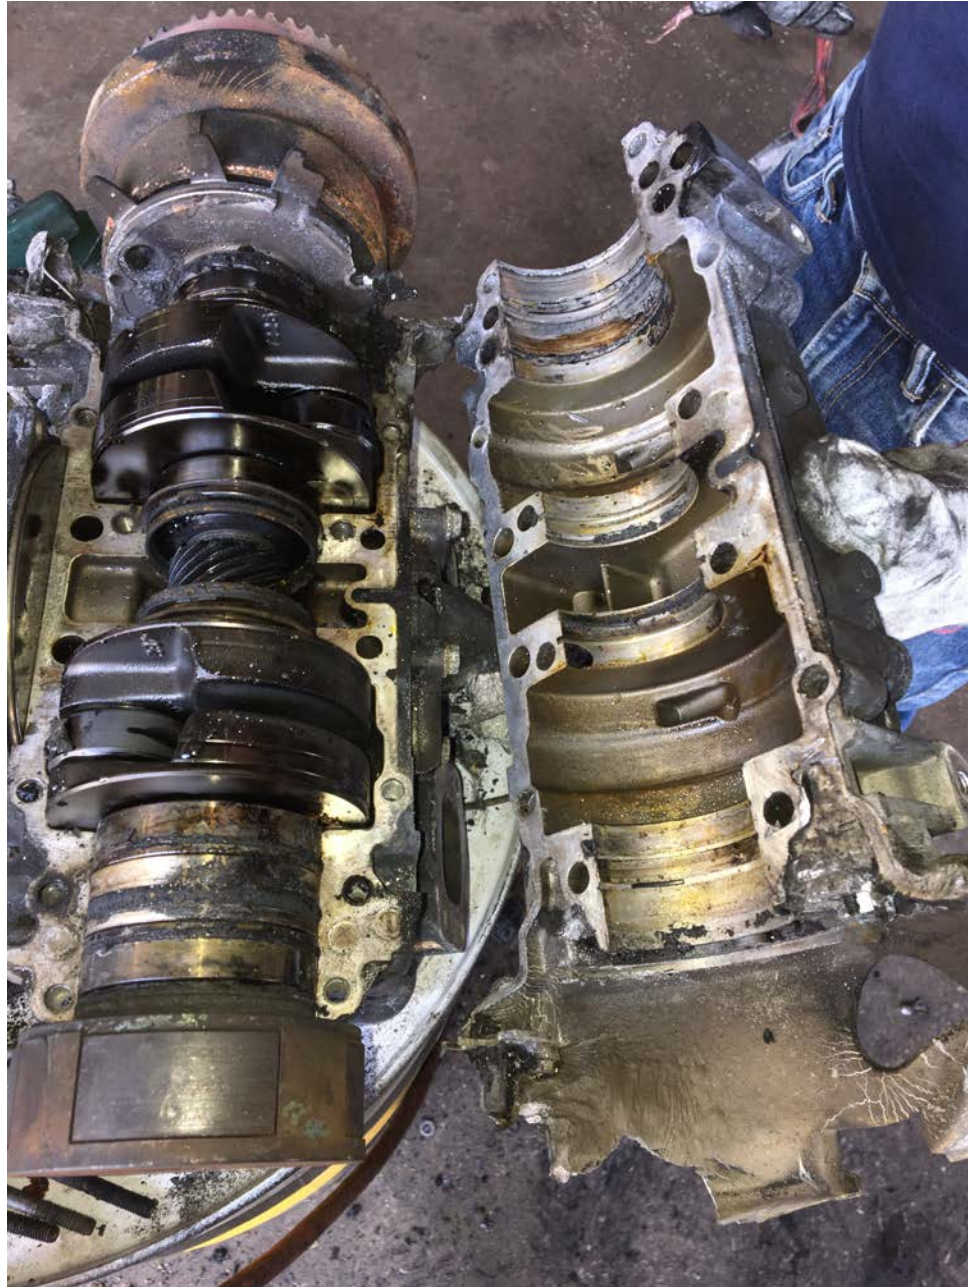
**Photo 6 – Interior of engine after crankcase separation.**
