## MEMORANDUM

**Daniel P. Boggs**  
**Air Safety Investigator**  
**National Transportation Safety Board**  
**Office of Aviation Safety - Eastern Region**

**Date: August 8, 2018**  
**NTSB Case Number: ERA17FA231**

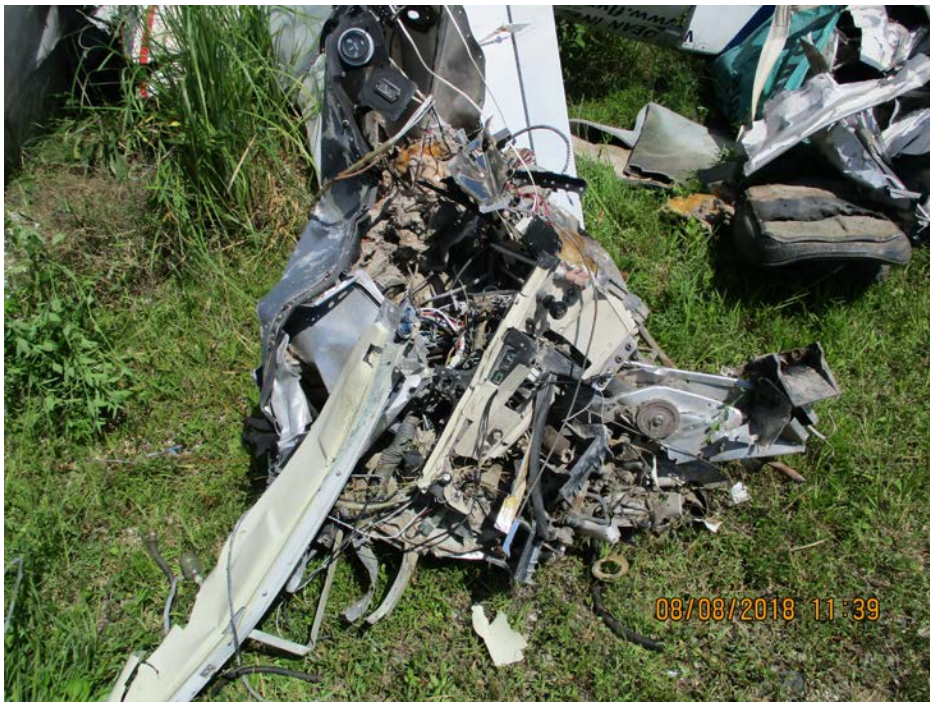
Per your request, I looked at the instrument panel on N49453. The instrument panel was extremely fragmented. There were no instruments installed in the panel or connected to the wiring harness. (see photo 1.)

Photo 1. Instrument panel

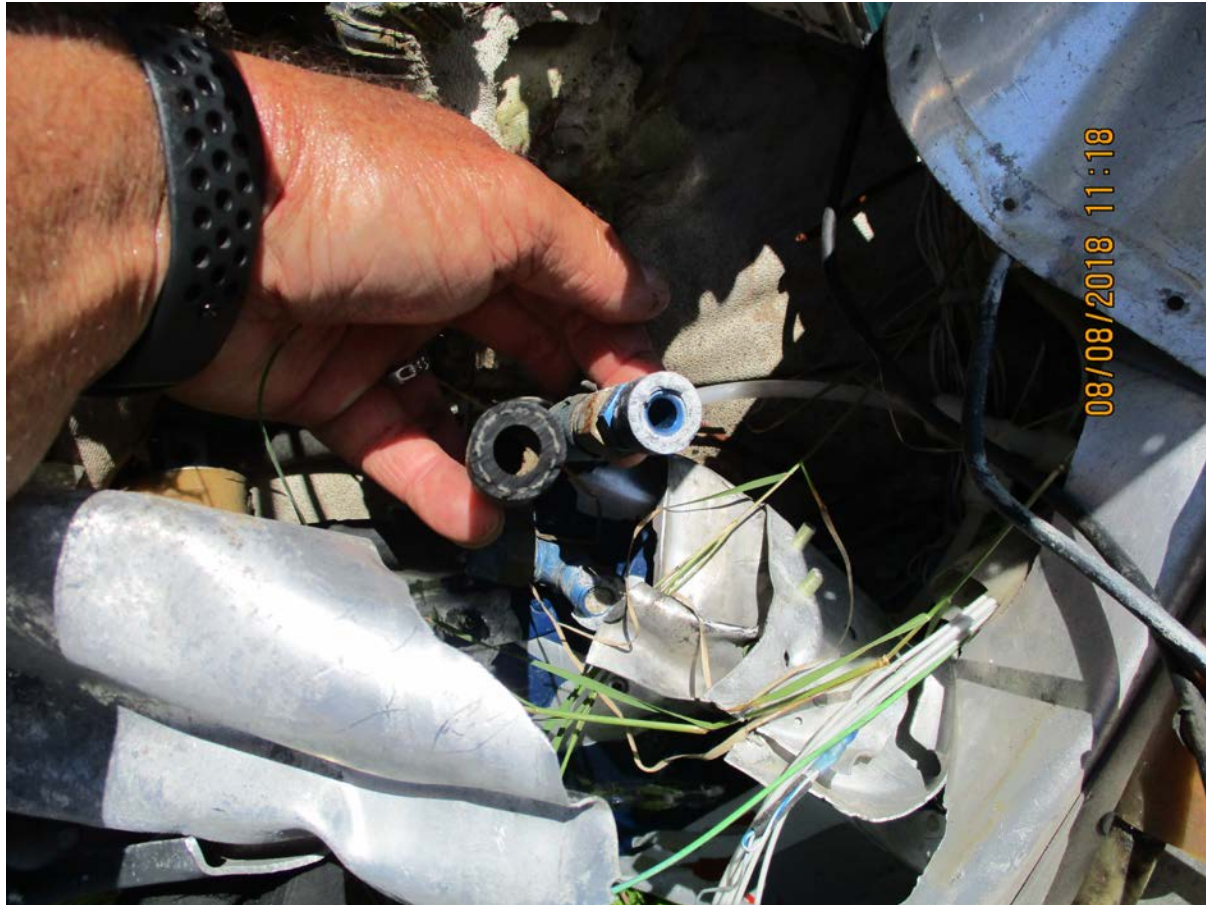
The shock mounts for the instrument panel were missing. The vacuum system was fragmented and only a couple hoses were present. (see photo 2.)

Photo 2. Vacuum lines.

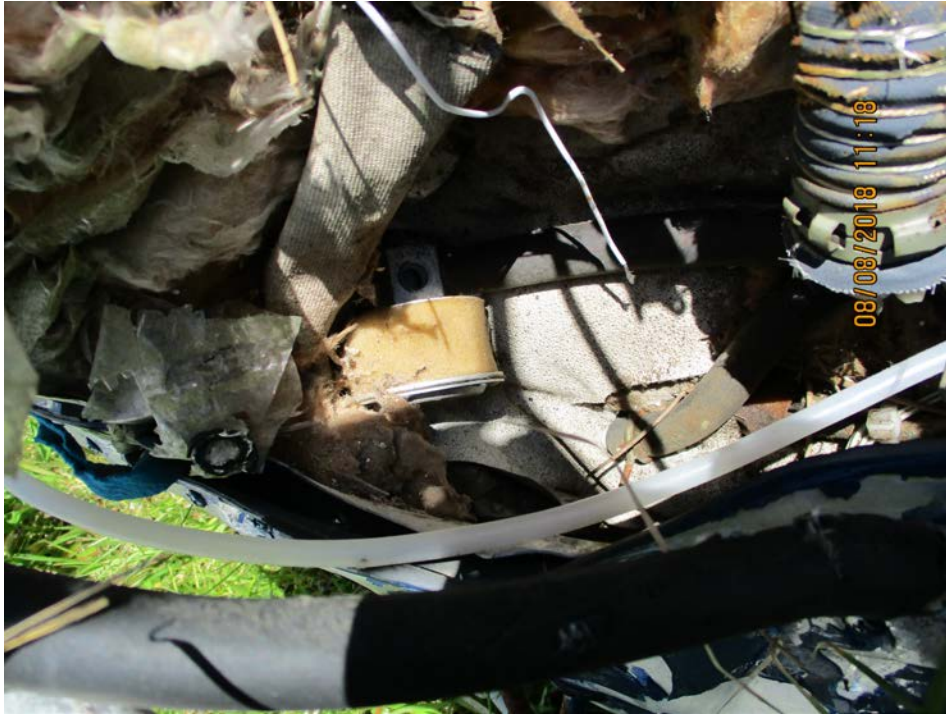
The vacuum regulating valve was located still connected to the firewall. A rubber hose about 12 inches in length was still attached to the left port on the aft side of the valve. (see photo 3.)

Photo 3. Vacuum regulating valve.

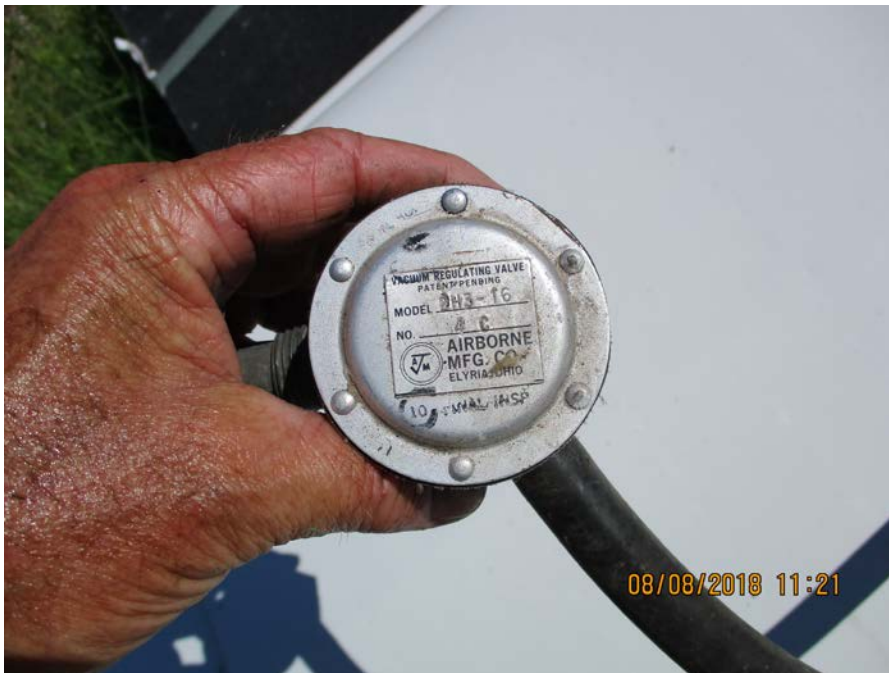
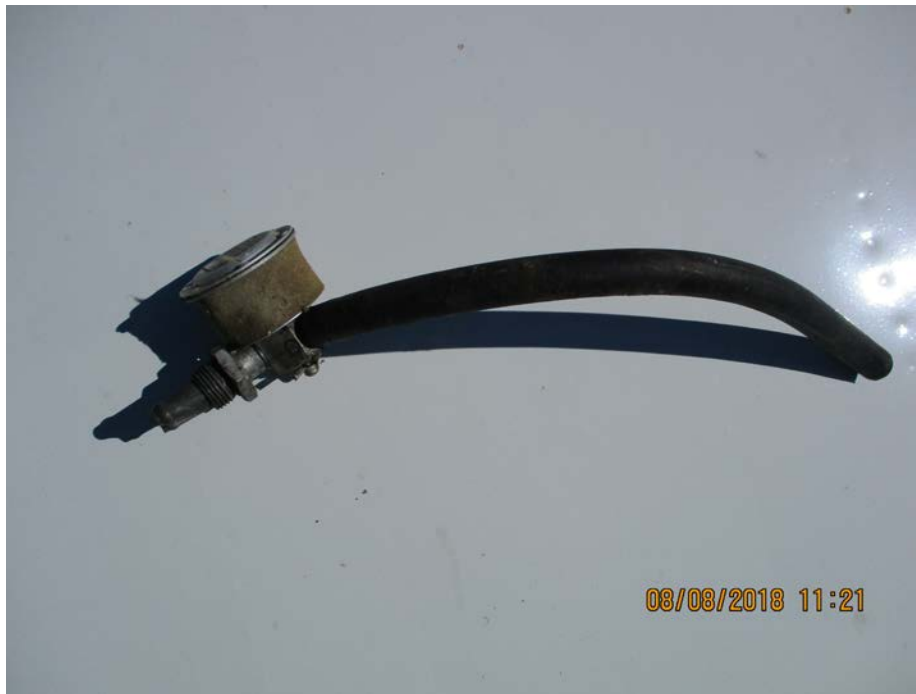
The regulating valve was removed and appeared to be in good condition; however, the valve has been sitting outside in the weather for some time and some corrosion was present on the valve. The foam protecting the valve from dirt and debris was in good condition. (see photo 4-5)

Photo 4. Regulating valve.

Photo 5. Regulating valve with a 12 inch long hose attached.

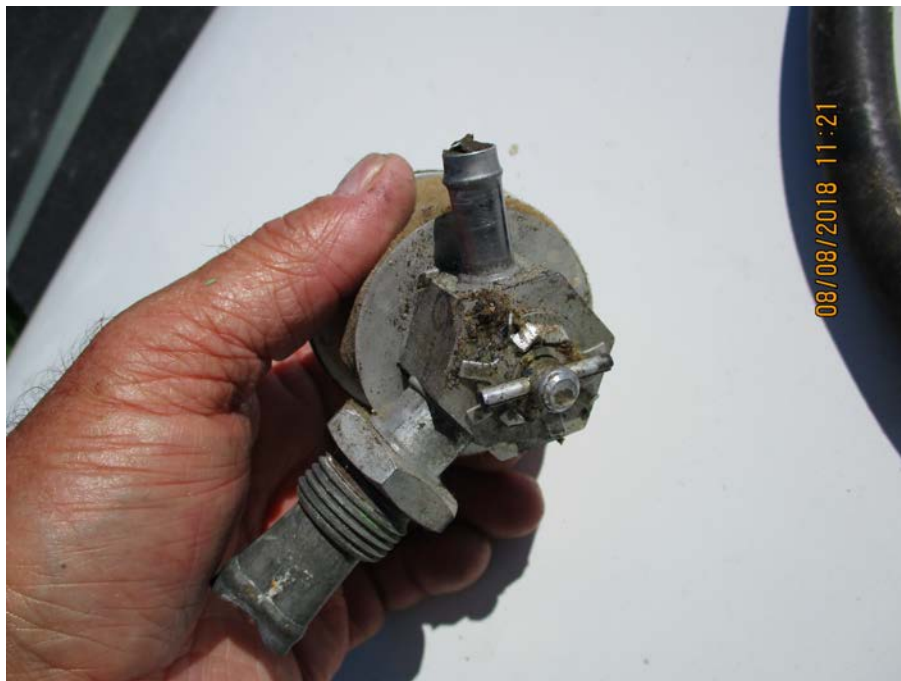
The valve has two output ports. One port was fractured off which was opposite the port that connected to the engine-driven vacuum pump. See photo 6.

Photo 6. Port missing.

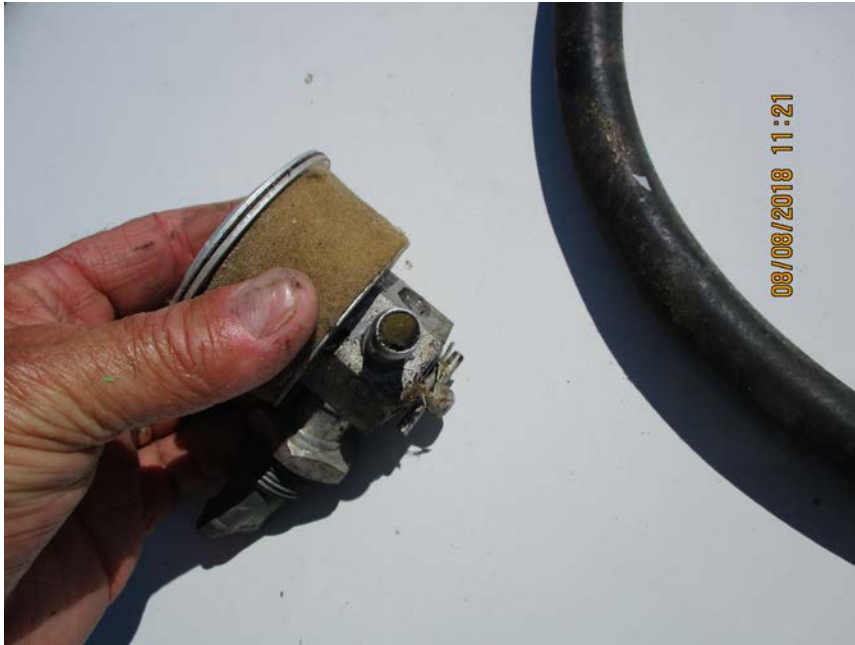
The vacuum hose was removed from the existing port and it was noticed that the port was clogged with some debris. The debris was hard and appeared to be convex as first viewed. See photo 7.

Photo 7. Clogged port.

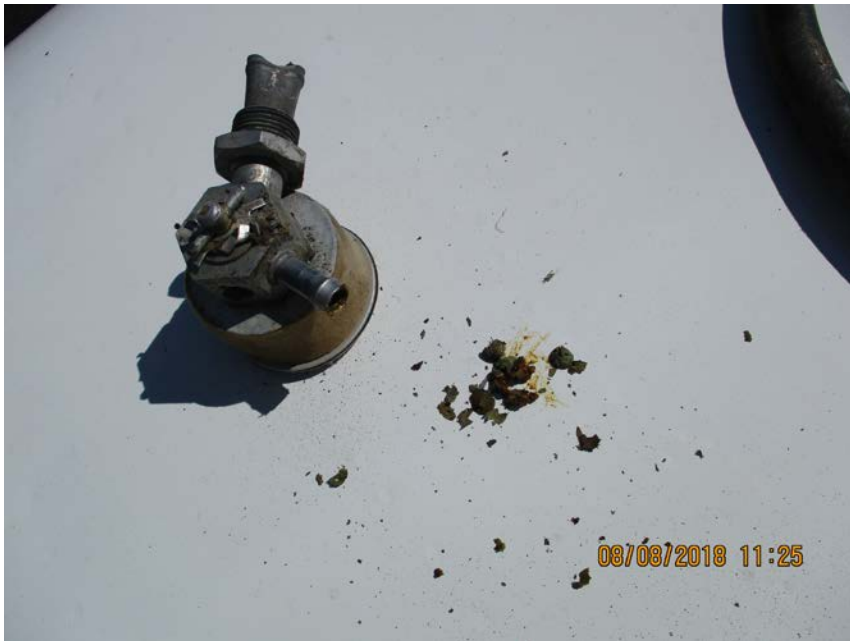
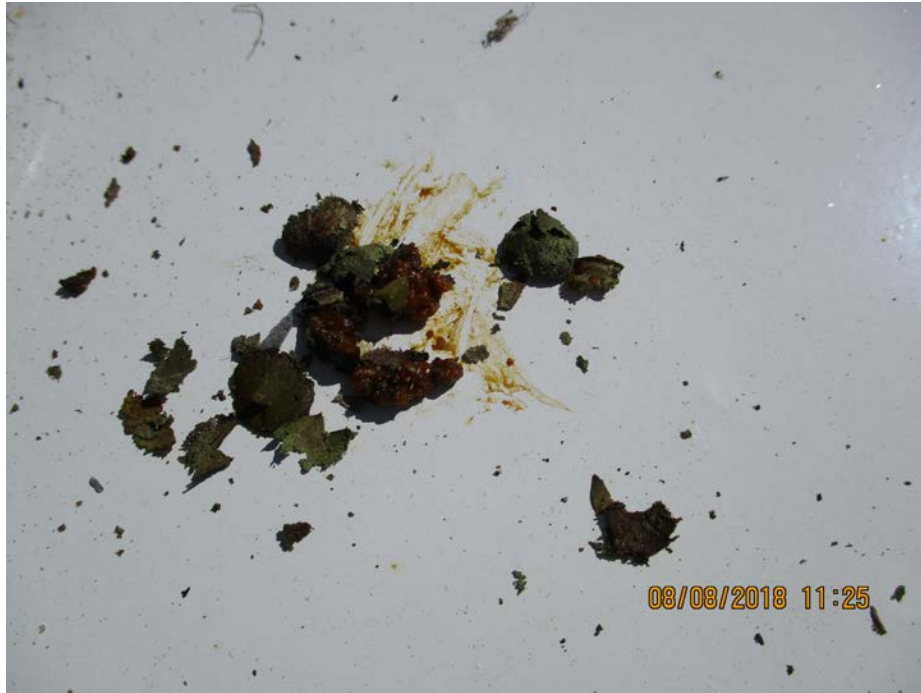
The debris was removed from the port for further examination. The debris was soft in the middle. (See photo 8-9)

Photo 8. Debris.

Photo 9. Close-up of the debris.
