# Federal Aviation Administration

## Memorandum

Subject: Teardown investigation of an Ameri-King AK-450-[] series Emergency Locator  
Transmitter (ELT) sent from the National Transportation Safety Board (NTSB).  
(Refer to NTSB ERA17FA231)

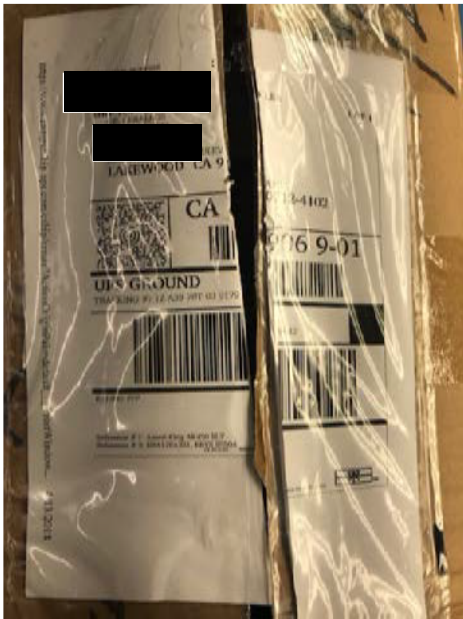
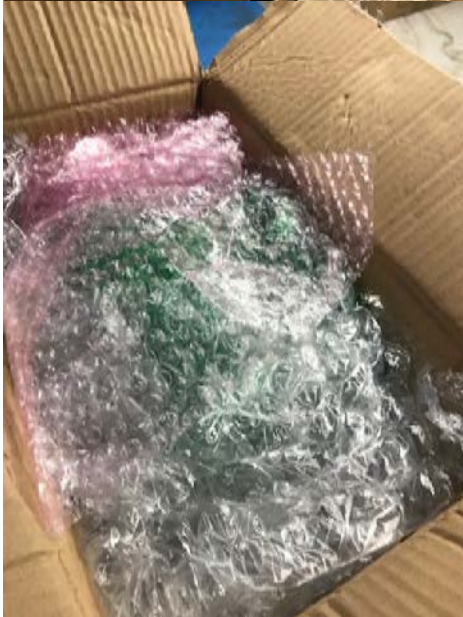
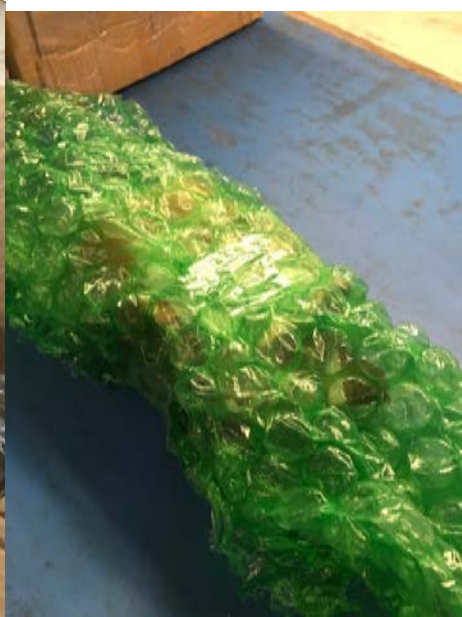
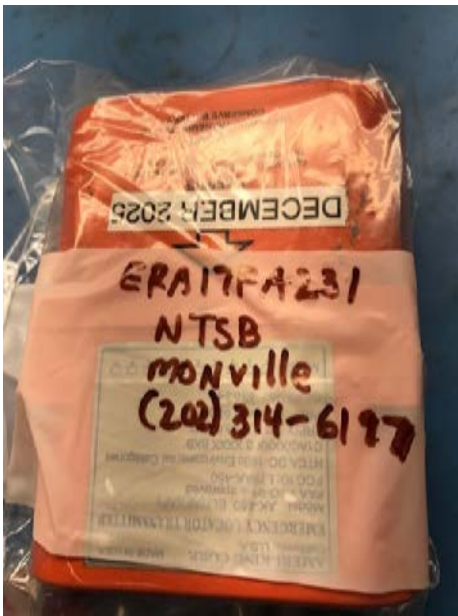
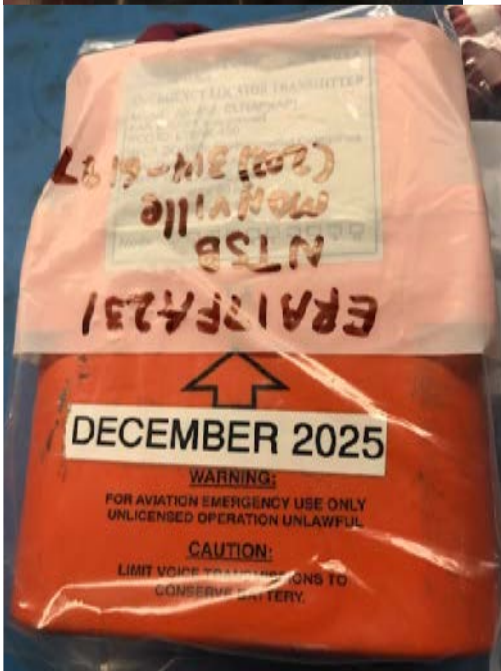
Keith Van (Ameri-King owner) who conducted the tests greeted us. We started by unpackaged the ELT unit shown in the pictures below.

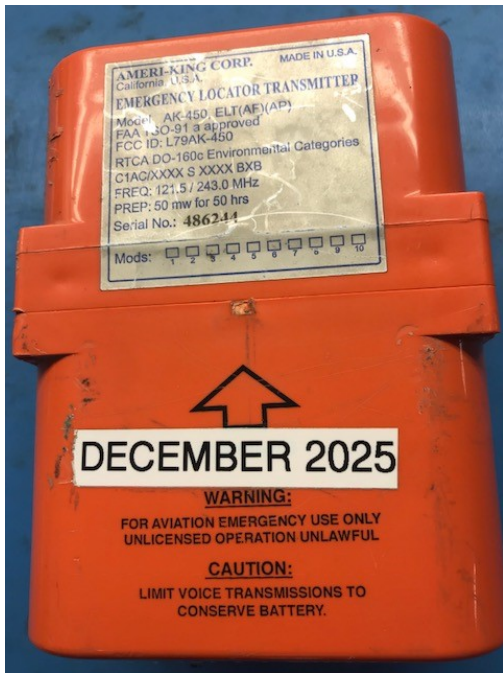
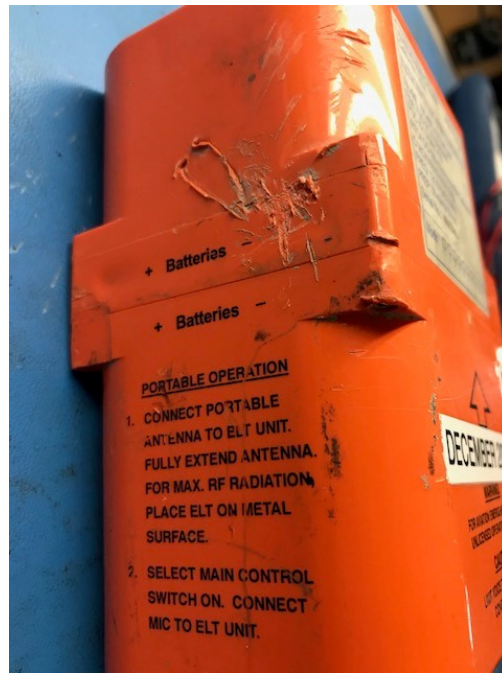
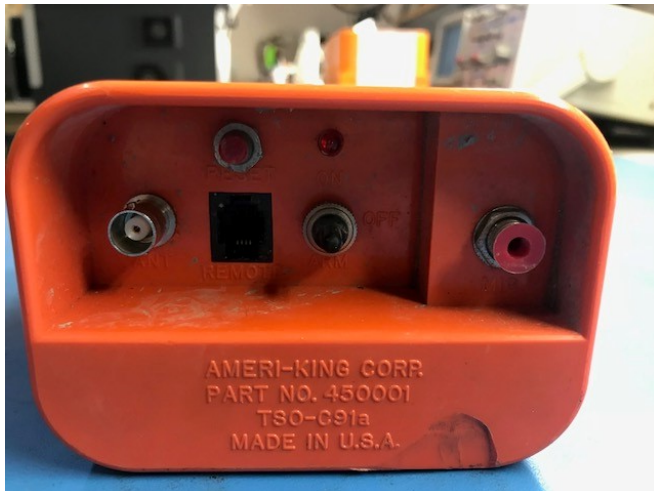
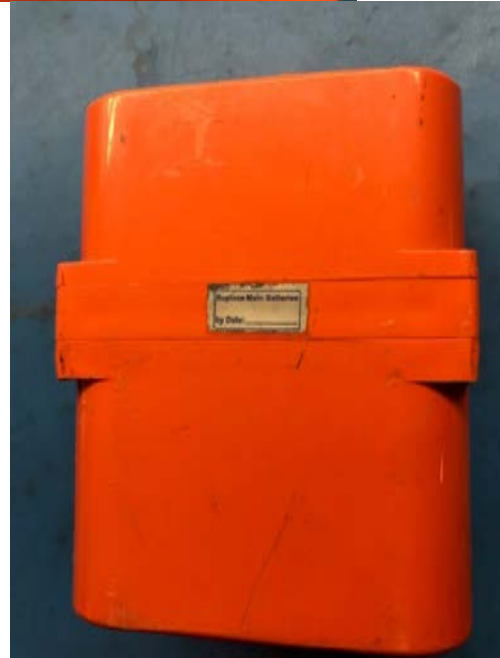
An external inspection of the unit was performed and the serial number “486244” was confirmed. Other than scuffmarks and some scratches on the side shown below, no dents, holes, cracks, or penetrating damage was seen.

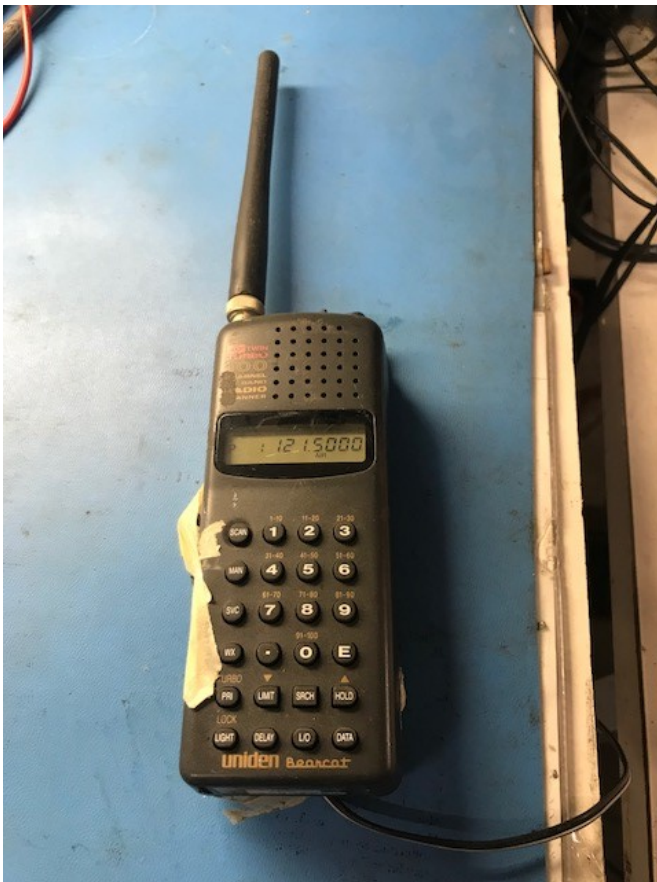
During the functional testing handheld Bearcat receiver was used to monitor the 121.5 MHz frequency.

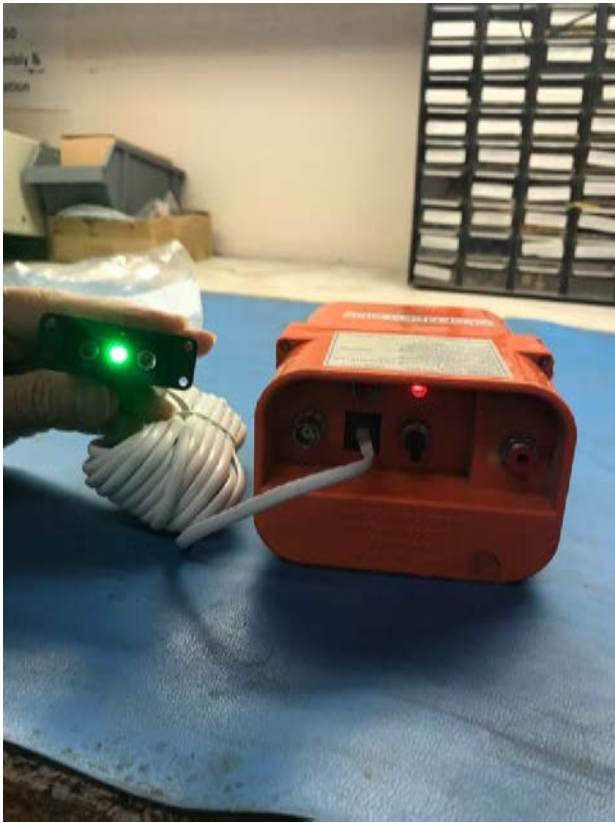
No remote switch was included in the packaging with the unit so a new switch and wire were used for the functional test and connected to the unit. The unit was switched to the ARM position (switch down) and the remote was used to turn on the unit for self-test. The LED light on the remote lit up as expected as did the LED on the unit to indicate it was active. Although the unit indicated it was active, no tone was heard on the Bearcat receiver. The reset button on the remote was selected and the unit turned off (LED turned off) as expected. A separate unit at the manufacturers facility was activated by shaking to verify that the tone could be heard using the receiver and it was heard. The test on the unit in question was repeated multiple times with the same result. It was noted that when the unit indicated that it was active (LED light on the ELT was lighted), the static on the Bearcat receiver went away.

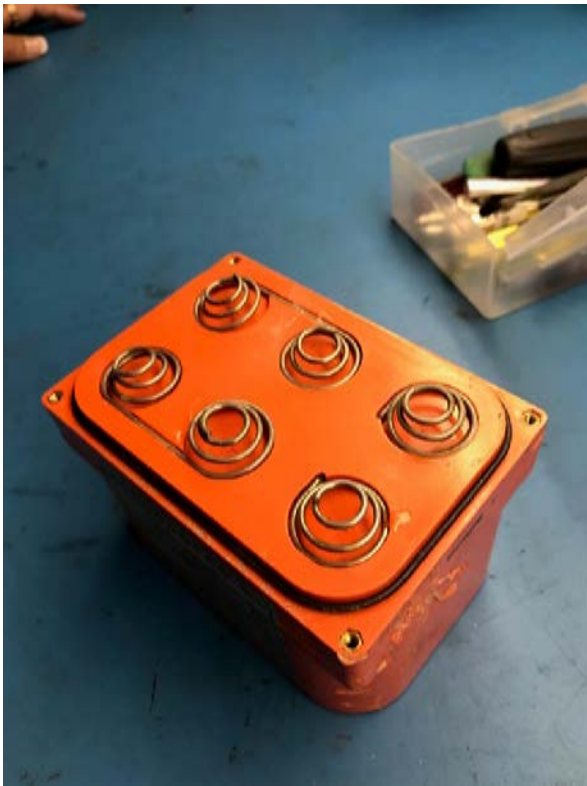
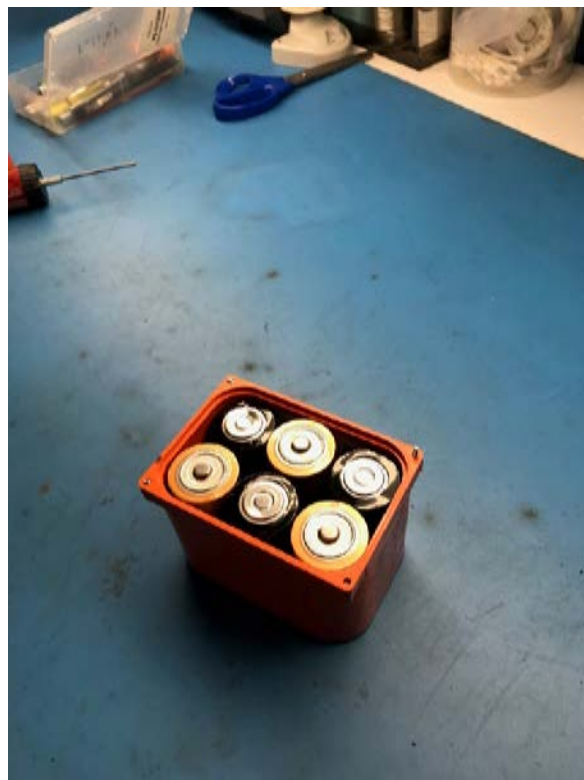
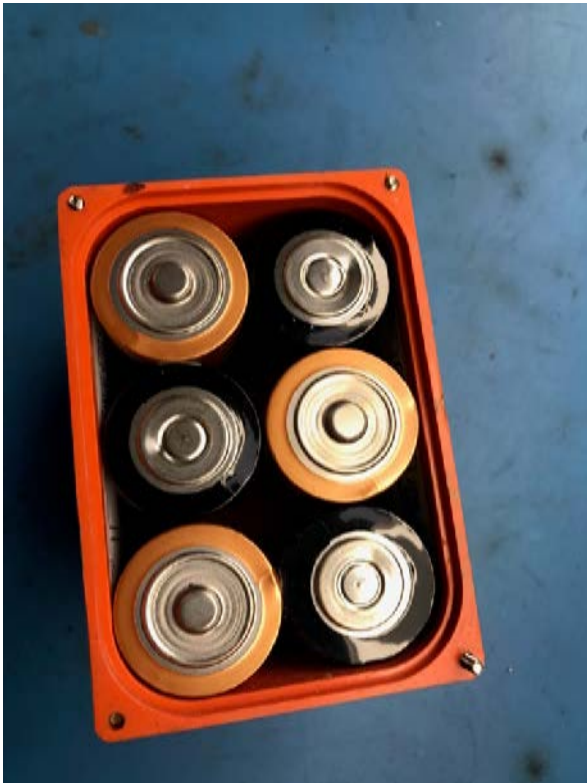
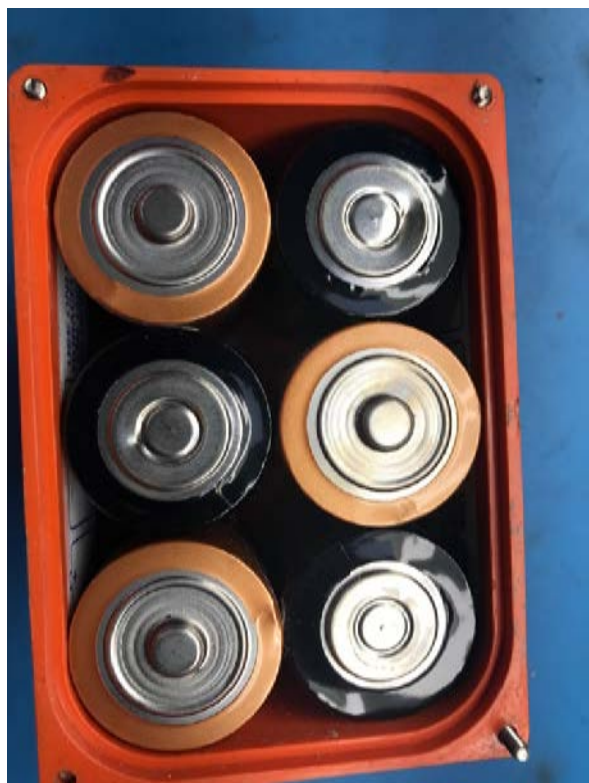
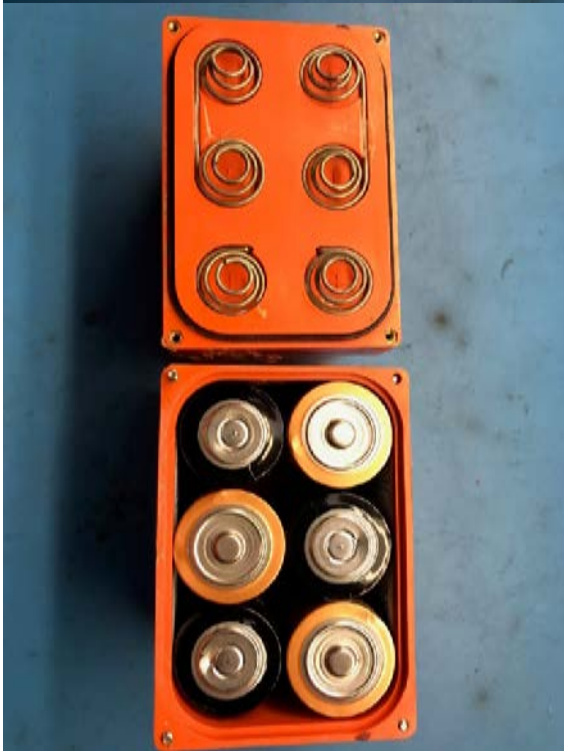
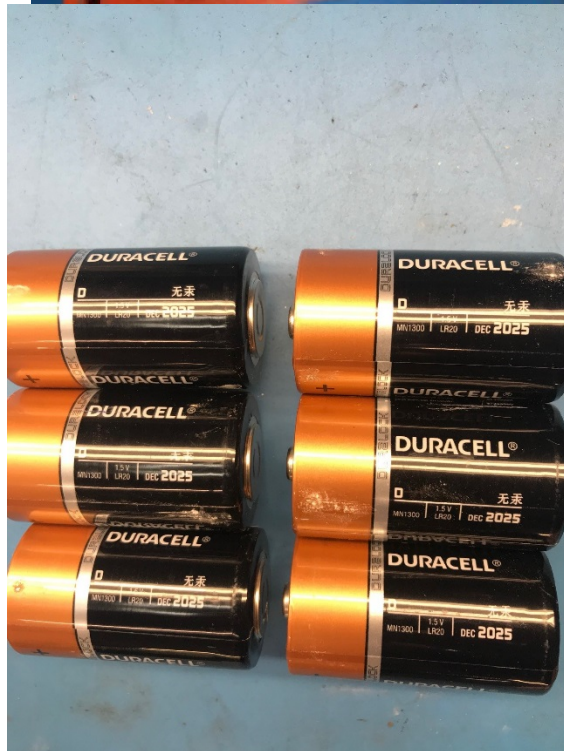
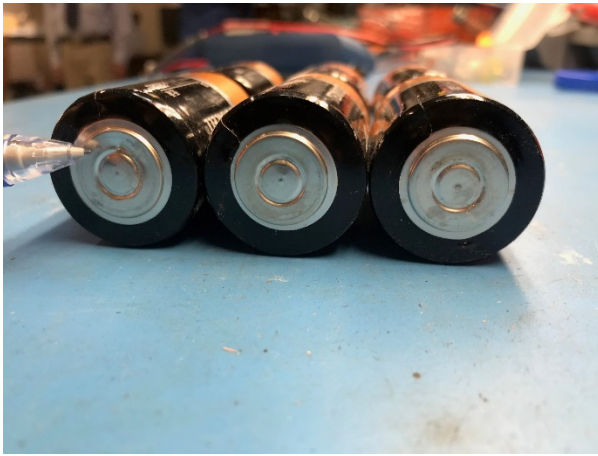
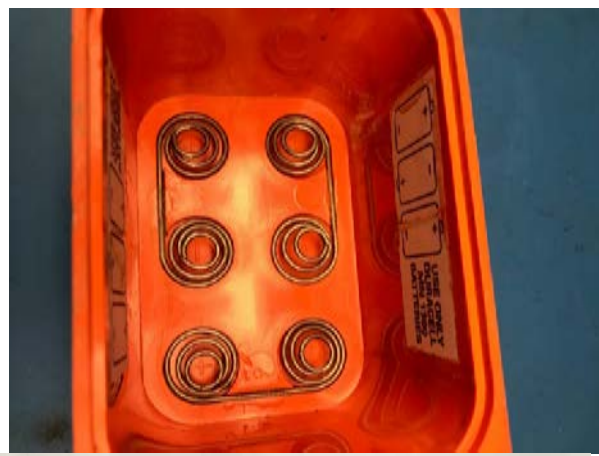
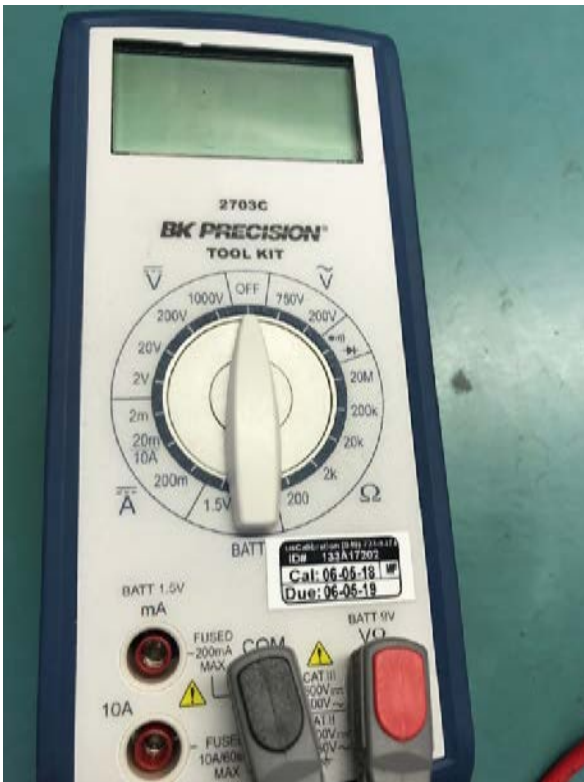
The battery pack on the unit was then opened up for an inspection of the batteries. The battery compartment appeared clean and dry. Some of the batteries had dents but not such that it affected their operation. The batteries were all Duracell “D” batteries with a stamped date of December 2025.

The voltage of each of the battery cells was measured at 1.36 volts, indicating some amount of discharge from the expected 1.5 volts.

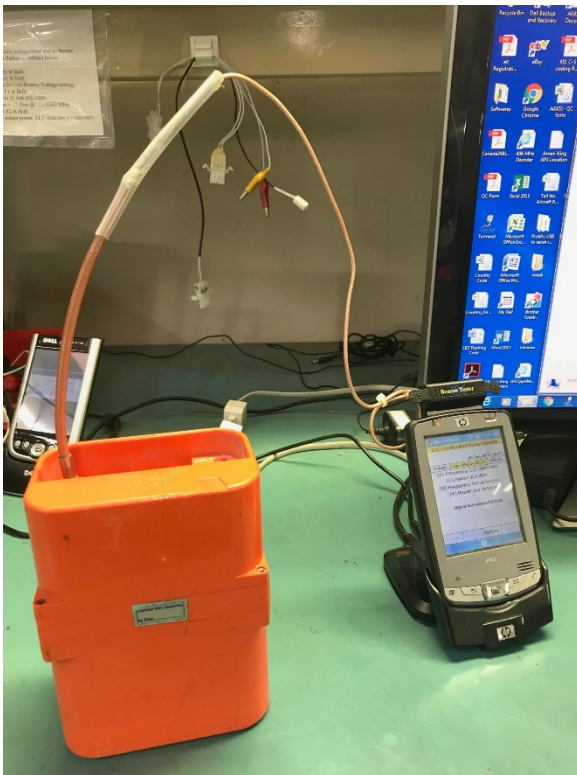
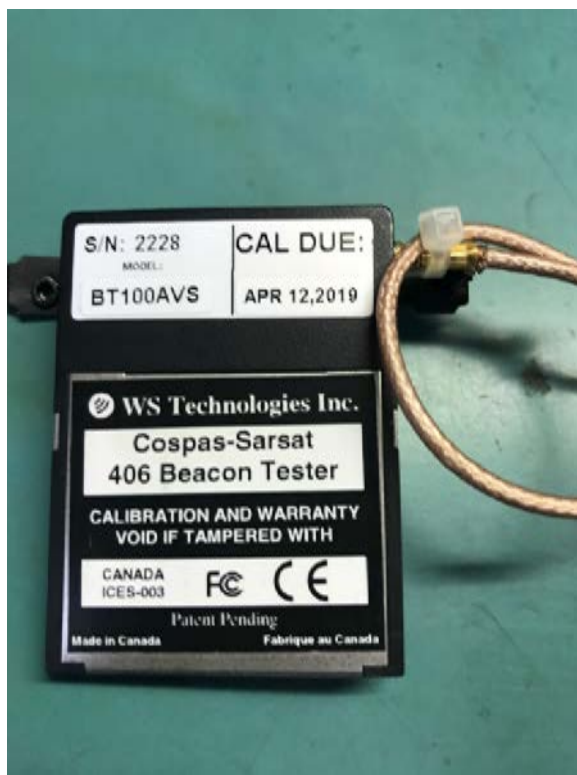
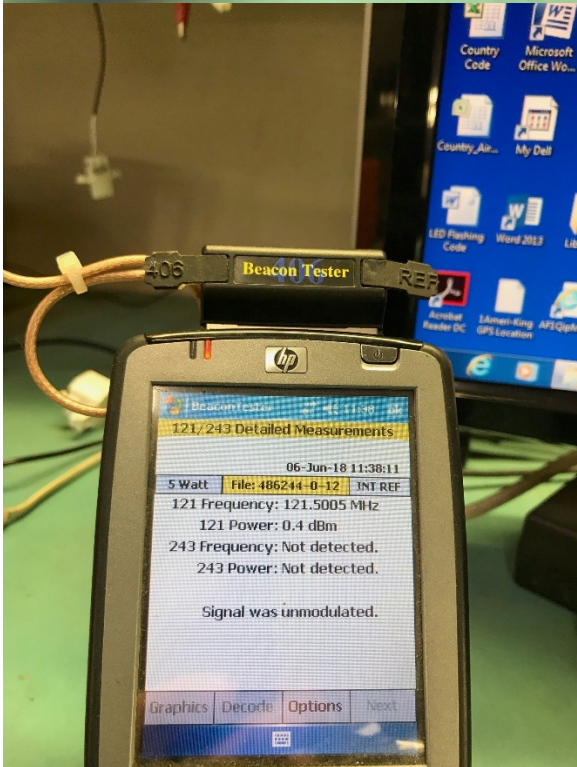
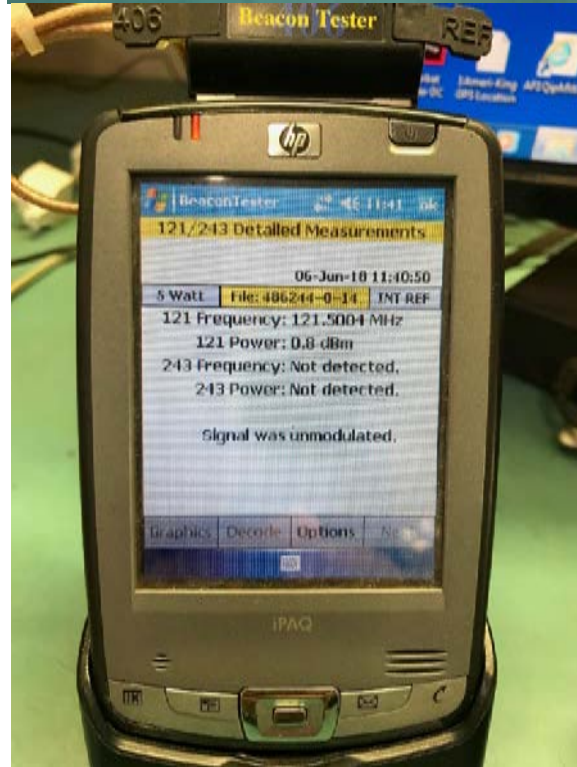
The battery pack was reinstalled and the G-Switch activation was tested. An abrupt and forceful shake was performed multiple times but the unit never activated. The manufacturer did not know why the G-Switch did not activate and did not have the capability to determine the cause. The same action was performed with a different unit on hand and it activated as expected. The unit was then tested using a spectrum analyzer attached to the antenna. The test software was executed on a HP PDA. Multiple runs were conducted. The power output varied from 0.4 dBm to 0.8 dBm with the expected to be 17.4 dBm.

3. Why didn't the unit activate when the G-switch was activated. The reason needs to be spelled out in the Memorandum  
[The manufacturer had no idea about why the unit did not activate, whether it was a defective G-switch or bad connection or something else and had no capability to determine the cause.](#)

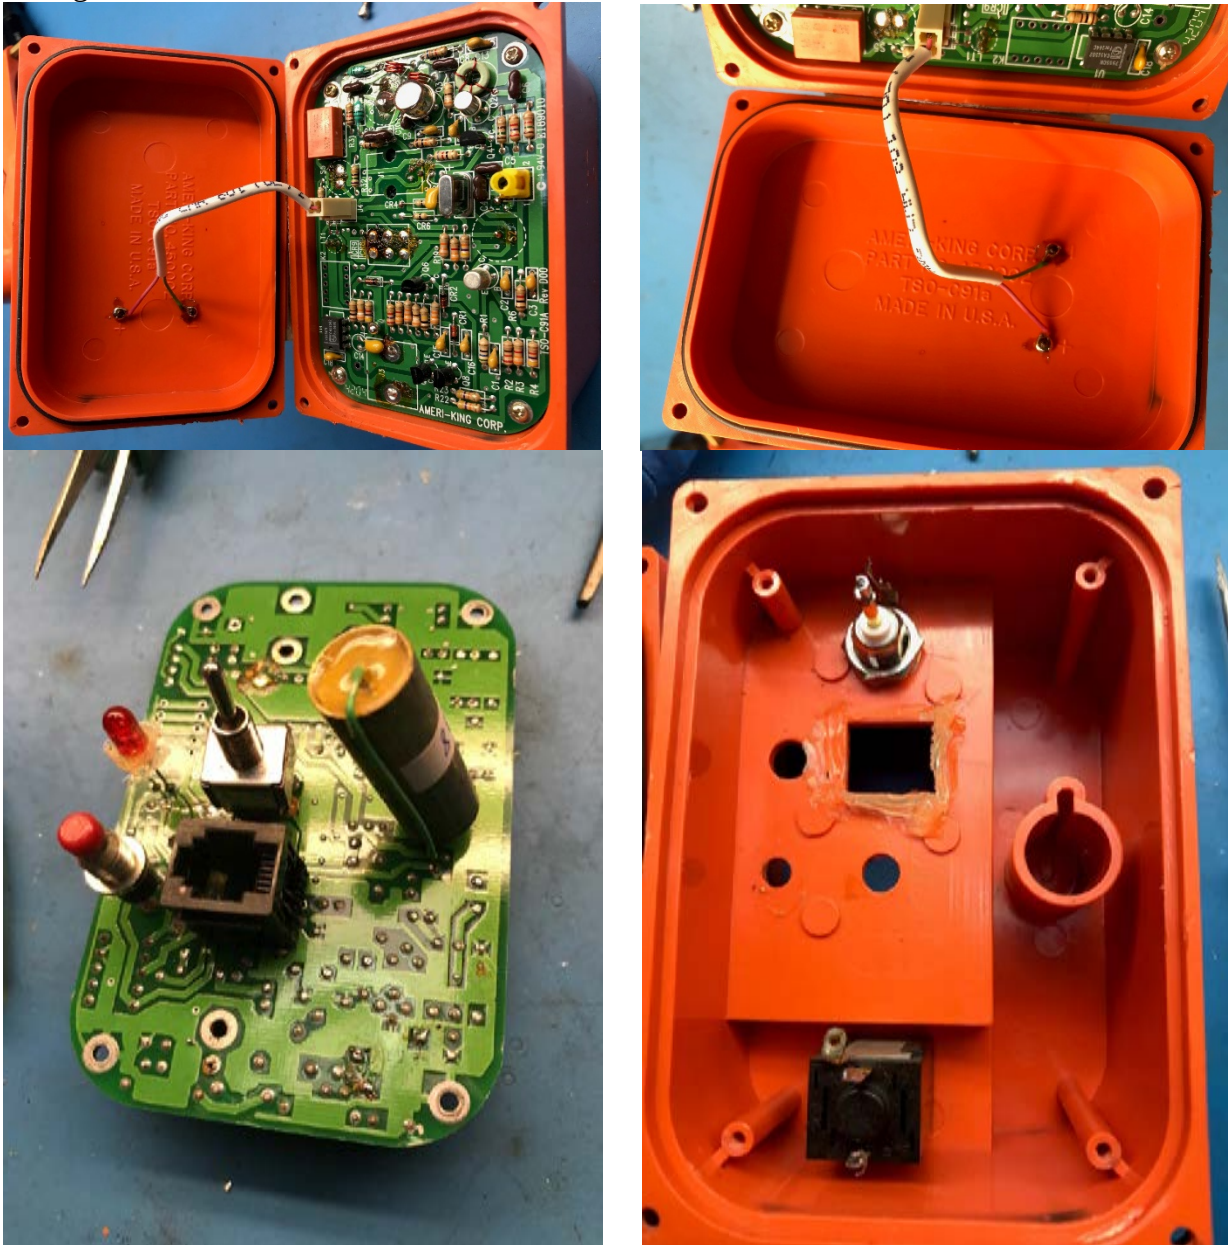
Next, the unit was disassembled and the circuit card was removed. No visible obvious damage was observed on the circuit card and all electronic components appeared to be adequately secured on its board. The wires on the connection to the battery pack did not look like the solder was well bonded to the pins for the battery connectors but a continuity test was performed from the circuit board connection to the battery pack side and it was a very good low resistance connection (0.001 ohm).

The plastic casing securing the circuit board appeared to be clean and dry with no obvious signs of damage.

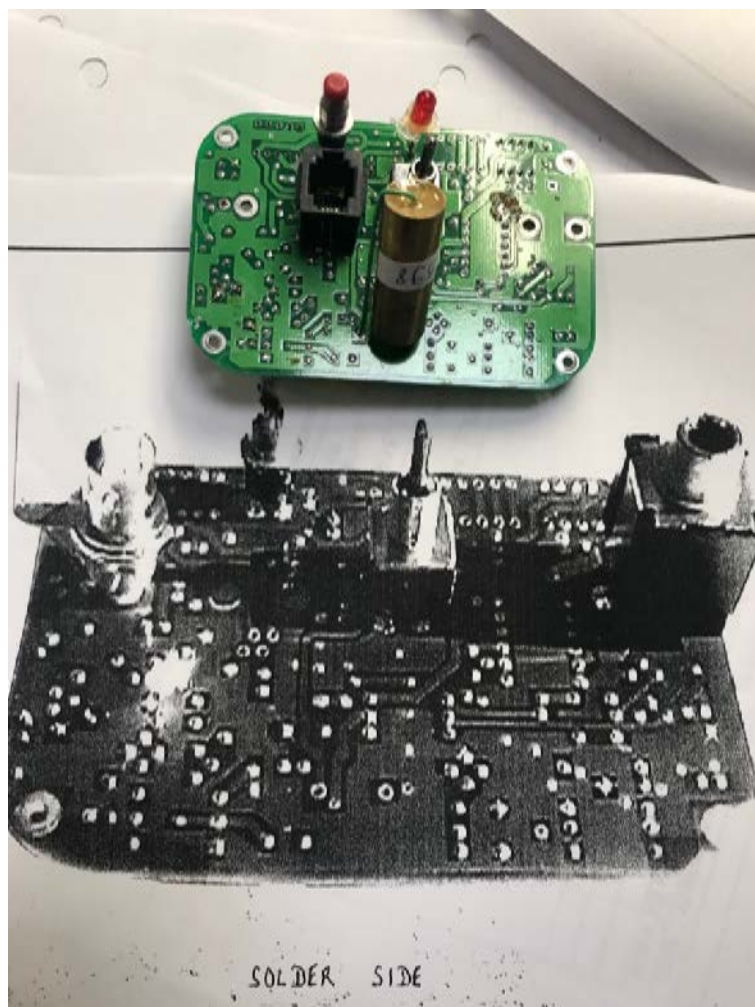
It was noted that the circuit board did not match the photo with the approved drawings indicating it was not the approved design.

5. On Page 12 it indicates that the circuit board did not match the photo with the approved drawings. Was it an unapproved part?  
[The circuit board did not match the approved drawing so as it was observed it was not approved.](#)

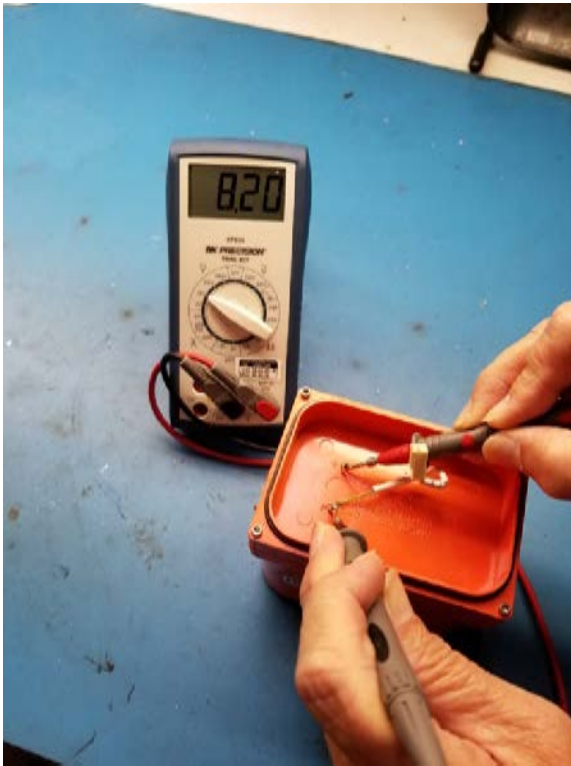
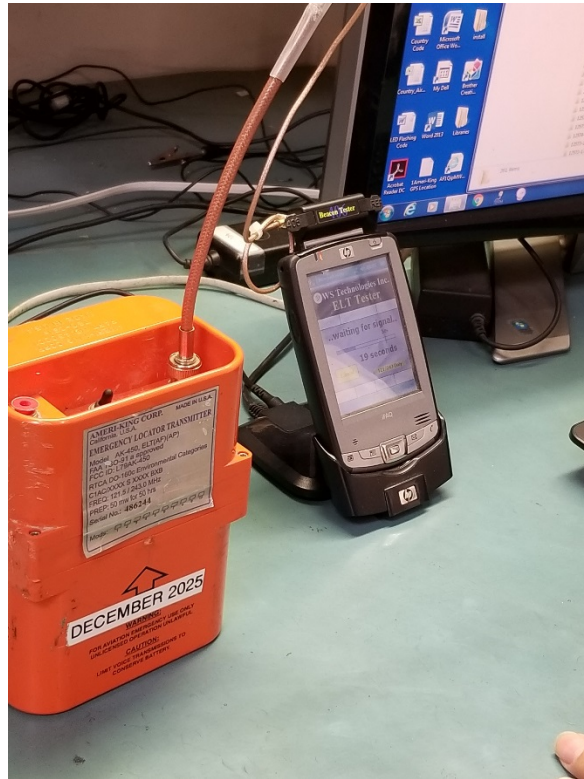
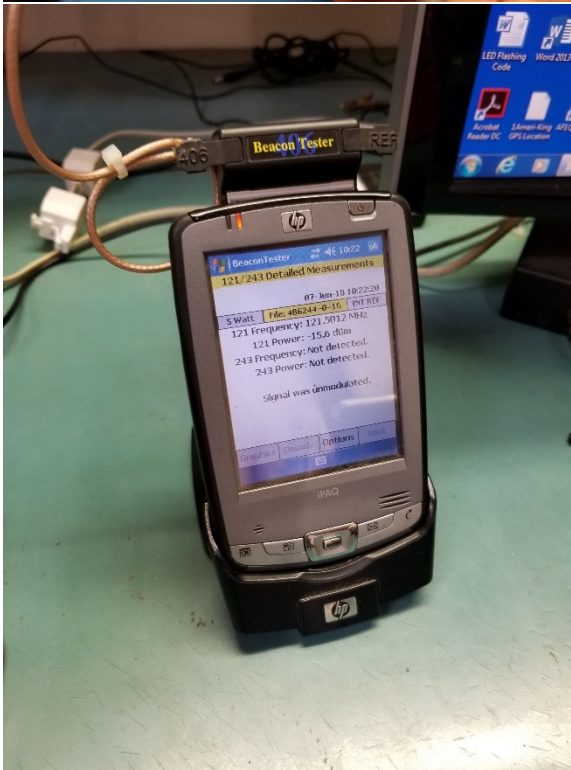
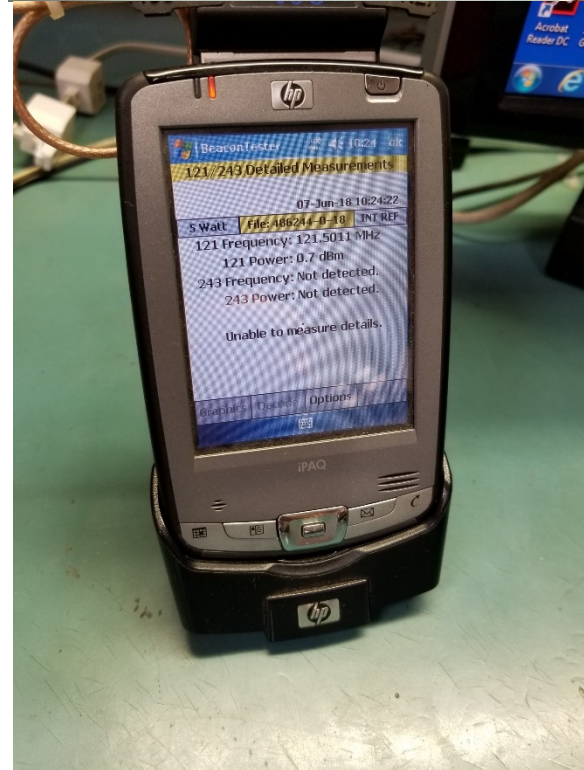
We returned the following day at 10am. The voltage of the battery pack as a unit was measured at 8.20 volts. The batteries were replaced with new batteries and the battery pack was reinstalled. The unit was activated using the on position on the on/off/arm switch on the ELT again with the test unit connected to the BNC antenna connection on the ELT. When the ELT was activated using the on position on the on/off/arm switch on the ELT, the automated test run via a Dell Axim X-50 Personal Digital Assistant (PDA) failed to detect any signal until Mr. Van wiggled / tightened the antenna connector to the BNC connector on the ELT until a signal was detected. There are no known recorded issues of a design or manufacturing defect that would be related to the loose antenna connection. This may have been because of the reassembly and re-soldering of the connector after the teardown the day before as this was not an issue during the prior testing. The measured power level was almost non-existent this time at -15.6dbm. We repeated the test and the antenna connector again had to be wiggled to get a signal, resulted in a power level similar to what we had seen the day before at 0.7 dbm. We noticed on the Bearcat receiver that we could hear a very slight tone that faded a lot after initial activation. We turned the volume up to a high level and were able

to hear the tone. The silence on the receiver we heard the day before may have been that the unit was transmitting the tone but the receiver was not turned up to a sufficient level to hear. The original batteries were reinstalled in the unit and the testing was concluded and the unit was re-packaged.
