**Photo 1 – NTSB Photograph Depicting the Initial Impact Site Location and Energy Path Direction**

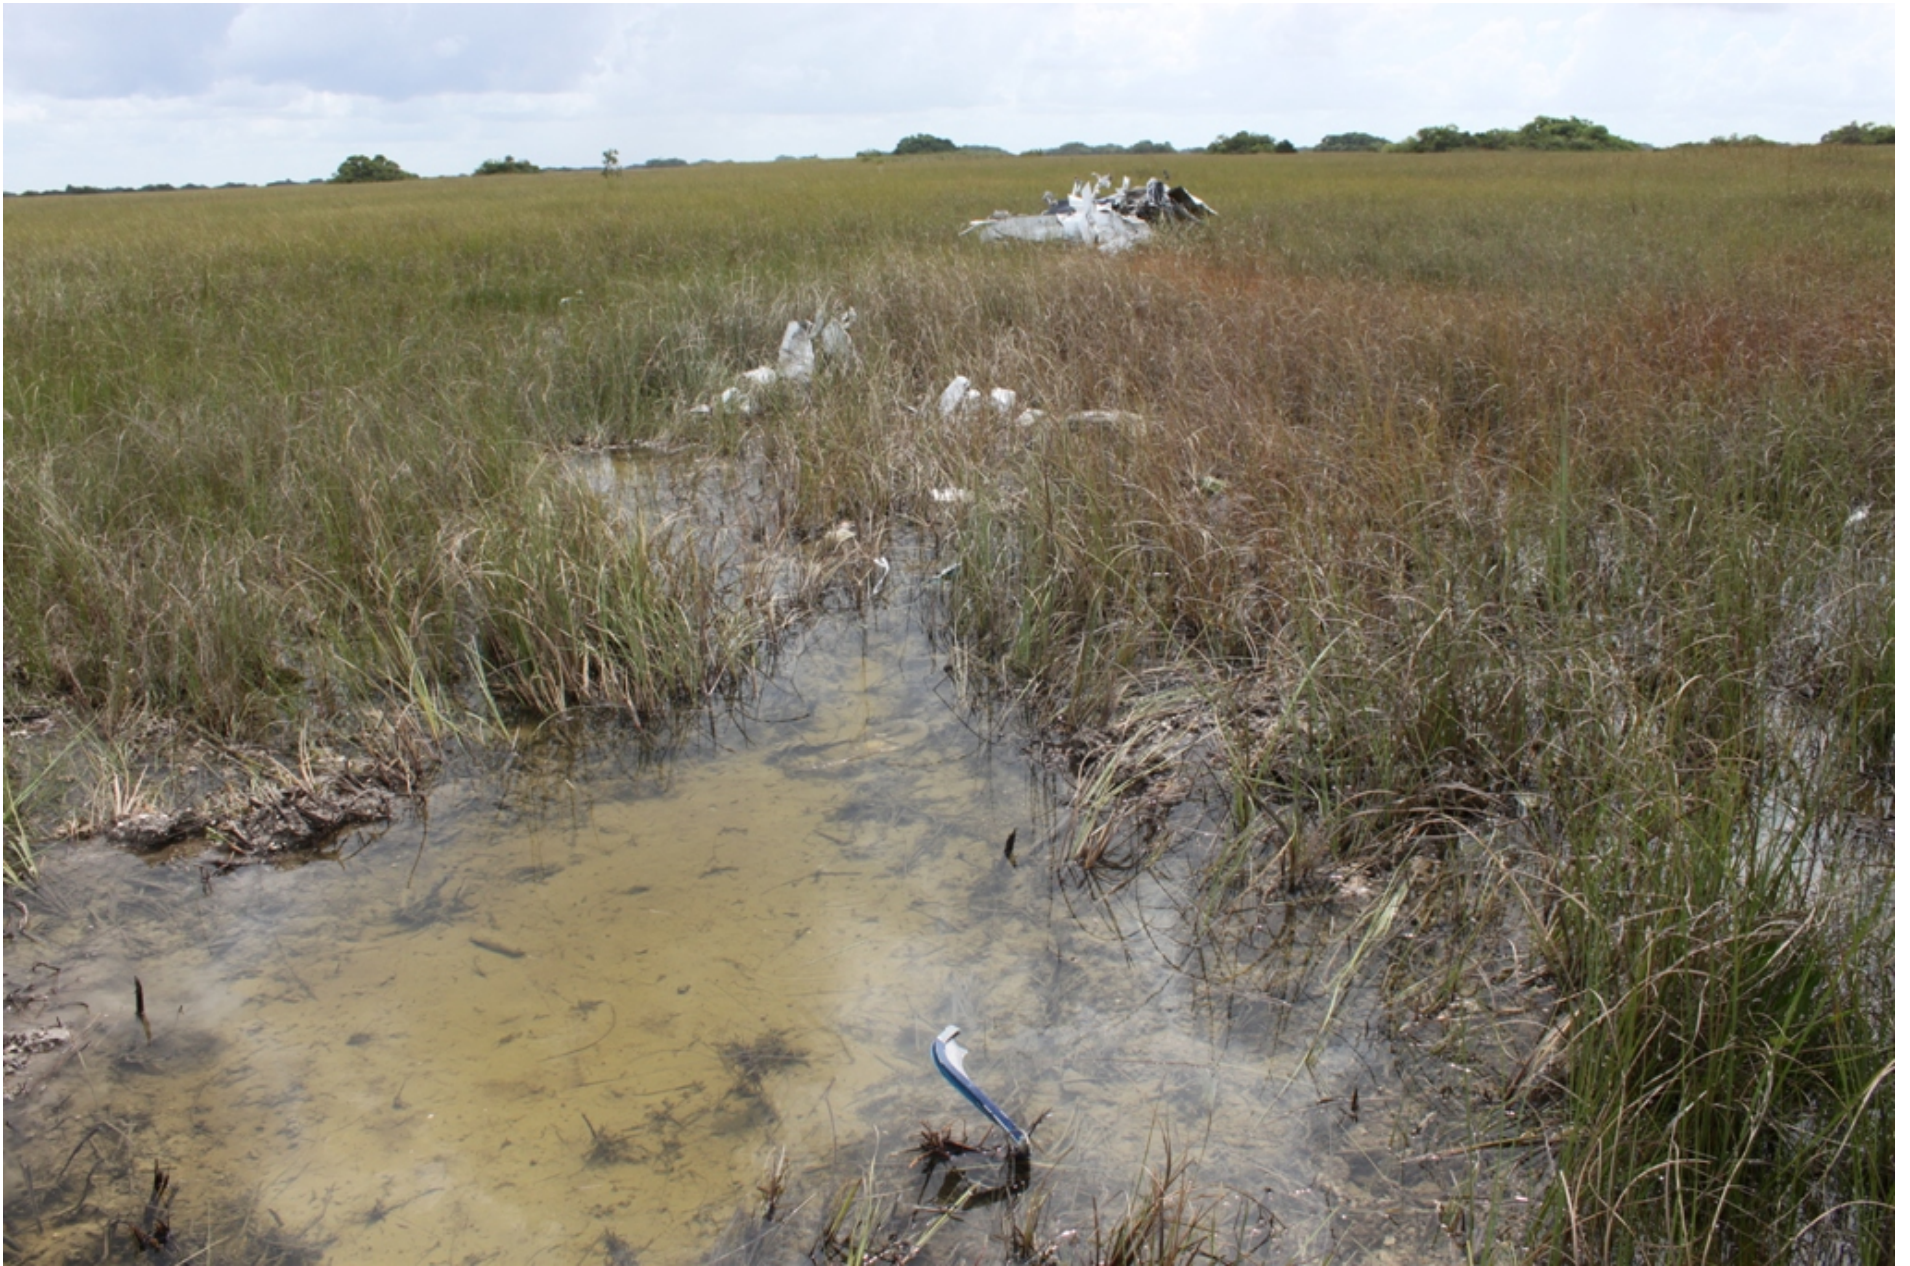
**Photo 2 - NTSB Photograph Depicting The Initial Impact Site and the Wreckage in the Background.**

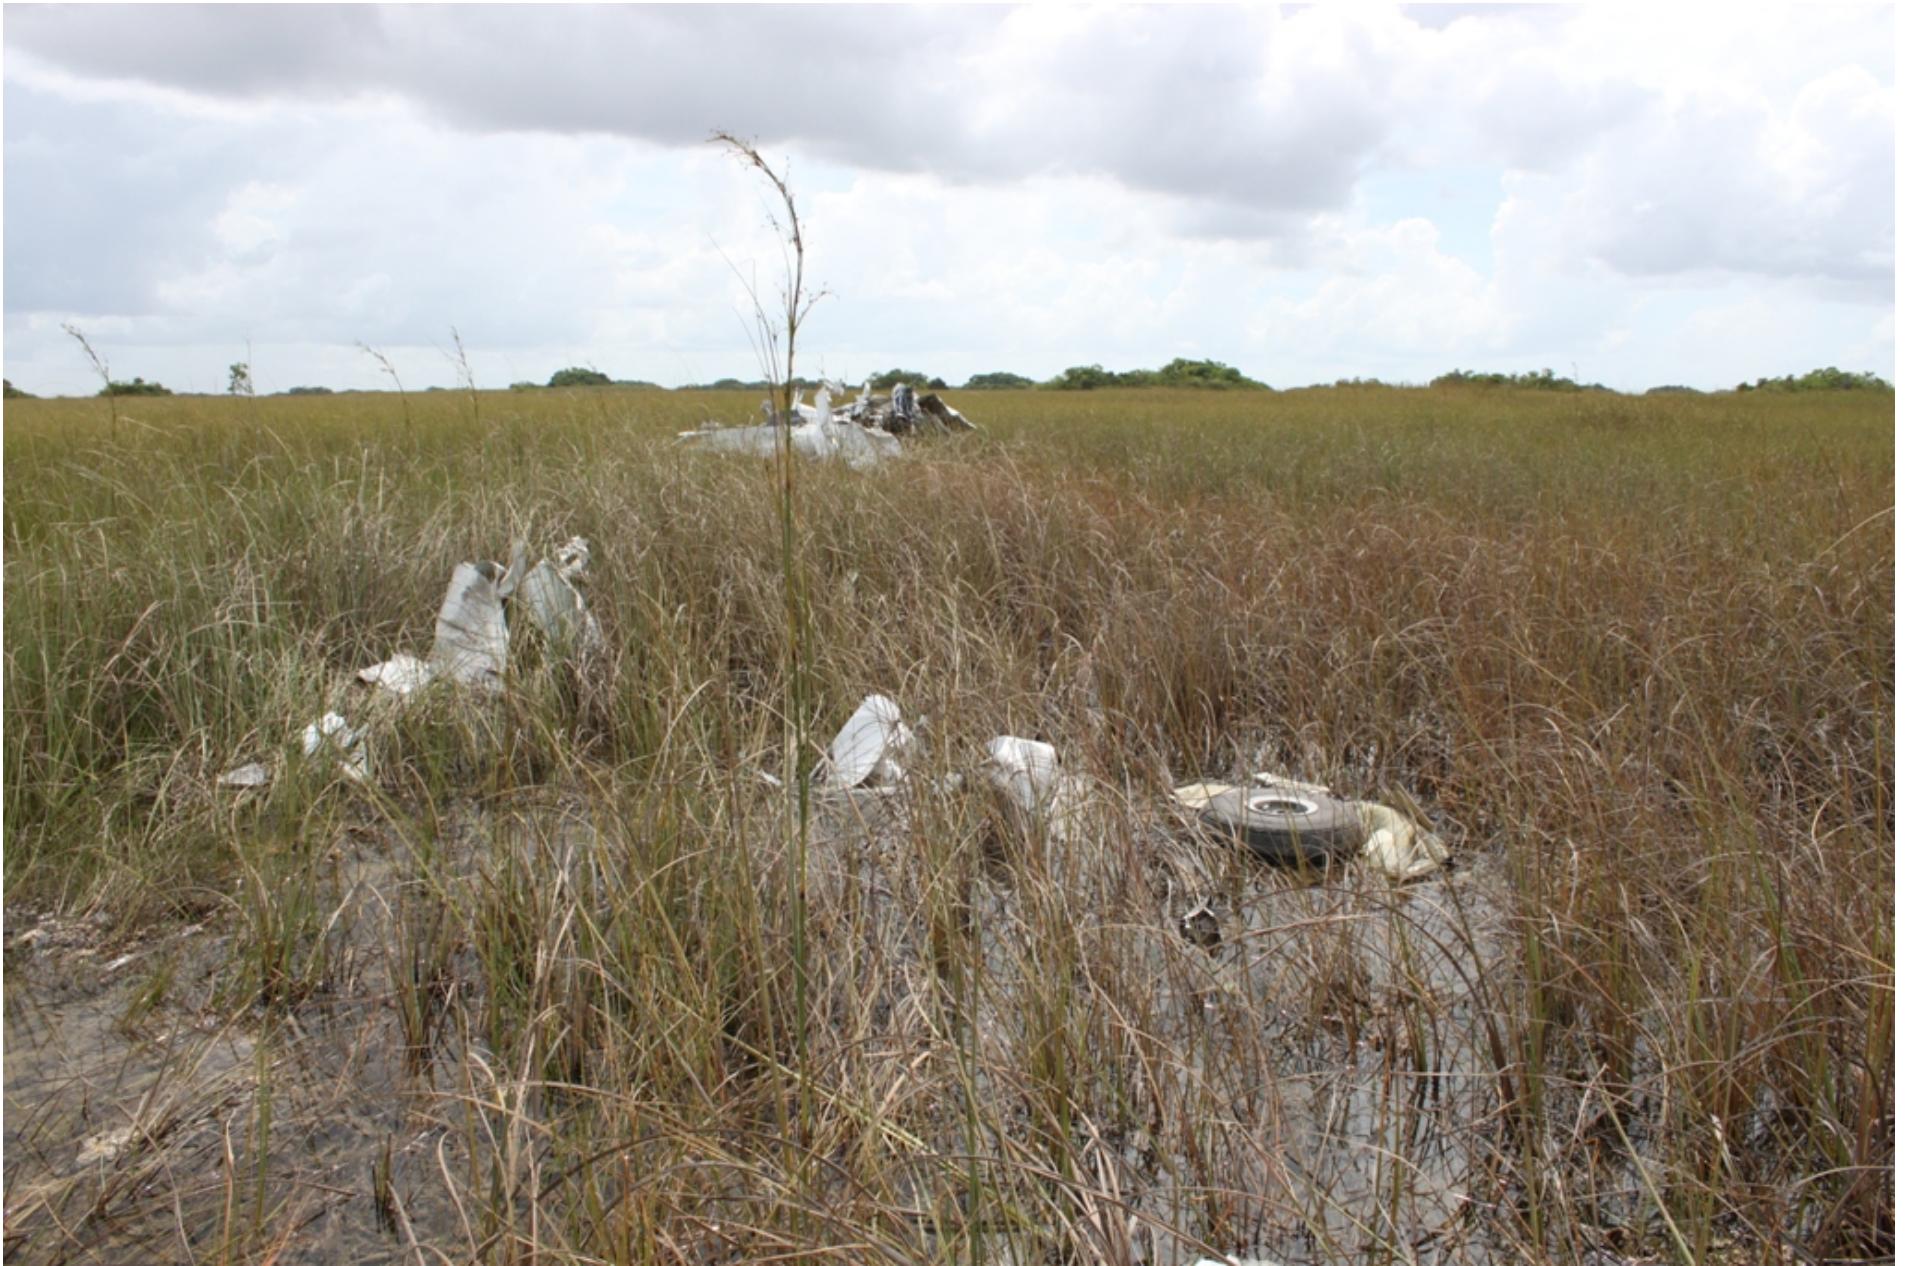
**Photo 3 - NTSB Photograph Depicting Debris Between the Initial Impact Site and Wreckage.**

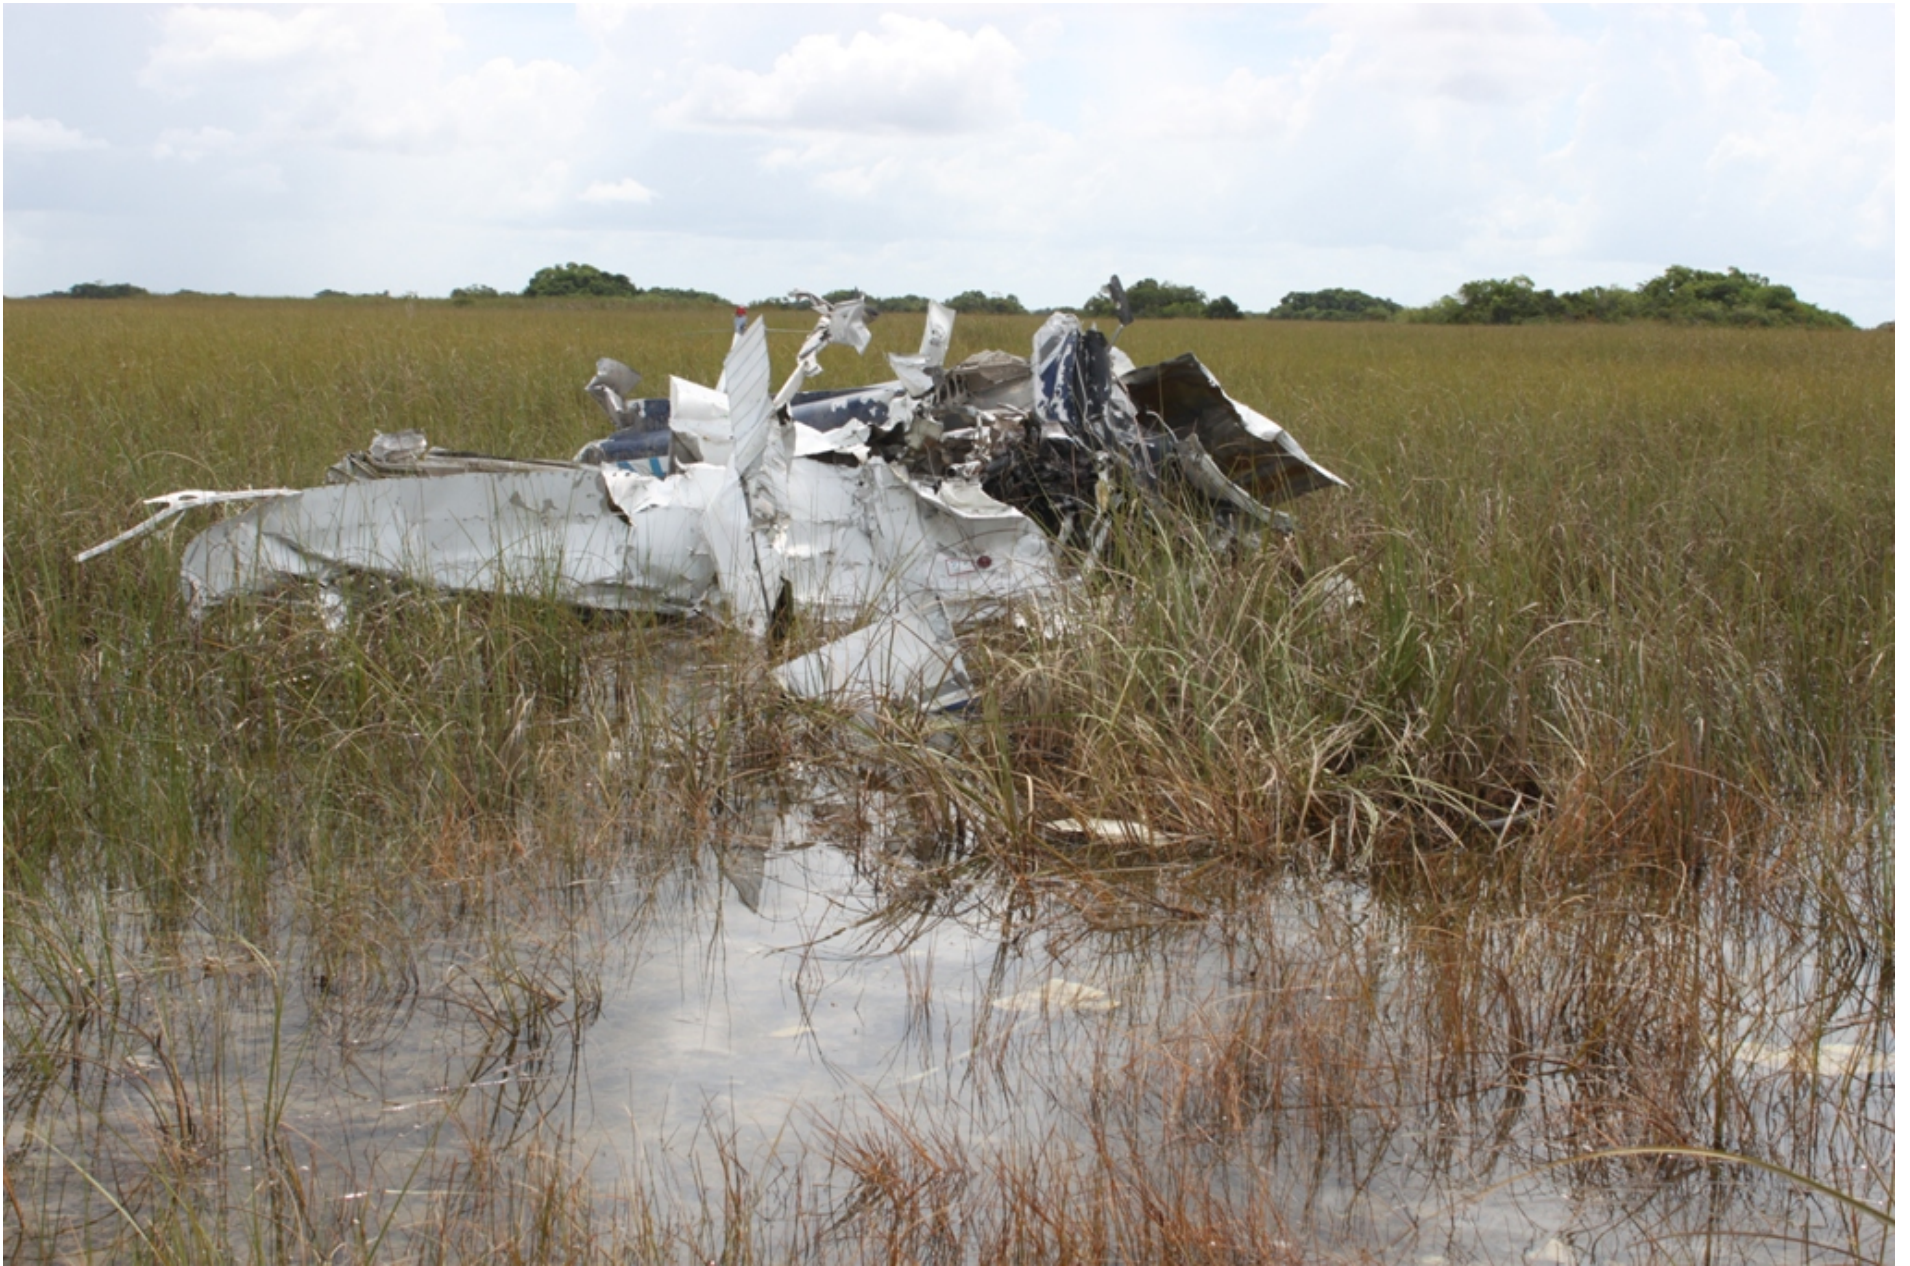
**Photo 4 - NTSB Photograph Depicting Main Wreckage.**

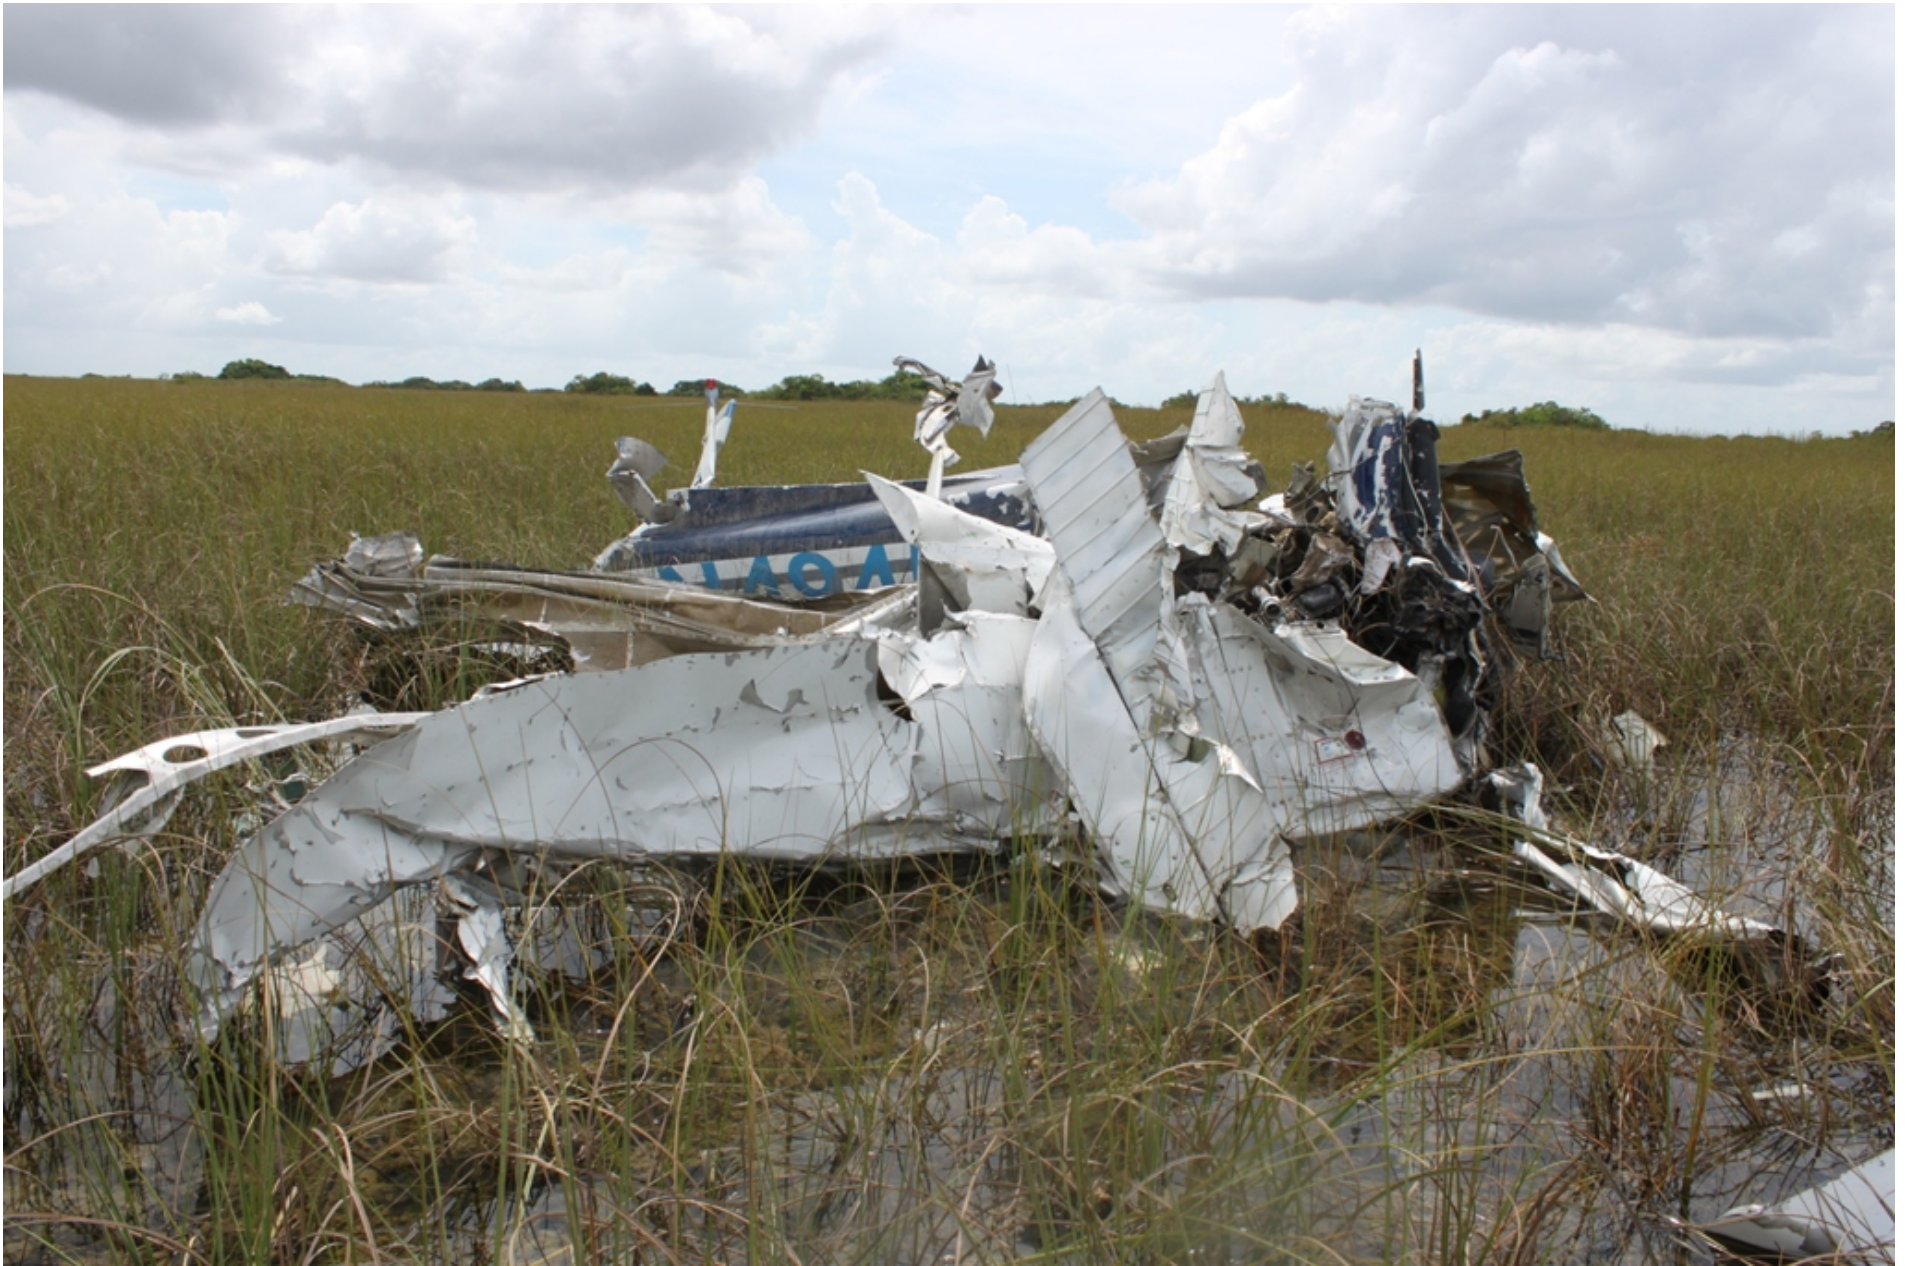
**Photo 5 - NTSB Photograph Depicting Closer View of the Wreckage at the Accident Site. Note the extensive damage to the Right Wing, Cockpit, and Fuselage.**

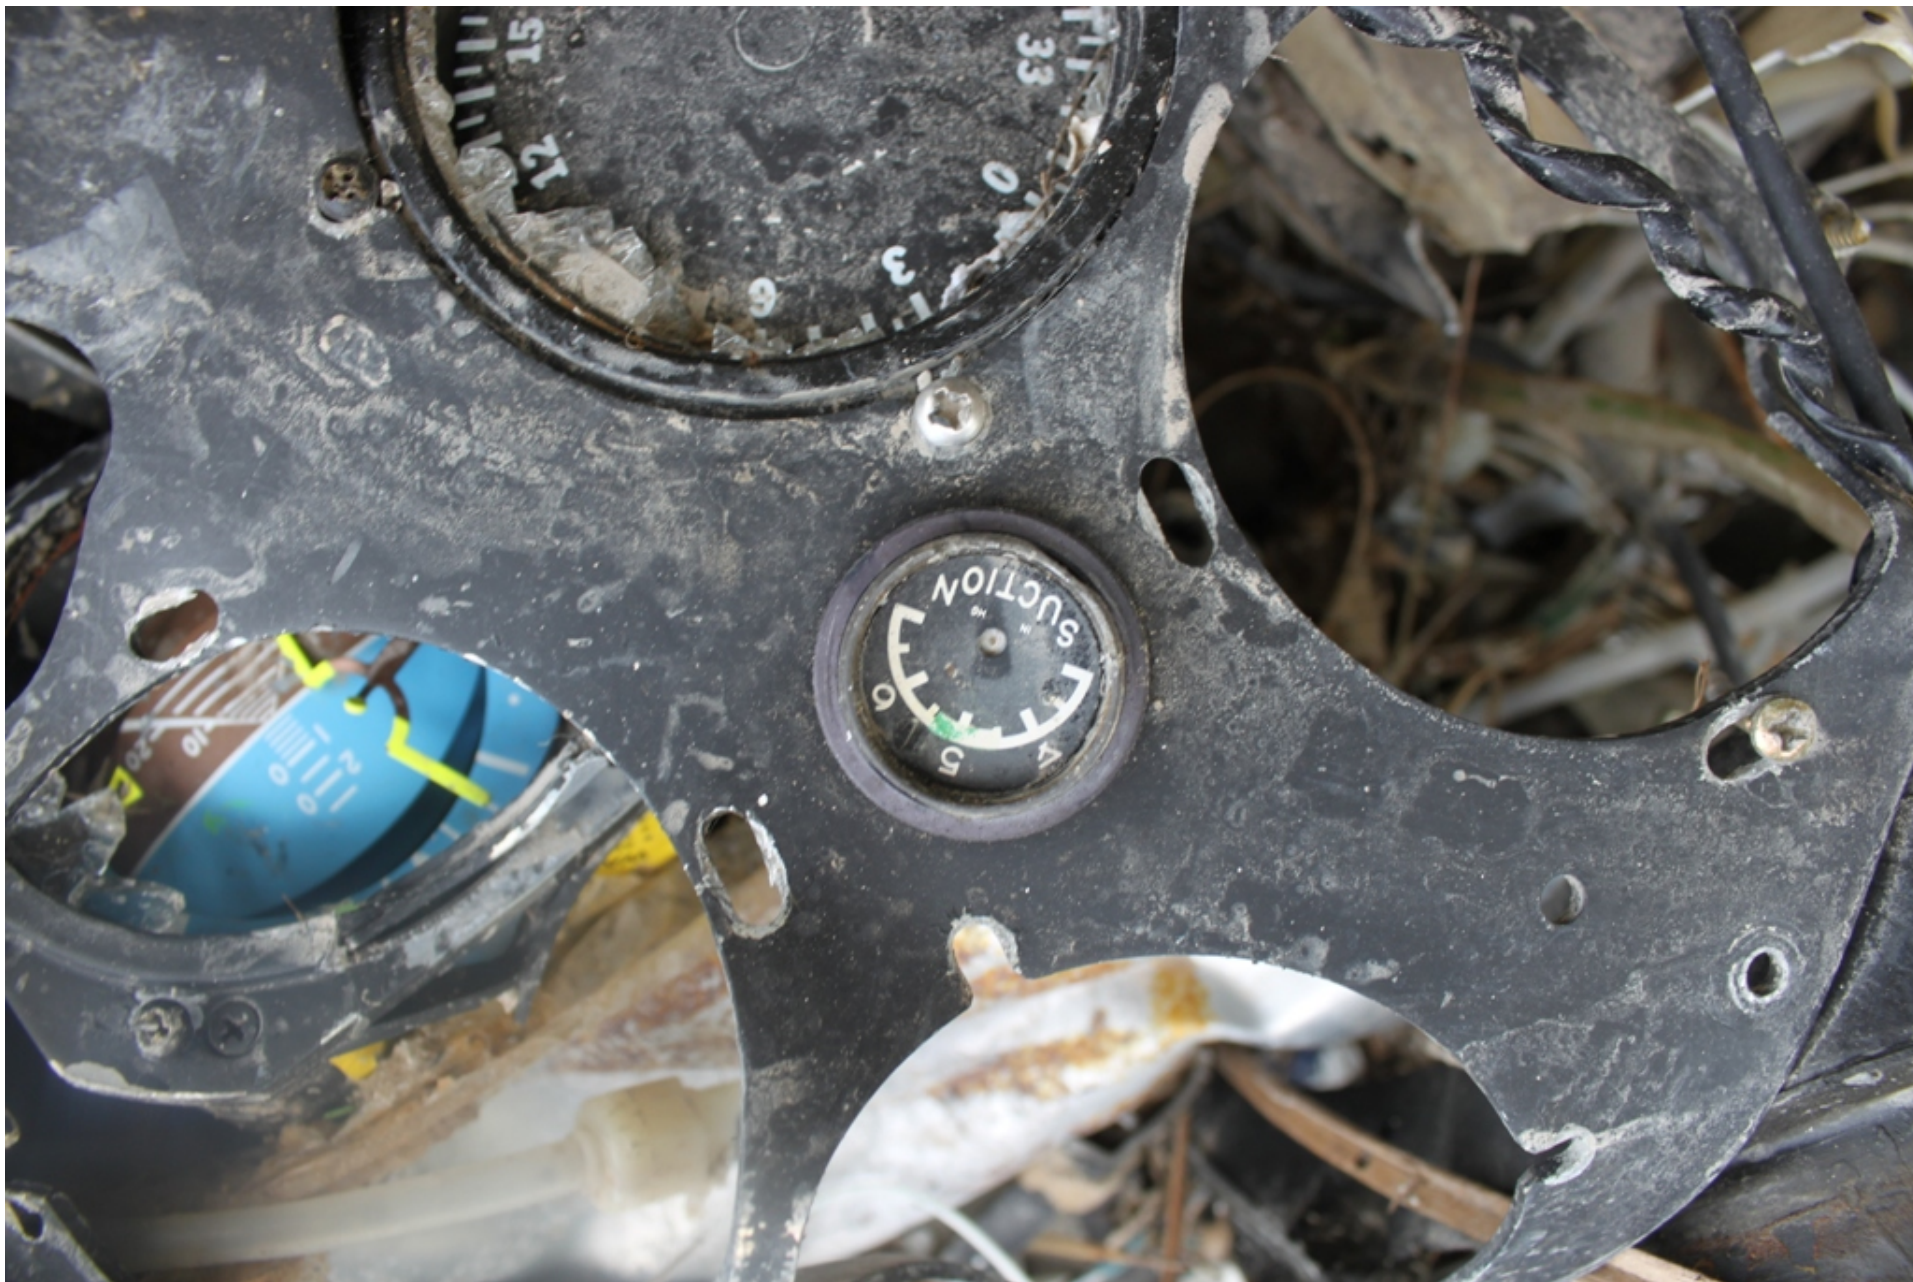
**Photo 6 - NTSB Photograph Depicting a Section of the Instrument Panel Containing the Suction Gauge, Separated Attitude Indicator, and Portion of Directional Gyro.**

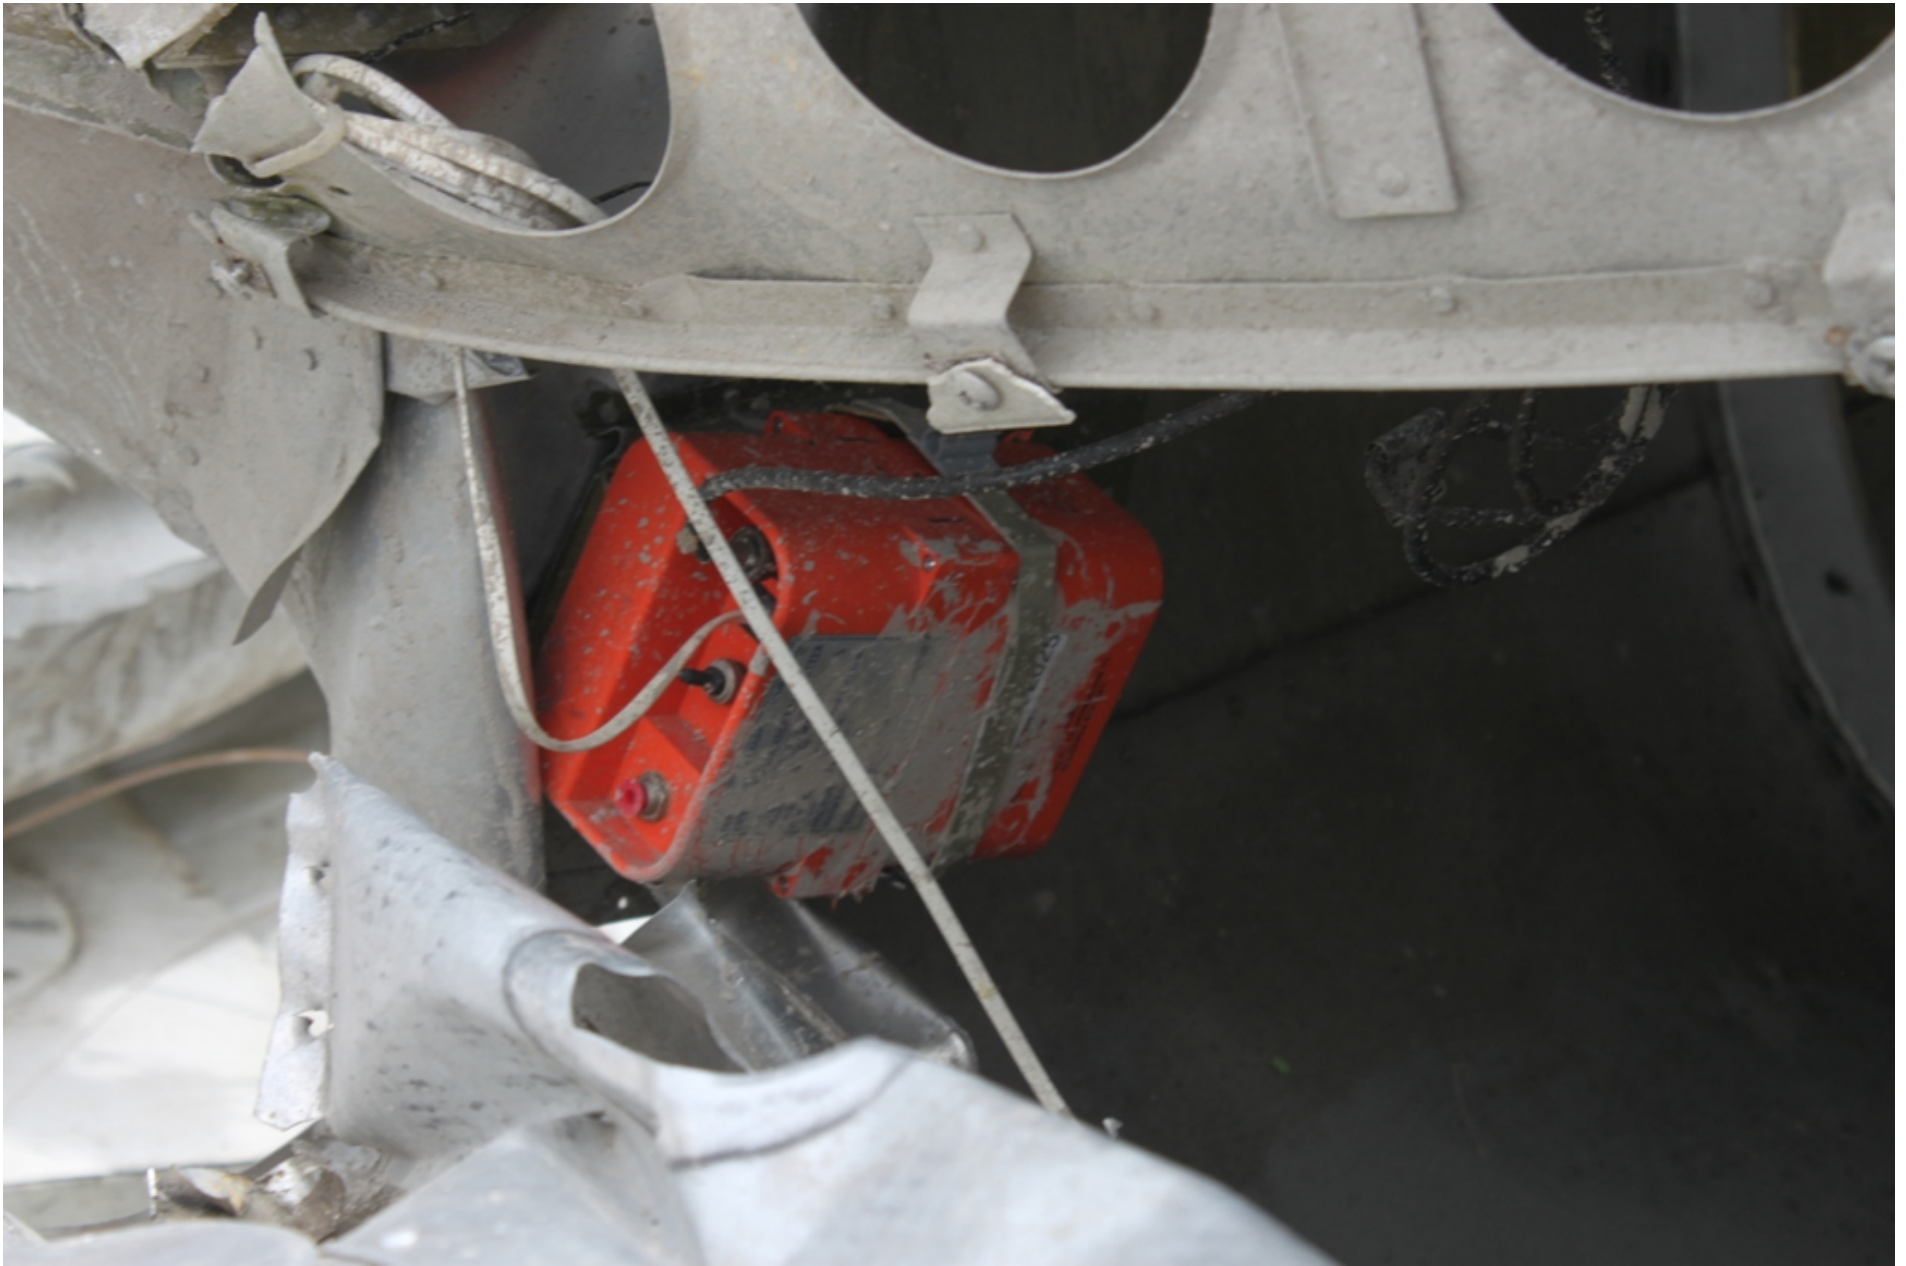
**Photo 7 - NTSB Photograph Depicting the Emergency Locator Transmitter (ELT) as First Viewed. Note the ELT is Partially Out of Its Bracket.**

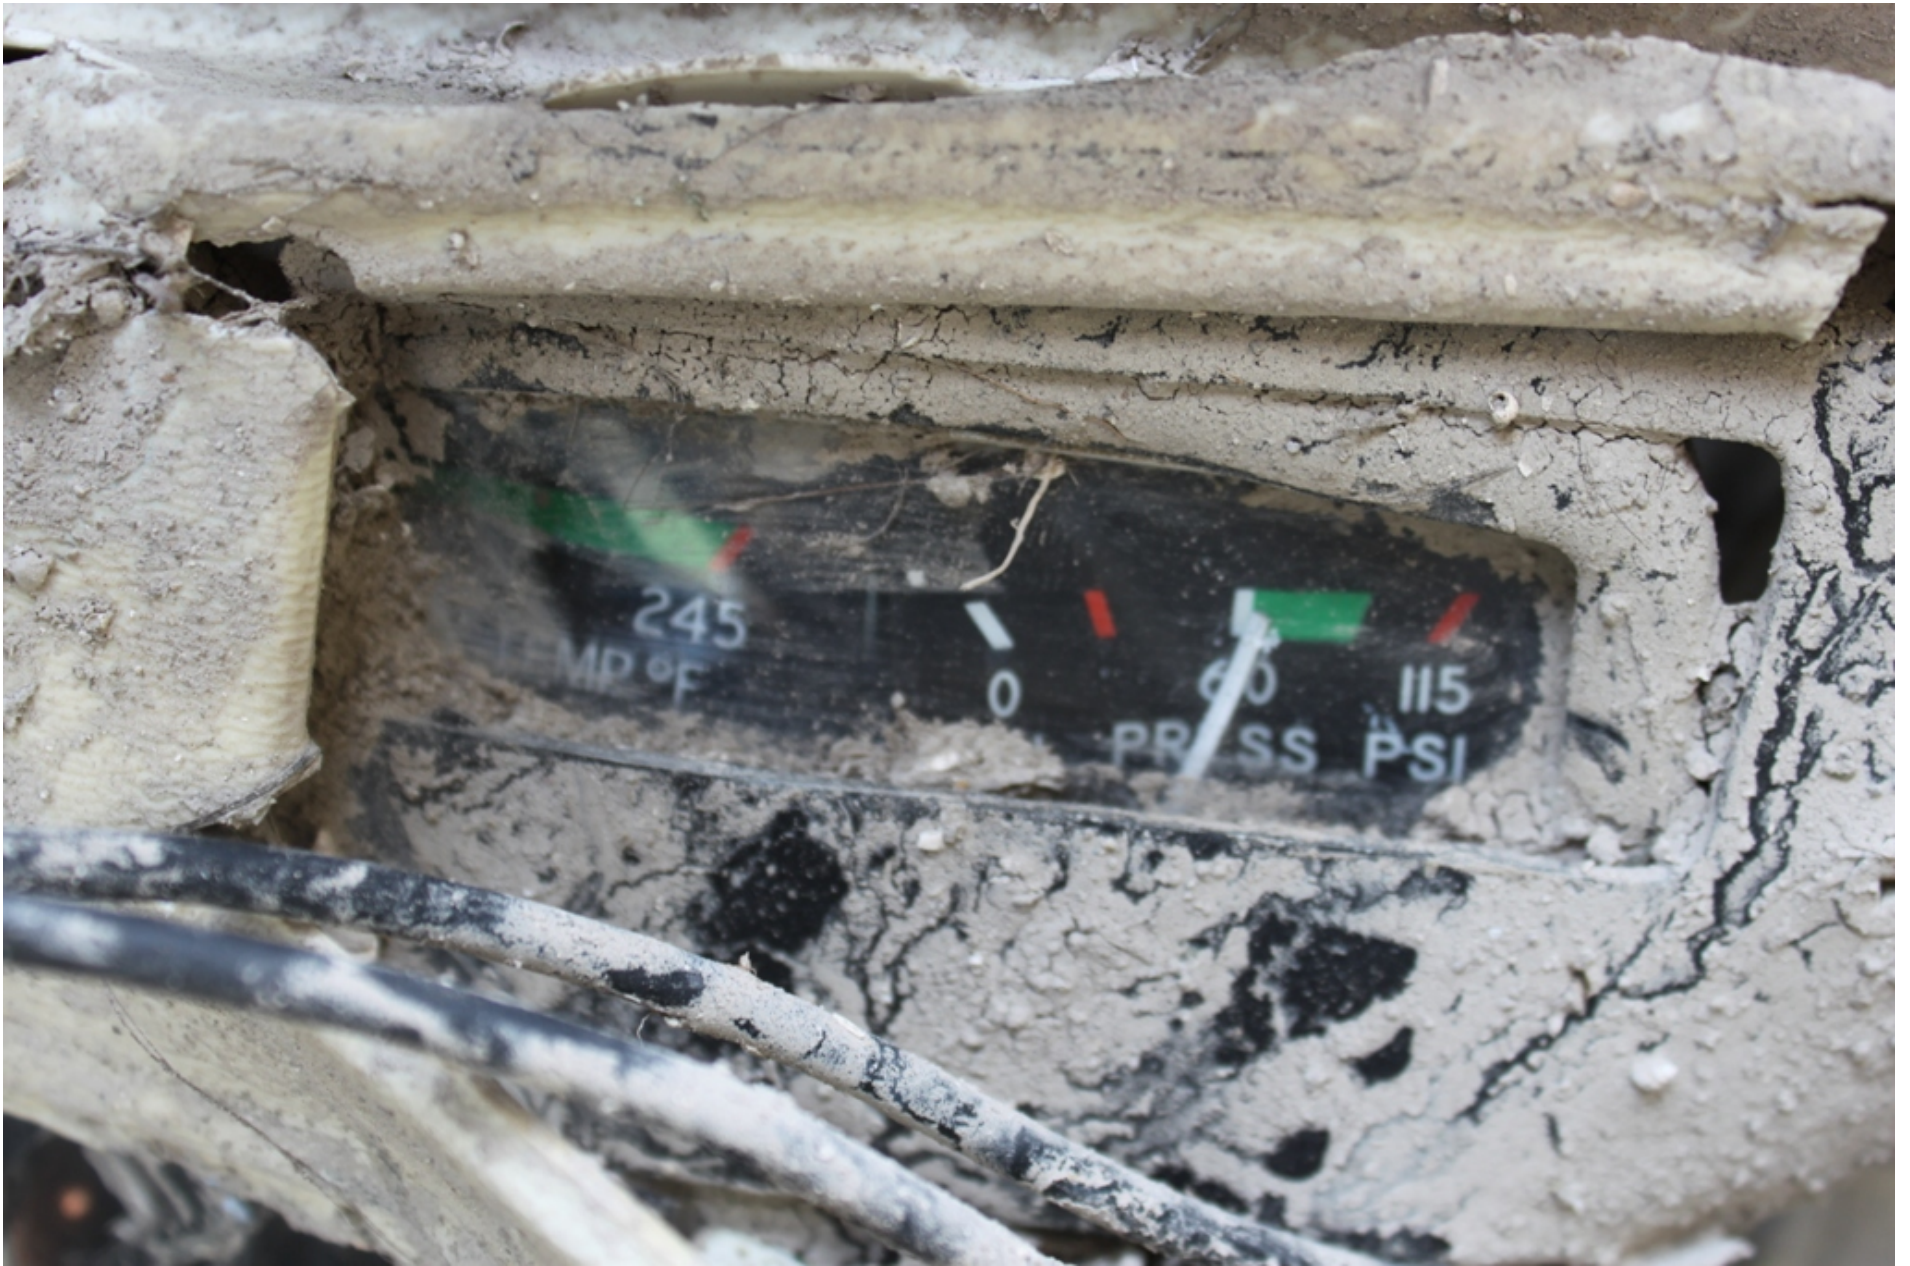
**Photo 8 - NTSB Photograph Depicting the Engine Instruments.**

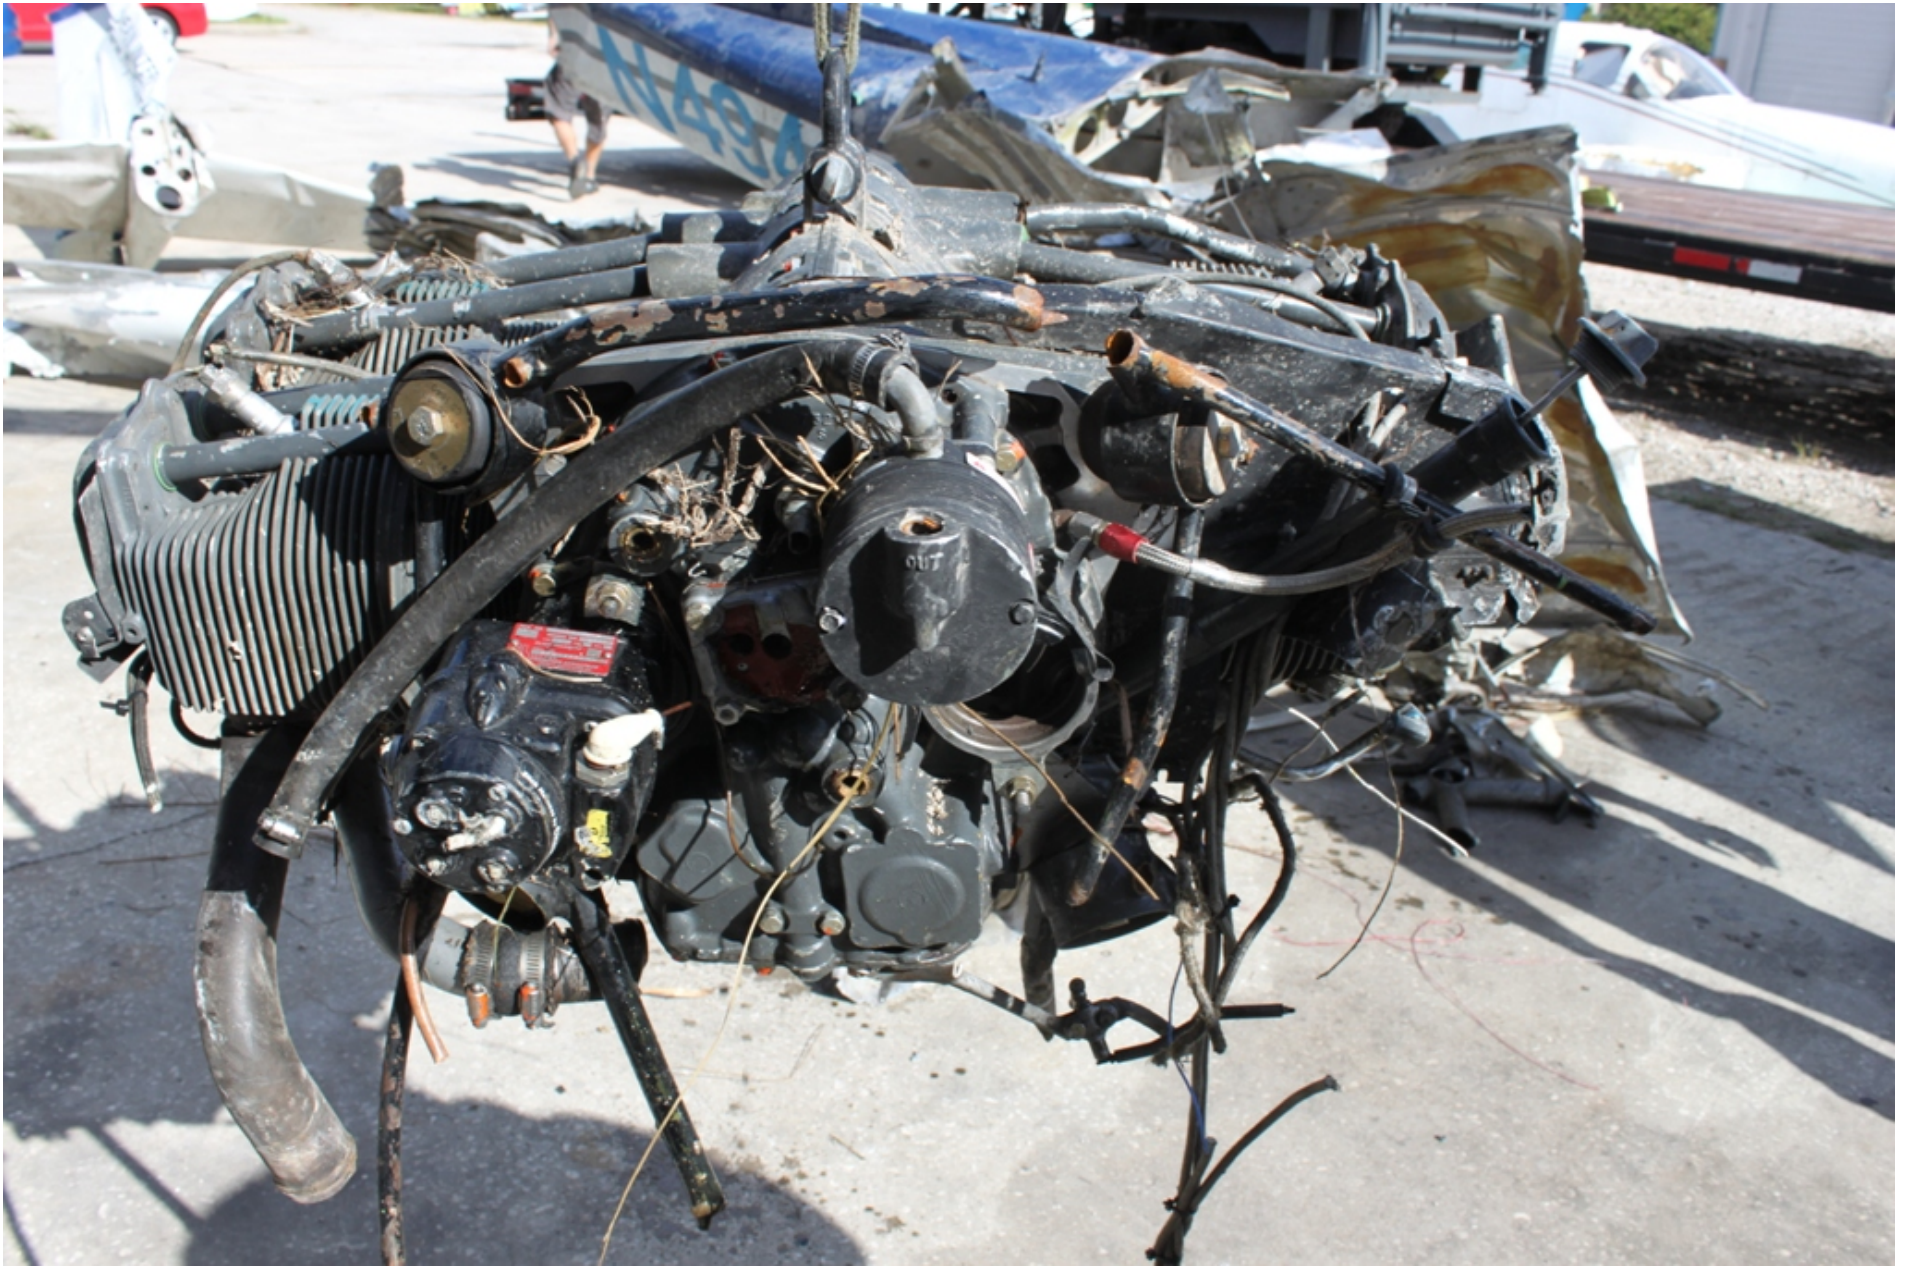
**Photo 9 - NTSB Photograph Depicting the Rear Side of the Engine Assembly, and View of the attached Engine-Driven Vacuum Pump.**

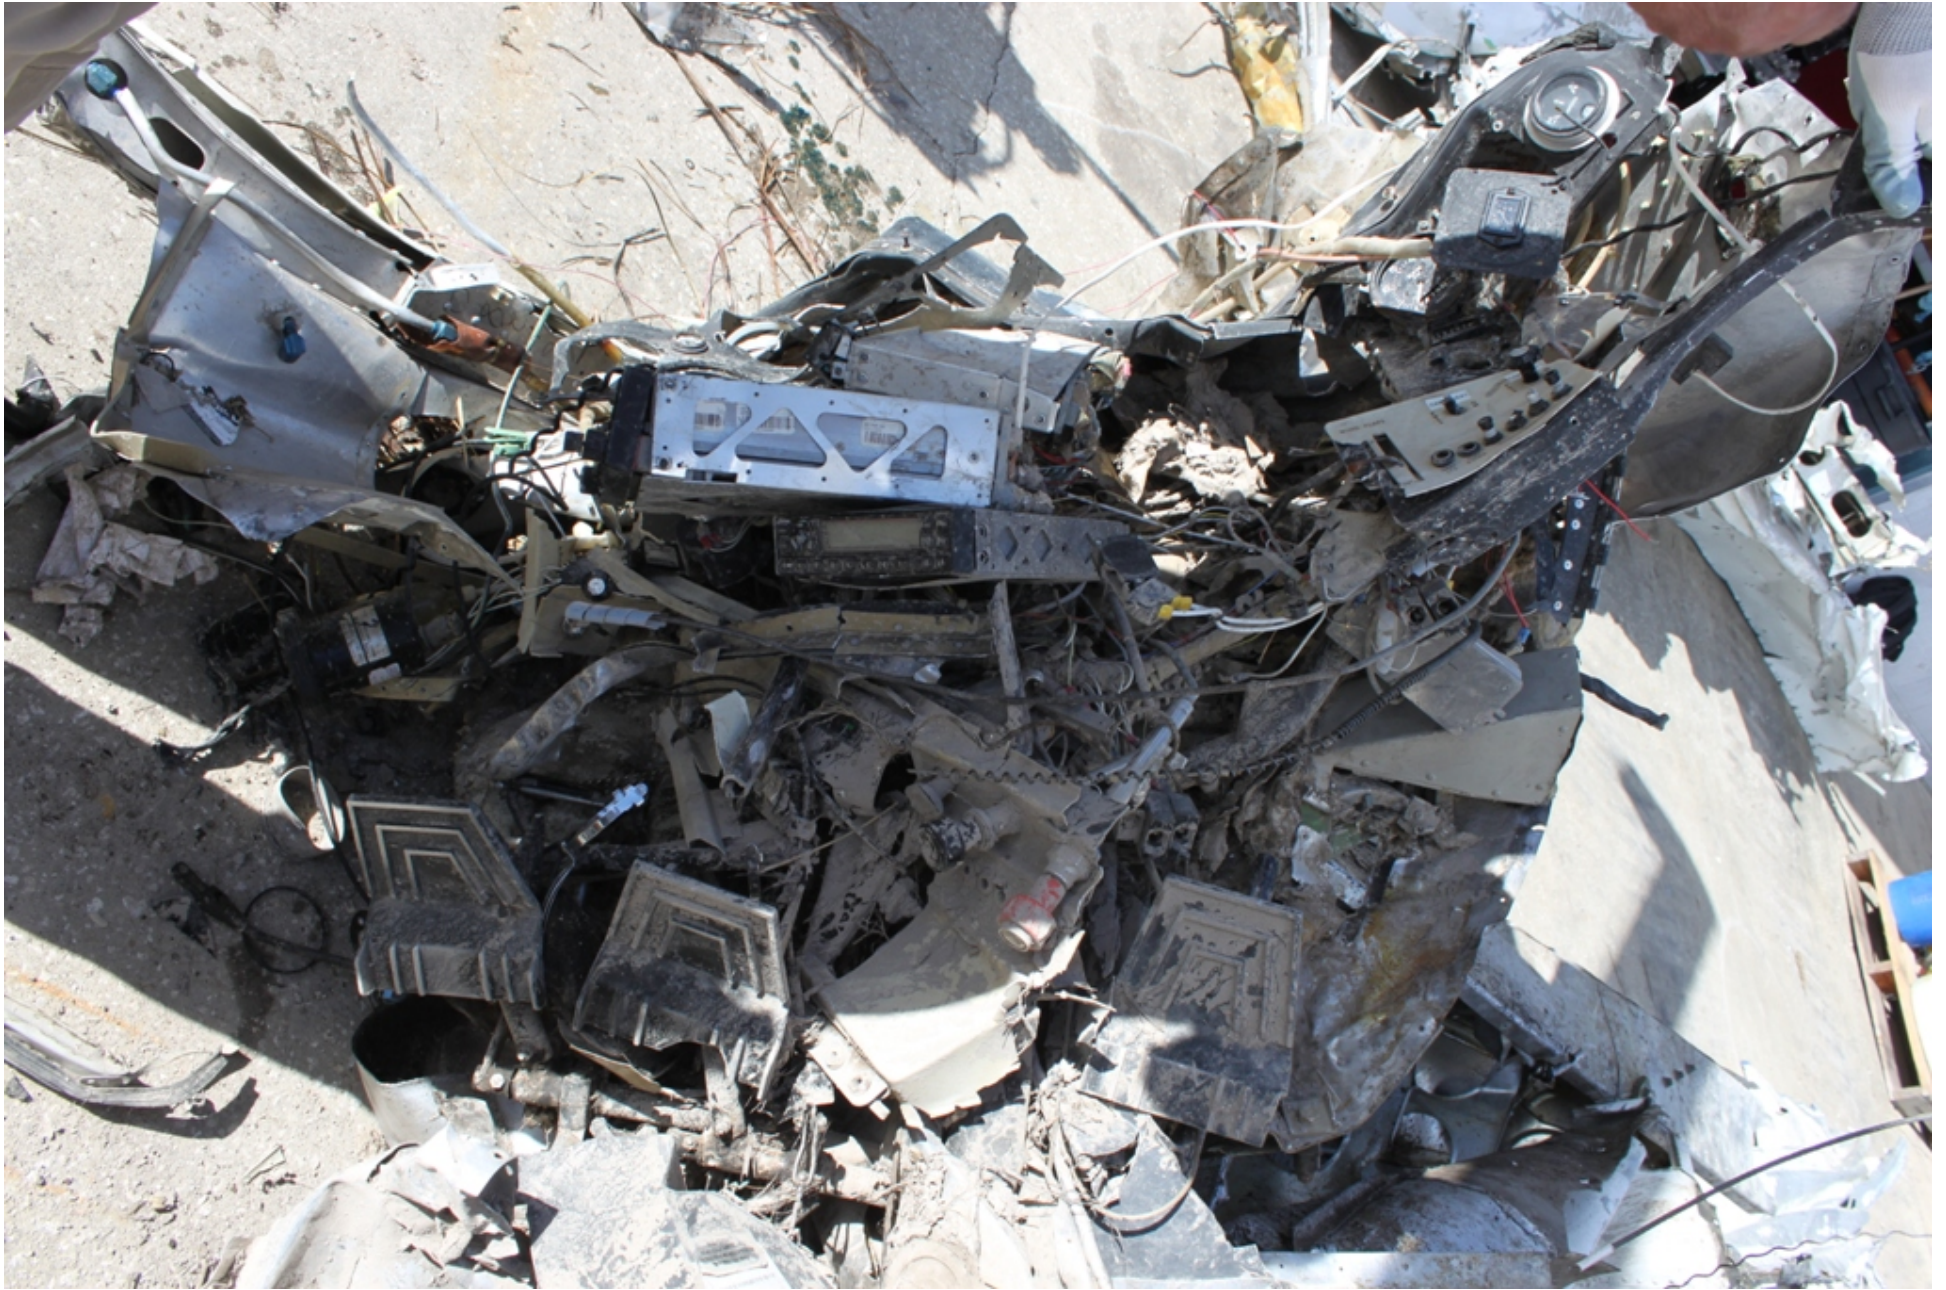
**Photo 10 - NTSB Photograph Depicting the Instrument Panel, Throttle Quadrant, Rudder Pedals, Avionics, and Instruments.**
