**Photo 1 – NTSB Photograph Depicting the Initial Impact Site Location and Energy Path Direction**

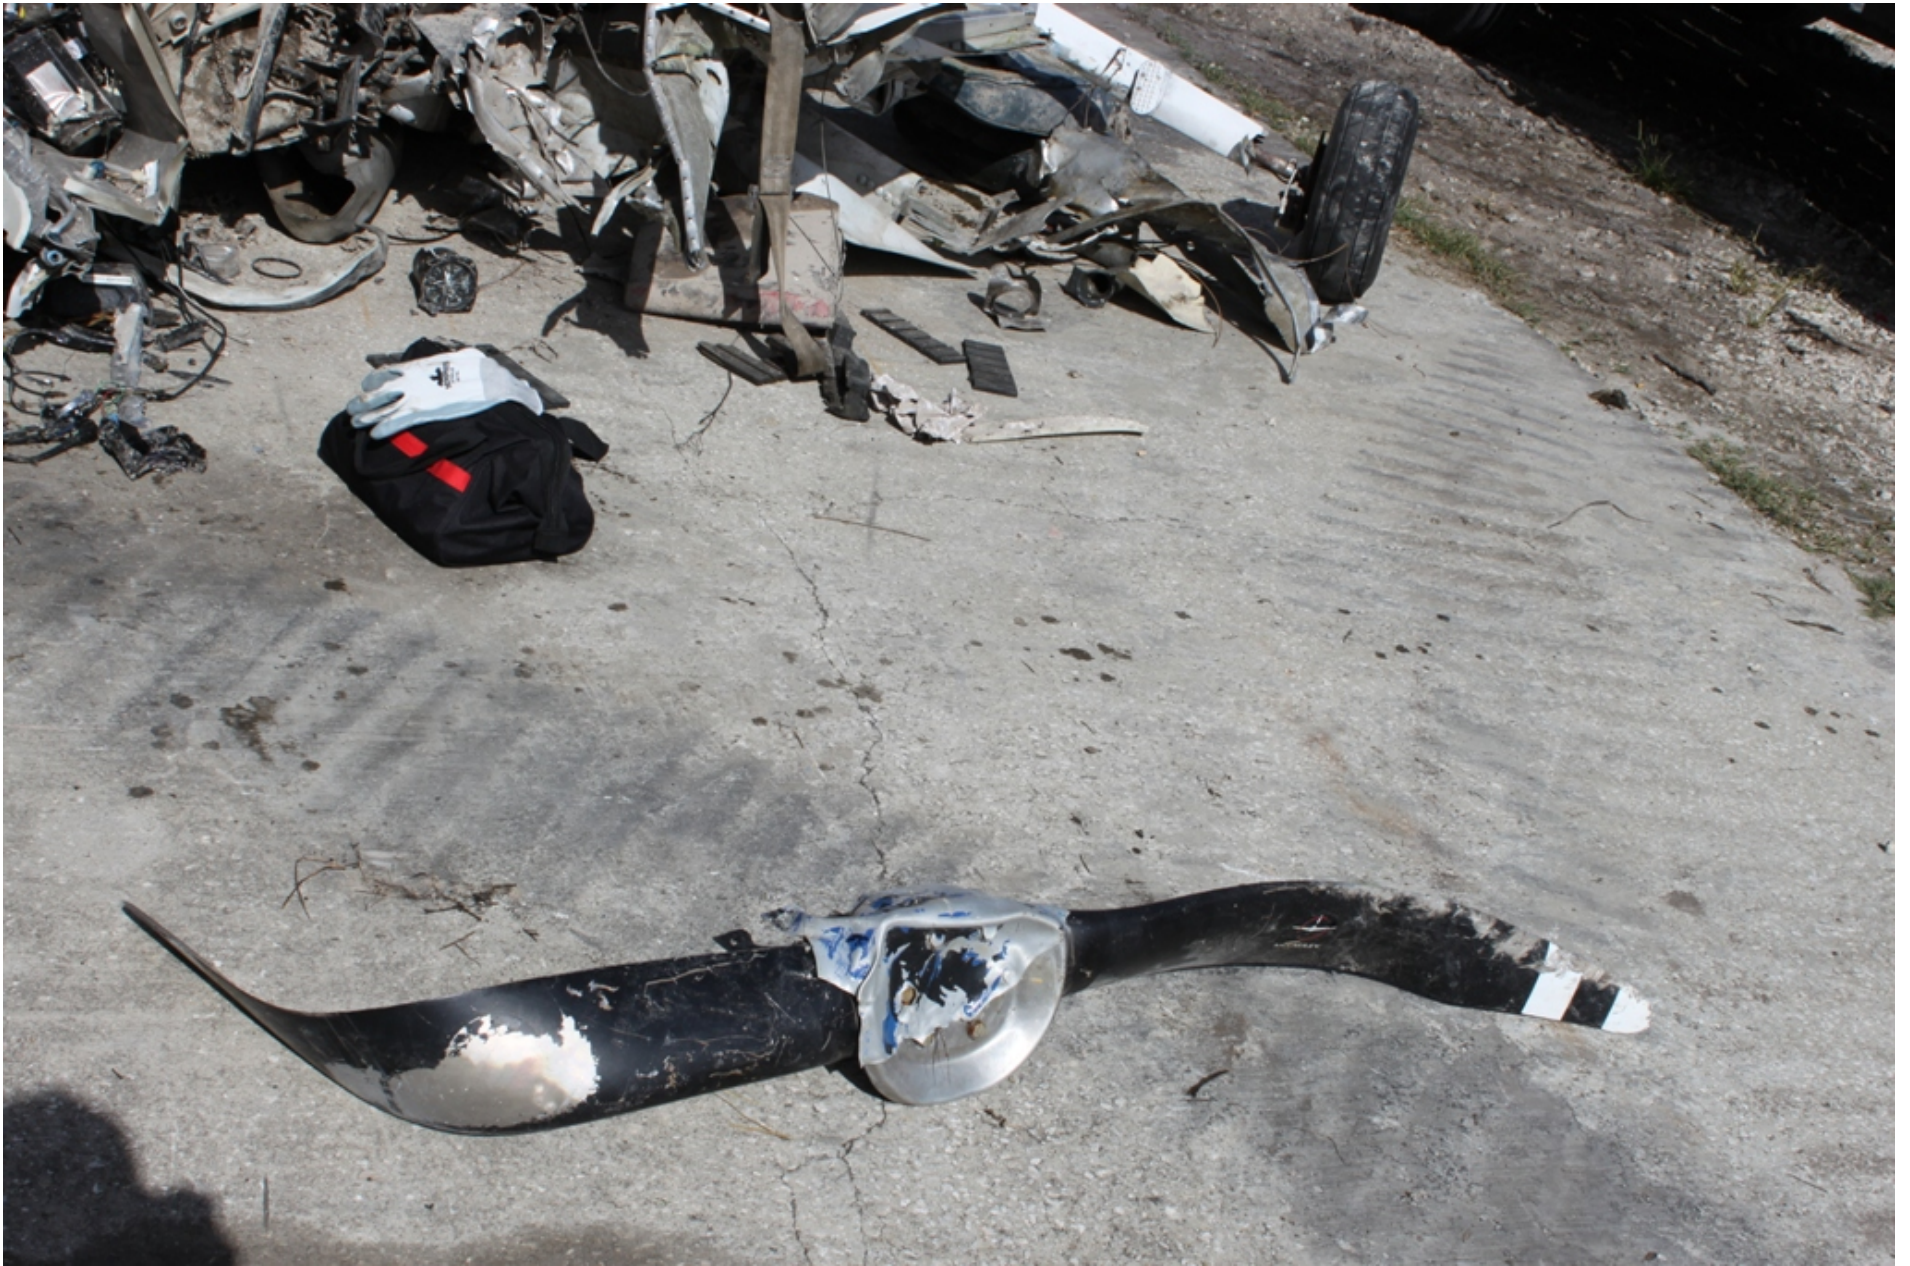
**Photo 11 - NTSB Photograph Depicting the Propeller. Note the Blade Bending and Damage.**

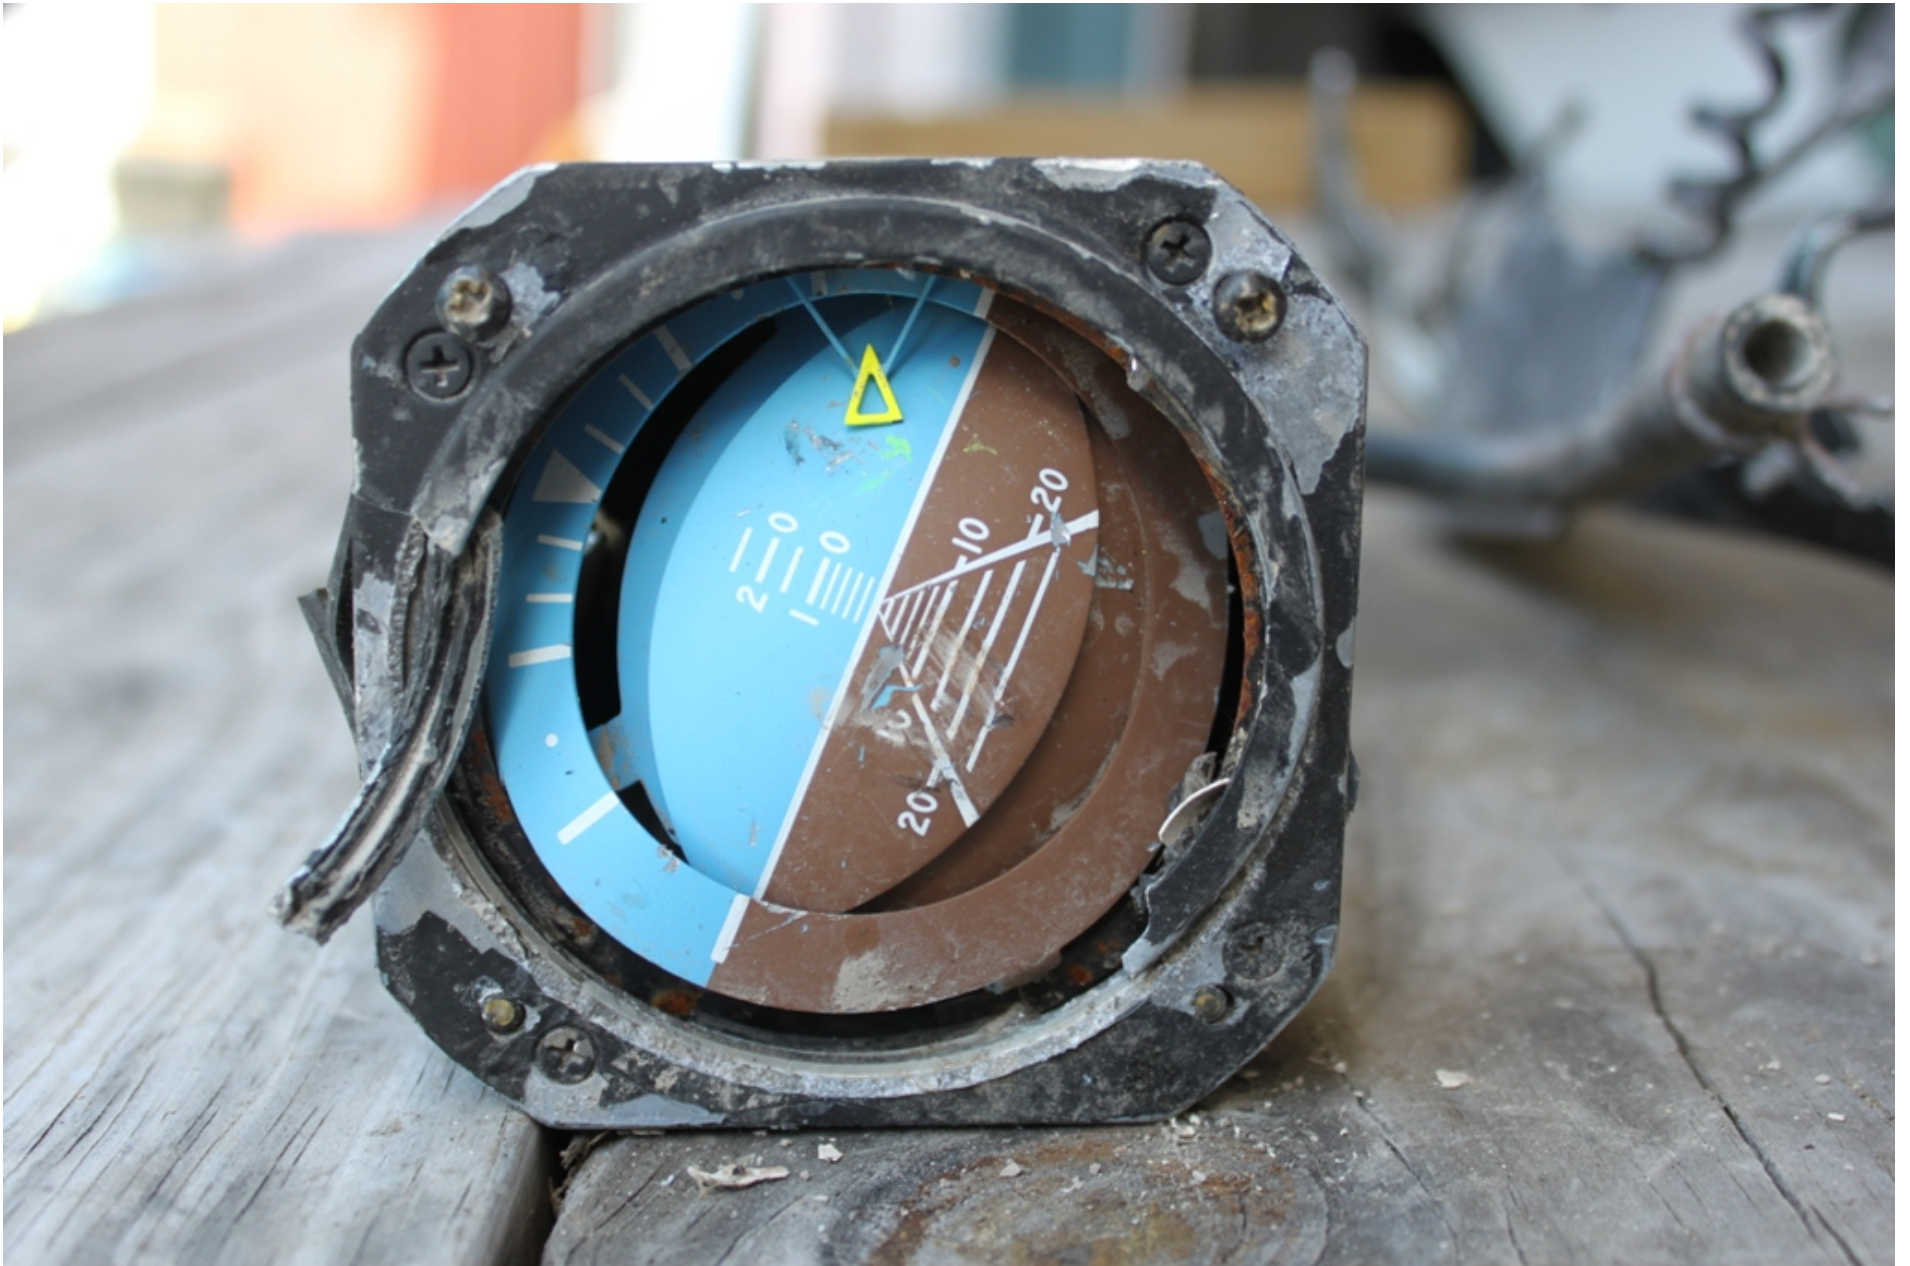
**Photo 13 - NTSB Photograph Depicting the Attitude Indicator Following Removal from Behind The Instrument Panel.  
Note the Fixed Pointer Position.**

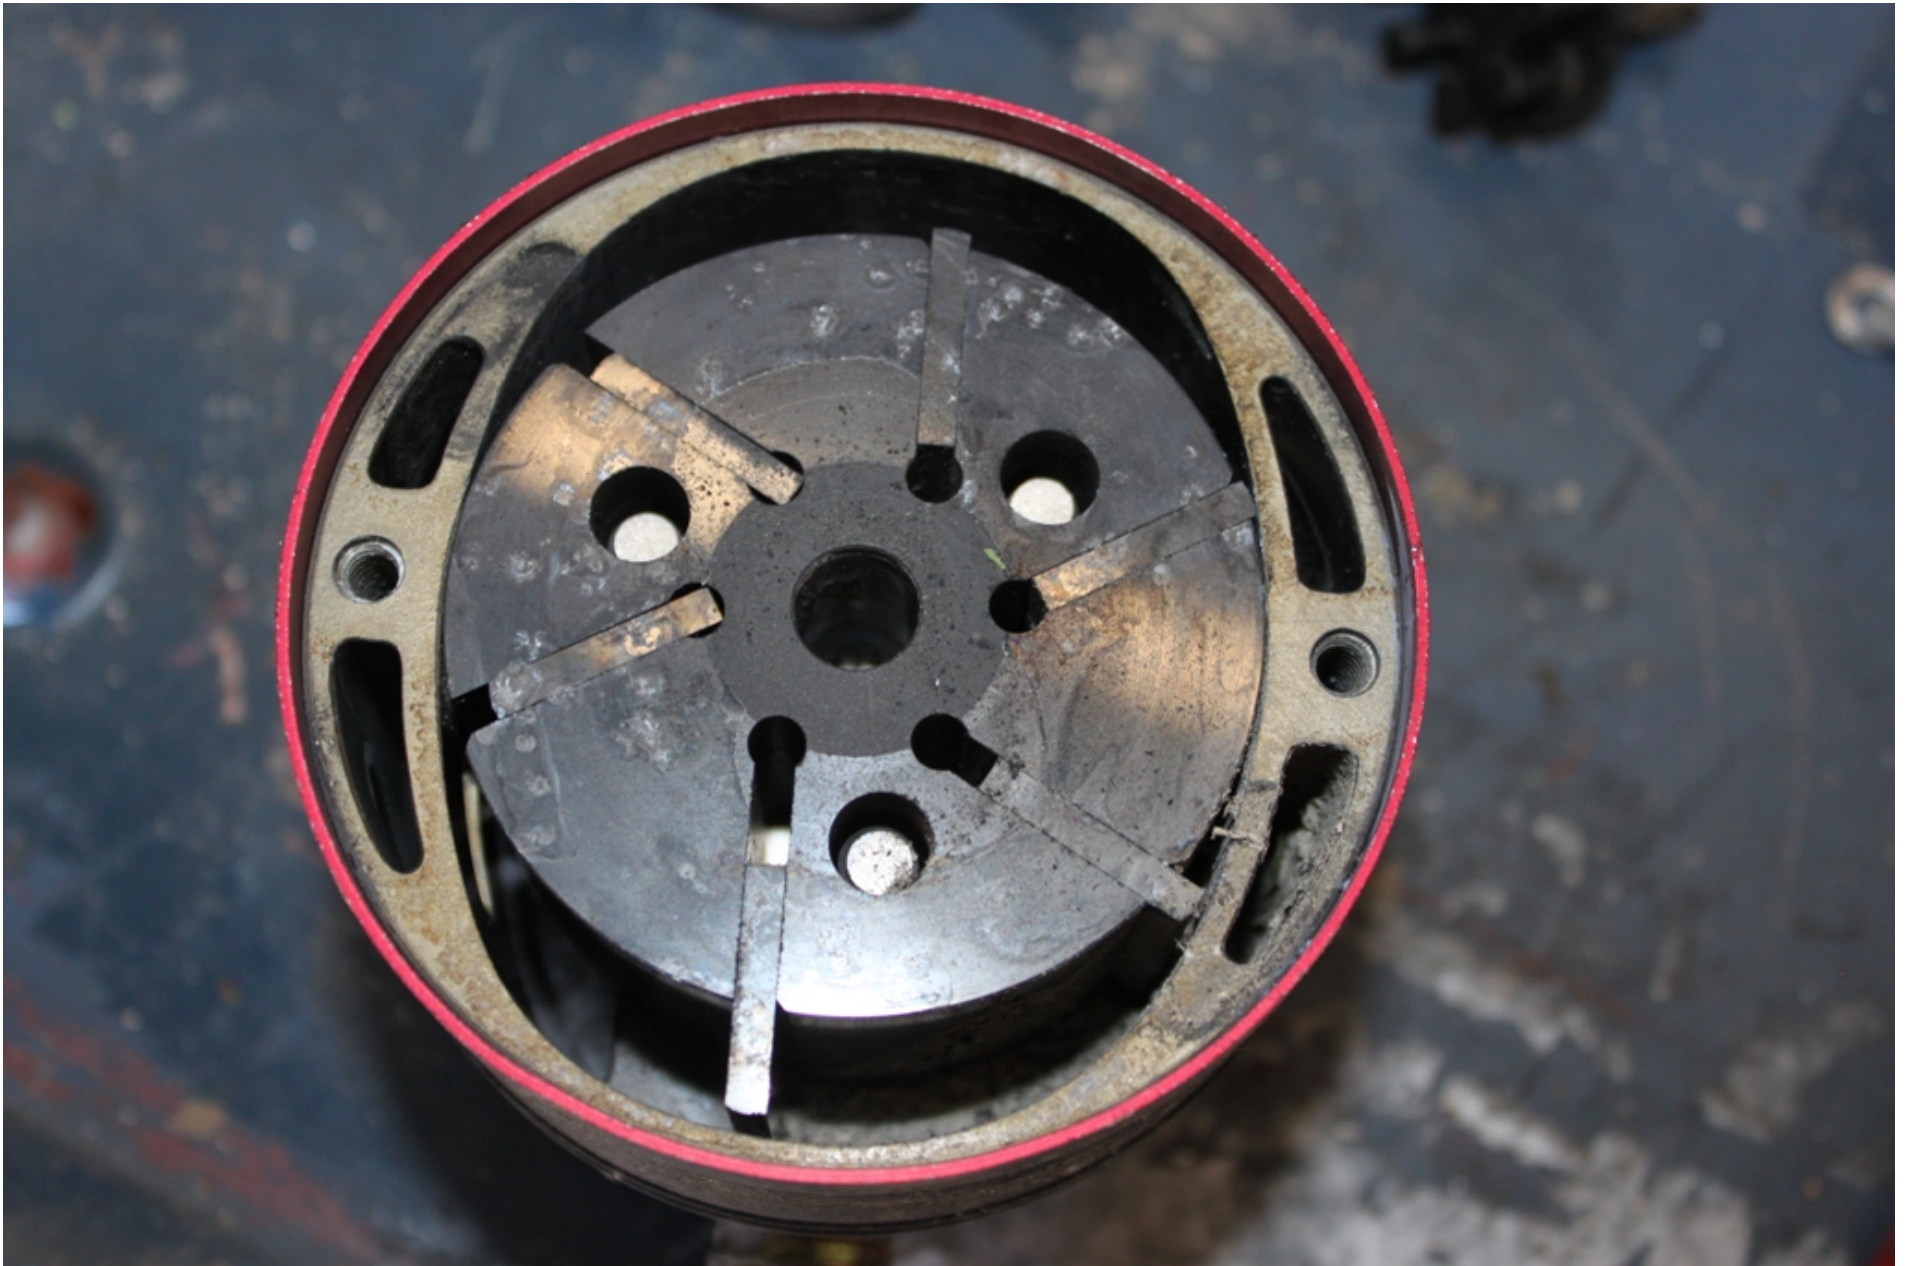
**Photo 14 – NTSB Photograph of the Engine-Driven Vacuum Pump Showing the Intact Rotor and Vanes.**

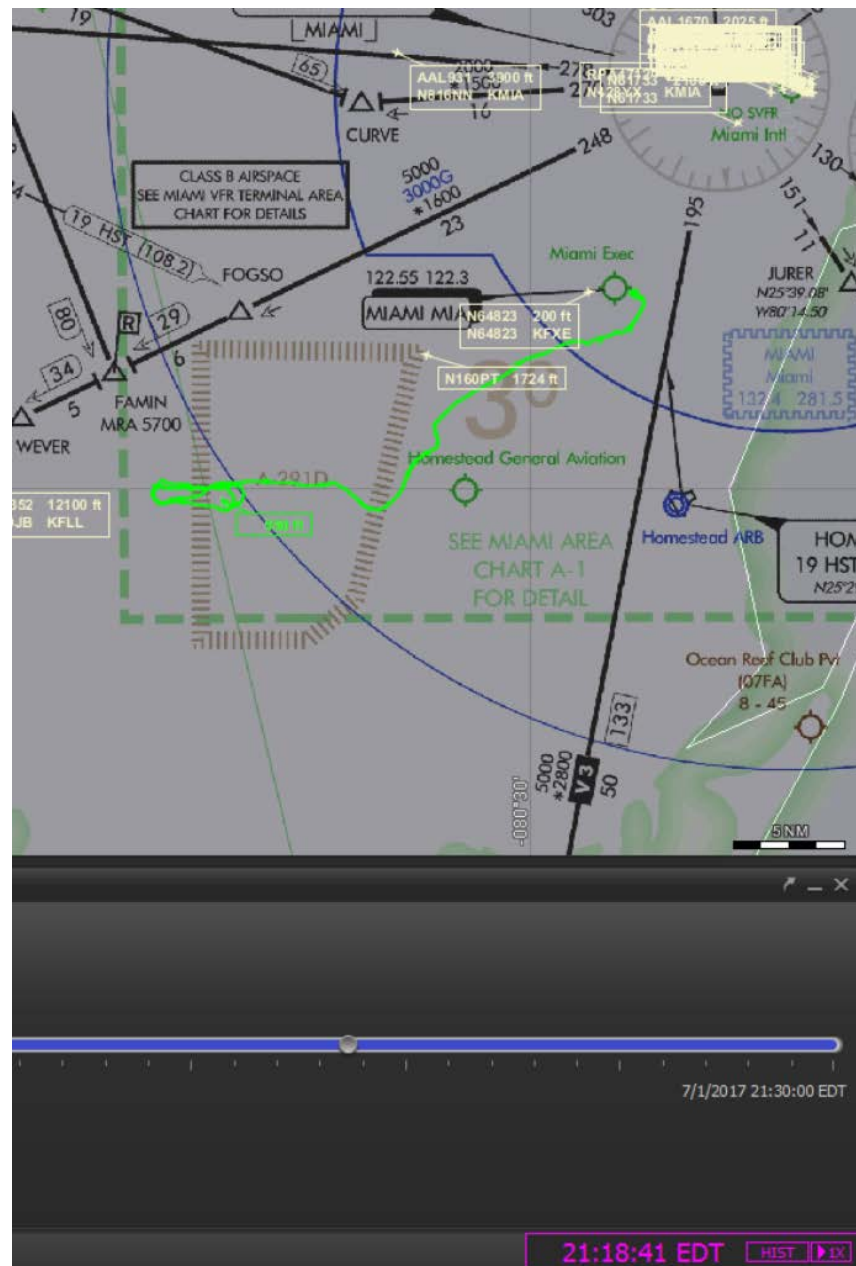
Photo 15 – NTSB Plotting of Non-Correlated Radar Data onto IFR Low Altitude Chart.
