**NATIONAL TRANSPORTATION SAFETY BOARD**  
**Office of Aviation Safety**  
**Washington, D.C. 20594**

**AIRWORTHINESS GROUP CHAIRMAN'S FACTUAL REPORT**

**NTSB No: ERA17FA274**

Operator: Virginia State Police  
Aircraft: Bell 407, Registration N31VA  
Location: Charlottesville, Virginia  
Date: August 12, 2017  
Time: 1649 eastern daylight time

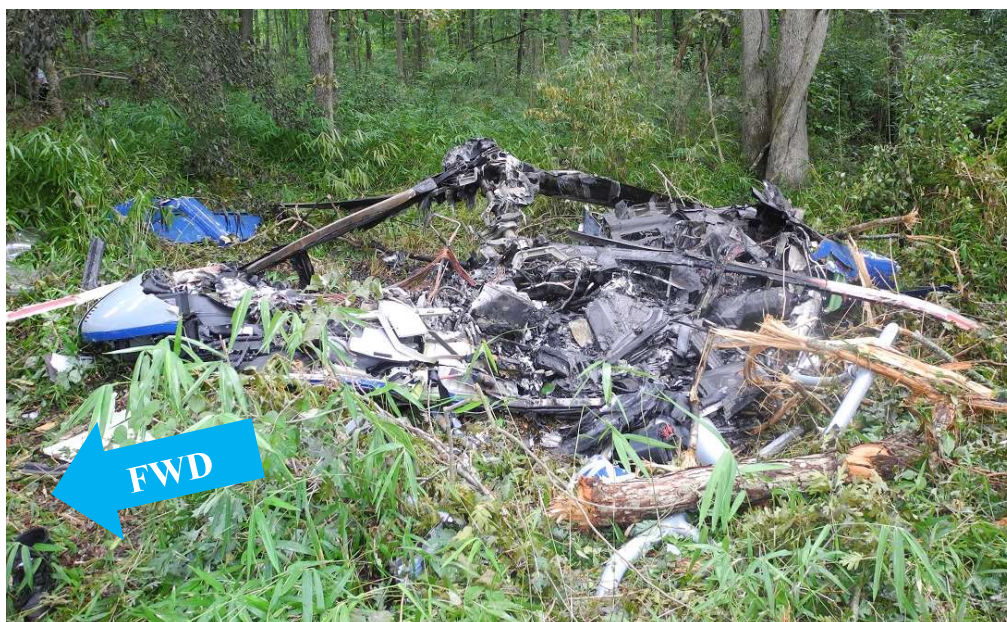
The main fuselage came to rest at a magnetic heading of 333 degrees ([Figure 1](#)). The cockpit and main rotor system came to rest upright. The engine deck, containing the engine, and the forward section of the tail boom came to rest on its right side. A postcrash fire damaged a significant portion of the main wreckage. The tail boom section containing the horizontal stabilizer was found adjacent to the nose of the helicopter. The left horizontal stabilizer exhibited an angled cut consistent with main rotor blade contact. The outboard forward slat of the left horizontal stabilizer was found separate from the horizontal stabilizer. The upper and lower vertical end plates were separated from the left horizontal stabilizer and found loose in the debris field. The right horizontal stabilizer remained mostly intact, with partial fractures of its upper and lower vertical end plates.

**Figure 1. The main wreckage site containing the main fuselage.**

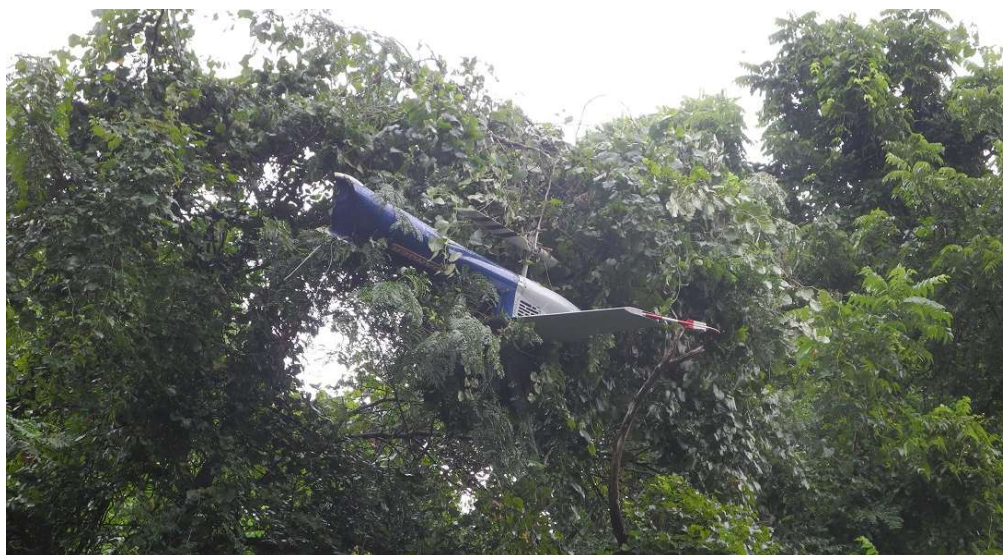
The aft section of the tail boom, containing a portion of the tail rotor drive system, tail rotor, and vertical stabilizer, was found within a tree canopy about 100-150 feet south-southwest of the main wreckage site (**Figure 2**). The left side of the tail boom aft section exhibited an impact mark consistent with tail rotor blade contact.

**Figure 2. The aft section of the tail boom found in a tree canopy.**

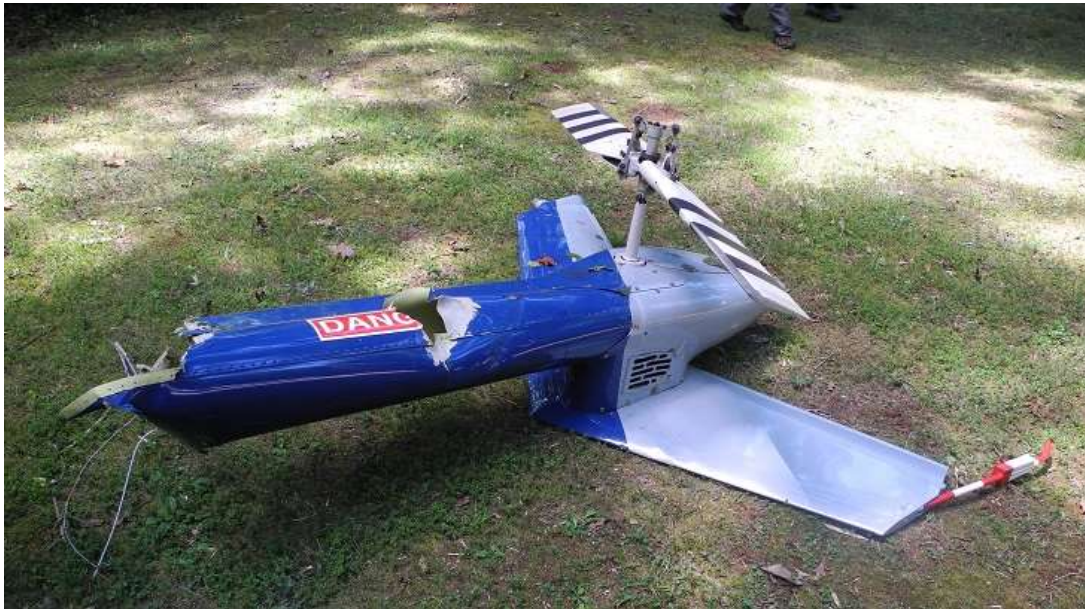
Both tail rotor blades remained attached to its yoke (**Figure 3**). The 'white' tail rotor blade exhibited damage on its tip end. The leading edge of the 'white' tail rotor blade exhibited impact damage about 15.5 inches inboard of the tip end; the impact damage was about 3 inches wide. The 'red' tail rotor blade did not exhibit anomalous damage.

**Figure 3. The recovered aft tail boom section and tail rotor.**

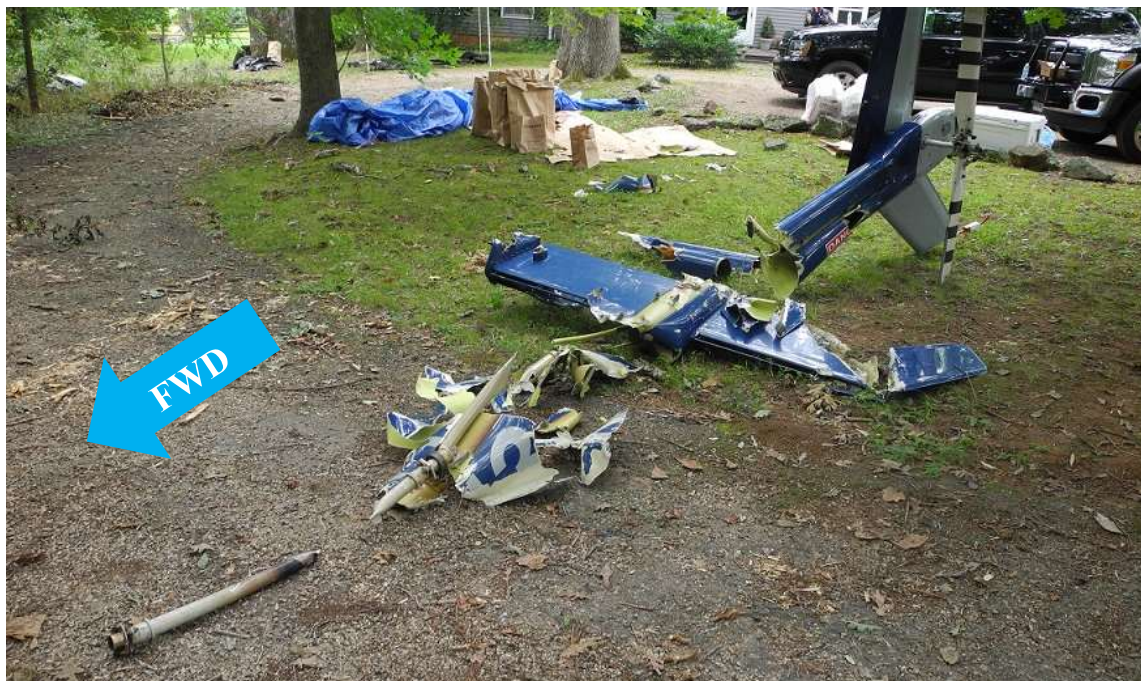
The steel TRDS was found whole and thermally damaged. The forward flexible coupling was fractured but its attaching hardware was present. The splines at the aft end of the steel TRDS did not exhibit evidence of smearing or missing spline teeth. The oil cooler blower remained attached to the airframe. The forward and aft splines of the oil cooler blower were thermally damaged but did not exhibit evidence of smearing or missing spline teeth. Rotation of the forward splines resulted in a corresponding rotation of the blower and the aft splines.

The No. 1 TRDS was fractured about 1/3 of its length from its aft end, which was in line with an impact mark on the tail boom consistent with main rotor blade contact. The splines on the forward end of the No. 1 TRDS did not exhibit evidence of smearing or fractures. The aft end of the forward portion of the No. 1 TRDS exhibited thermal damage and remained attached to the forward flange of the No. 2 TRDS via aft coupling disc pack. The aft coupling disc pack exhibited a serpentine (wavy) appearance about its circumference as well as opening of the disc pack laminates.

The No. 2 TRDS was fractured about its longitudinal midpoint, which was in line with an impact mark on the tail boom consistent with main rotor blade contact. The shaft tube was separated from its riveted connection to the forward end cap and flange. The forward end cap and flange remained attached to the hanger bearing, which remained attached to the support bracket and a remnant piece of tail boom. The aft coupling disc pack exhibited a serpentine appearance about its circumference.

The majority of the No. 3 TRDS was not recovered and only the forward riveted end cap and flange for the No. 3 TRDS was found; its rivets exhibited signatures consistent with shear.

The No. 4 TRDS was fractured about 1/3 of its length from its aft end. Only the aft portion of the No. 4 TRDS was recovered. The aft coupling disc pack exhibited opening of the disc pack laminates. The fractured attachment flange lobes from the No. 5 TRDS, along with its attaching hardware, remained connected to the aft portion of the No. 4 TRDS. The aft portion of the No. 4 TRDS remained attached remnant tail boom structure.

The No. 5 TRDS remained intact except for the fracture of its forward attachment flange lobes. The No. 5 TRDS remained attached to the tail rotor gearbox input flange via its aft flexible coupling. The aft flexible coupling remained attached to the No. 5 TRDS and was intact.

**Figure 4. A reconstruction of the recovered tail rotor drive train.**

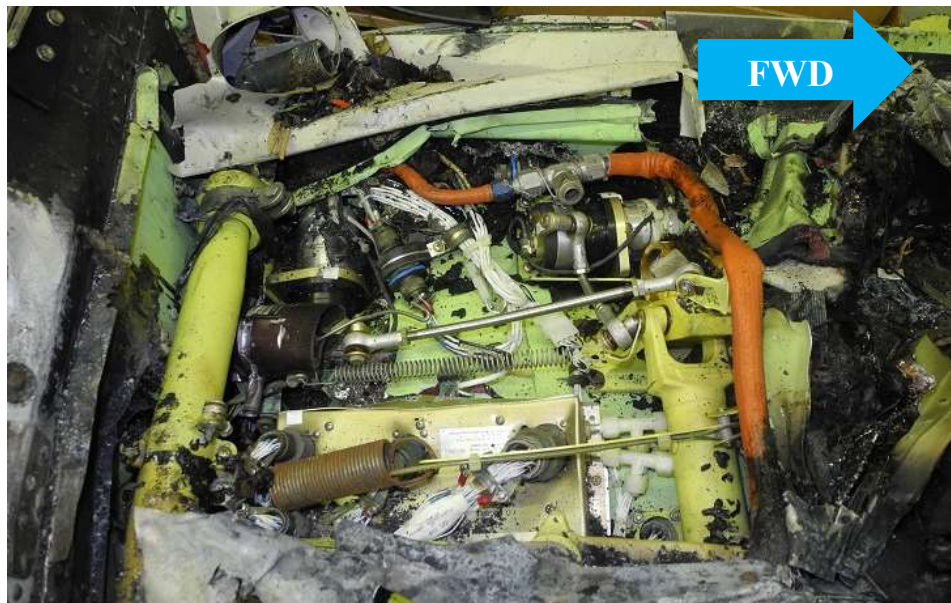
The HeliSAS roll and pitch servo actuators, as well as the FCC, remained installed underneath the copilot seat (**Figure 5**). The linkage between the roll servo actuator and the cyclic lateral jackshaft was bent. The linkage between the pitch servo actuator and the cyclic lateral jackshaft bracket was intact but the bracket had separated

**Figure 5. The cyclic and collective jackshafts and the HeliSAS actuators.**

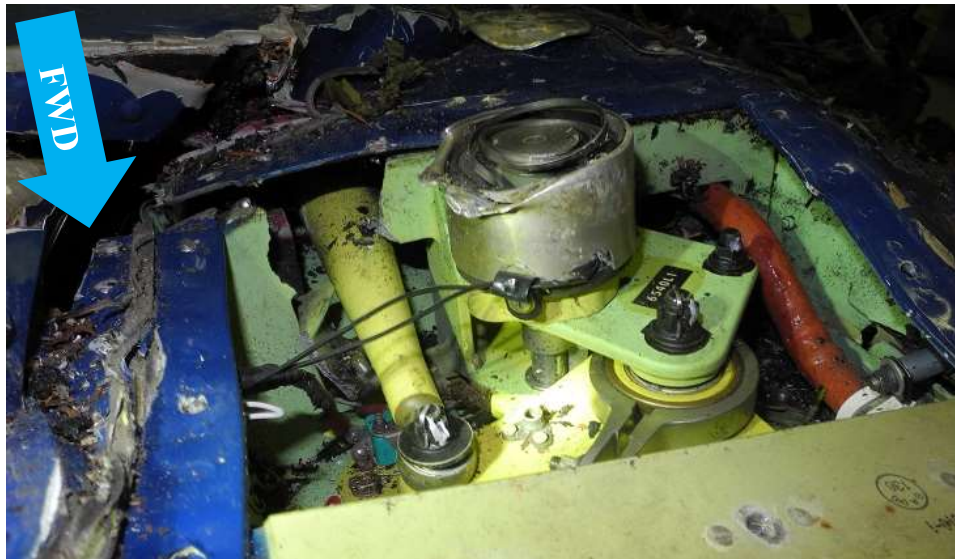
The pilot pedal set was found loose in the wreckage. The lateral push-pull tube was fractured. The copilot pedal set remained installed in the cockpit but its lateral push-pull tube was fractured. The left pedals were consistent with being “locked out.” The tail rotor fore-aft push-pull tube, routed under the right collective stick, remained connected at the forward bell crank and was continuous to the bell crank underneath the mixing unit. The bell crank underneath the mixing unit remained attached to the airframe. The vertical push-pull tube was fractured at the lower rod end threads, but the lower rod end remained attached to the bell crank underneath the mixing unit. The vertical push-pull tube exhibited thermal damage. The lateral push-pull tubes, between the left and right pedals, remained attached to the forward bell crank. The PRCS remained installed but its solenoid exhibited impact damage ([Figure 6](#)). The PRCS cam was found in the engaged position ([Figure 7](#)). The PRCS emergency release cable was found in the cockpit and was thermally damaged, but the copper witness wire for the emergency release cable was found unbroken. The plastic pull knob for the emergency release cable was not recovered, and the adjacent cable housing exhibited thermal damage. The PRCS was removed from the helicopter for further examination. For information on the examination of the PRCS, see section 5.0 of this report.

**Figure 6. The pedal bell crank and PRCS solenoid.**

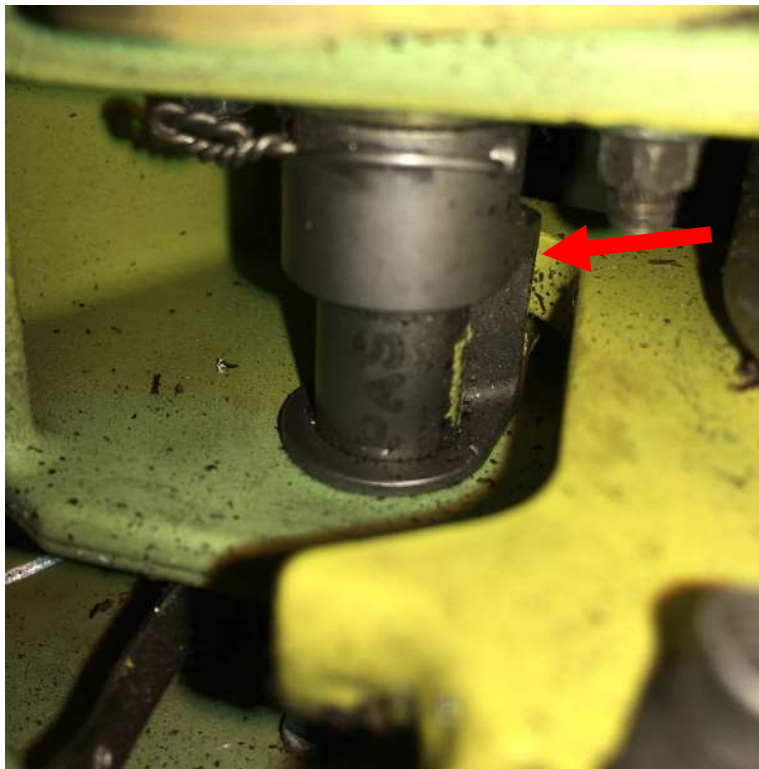
**Figure 7. The PRCS cam (red arrow) found in the engaged position.**

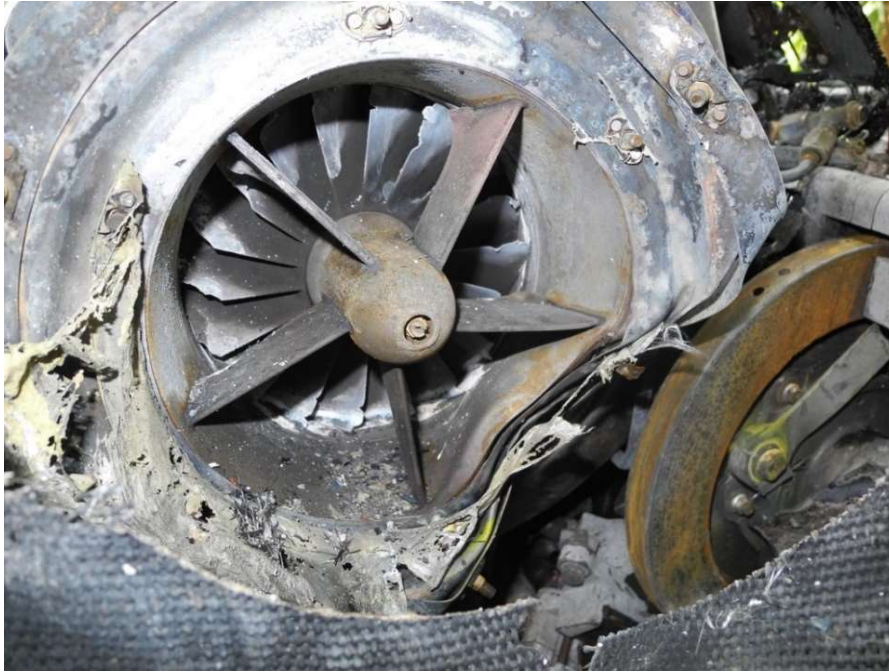
The engine was found laying on its right side near its normally installed location on the airframe. The engine mounts had fractured from the airframe. The engine assembly was bent about 30 degrees laterally, at the junction of the turbine and gearbox modules, resulting in a disengagement of the compressor-to-turbine shaft as well as the power turbine shaft. The engine exterior exhibited damage consistent with exposure to the postcrash fire. The first stage compressor blades exhibited evidence of hard body foreign object debris (FOD) damage ([Figure 8](#)).<sup>9</sup> Manual rotation of the compressor resulted in a corresponding rotation of the N1 gear train. The splined coupling to the compressor turbine shaft also rotated. Due to the decoupling of the compressor turbine shaft, rotation of the gas generator turbine from the compressor was not possible. Rotation of the transmission input shaft (the engine power output shaft) resulted in a corresponding rotation of the N2 gear train. The power turbine had decoupled from the

**Figure 8. The engine inlet vanes and the first stage compressor blades.**

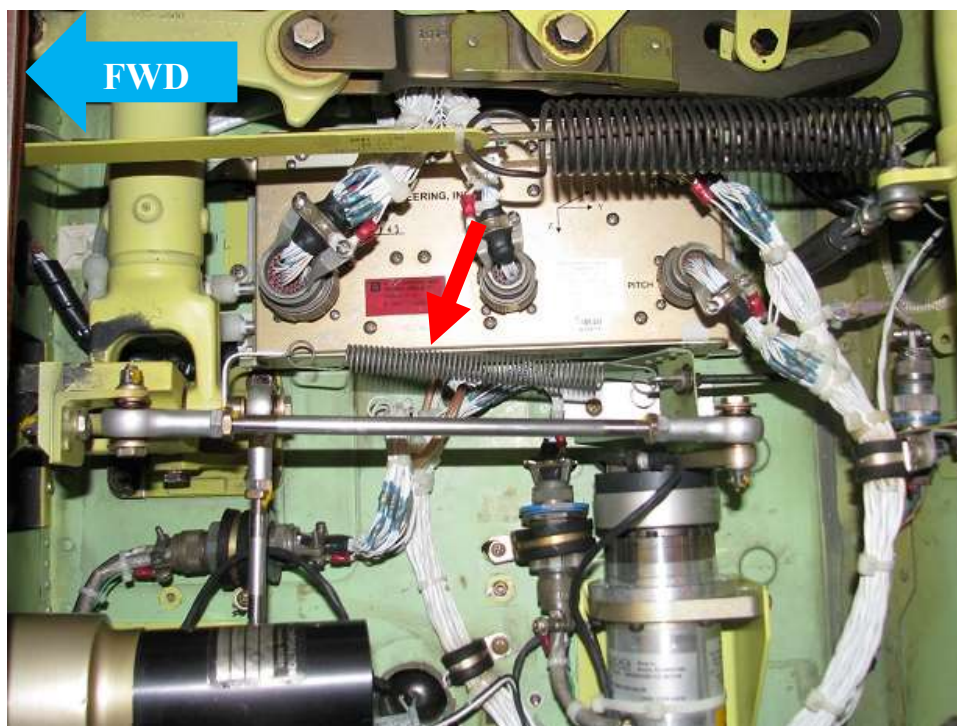
With the cyclic longitudinal balance spring adjusted to 7.08 inches and a dual-cyclic installation, the cyclic centering force was about 1.5–3.0 pounds. With the cyclic stick centered, disengaging SAS mode resulted in no movement of the cyclic stick. SAS mode was re-engaged and the cyclic was trimmed slightly forward of center, illuminating the “cyclic centering” light on the caution and warning panel. SAS mode was subsequently disengaged using the control panel button; no movement of the cyclic was observed.

**Figure 9. The HeliSAS installation and the adjusted cyclic longitudinal balance spring (red arrow).**

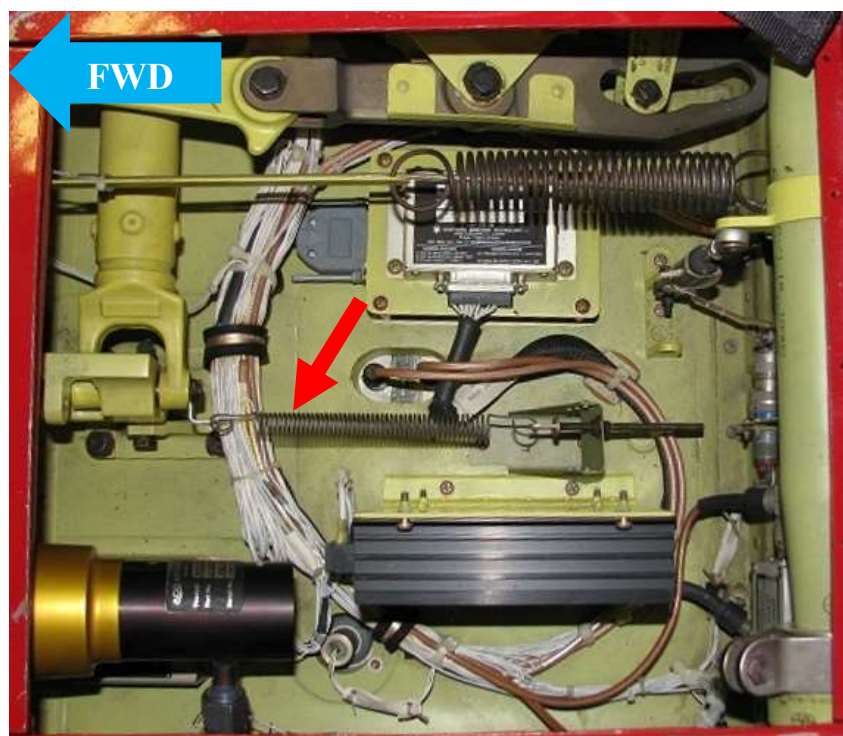
**Figure 10. An exemplar cyclic longitudinal balance spring installation without the HeliSAS.**
