**National Transportation Safety Board**  
Office of Research and Engineering  
Washington, D.C. 20594

**Performance Study**

| Airplane: | Cessna 150G, N3875J |
| NTSB Number: | ERA17FA330 |

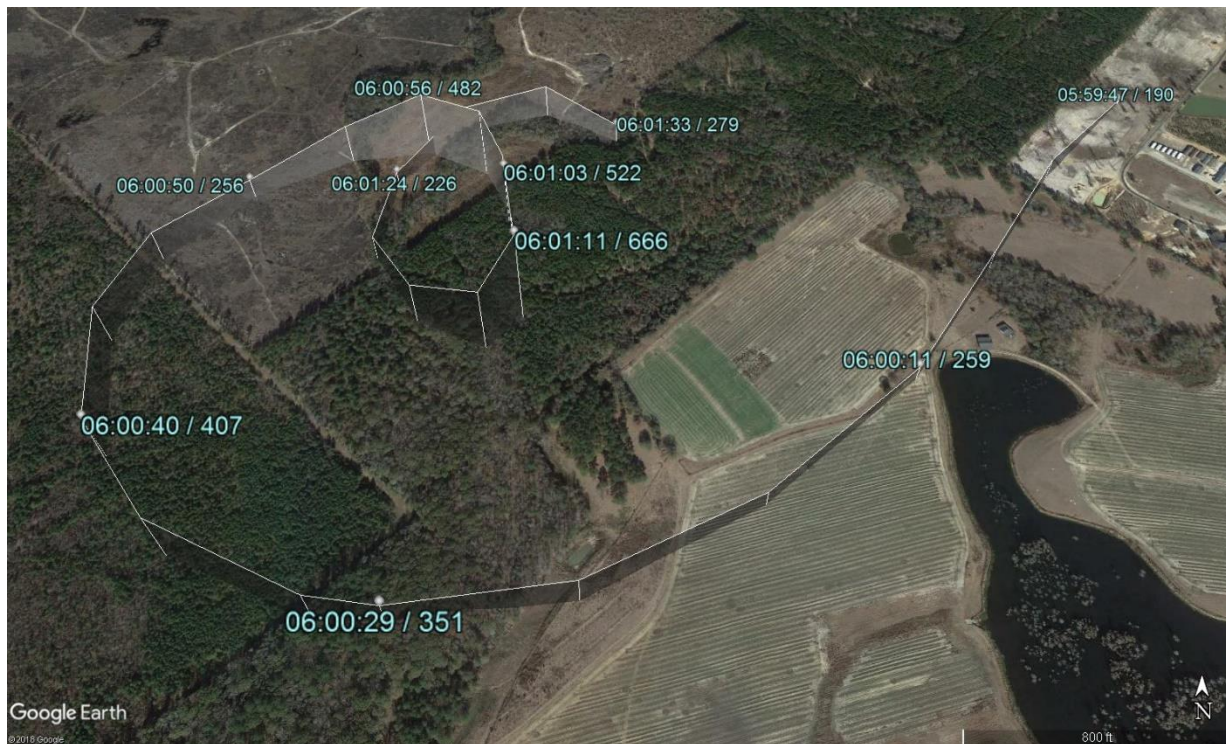
Figure 1 shows the accident flight path. The aircraft took off from the private airfield at approximately 05:59:47. It climbed while turning right to an altitude of 407 ft at 06:00:40. It then descended to 256 ft while continuing the right turn. The airplane then climbed in a tightening right turn to a maximum altitude of 666 ft at 06:01:11, before quickly losing altitude while rolling right. By 06:01:24 the airplane had descended to 226 ft. The last GPS data point was at 06:01:33 at an altitude of 279 ft.

**Figure 1.** Aircraft flight path shown with times and recorded altitude. The Google Earth imagery is from 2014 and does not reflect the current airfield at the location.

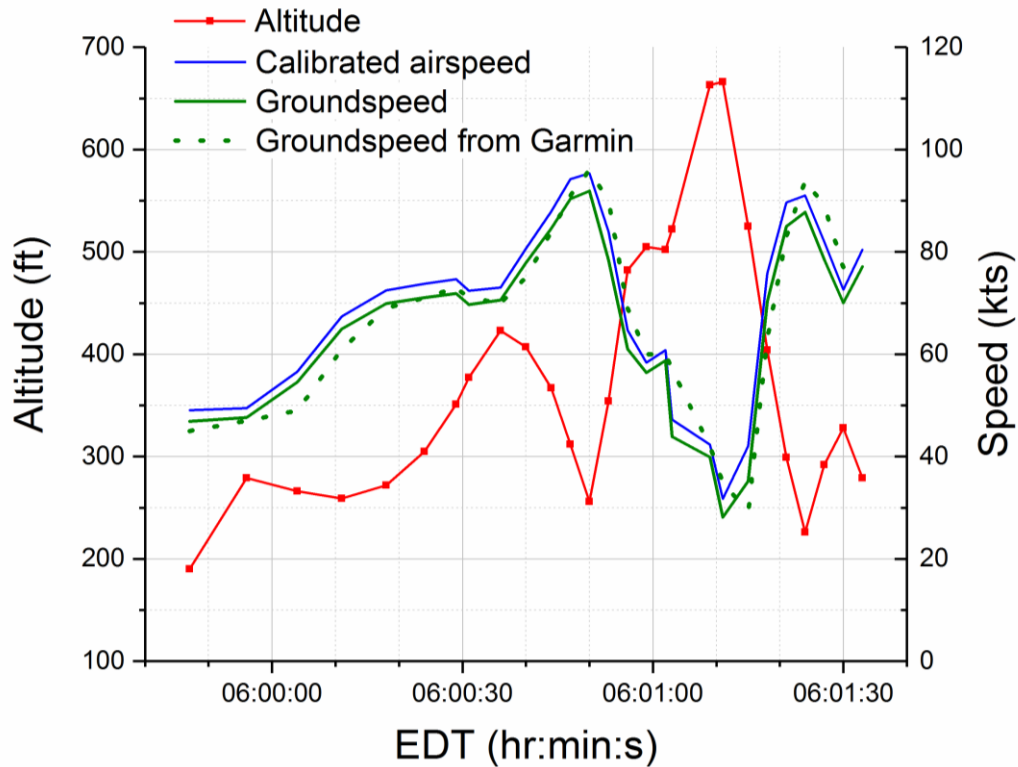
Figure 2 shows the recorded altitude and calculated calibrated airspeed and groundspeed for the flight path. The Garmin device also recorded an averaged groundspeed and the numbers were very similar to those calculated in this Study. The airplane's maximum calibrated airspeed was 95 kts and occurred at 06:00:50, when it had descended to 256 ft after the initial climb. The airplane then began to climb while losing airspeed, culminating in a minimum calibrated airspeed of 32 kts at a maximum altitude of 666 ft. The airplane then rolled right and lost 440 ft of altitude in 13 seconds. Figure 3 shows the airspeed and calculated bank angle from the flight path. After 06:01:02, the bank angle was increasingly right wing down as the airspeed decreased.

**Figure 2.** Aircraft flight altitude and calculated calibrated airspeed and groundspeed.

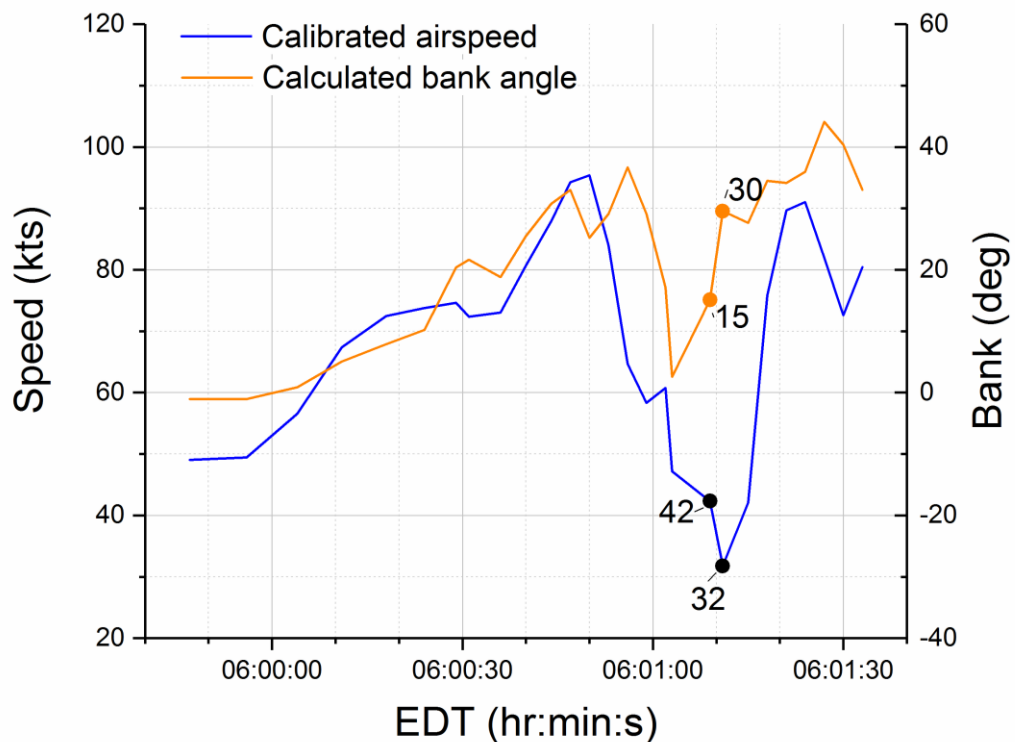
**Figure 3.** Calculated calibrated airspeed and bank angle. The two lowest airspeeds and their corresponding bank angles are noted.

Increased bank angle raises the stall speed, as shown in Table 1. The flight path data resulted in a minimum calculated calibrated airspeed of 32 kts while at a calculated bank angle of 30° right wing down, which was below the minimum power-off stall speed for all configurations and bank angles. The prior calculated airspeed was 42 kts at a bank angle of 15° right wing down, which was also below the reported power-off stall speed values.

At 06:00:50 the airplane began to climb while losing airspeed in a banked right turn. During the climb, the airplane slowed below all reported power-off stall speed values before rapidly losing altitude while rolling right. This behavior was consistent with aerodynamic stall.
