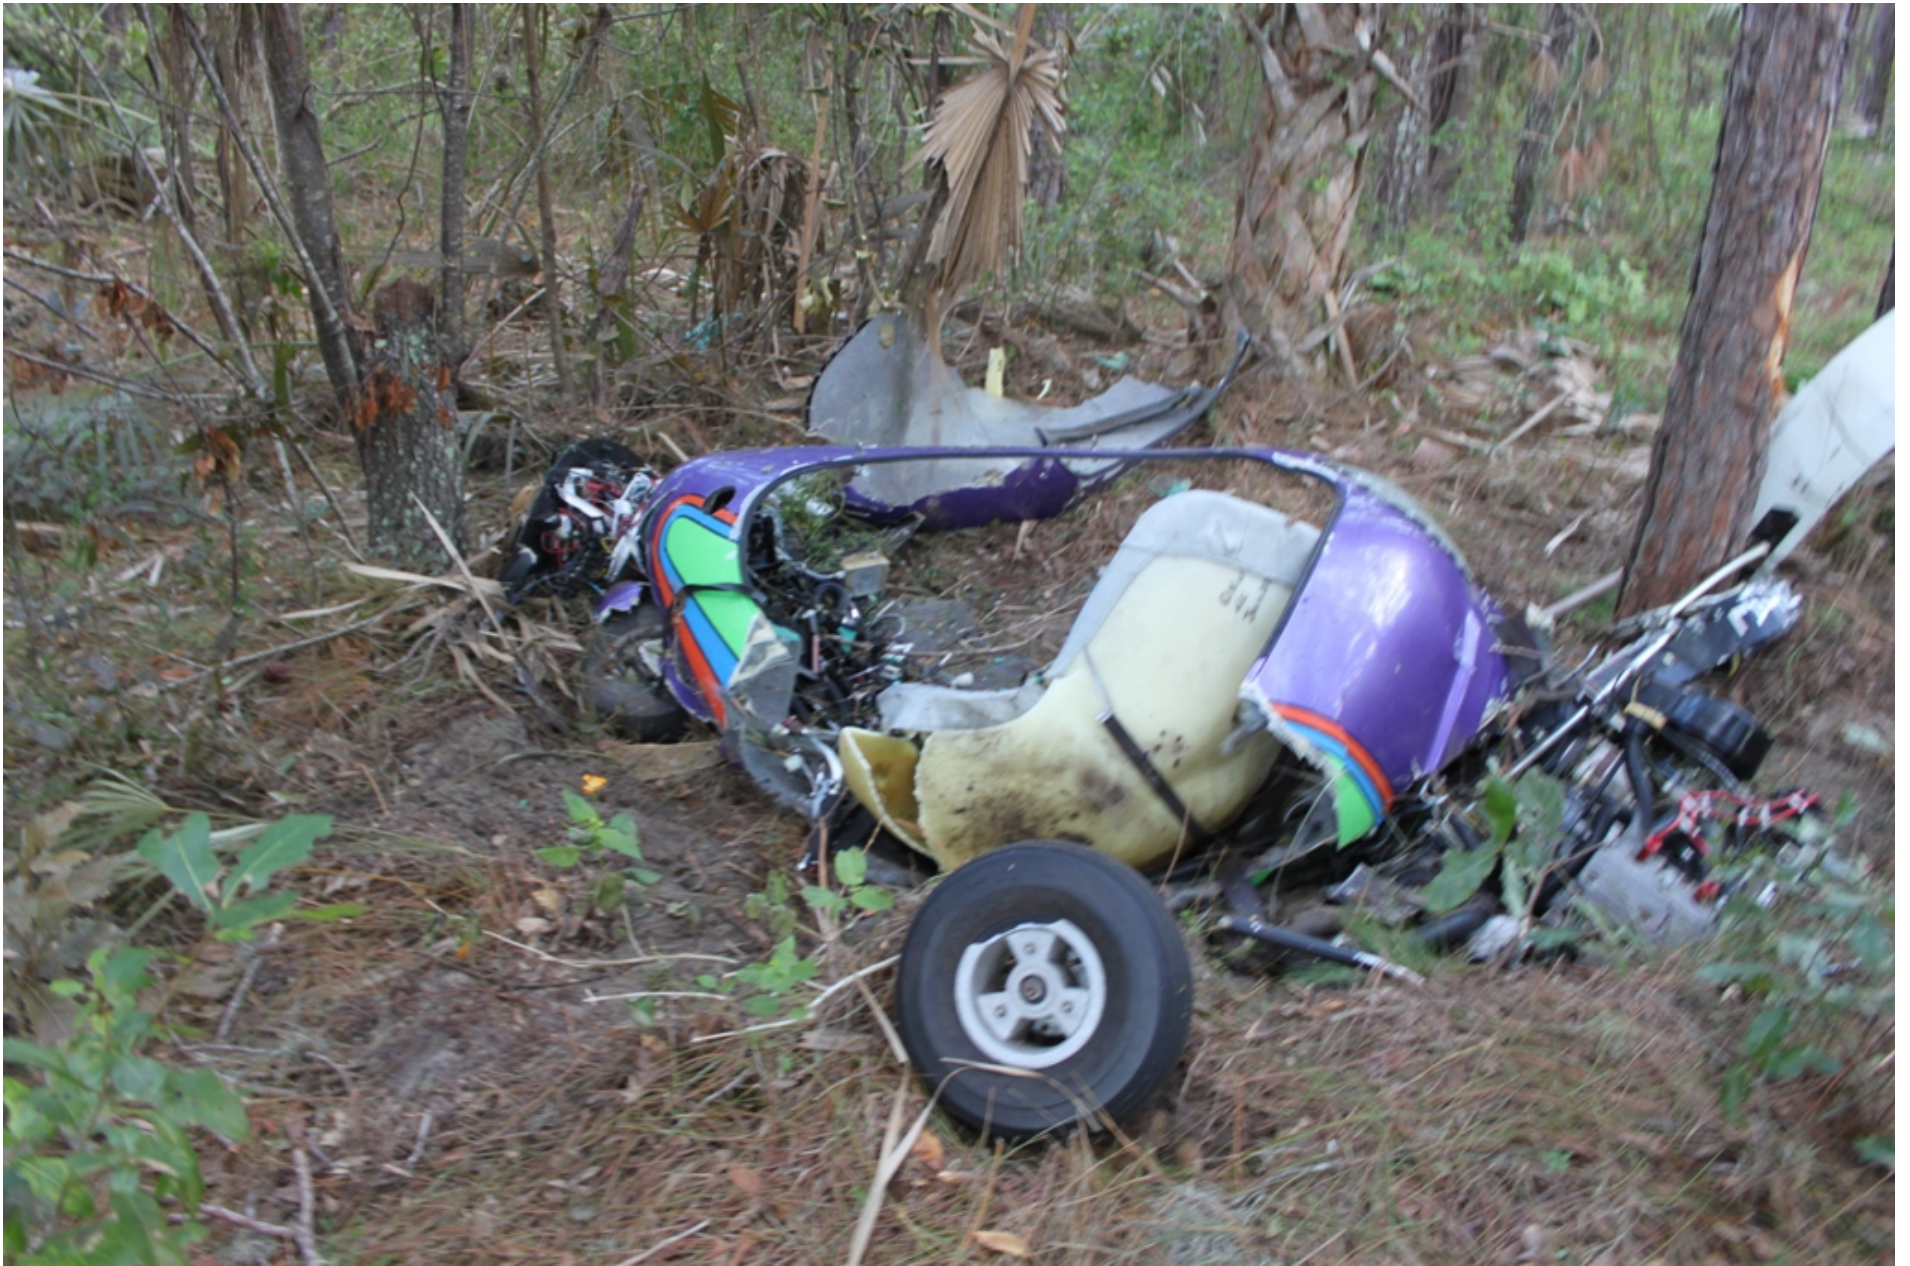
**Photo 1 – NTSB Digital Photograph. Left Rear Quartering View of the Wreckage at the Accident Site.**

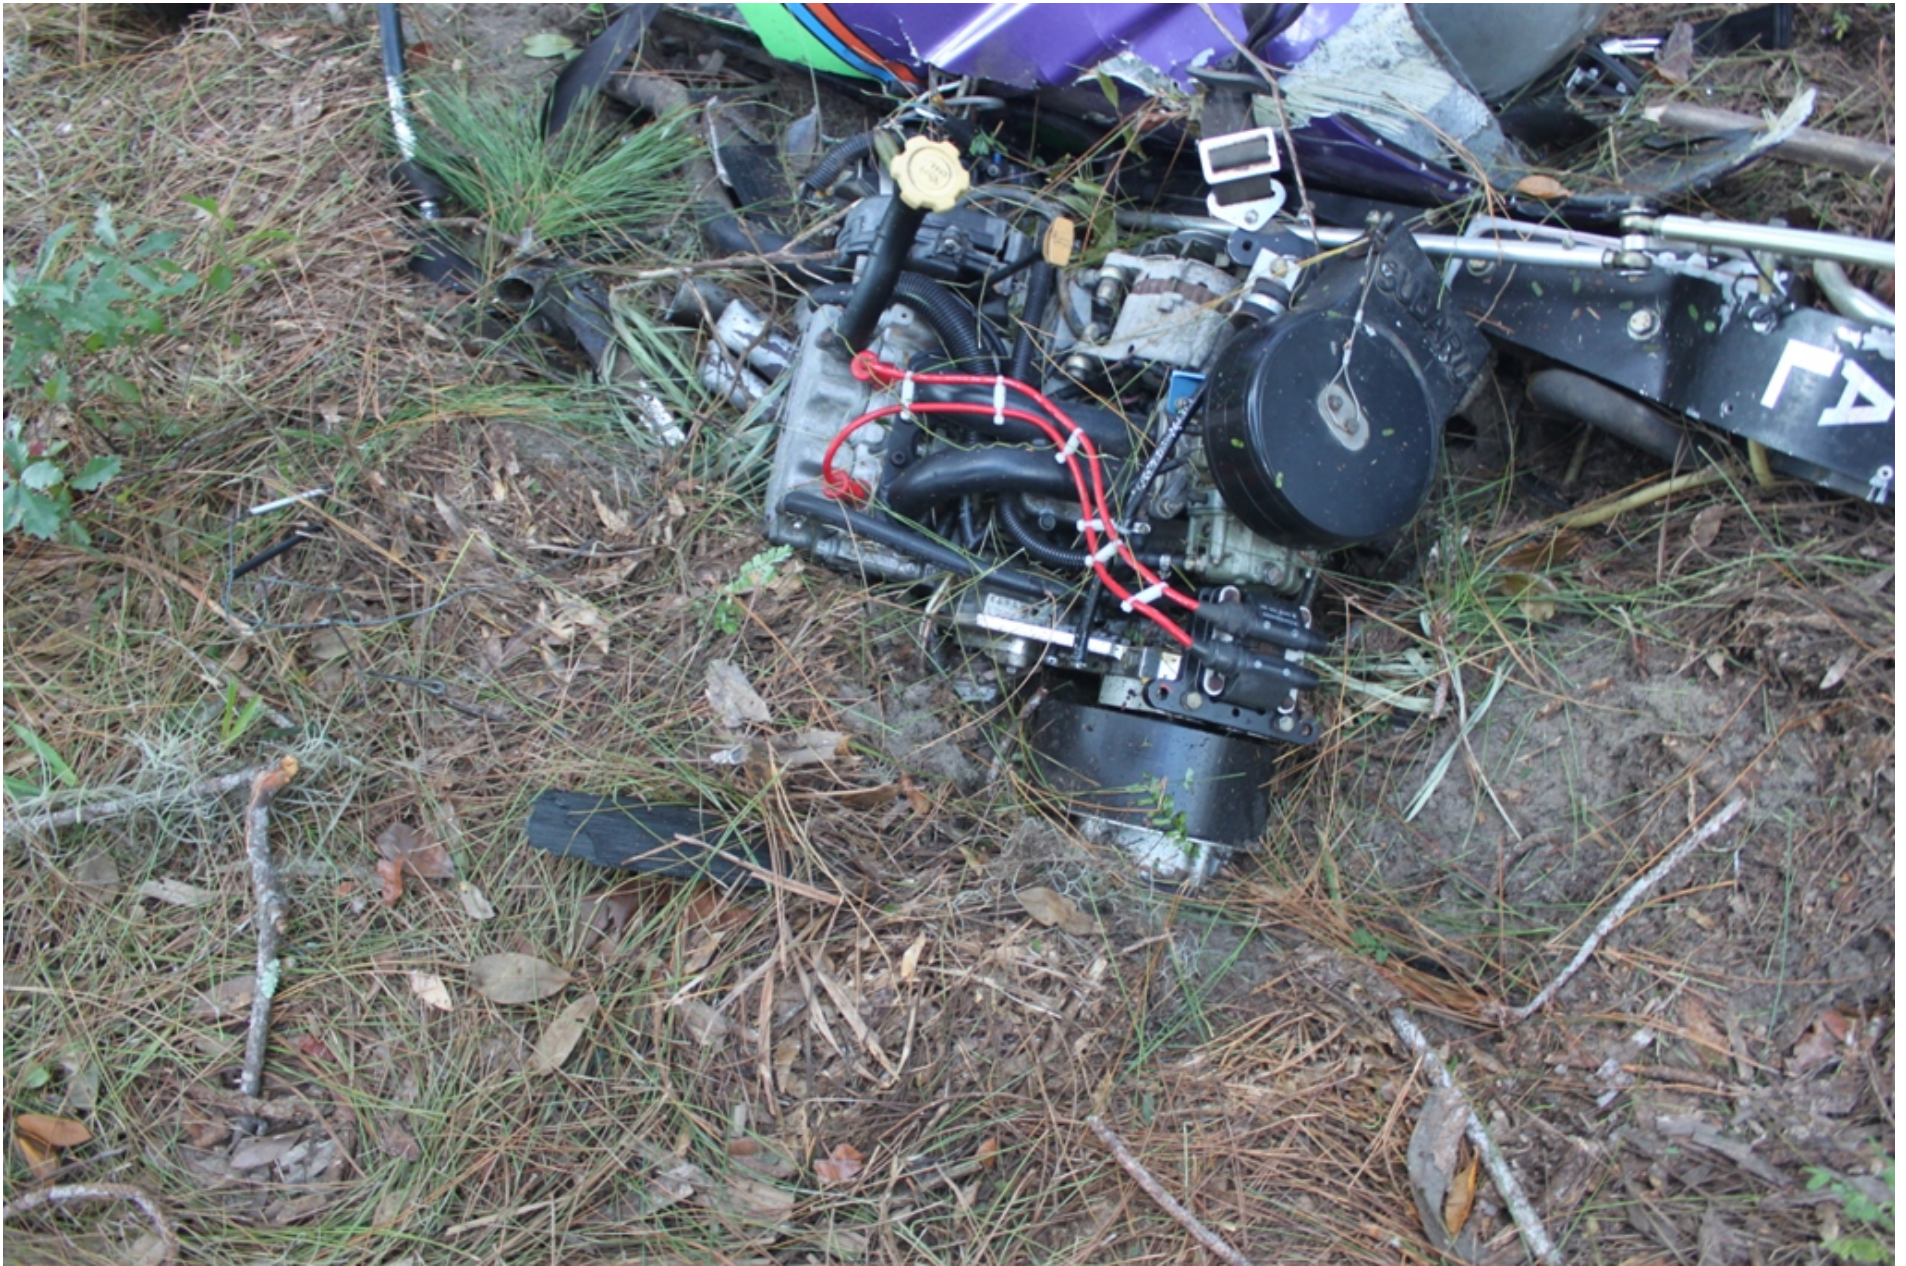
**Photo 2 - NTSB Digital Photograph. View of the Engine Assembly at the Accident Site. Note the Ignition Control Module.**

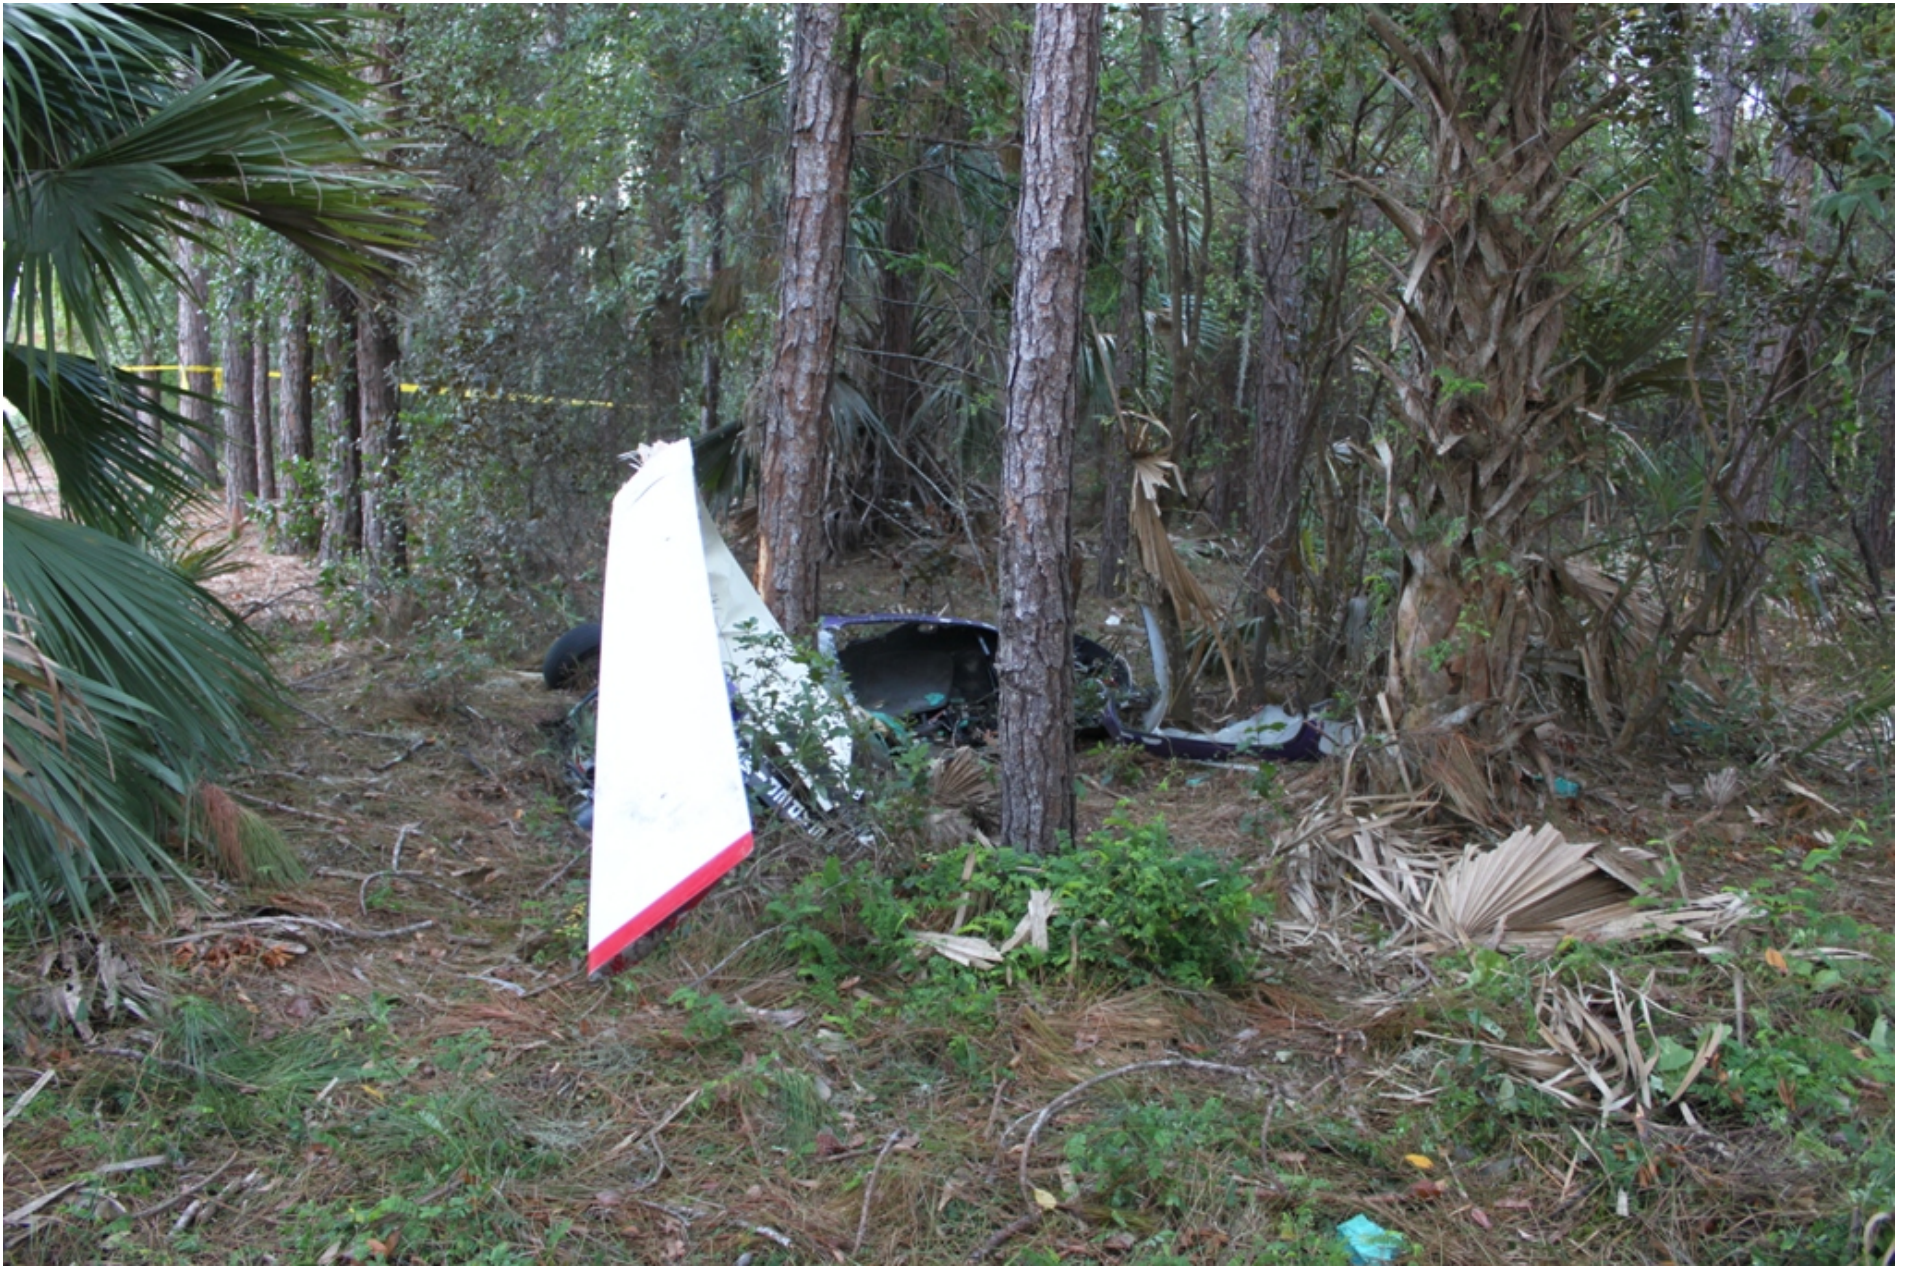
**Photo 3 - NTSB Digital Photograph. Right Rear Quartering View of the Wreckage at the Accident Site.**

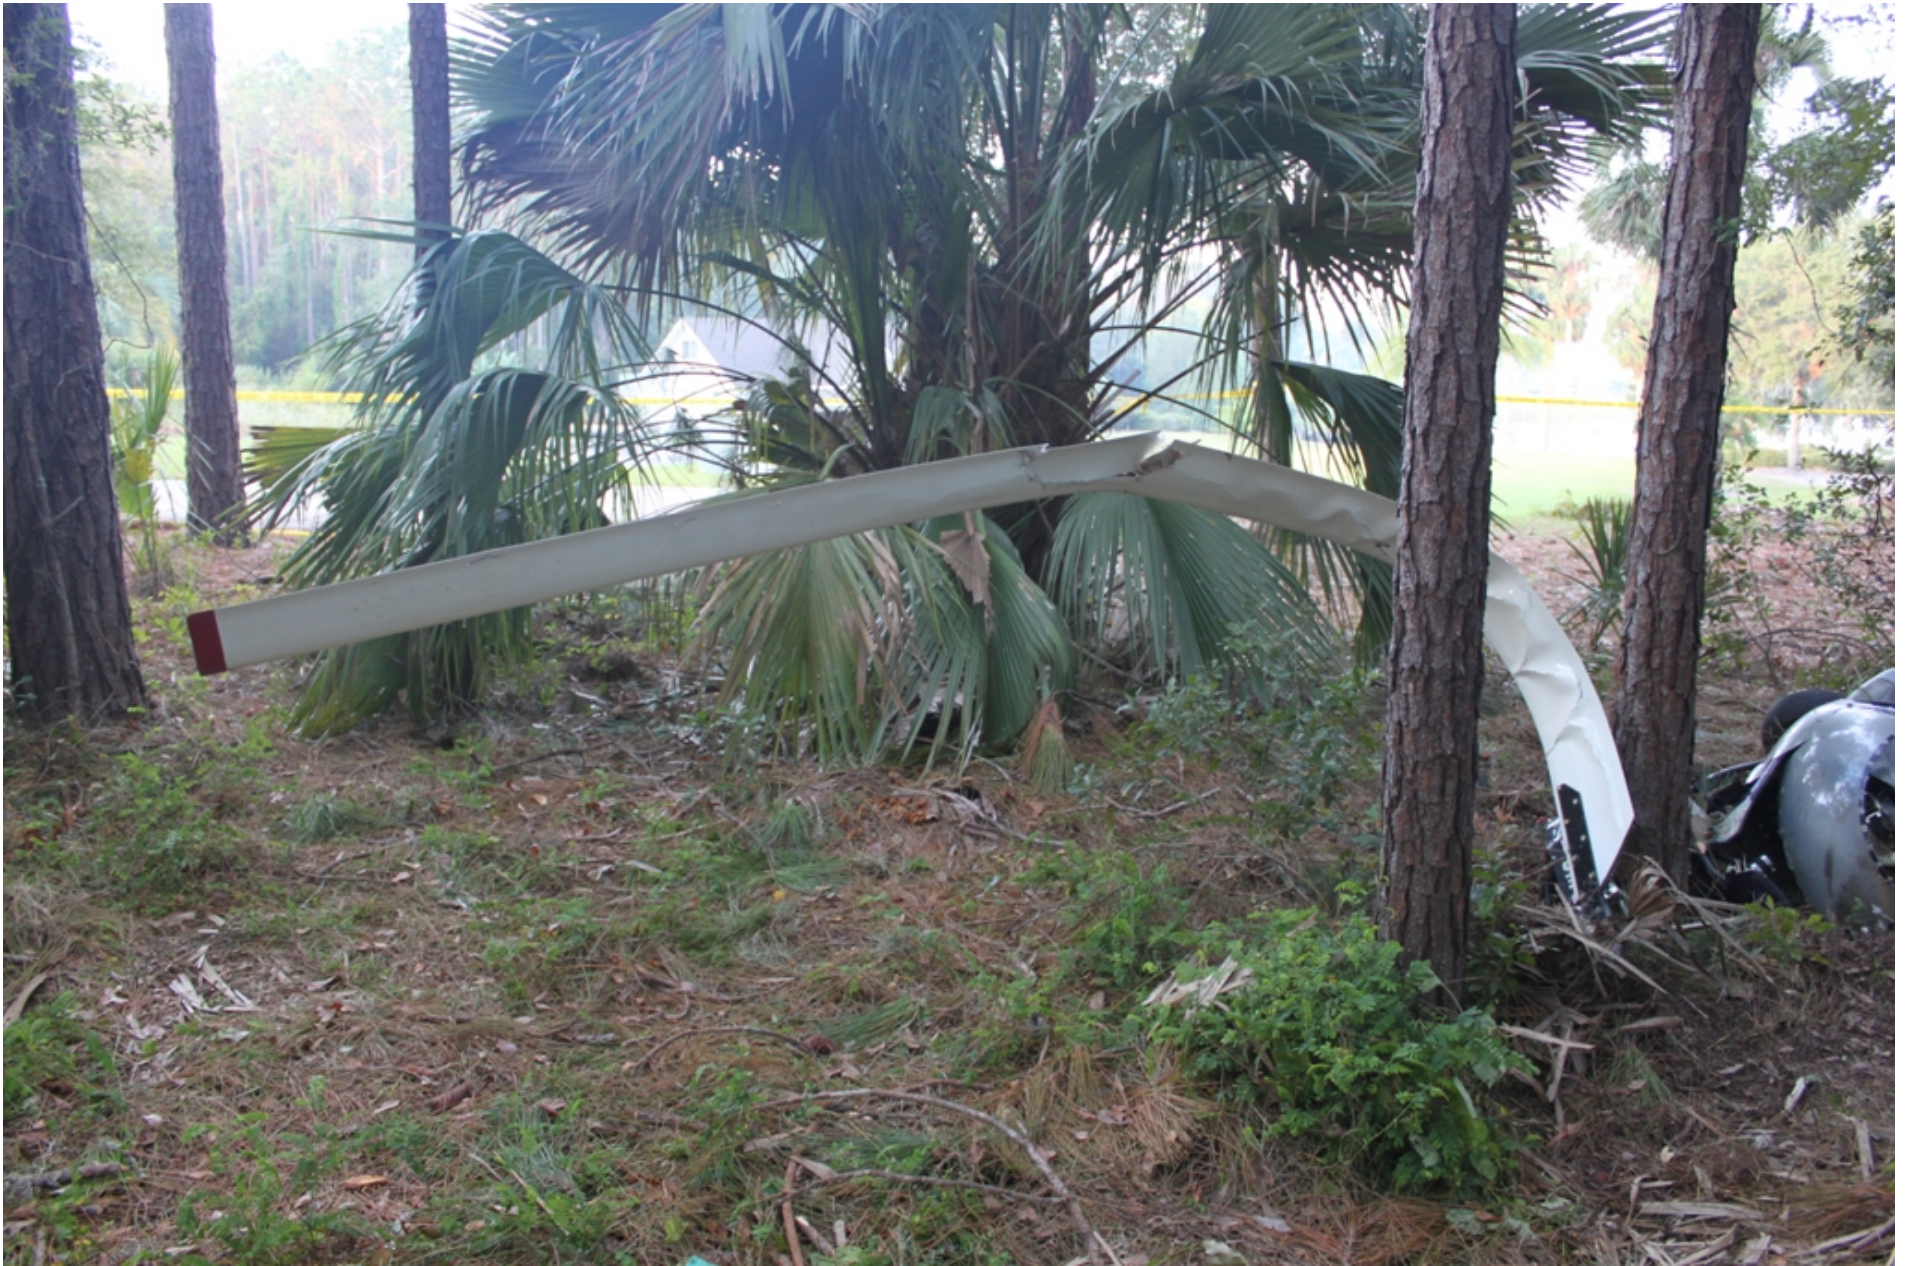
**Photo 4 - NTSB Digital Photograph. View of the Damage to One of the Main Rotor Blades.**

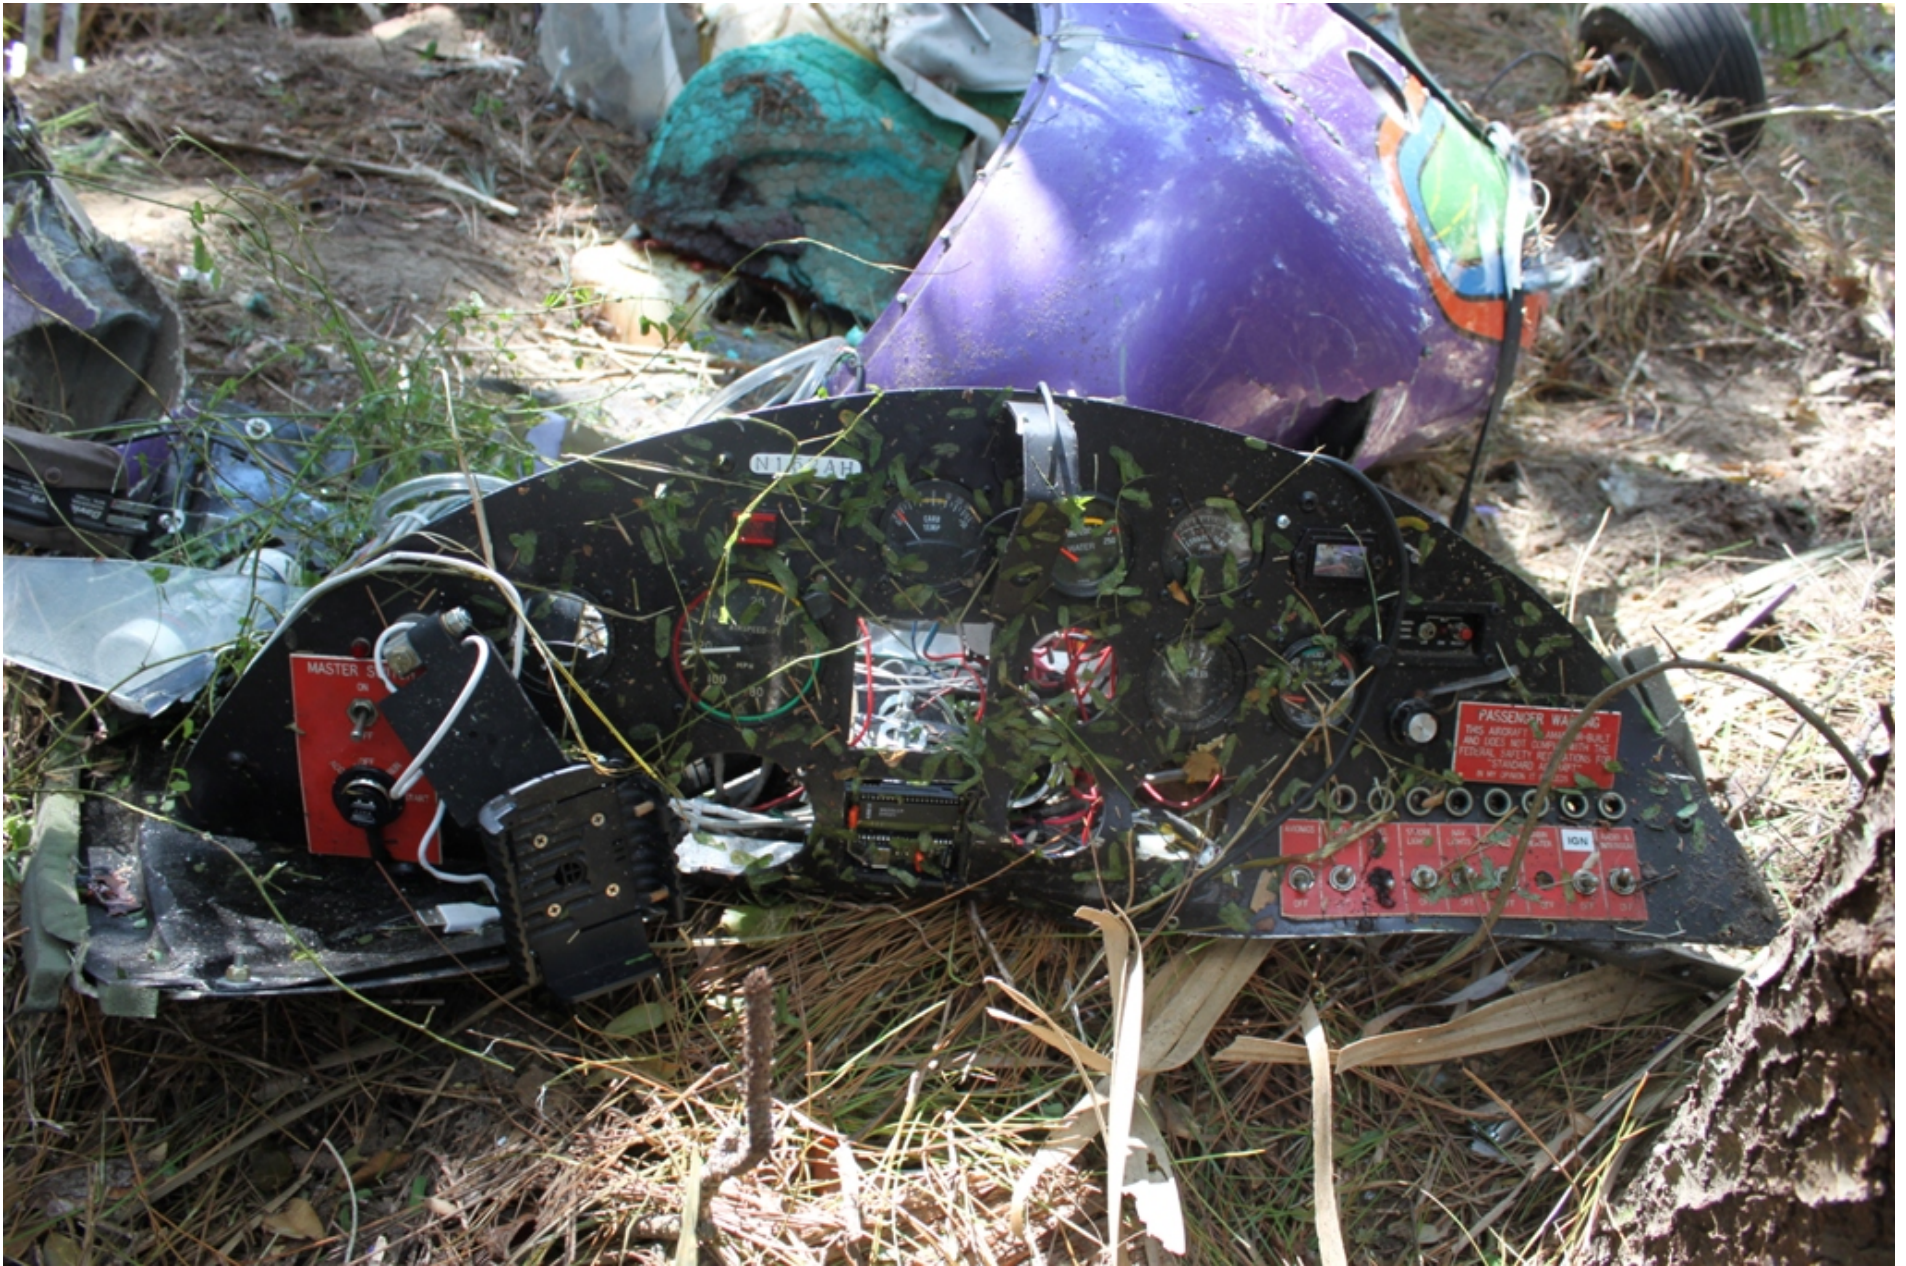
**Photo 5 - NTSB Digital Photograph. View of the Instrument Panel.**

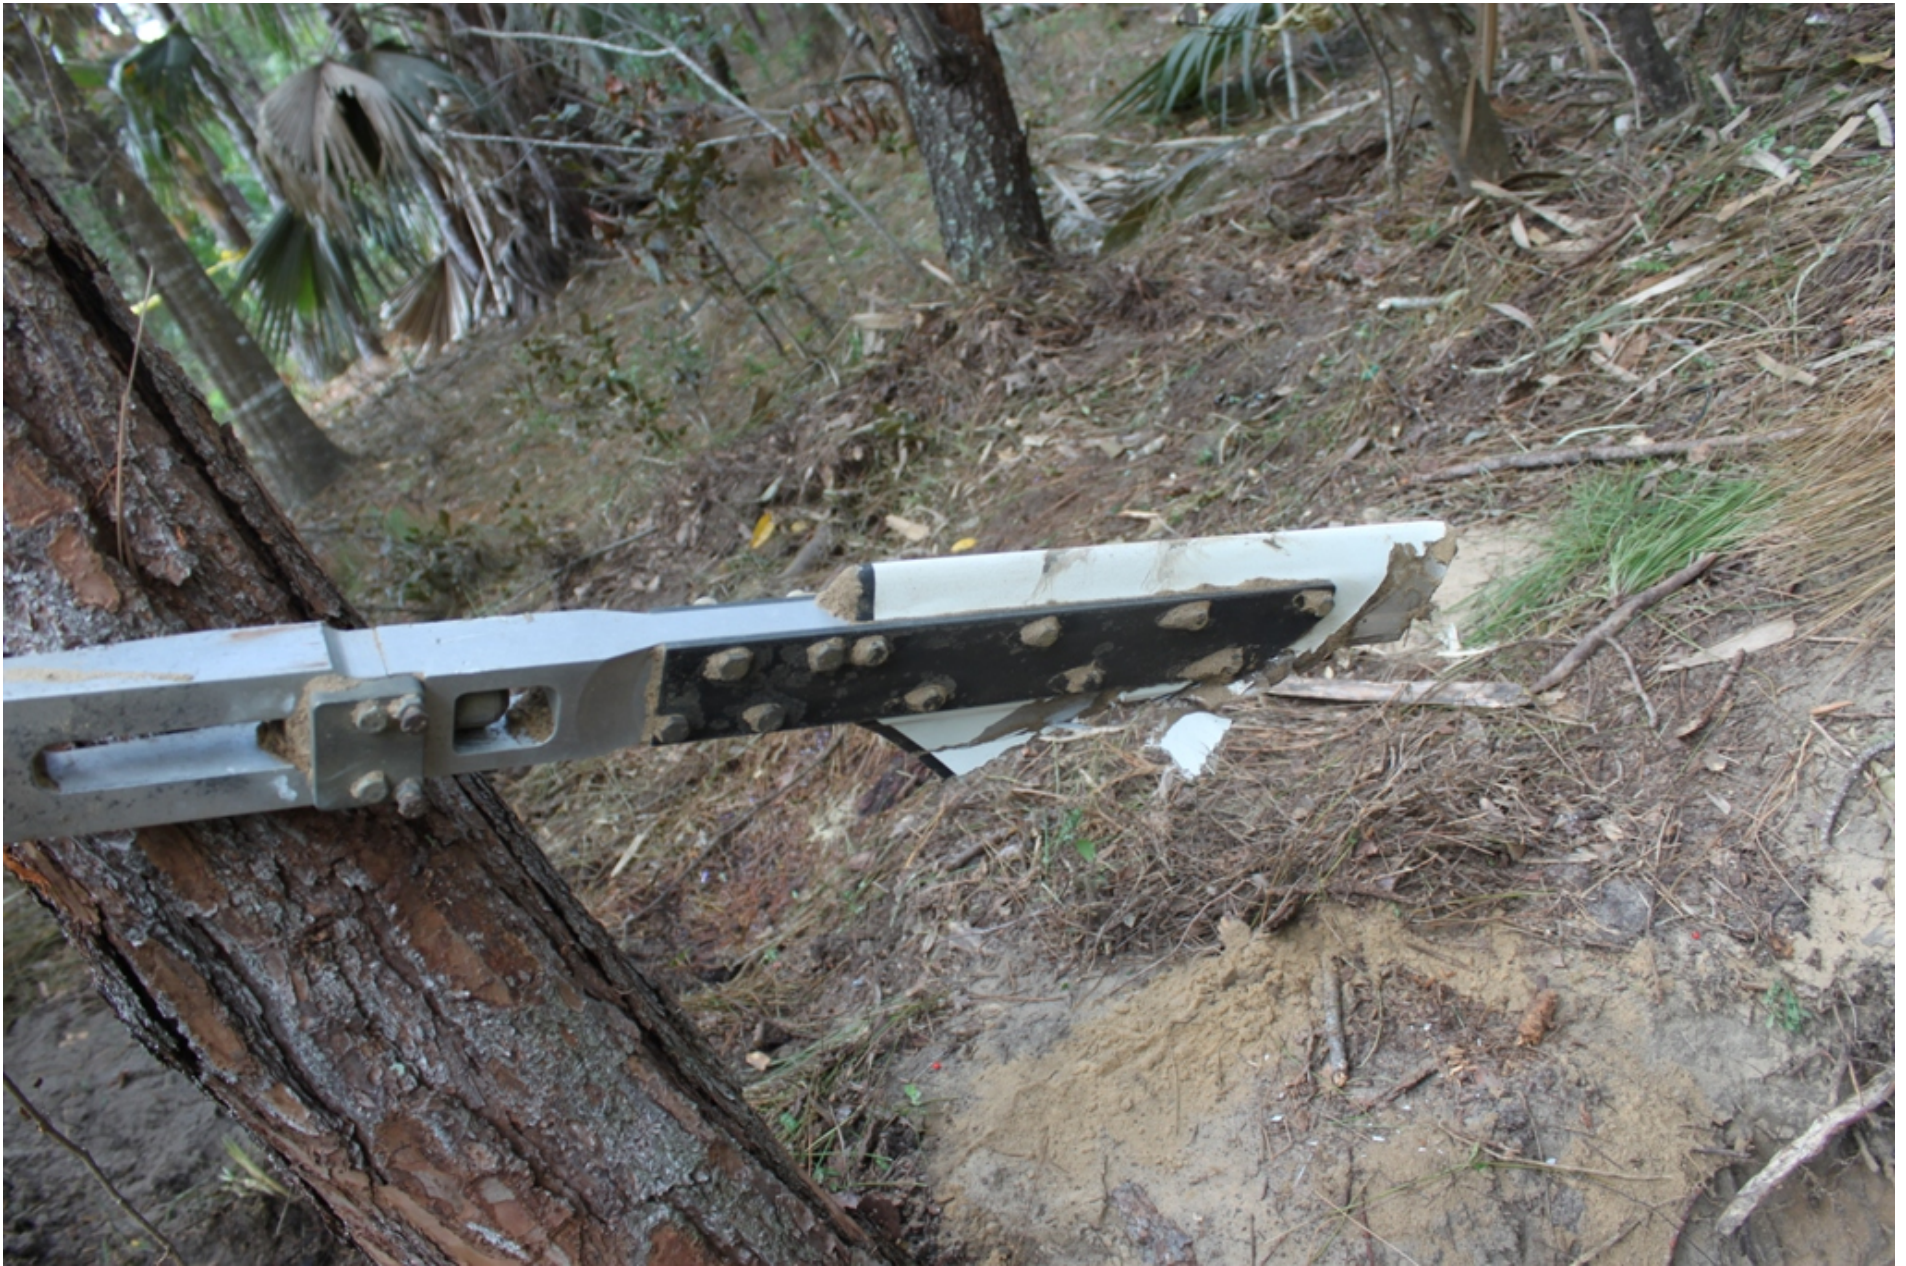
**Photo 6 - NTSB Digital Photograph. View of the Remaining Section of the Fractured Main Rotor Blade that Was Buried in the Ground.**

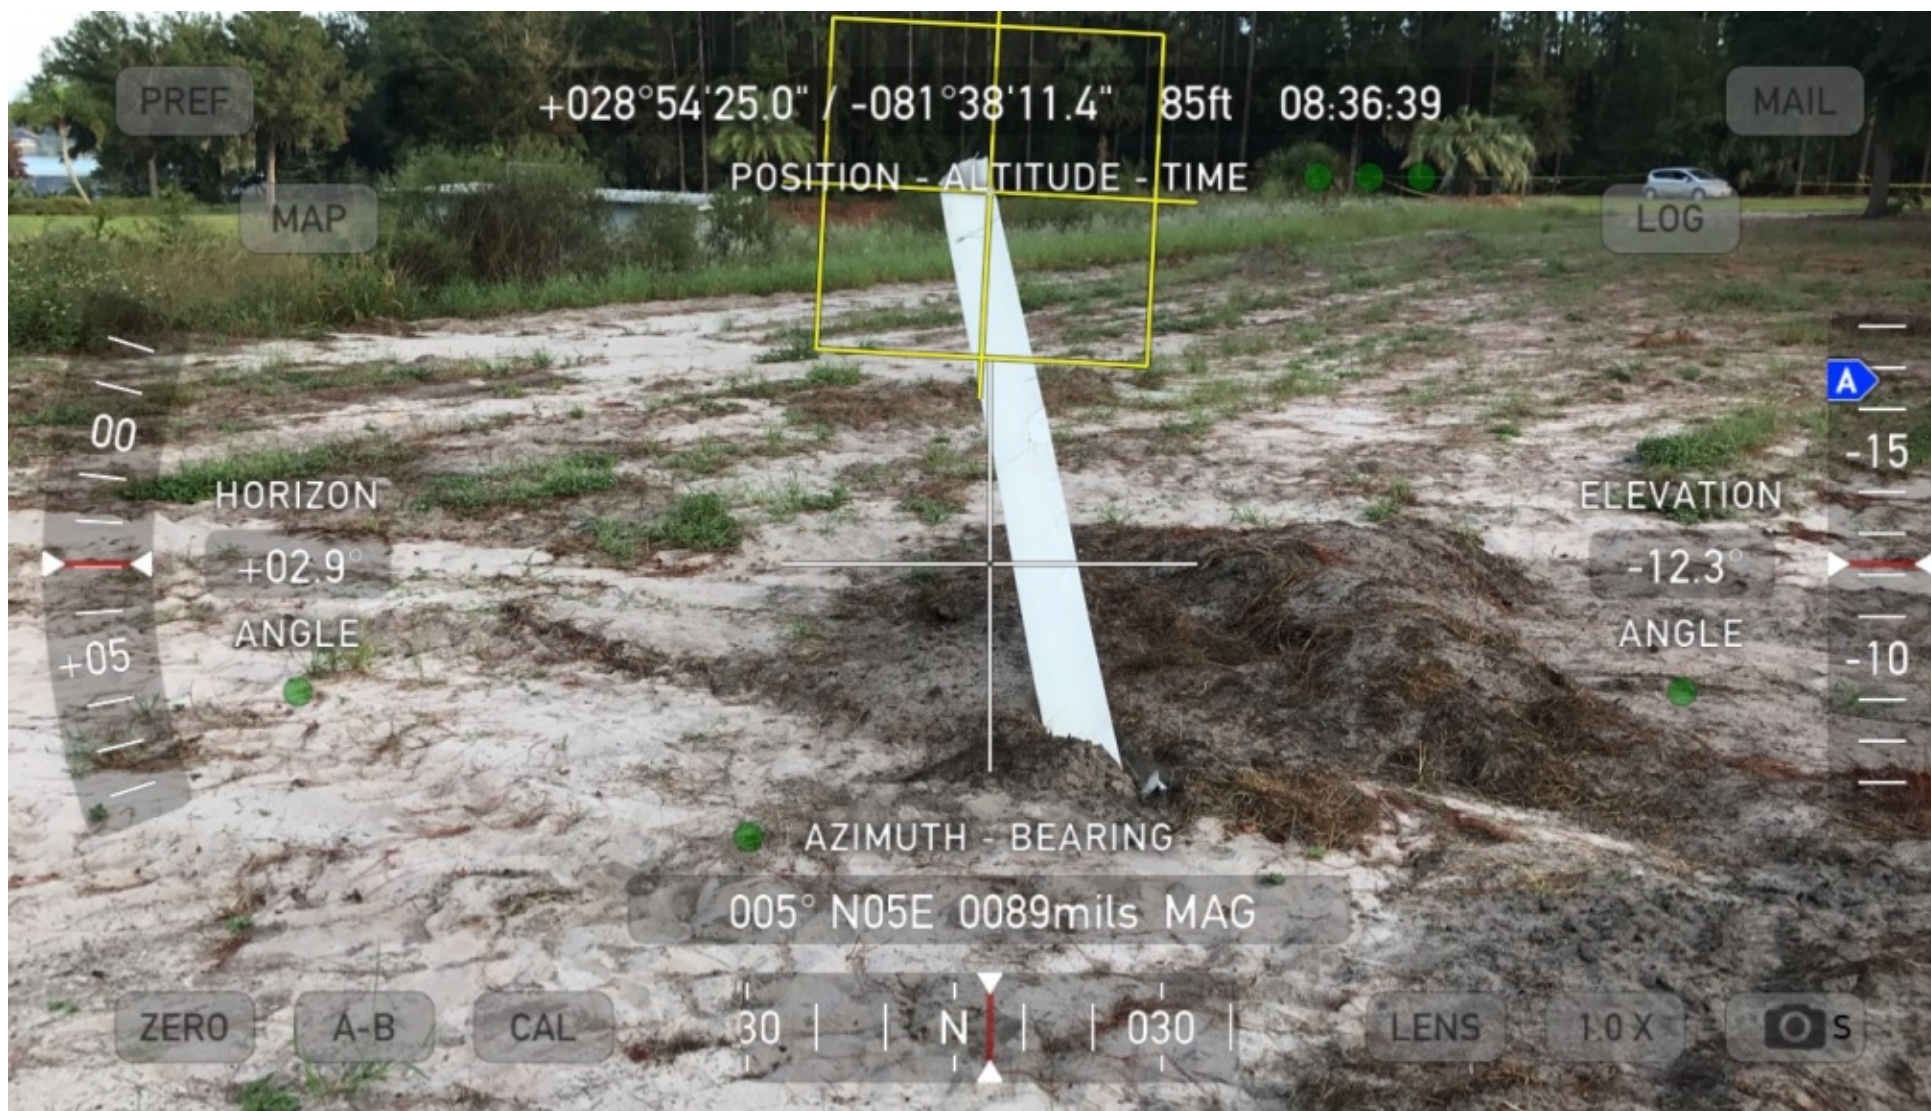
**Photo 7 - NTSB Theodolite Digital Photograph. View of the Separated Main Rotor Blade with Location Depicted.**

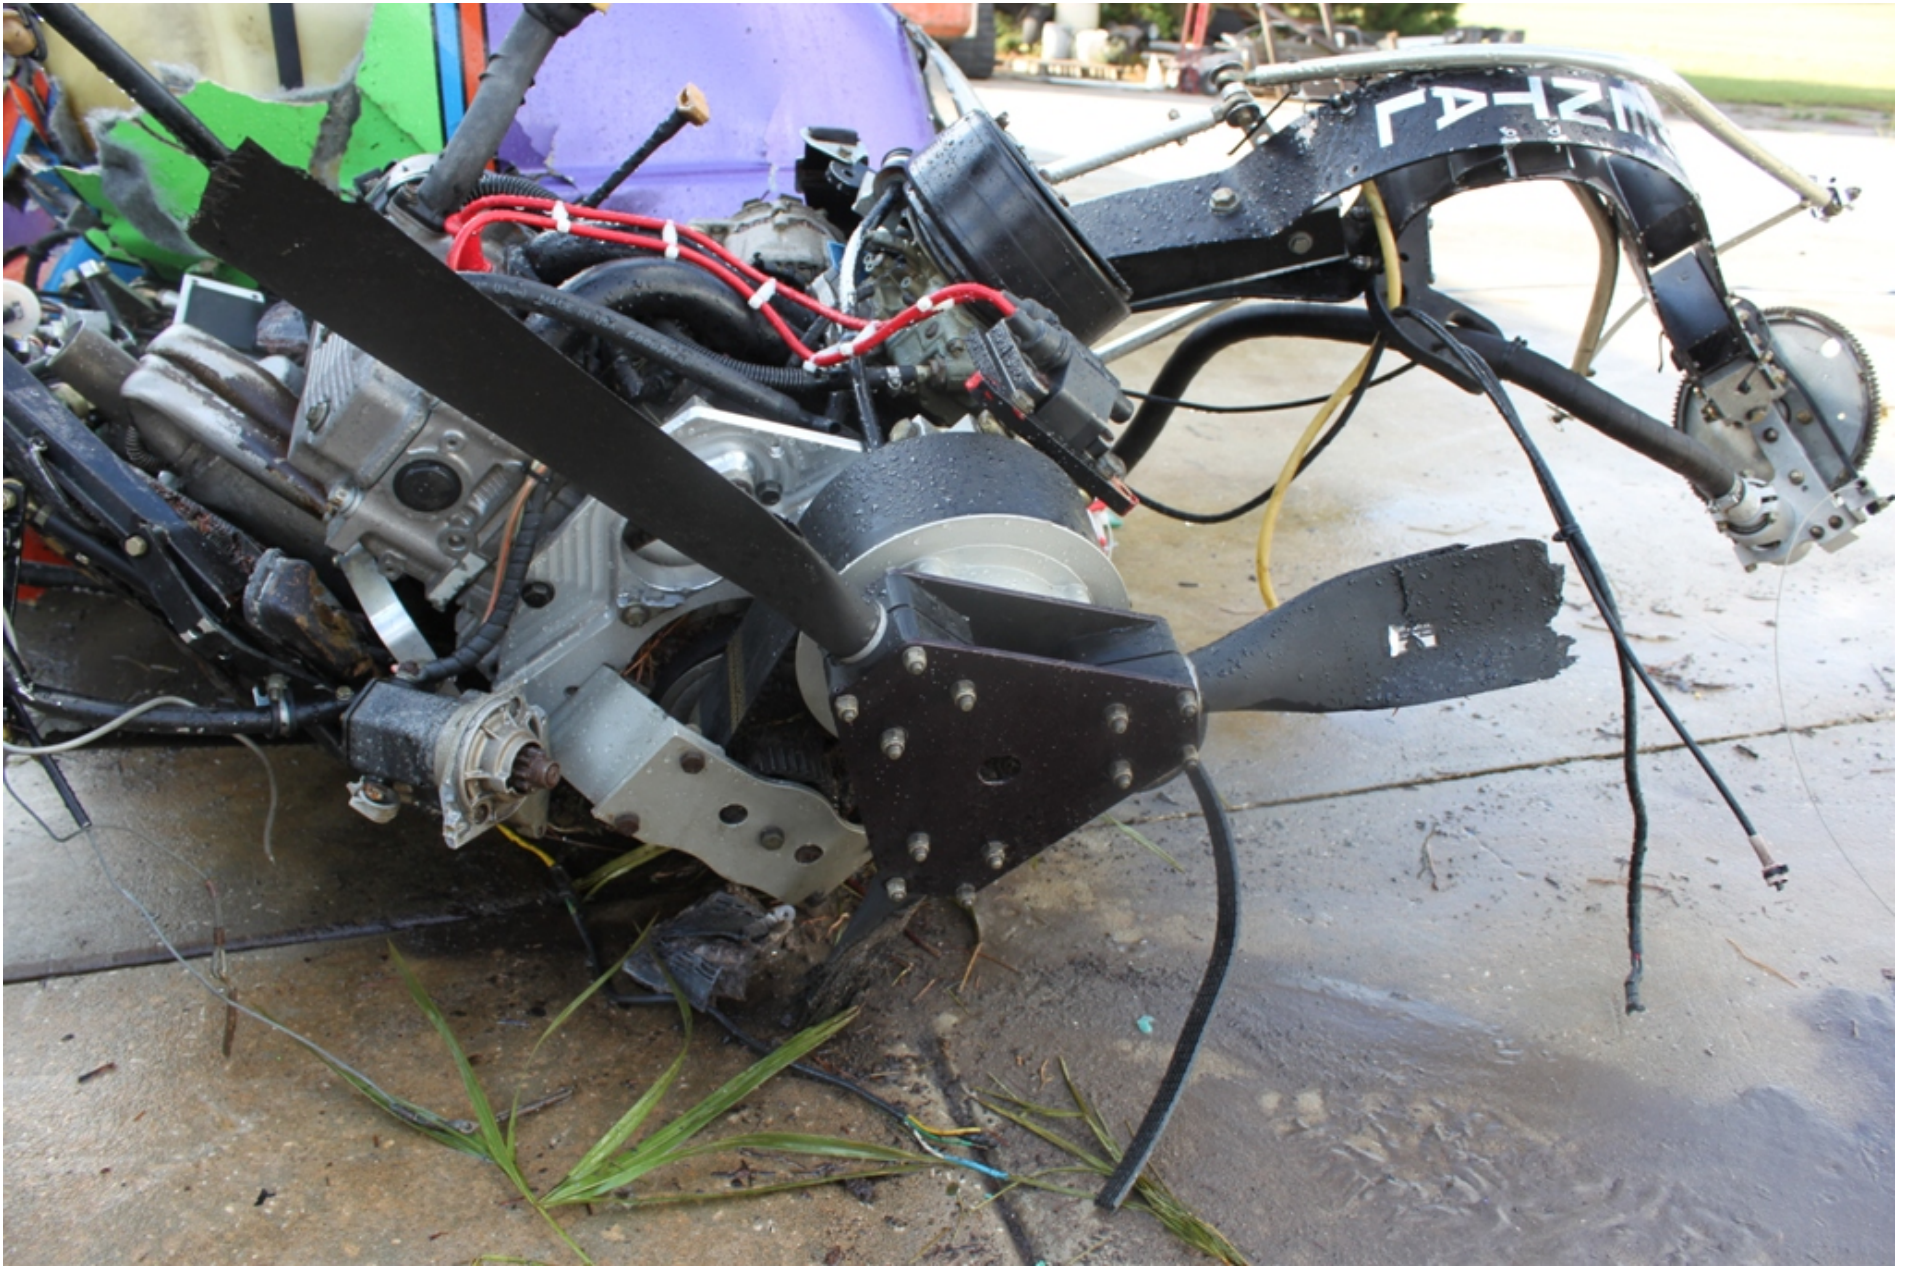
**Photo 8 - NTSB Digital Photograph. Rear View of the Engine Assembly and Propeller.**

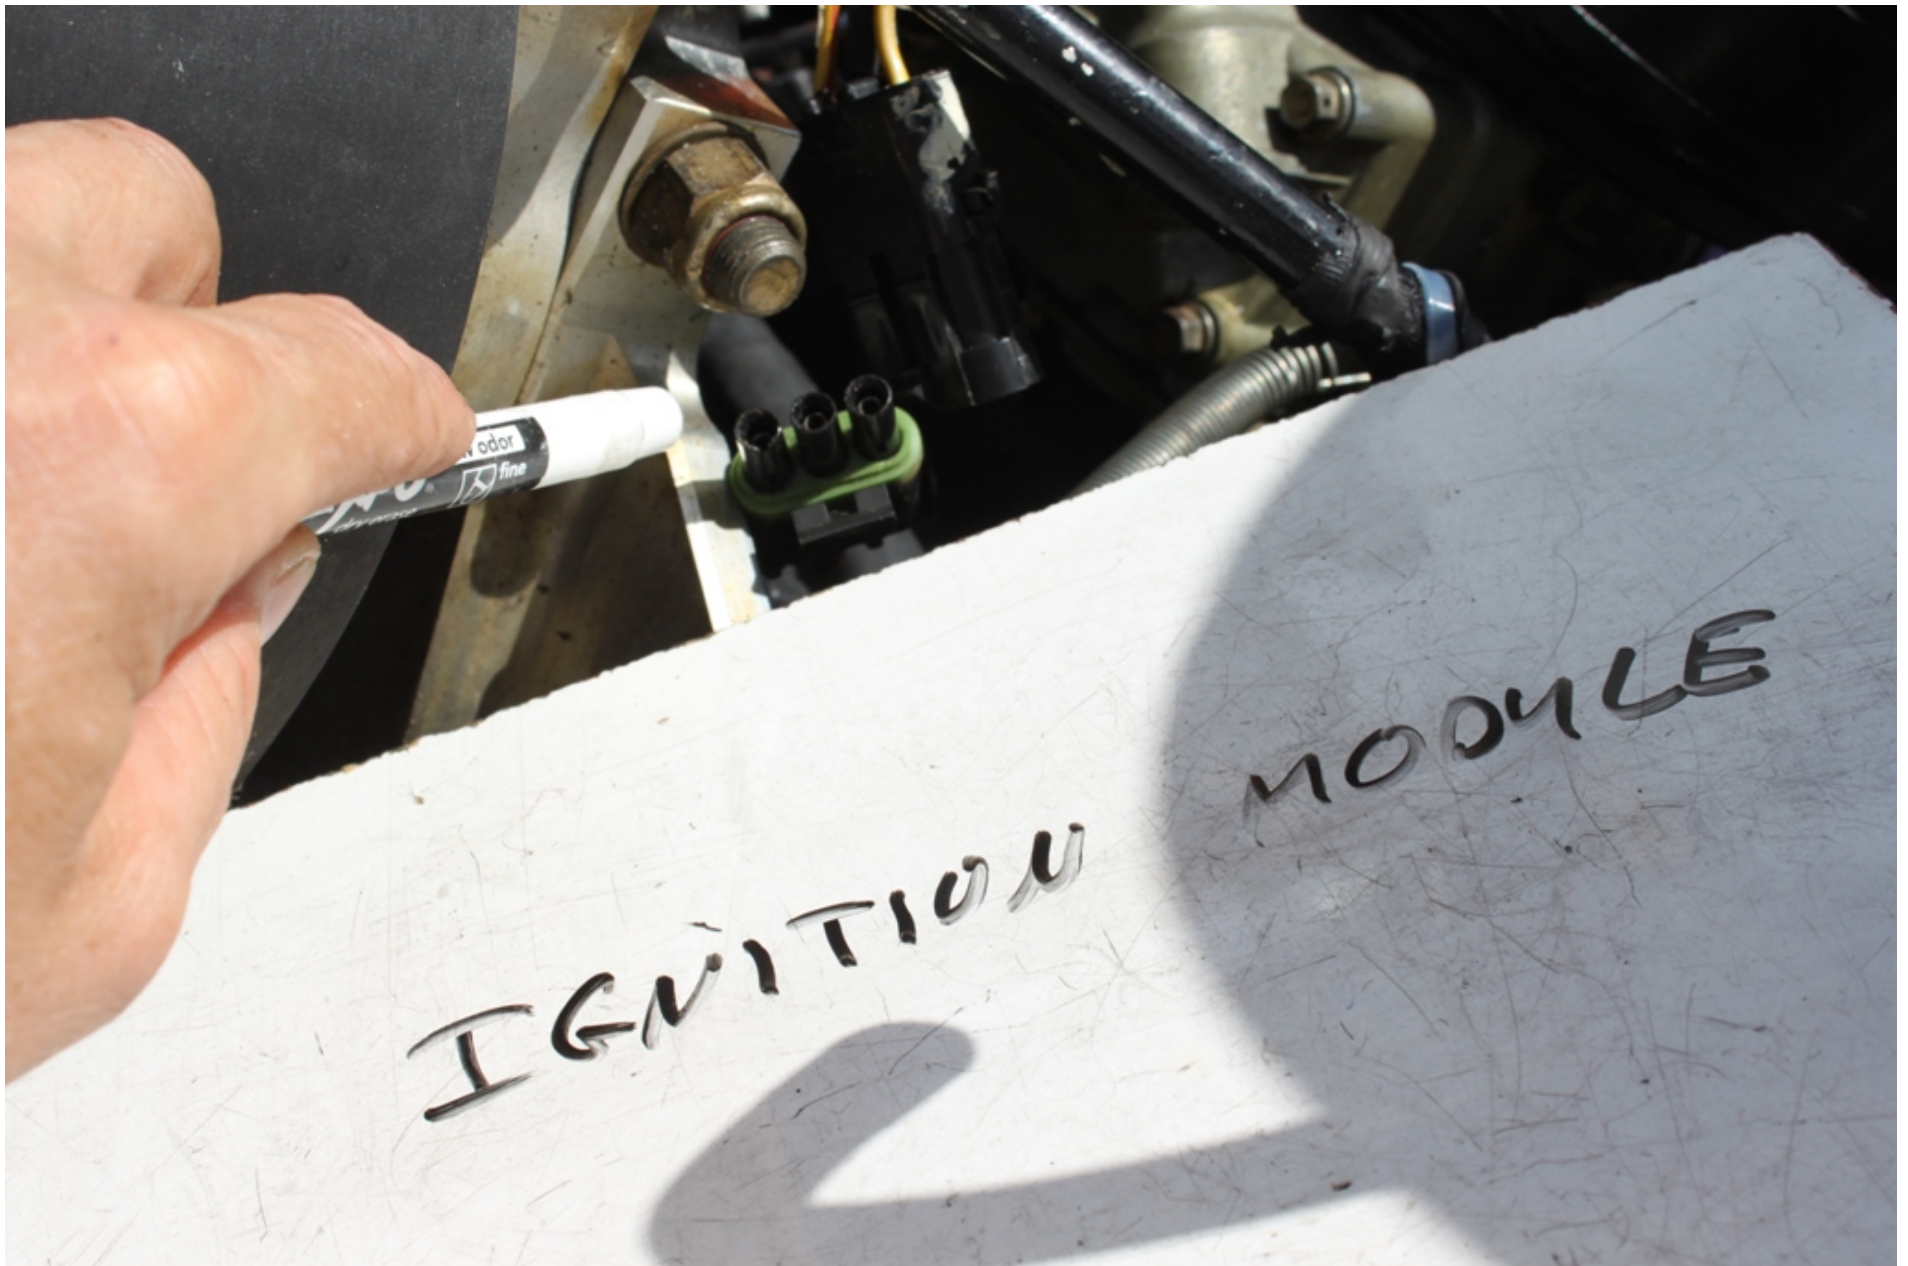
**Photo 9 - NTSB Digital Photograph. View Depicting the Separated Electrical Connection at the Ignition Control Module.**
