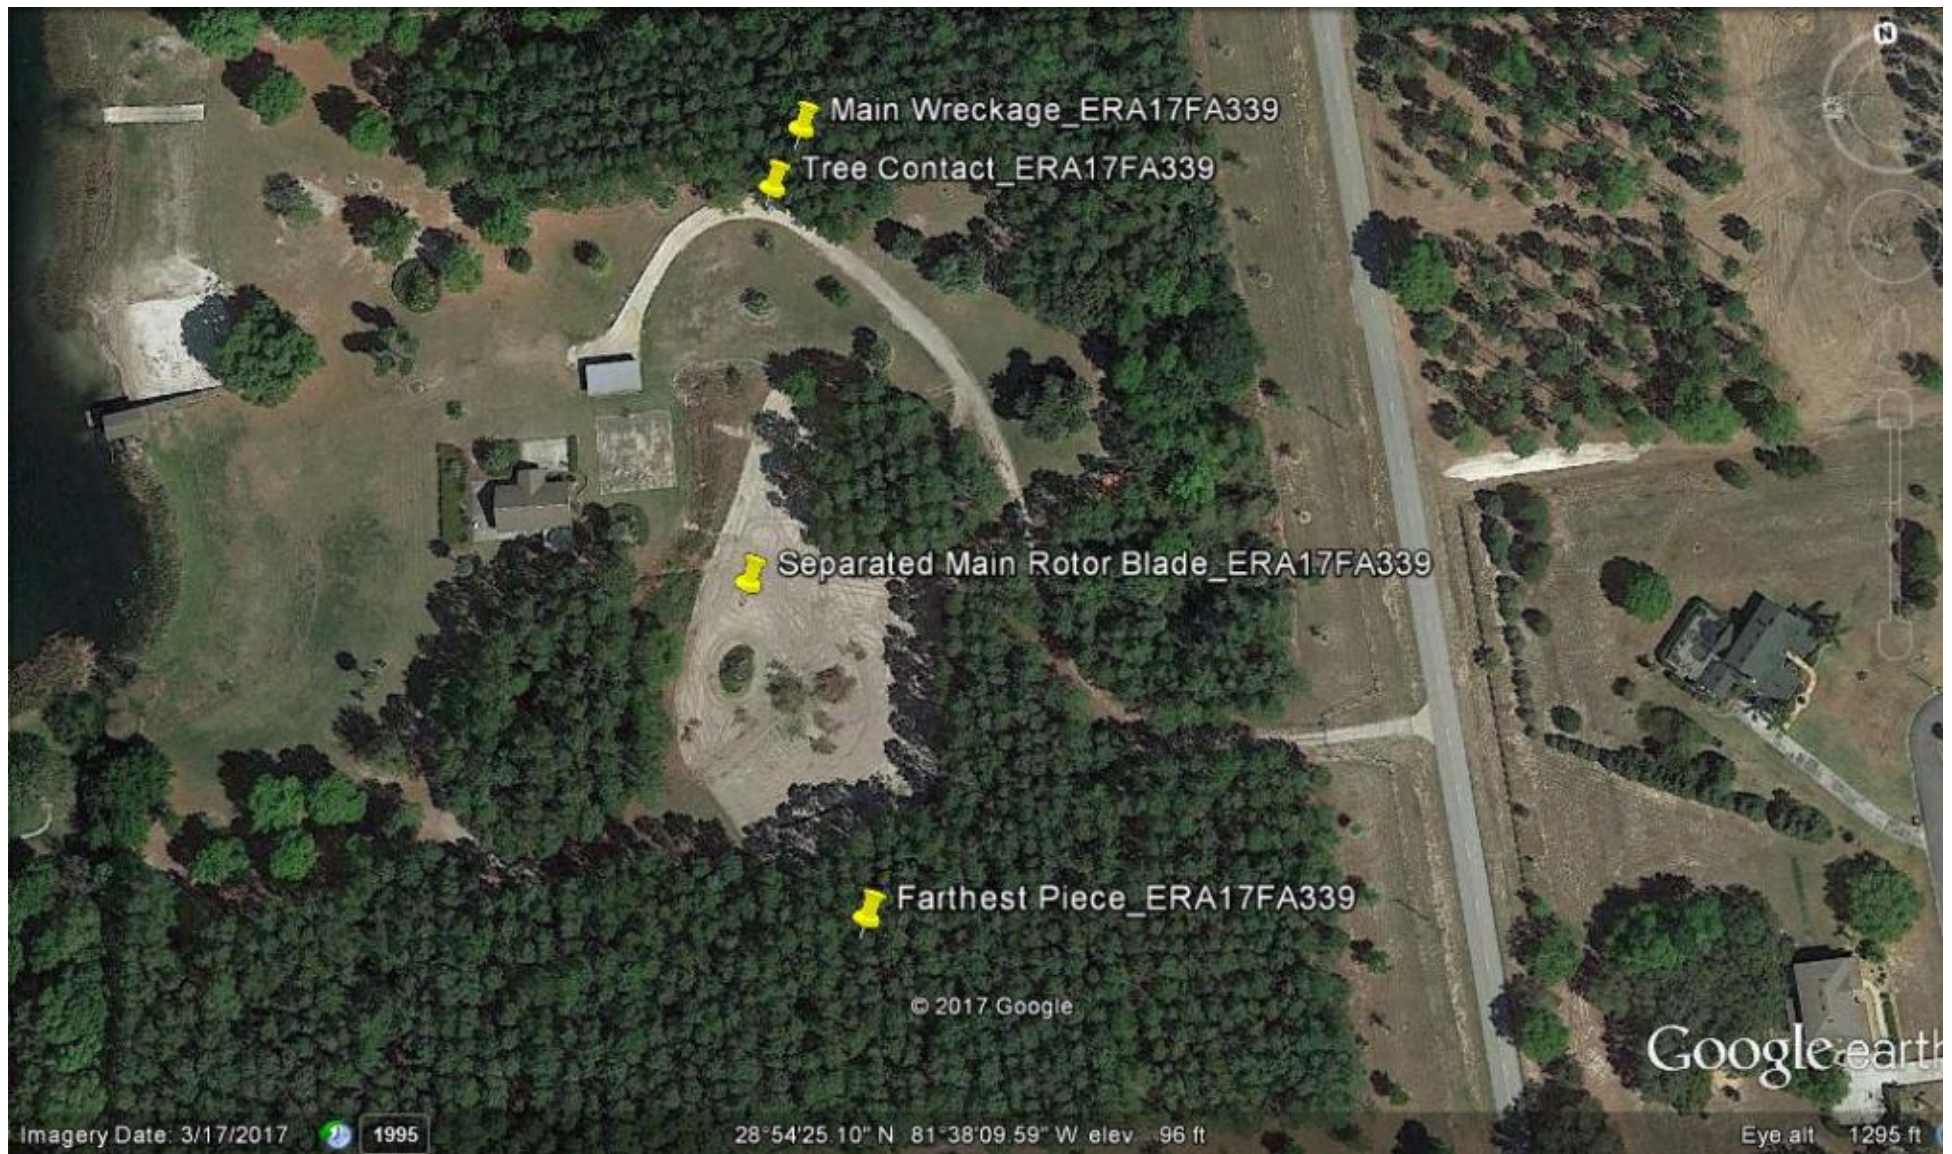
**Photo 10 – Google Earth Plot Depicting Key Position of Components.**
