ERA17FA339  
Verbiage and Pictures from NTSB Materials Laboratory

9/28/2017  
Umatilla, FL  
Hickox Andy Gyroplane, N152AH  
ERA17FA339

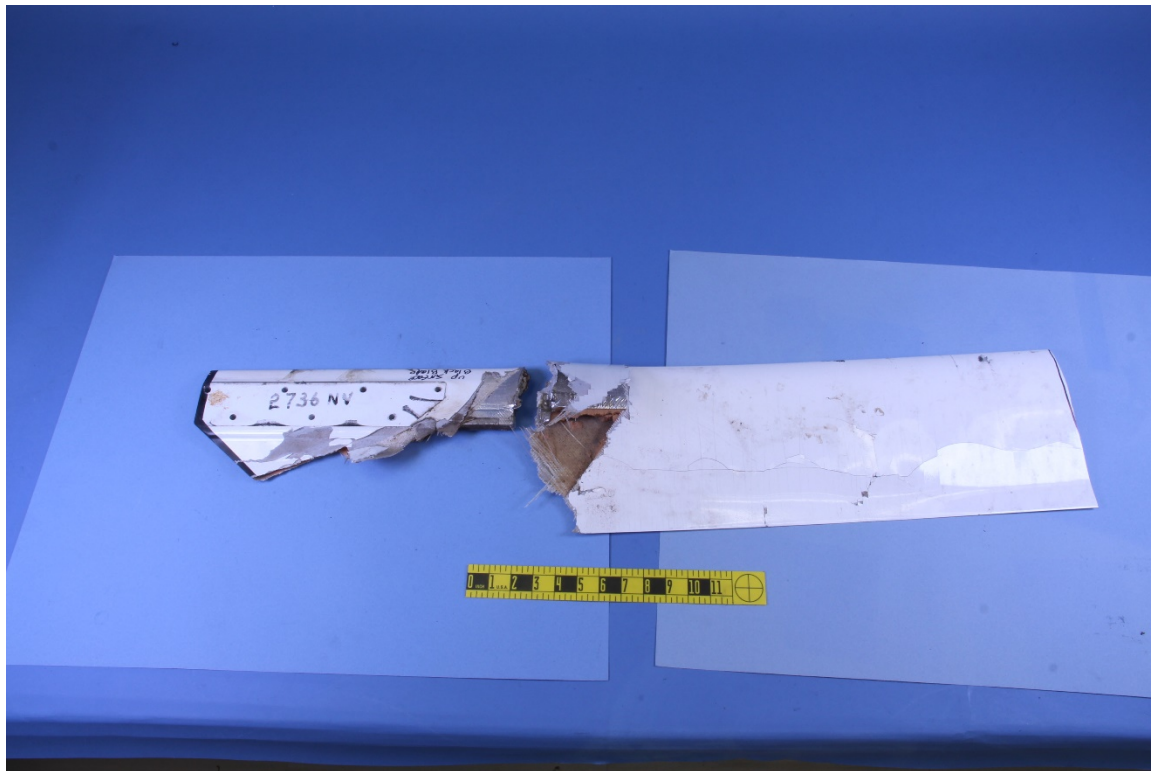
Figure 1: NTSB Photograph IMG\_0216

Three images are attached to this email. One showing the two blade pieces as-received (IMG\_0216) a second (IMG\_0221) showing a close up of the fracture area and a third (IMG\_0220) with the fracture faces in close proximity depicting the amount of deformation and blade bending that was present at the time of the spar fracture.

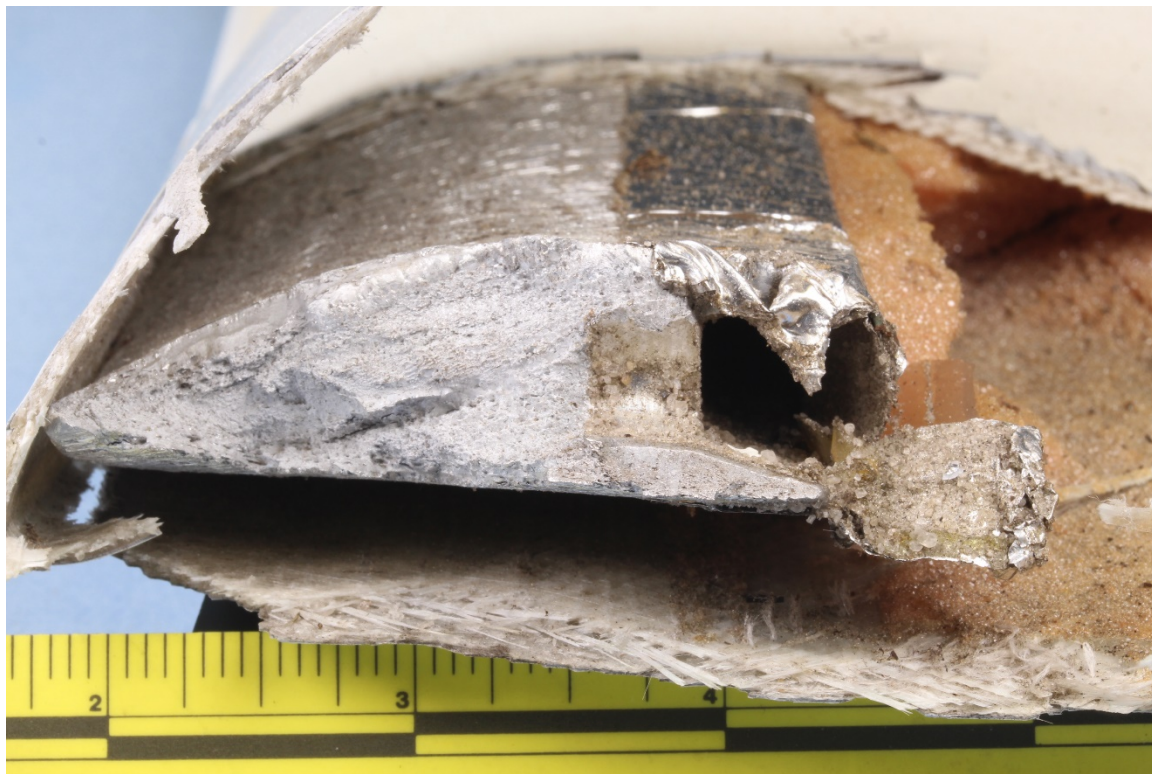
Figure 2: NTSB Photograph IMG\_0221

Two pieces of a fractured main rotor blade were examined in the NTSB Material Laboratory. The blade consisted of an aluminum main spar with a composite airfoil wrapped around the spar. Visual examination revealed a highly textured matte gray fracture surface consistent with an overstress separation. No indications of preexisting cracking such as fatigue or corrosion were noted at the fracture. The adjacent portions of the spar and skin were deformed and cracked indicating nearly 90 degrees of blade bending when the spar separation occurred.
