# Continental Motors

## ENGINE FIELD INSPECTION REPORT

| ENGINE MODEL | O-200-A(48) |
| FILE NUMBER | 16-227 |

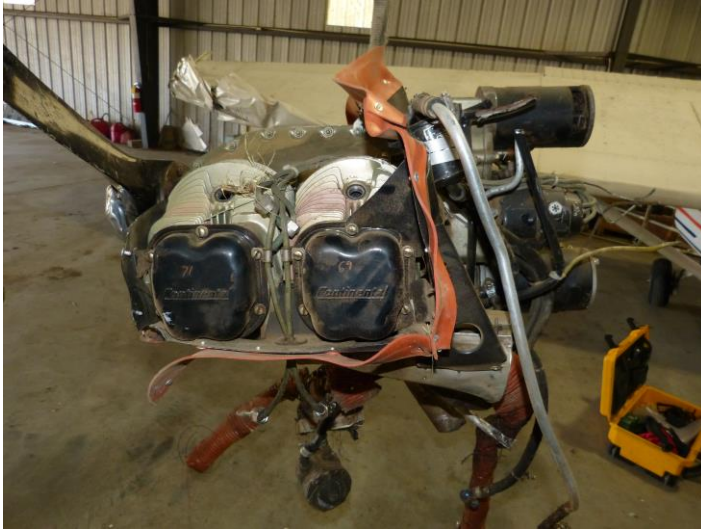
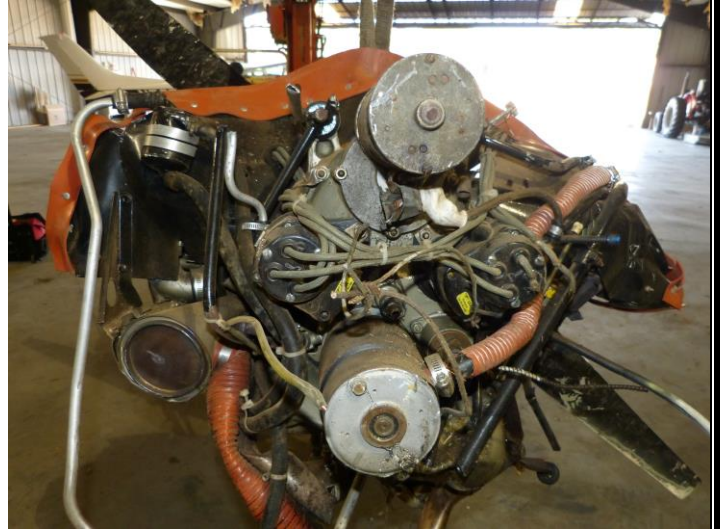
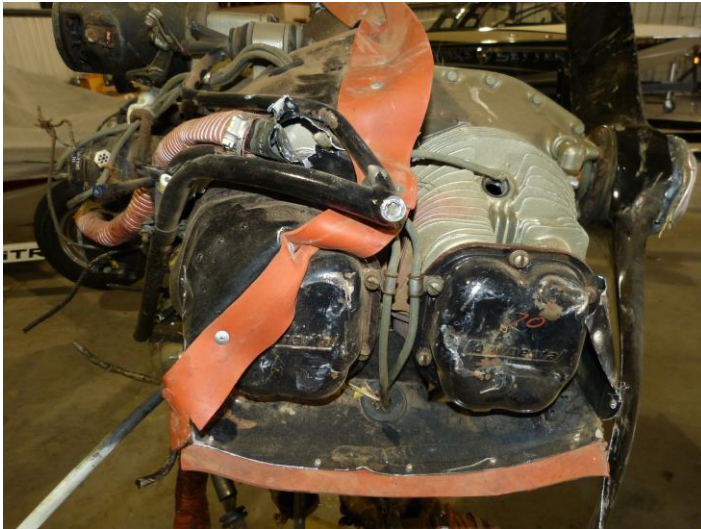
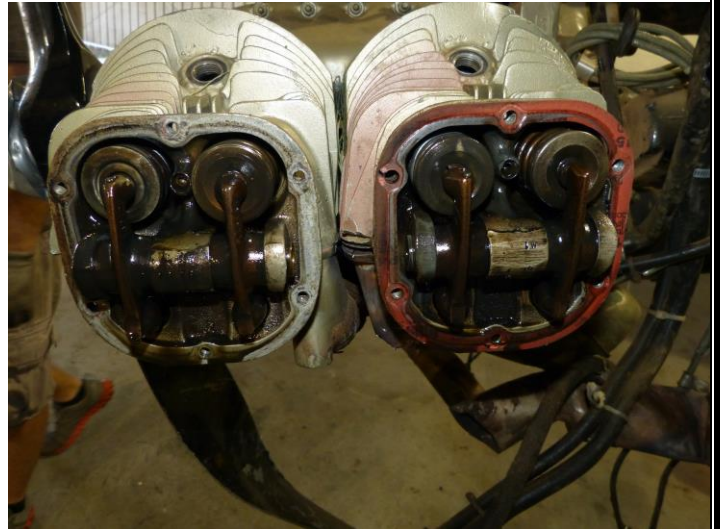
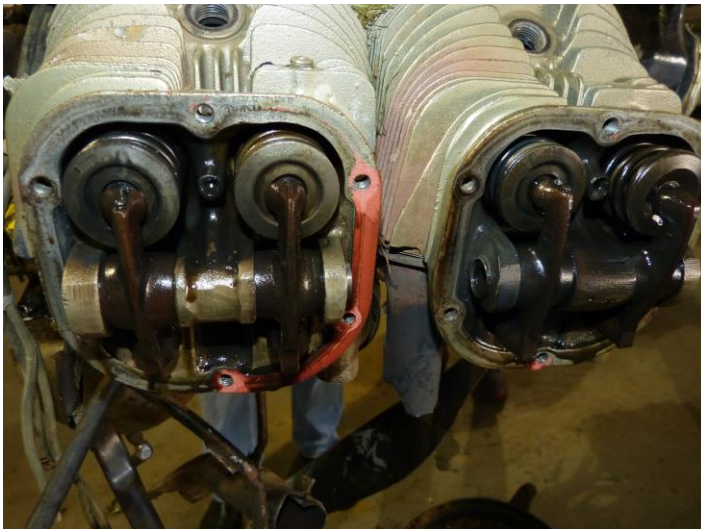
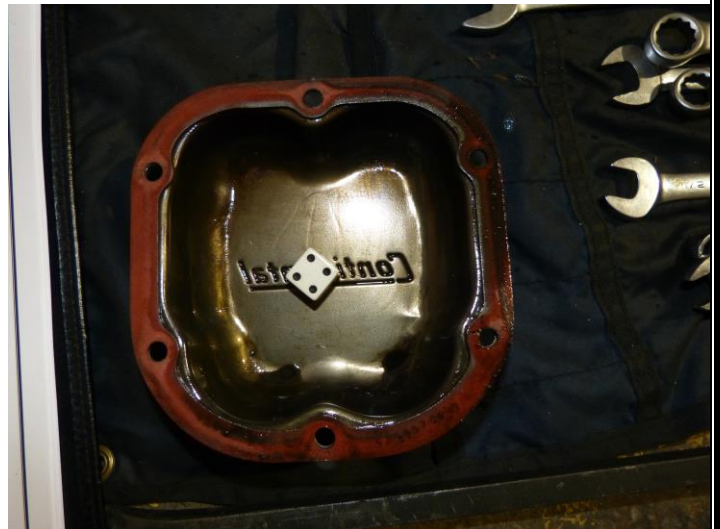
The engine was intact with the vacuum pump, carburetor, and the right side muffler separated. The carburetor was hanging by the mixture control wire. The left side muffler was crushed up into the left side cylinders. The oil sump was pushed up and to the rear. The rear baffling was pushed forward.

The cylinders were examined using a lighted boroscope. The cylinders all had dark deposits on the pistons and cylinder domes. All of the valves were in place.

The rocker covers were removed and the crankshaft was rotated. Continuity was confirmed to cylinders one, two, and three. Good thumb compression was confirmed to cylinders one, two, and three. The number four cylinder exhaust valve was found to be stuck in the full open positions. Impact damage was observed on the number four cylinder exhaust push rod tube, and the rocker arm was stiff and hard to rotate. The number four cylinder was removed and examined. The exhaust valve had to be driven out of the cylinder with a drift and a hammer. The valve stem was dark and coated with a carbon type material.

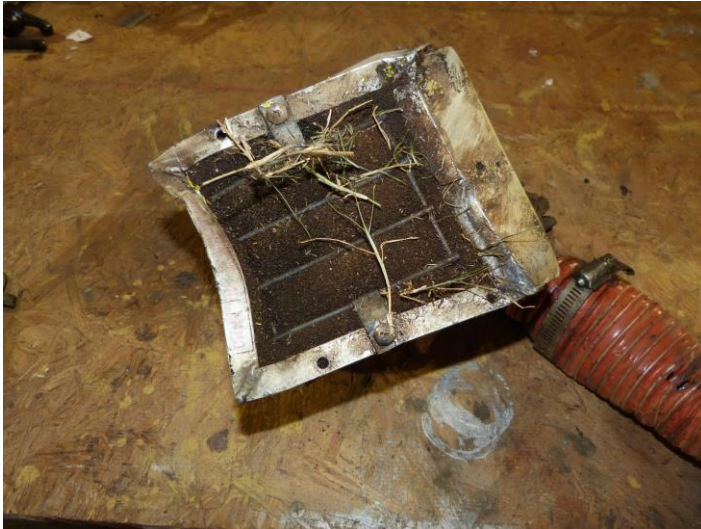
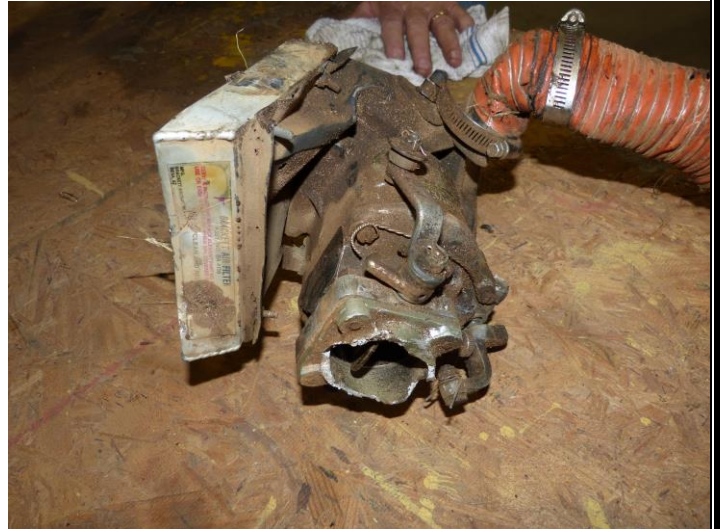
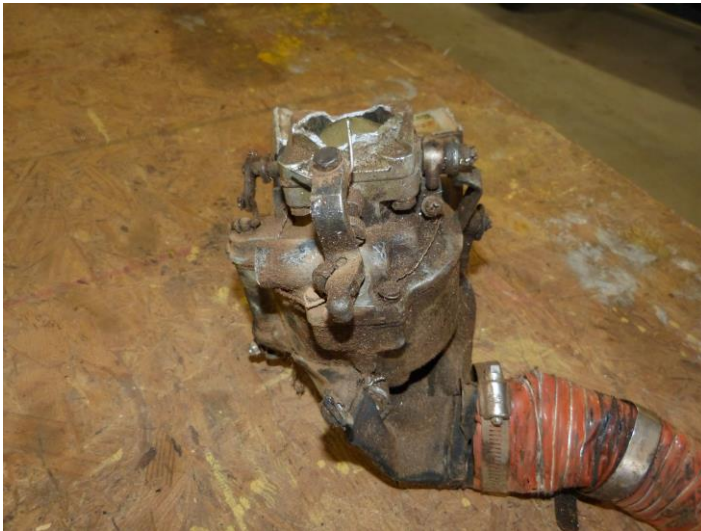
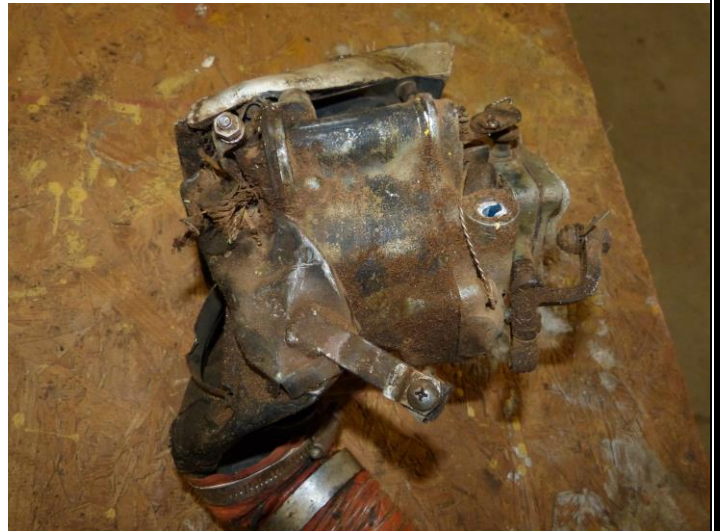
Carburetor: Marvel Schebler, MA3-SPA, PN-10-4894, SN-1226??

The carburetor was separated and impact damaged. The throttle control was separated, but the actuating arm was free to move. The mixture control was hooked up and was free move. The carburetor heat control was in the center position and would not move. There was no fuel screen installed. The carburetor was disassembled and no fuel was found. The bowl was clean and dry. The floats were intact and attached to the needle valve. The needle valve seat was clean.

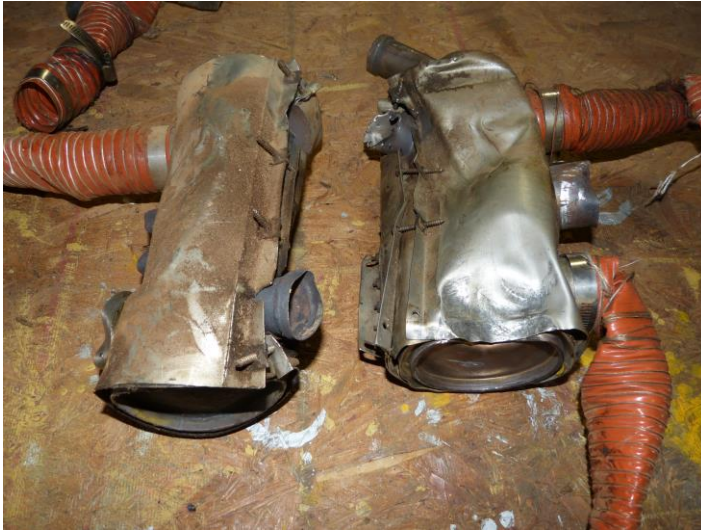
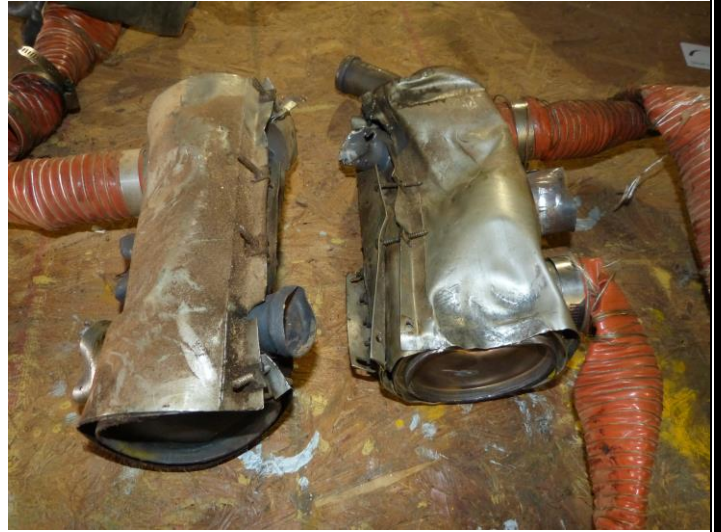
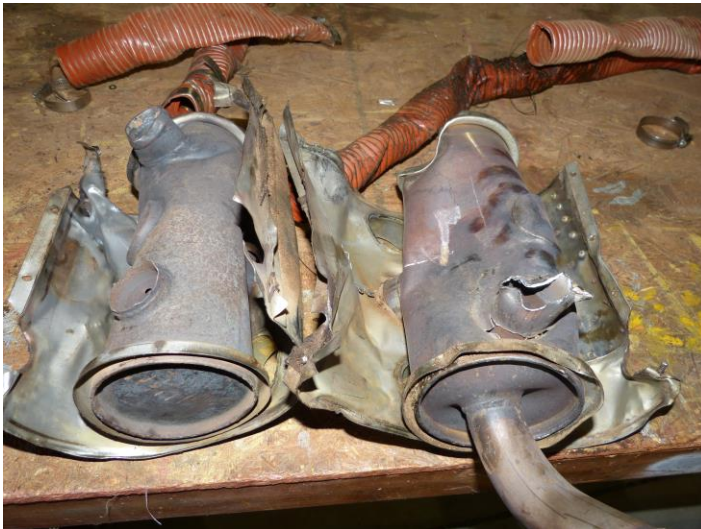
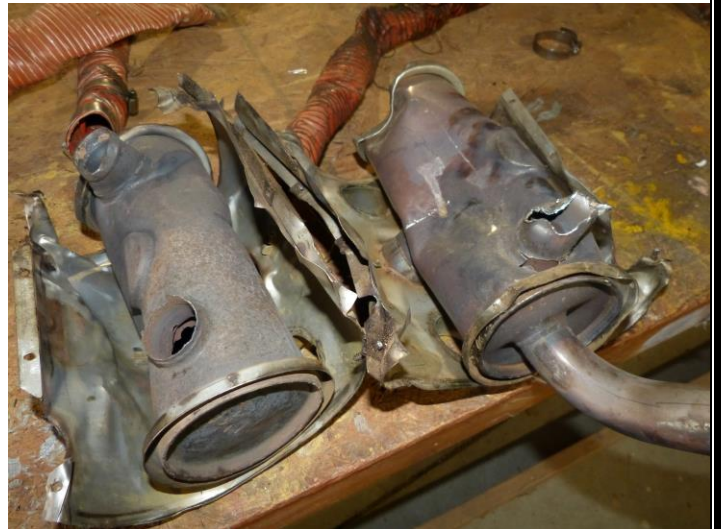
Mufflers: The mufflers both had heavy impact damage. They were both opened and they were internally intact.

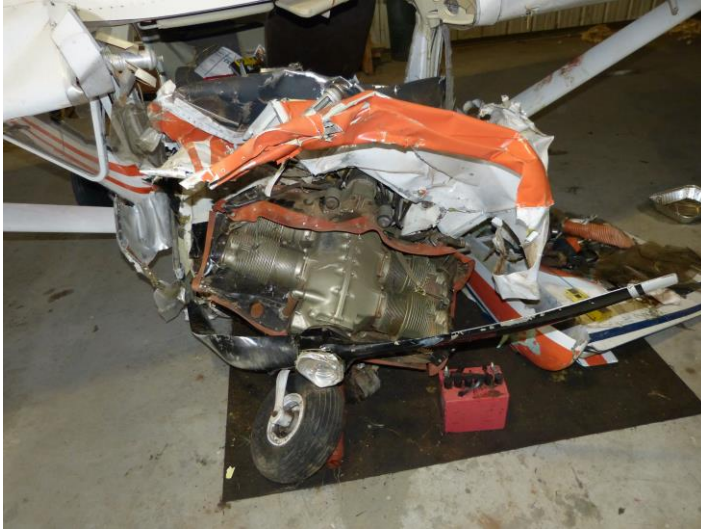
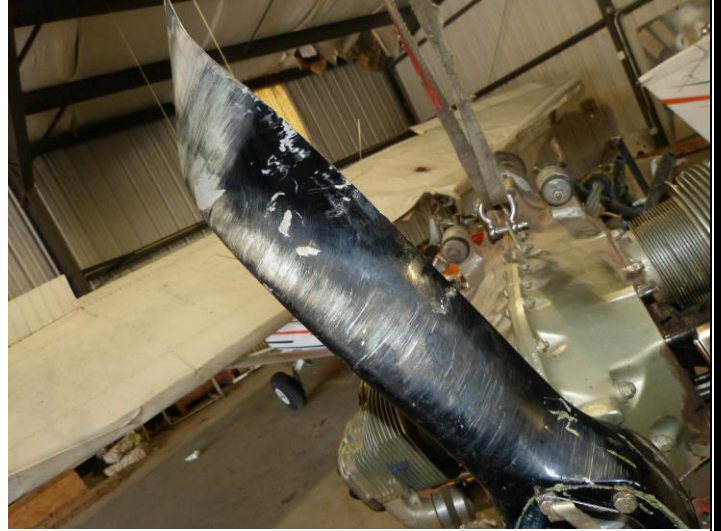
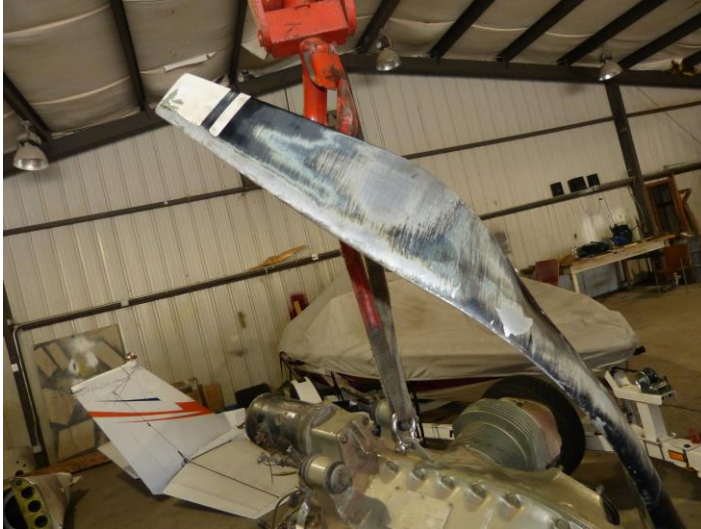
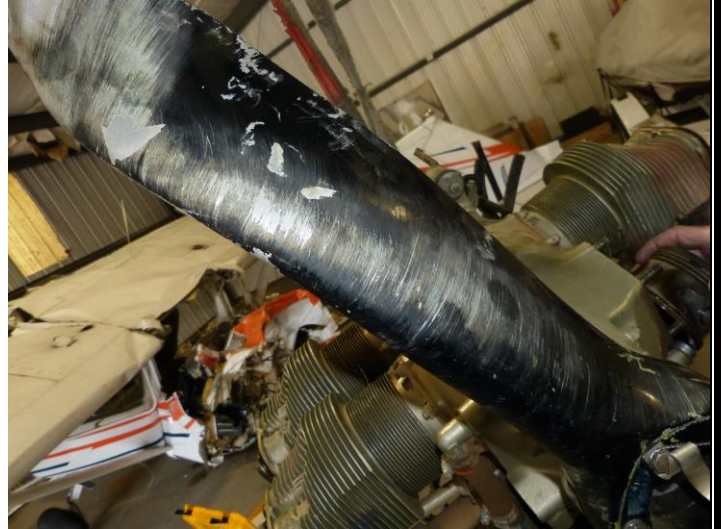
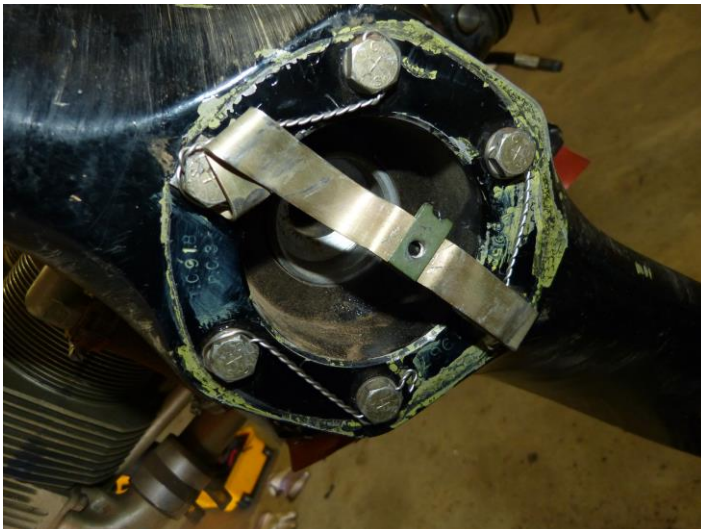
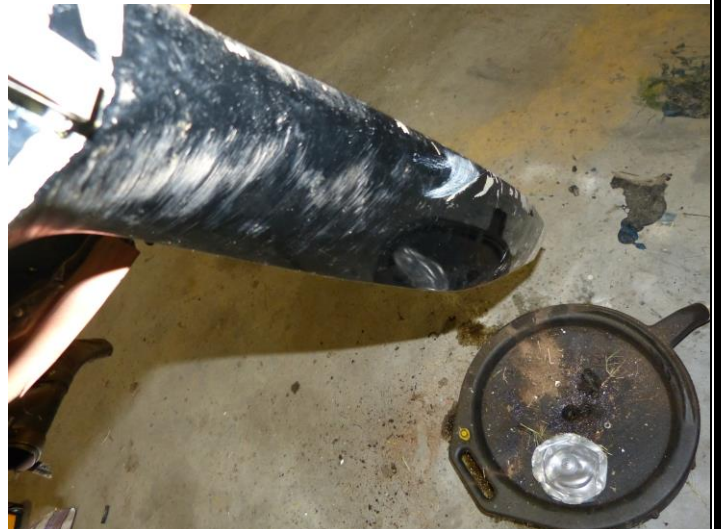
Propeller: McCauley, 1A100, SN-G1967

The propeller remained attached to the engine crankshaft. The spinner was missing. Blade one was twisted toward the direction of rotation and had chordwise scarring on the cambered side of the blade. Blade two had leading edge damage and was slightly bent toward the non-cambered side.
