# NATIONAL TRANSPORTATION SAFETY BOARD

MATERIALS LABORATORY FACTUAL REPORT

Report No. 17-023

Place : Cameron, North Carolina  
Date : November 1, 2016  
Vehicle : Bell OH-58C, N139RD  
NTSB No. : ERA17LA032  
Investigator : Chihoon Shin, AS-40

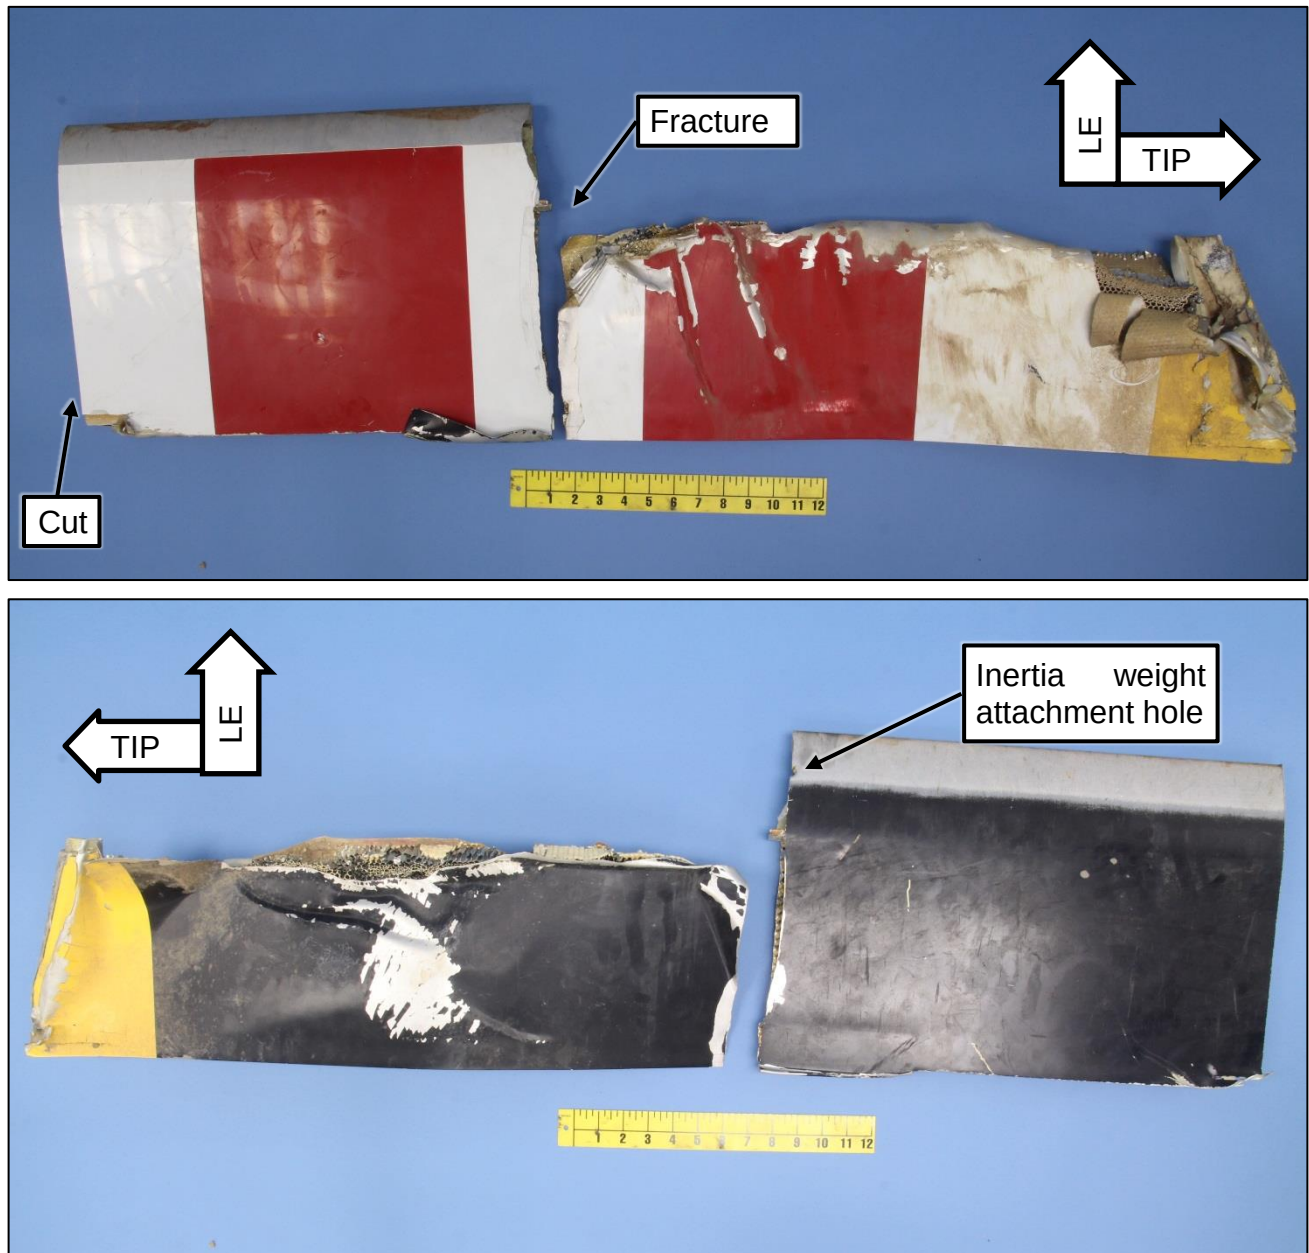
Overall views of the submitted main rotor blade pieces are shown in figure 1. The piece with the yellow end included the tip face of the blade, and fracture occurred at a location 27.75 inches from the tip end. The inboard blade piece was cut as indicated. The leading edge spar was missing from the length of the outboard piece, and the leading side of the remaining trailing skin and core was crushed and bent toward the trailing edge.

Figure 1. Overall views of the fractured main rotor blade pieces as viewed from above (upper image) and from below (lower image).

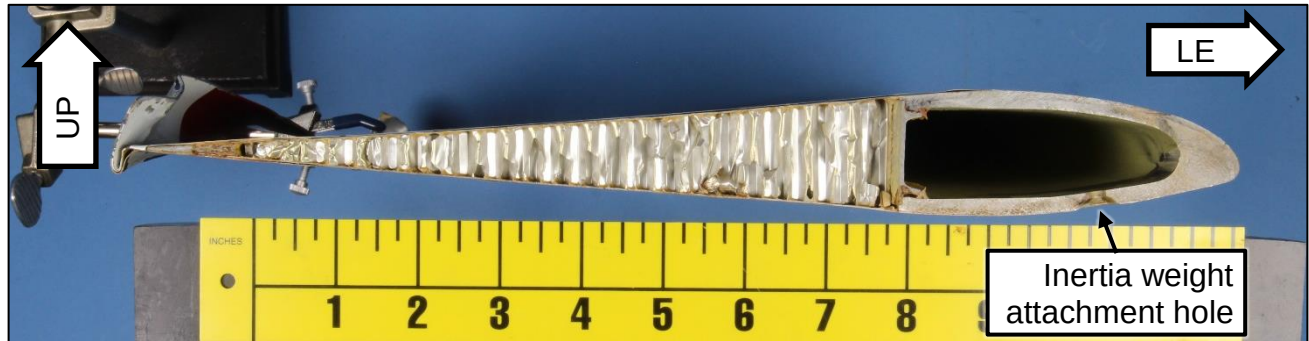
An overall view of the fracture surface is shown in figure 2. The fracture in the leading edge spar intersected the inertia weight attachment hole as shown in figures 1 through 3. The lower side of the inertia weight attachment hole was cone-shaped consistent with a countersunk attachment. The surface of the inertia weight hole in the countersunk face appeared rough and oxidized consistent with fretting contact damage with the inertia weight attachment screw head.

Figure 2. View of the fracture on the inboard piece of main rotor blade.

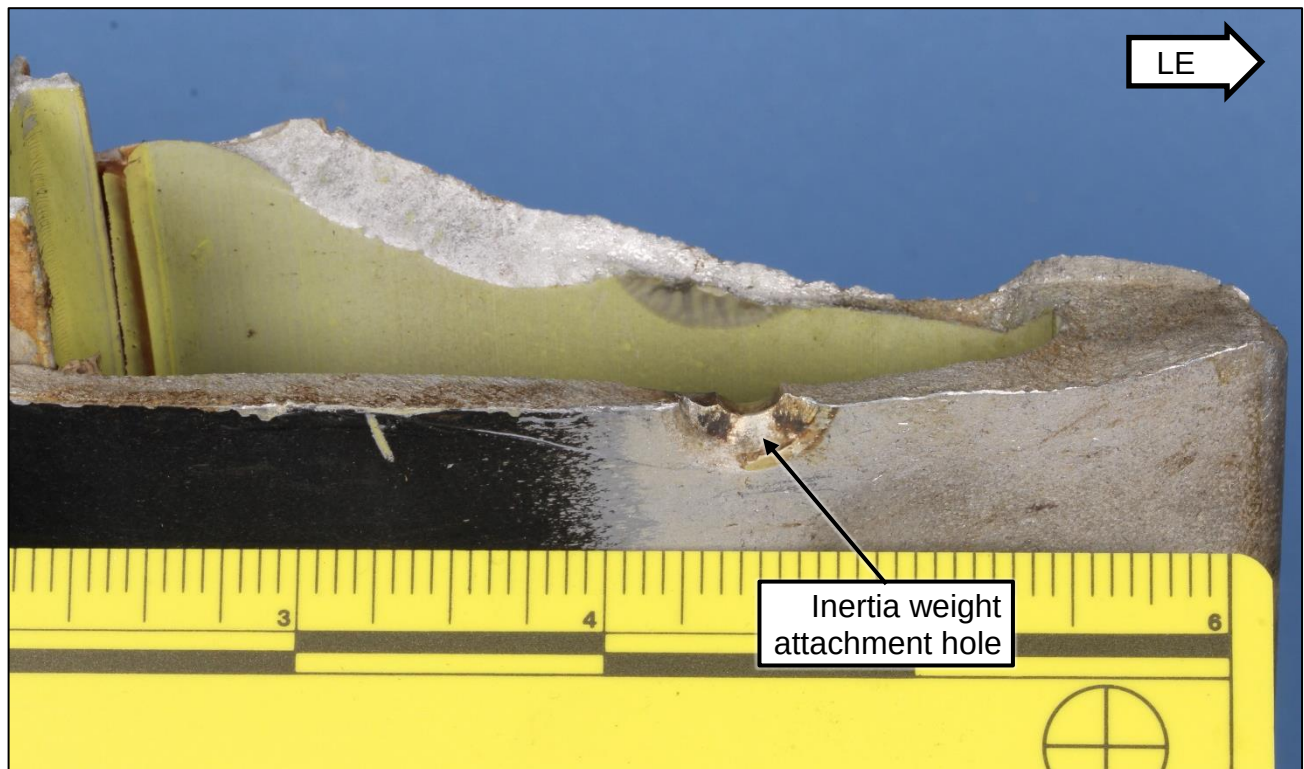
As shown in figure 3, the lower leading edge of the paint had a tapered edge consistent with erosion wear. No evidence of a clear-coat finish was observed on the lower surface.

Figure 3. Oblique view of the inertia weight attachment hole on the lower side of the main rotor blade leading edge spar.

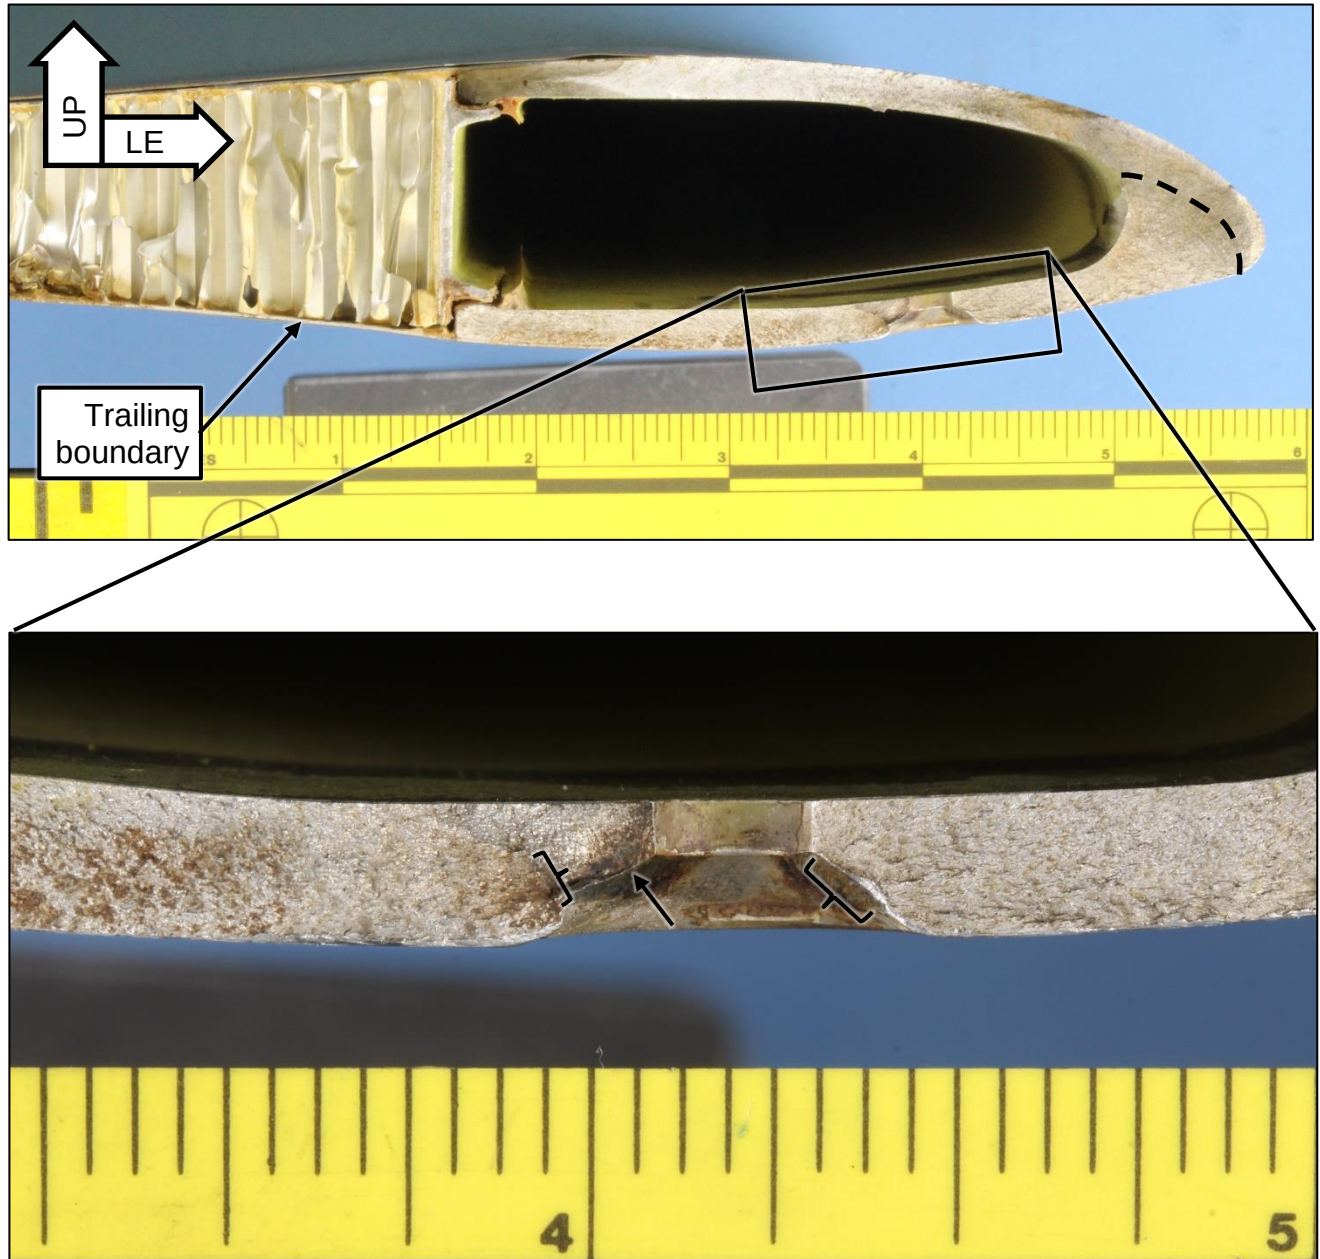
Closer views of the fracture surface are shown in figure 4. A portion of the fracture surface in the leading edge spar and the lower skin were in a plane perpendicular to the surface and had curving crack arrest lines, features consistent with fatigue. Fatigue features emanated from multiple origins in the fretted area of the inertia weight attachment hole. In the detail image in figure 4, a bracket at the leading side of the attachment hole and an arrow at the trailing side of the hole indicate primary fatigue crack origin areas located at the inertia weight attachment hole. A bracket at the trailing side of the hole

indicates a secondary fatigue origin area that initiated from the edge of the primary fatigue region that had initiated from the location indicated by the arrow.

The fatigue region extended up to the boundary indicated with a dashed line on the leading edge spar in the upper image in figure 4 and along the entire lower side of the spar to the trailing edge of the spar. The fatigue region also extended into the lower skin from the leading edge of the lower skin to the trailing boundary location indicated in figure 4. The total length of the fatigue region measured at the lower surface of the blade was 1.4 inches from the leading edge of the inertia weight attachment hole to the leading boundary (dashed line in figure 4) and 3.0 inches from the trailing edge of the hole to the trailing boundary.

Figure 4. Closer view of the fatigue region in the main rotor blade leading edge spar and adjacent lower skin (upper image) with a detail image of the inertia weight attachment hole. A dashed line in the upper image indicates the leading boundary of the fatigue region, and the trailing boundary in the lower skin is indicated. Unlabeled brackets and an arrow in the detail image of the inertia weight attachment hole indicate fatigue origin areas.
