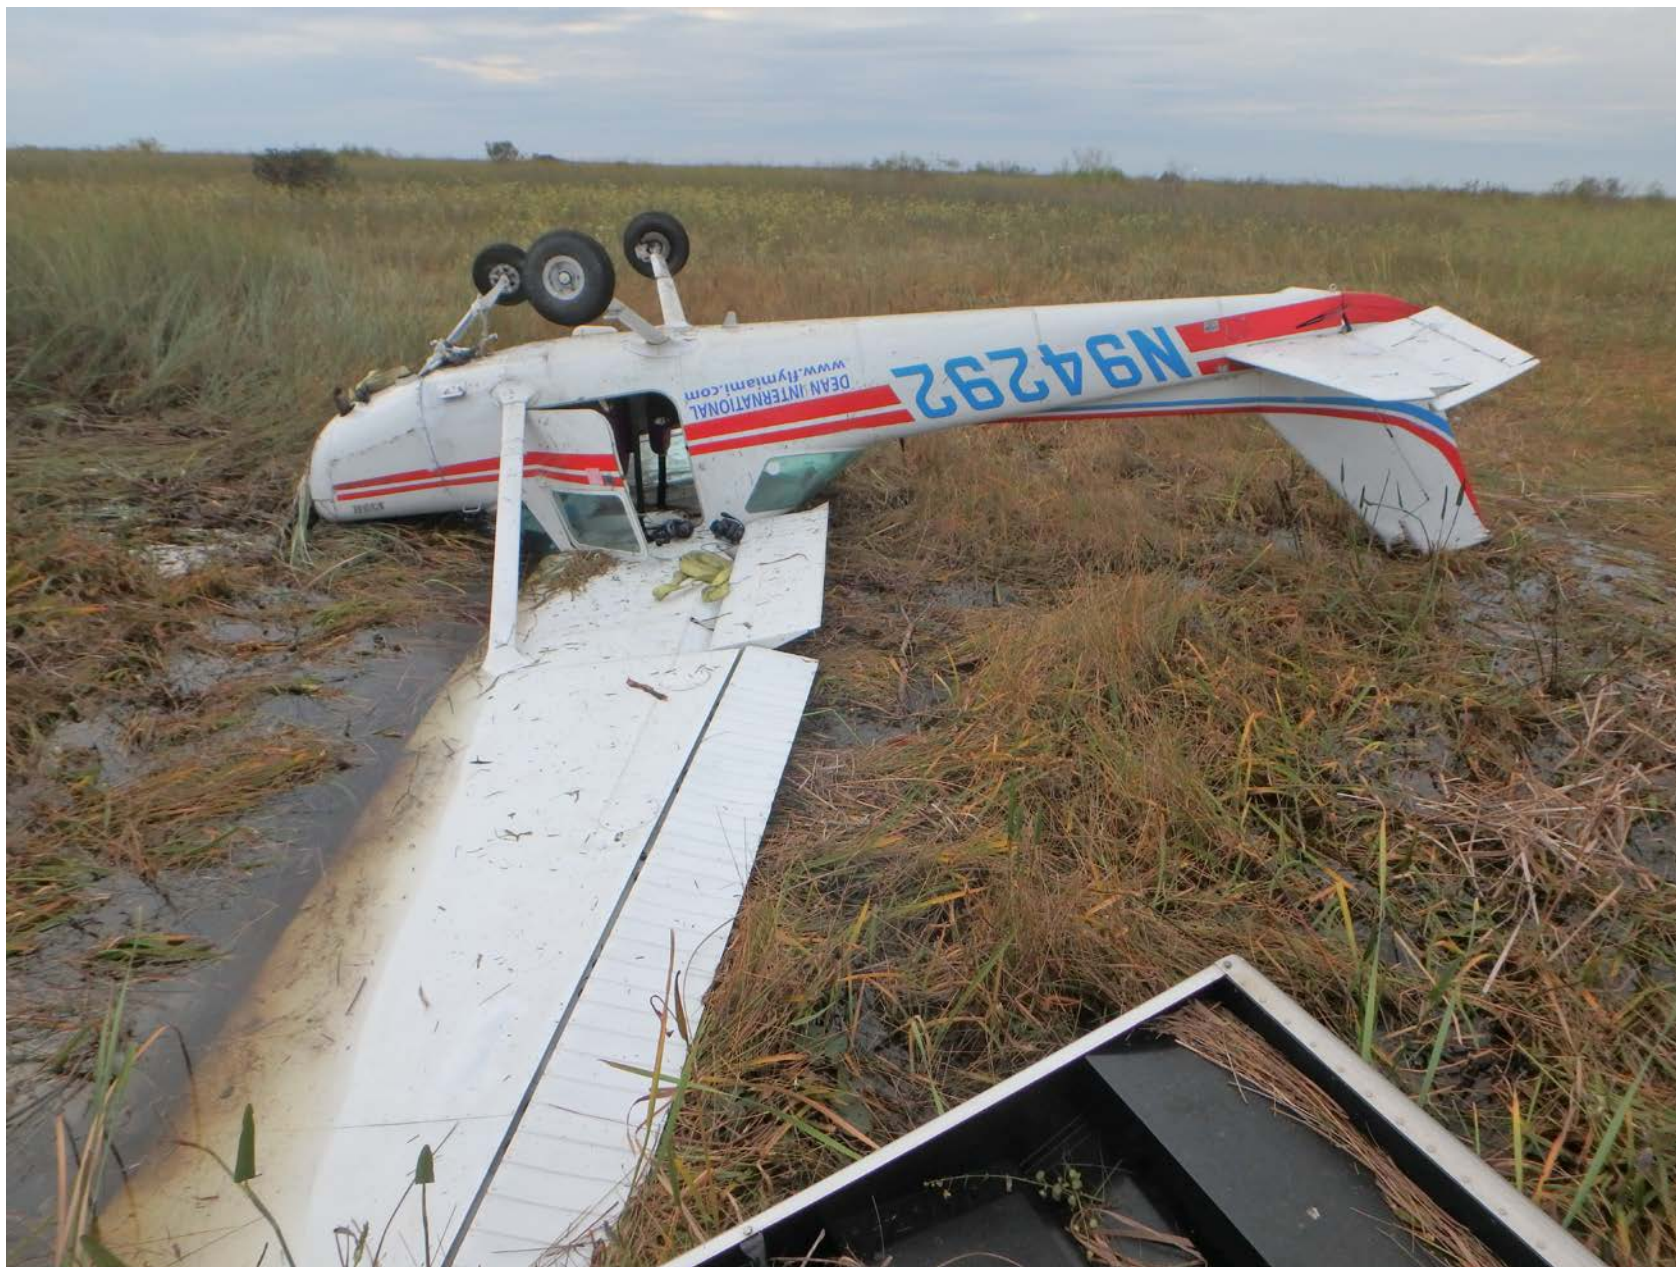
**Photo 1 – View of Airplane as Found (FAA)**

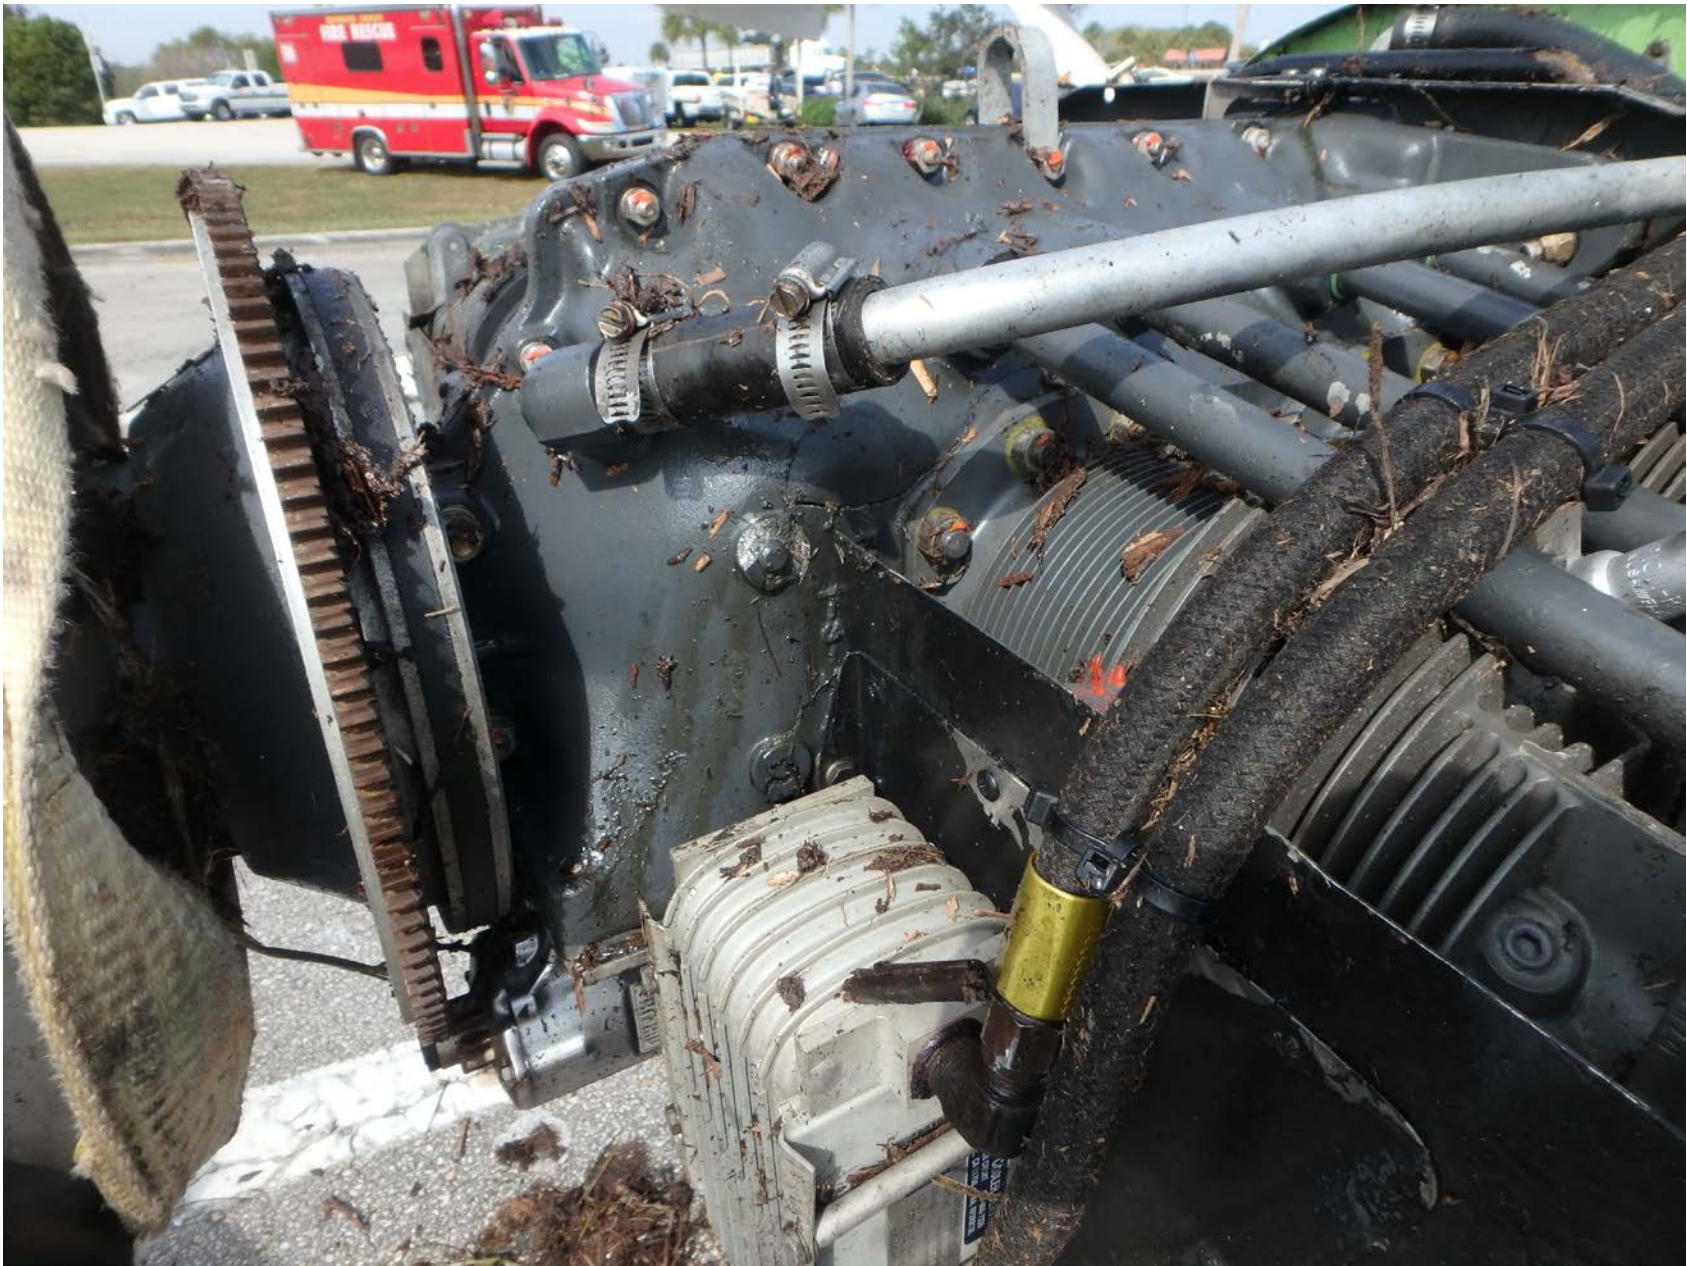
**Photo 2 – View of cracked engine case after recovery. (FAA)**

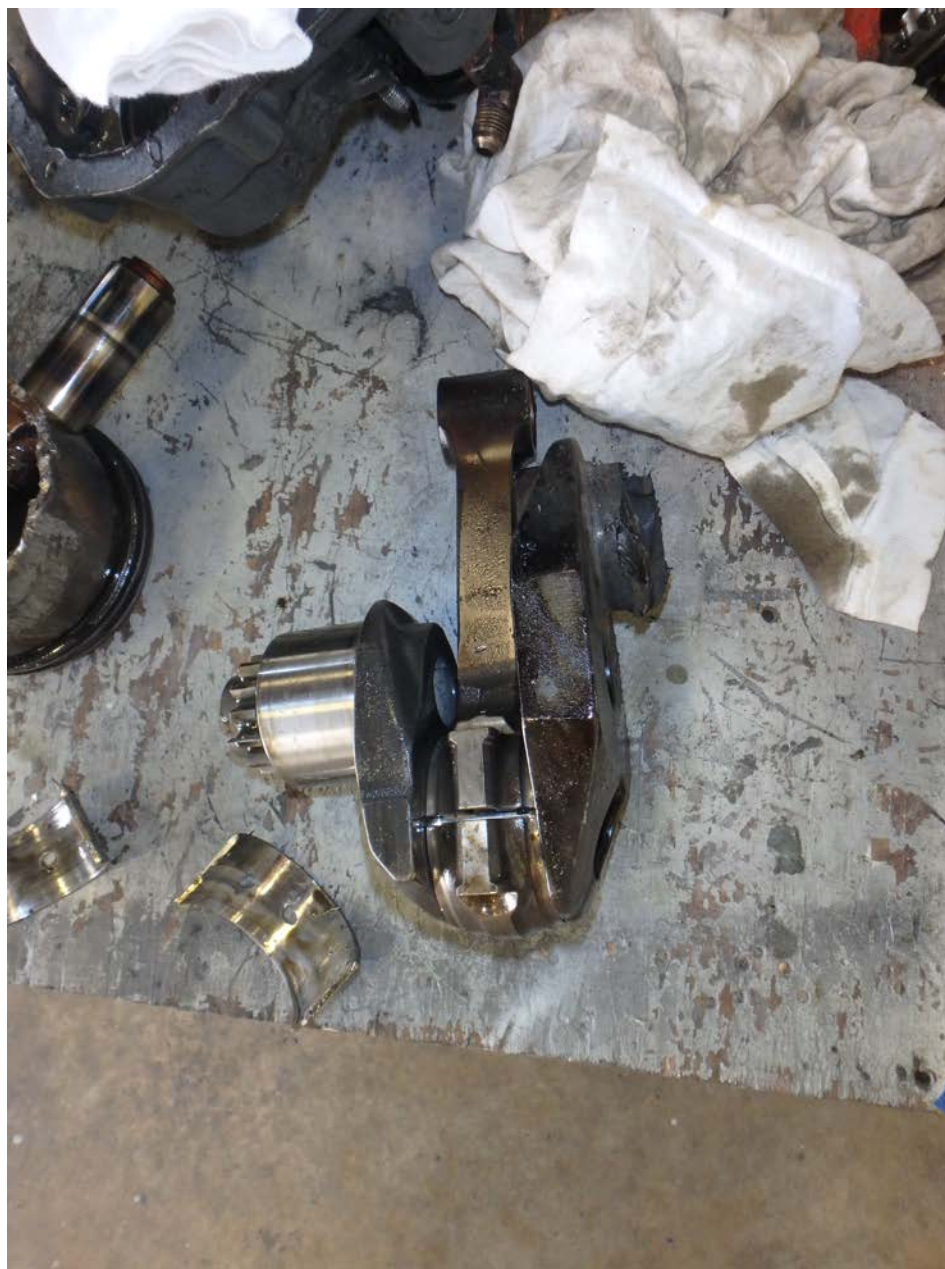
**Photo 3 – View of fractured crankshaft at No. 3 bearing journal. (FAA)**

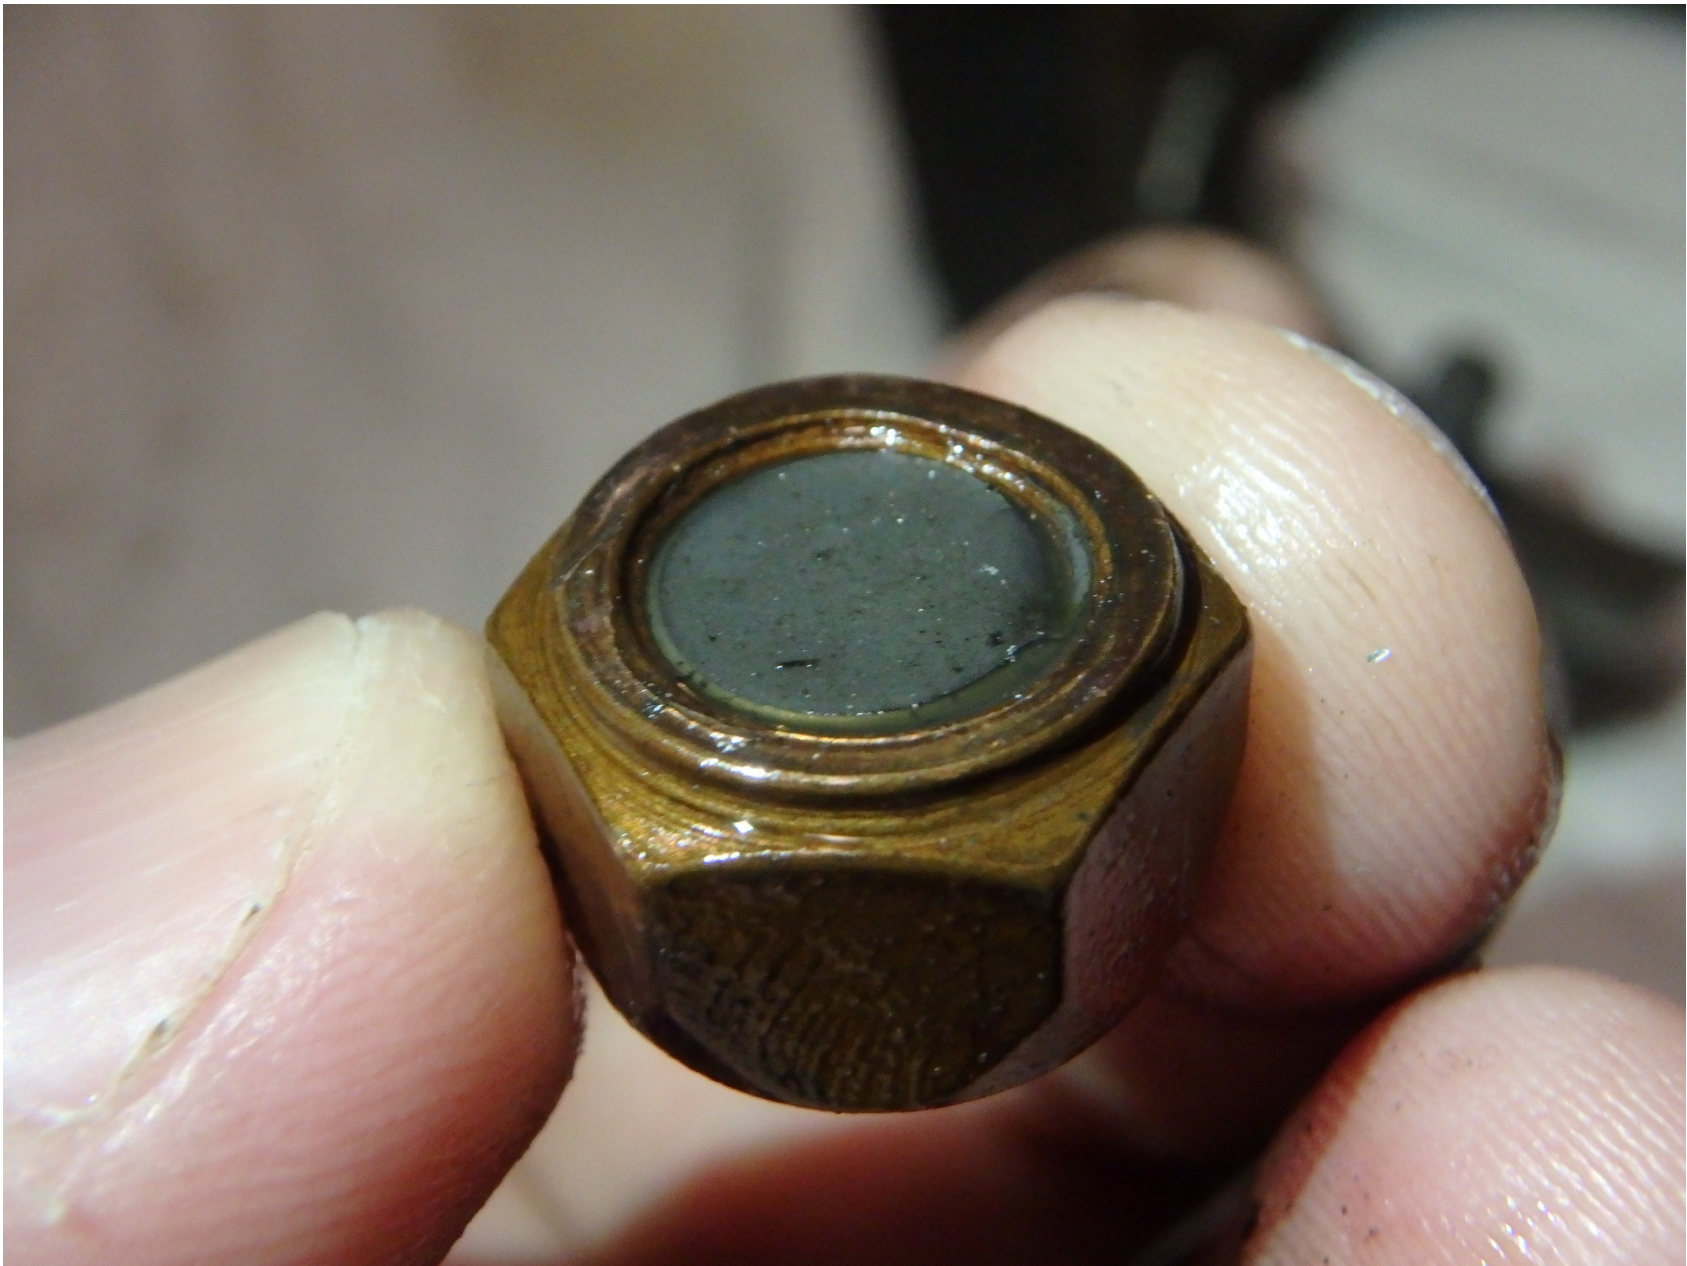
**Photo 4 – View of Nut A fracture surface on raised-lip side of nut. (FAA)**

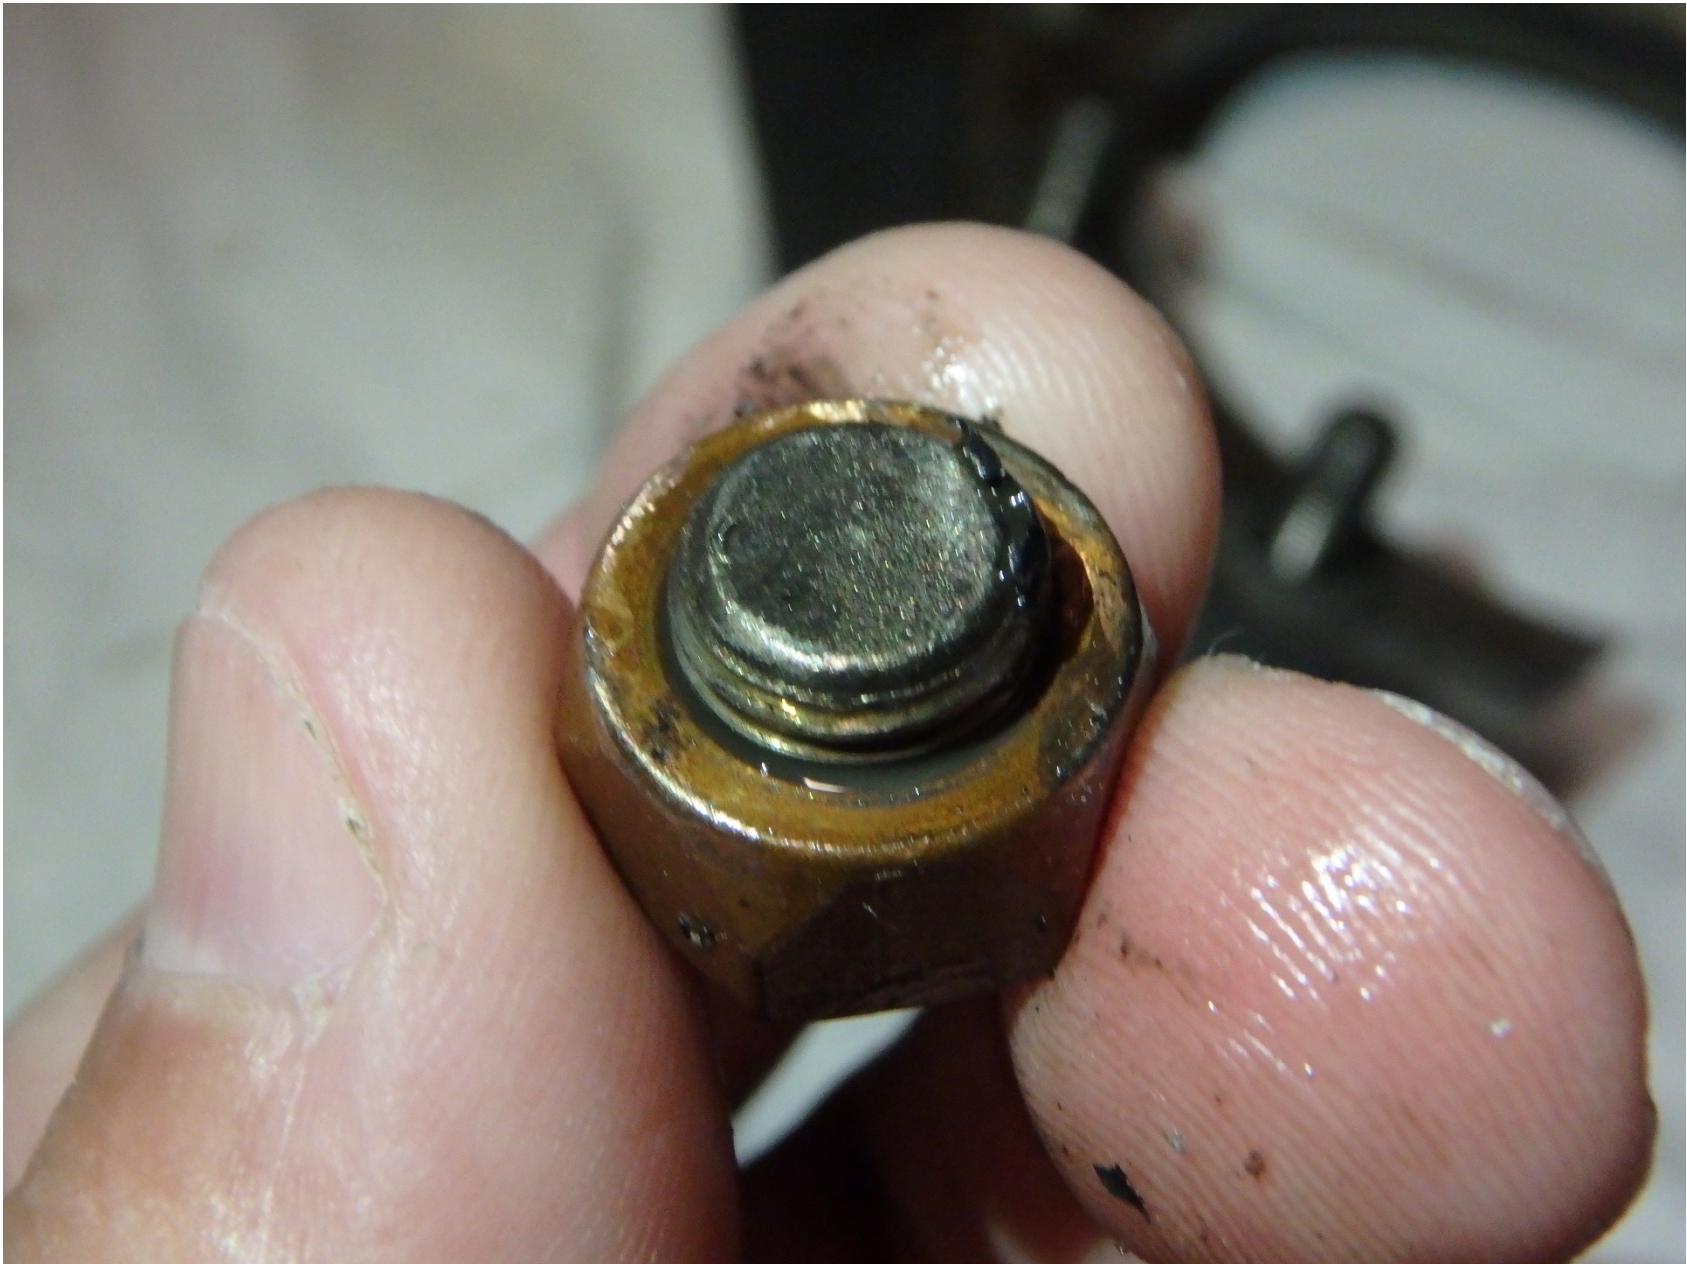
**Photo 5 – View of Nut A with exposed bolt threads on flat side of nut. (FAA)**
