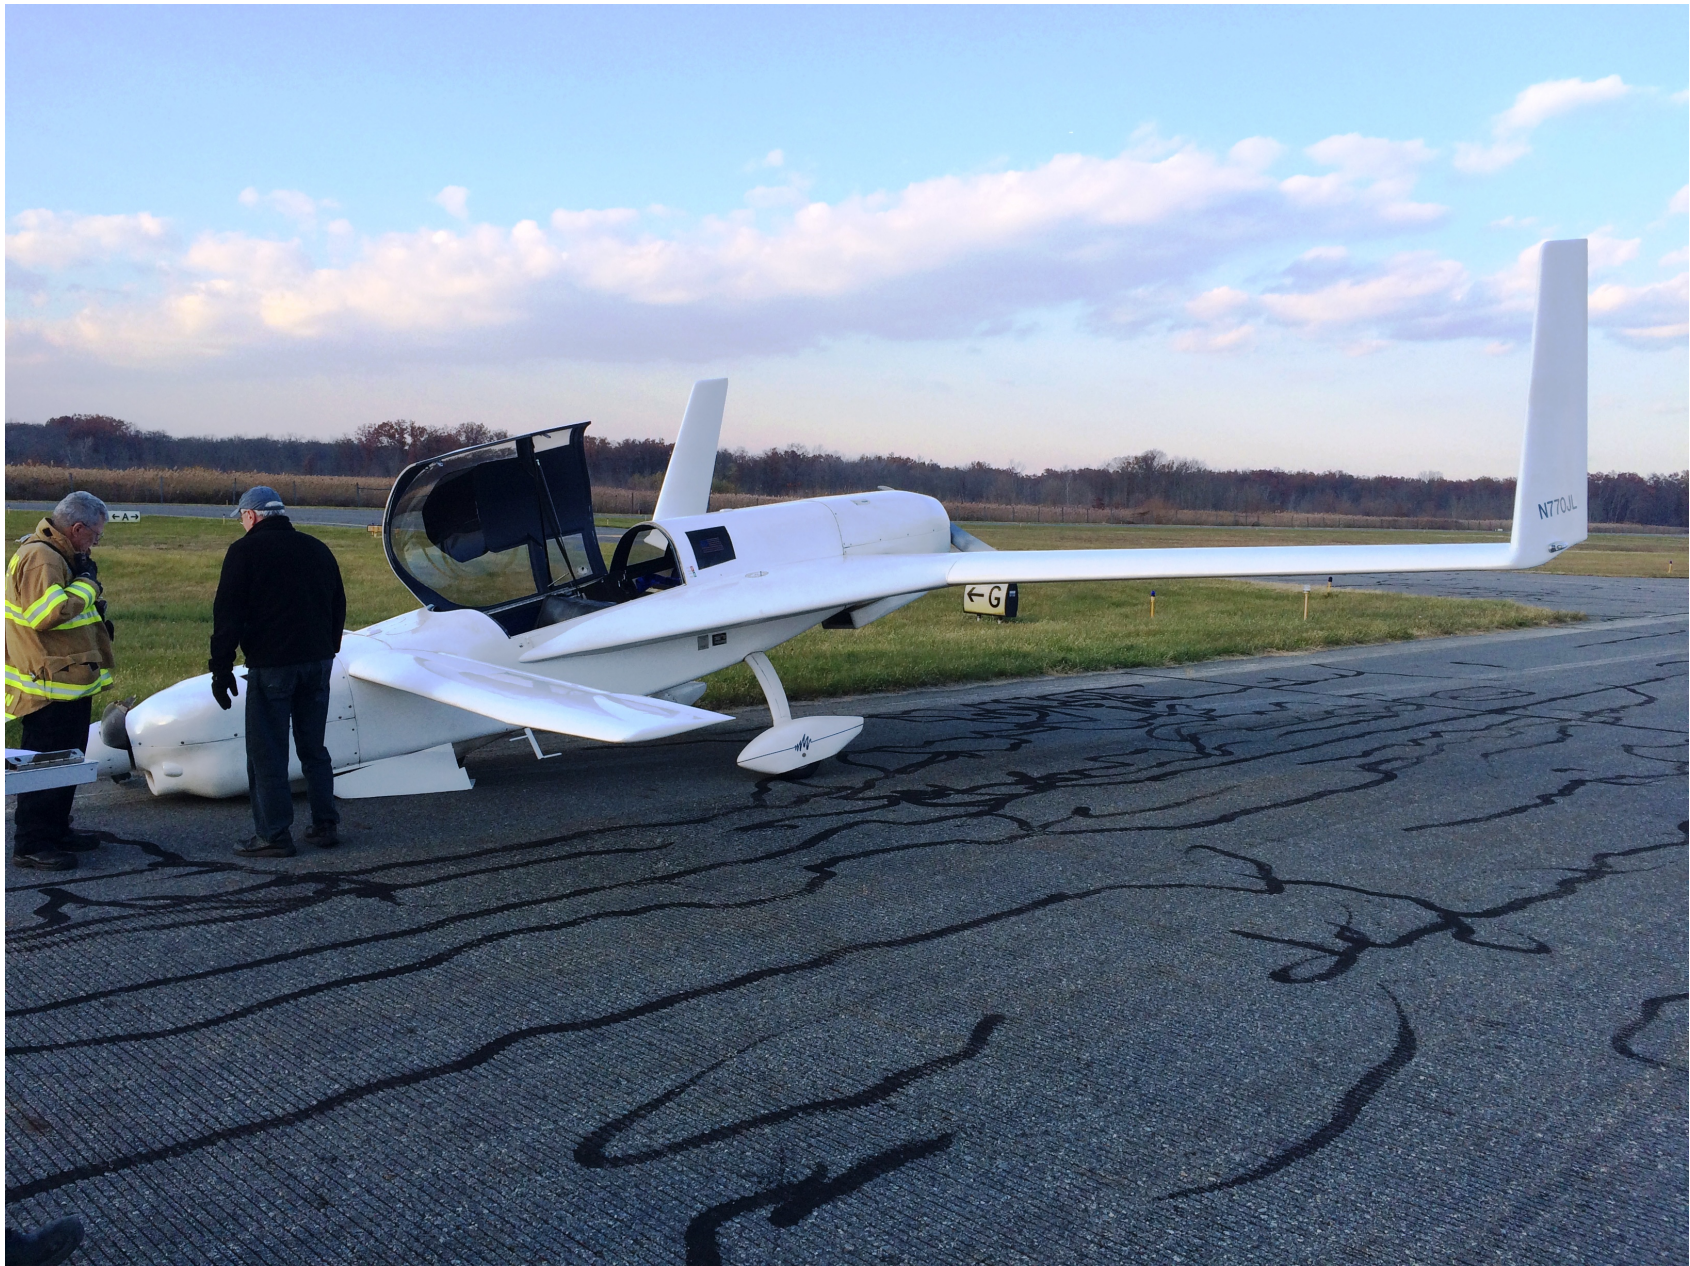
**Photo 1 – Left Side View of Main Wreckage – Courtesy of Morristown Municipal Airport**

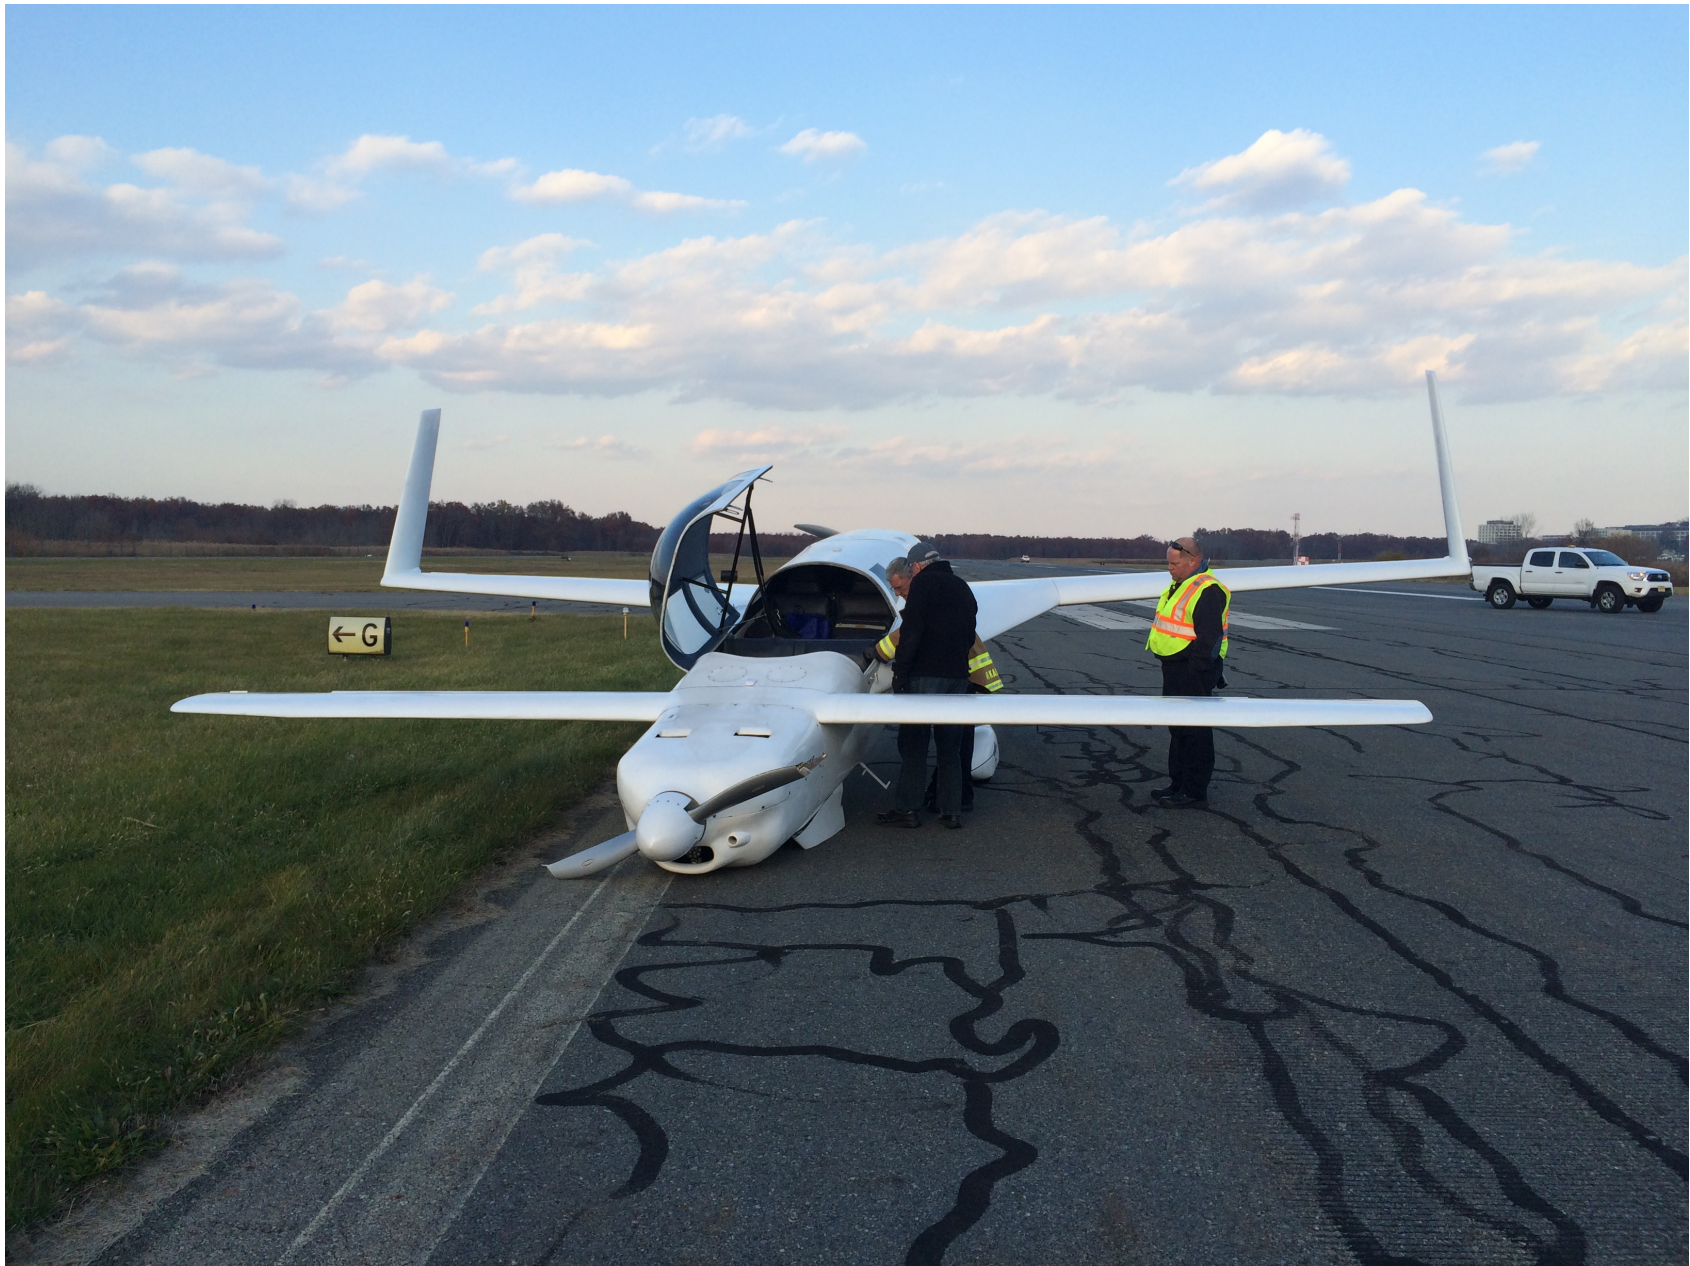
**Photo 2 – Front View of Main Wreckage – Courtesy of Morristown Municipal Airport**

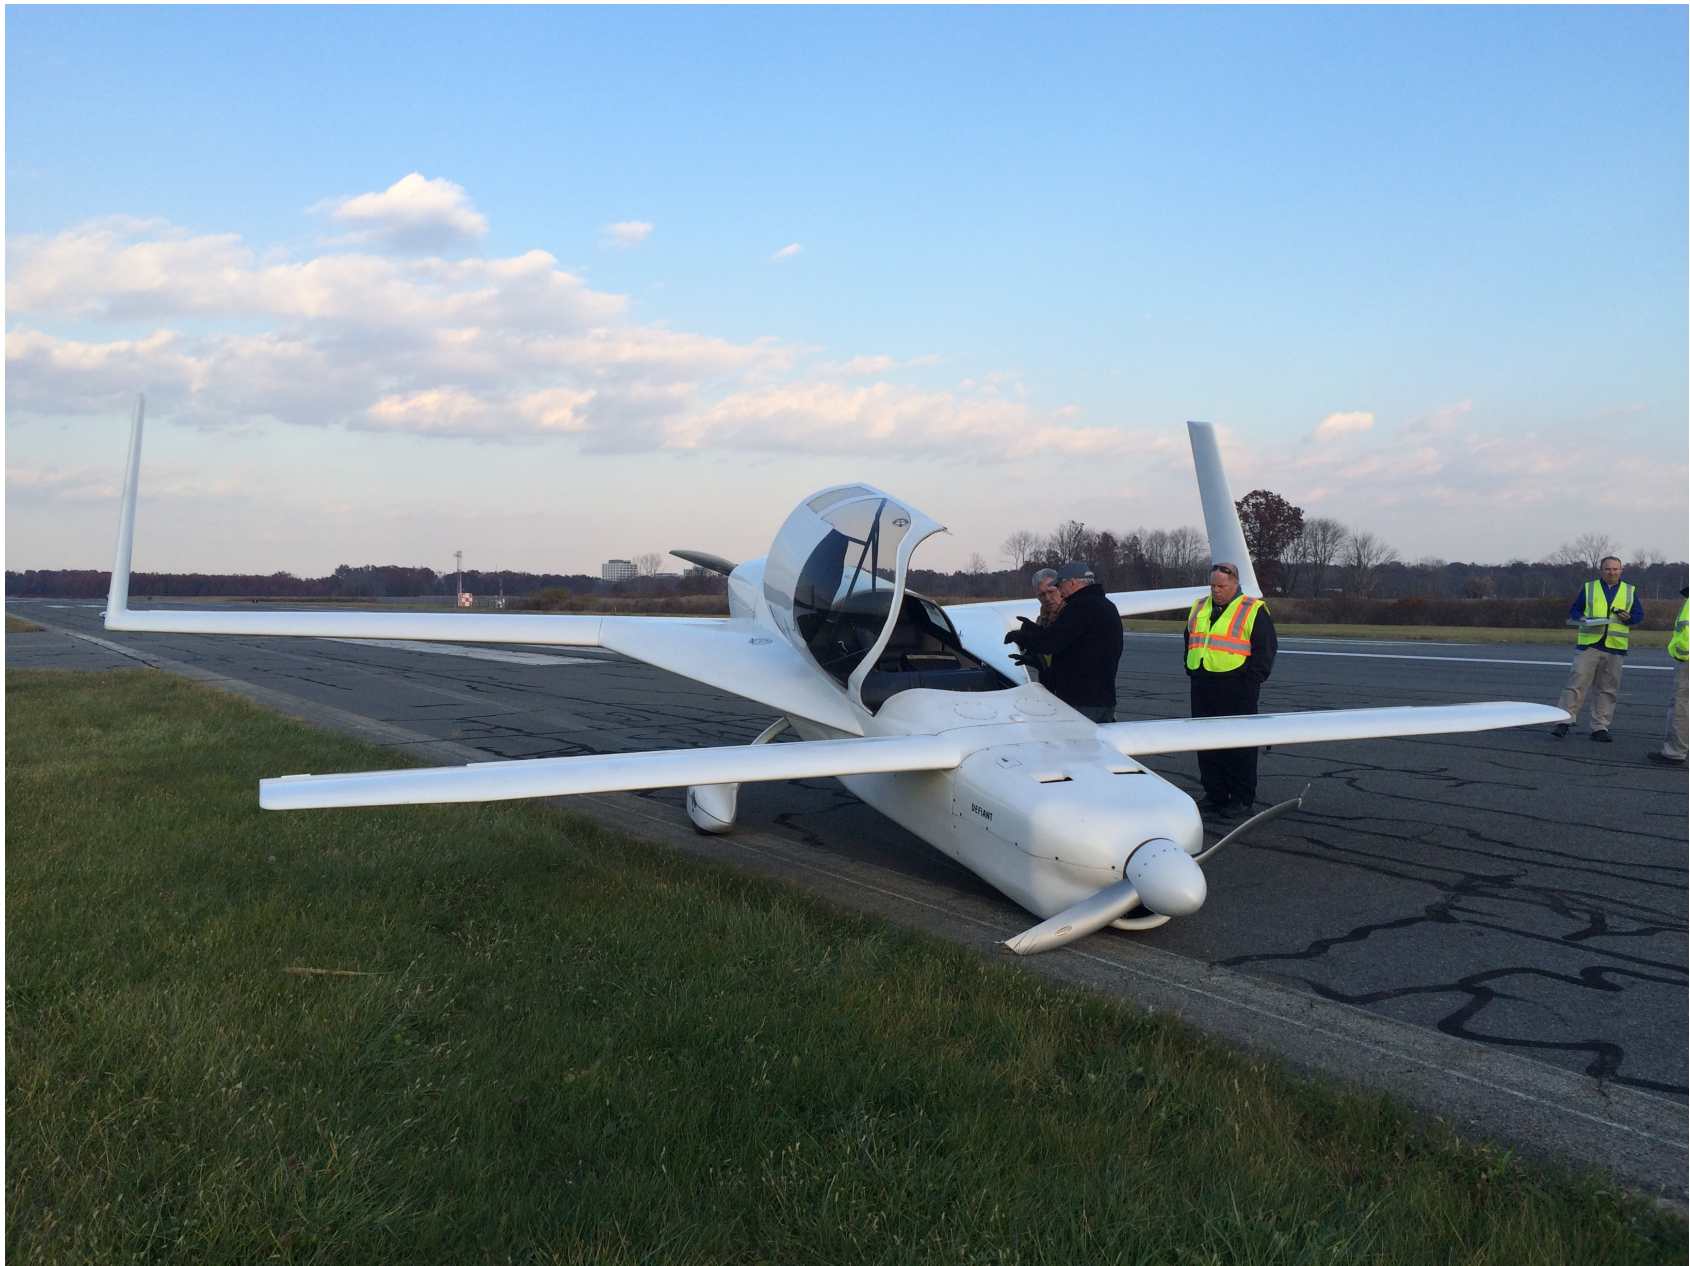
**Photo 3 – Right Side View of Main Wreckage – Courtesy of Morristown Municipal Airport**

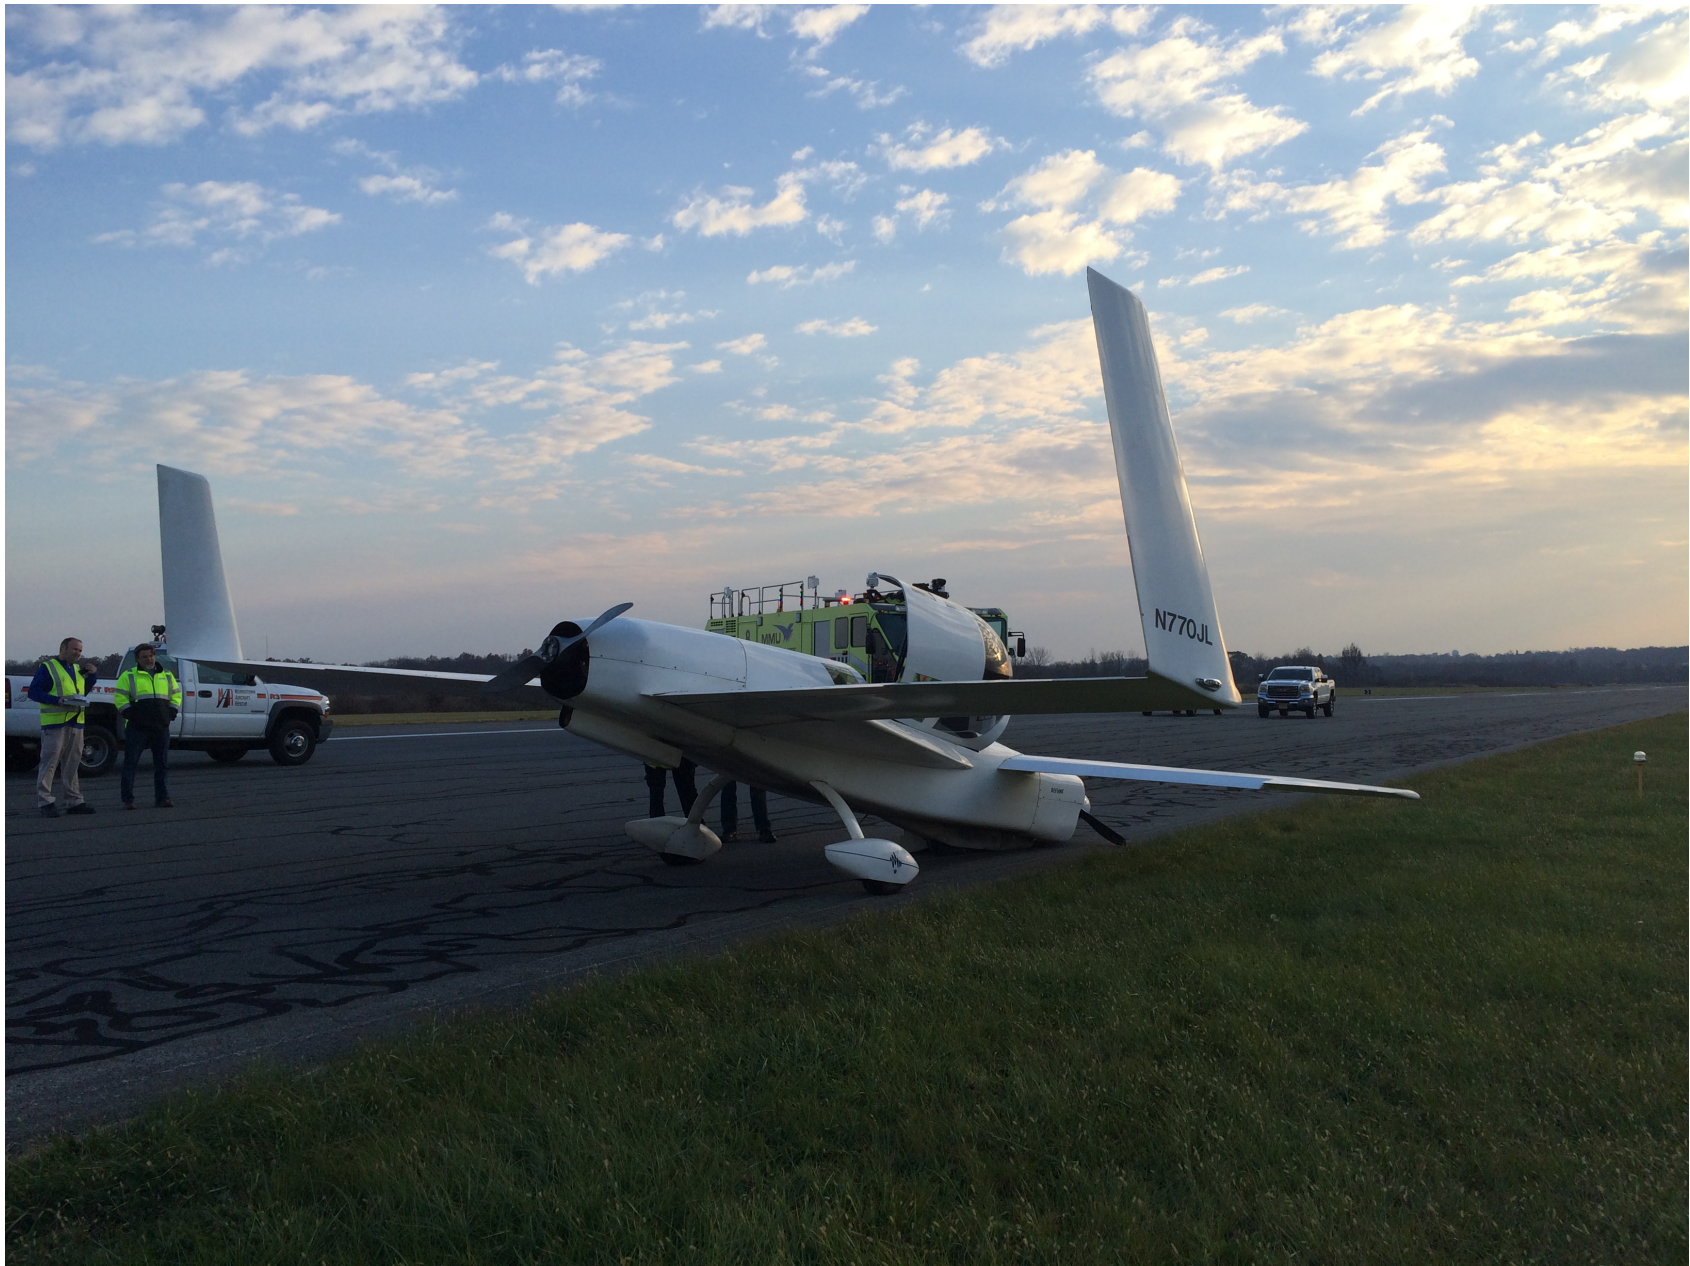
**Photo 4 – Rear View of Main Wreckage – Courtesy of Morristown Municipal Airport**

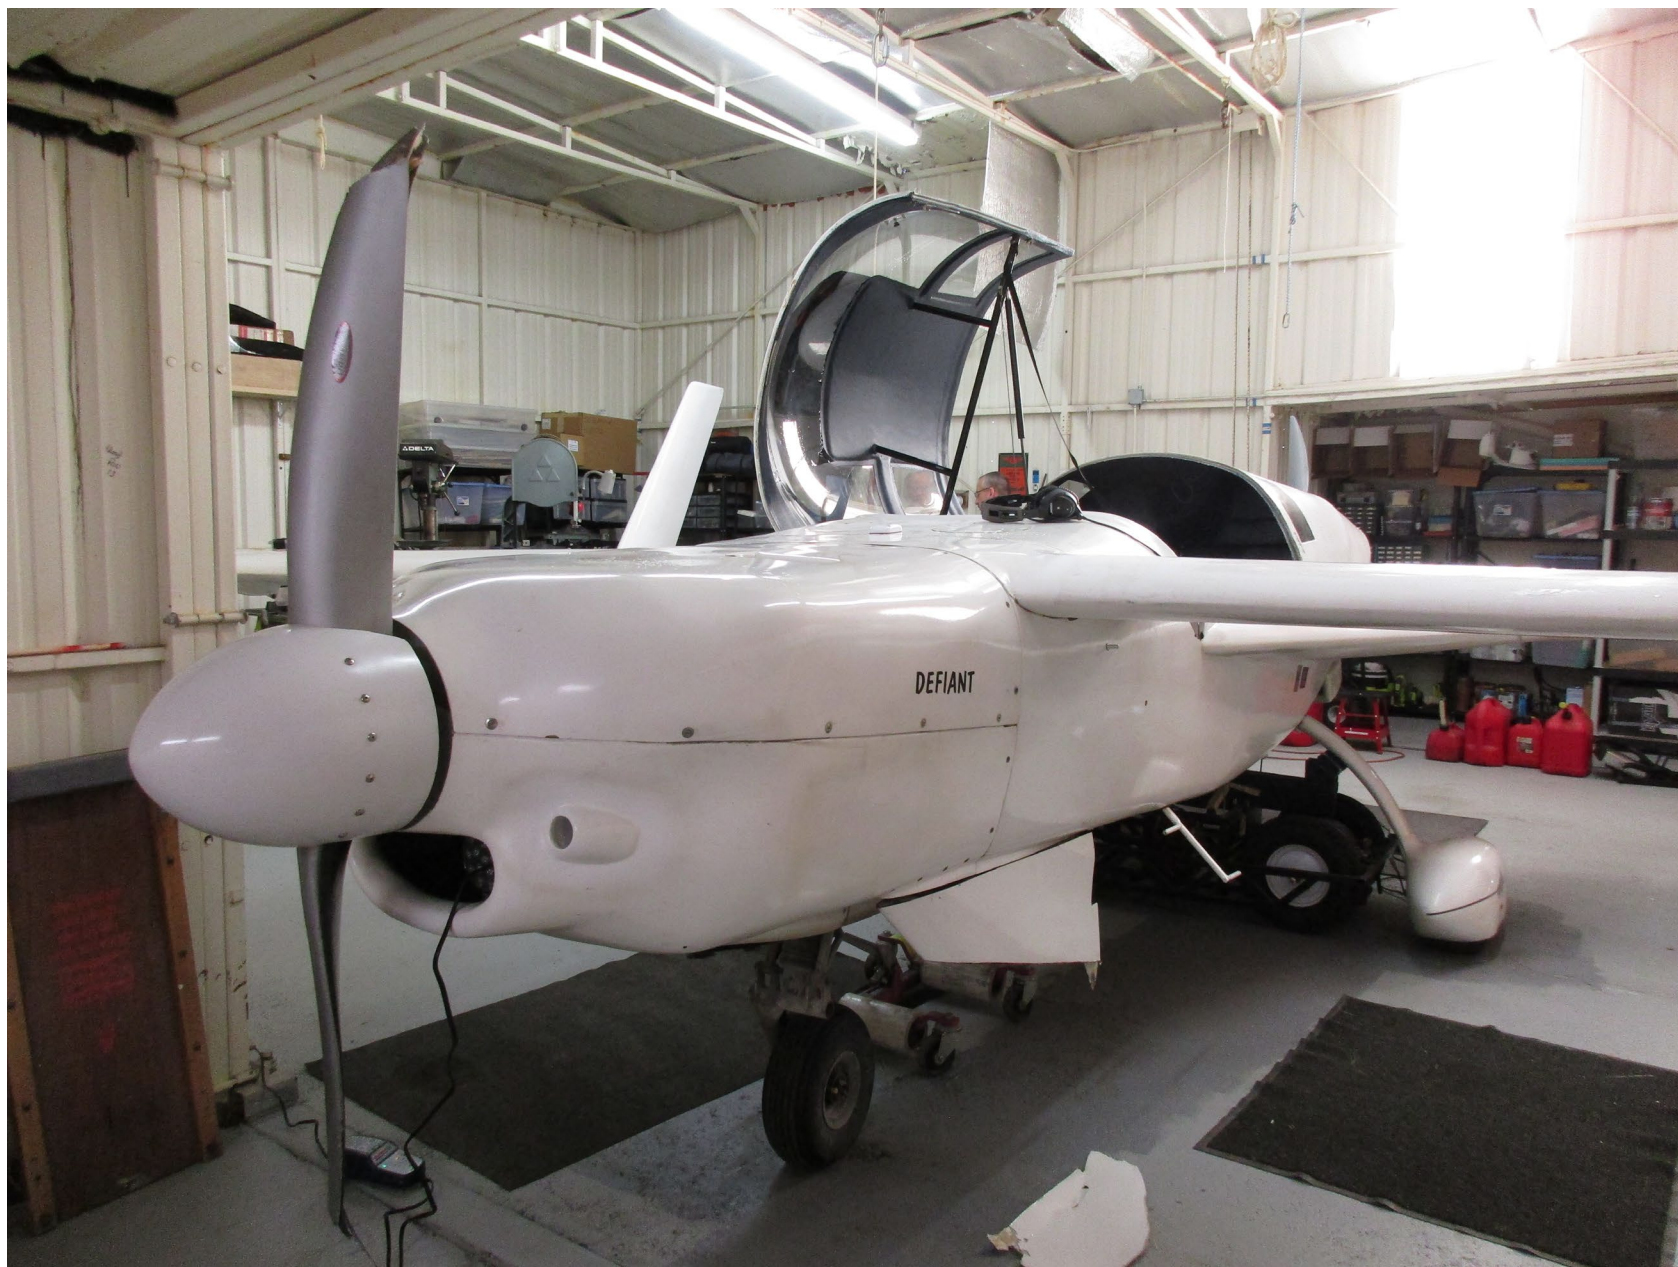
**Photo 5 - Close Up of Nose Section Showing Propeller and Rudder Damage – Courtesy of FAA**

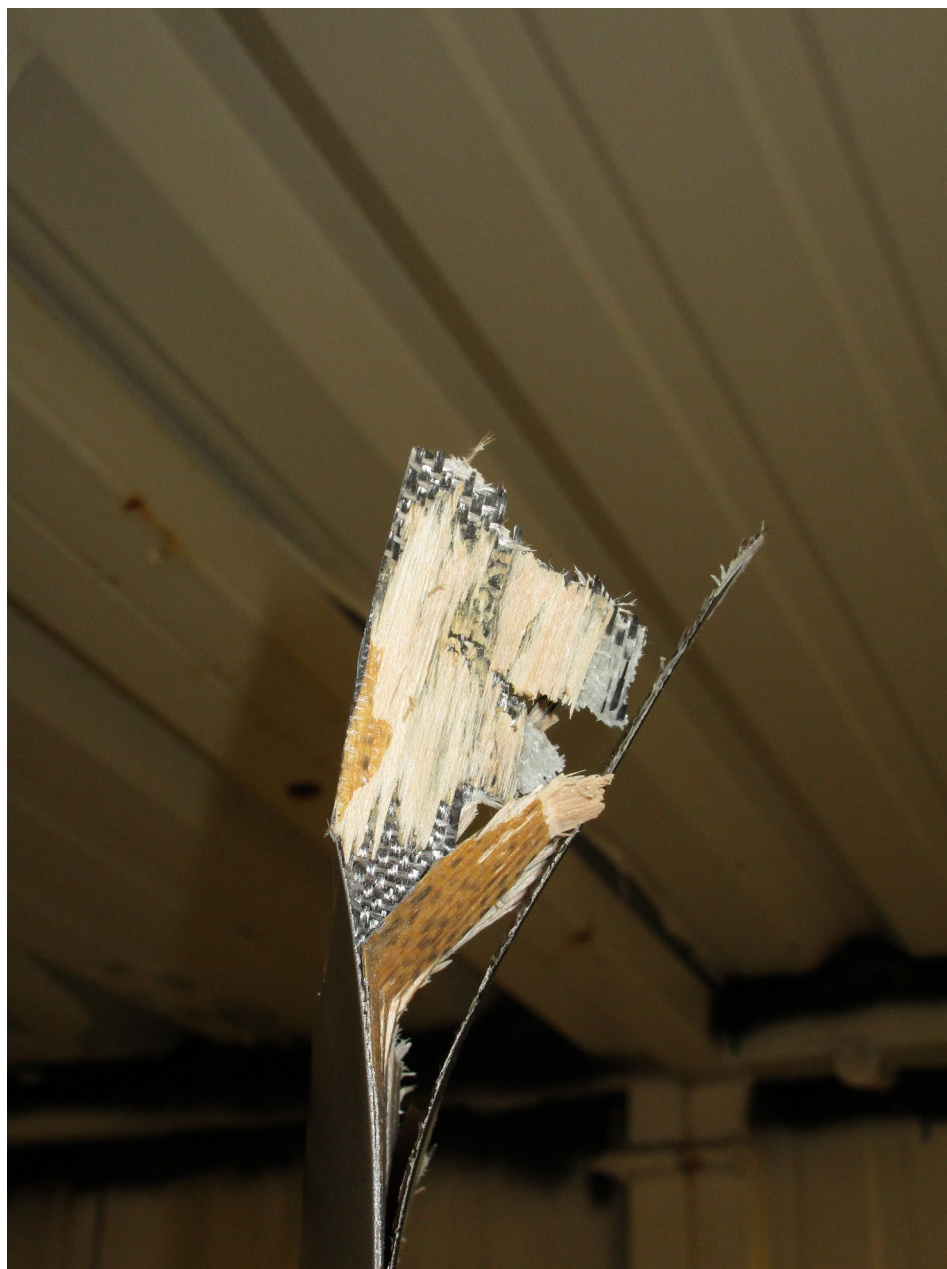
**Photo 6 – Propeller Tip – Courtesy of FAA**

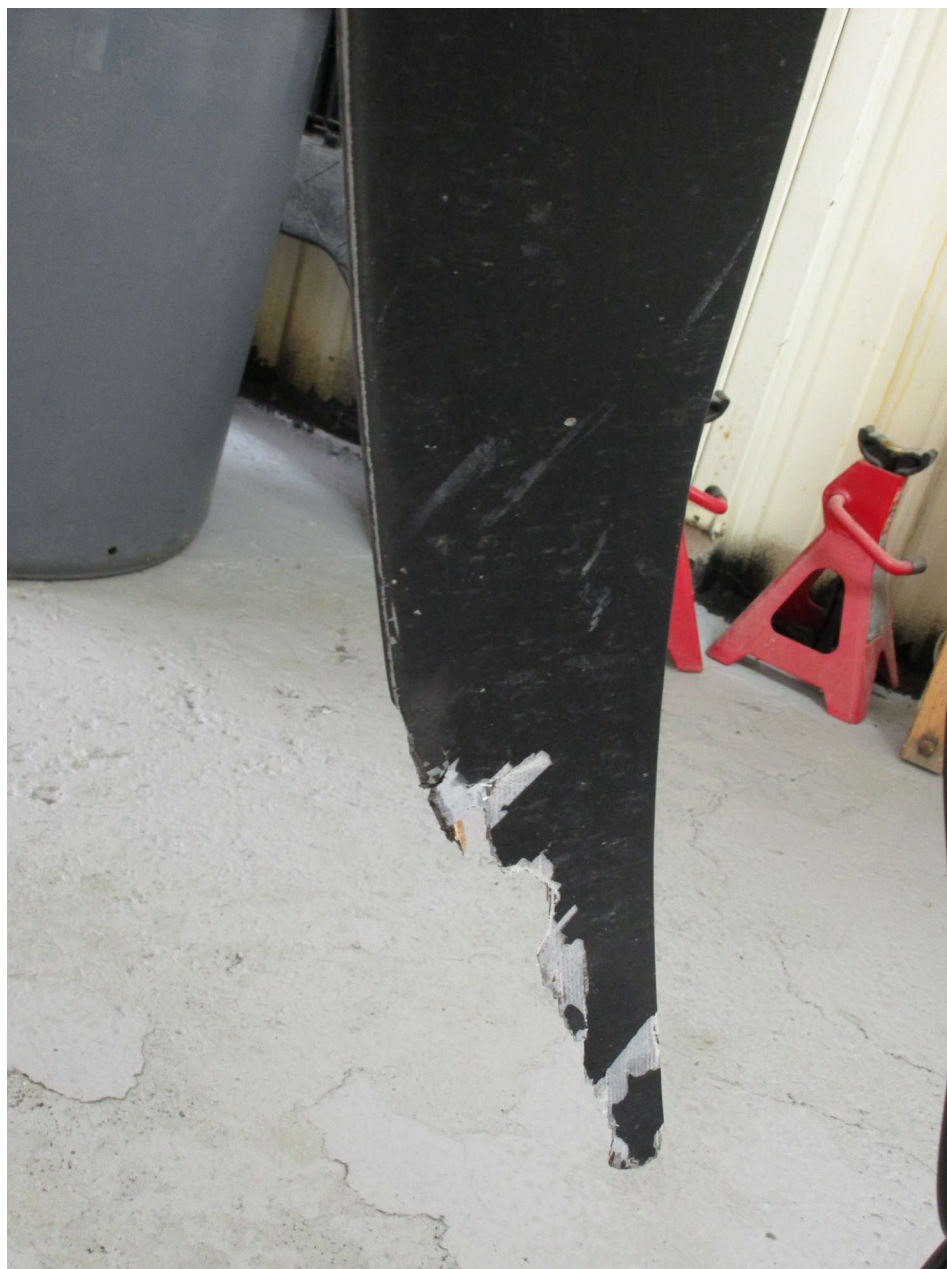
**Photo 7 – Other Propeller Tip – Courtesy of FAA**

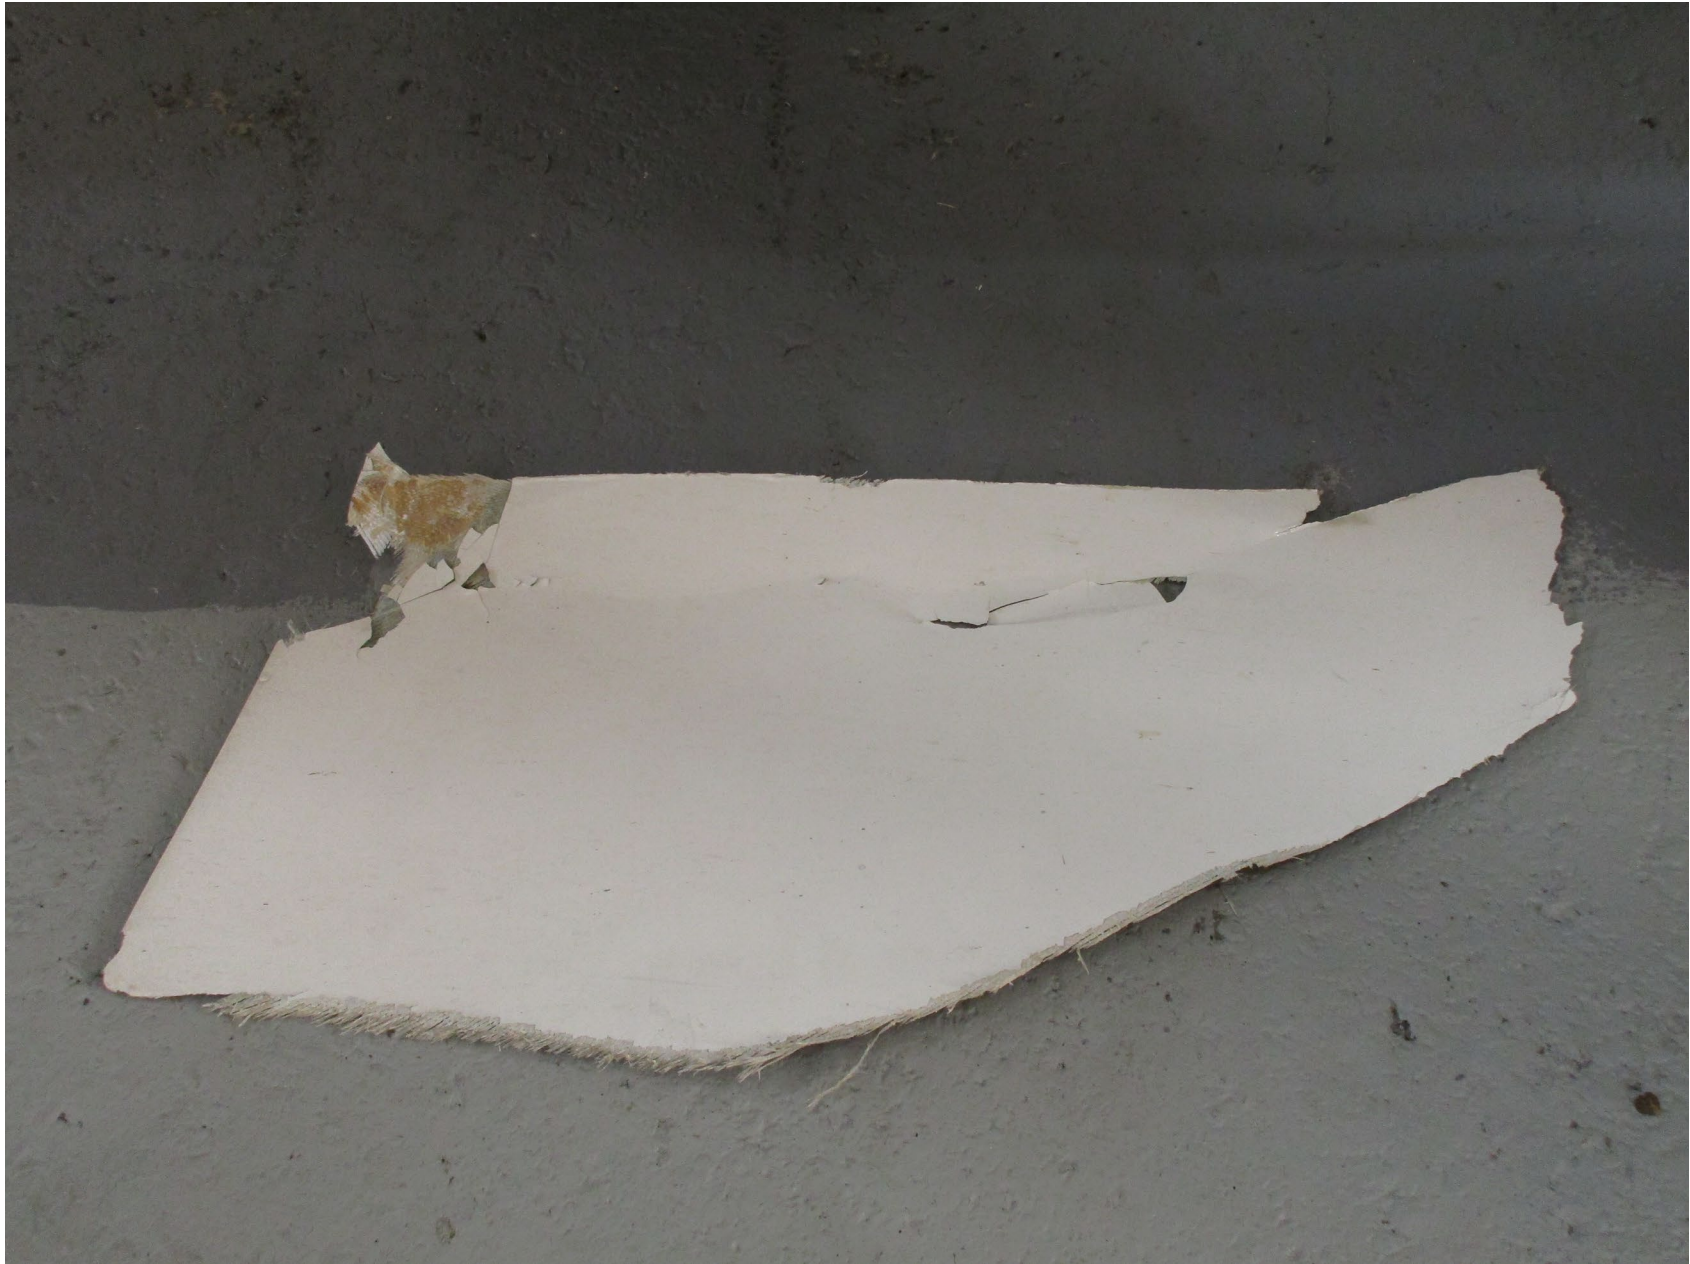
**Photo 8 – Separated Section of Rudder – Courtesy of FAA**

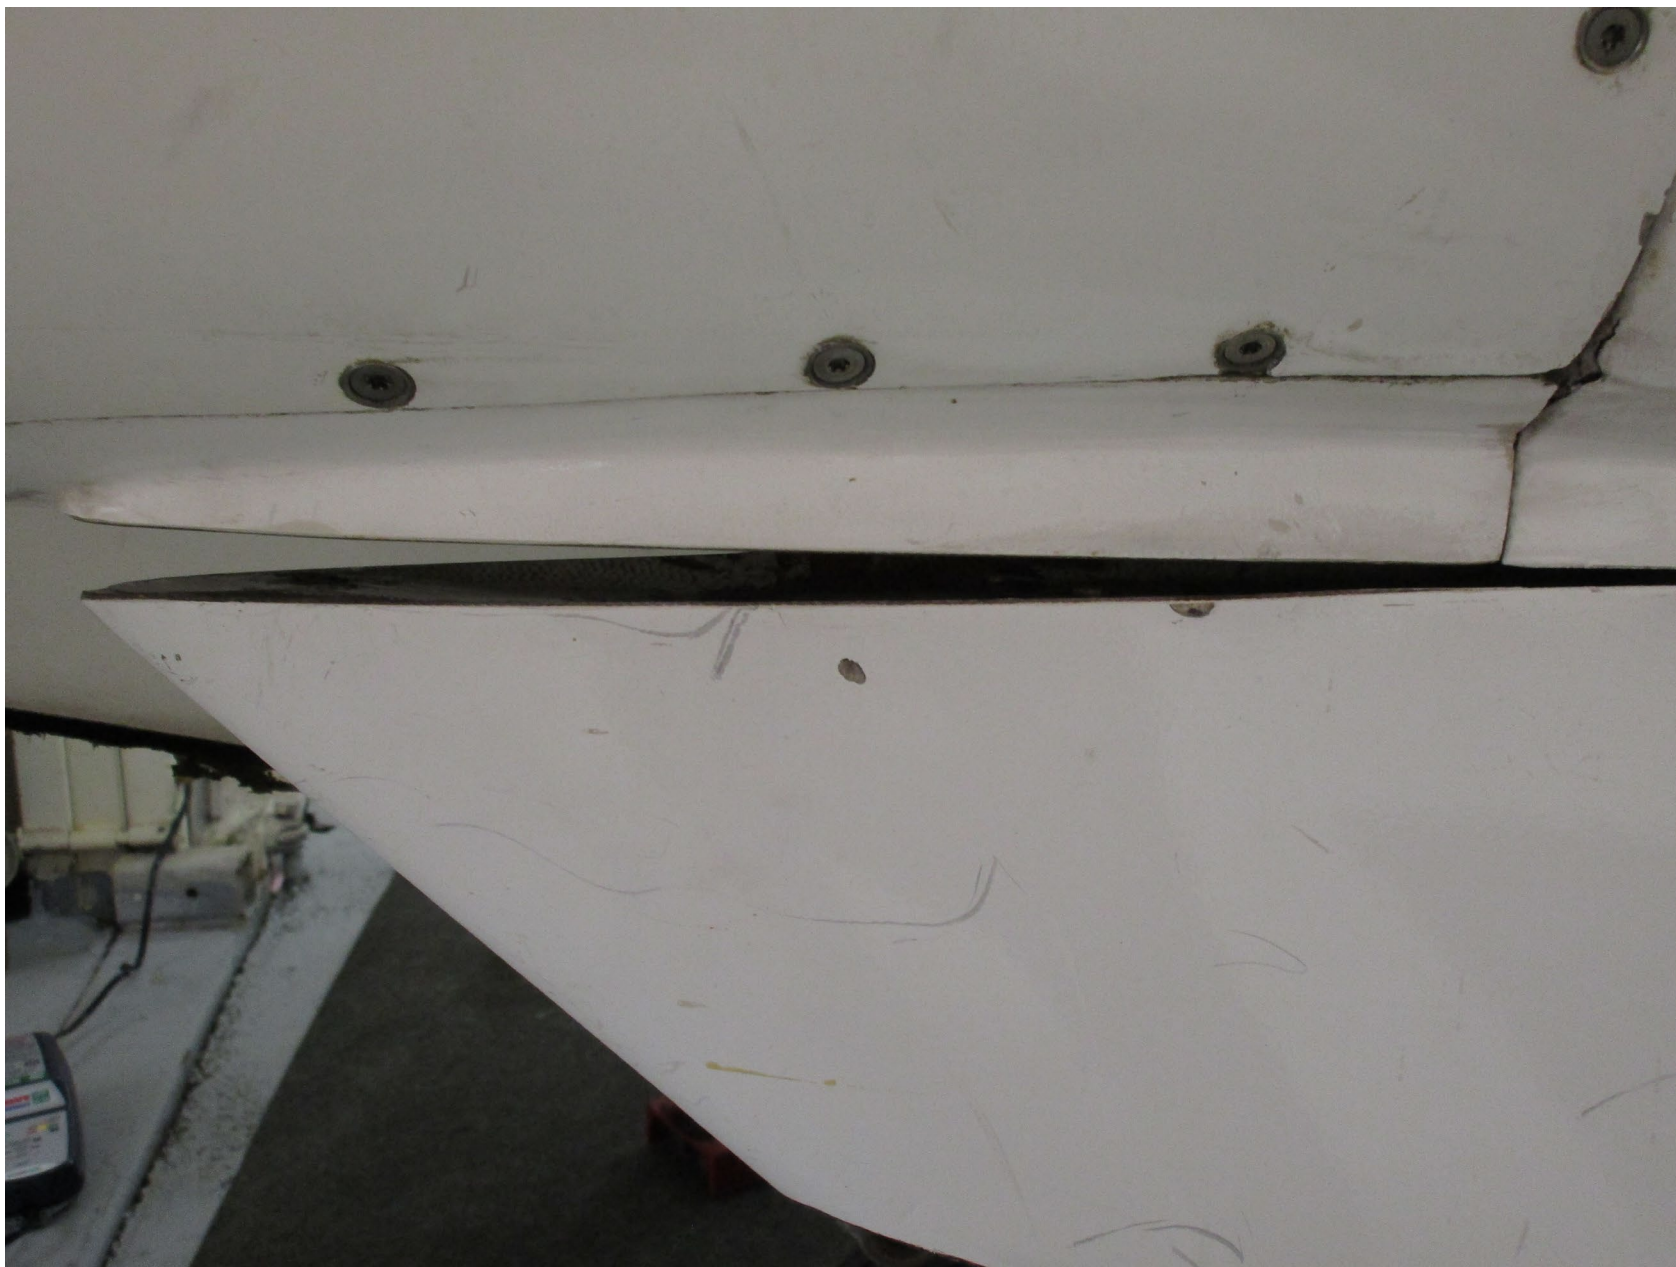
**Photo 9 – Gap in Rudder / Fuselage Juncture – Courtesy of FAA**

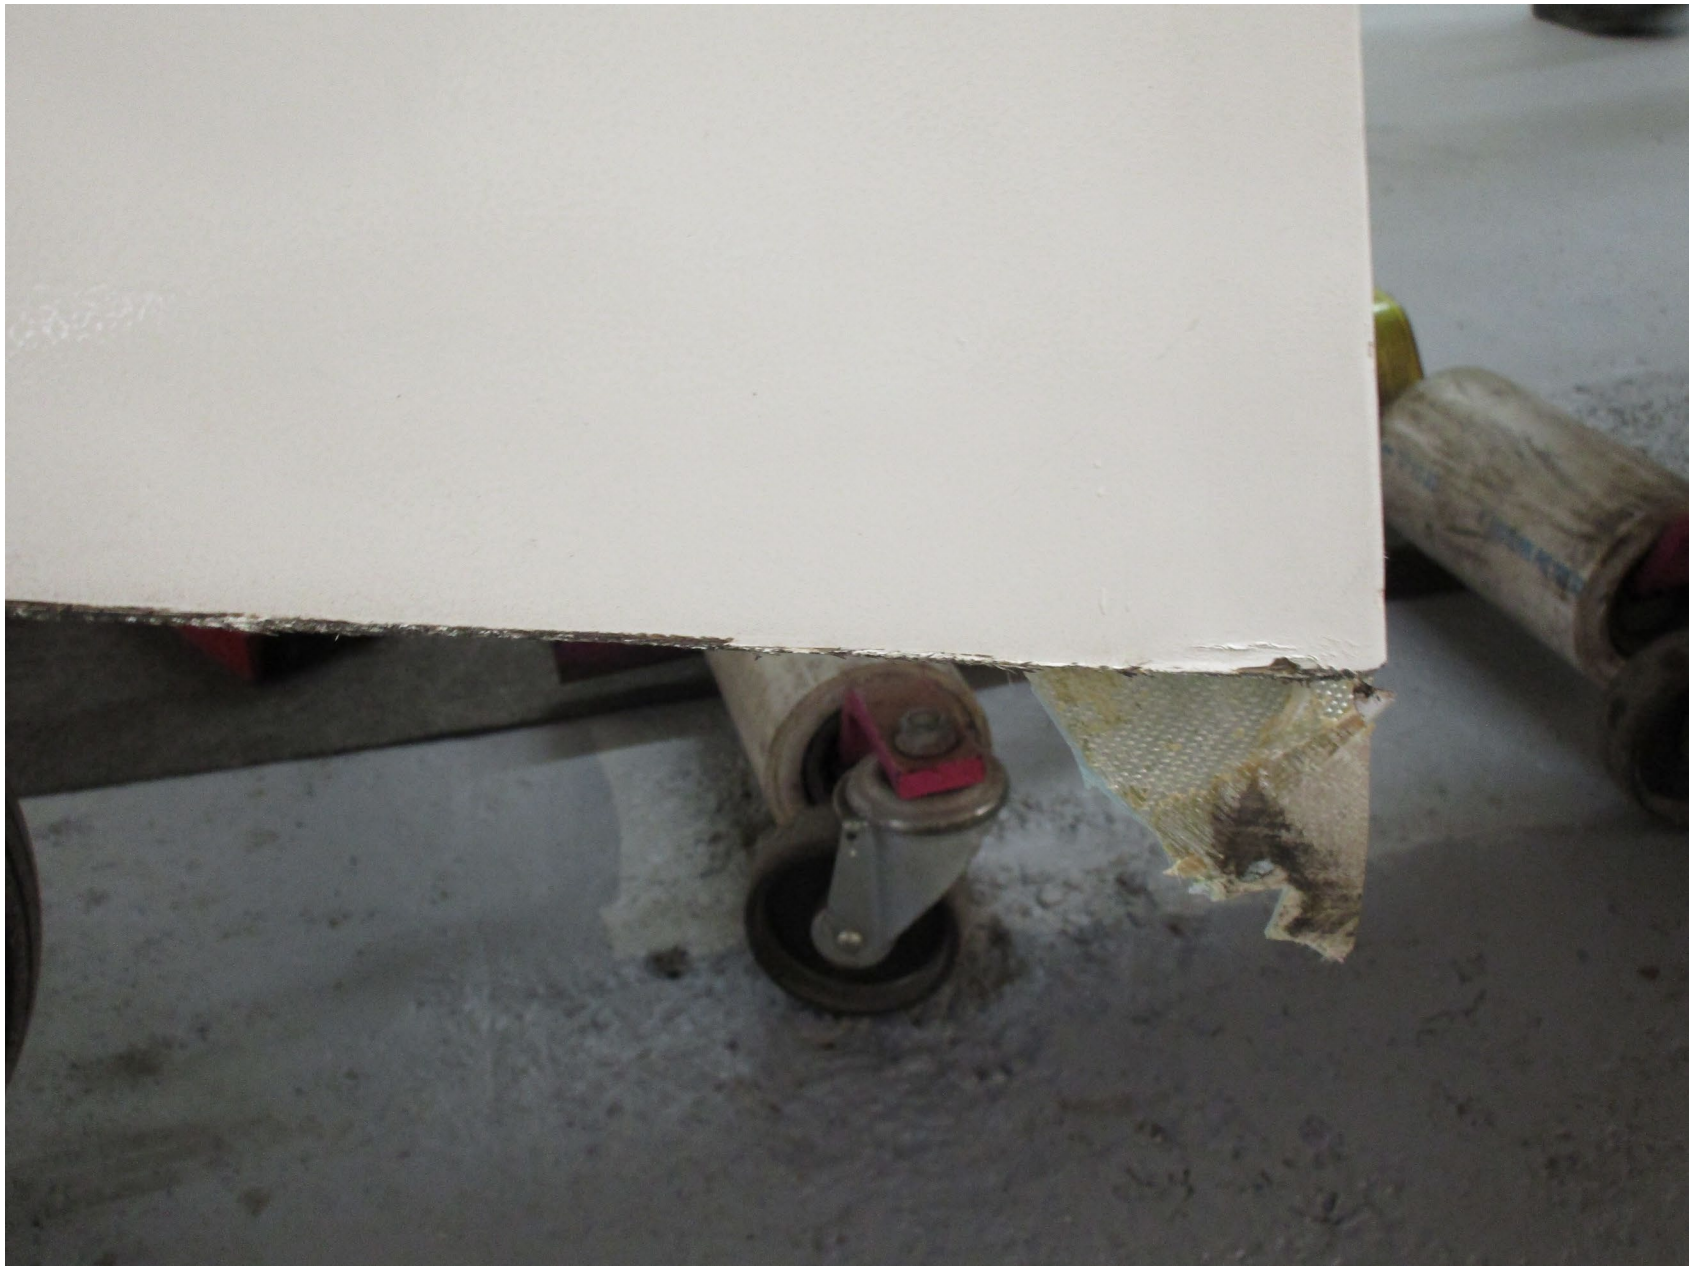
**Photo 10 – Ground Down Section of Rudder – Courtesy of FAA**

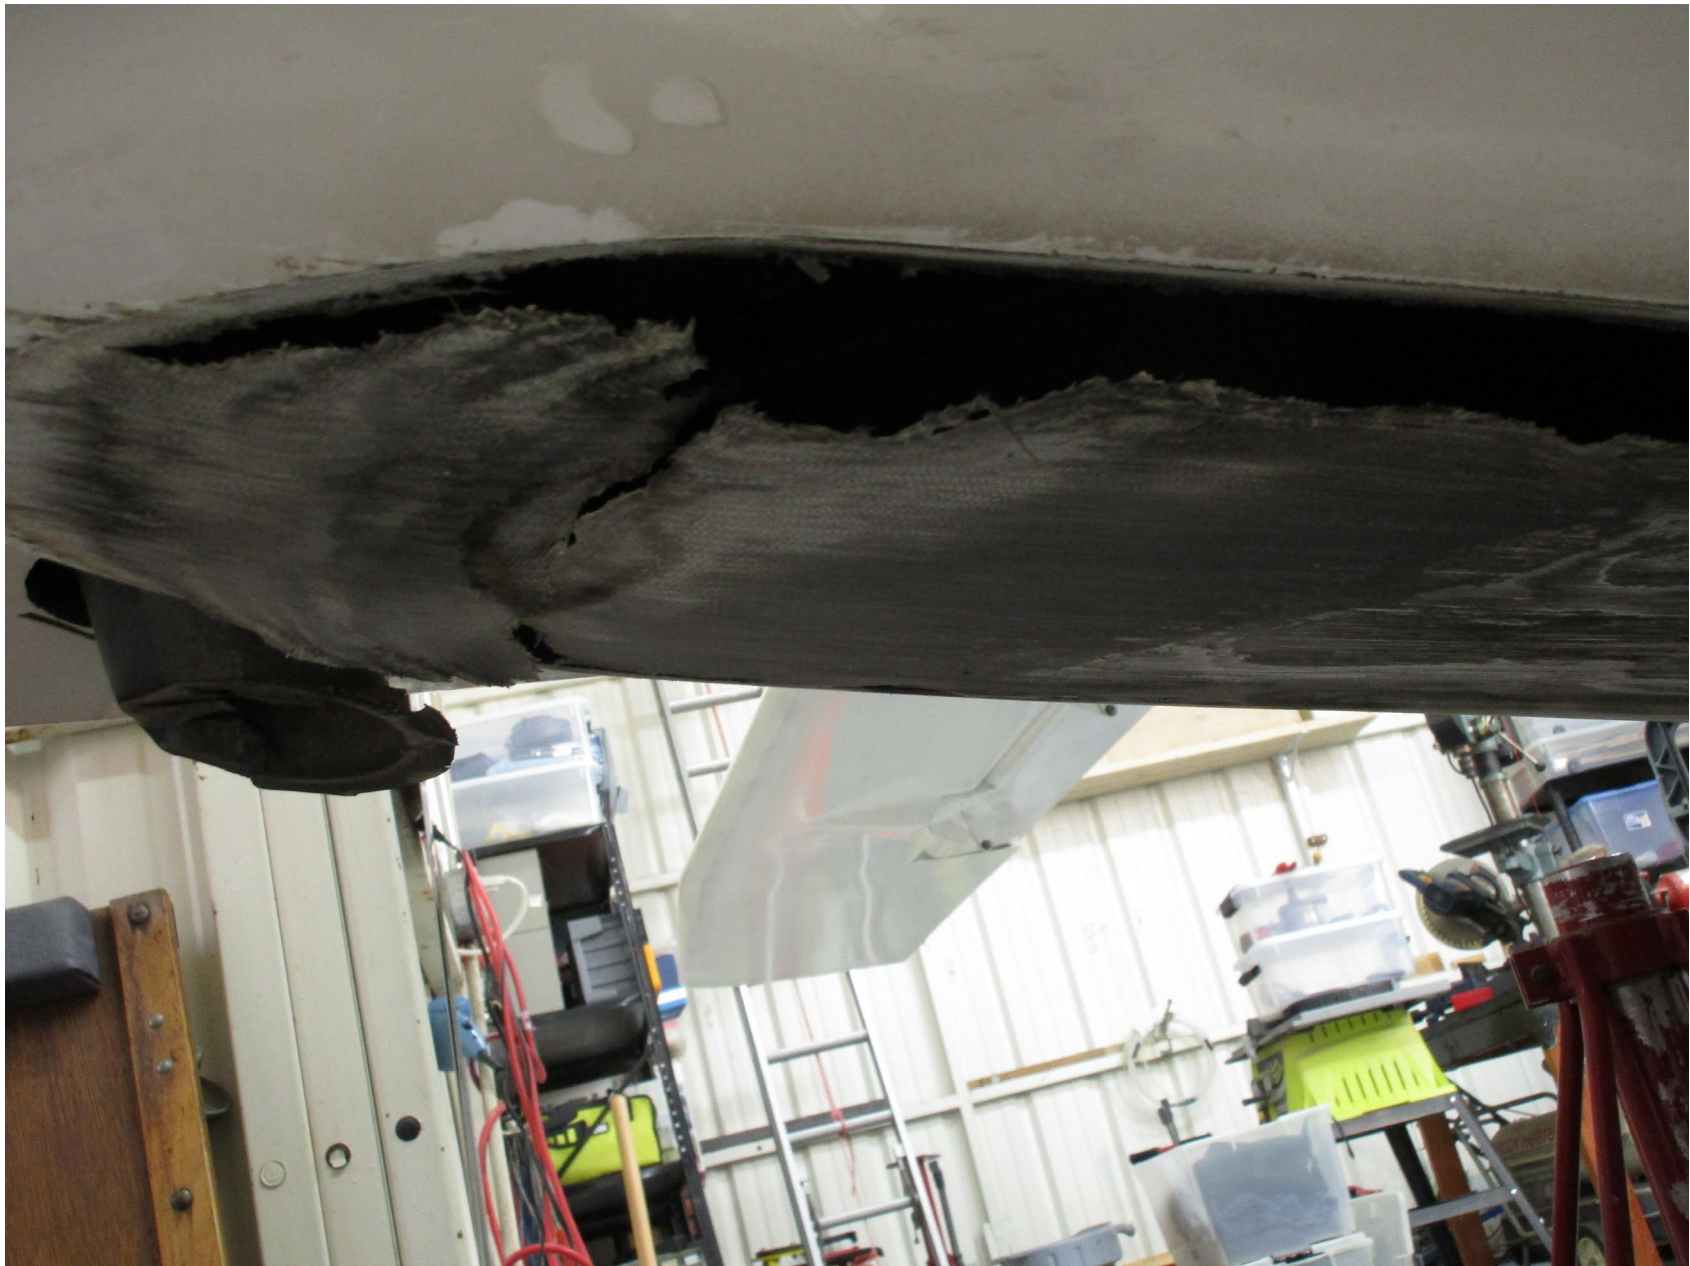
**Photo 11 – Damaged Front Engine Exhaust Pipe and Lower Cowling – Courtesy of FAA**
