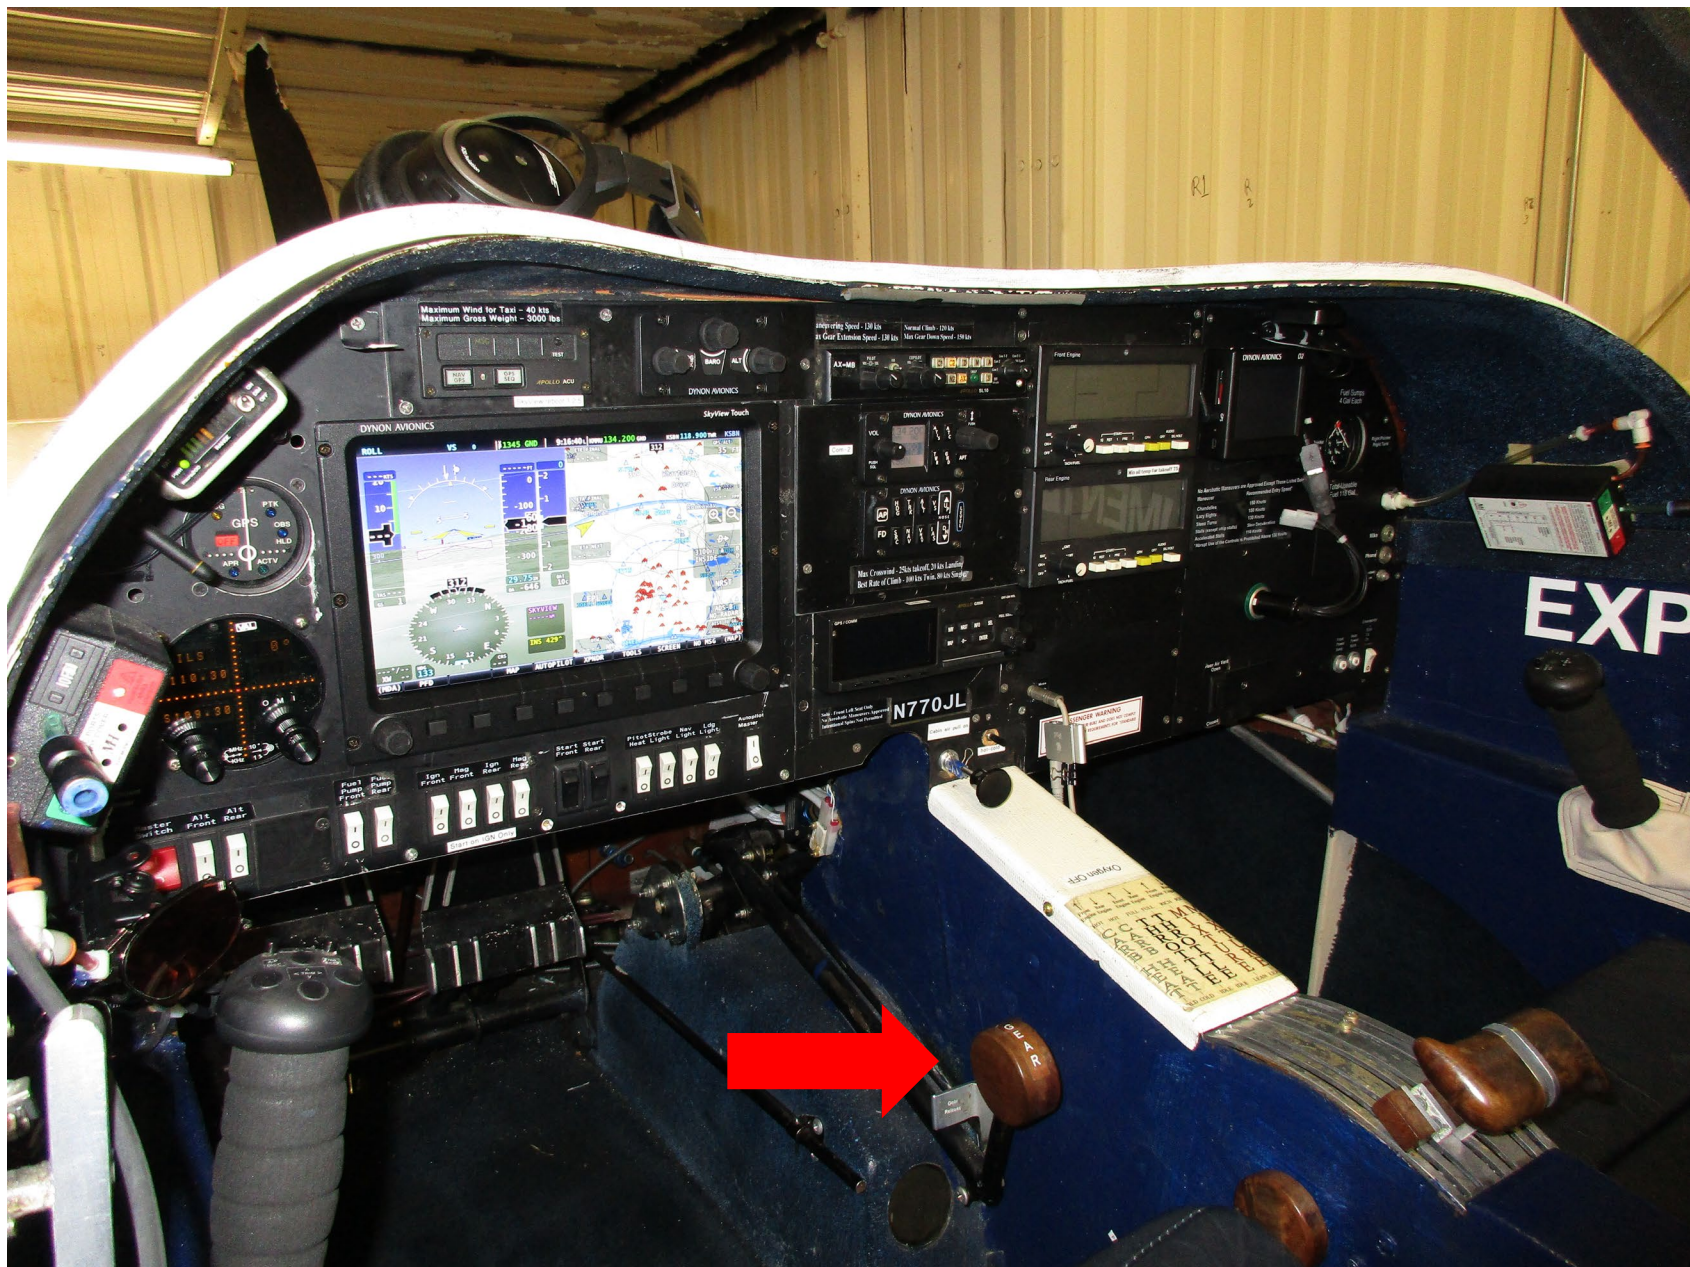
Photo 12 – Landing Gear Actuation Handle – Courtesy of FAA

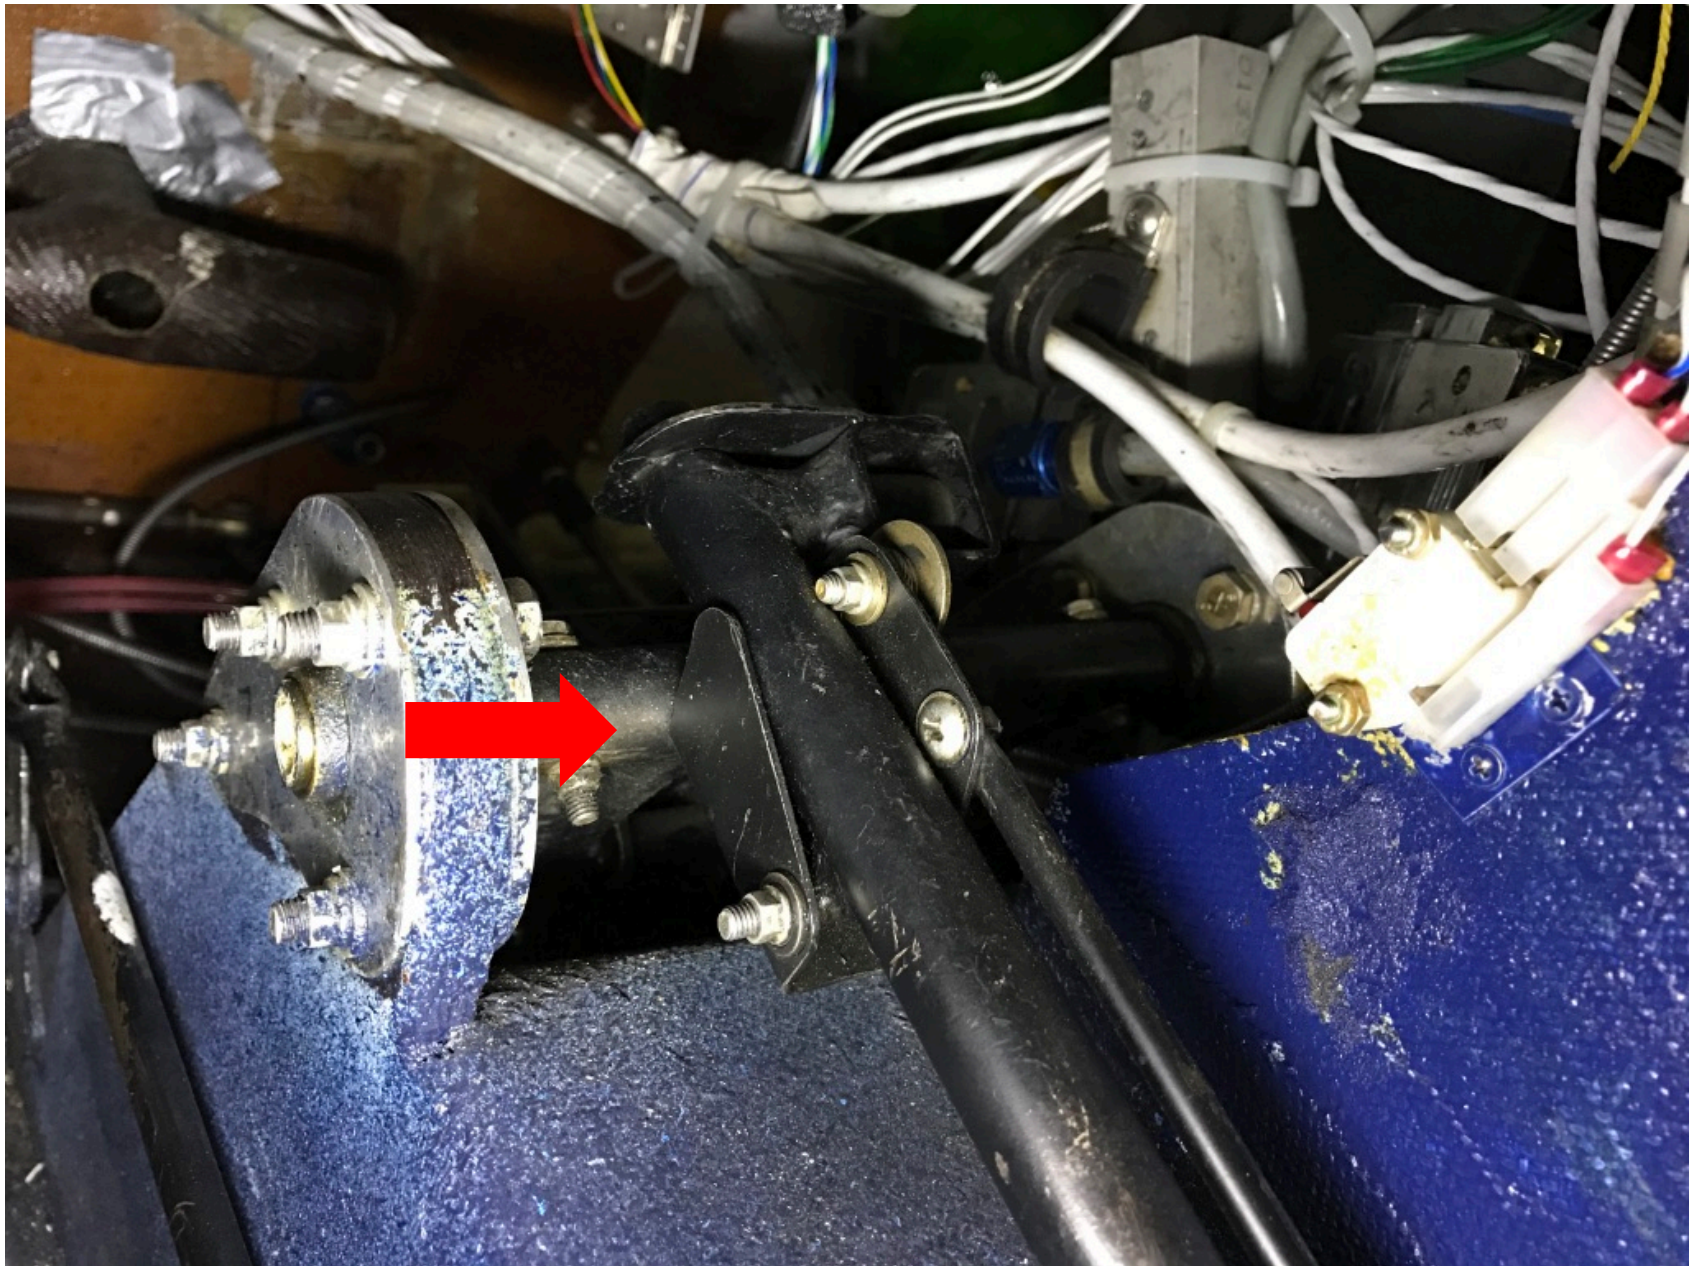
**Photo 13 – Nose Gear Down Lock Displaying Minimal Contact with Pivot Shaft – Courtesy of FAA**
