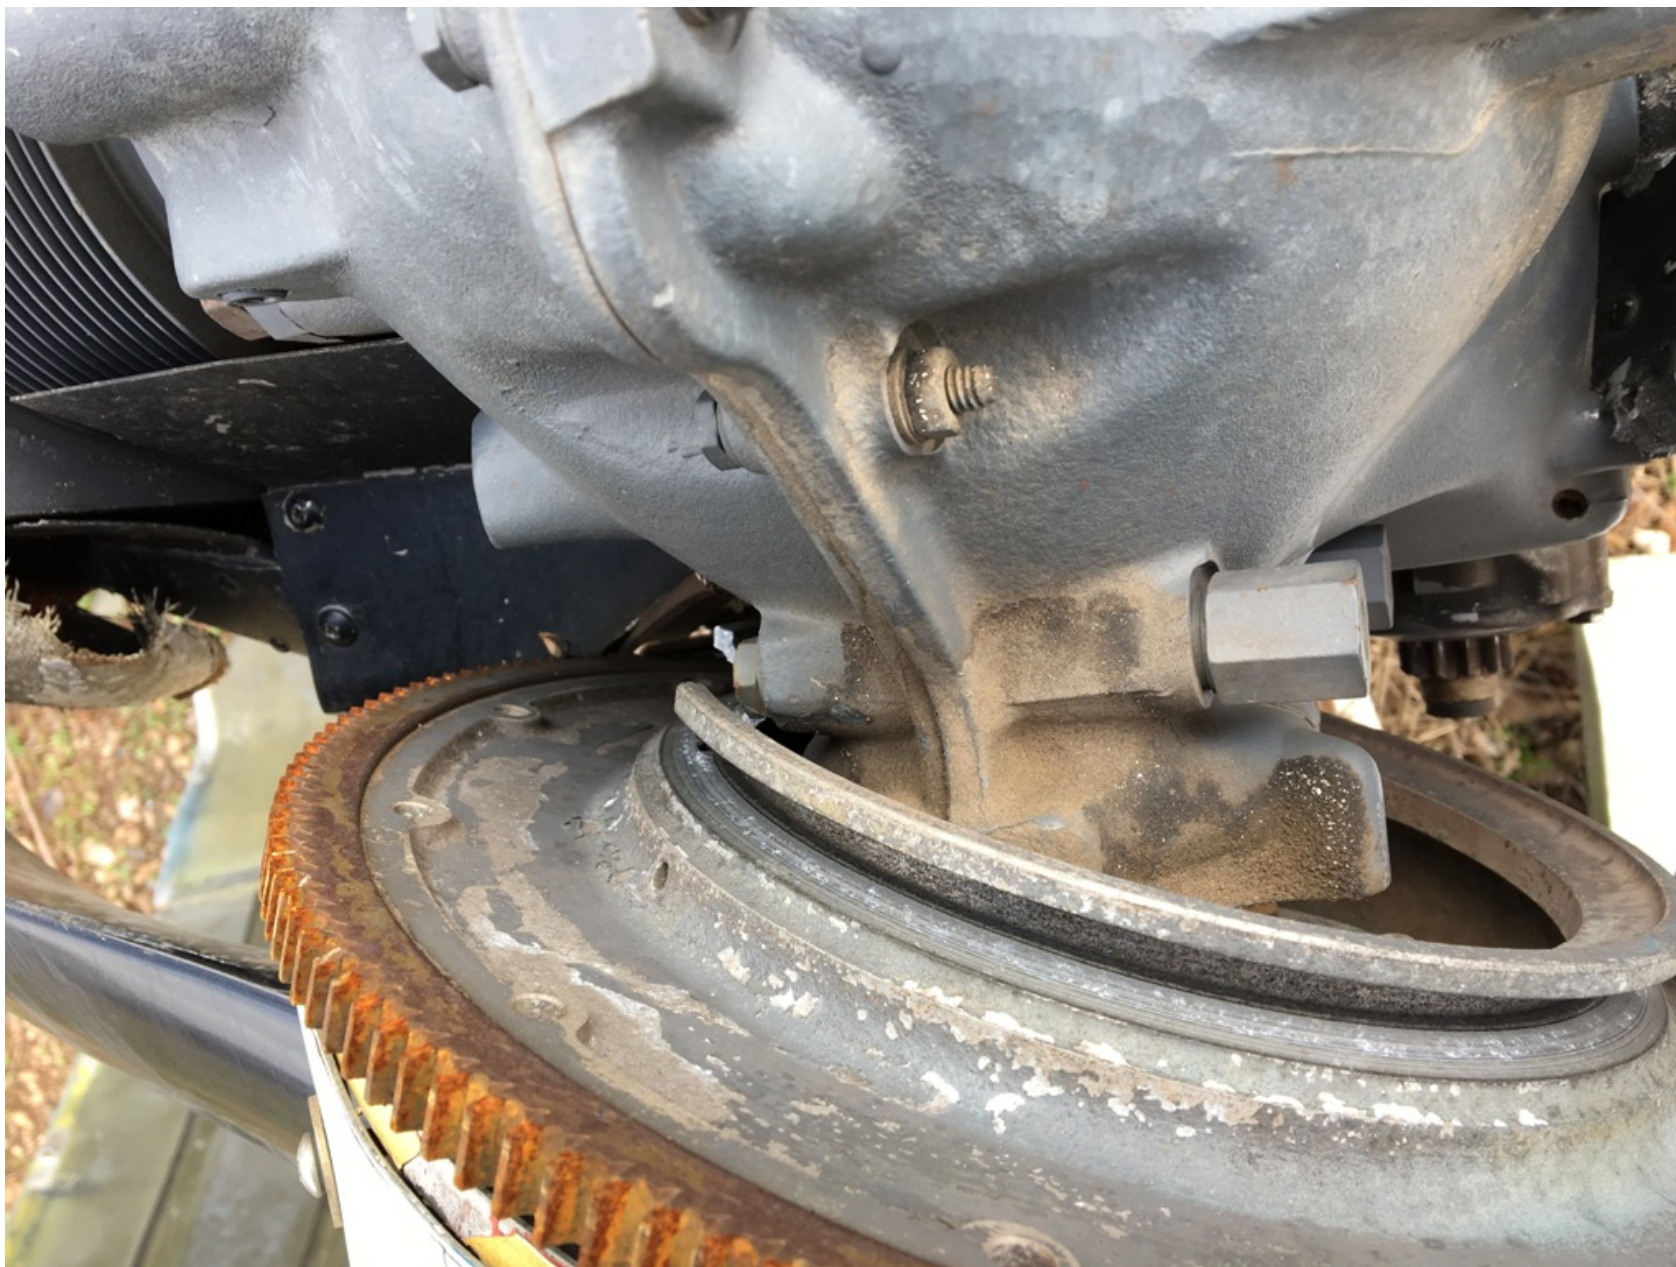
**Photo 5 – Damaged Propeller Flange (NTSB Photo)**
