## HISTORY OF FLIGHT

On November 22, 2016, at approximately 1142 EDT (1542 UTC), Cirrus SR22-3812, registration N217CE, was substantially damaged during takeoff. The pilot reported the engine was not making full power, aborted the takeoff, a loss of directional control ensued, and the airplane went off the side of the runway striking a runway marker light. The pilot and passenger reported no injuries. Day visual meteorological conditions prevailed at the time of the accident.

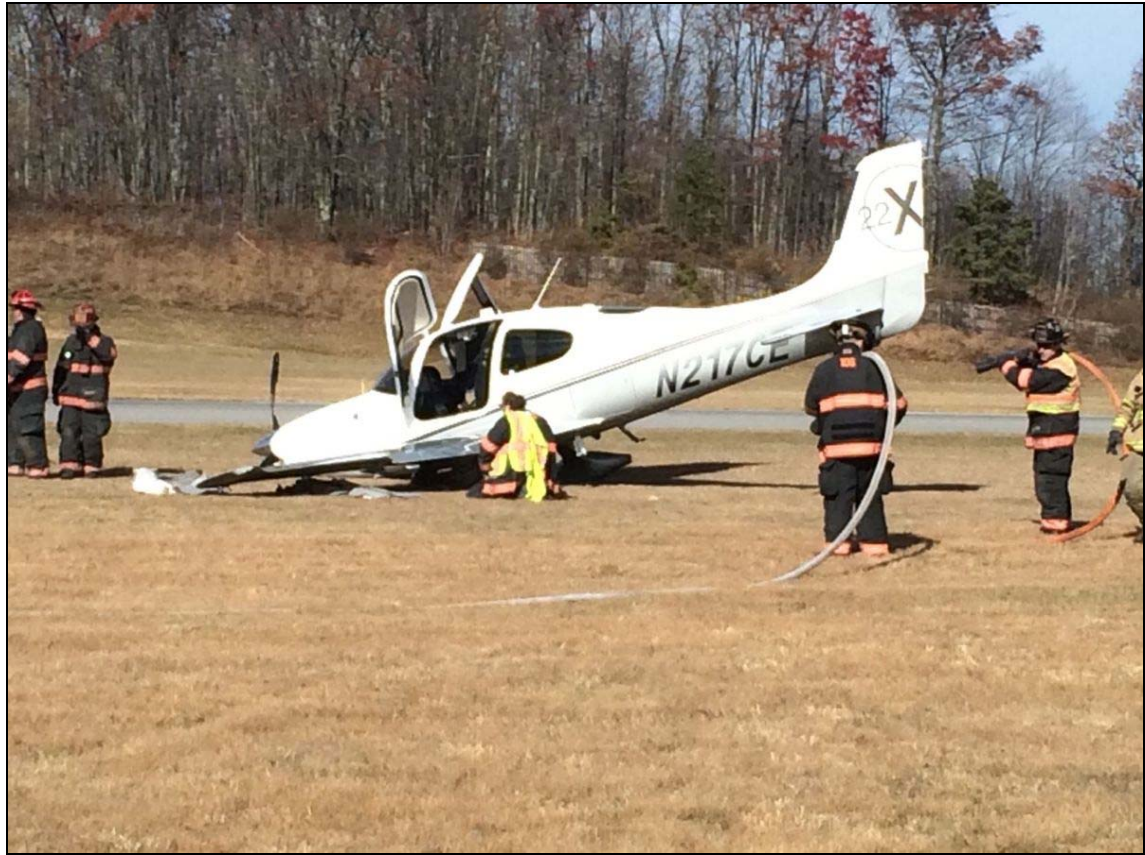
Figure 1 – Accident site (photo taken off of internet)

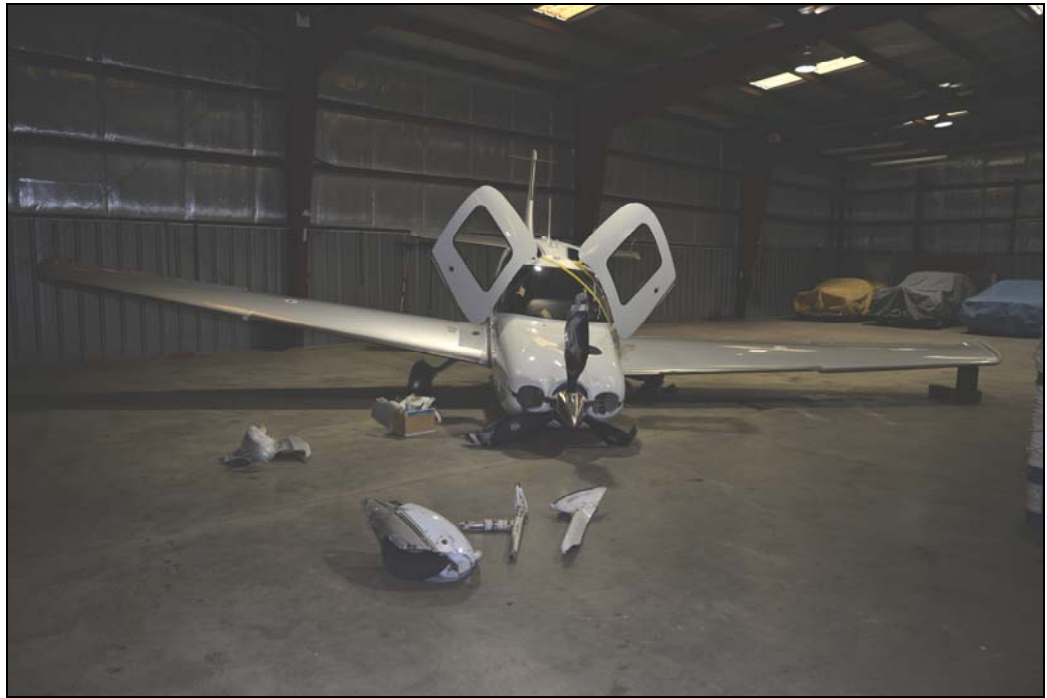
The accident airplane was resting on the right main landing gear with the left wing tip up on a railroad tie (to prevent fuel from leaking) and the engine on the ground. A fork lift was used to lift the airplane to facilitate removal of the lower cowlings and examination of the engine.

*Figure 2 – Accident airplane.*

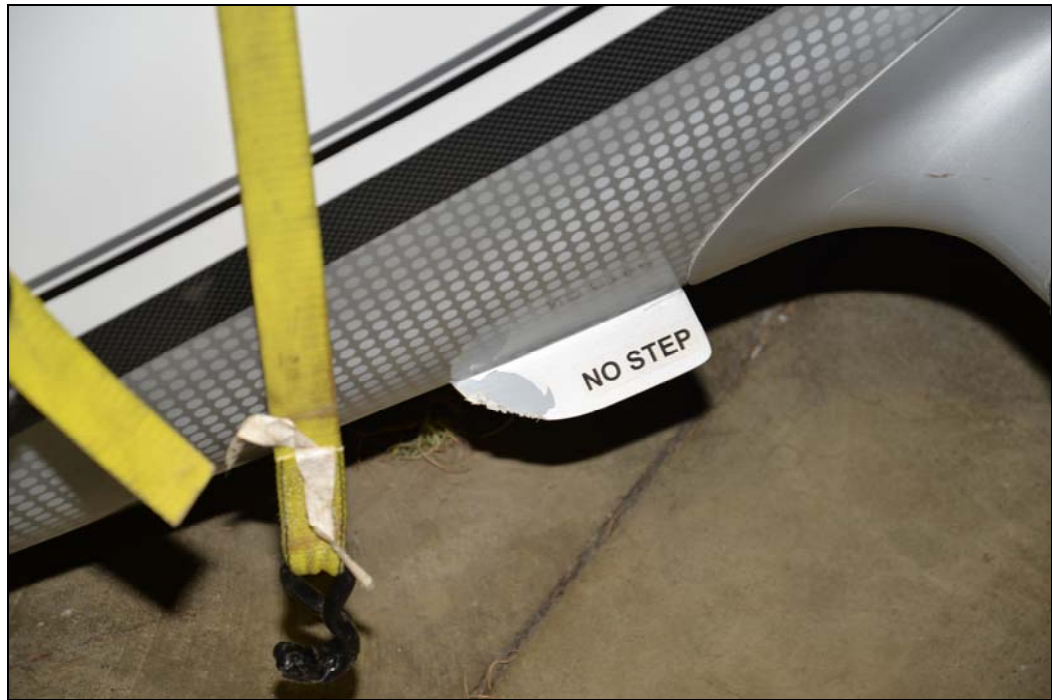
The fuselage was intact with minor damage present. The left vortex generator was damaged.

*Figure 3 – Left vortex generator.*

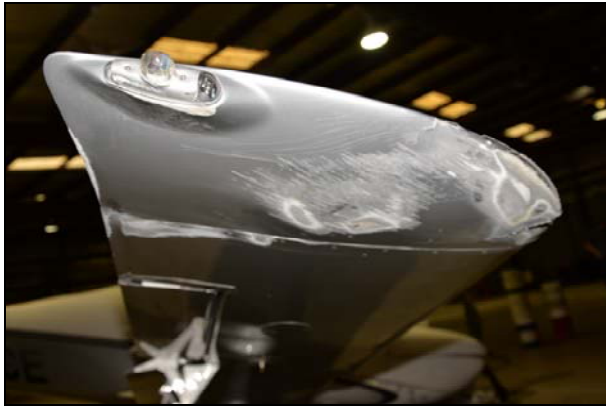
The outboard end of the right lower wing skin exhibited scratches and scuff marks. The right wingtip had impact damage. The upper and lower wing skins were separated for approximately 6 inches along their trailing edge starting at the right wingtip mounting flange and extending inboard. The right wing fuel tank had fuel present and spilled out when an attempt to open the filler cap was made.

*Figure 4 – Right wingtip.*

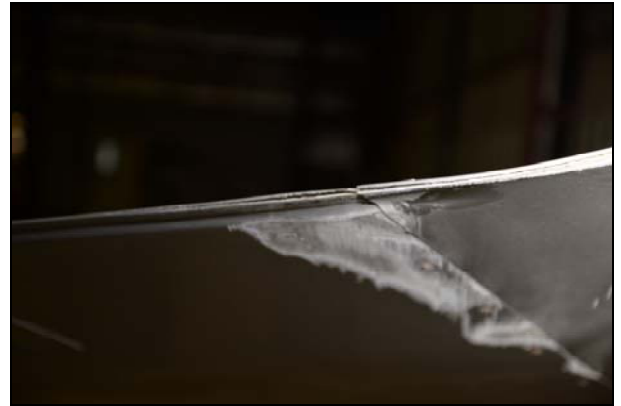
*Figure 5 – Right wingtip aft edge.*

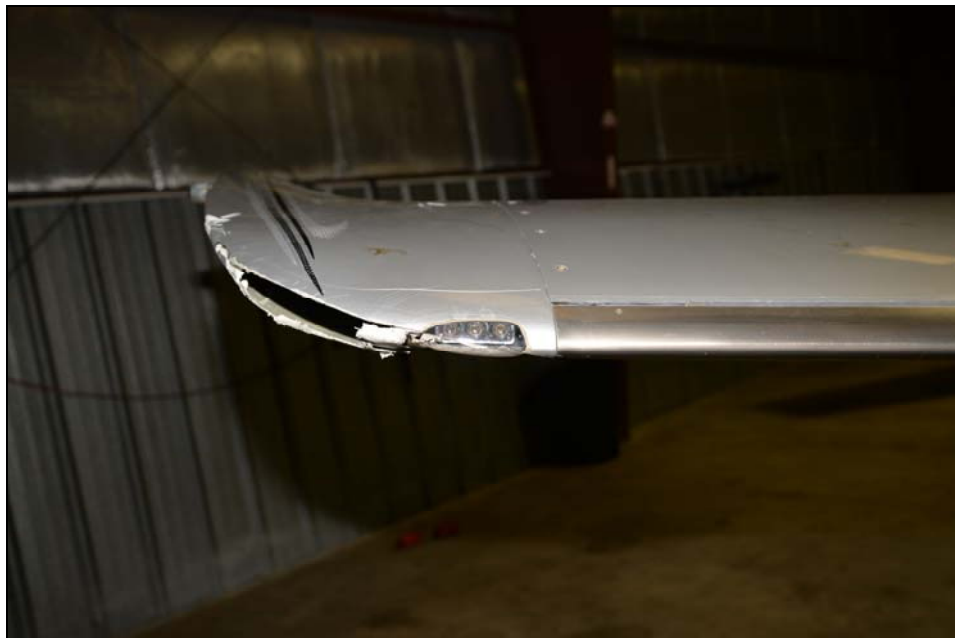
*Figure 6 – Right wingtip forward edge.*

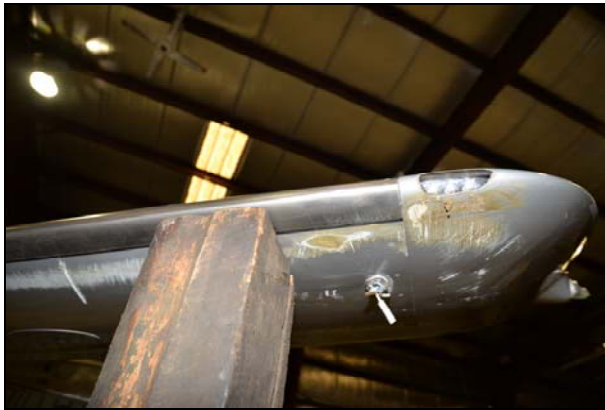
Scuffing was present just aft of the outboard TKS panel along the outboard 3 feet of the left lower wing skin. The pitot tube mast was separated and damage to the wingtip was present. Someone had applied some type of sealant around the fuel tank NACA vent to prevent fuel leakage. The left flap hinges were bent inboard. The left flap exhibited buckling in multiple locations and there was impact damage to the inboard flap cove consistent with the left main landing gear wheel assembly having struck it. Fuel was present in the left wing fuel tank to just below the tab.

Figure 7 – Left wingtip.

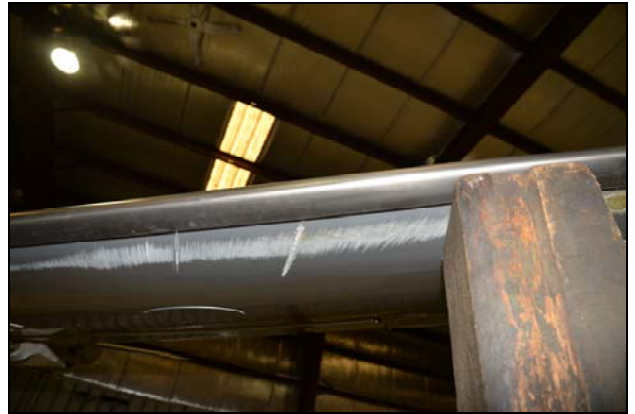
Figure 8 – Outboard left lower wingskin.

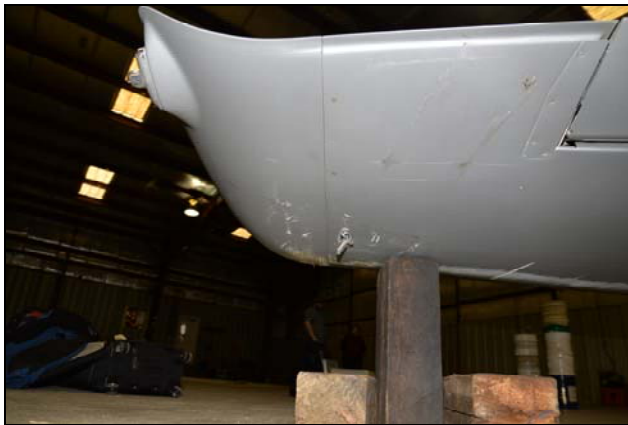
Figure 9 – Left wingtip.

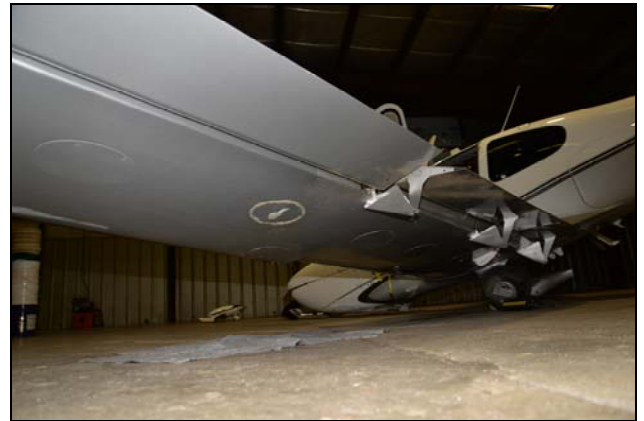
Figure 10 – Left lower wingskin.

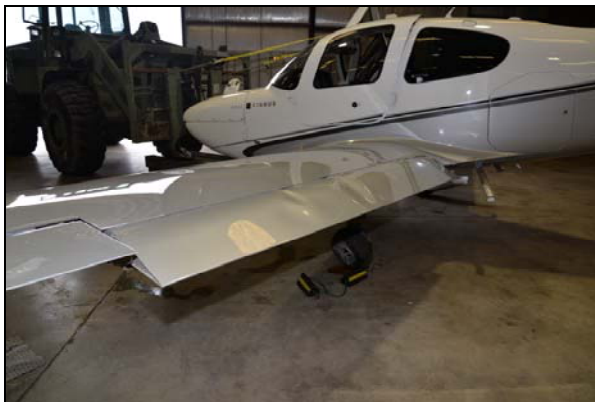
Figure 11 – Left upper wingskin.

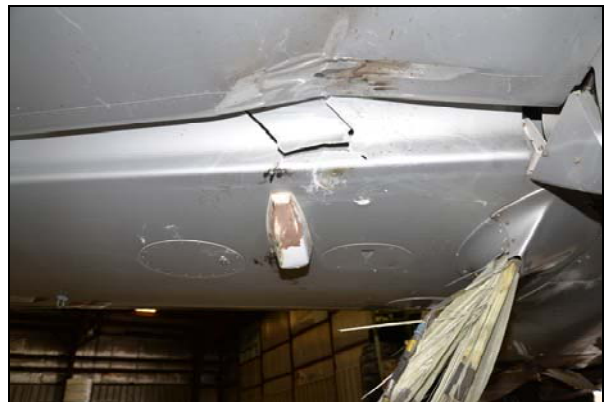
Figure 12 – Left lower wingskin.

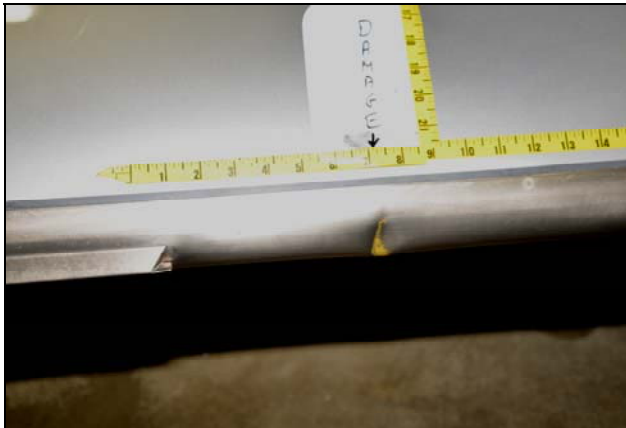
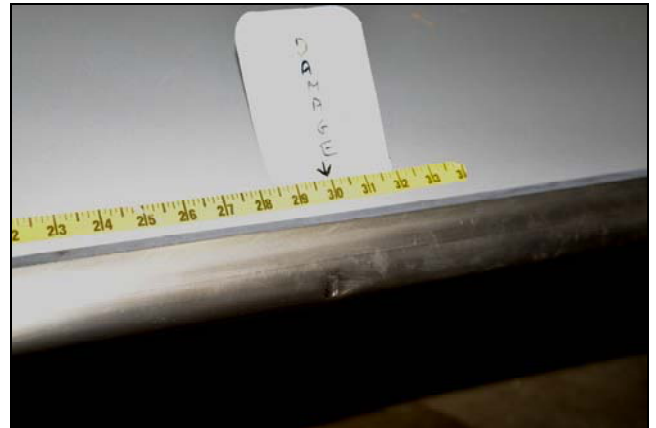
The left inboard TKS panel had a dent approximately 6.5 inches outboard of the inboard stall strip. This dent also had yellow paint transfer present. The FAA stated the airplane had struck a yellow runway marker light.

A second dent was present on the inboard TKS panel approximately 28.5 inches outboard of the inboard stall strip.

*Figure 13 – Left inboard TKS panel.*

*Figure 14 – Left inboard TKS panel.*

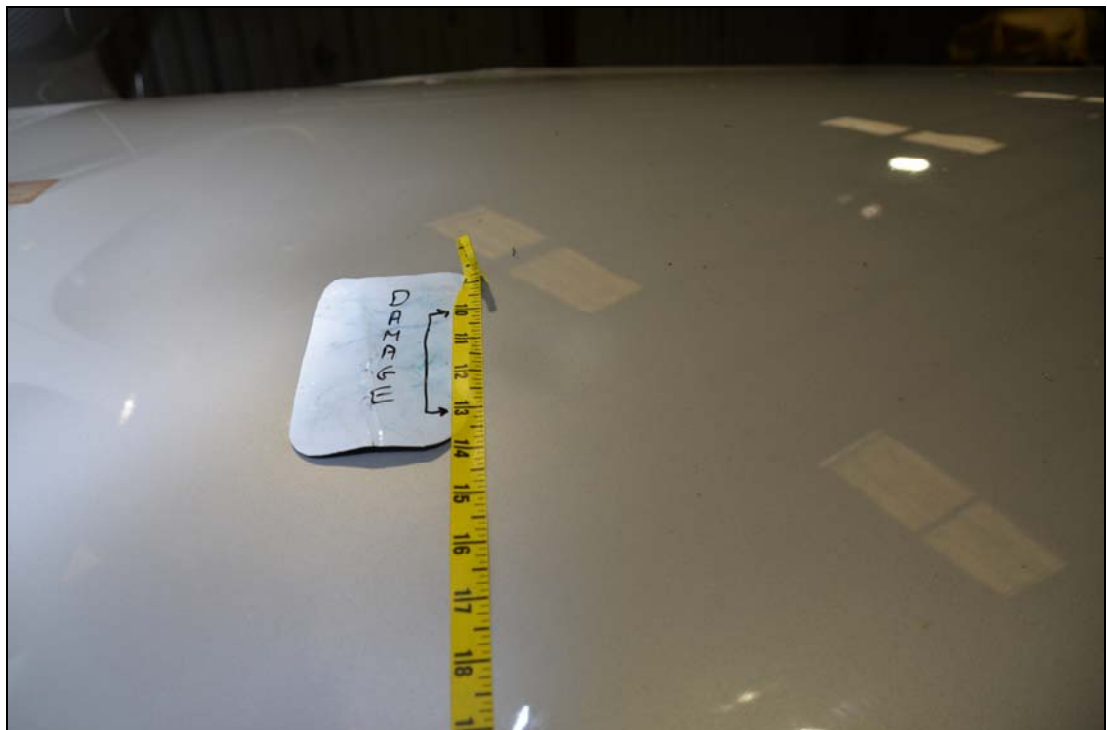
A 3-inch circular dent was present in the left upper wing skin approximately 10 inches outboard of the inboard stall strip and roughly 8.5 inches aft of the inboard TKS panel.

*Figure 15 – Left upper wing skin.*

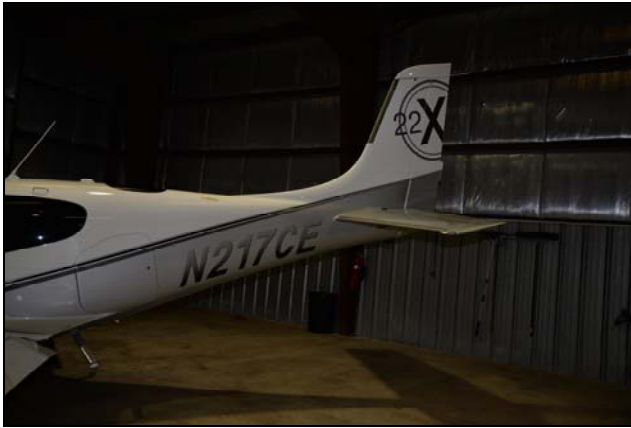
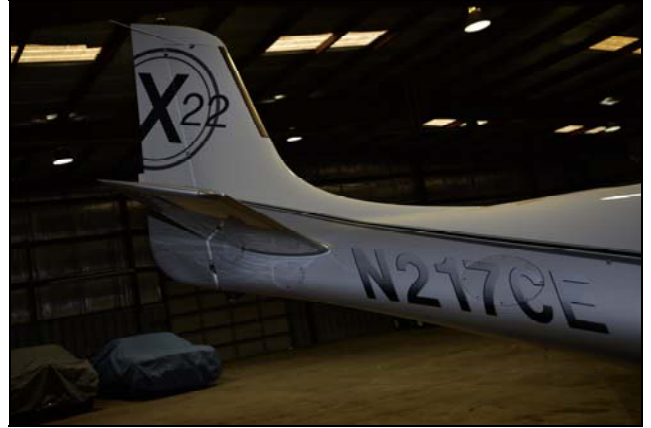
The empennage was intact and no obvious damage was noted. The horizontal and vertical stabilizers had no obvious damage. The rudder and elevators had no obvious damage. The tail tie down had no evidence of ground contact present.

*Figure 16 – Empennage.*

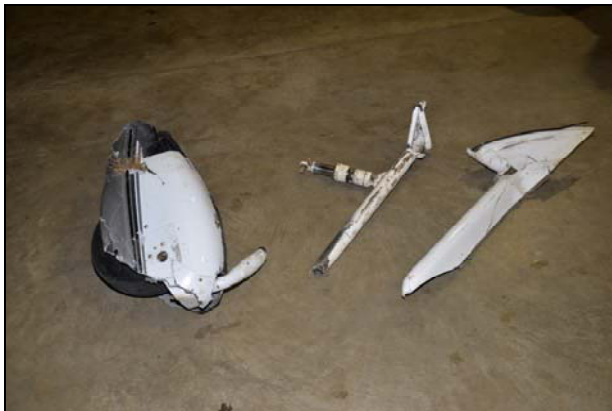
The nose landing gear separated from the airplane. The landing gear strut separated above the wheel assembly, the oleo separated from its top mounting point, and the strut assembly separated from the two mounting points at the engine mount / weldments. The forward portion of the nose landing gear wheel pant separated, and scuffing / scratches were present on the nose wheel fork assembly.

*Figure 17 – Nose landing gear.*

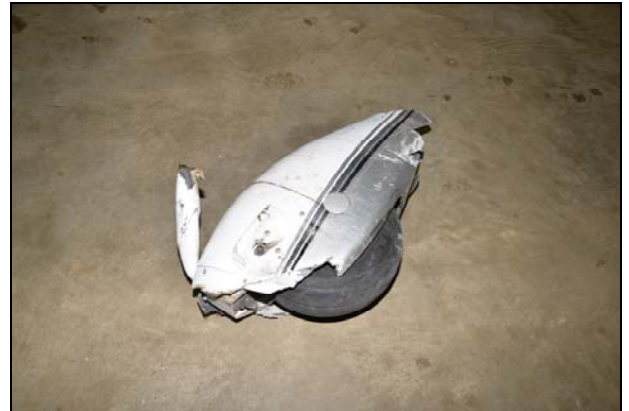
*Figure 18 – Nose wheel assembly.*

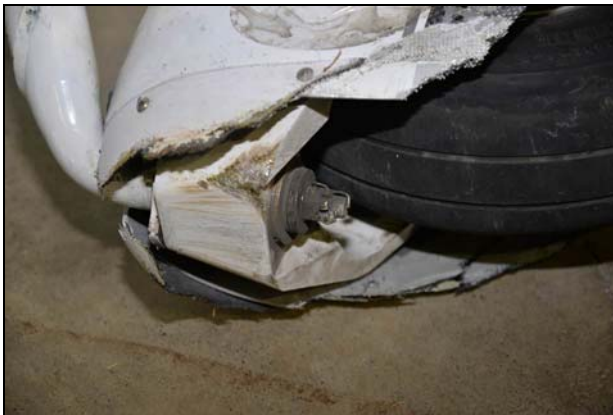
*Figure 19 – Nosewheel assembly.*

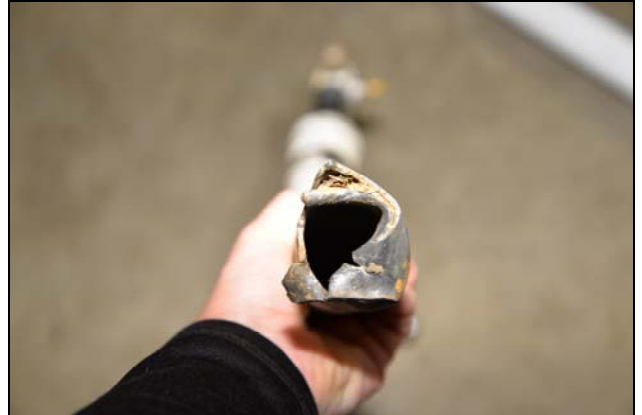
*Figure 20 – Nose landing gear strut.*

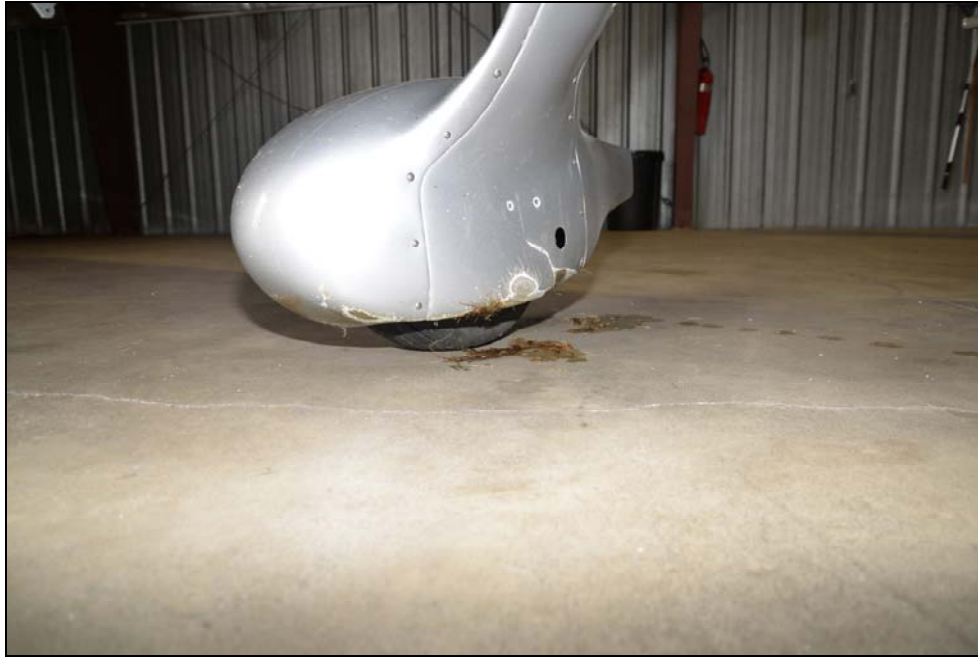
The right main landing gear remained attached to the wing and exhibited impact damage. The bottom of the wheel pants were cracked. The fairings were not removed for further inspection of the gear strut assembly and mounting location.

*Figure 21 – Right main landing gear.*

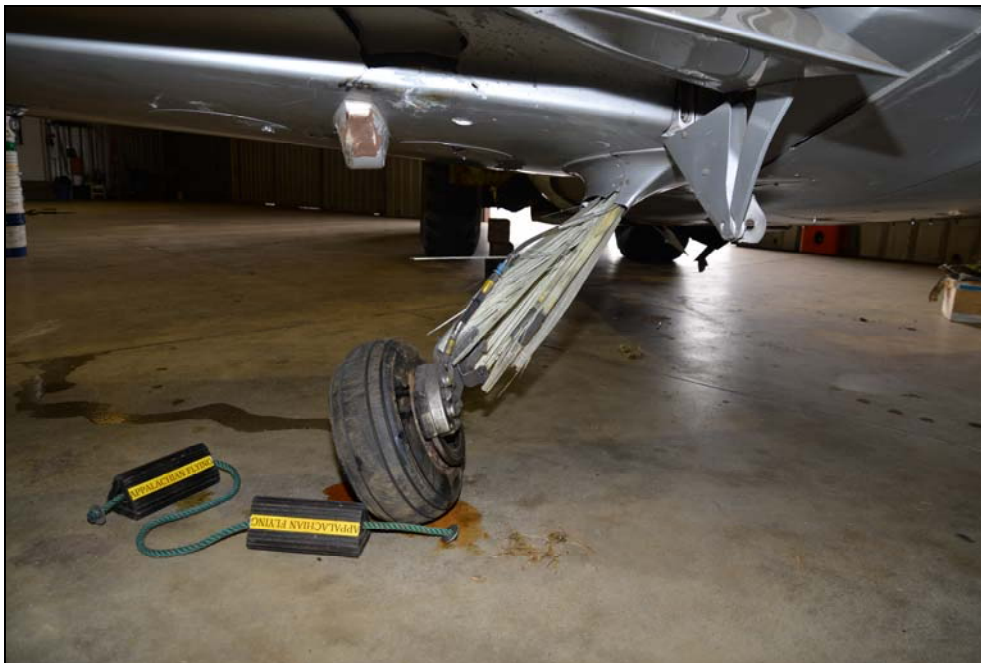
The left main landing gear remained attached to the wing and exhibited impact damage. The bulk of the landing gear strut assembly was delaminated. The fairings were not removed for further inspection of the gear strut upper mounting location. Brake fluid was present on the ground below the tire.

*Figure 22 – Left main landing gear.*

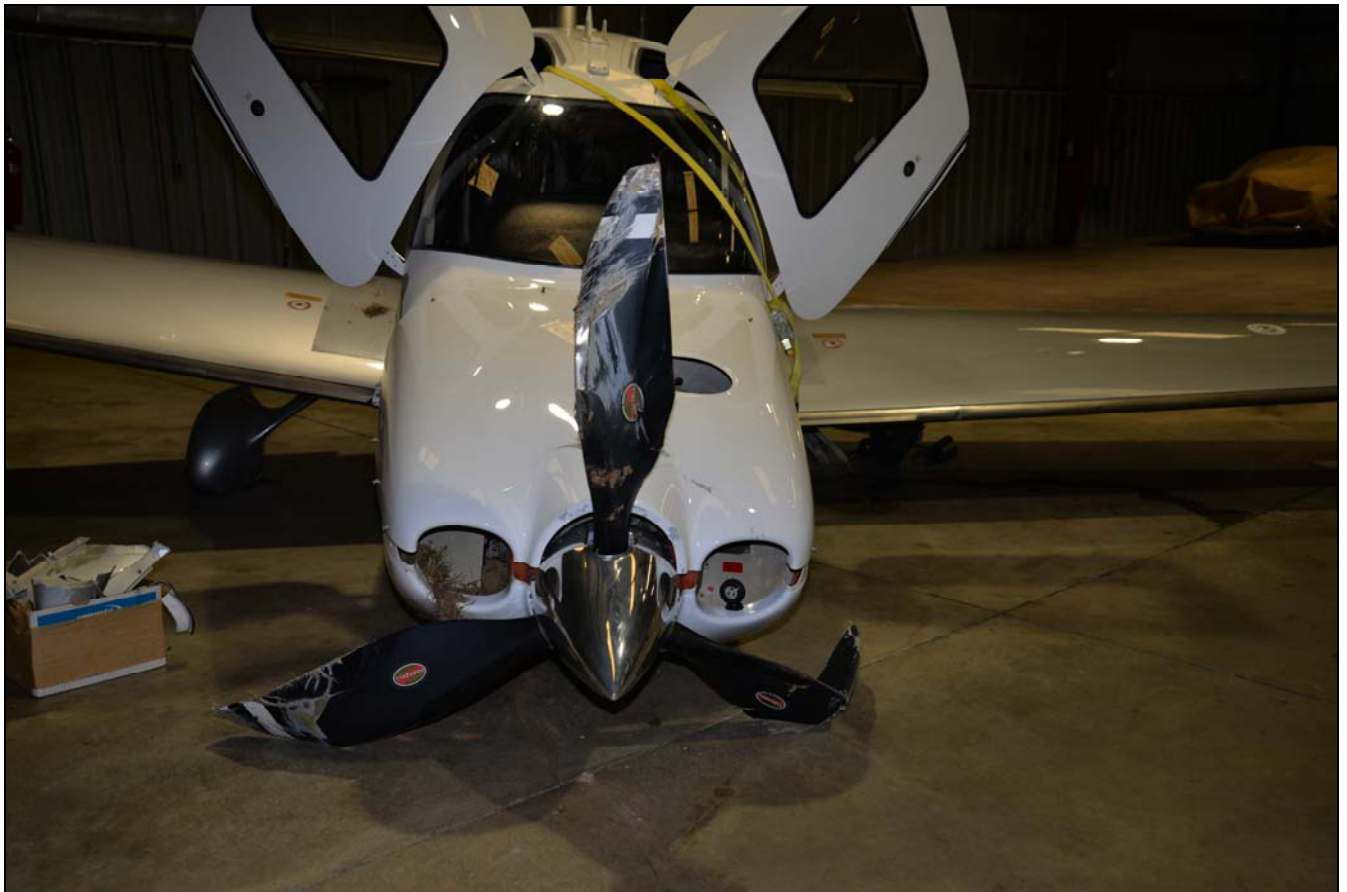
The propeller spinner was intact. The tip of the spinner was flat but no determination could be made if this occurred during impact or handling afterwards.

All three composite propeller blades exhibited impact damage.

Figure 23 – Propeller.

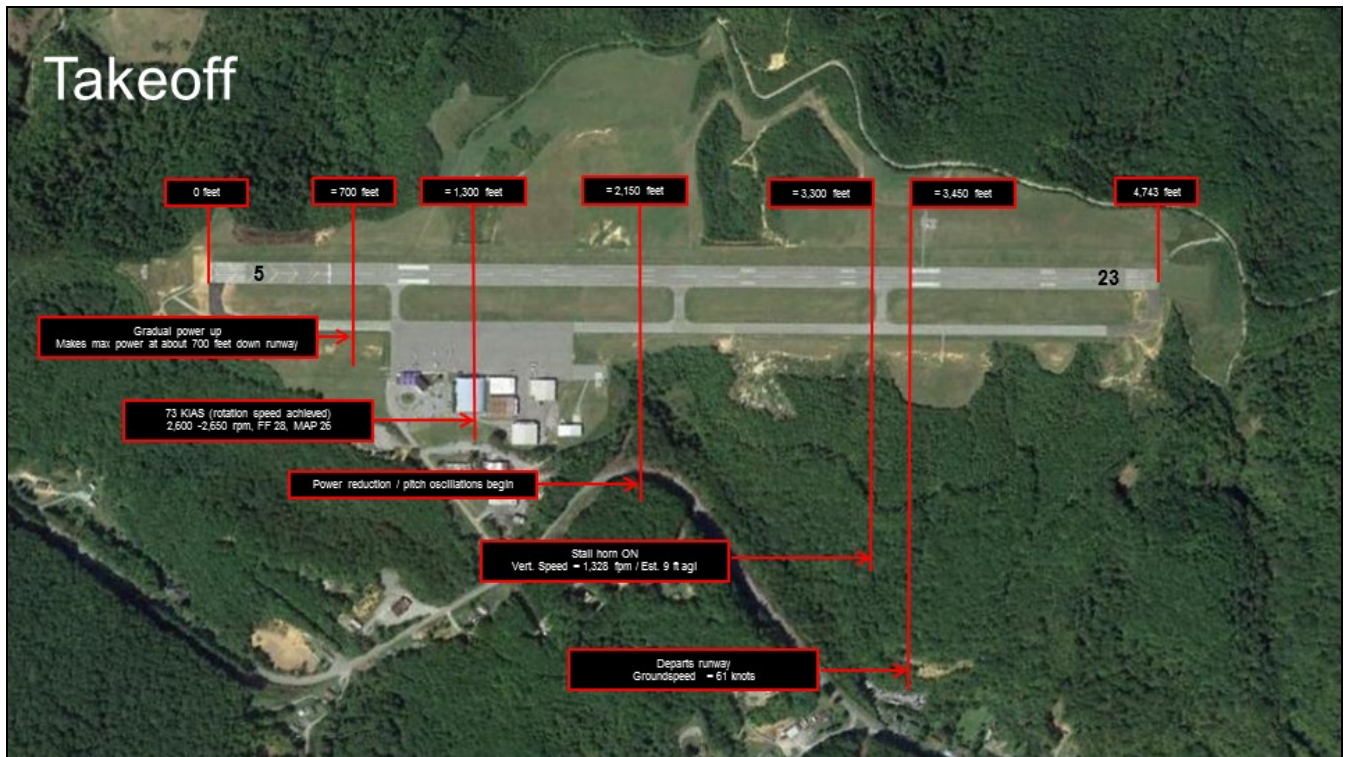
At 16:42:29 (17977), approximately 2,150 feet from the start of the runway 5 pavement, data indicated a power reduction. The data shows a decrease in engine rpm from about 2,600 rpm to about 1,500 rpm. 2,590 feet of runway feet remained at this time. Up to this time there is no indication in the data of rotation occurring, however when the power reduces pitch attitude goes to 7 degrees nose up, one second later 1 degree nose up, one second after that 7 degrees nose up, followed by 3 degrees nose down the following second. After this point all dashes appear in the data for accelerometer related data (pitch, yaw, and roll attitude and rates).

At 16:42:37 (17985), approximately 3,300 feet from the start of the runway 5 pavement, data indicated: a GPS altitude of 2,864 feet; indicated airspeed 79 knots; vertical speed 1,328 fpm (the vertical speed one second prior was +176); and the stall horn was on. Google Earth shows the elevation at the coordinate given for this data point as 2,855 feet, which gives the airplane an estimated altitude of approximately 9 feet agl.

At 16:42:39 (17987), approximately 3,500 feet from the start of the runway 5 pavement, data indicated that the airplane departed the right side of the runway with approximately 61 knots of groundspeed.

Figure 24 – Takeoff diagram.
