## ENGINE RUN REPORT

| ENGINE MODEL | IO-550-N68B |
| FILE NUMBER | 16-295 |

| GENERAL INFORMATION | | | |
|---|---|---|---|
| DATE | 04/04/201 | NTSB ACCIDENT # | ERA17LA063 |

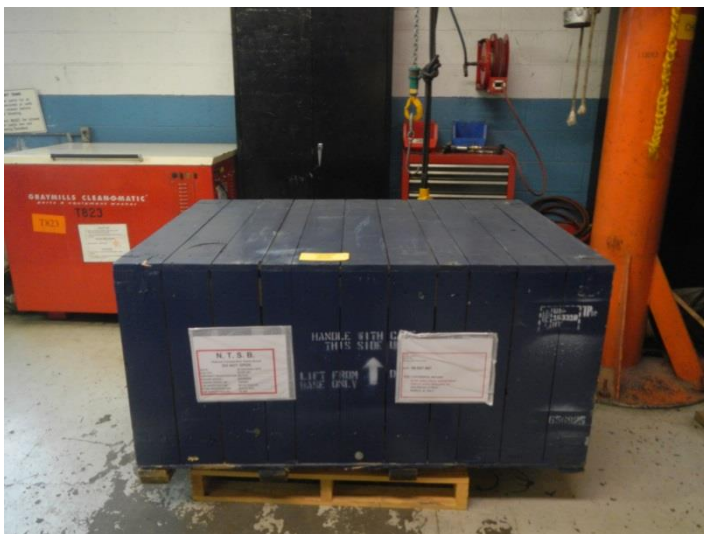
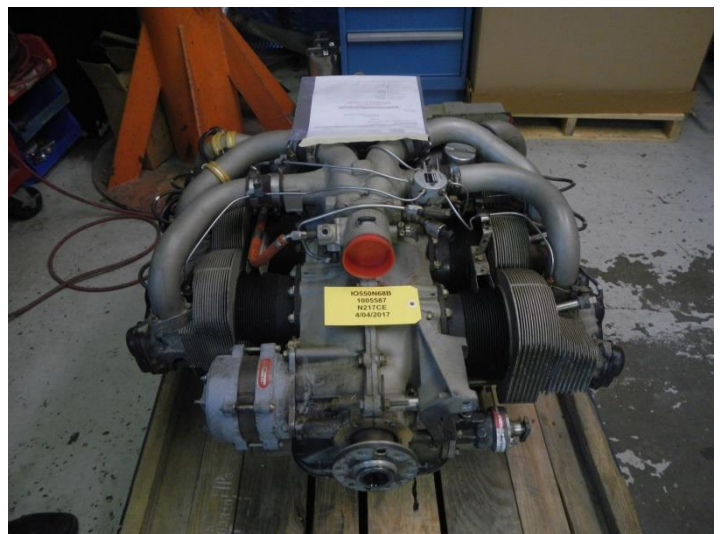
The engine was in the shipping crate with the exhaust manifold removed and placed within the crate separately. There were no external anomalies noted with the engine or the engine-related systems. Movement of the throttle and mixture control levers resulted in a coinciding movement of their control shafts with no slipping or binding noted. Only residual oil remained on the oil dipstick. The engine was placed on a test stand for pre-test run examination.

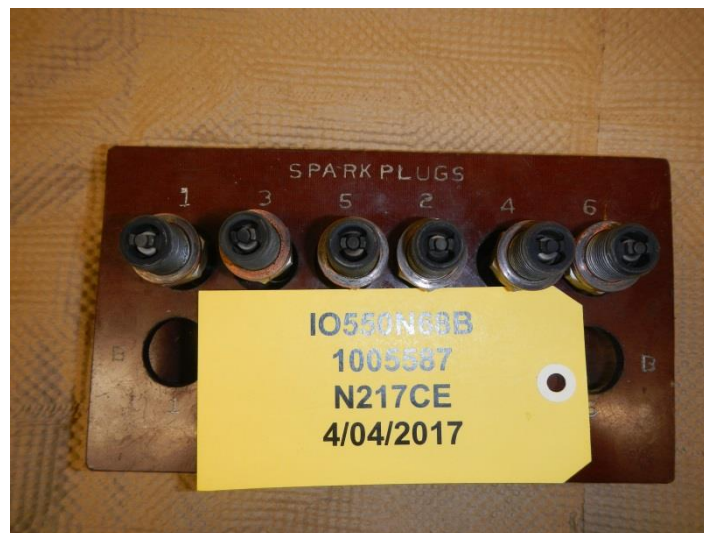
The top sparkplugs were removed and examined. The top sparkplugs displayed a near-new were condition with normal combustion deposits. There was no sign of carbon or lead fouling.

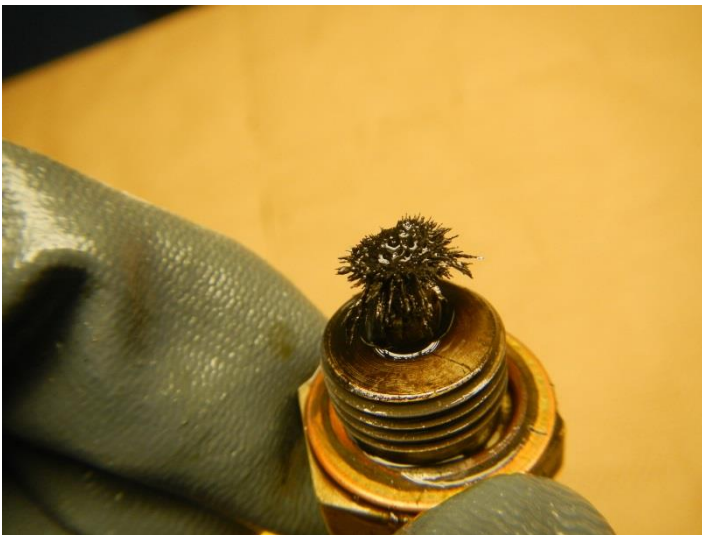
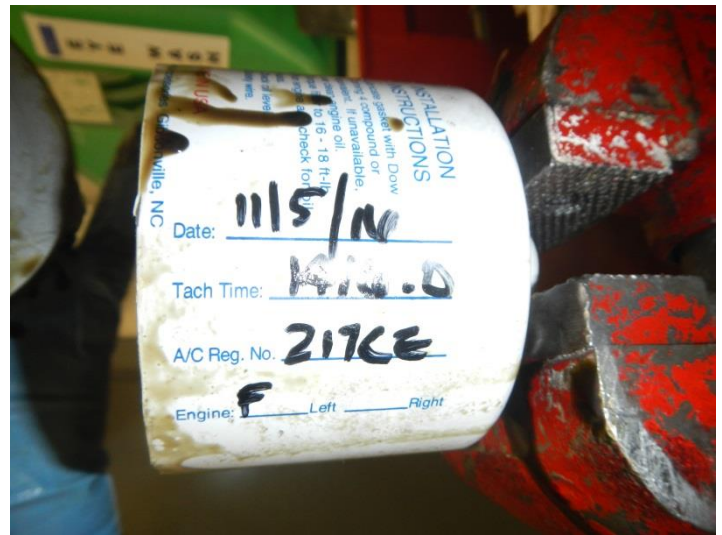
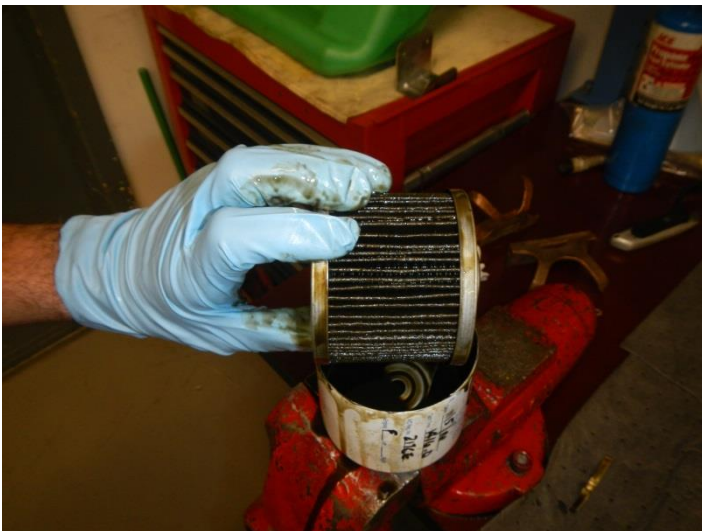
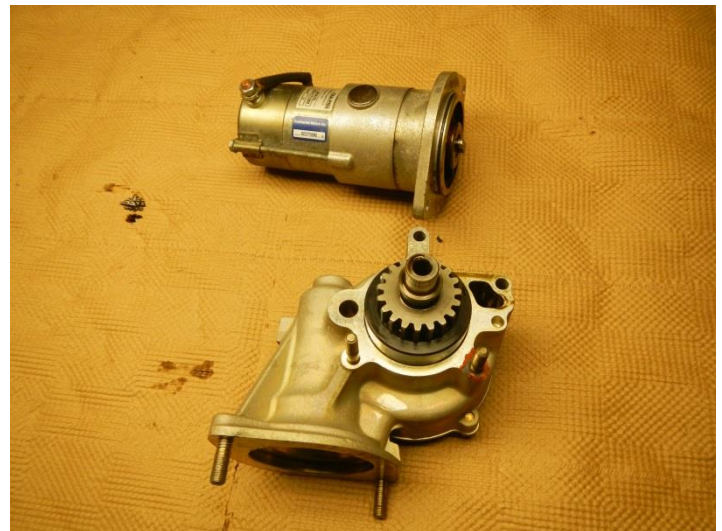
Only residual oil registered on the oil quantity gauge (dipstick) and it was assumed that the oil was drained prior to shipping. Prior to the engine run, the oil drain plug was removed and slivers of ferrous material were adhering to the drain plug magnet. The oil filter was removed and cut open prior to the engine run and a replacement filter was used for the test. Examination of the original oil filter prior to the test run revealed small pieces of metal and carbon within the pleats of the filter.

Review of recorded engine data revealed that the engine underwent 32 start attempts prior to the accident flight. Therefore, the starter adapter was removed for examination in accordance with Service Bulletin 16-6, Engine Damage Due to Kickback. Manual rotation of the starter shaft gear resulted in a ratcheting effect. A replacement starter adapter was placed on the accident engine and the original adapter was examined further (see Appendix A of this report for more information regarding the examination).

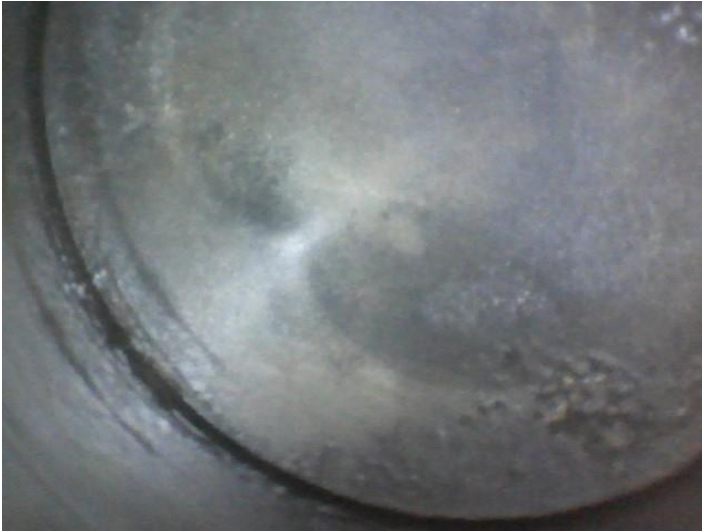
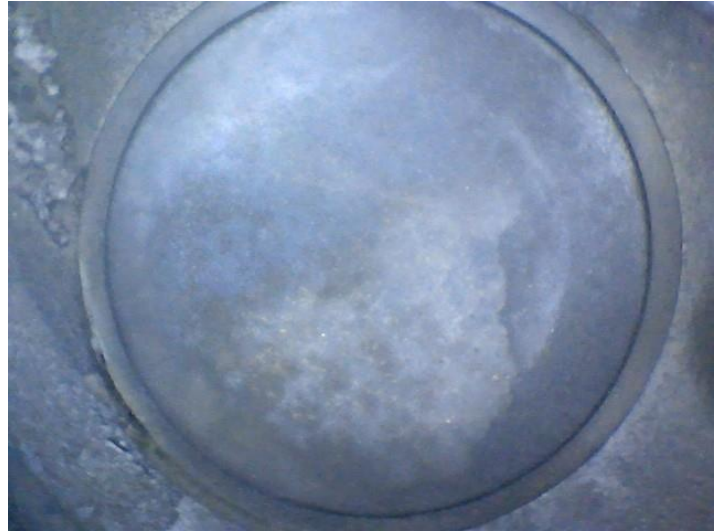
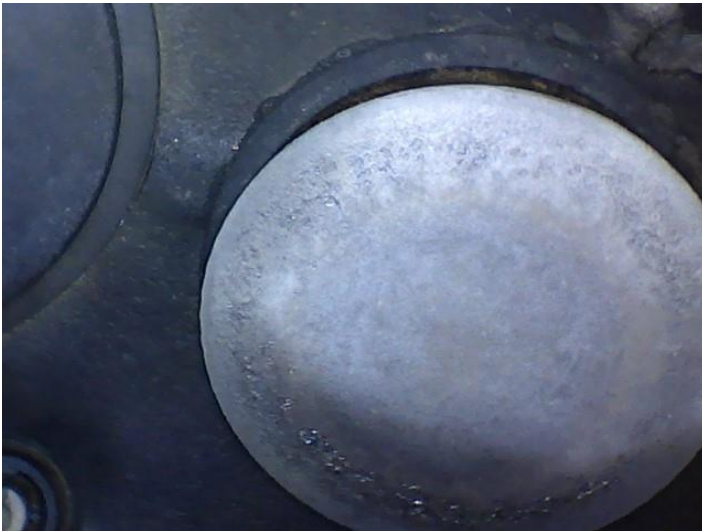
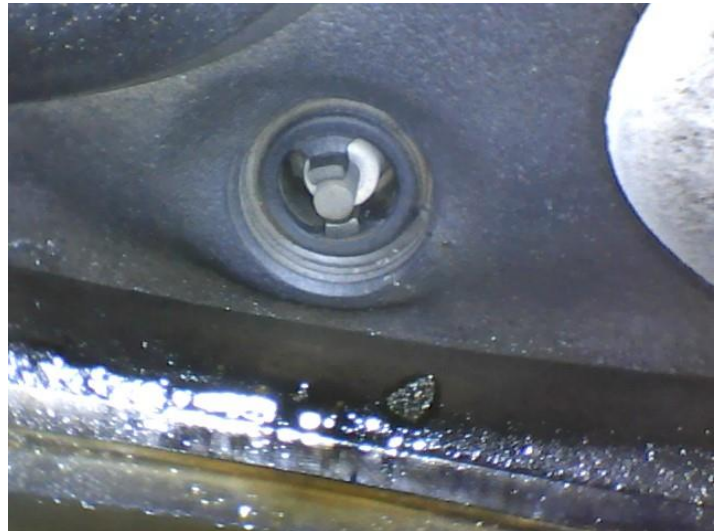
### CYLINDER 1

The cylinders were examined utilizing a lighted borescope and no pre-accident anomalies were noted. The photographs that follow each cylinder number represent the cylinder's piston, intake valve, exhaust valve, and bottom sparkplug, in that order.

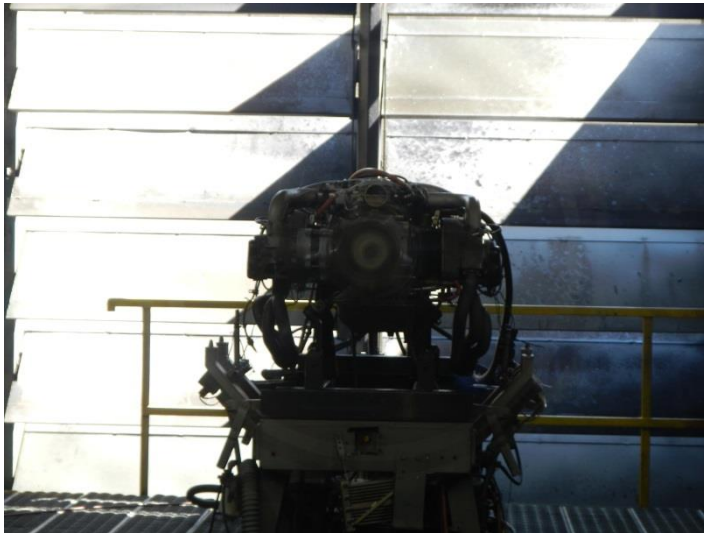
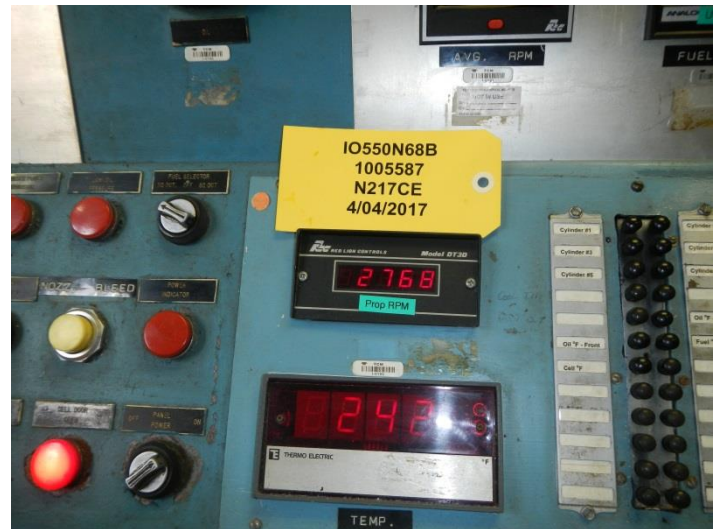
The engine experienced a normal start on the first attempt without hesitation or stumbling in observed RPM. The engine RPM was advanced in steps for warm-up in preparation for full power operation. The engine throttle was advanced to 1200 RPM and held for five (5) minutes to stabilize. The engine throttle was advanced to 1600 RPM and held for five (5) minutes to stabilize. The engine throttle was advanced to 2450 RPM and held for five (5) minutes to stabilize. The engine throttle was advanced to full open position and held for five (5) minutes to stabilize. The engine throttle was rapidly advanced from idle to full throttle five times where it performed normally without any hesitation, stumbling or interruption in power.

Throughout the test phase, the engine accelerated normally without any hesitation, stumbling or interruption in power and demonstrated the ability to produce rated horsepower.

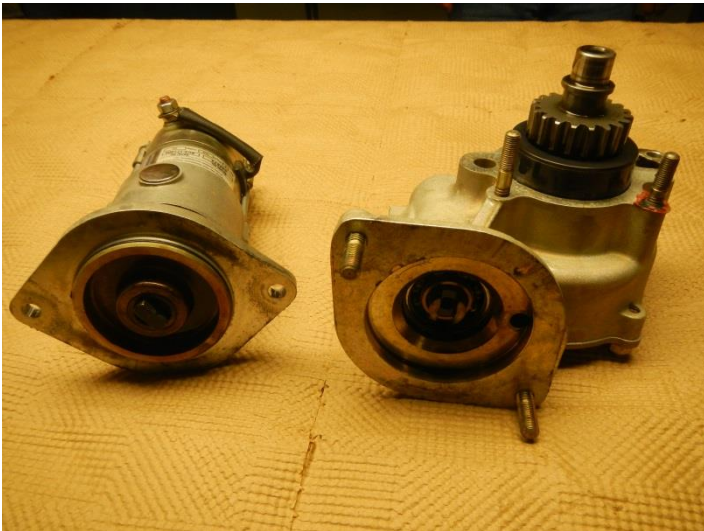
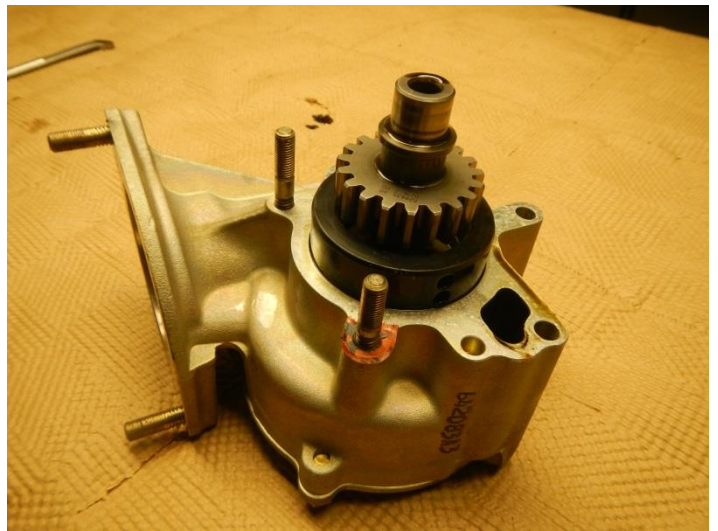
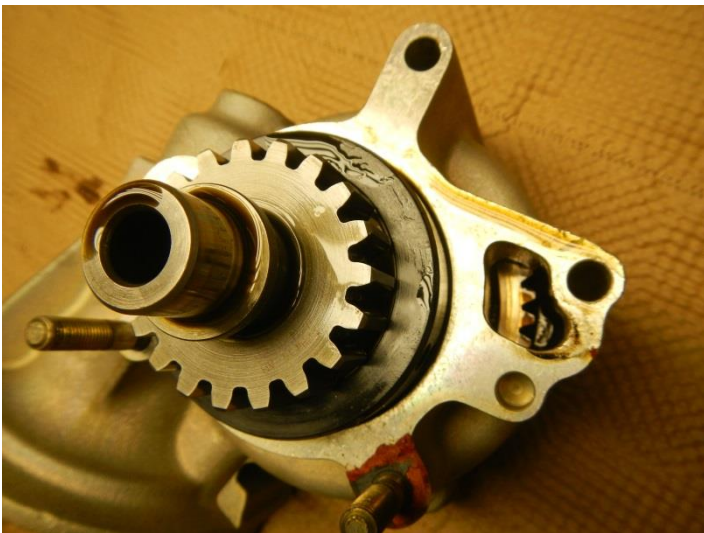
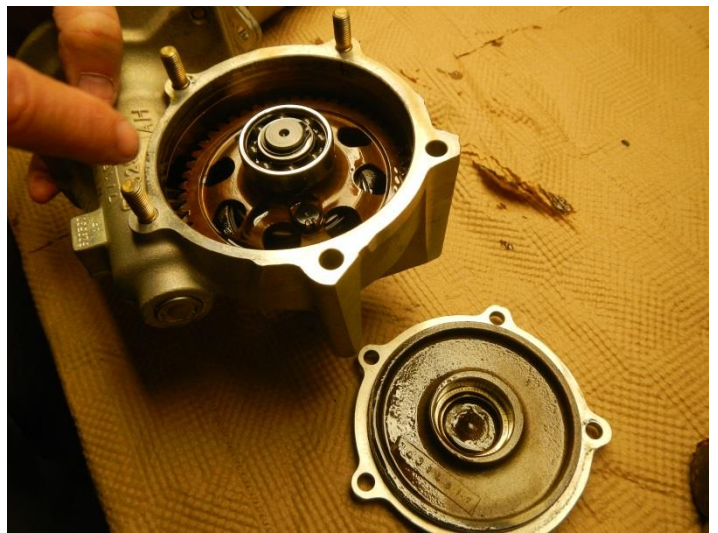
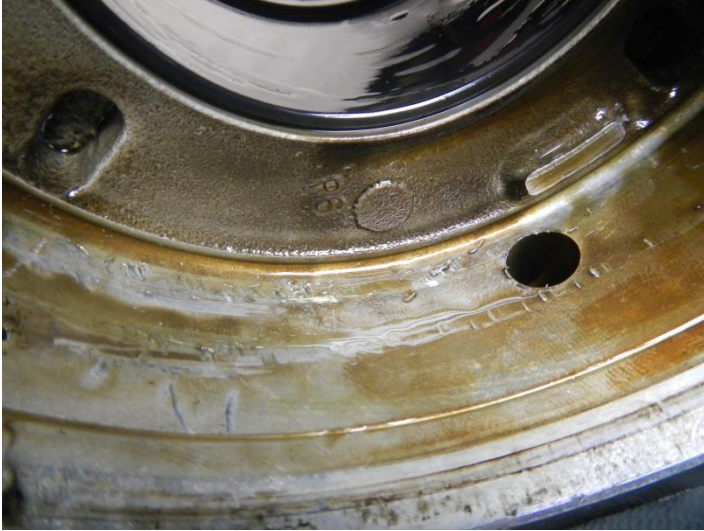
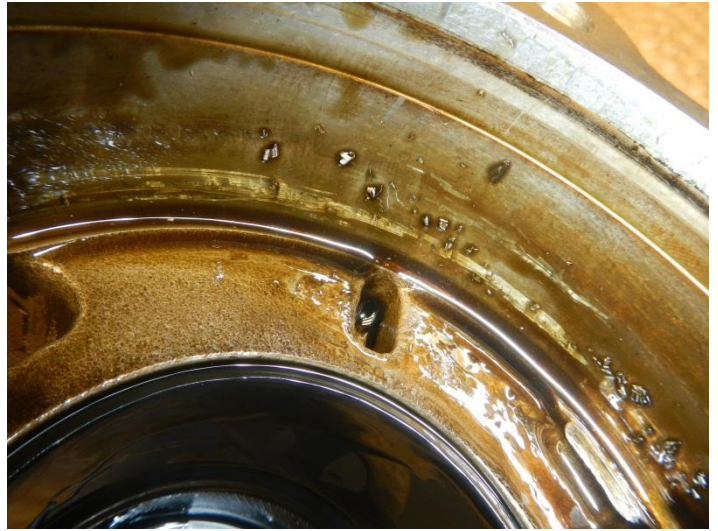
The starter adapter underwent a teardown examination. Removal of the starter adapter housing cap revealed metal debris adhering to the sides of the housing along with gear impressions as well as circumferential scrapes and gouges in the housing walls.

The damage noted on the starter adapter components were consistent with that noted on starter adapters that have been involved in engine kickback events. In addition, the magneto-to-engine timing was advanced of that specified for this engine model, which can contribute to a kickback event. As such, a decision was made to examine the crankshaft gear bolts as directed in Service Bulletin 16-6, Engine Damage Due to Kickback. The crankshaft gear bolts remained in place with the safety-wire intact. The bolts were removed from the crankshaft gear and there was no visible damage to the bolts noted. The NTSB investigator-in-charge authorized further examination/testing for the crankshaft gear bolts.

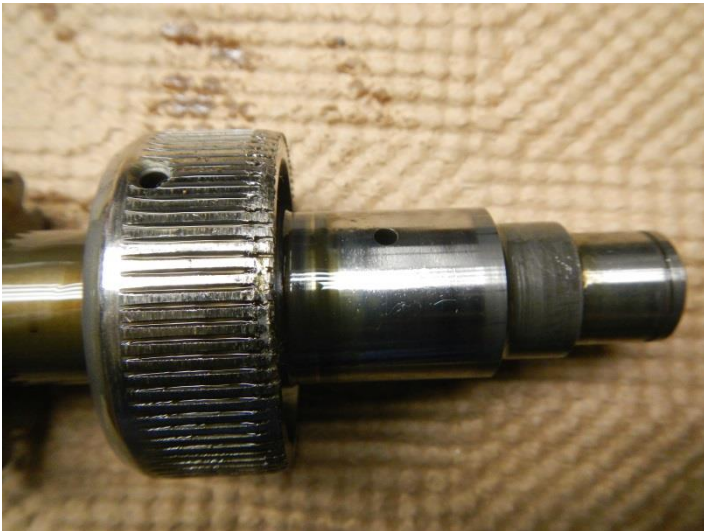
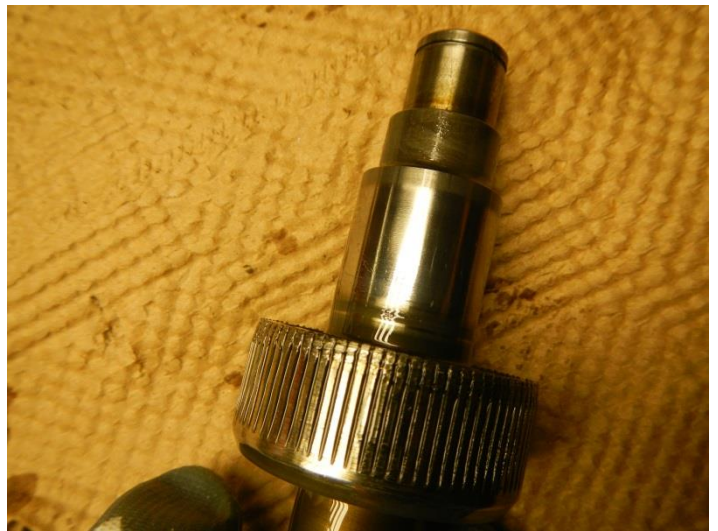
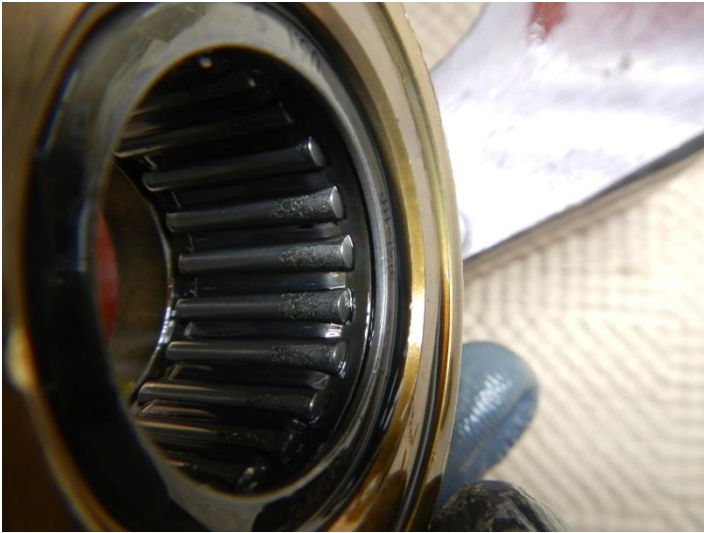
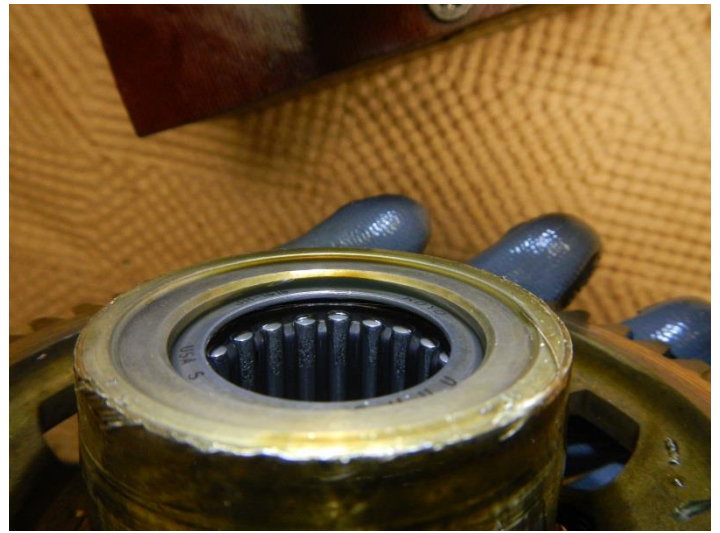
Removal of the gear shaft revealed that the drum displayed compression damage from the spring that smeared and deformed the aft ends of the splined area. The gear shaft displayed denting marks consistent with needle bearing impingement. The needle bearing rollers displayed areas of galling.

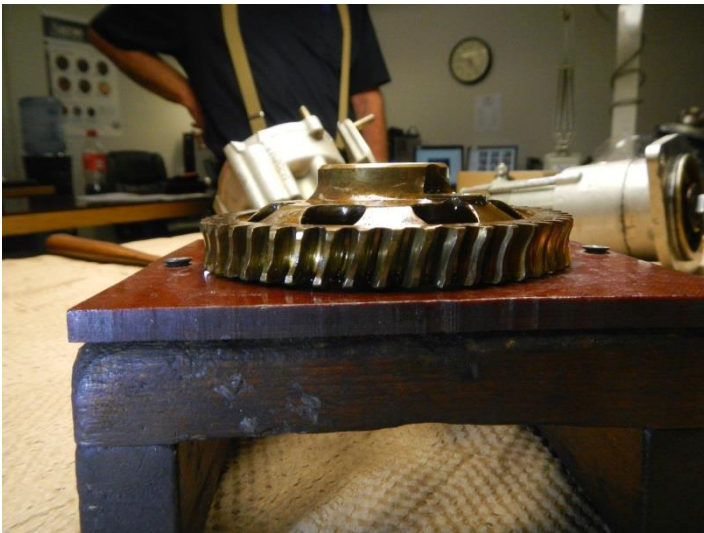
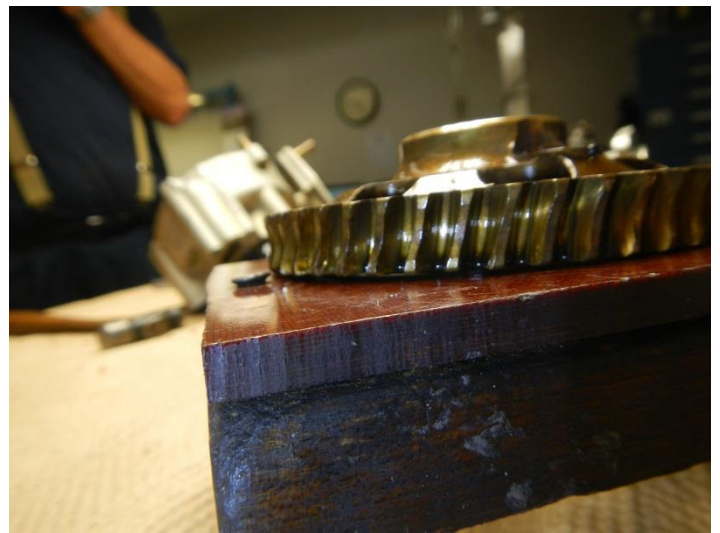
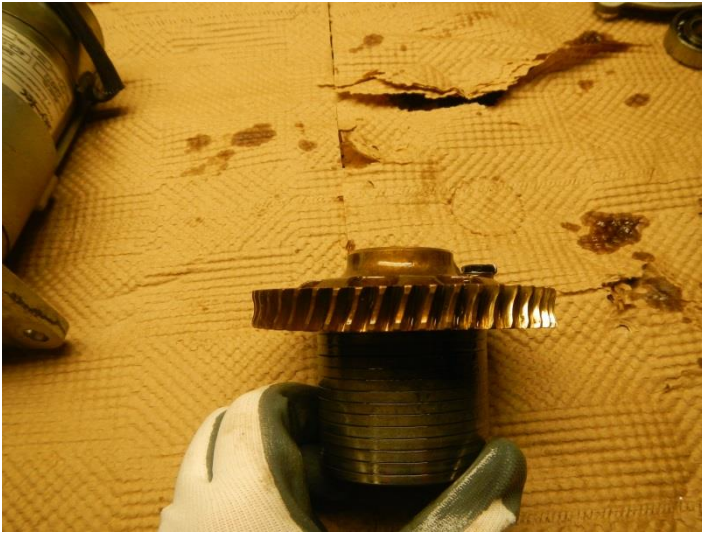
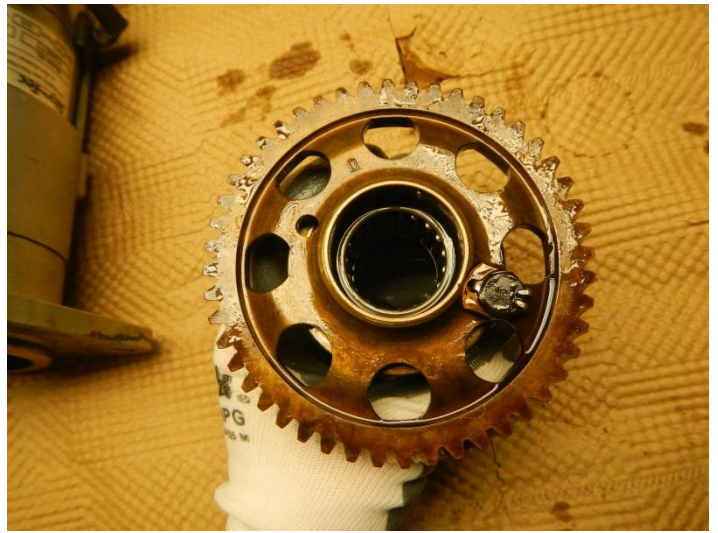
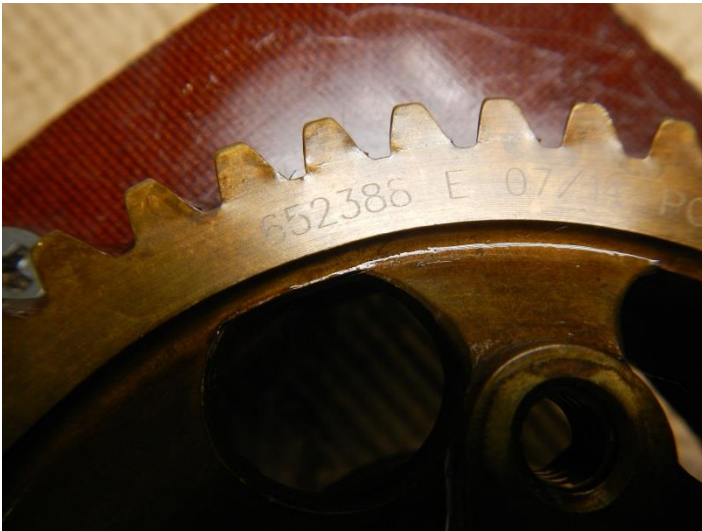
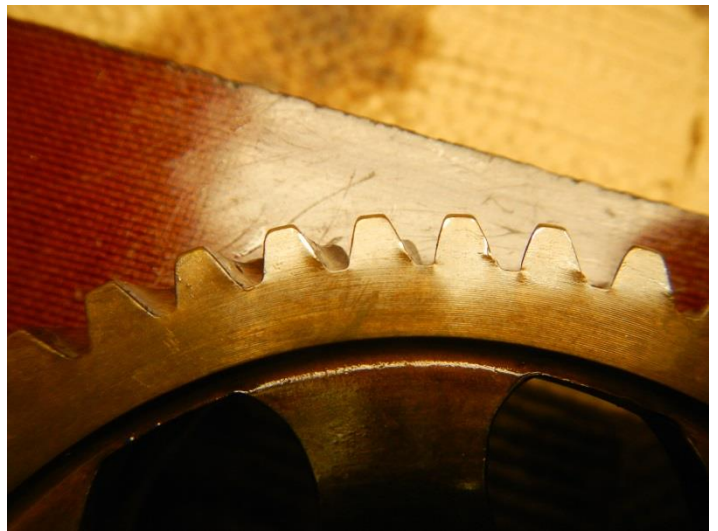
The gear that engages with the worm gear displayed deformation damage and impression damage was noted near the teeth valleys.
