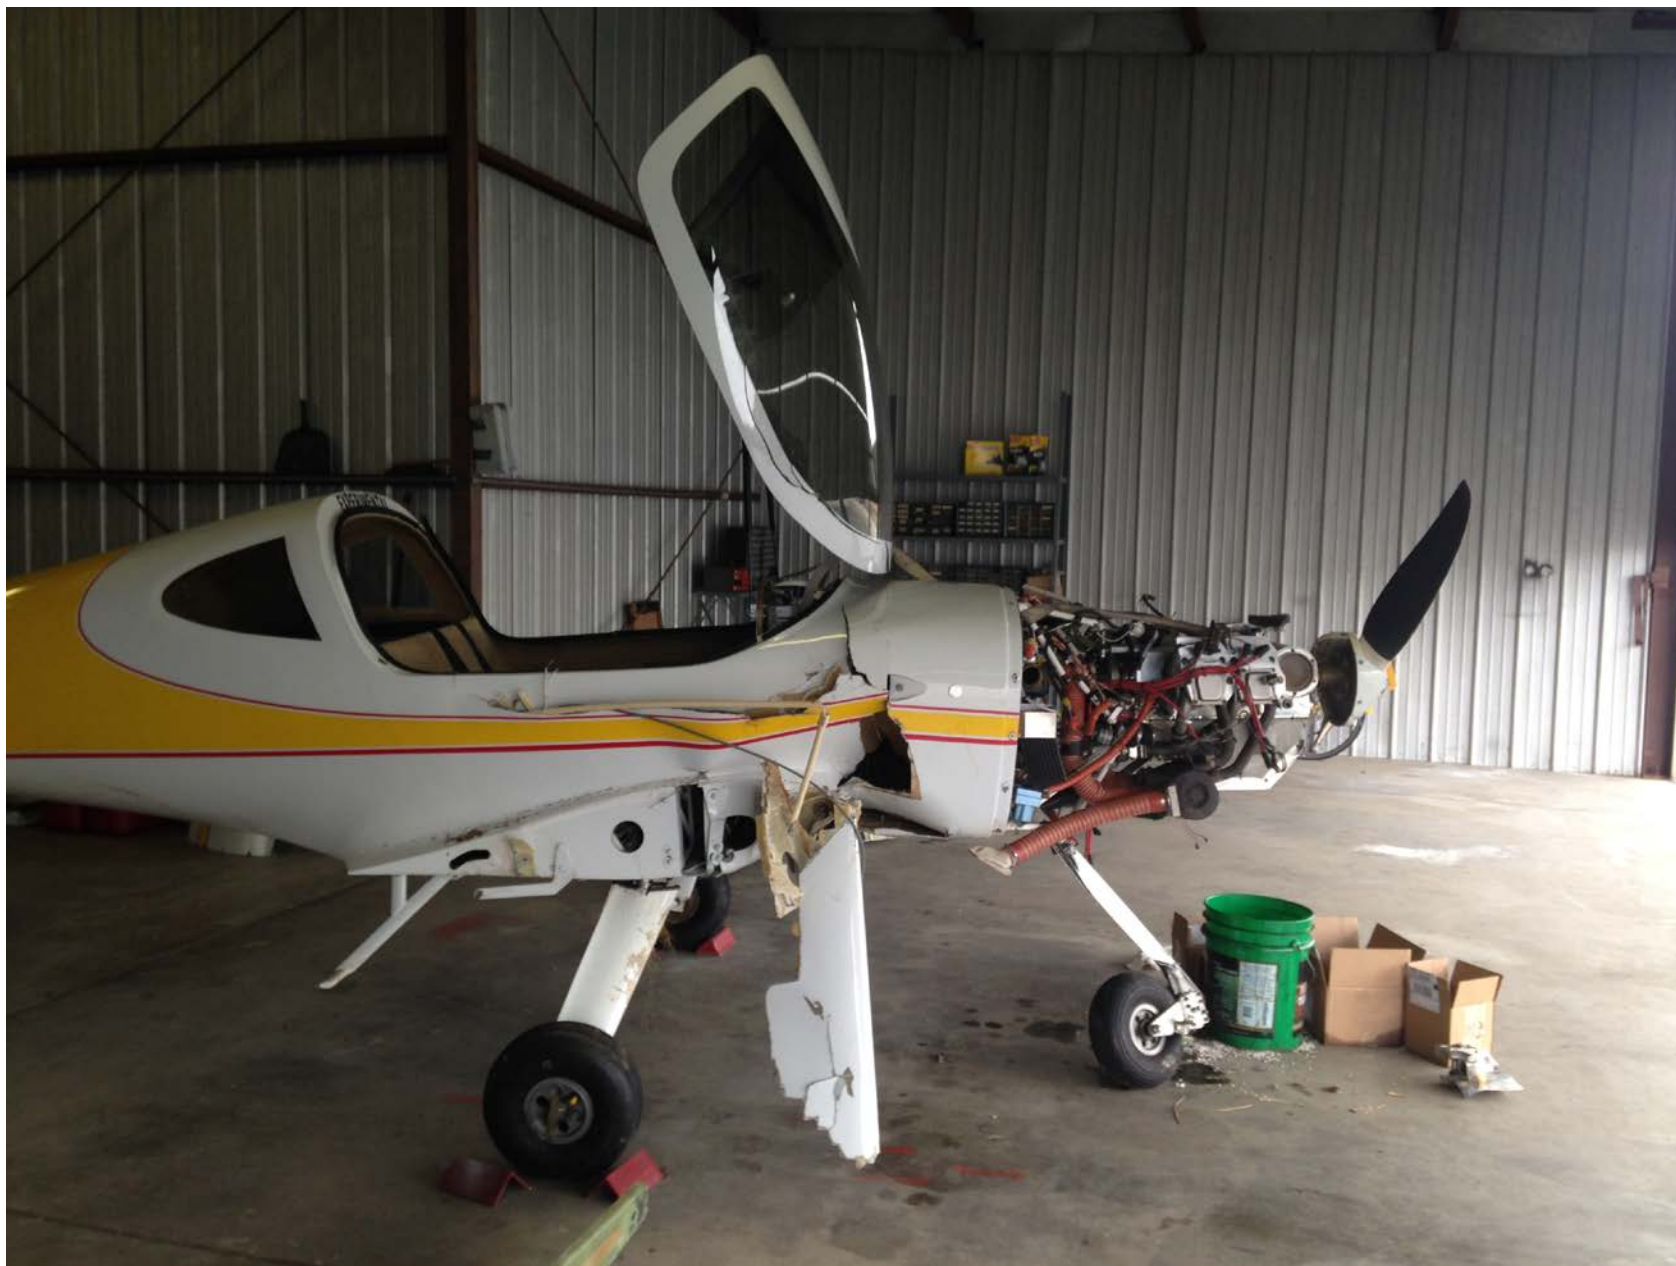
**Photo 1 – Photo From Owner. Right Side View of the Fuselage, Engine Assembly and Propeller Following Recovery.**

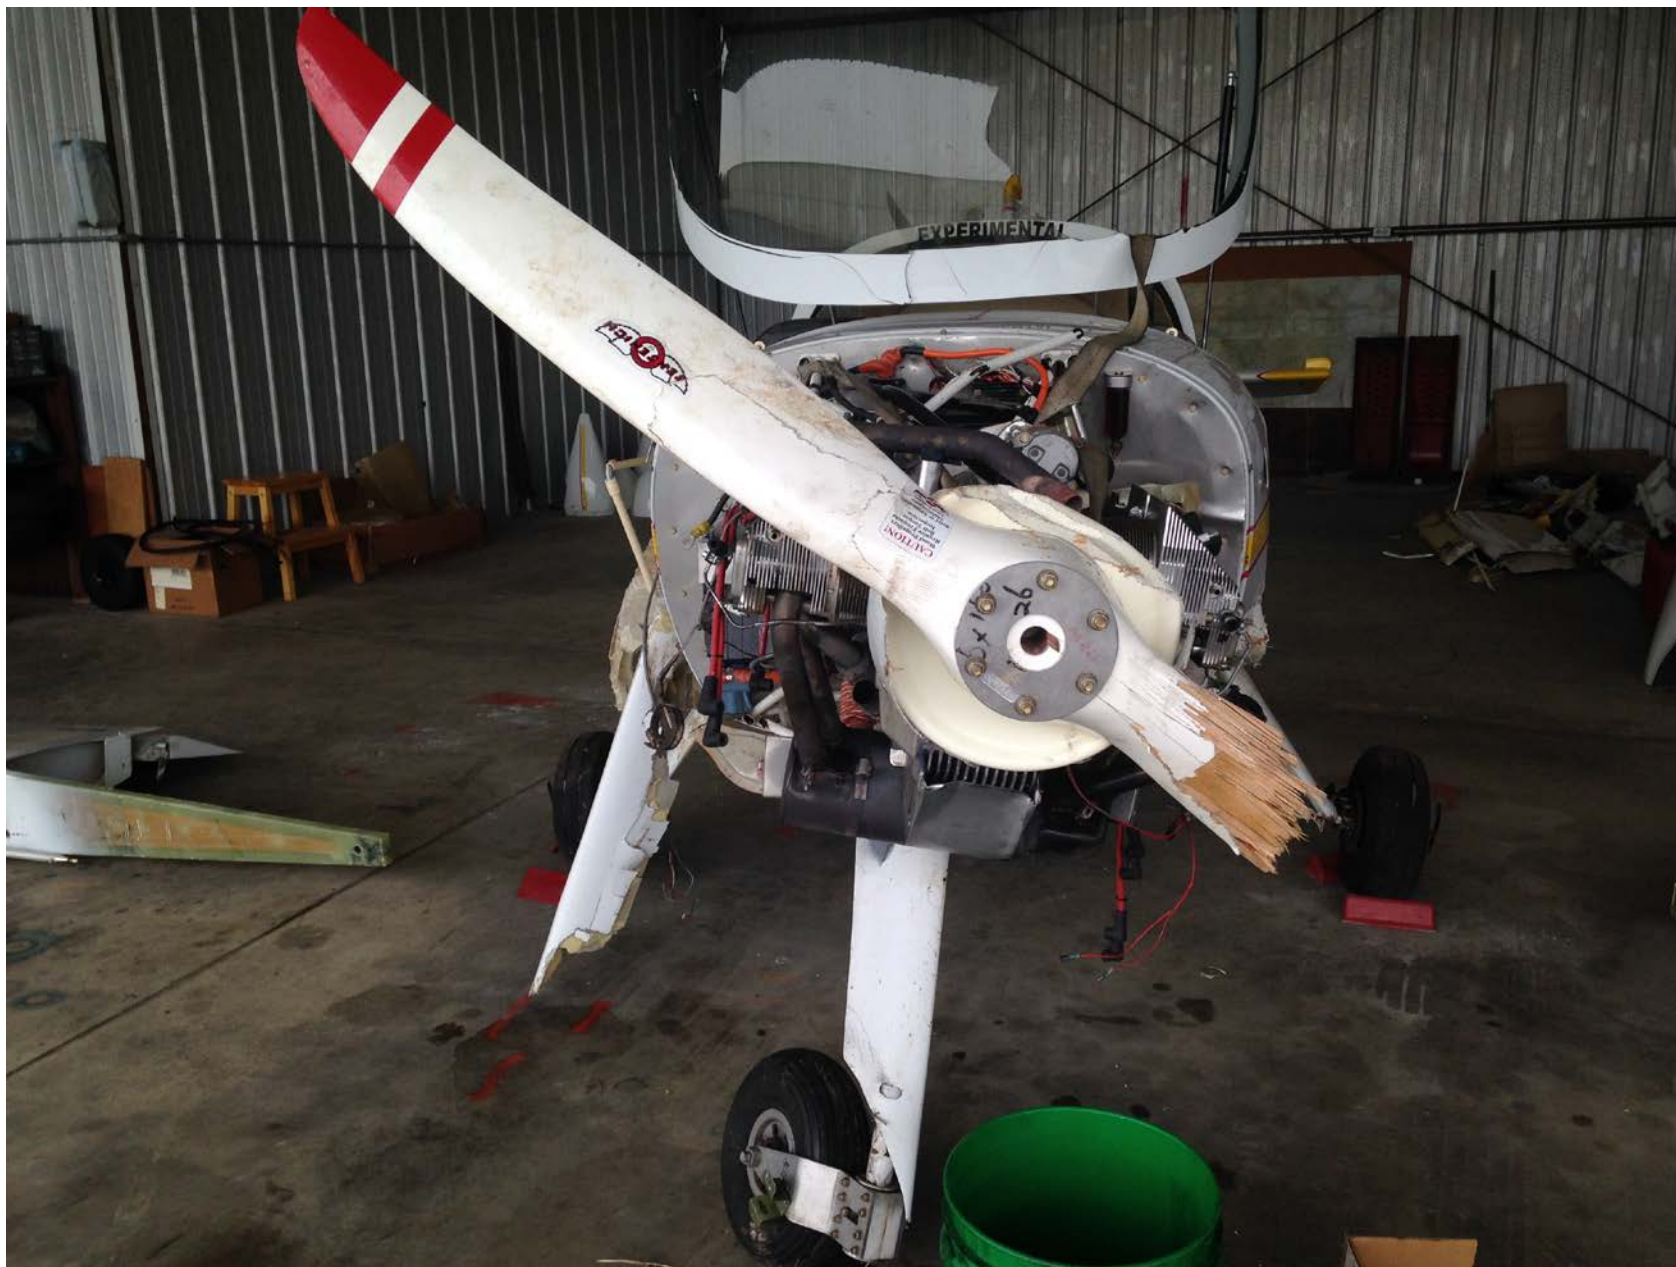
**Photo 2 - Photo From Owner. Forward View of the Propeller and Engine Assembly Following Recovery. Note the Shattered propeller Blade.**

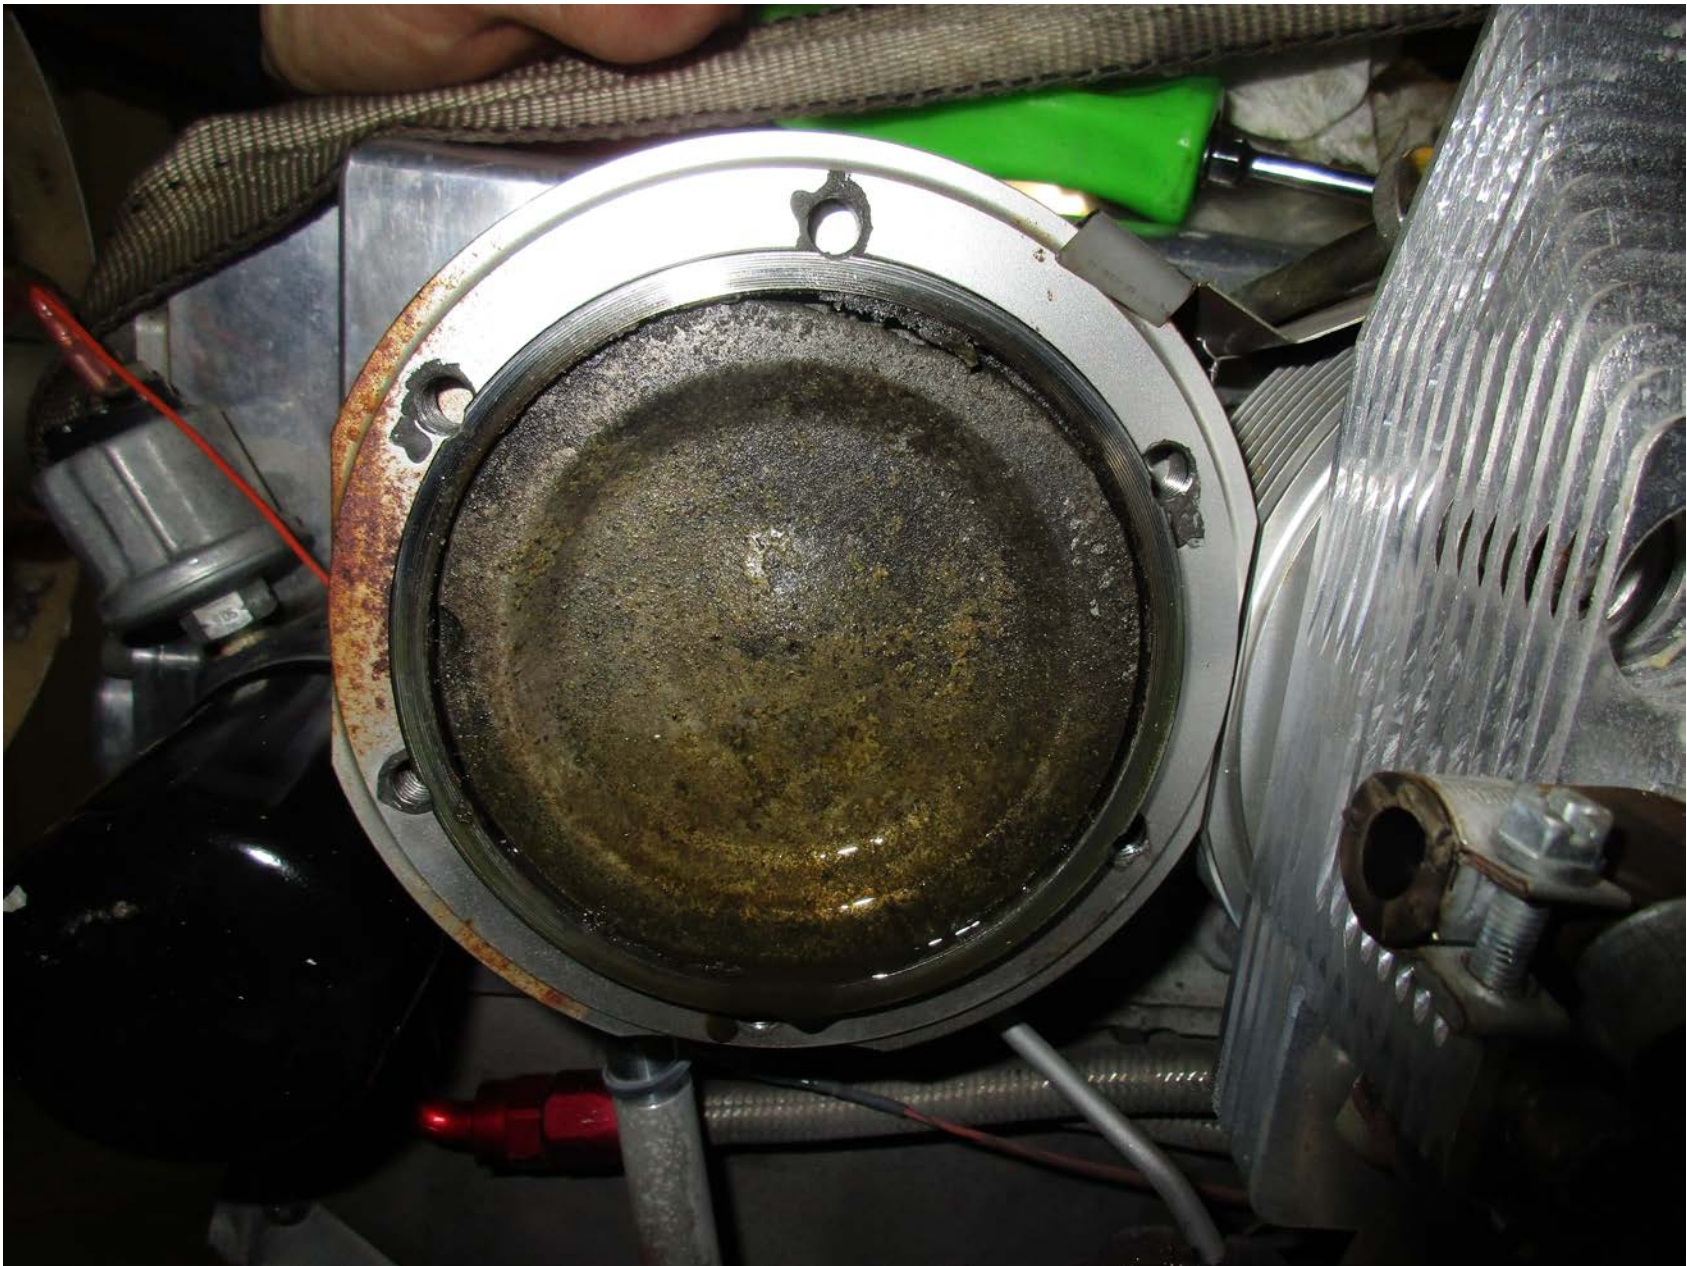
**Photo 3 - Photo From FAA. View of the No. 2 Cylinder Piston and Barrel. Note the Erosion of the Piston Edge Near the 1 O'Clock Position.**
