# NATIONAL TRANSPORTATION SAFETY BOARD

## MATERIALS LABORATORY FACTUAL REPORT

Report No. 17-041

Place : Franklin, Virginia  
Date : December 10, 2016  
Vehicle : EAB Lightning, N59JL  
NTSB No. : ERA17LA067  
Investigator : Timothy Monville, AS-ERA

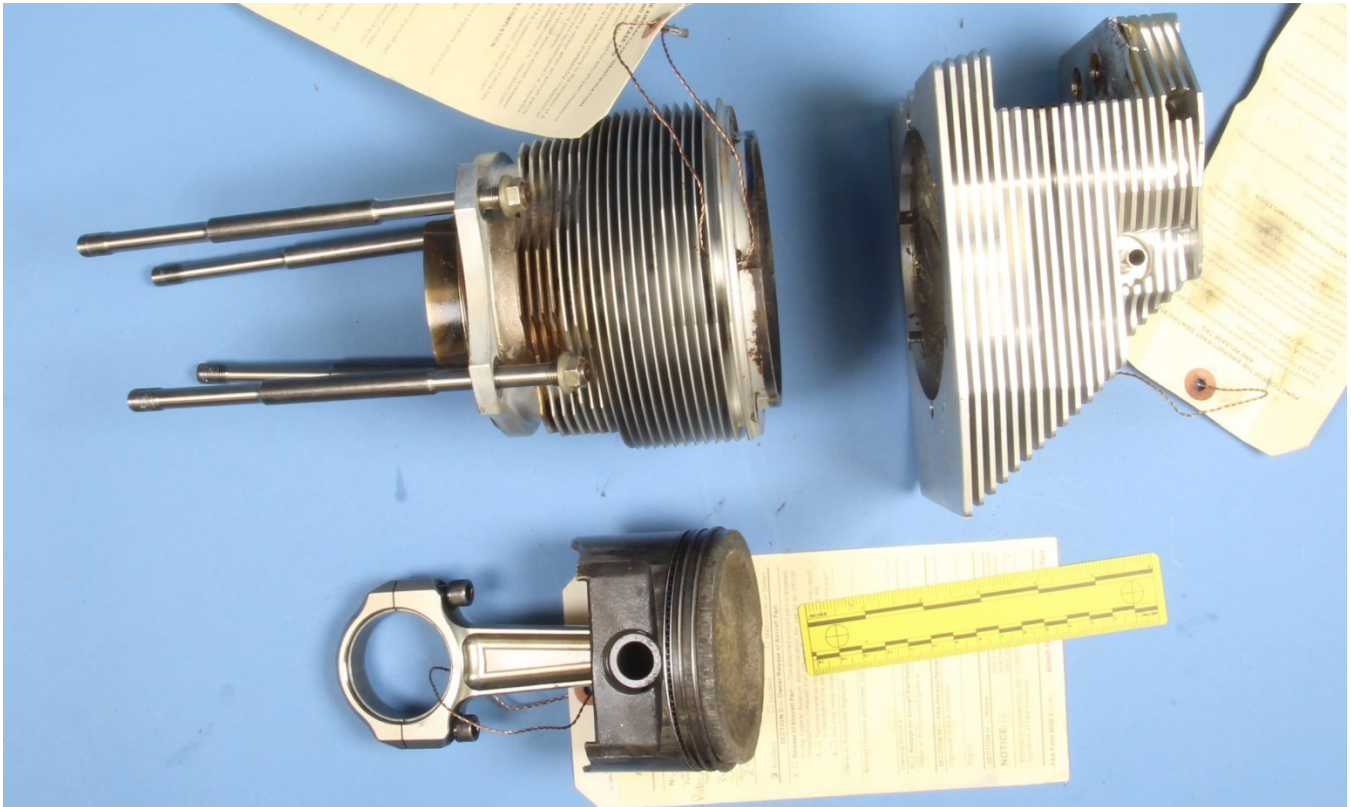
The cylinder (barrel and head), along with the piston and the connecting rod, from the number 2 position in the Jabiru 3300 engine (S/N 33A1085) were retained and sent to the NTSB Materials Laboratory for further examination.<sup>1</sup> These components are pictured in Figure 1, as received.

Figure 1 – The components from the engine, as received.

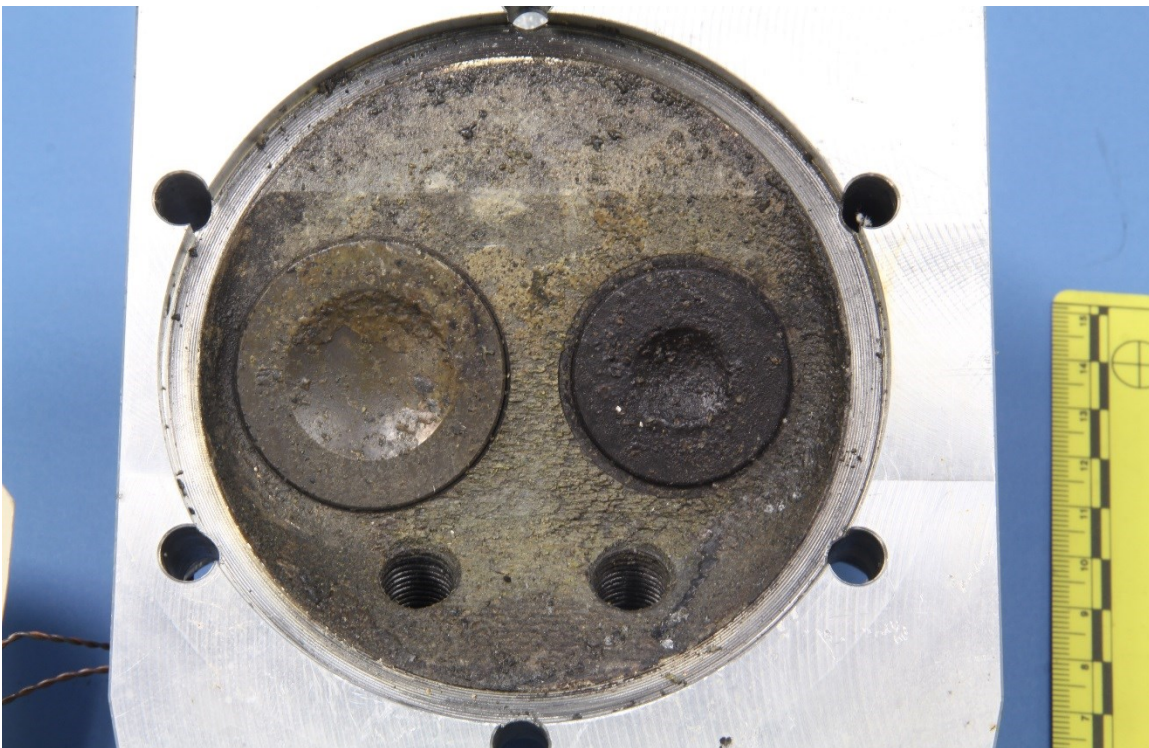
The cylinder, normally affixed with four through-bolts on the outside of the barrel, had been disassembled, as received. The valves were still part of the cylinder assembly, along with the rocker arms. The face of the cylinder head is shown in Figure 2 and Figure 3. These surfaces exhibited flat, flaky compounds that adhered to all the inner surfaces. These compounds generally exhibited a brownish-yellow color, with a waxy luster.

Figure 2 – View of the cylinder head with the valve faces, as received.

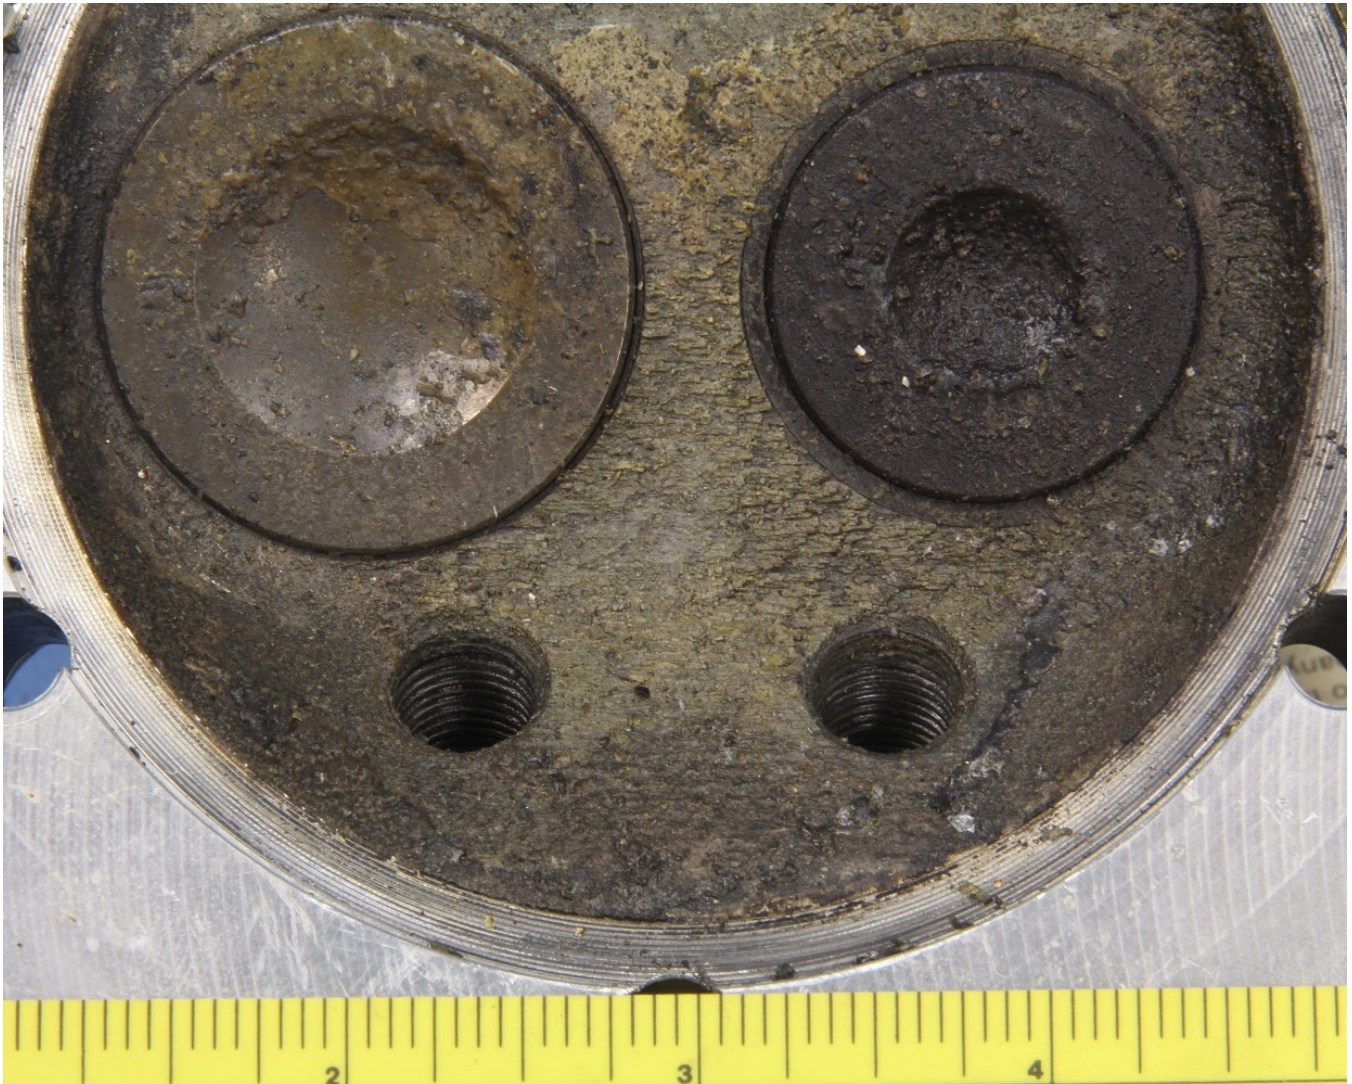
Figure 3 – A closer view of the cylinder head, showing adherent lead-based compound deposits (brownish-yellow) on the valve faces and cylinder surfaces.

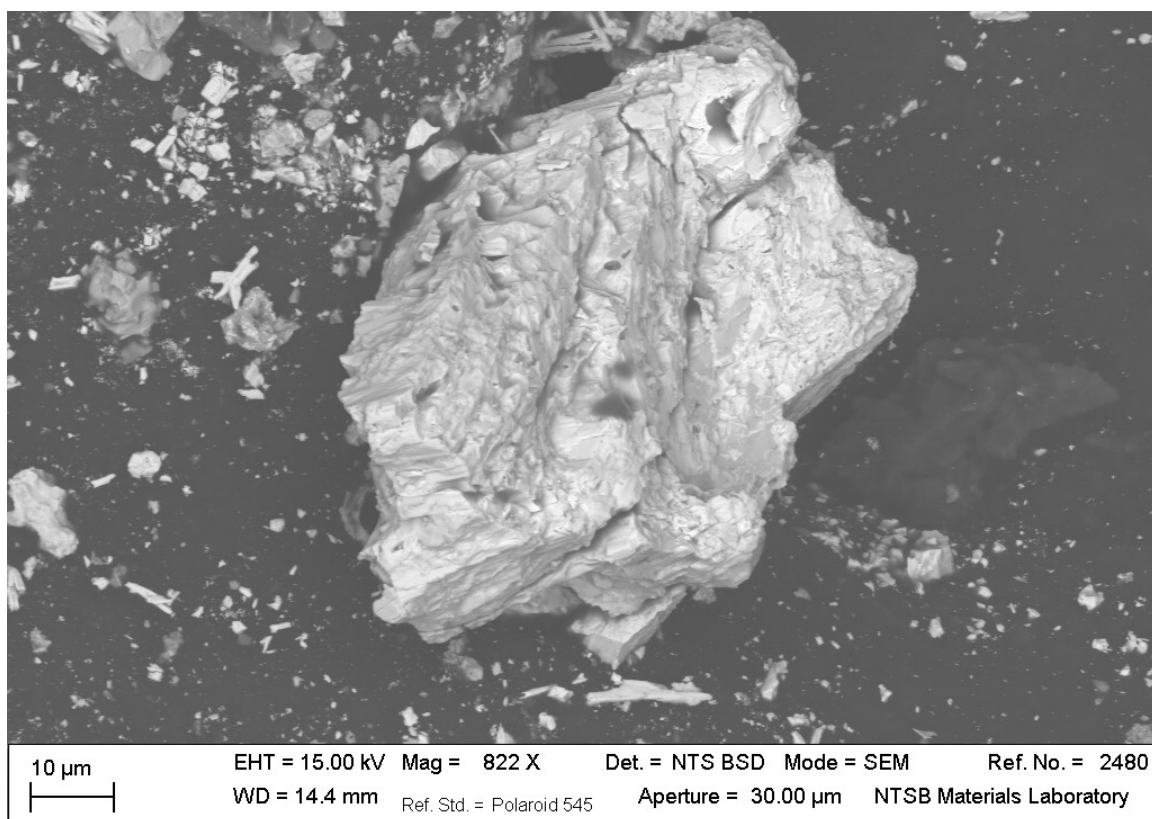
These compounds were examined using a scanning electron microscope (SEM). One such particle is illustrated in Figure 4. As imaged using backscattered electrons, these particles contrasted bright white against other examined particles, consistent with higher atomic mass elements.<sup>2</sup> Inspection using energy dispersive x-ray spectroscopy (EDS) found these particles to be consistent with lead oxides and lead bromide, as typified in Figure 5. These compounds were consistent with compounds that form after combustion of tetraethyl lead and 1,2-dibromoethane—the anti-knocking and lead scavenging additives in aviation gasoline (avgas).

Figure 4 – Backscattered electron (BE) micrograph of a lead-based compound on the cylinder head.

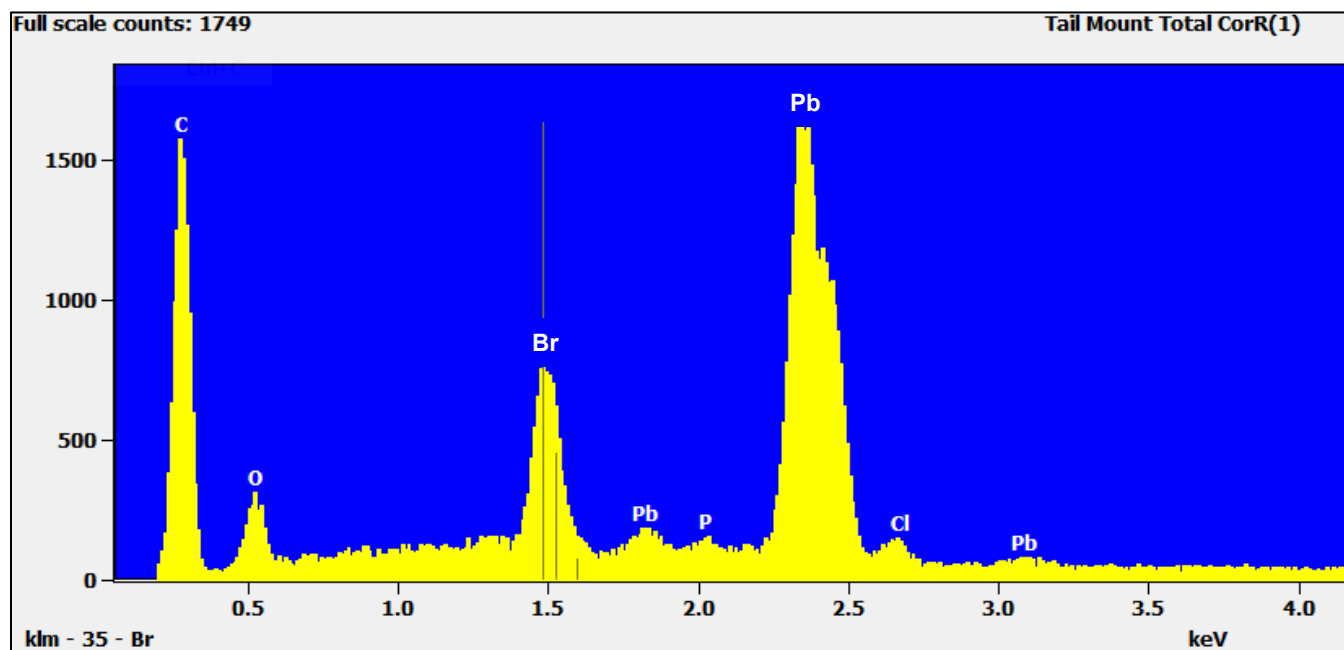
Figure 5 – Energy dispersive spectroscopy (EDS) spectrum of the particle shown in Figure 4.

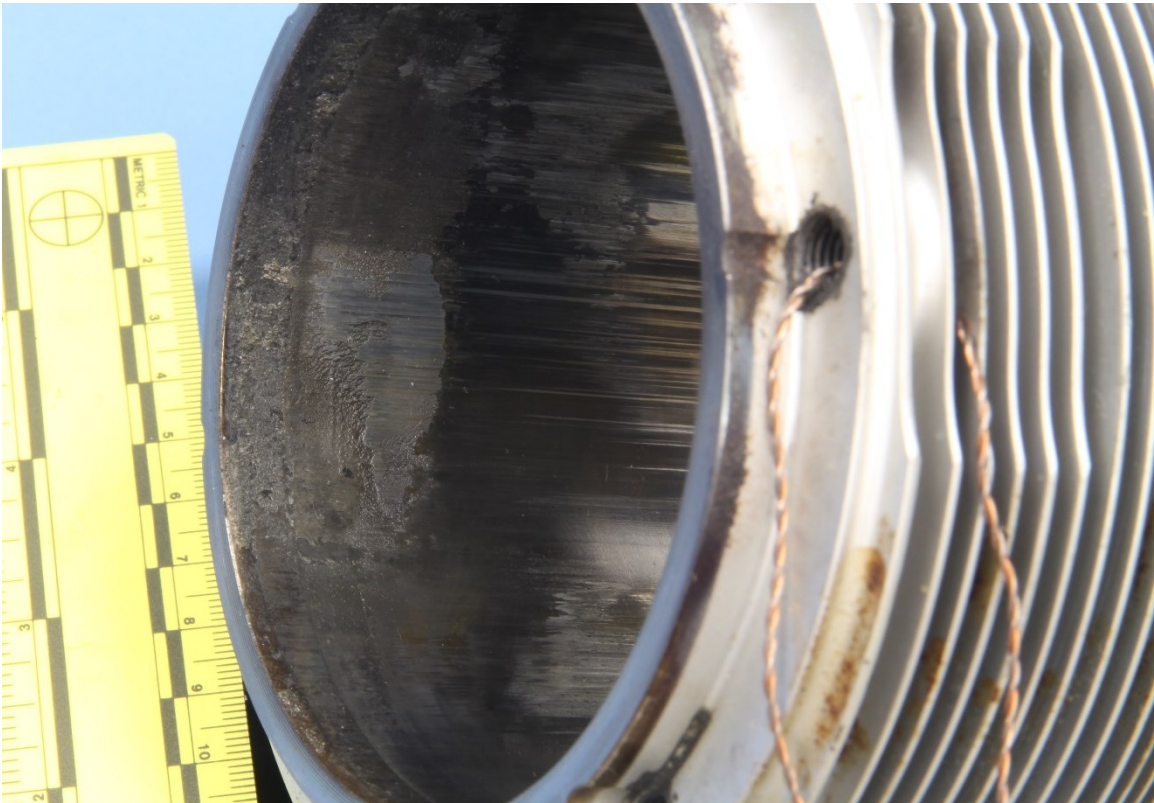
Figure 6 shows damage to the inside of the cylinder barrel, which had been separated prior to examination. The inner surface damage manifested as wear scars. This was consistent with sliding wear from the adjacent piston crown and piston pin. The mating damage to the piston assembly is shown in Figure 7.

The high amount of lead-based compounds, rough texture and spalling of the piston, and sliding damage to the cylinder barrel were consistent with damage incurred from pre-ignition.<sup>3</sup>

Figure 6 – Angled view of the interior of the cylinder barrel, showing sliding wear and rough erosion scars on the surface.

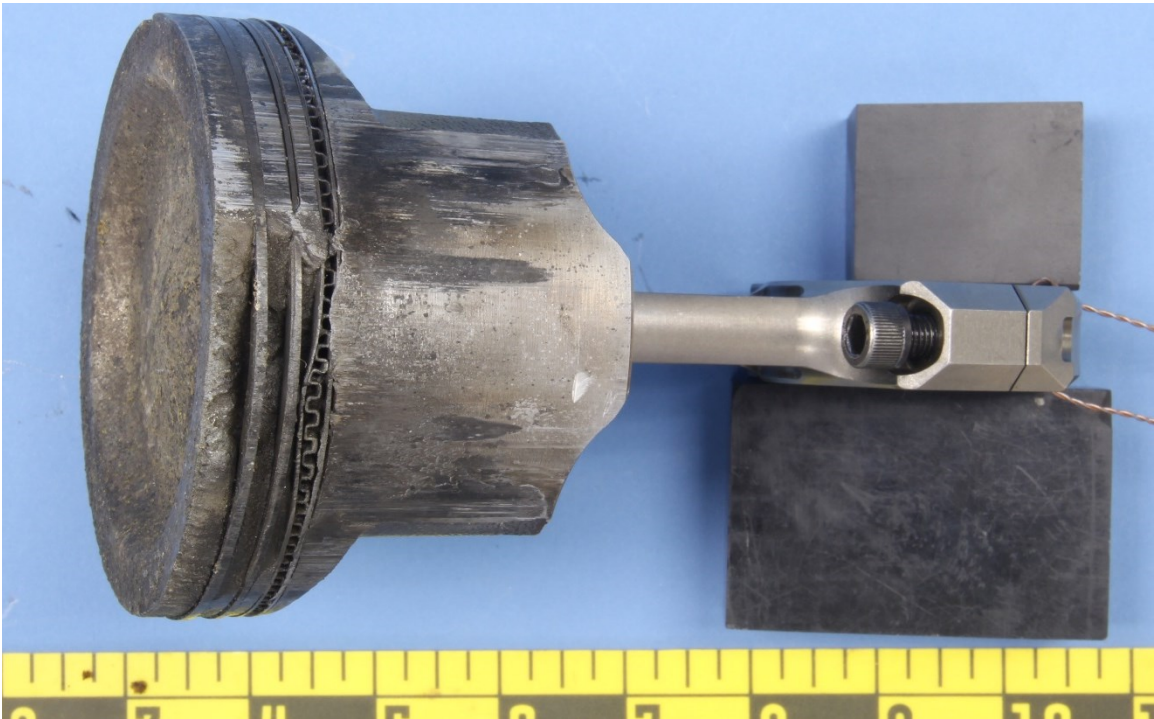
Figure 7 – Closer view of the blow-by damage on the corner of the piston crown.

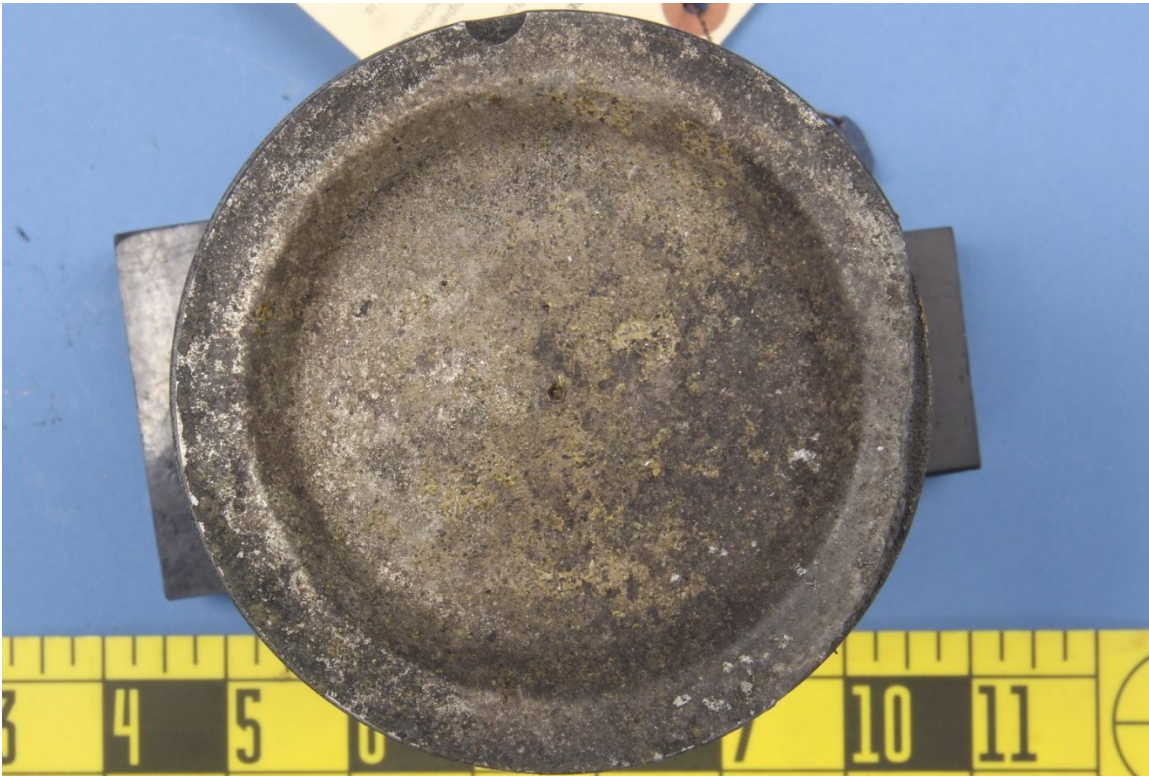
The sides of the piston exhibited material loss from wear and material spalling. The crown of the piston exhibited a rough surface, with erosion of the surfaces facing the cylinder head and barrel. These piston surfaces contained the same deposits found on the cylinder head (Figure 8). The most damaged corner of the piston, illustrated in Figure 9, allowed light to shine through the spalled regions. This cavity was consistent with gas blow-by of the piston past the oil rings. This piston damage was consistent with the damage on the inner surface of the barrel.

Figure 8 – View of the face of the piston crown, showing deposits, and erosion damage about the periphery.

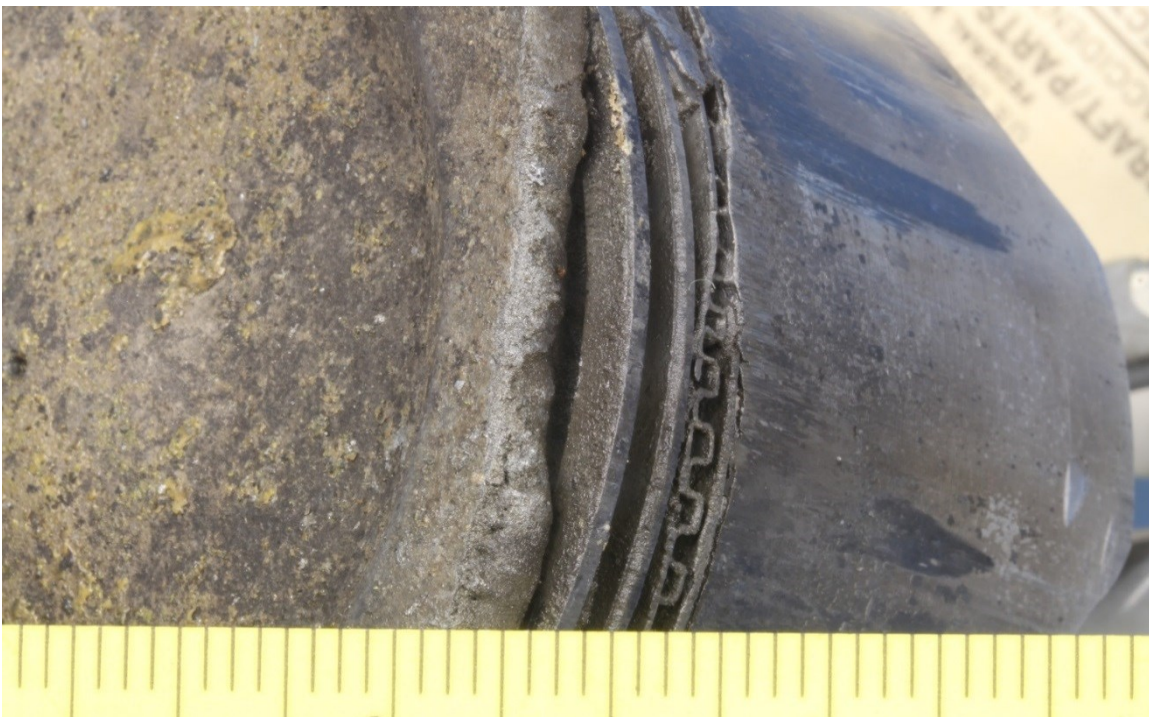
Figure 9 – View of material loss due to wear on a corner of the piston crown, showing where blowby occurred past the oil rings.
