# NATIONAL TRANSPORTATION SAFETY BOARD

MATERIALS LABORATORY FACTUAL REPORT

Report No. 17-060

Fractured crankshaft from a Continental IO-550-B1A engine.

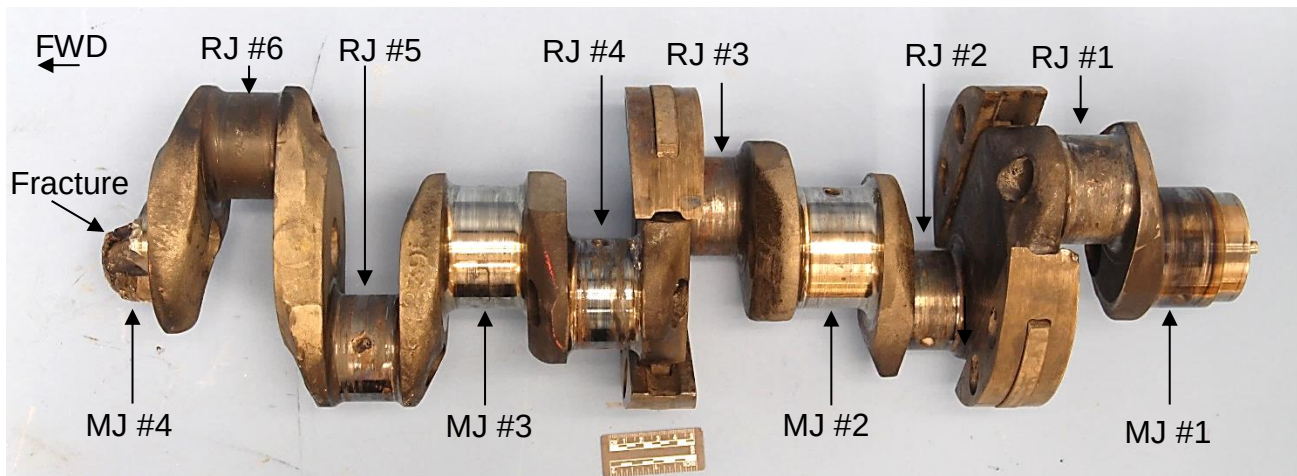
Figure 1 shows a photograph of the as-received crankshaft. Main and rod journals were numbered sequentially back to front, starting with main journal number 1 (MJ#1) and rod journal number 1 (RJ#1) on the right side of the page. A fracture intersected the aft radius of main journal number 6 (MJ#6). The forward end of MJ#6 and the propeller flange were not submitted and presumed missing. Visual examination of this crankshaft revealed the surfaces of RJ #6 and RJ#1 exhibited evidence of black-brown tint and a rough texture. The surfaces of RJ#5, RJ#4, and RJ#2 showed evidence of blue tint and contained evidence of metal transfer from the shell bearings. The surfaces of MJ#3 and RJ#2 exhibited a luster appearance and showed evidence of fine circumferential abrasion marks, with no evidence of blue or black tint. A steel wire was inserted into and pushed through the oil lubrication holes for the main and rod journals. No evidence of obstruction was found in the oils holes. The end of the wire that was pushed through the oil holes contained no evidence of metal fragments.

Figure 1. Photograph of the crankshaft that fractured at the aft fillet of main journal number 4 (MJ#4). The forward end of the crankshaft is located on the left side of the page. Main and rod journals are numbered sequentially back to front, starting with MJ#1 and rod journal number 1 (RJ#1) on the right side of the page.

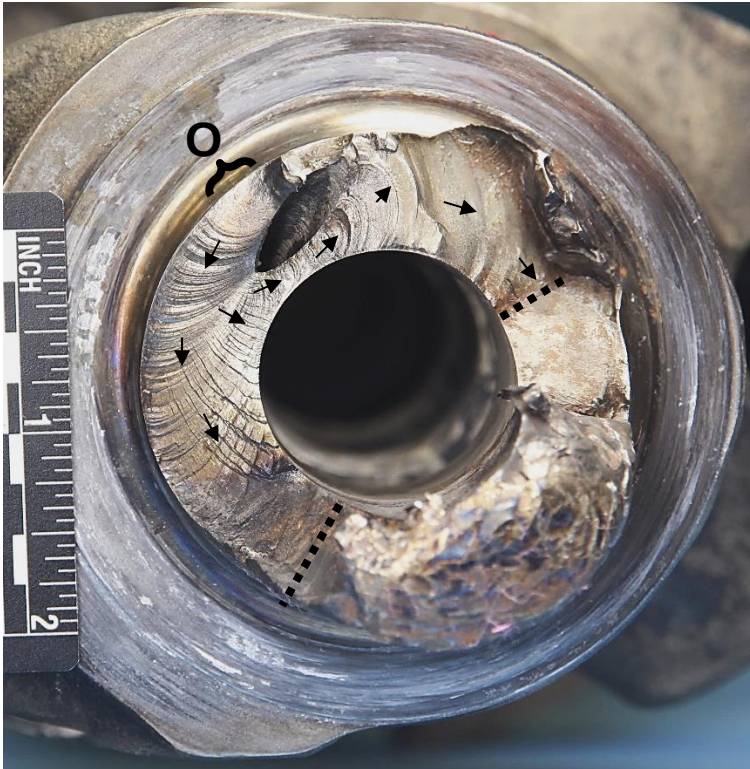
Bench binocular microscope examination of the fracture face revealed crack arrest marks typical of fatigue cracking emanated from the surface of MJ#6, adjacent to the aft radius, in the area indicated by bracket "O" in figure 2. Fatigue propagation was in the general direction indicated by arrows in figure 2. The fatigue crack terminated in the area indicated by dashed lines in figure 2. A portion of the main journal was missing from the area enclosed by a solid line in figure 3. The areas outside of the fatigue zone and the area enclosed by a dashed line in figure 3 contained features typical of overstress separation.

Figure 2. Close-up photograph of MJ#6 fracture face showing a fatigue crack that emanated from the aft radius, in the area indicated by bracket "O".

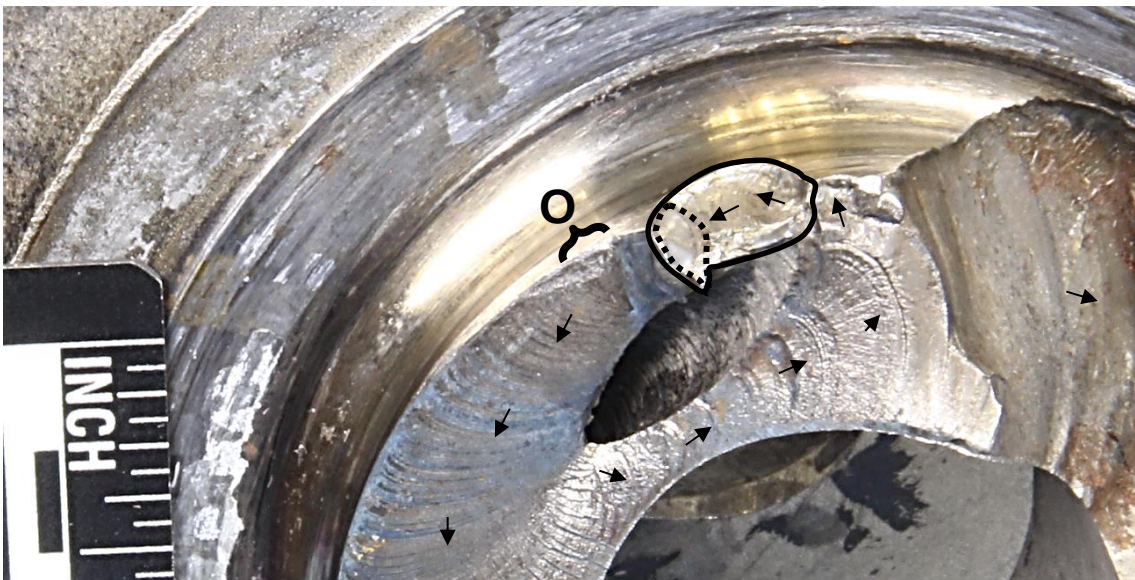
ray energy dispersive spectroscopy analysis of the deposits produced major elemental peaks of zinc and minor elemental peaks of iron, oxygen, and carbon. The fatigue zone contained coarse fatigue striations. The areas outside of the fatigue zone and within the dashed line in figure 3 contained micro-void coalescence features typical of overstress separation.

Figure 3. Another close-up view of the MJ#6 in the area of the fatigue crack origin area indicated by bracket "O" in figure 2. A portion of the main journal was missing from the area enclosed by a solid line. The area enclosed by a dashed line contained features typical of overstress separation (micro-void coalescence).
