# Continental Motors

## ENGINE EXAMINATION REPORT

| ENGINE MODEL | IO-550-B1A |
| FILE NUMBER | 16-314 |

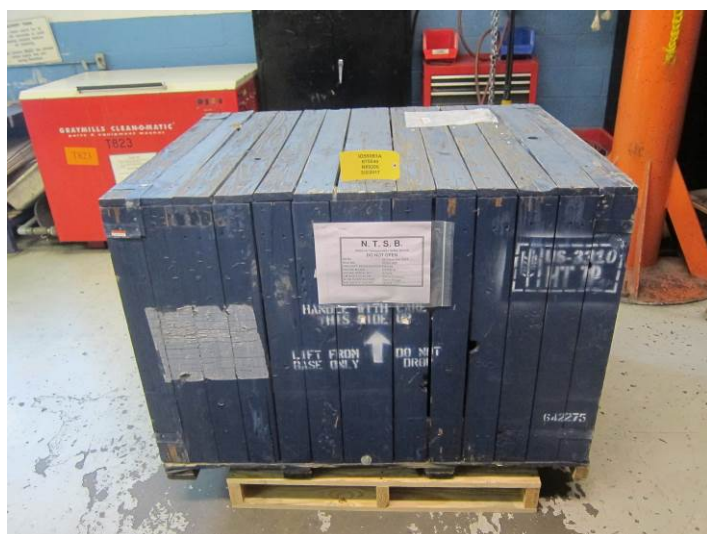
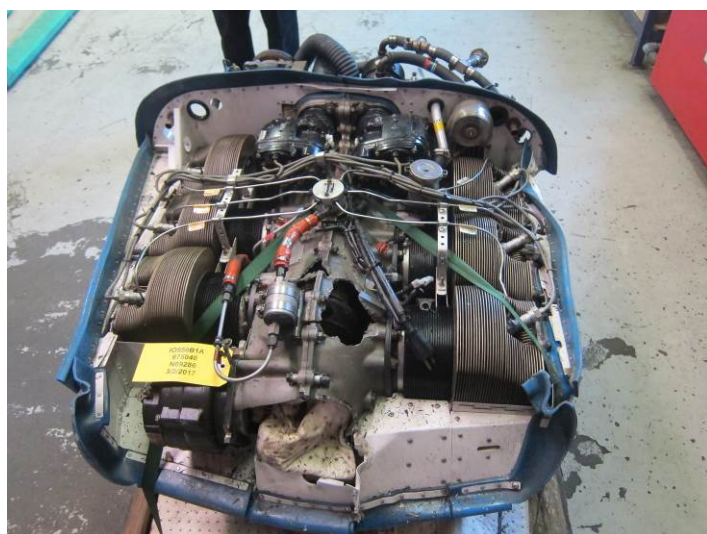
The engine crankshaft was fractured at the #4 main bearing journal and the portion of crankshaft forward of the #4 main bearing (that included the alternator drive gear mounting flange, oil transfer collar surface, the #5 main bearing journal and the propeller flange) was not recovered or observed. The crankcase forward of the alternator was also missing and not observed. The fracture surface of the observed crankshaft section revealed beach and crack arrest marks. The crankcase supporting the #4 main bearing was obliterated. The alternator drive gear remained in place and the alternator drive coupling was visible and displaced. A large hole was also observed in the crankcase around the #6 and #5 cylinders. A sealant was observed along the crankcase mating surfaces of the backbone. Pieces of fractured crankcase and connecting rods were observed outside the crankcase between the cylinders near the cooling baffle.
