# Continental Motors

## Component Examination Report

| Engine Model: | IO-550-B | | | | Engine S/N: | 685500 | | | | |
| Aircraft Make/Model: | Beechcraft A36 | | | | Aircraft S/N: | E-1606 | | Reg. #: | N410BC | |

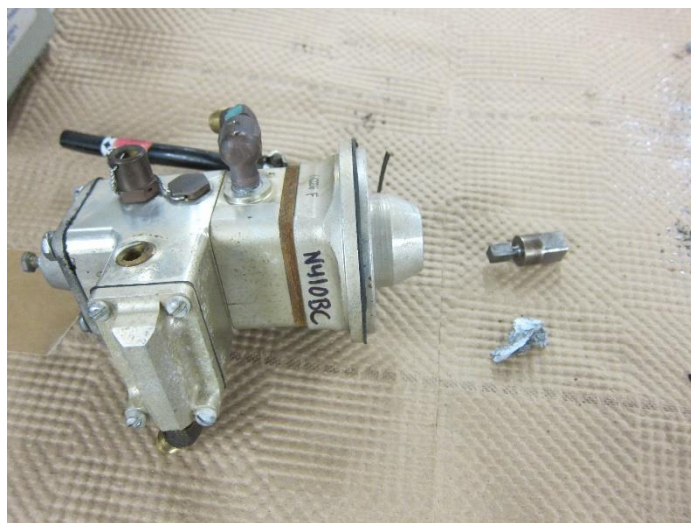
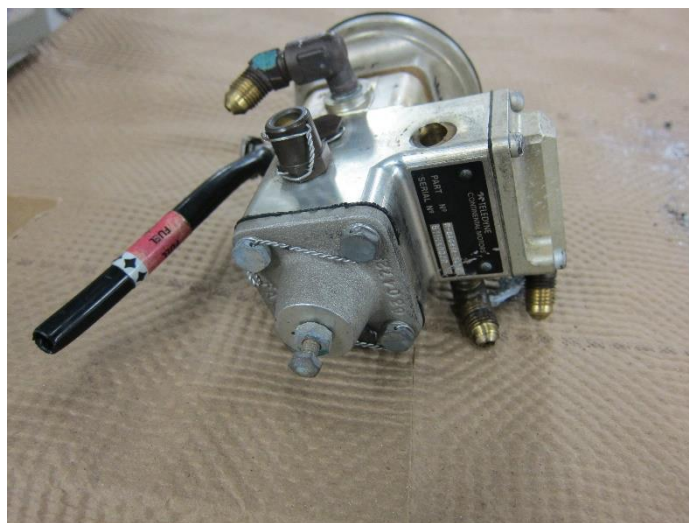
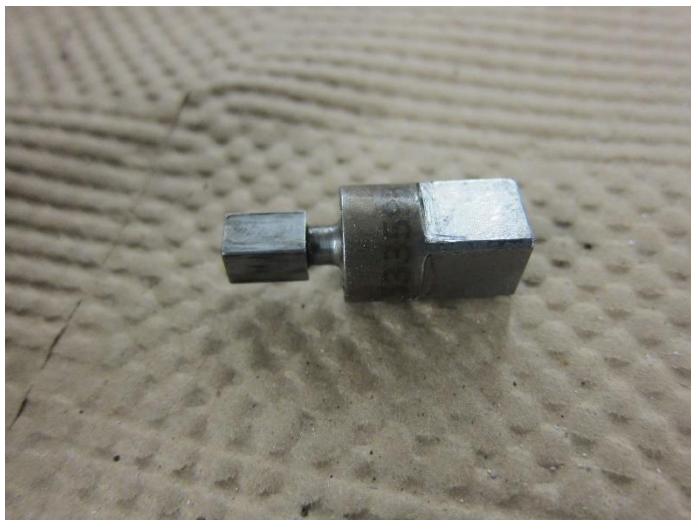
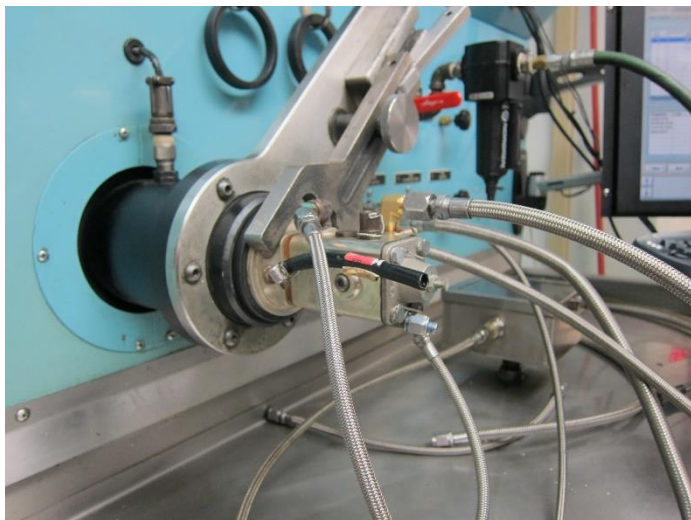
| Summary: | There were no anomalies noted that would have prevented normal operation. | | | | | | | | | |

| FUEL PUMP | | Manufacturer: CMI | P/N: R-646212-54?2 | S/N: B11HA037R |
|---|---|---|---|---|
| Condition: | The fuel pump displayed impact damage signatures; one of the fuel line AN fittings had broken off. The fuel pump drive shaft was noted to have remained intact and the fuel pump drive shaft was capable of normal rotation. The broken AN fitting was removed and a serviceable fitting was installed. The fuel pump was placed on a production test bench for testing; the fuel pump operated normally. There were no anomalies noted. | | | |
