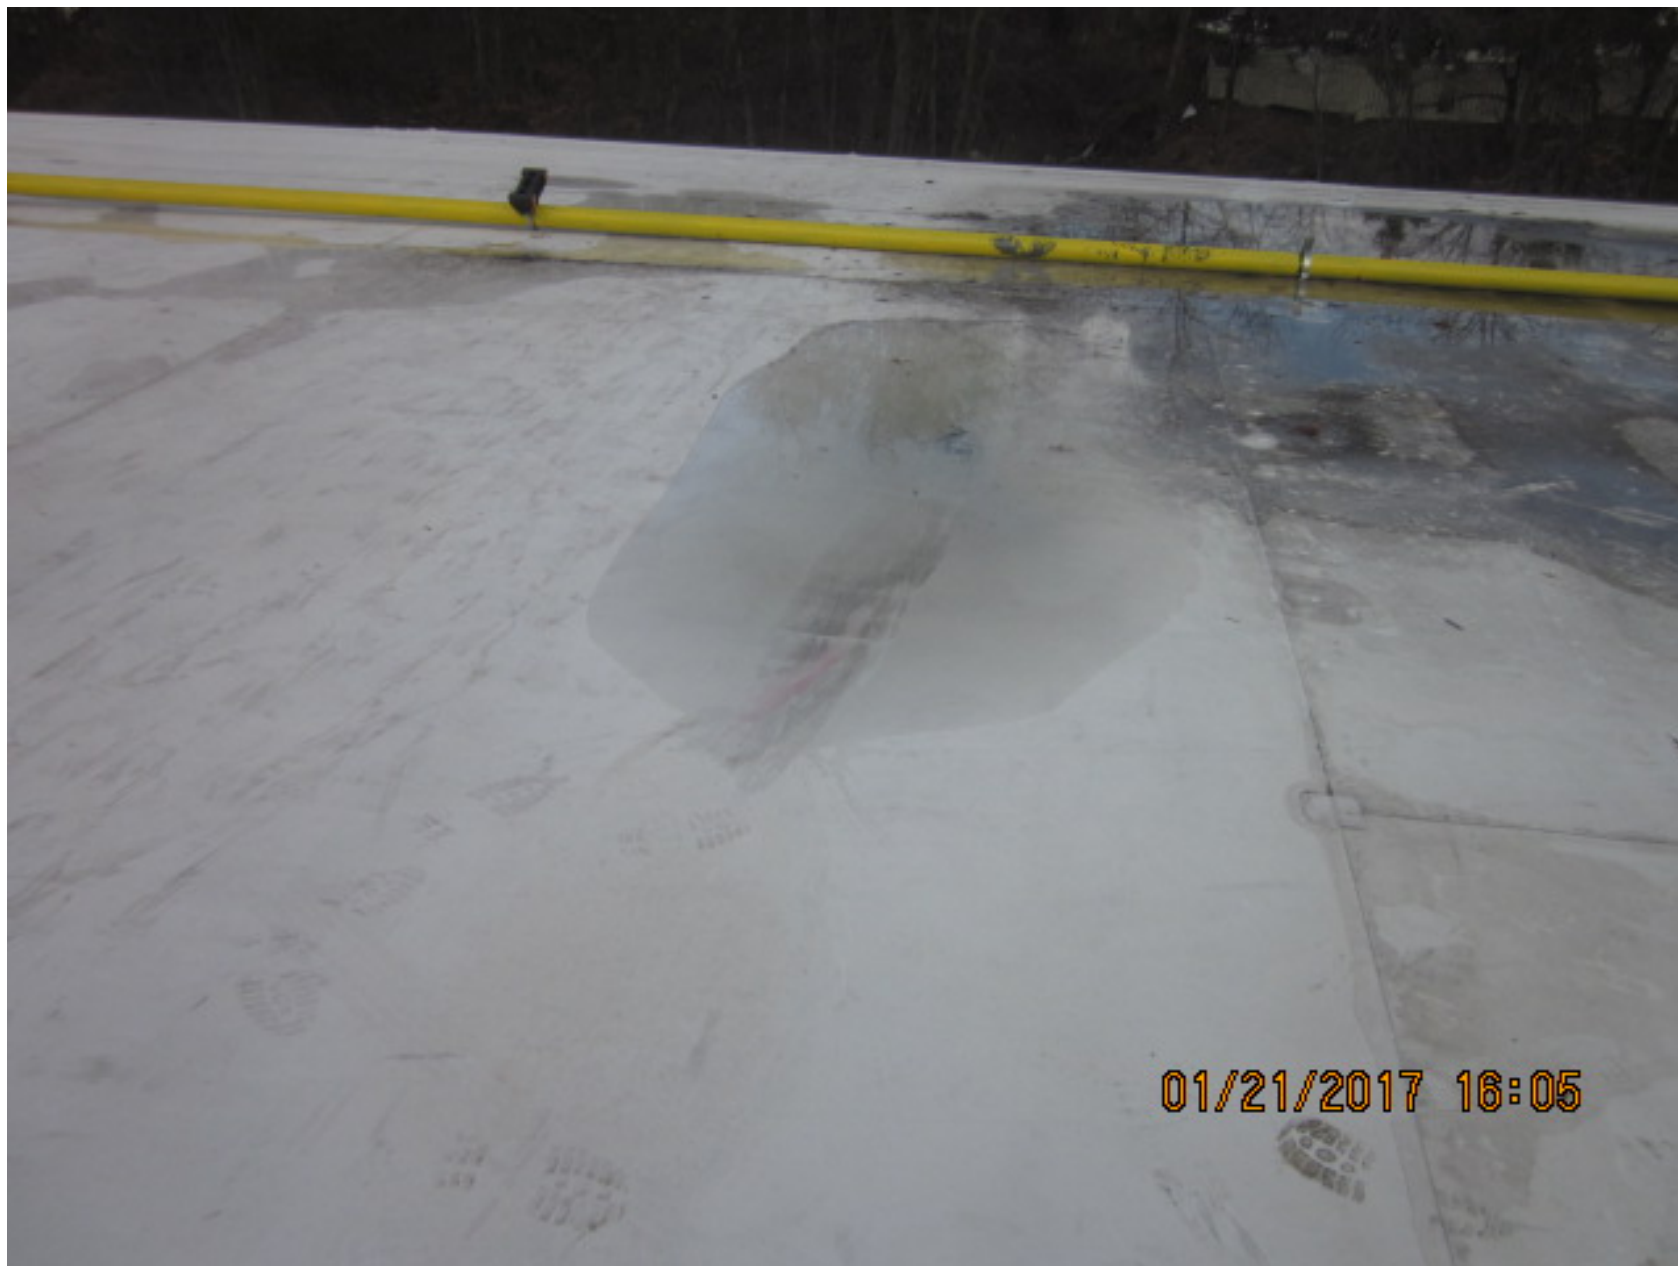
**Photo 1 – Point of Contact on Roof of Building – Courtesy of FAA**

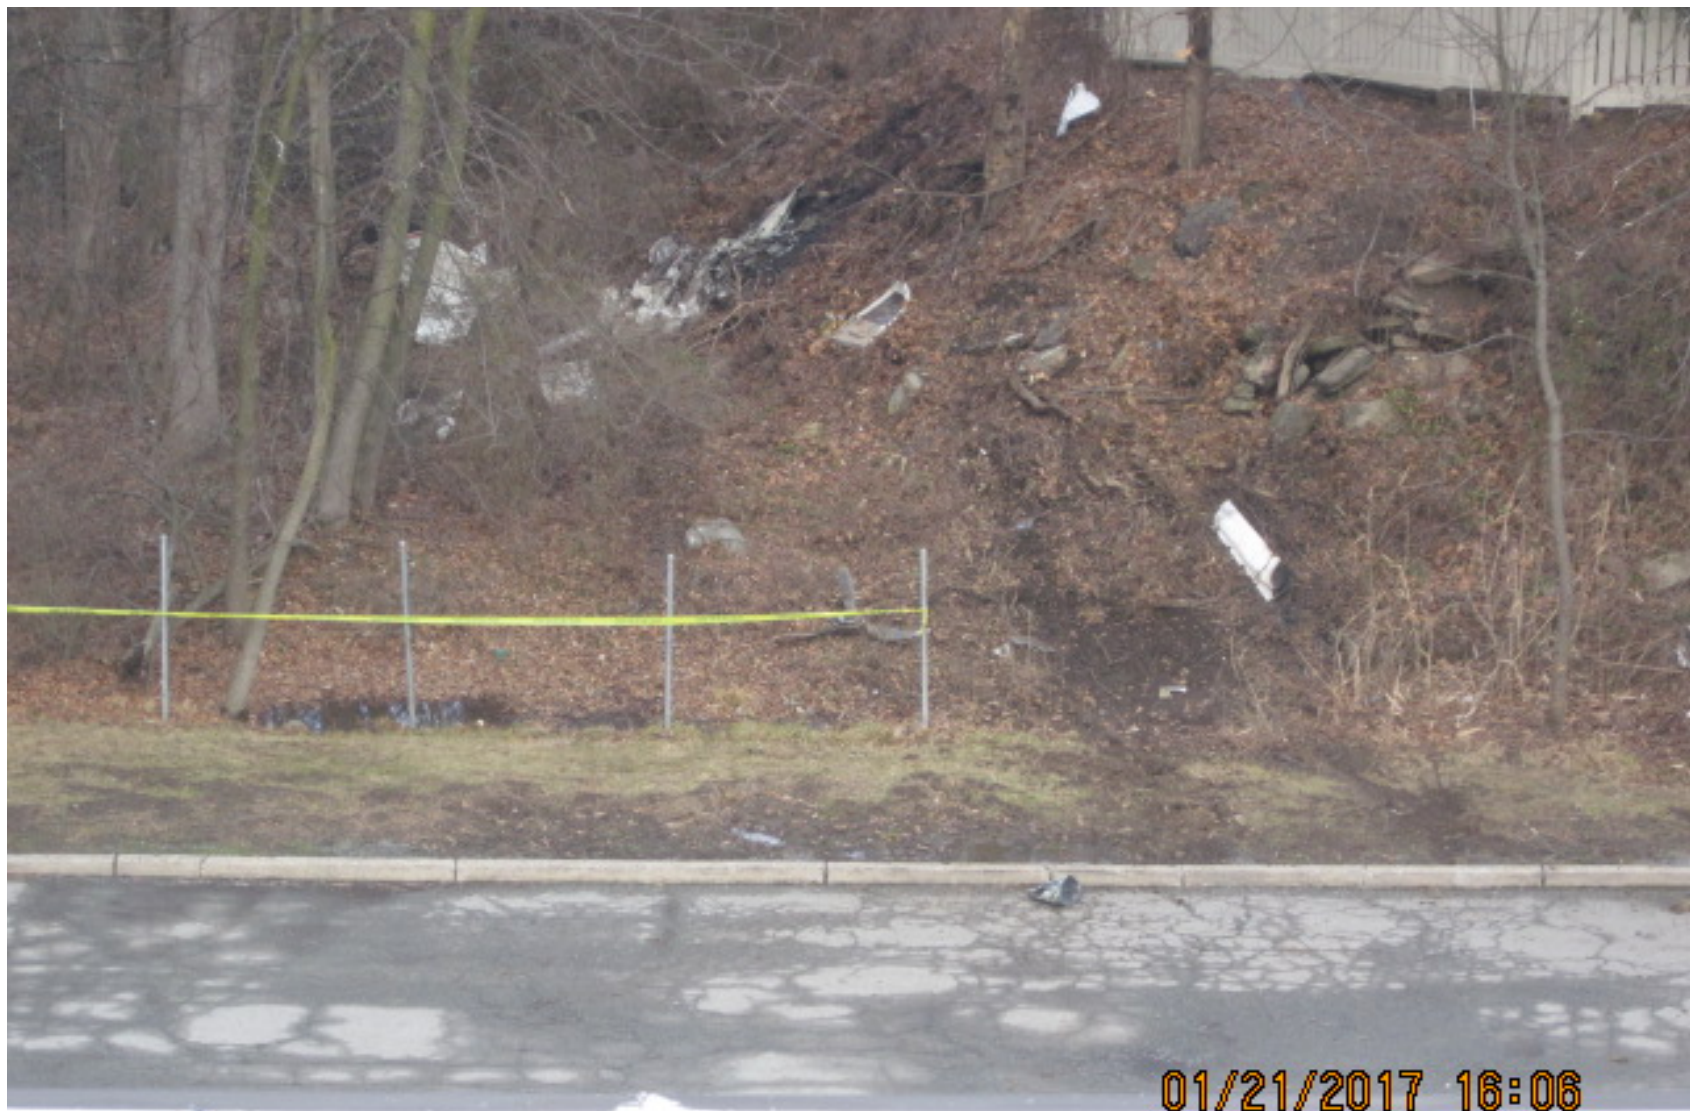
**Photo 2 – Point of Ground Impact as Viewed from Roof of Building – Courtesy of FAA**

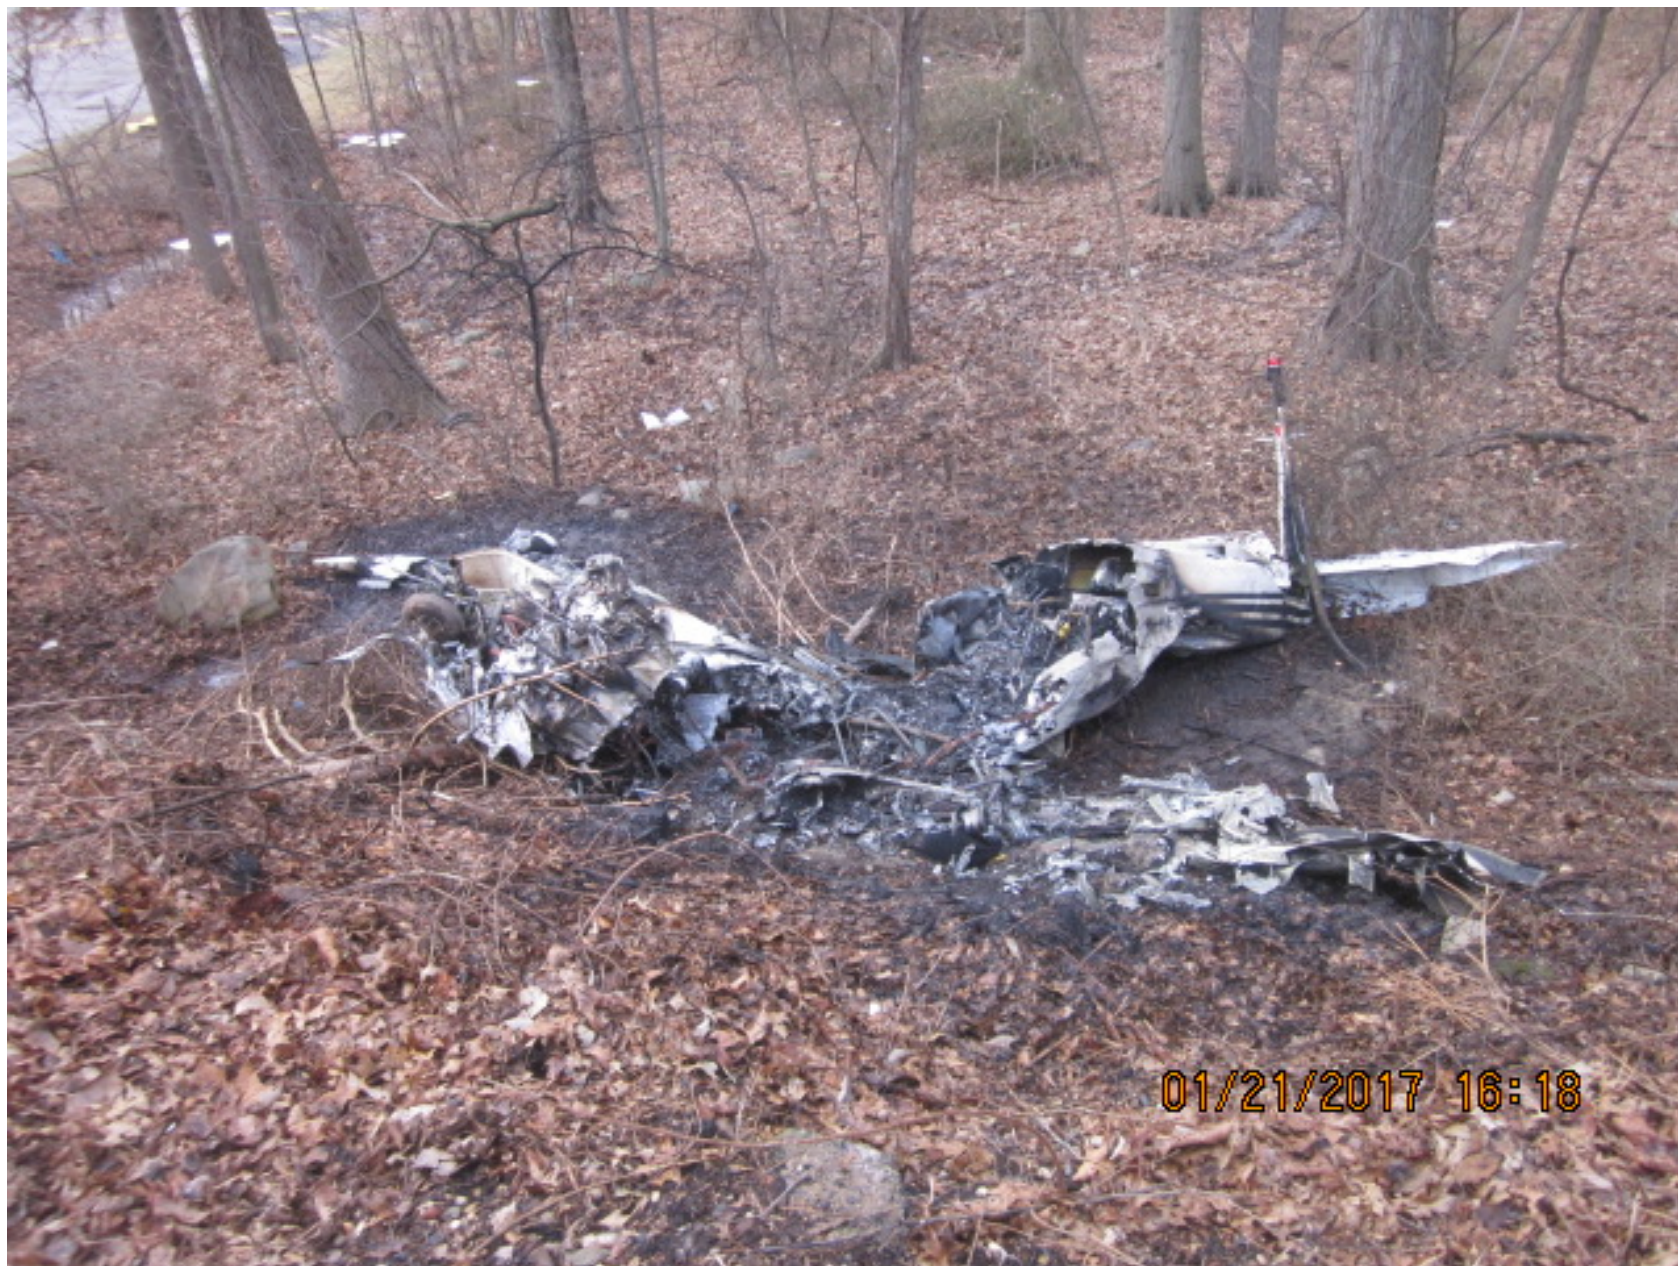
**Photo 3 – Main Wreckage – Courtesy of FAA**

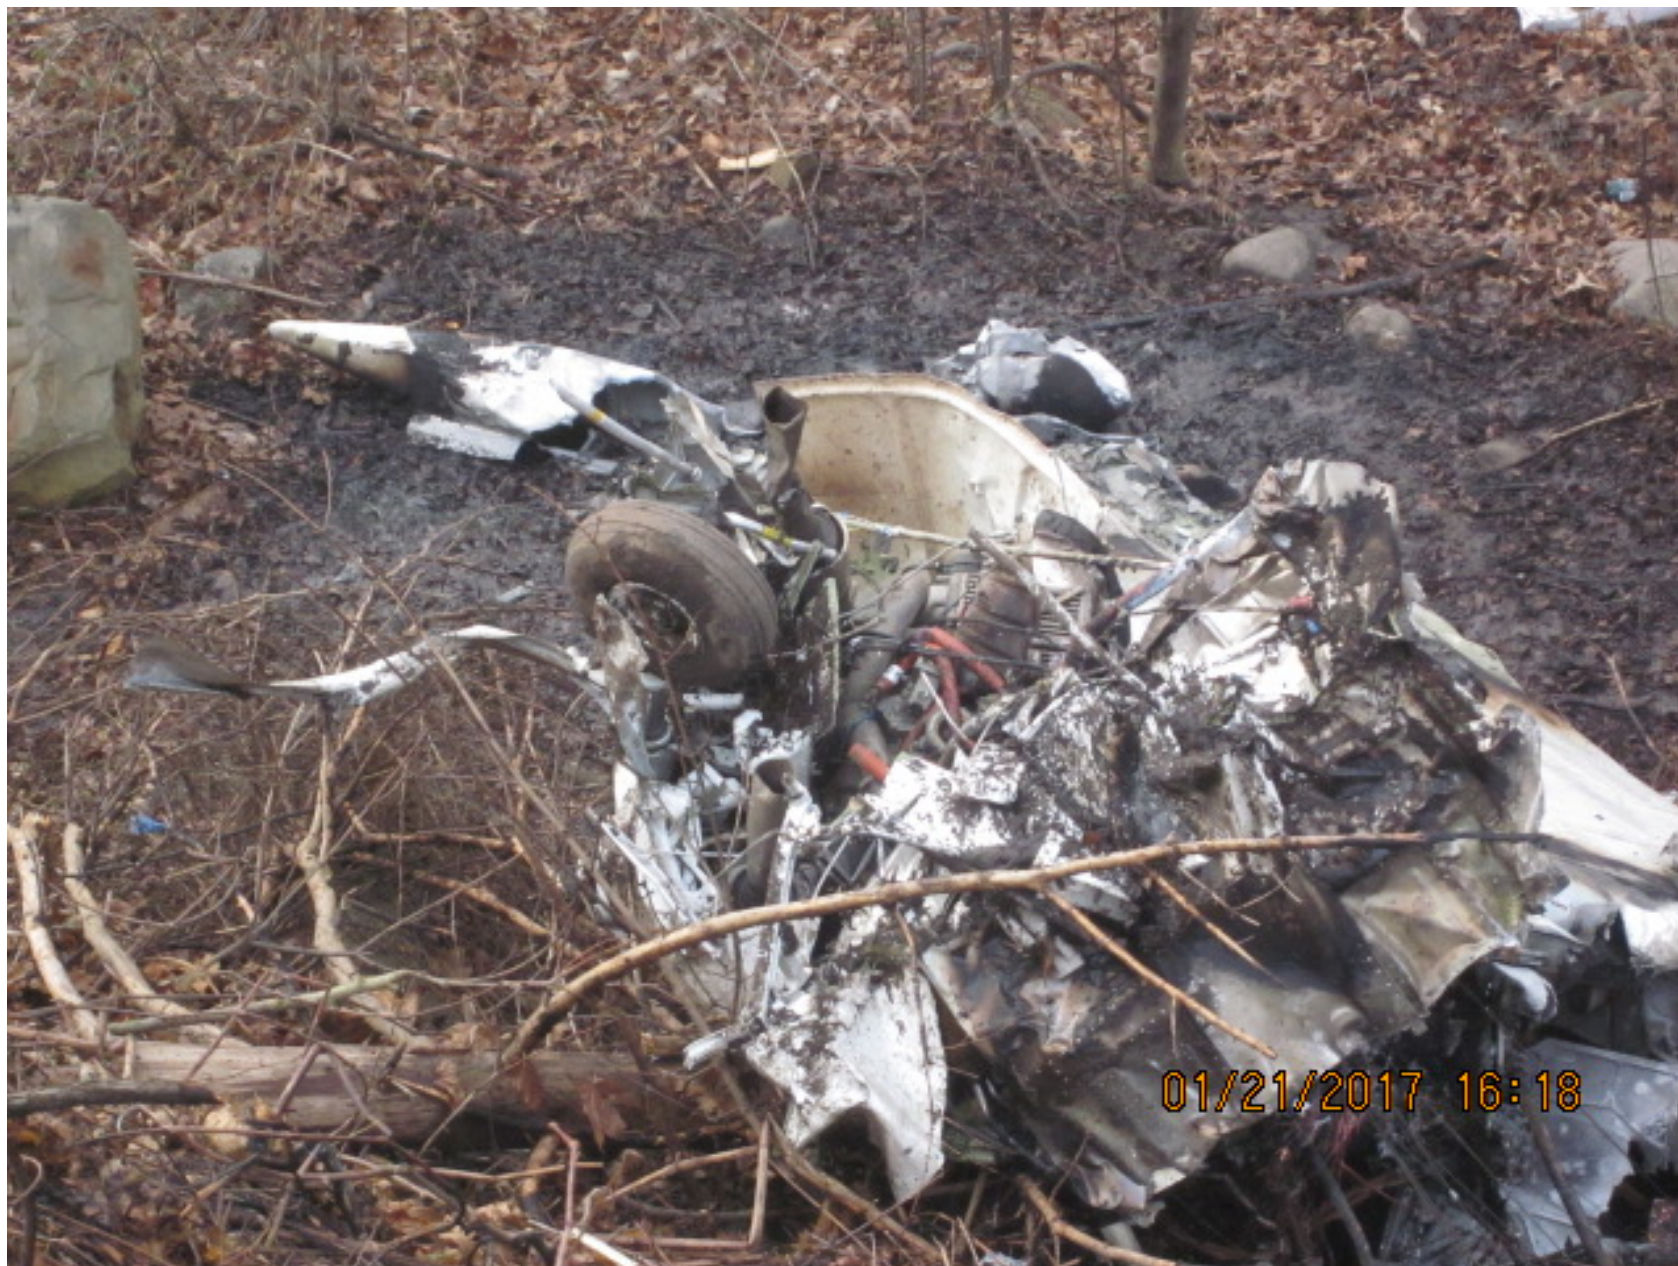
**Photo 4 – Nose Section – Courtesy of FAA**

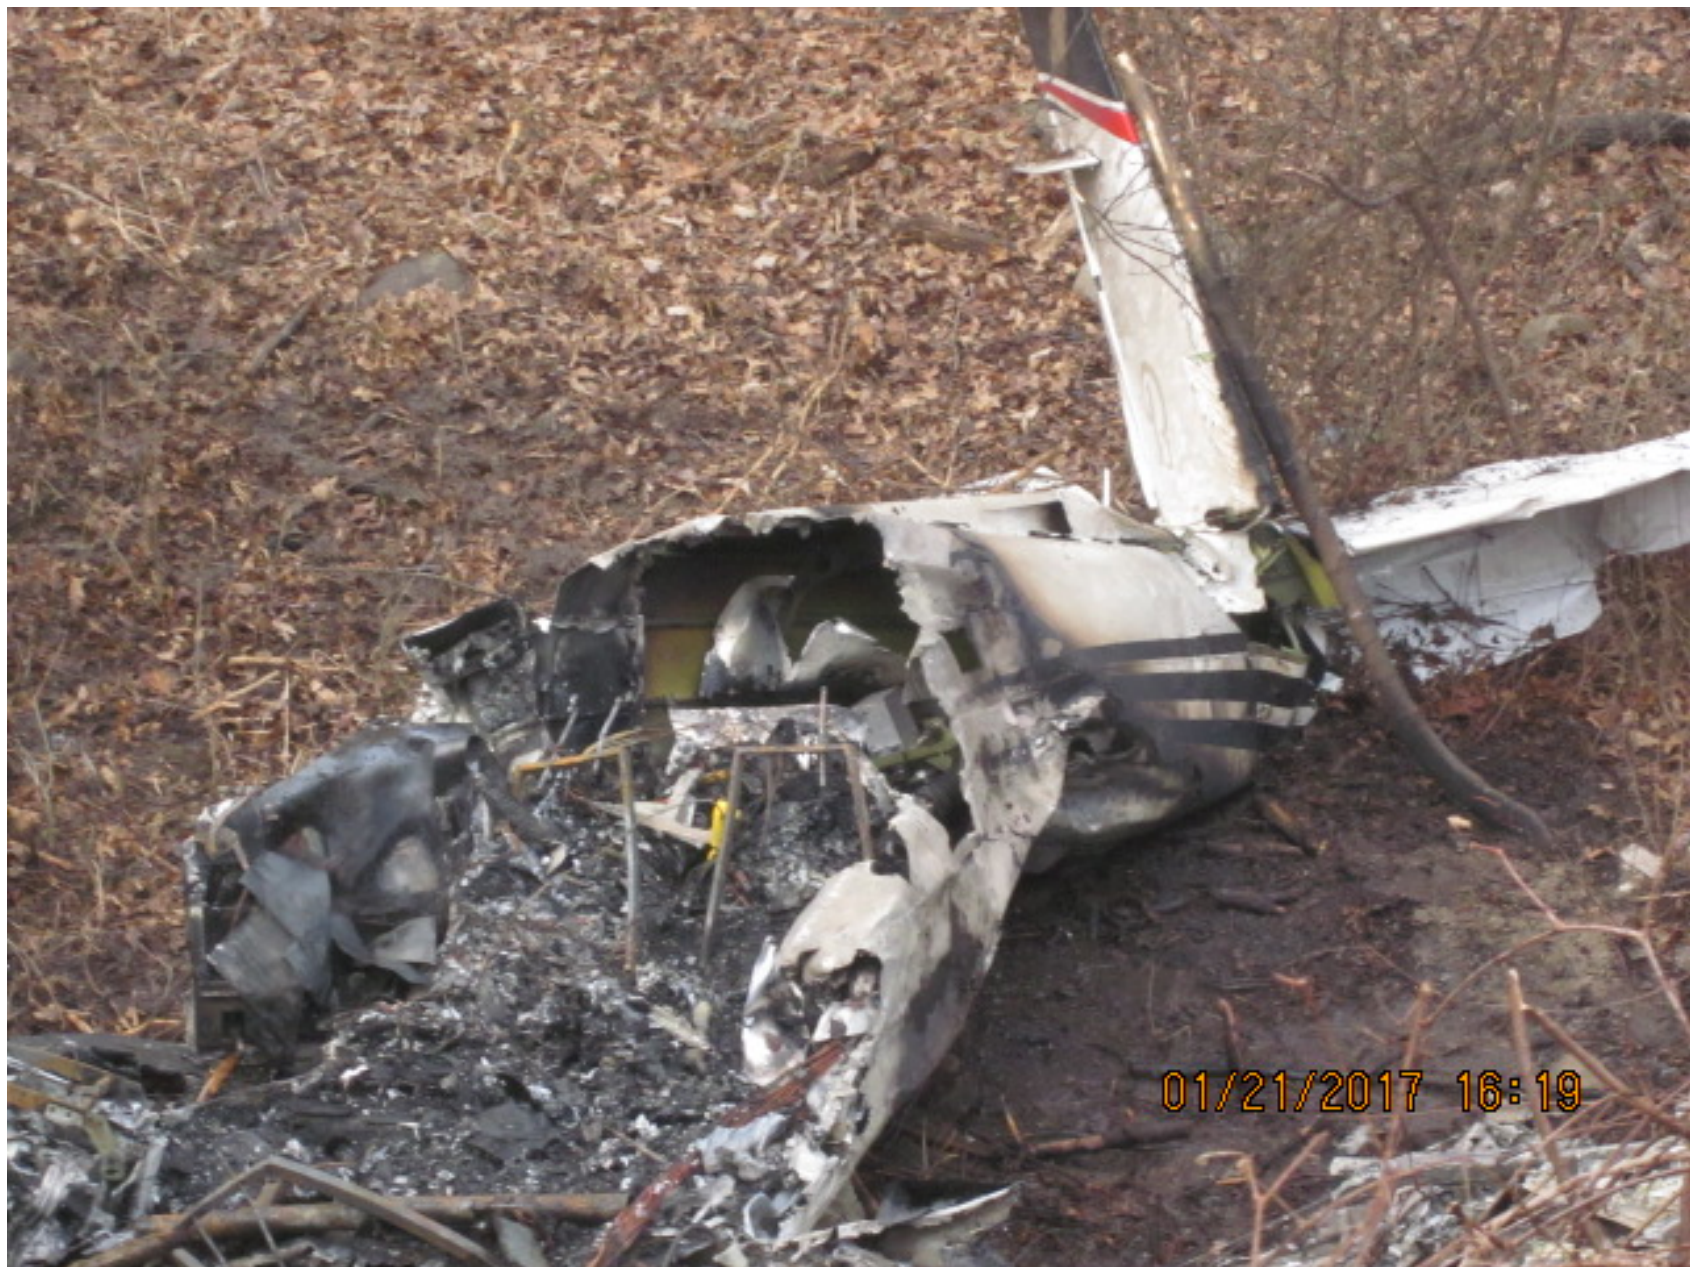
**Photo 5 -Aft Fuselage – Courtesy of FAA**

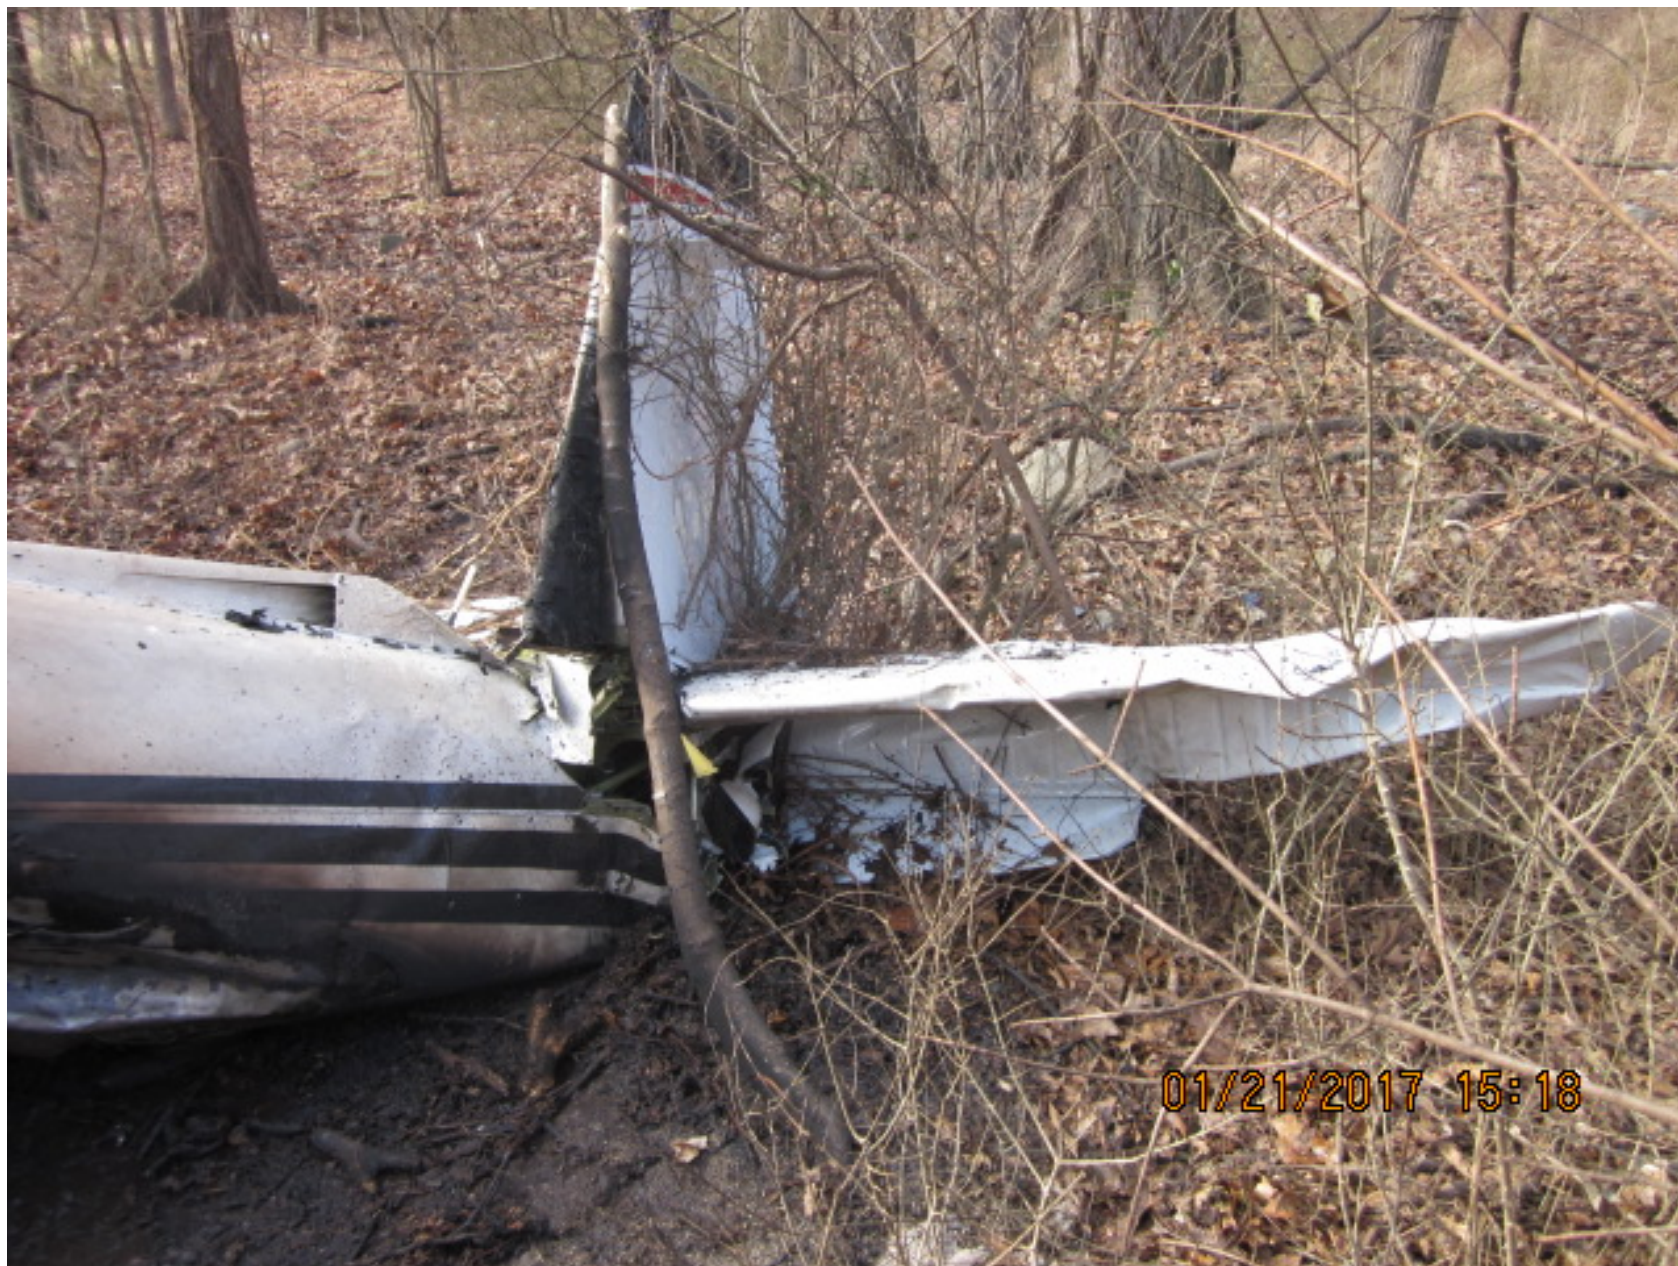
**Photo 6 – Empennage – Courtesy of FAA**

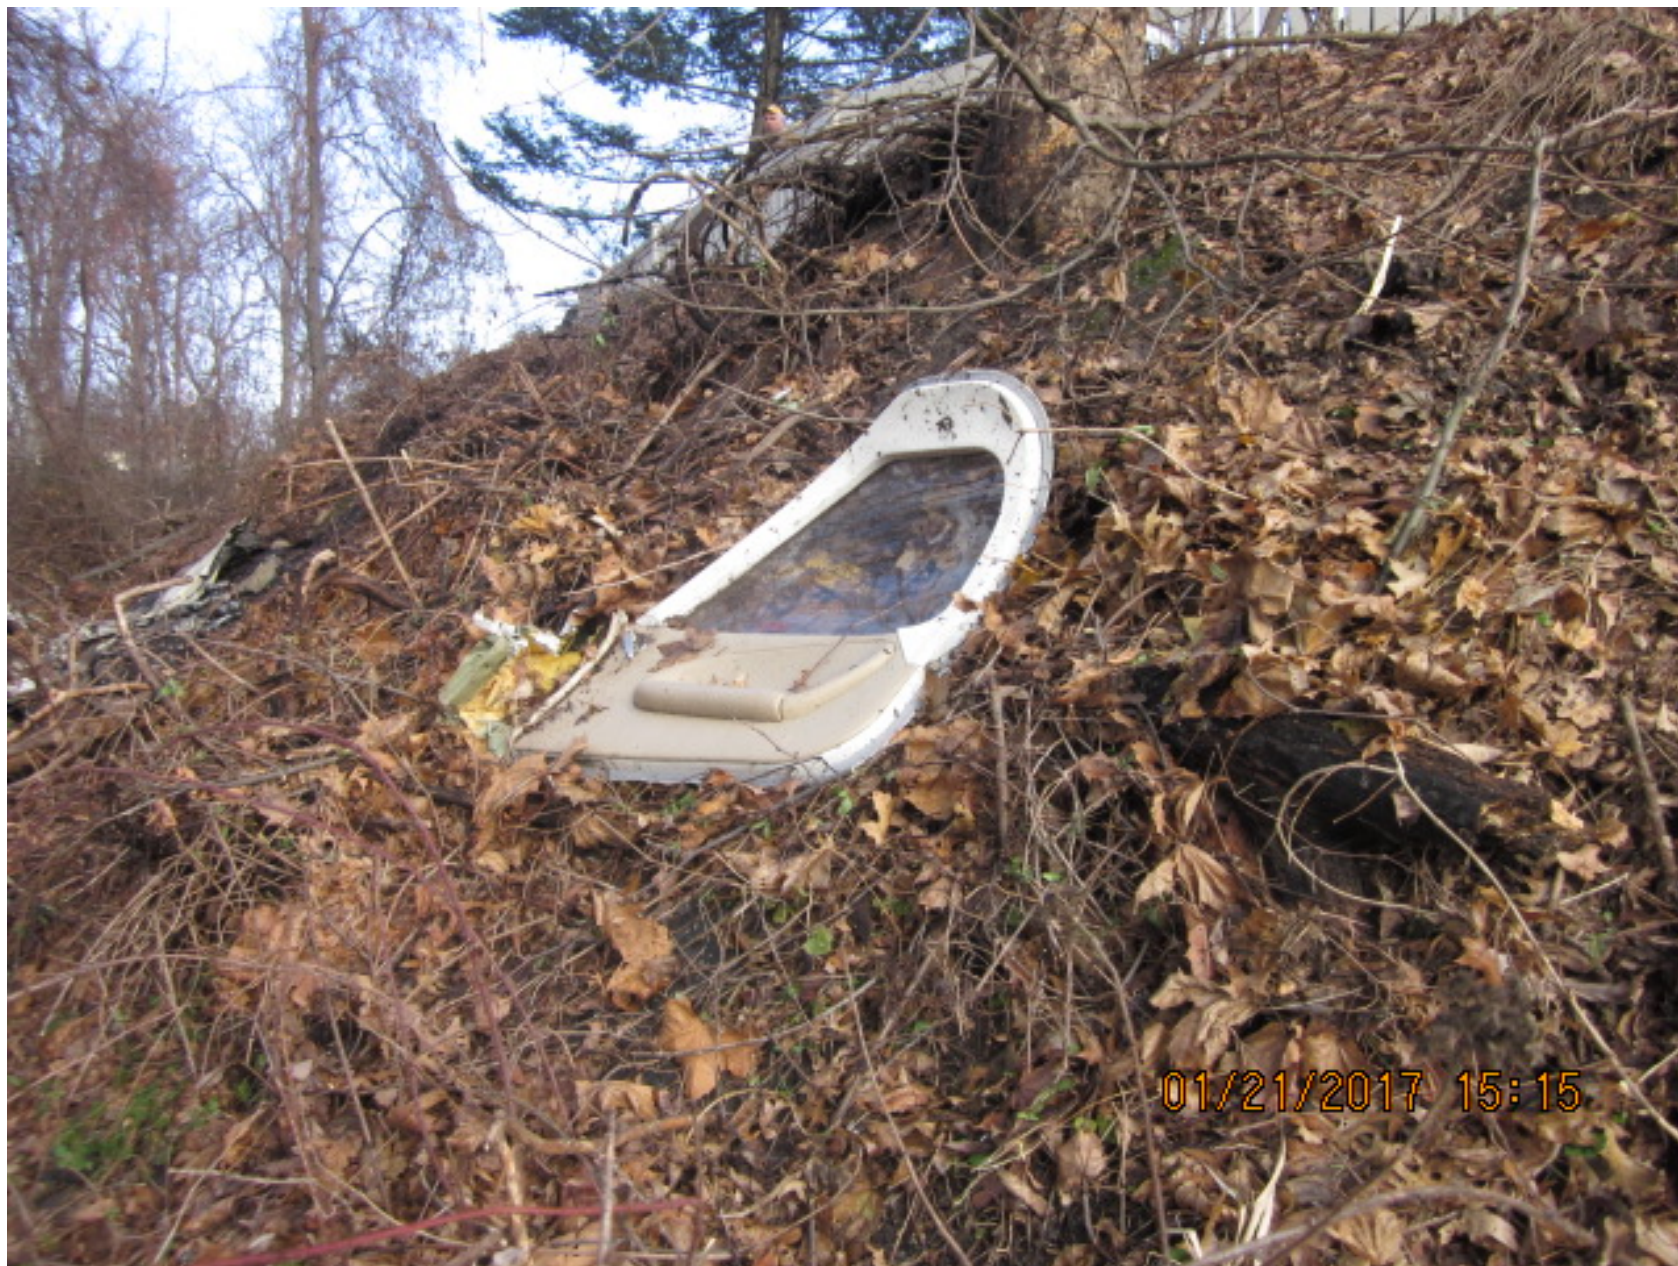
**Photo 7 – Cabin Door – Courtesy of FAA**

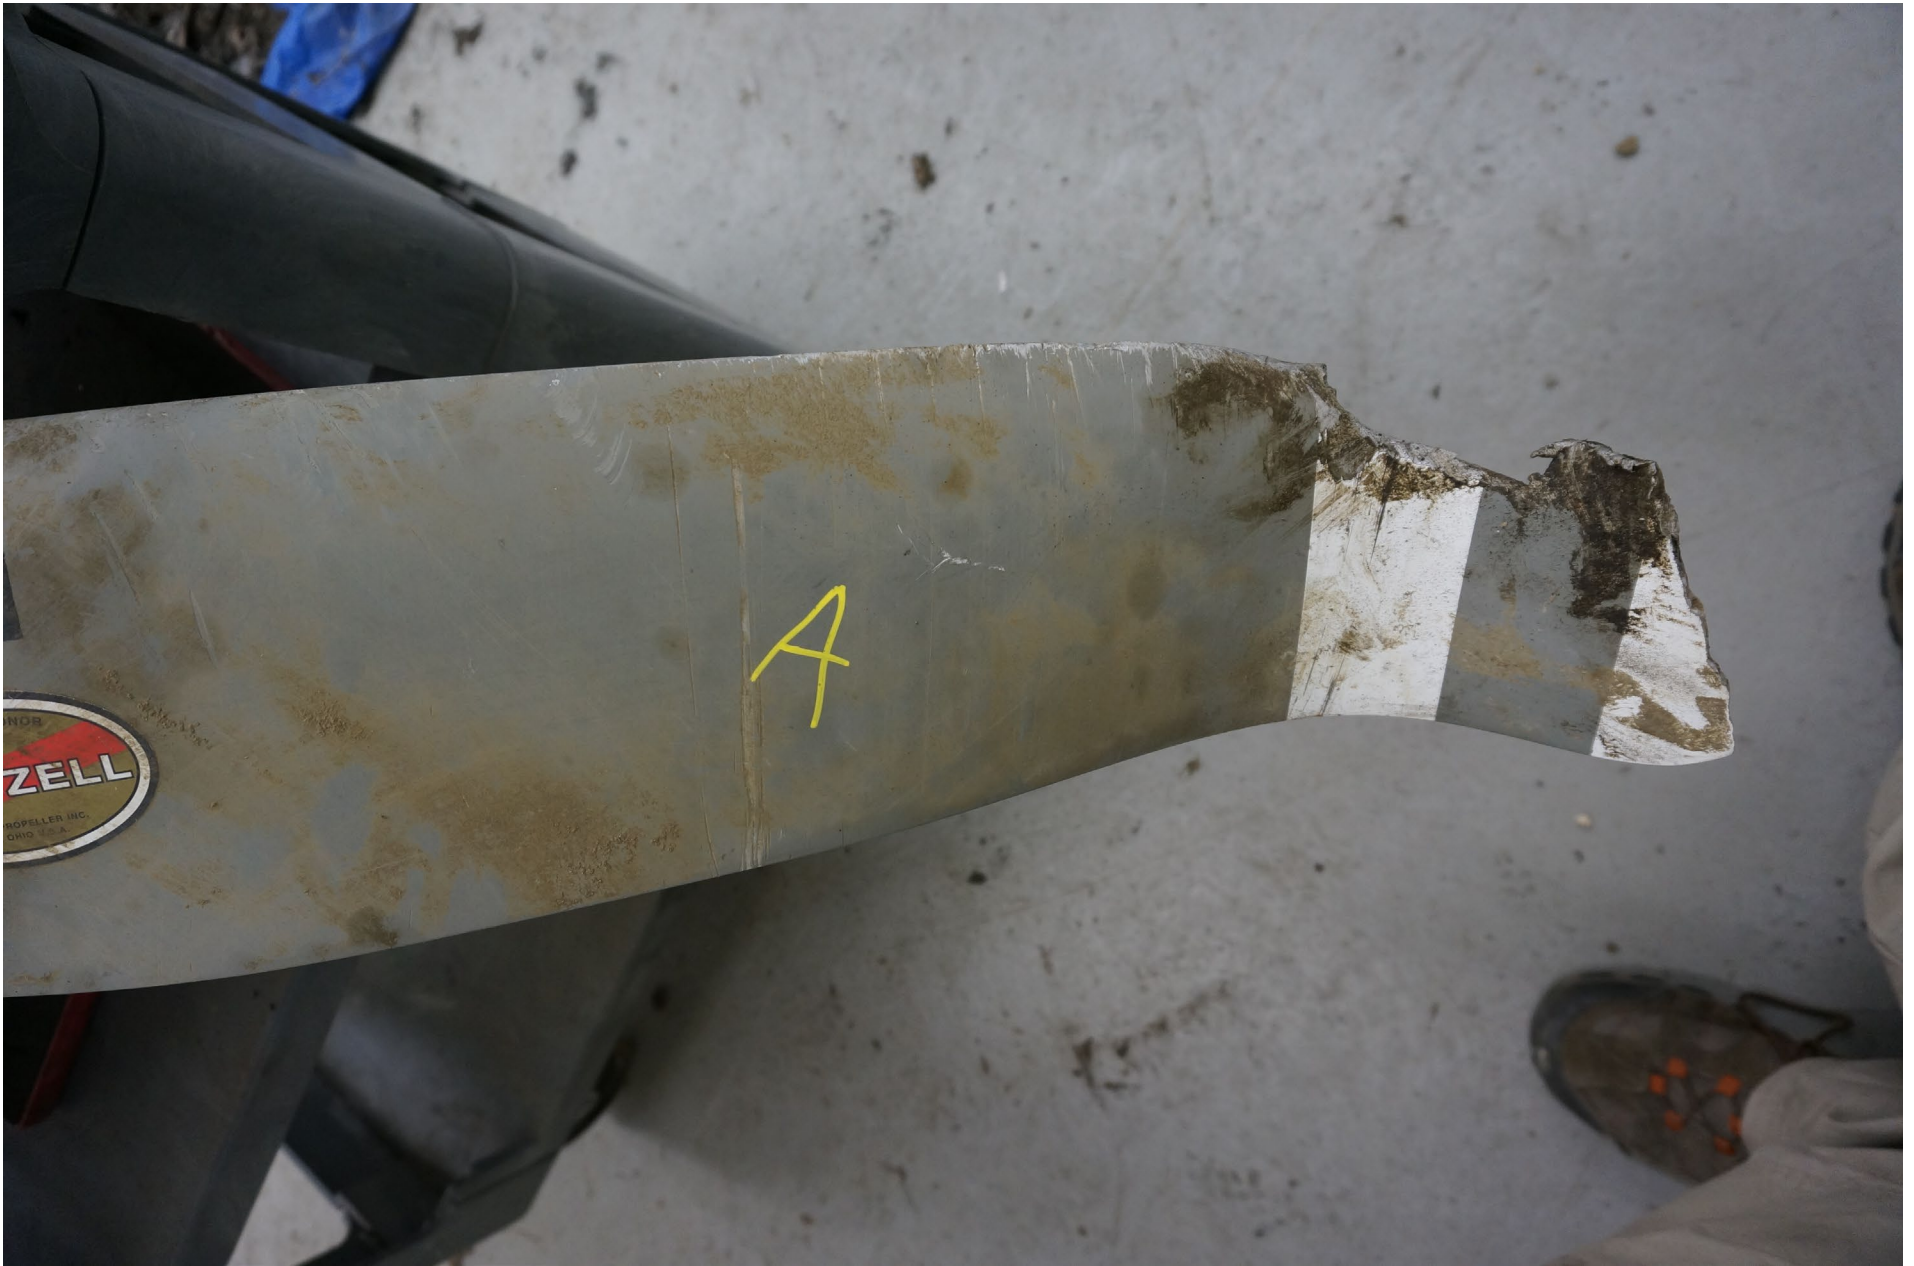
**Photo 9 – Propeller Blade “A”**

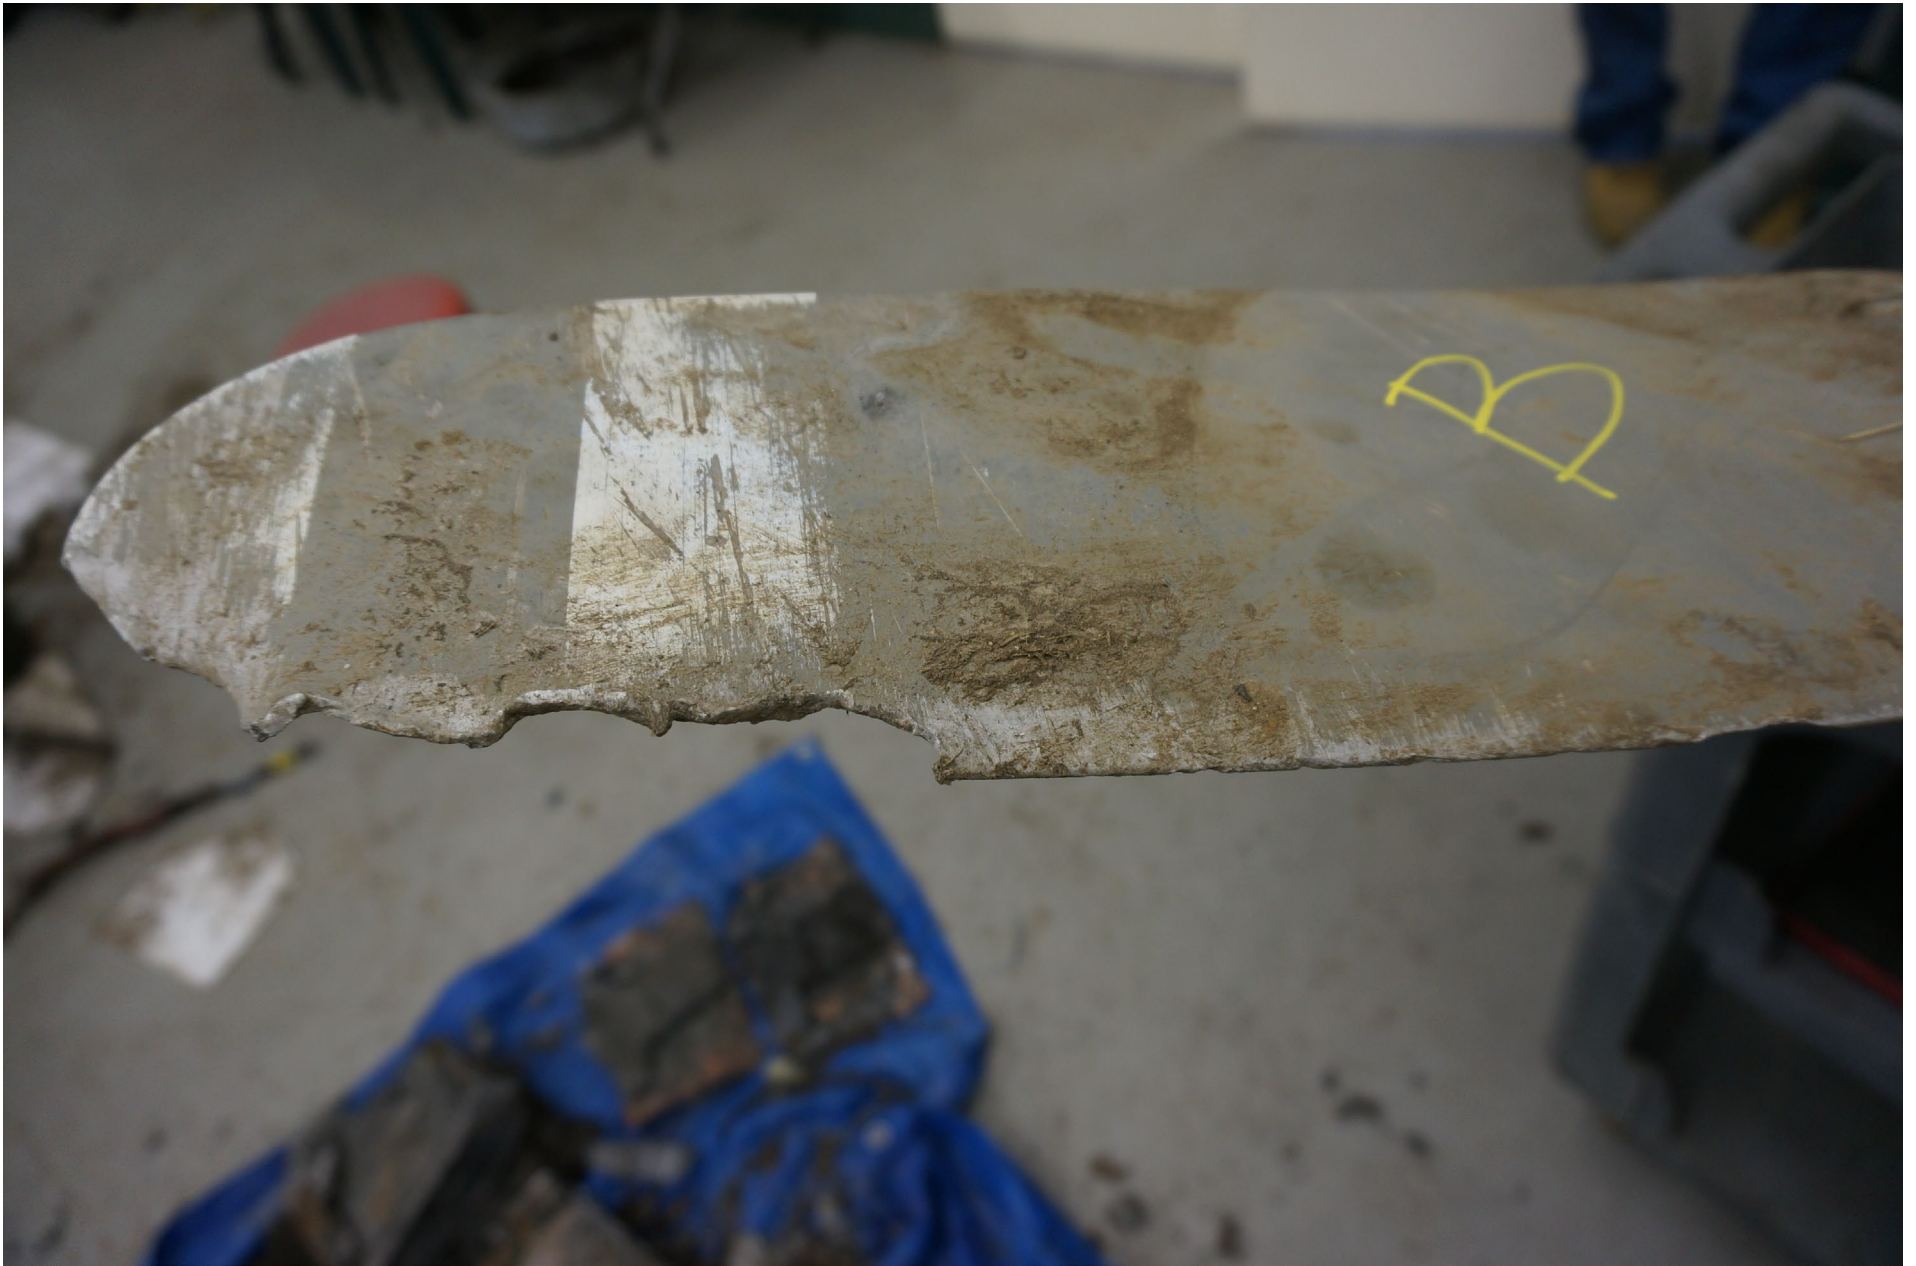
**Photo 10 – Propeller Blade “B”**

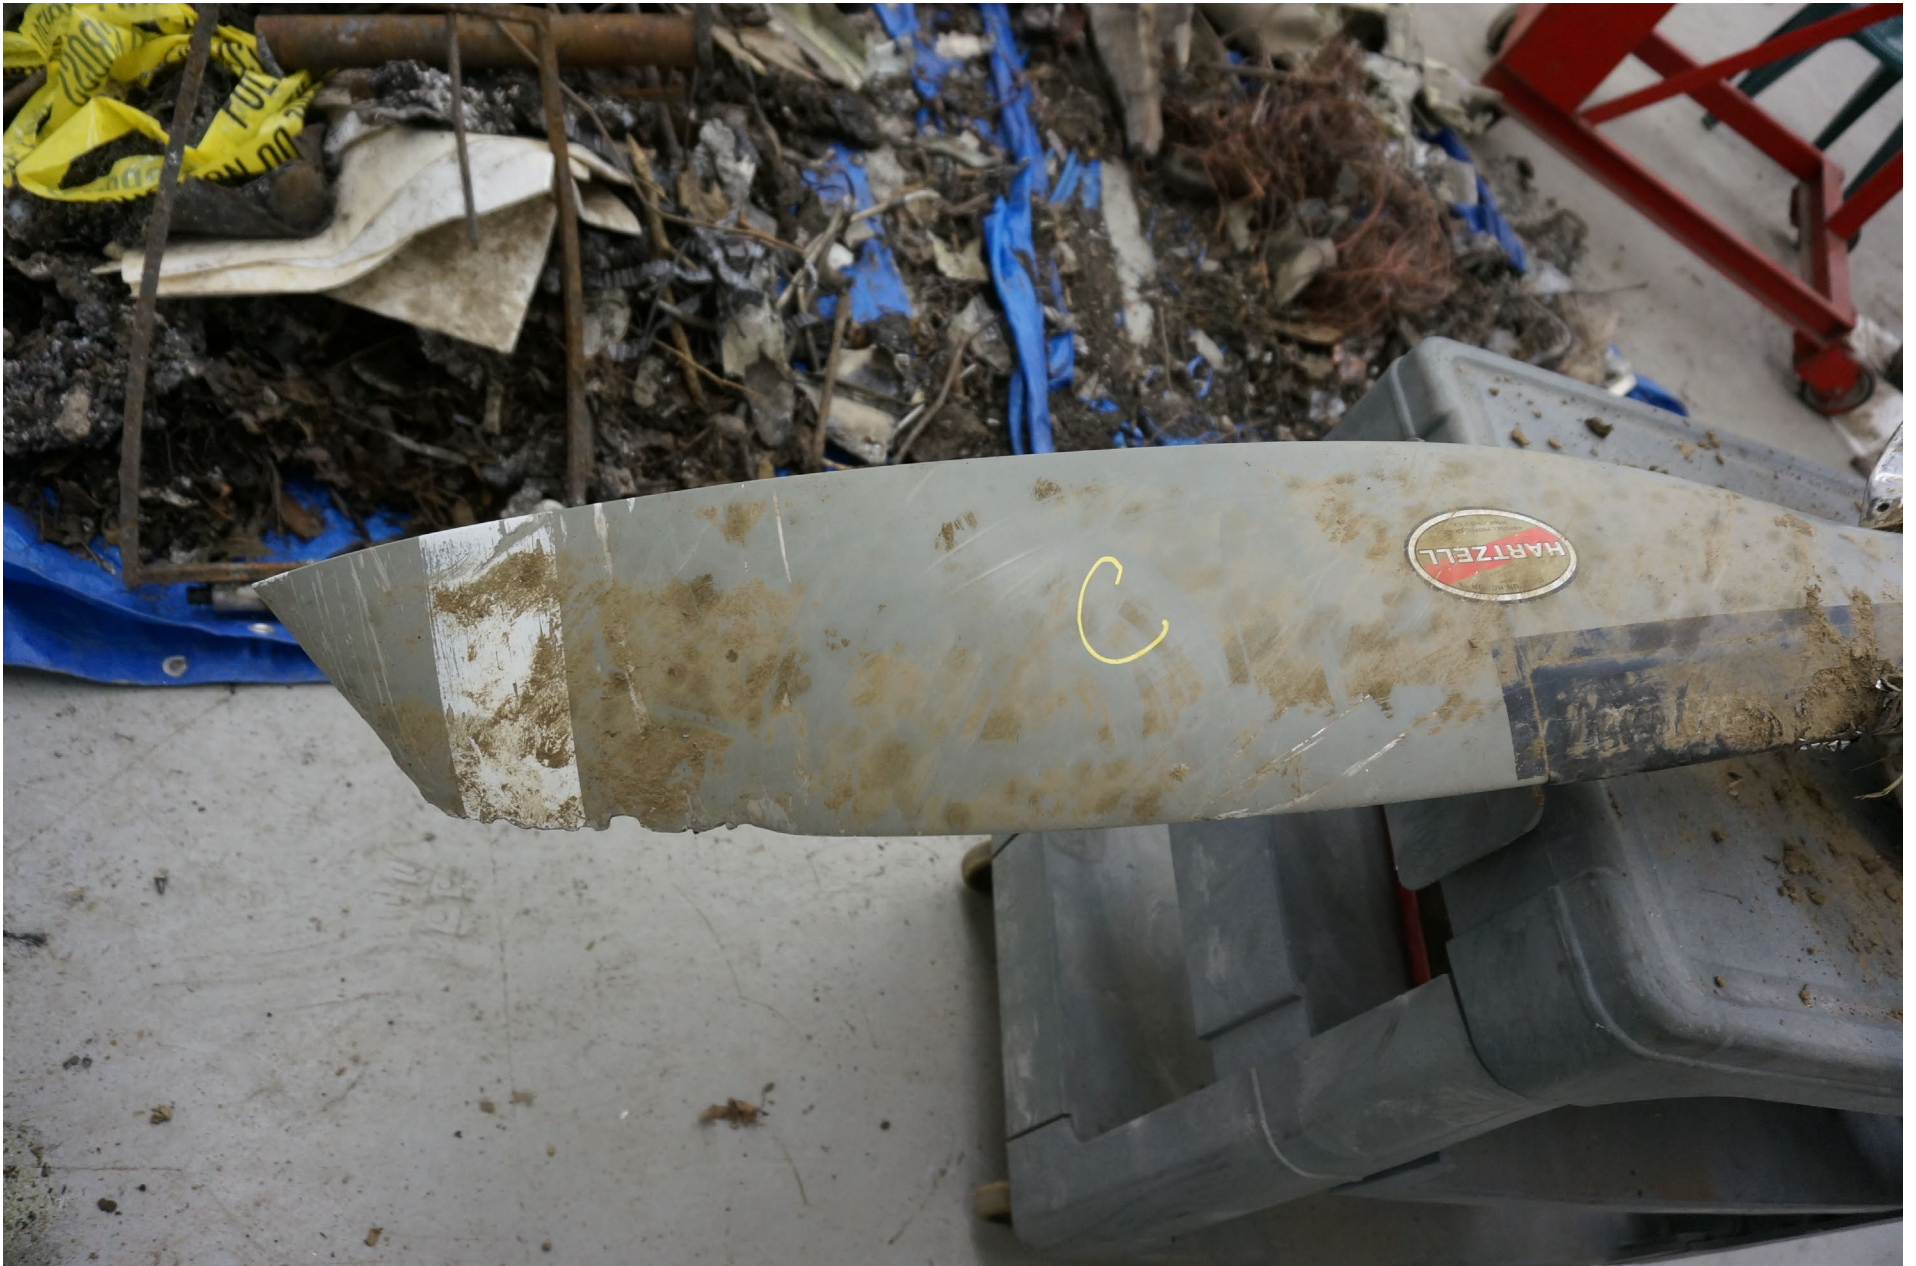
**Photo 11 – Propeller Blade “C”**
