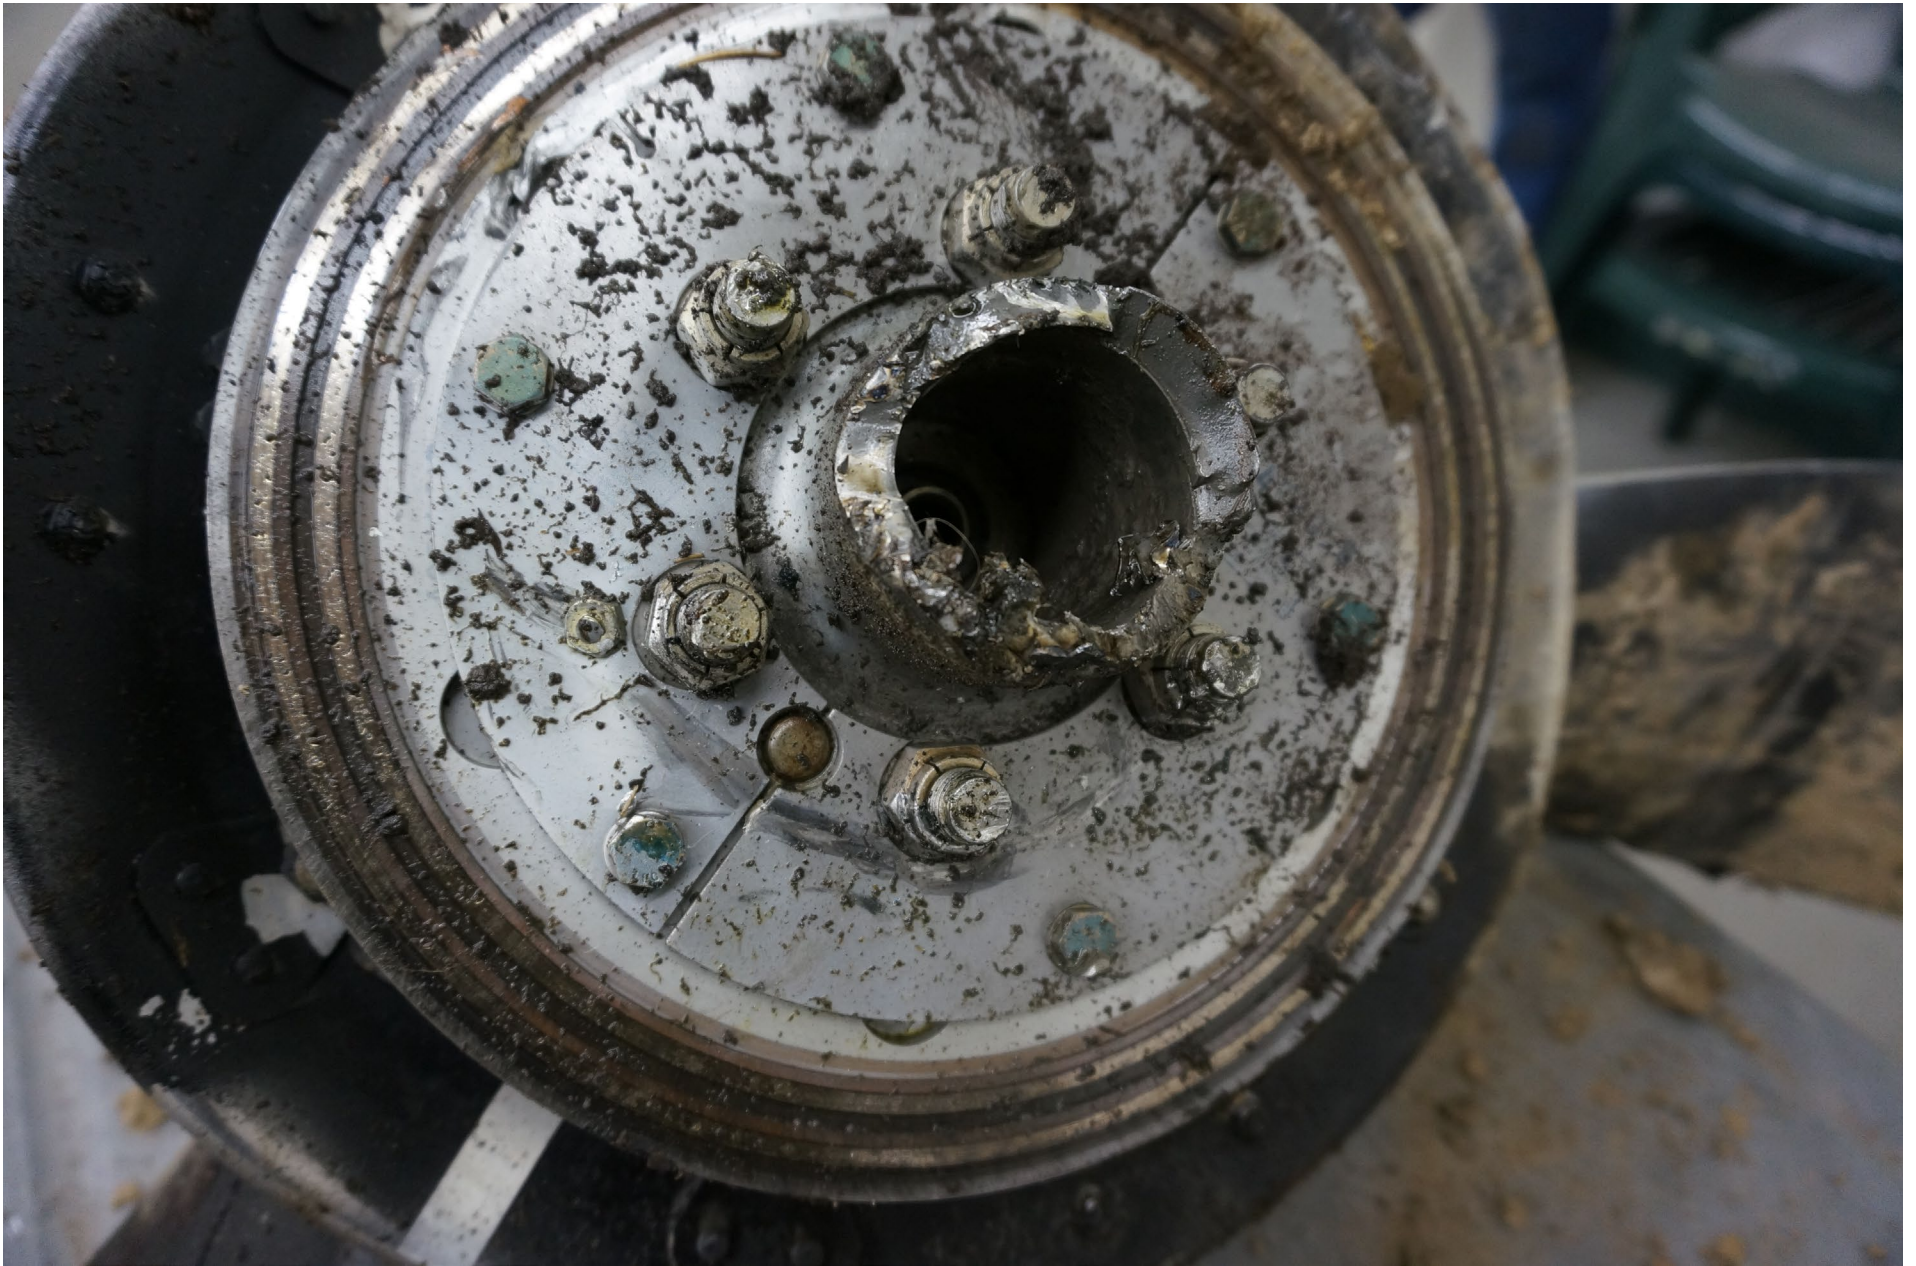
**Photo 12 – Shear Face on Crankshaft End Attached to Propeller**

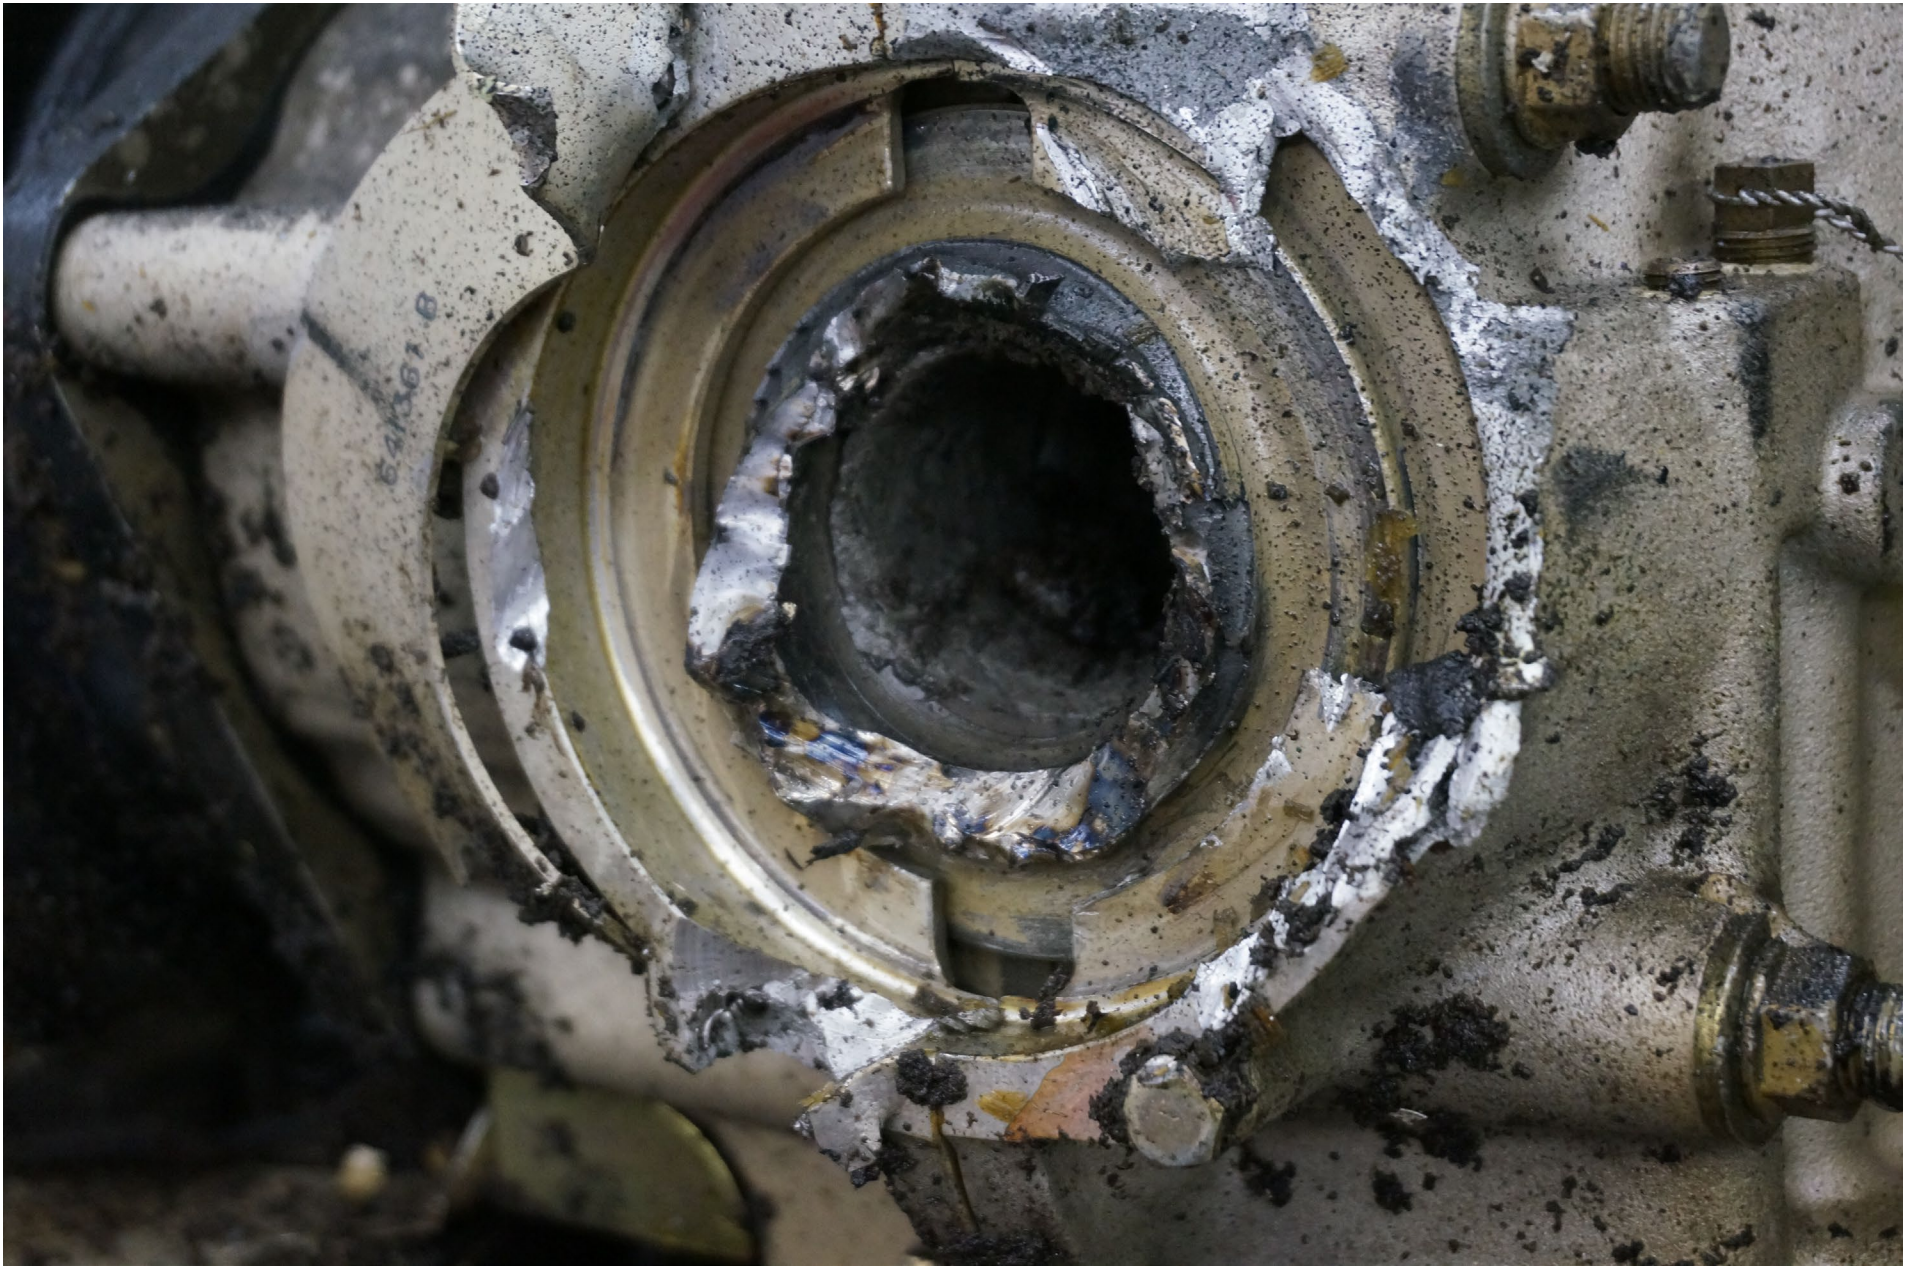
**Photo 14 – Sheared End of Crankshaft in Engine**

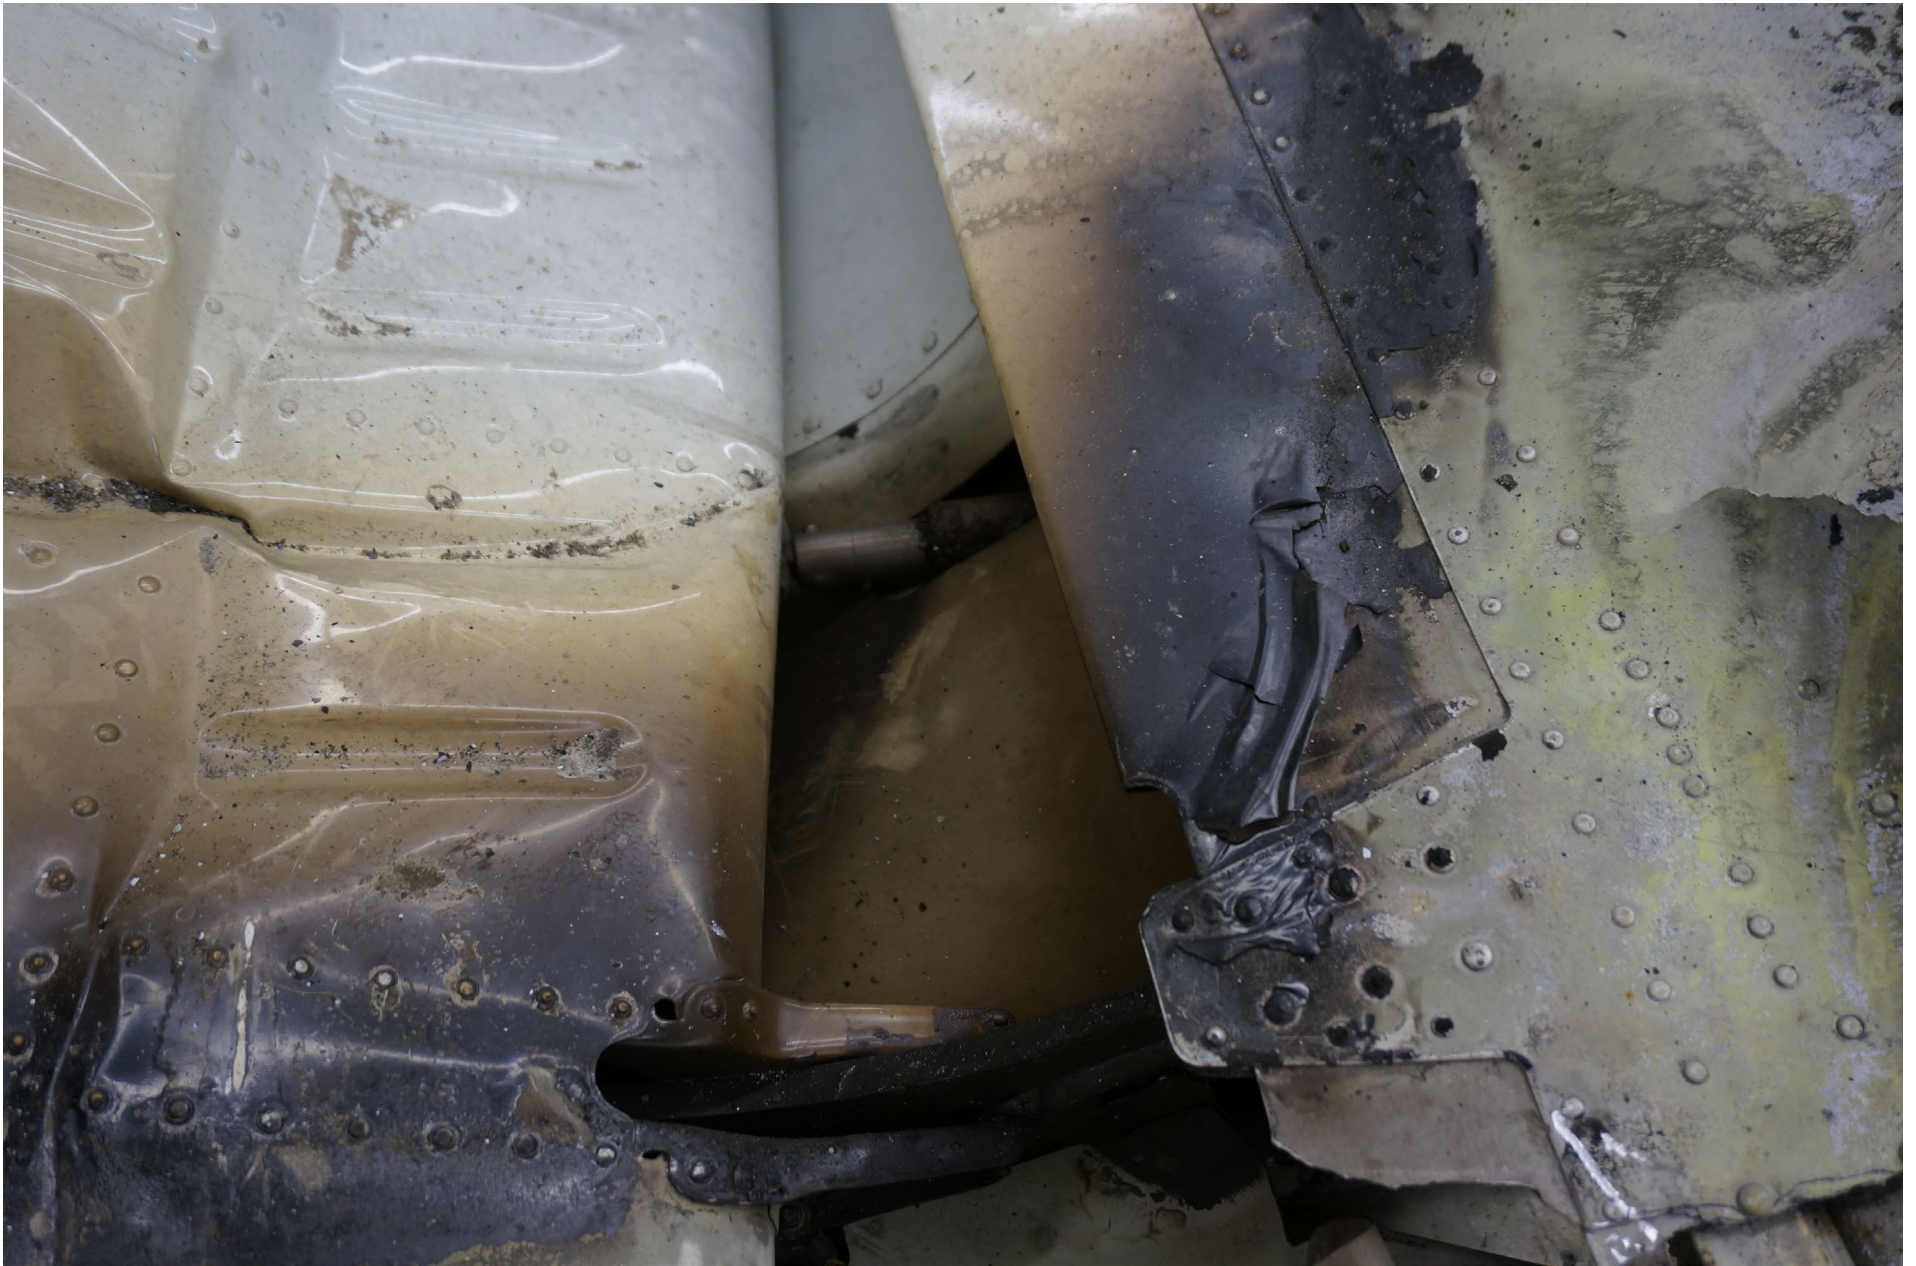
**Photo 15 – Right Flap Actuator**

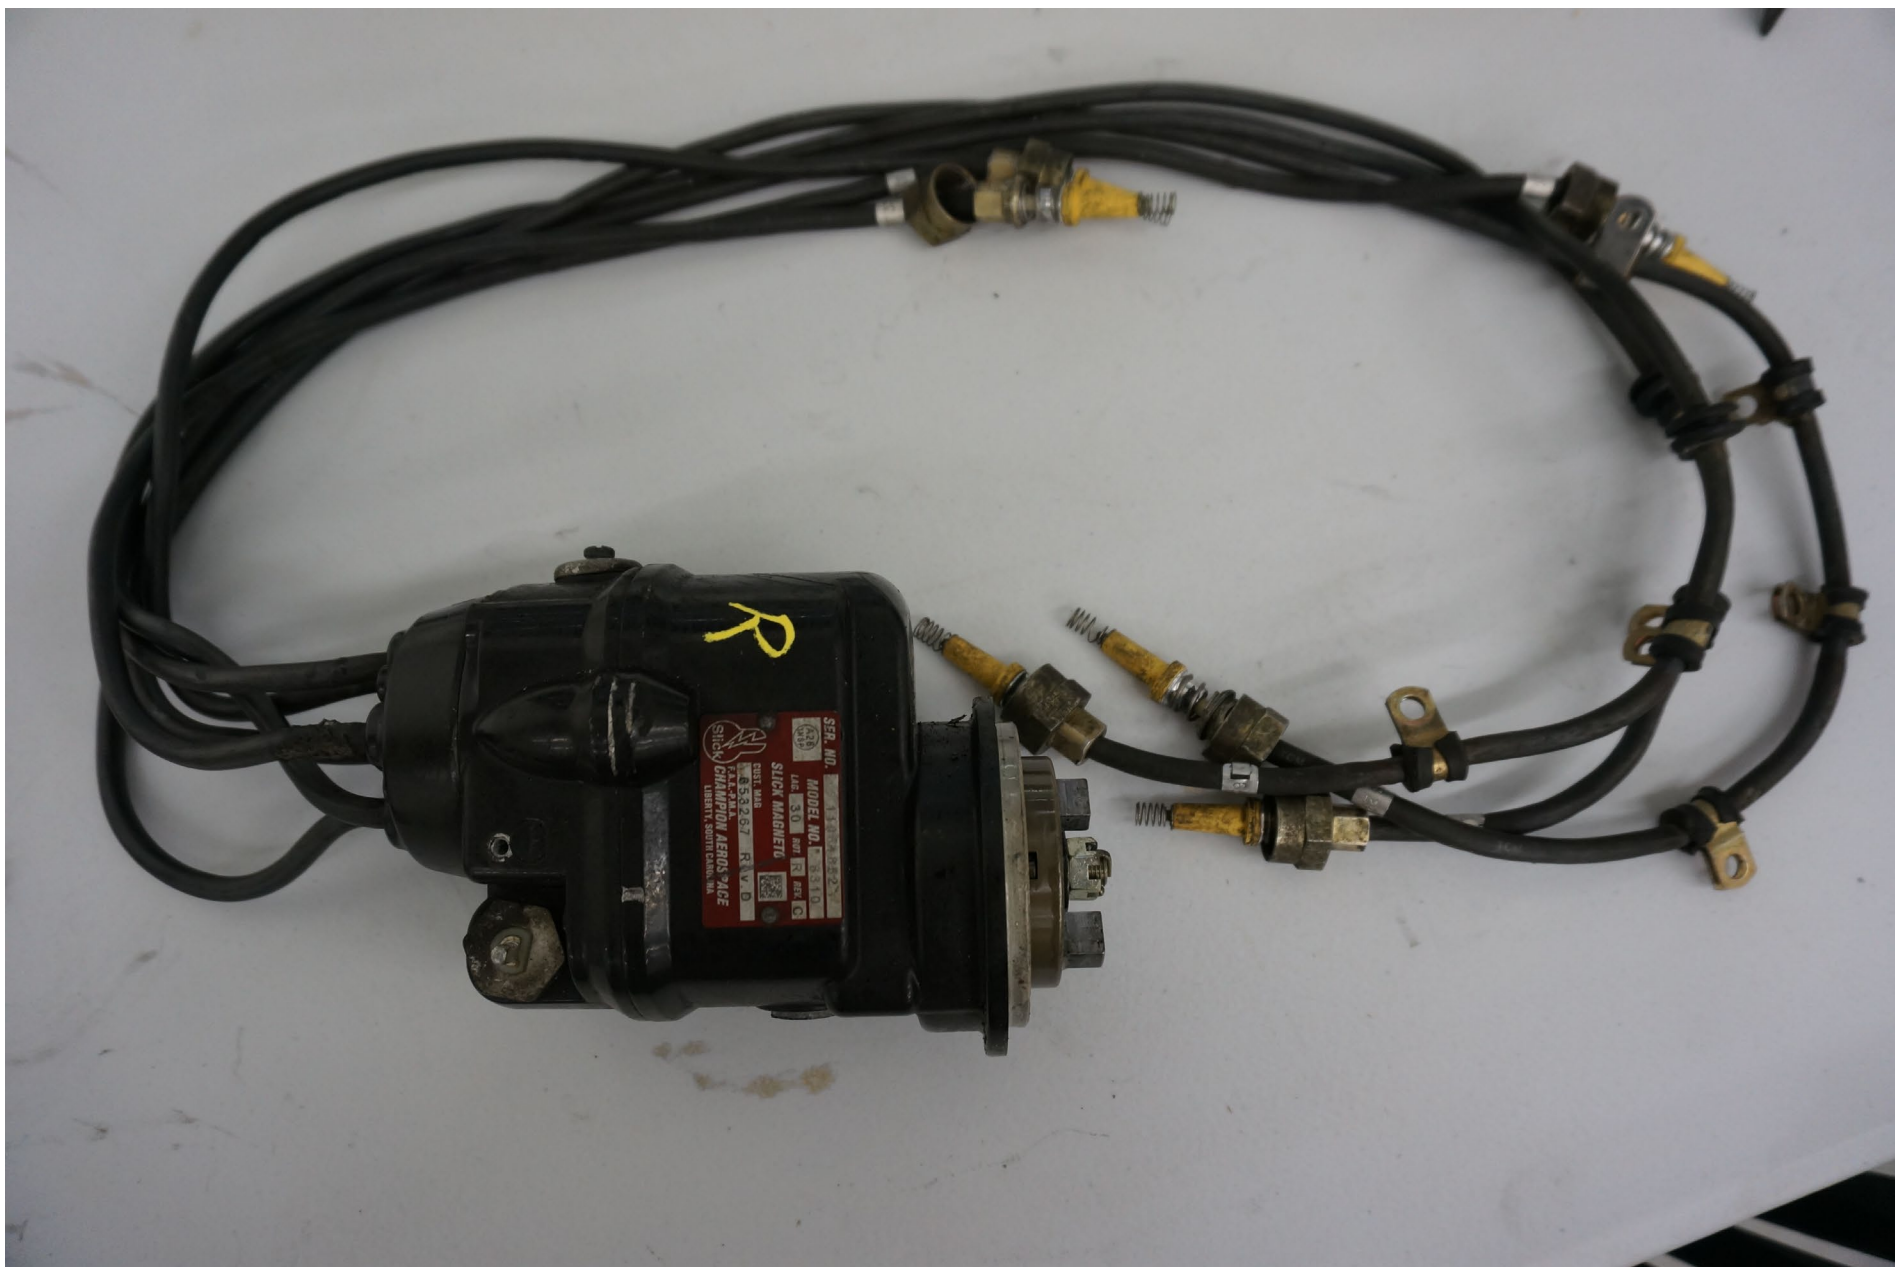
Photo 17 – Right Magneto and Ignition Harness

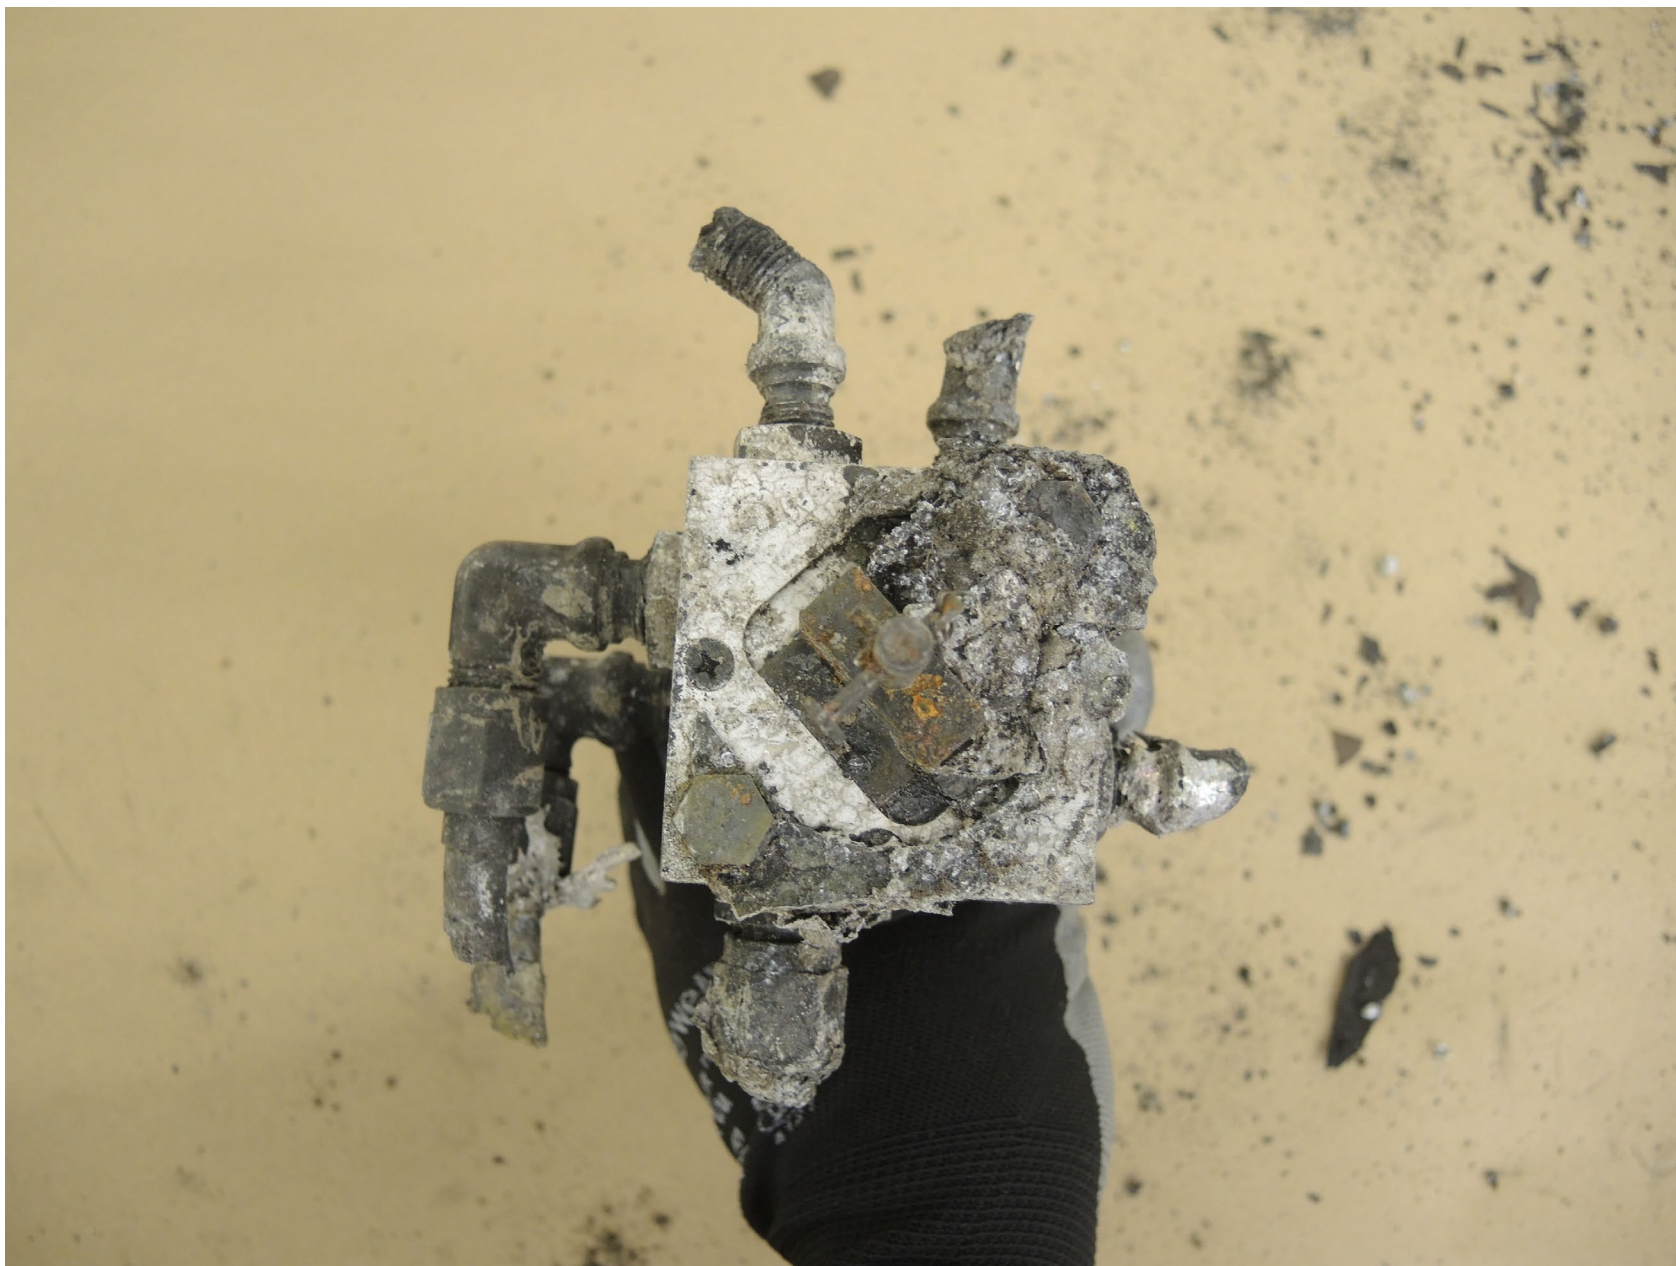
**Photo 18 – Fuel Selector Valve – Courtesy of Textron Aviation**
