**From:** [REDACTED]  
**Sent:** Tuesday, March 21, 2017 4:42 PM  
**To:** Gretz Robert  
**Cc:** [REDACTED]  
**Subject:** Re: Actuator Teardown

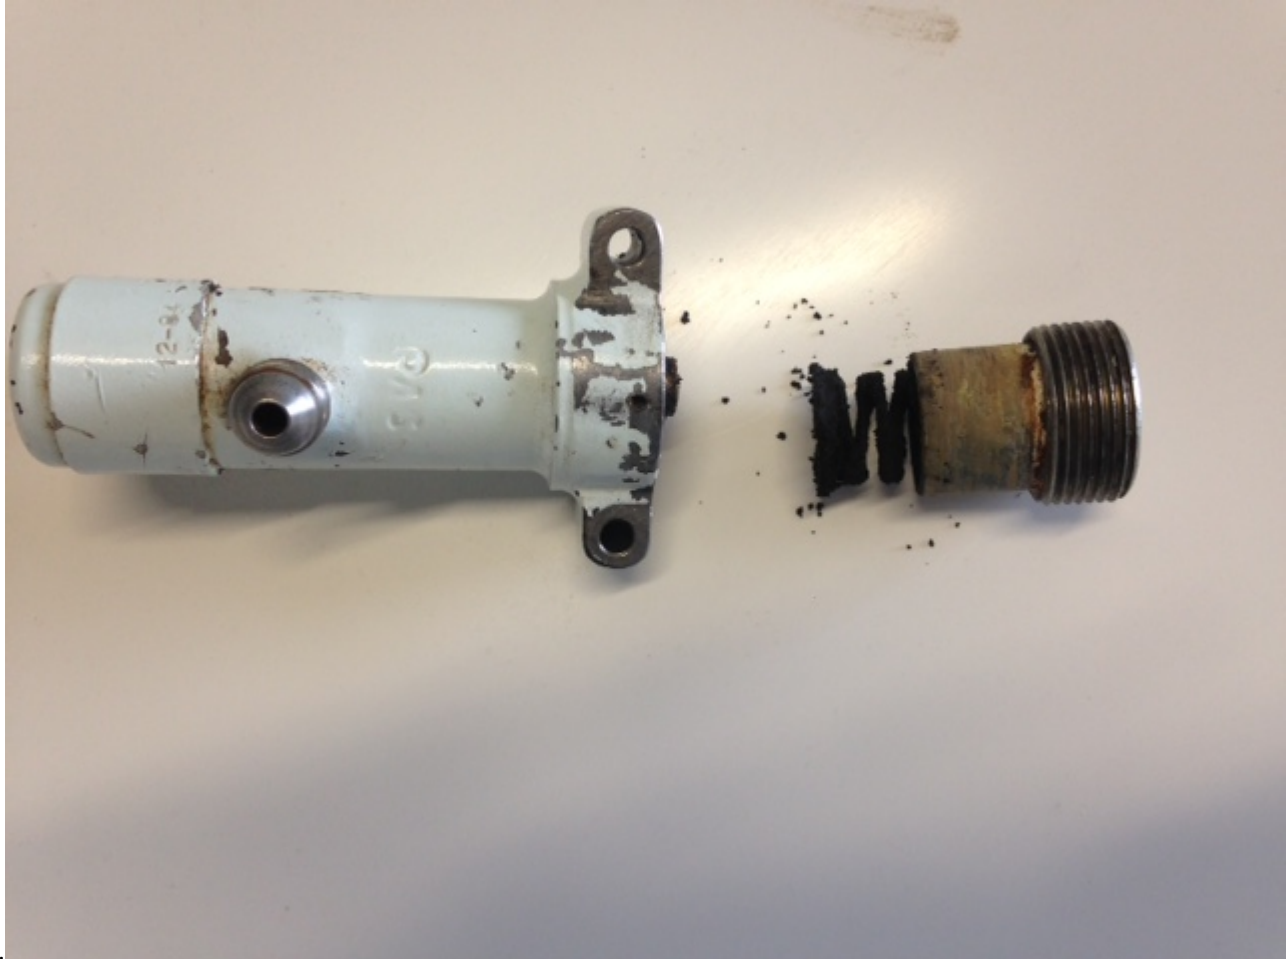
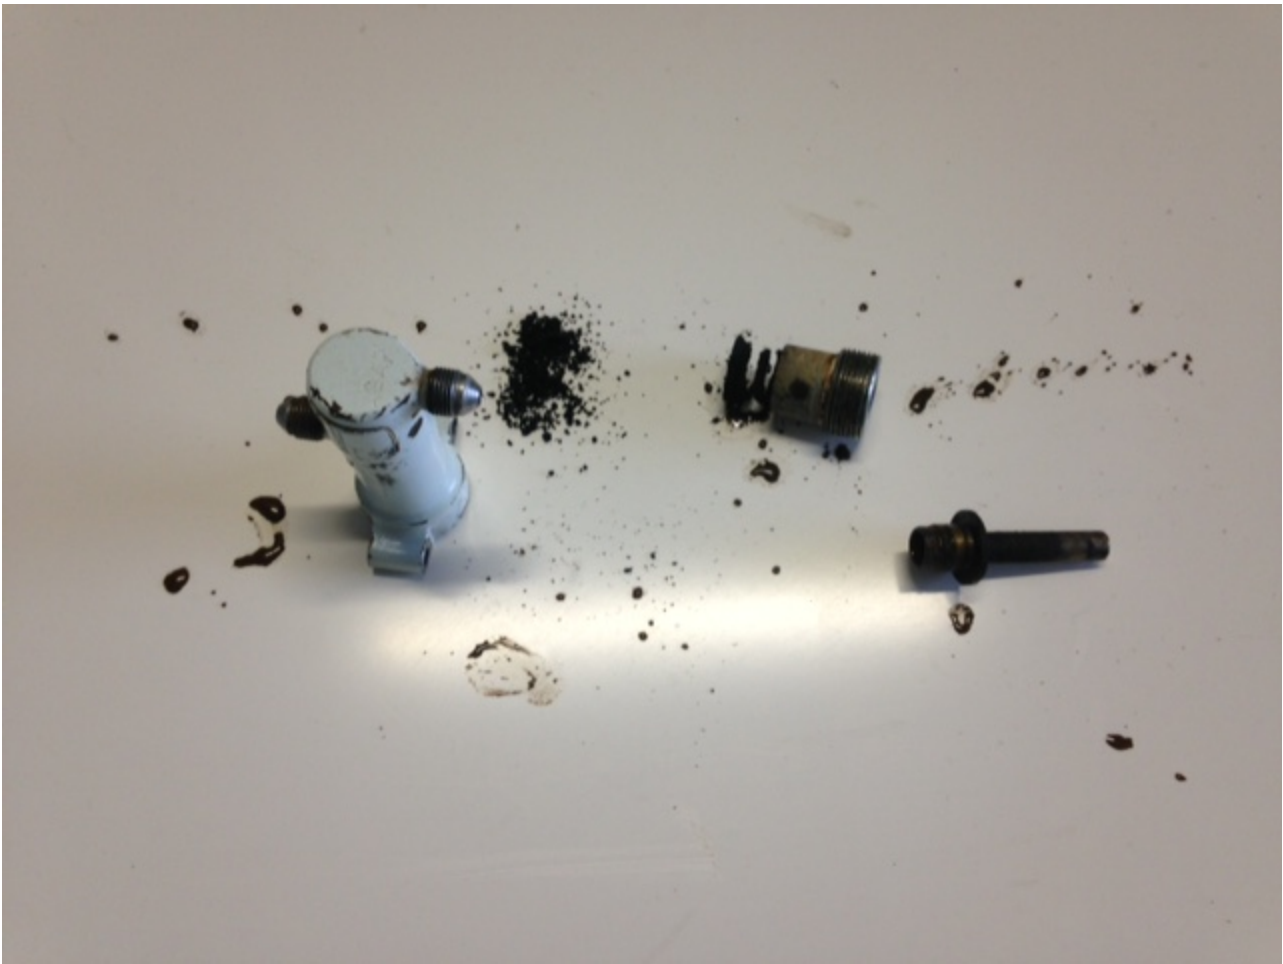
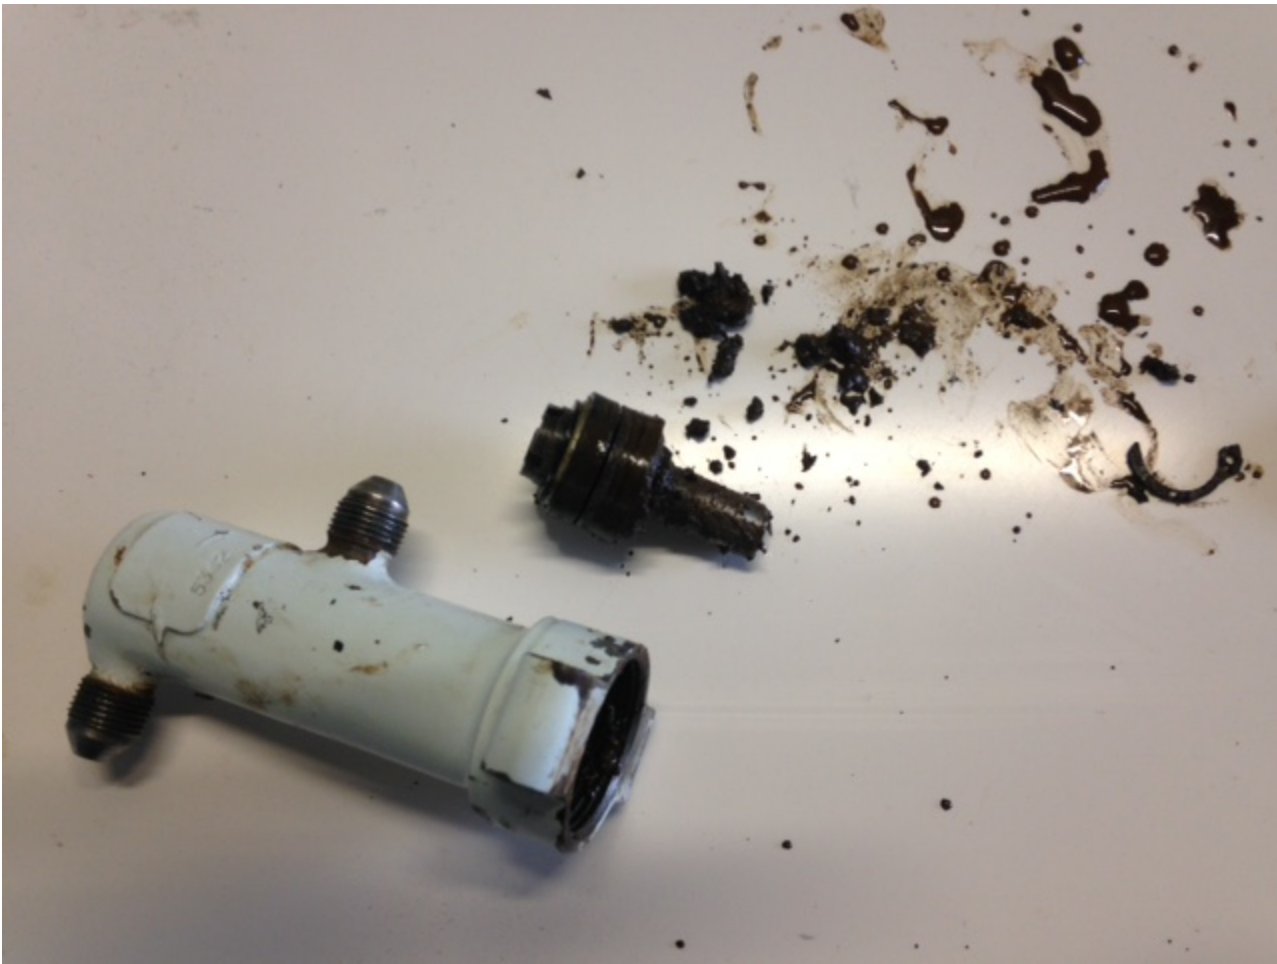
I found that moisture had been able to enter one side of the actuator. The actuator was full of rust that would've caused the actuator to not function properly. Please see the attached

pictures.

We are going to tear down and inspect the actuators on the other gear. We are also going to begin taking these units apart every 2 to 3 years to inspect for wear and rust. We also have a dryer system that we will be installing on the compressor/air system of this aircraft to keep moisture from getting into the lines.
