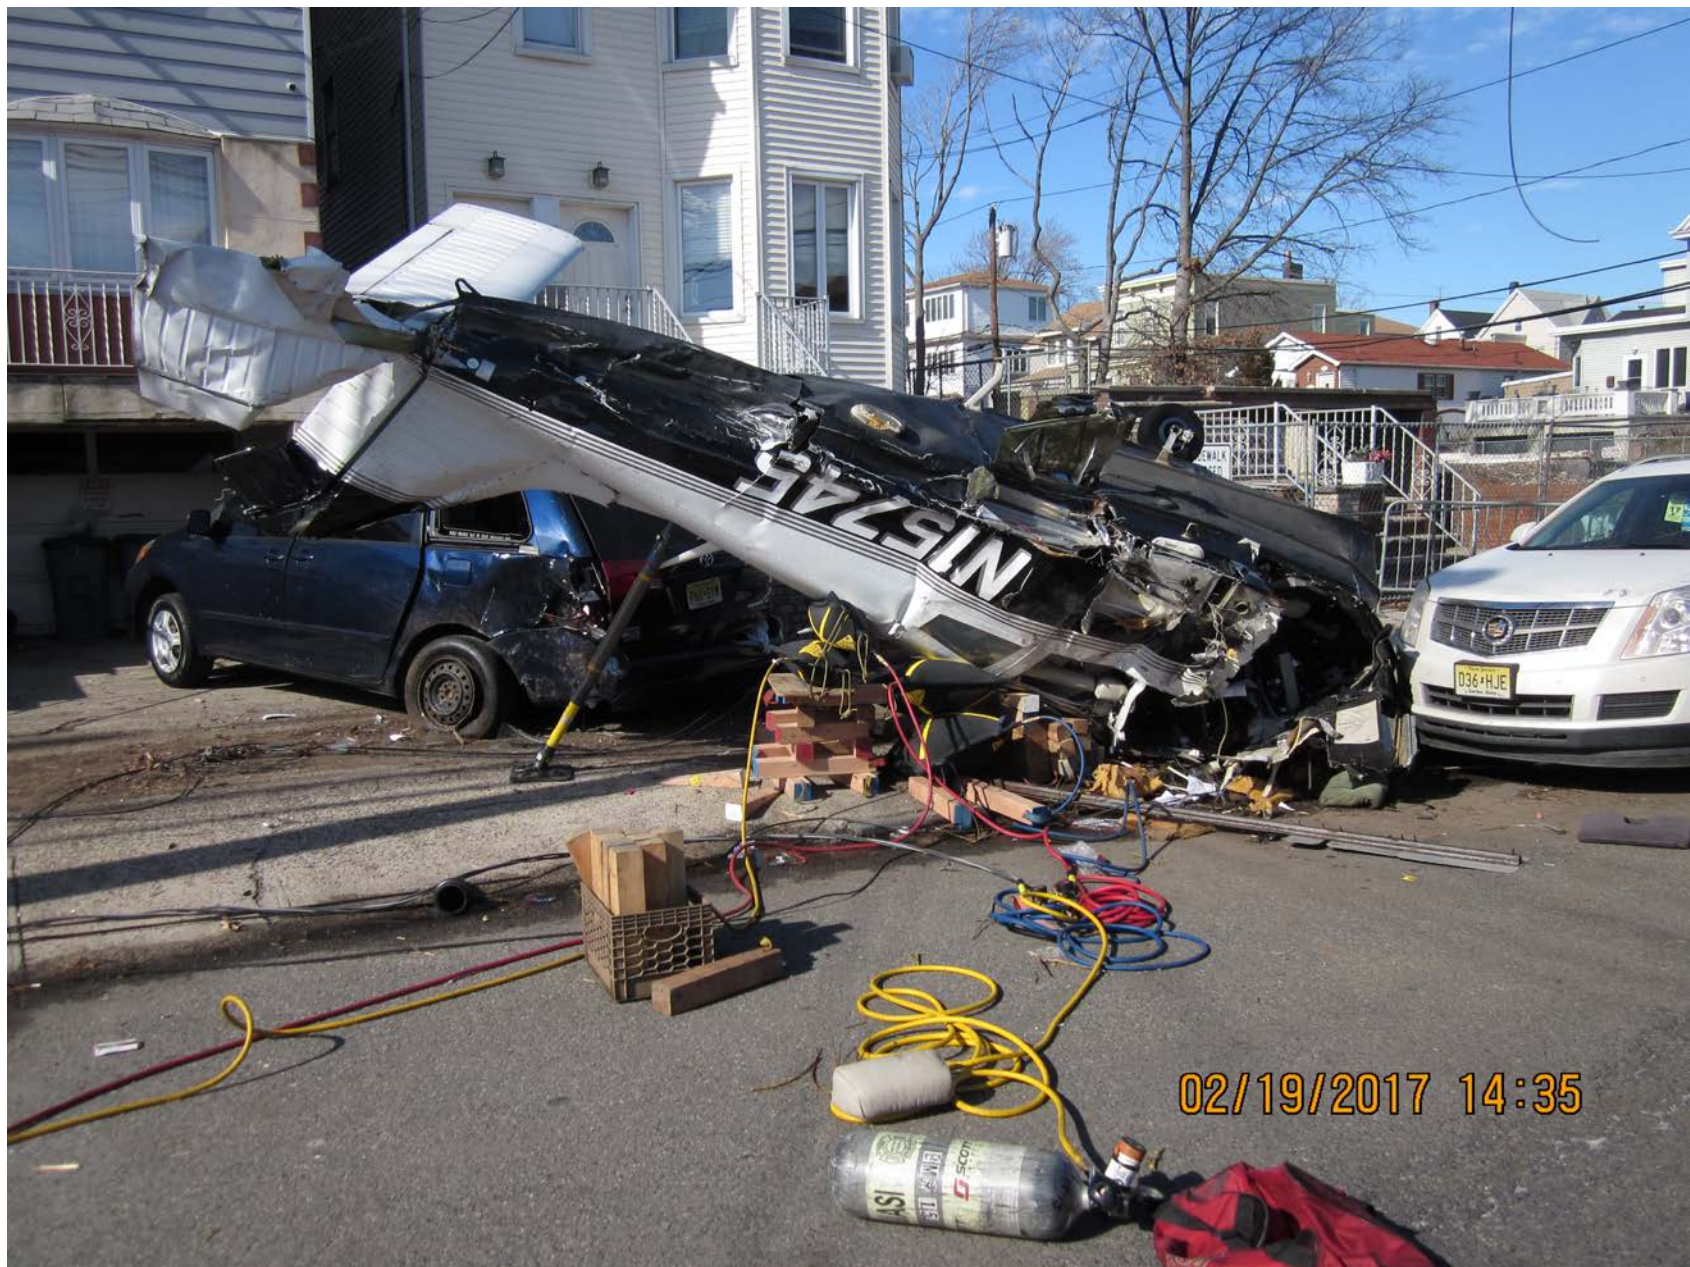
**Photo 1 – Airplane Wreckage inverted at Accident Site (FAA)**

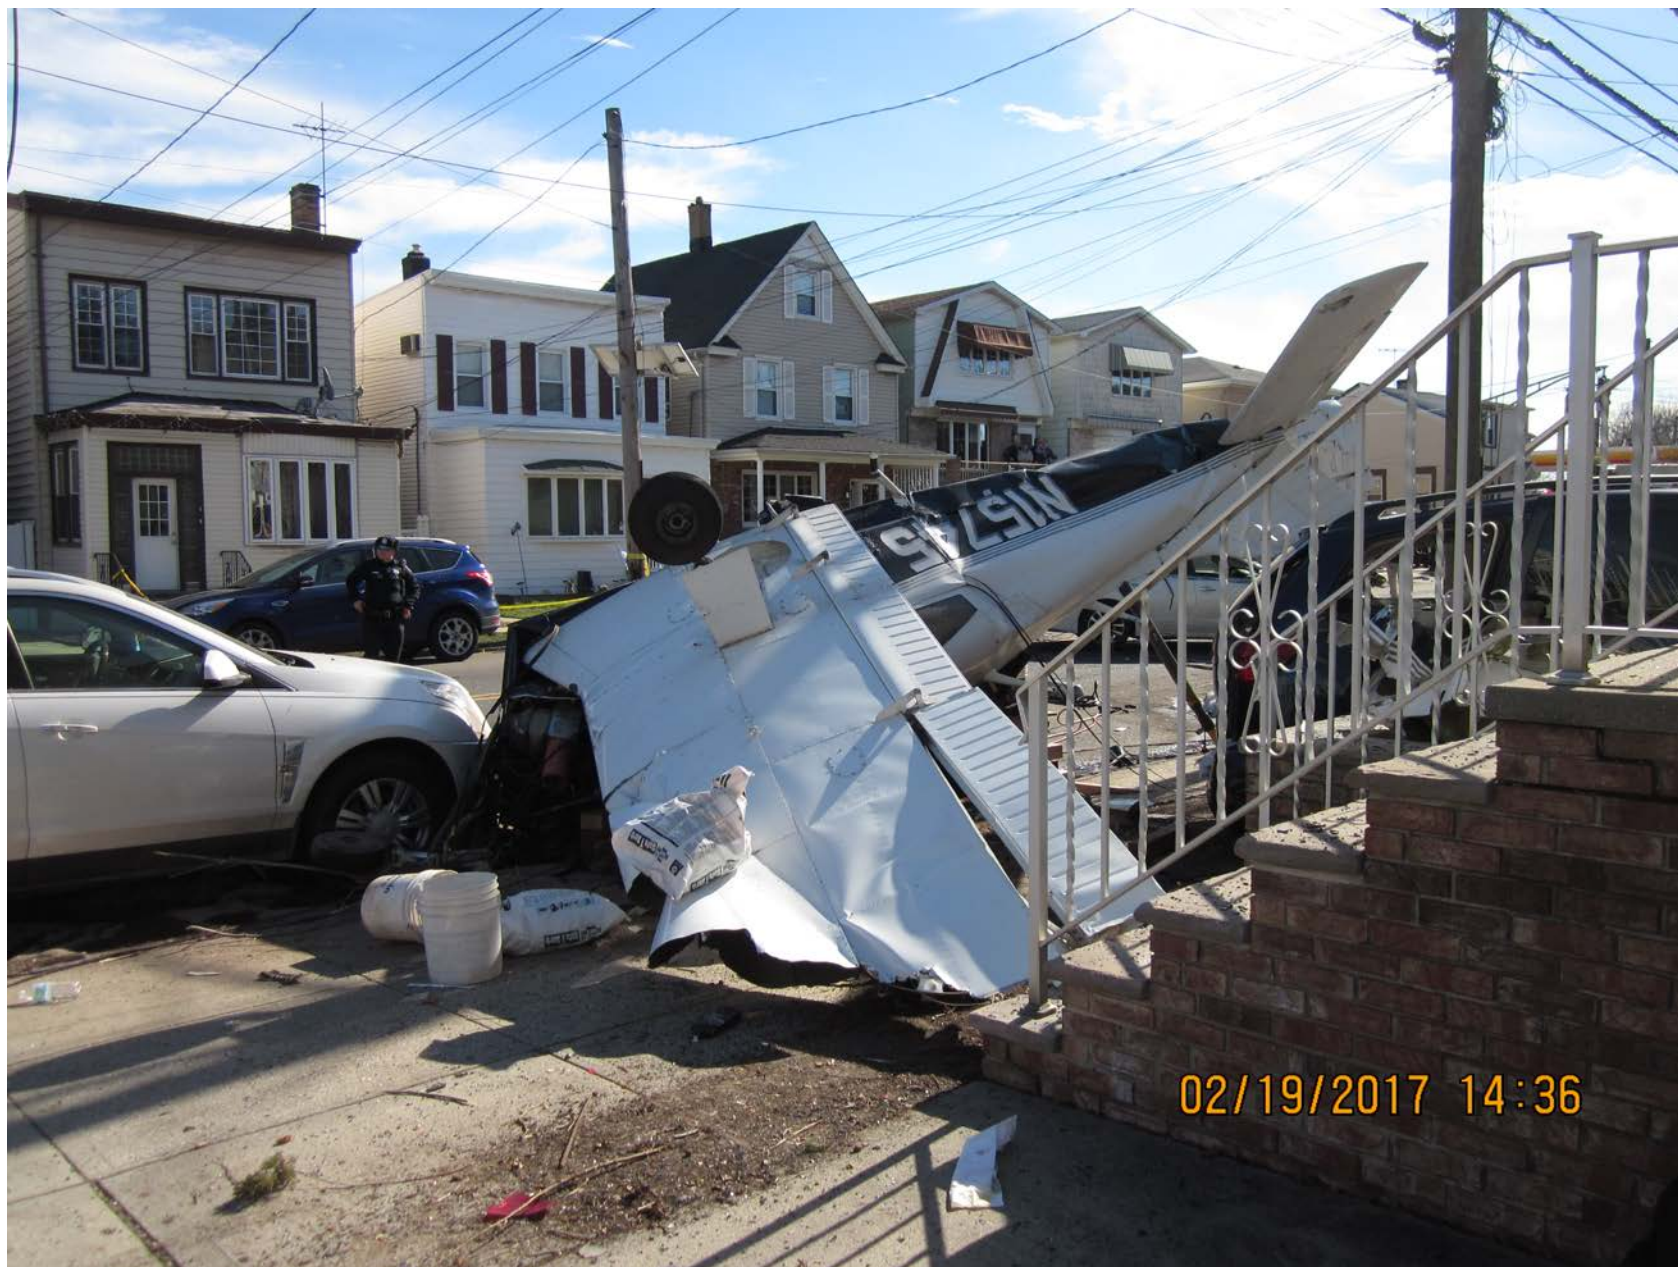
**Photo 2 – Airplane Wreckage inverted at Accident Site (FAA)**

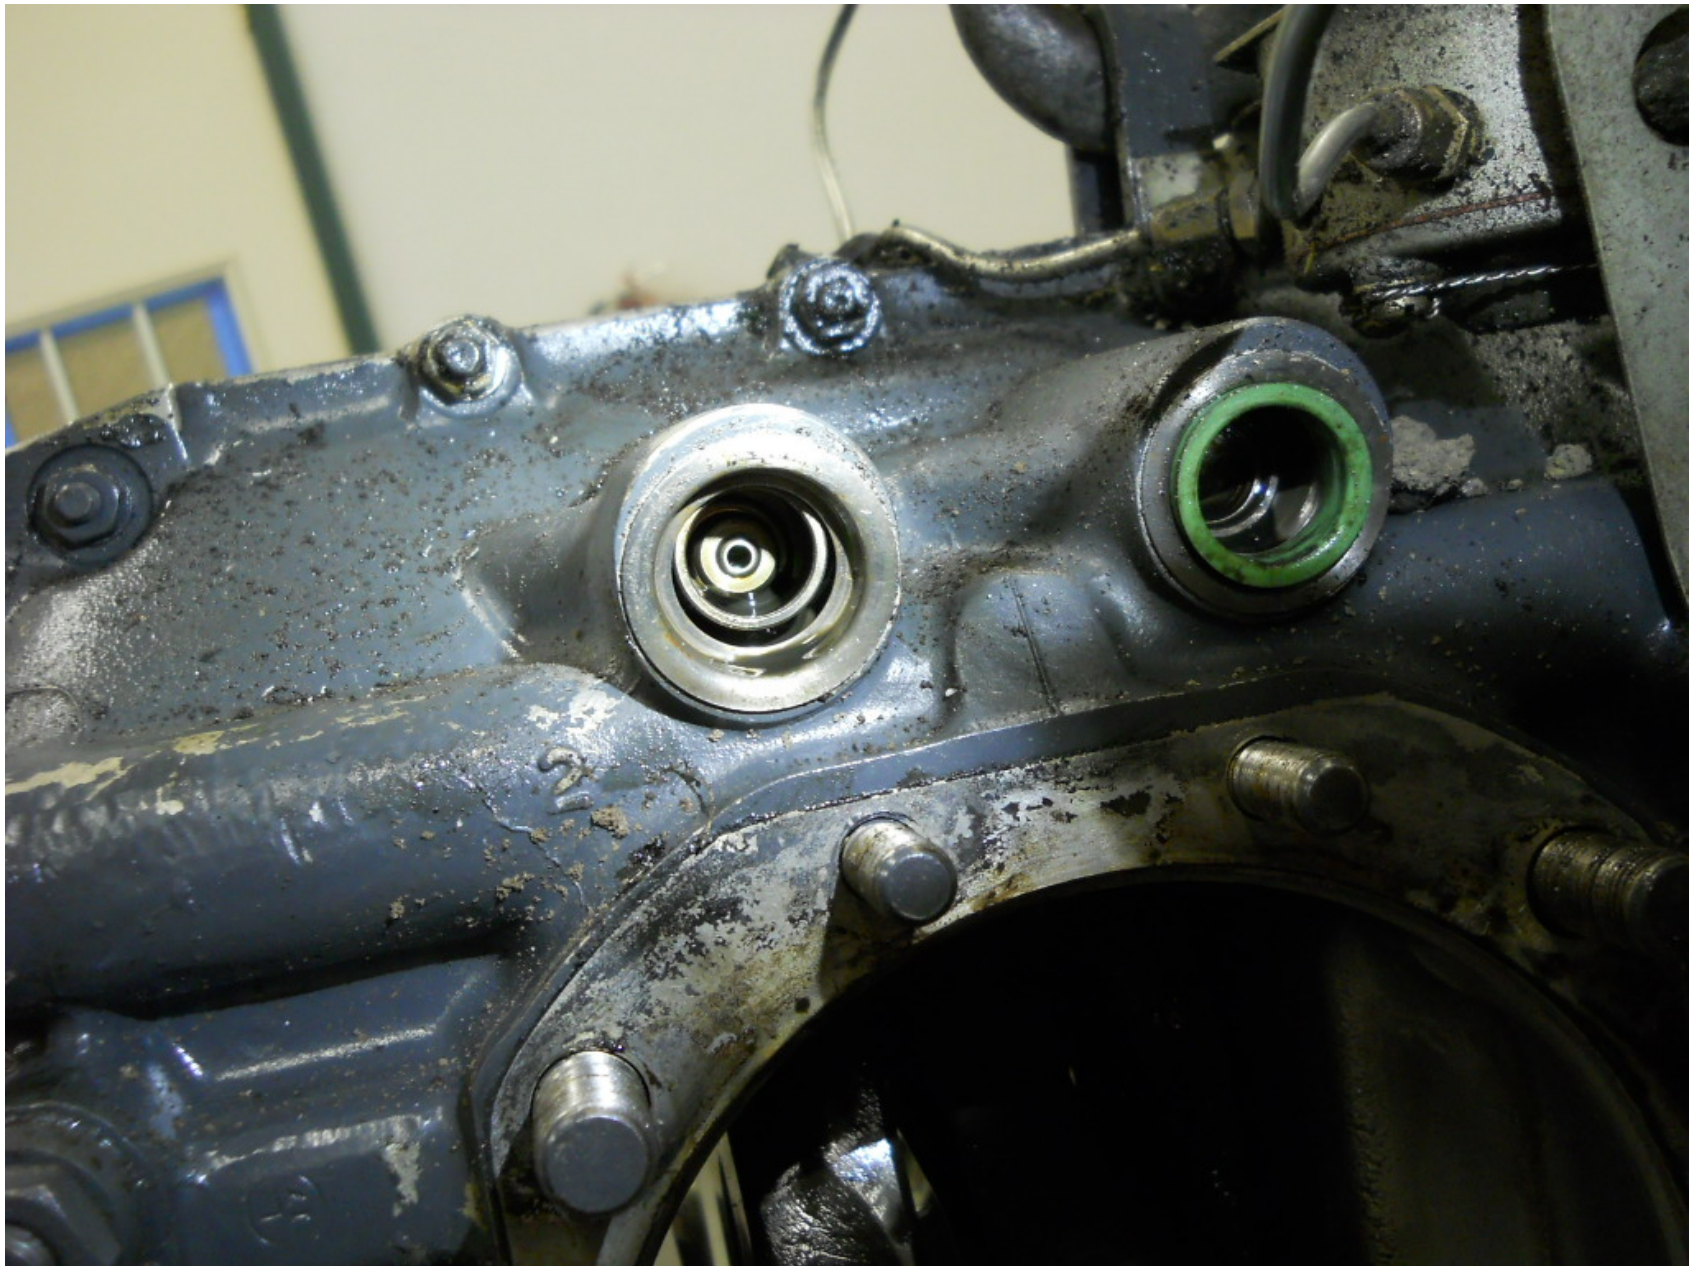
**Photo 3 - #2 Cylinder with View of Improperly Installed Tappet (NTSB)**
