# NATIONAL TRANSPORTATION SAFETY BOARD

## MATERIALS LABORATORY FACTUAL REPORT

Report No. 17-042

Place : Bayonne, New Jersey  
Date : February 19, 2017  
Vehicle : Piper PA-28R-200  
NTSB No. : ERA17LA110  
Investigator : Leah Read, AS-ERA

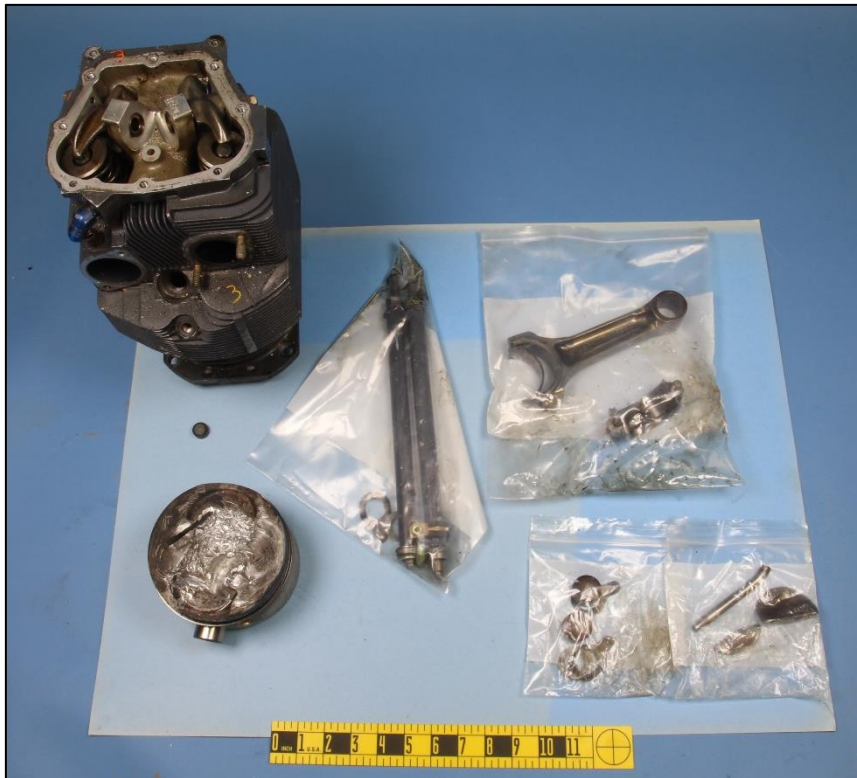
An overall view of the submitted number 3 cylinder assembly is shown in figure 1. The intake valve was fractured in the stem in two places and through the head in one place. The interior of the cylinder and the piston dome were battered consistent with impacts from the fractured intake valve. The connecting rod was intact, but the bearings were worn through both the Babbitt and copper layers.

Figure 1. Overall view of the submitted number 3 cylinder assembly components.

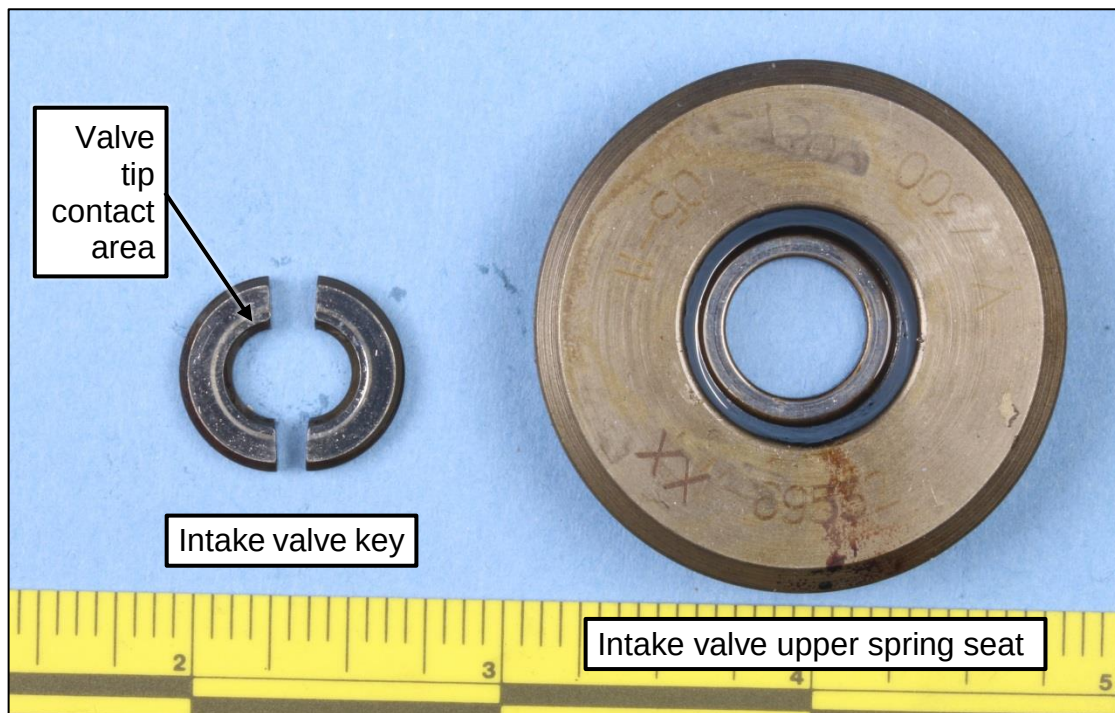
An overall view of the outboard faces of the intake valve key and upper spring seat are shown in figure 2. As installed, the underside of the intake valve tip contacted the intake valve key on the outboard surface near the inner diameter as indicated in figure 2. The valve tip contact area on the valve key was worn into a concave shape consistent with wear from contact with the intake valve tip.

Figure 2. View of the outboard faces of the intake valve key and upper spring seat.

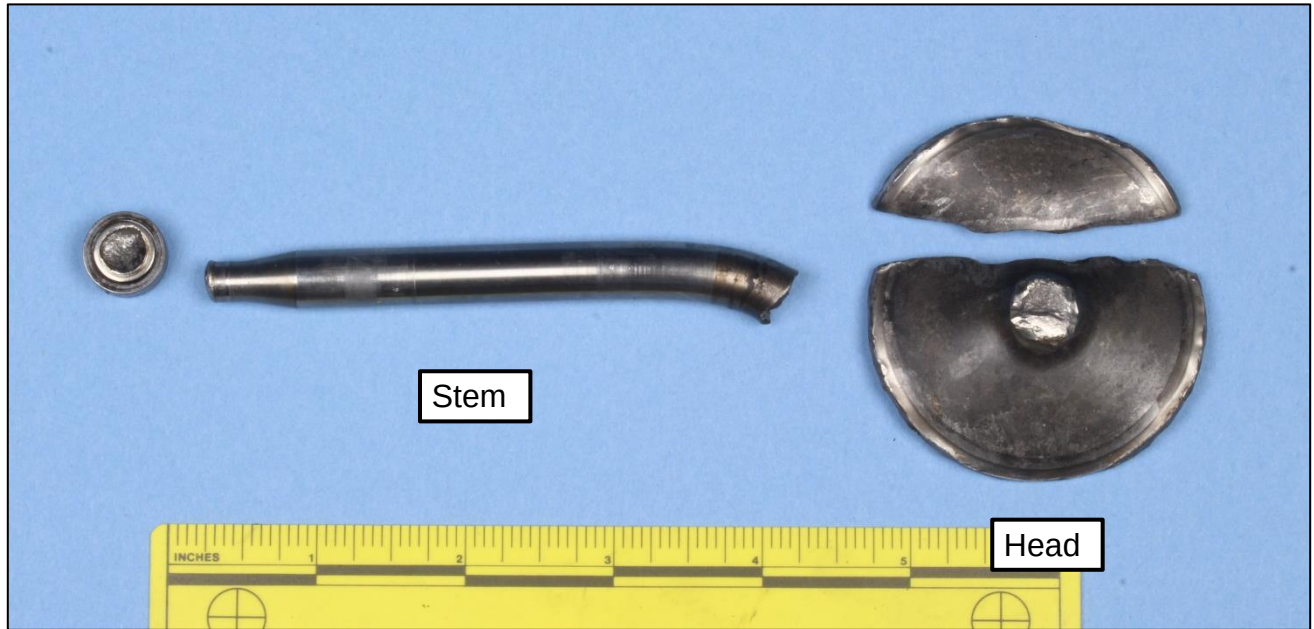
An overall view of the fractured intake valve is shown in figure 3. The head was fractured from the stem, and the head end of the stem was bent. The fracture features associated with the fracture at the head end of the stem were rough and matte gray, consistent with overstress fracture. The head was also fractured across a chord adjacent to the stem. The fracture surface of the head was rough matte gray appearance, and the adjacent areas showed deformation, features consistent with overstress fracture.

Figure 3. Overall view of the intake valve.

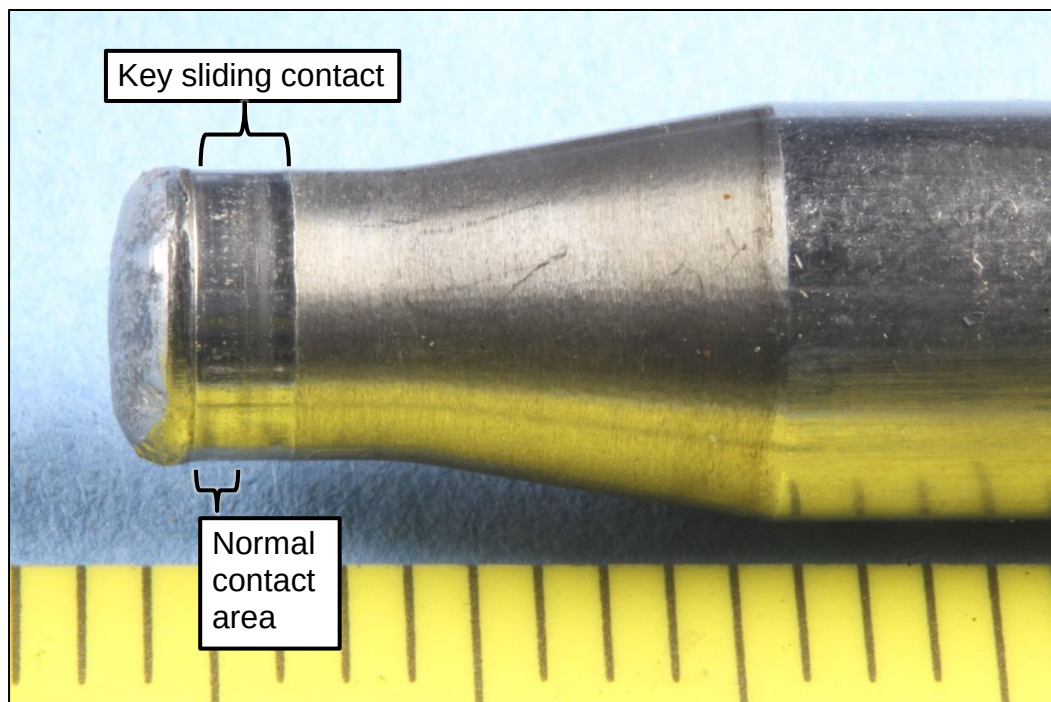
A closer view of the tip end of the intake valve stem is shown in figure 4. The stem showed rub marks consistent with sliding contact between the stem and the key in the area indicated in figure 4. The area of sliding contact was larger than the normal contact area also indicated in figure 4.

Figure 4. View of the tip end of the intake valve stem showing the area corresponding to sliding contact with the valve stem key.

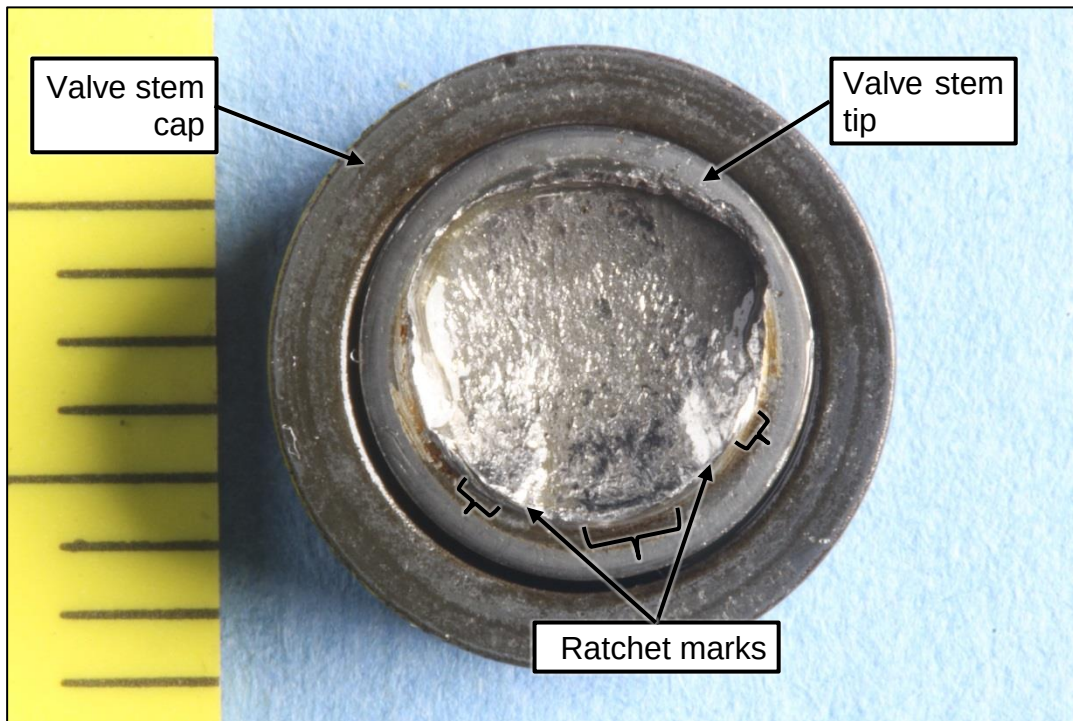
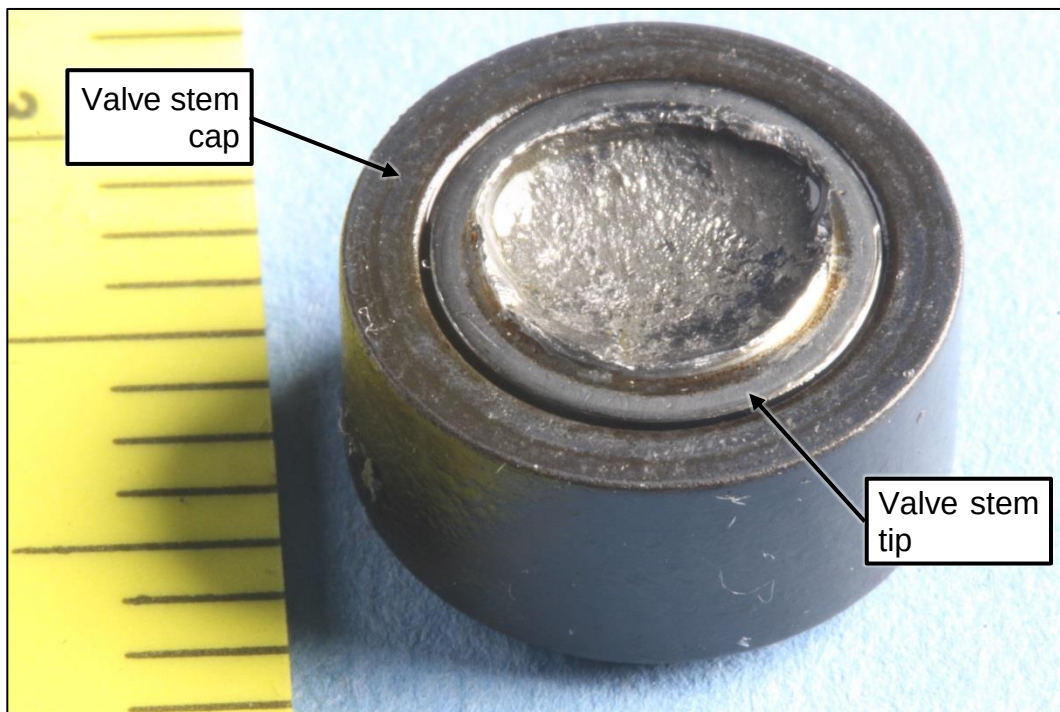
Views of the fracture surface on the intake valve stem tip are shown in figure 5. The fracture initiated at the fillet radius between the valve stem tip and the key area of the valve stem shaft. Fracture features were rubbed consistent with fracture surface recontact. However, radial features consistent with ratchet marks<sup>1</sup> were observed at one side of the fracture as indicated in the upper image in figure 5, features consistent with fatigue fracture with multiple origins. Brackets in the upper image in figure 5 indicate approximate fatigue origin areas. The fracture surface had a concave shape consistent with fatigue fracture from the fillet area associated with a change in diameter of a shaft.

Figure 5. Views of the fracture surface on the tip end of the intake valve stem.
