## VEMD READ-OUT & ANALYSIS REPORT

**Report EAI n°:** EAI 51\_2017  
**Date of examination:** 03/05/2017, Marignane, FRANCE  
**Attendees :** BEA representatives, Airbus Helicopters representatives

**Type of helicopter:** AS350 B3  
**S/N and registration:** SN3228 / N413LP  
**Customer:** HELICORP INC  
**Date of the accident:** 21/02/2017, San Juan, Puerto Rico, USA

**Designation:** VEMD mounted and powered on Airbus Helicopters test bench

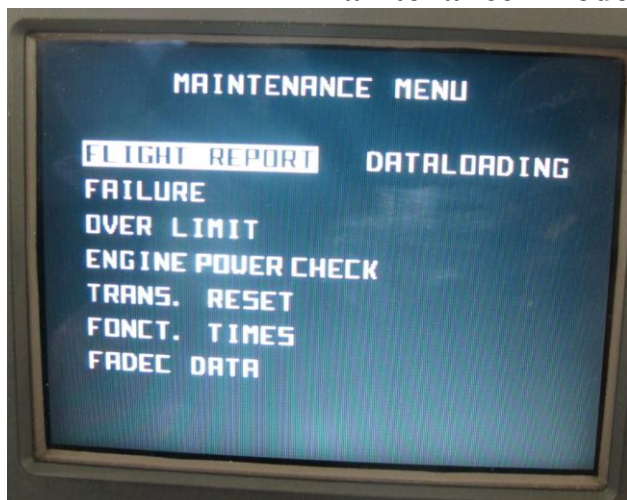
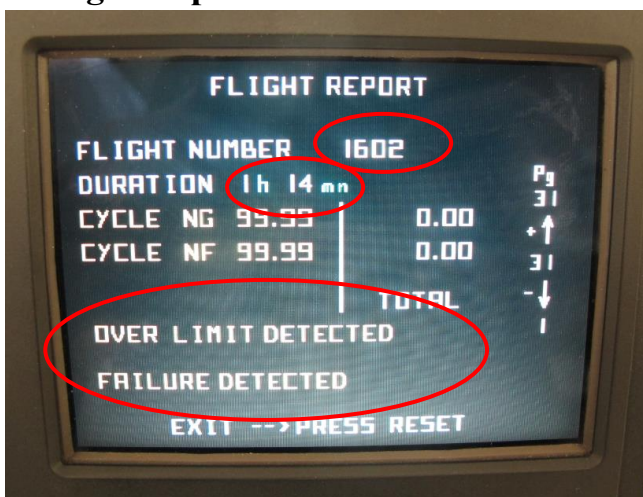
#### “Maintenance” mode – “Flight Report” submode

For the last flight recorded #1602 which was the accident flight, the flight duration was equal to 1h14min, over-limits and failures have been detected.

Due to the application of the closure process, the cycles were no longer correct as the test bench cannot replicate them.

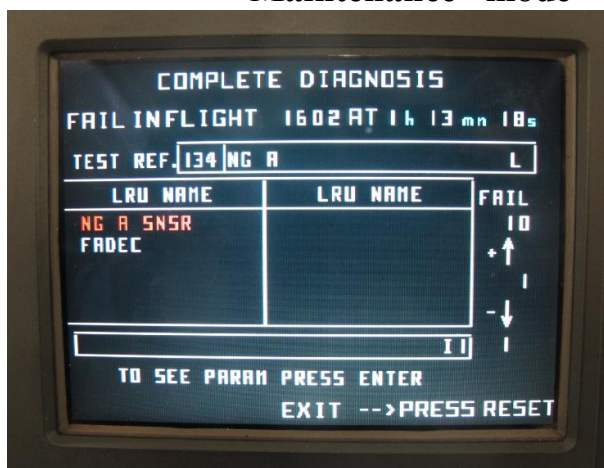
## “Maintenance” mode – “Failure” submode – Failure 1/10

**Failure 1/10 Test Ref 134: NG A**

This failure concerns the NG A failure: gas generator rotation speed validity.

It appeared on the left channel (L).

It was intermittent (I) at the flight duration of 1h13min18s for a total flight duration of 1h14min.

The associated parameters showed gas generator rotation speed 98.7%NG, Torque 75.3%TQ, Temperature 748°C T4 and free turbine rotation speed 513rpm (eq. NR).

Label 351 – FAIL2\_FADEC = 0080      Bit21 => NG A failure (Alternator)

Label 353 – LOG1\_OUT = 5204      Bit16 => Self-test ended  
                                          Bit23 => Control mode = Flight  
                                          Bit26 => Bleed valve closed  
                                          Bit28 => Proportional mode

Label 354 – LOG2\_OUT = 4020      Bit19 => Degraded operation  
                                          Bit28 => Mixed mode

When this NG A failure was recorded, the FADEC self-test were ended and the governing state was in flight.

The mixed mode corresponds to an intermediate mode: the fuel metering unit is out of the neutral position (eq. to the twist grip out of flight notch) and engine governing is still ensured by the stepper motor until it reaches its stops.

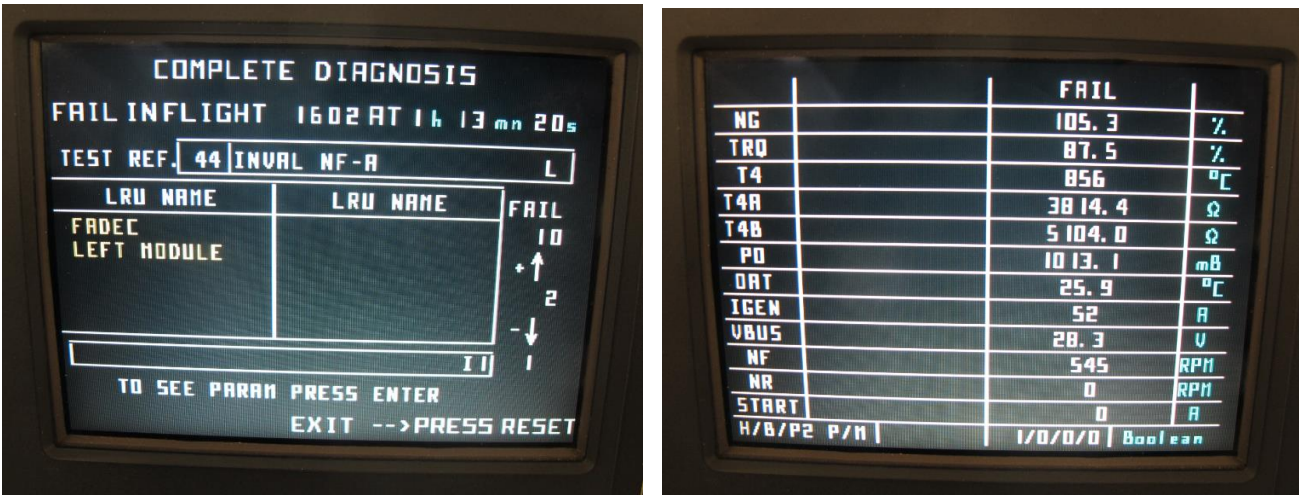
“Maintenance” mode – “Failure” submode – Failure 2/10

**Failure code 44: INVALID NF-A**

This failure concerns the free turbine rotation speed sensor A validity.

It appeared on the left channel (L).

It was intermittent (I) at the flight duration of 1h13min20s (2s after the first failure) for a total flight duration of 1h14min.

The associated parameters showed gas generator rotation speed 105.3%NG, Torque 87.5%TQ, Temperature 856°C T4 and free turbine rotation speed 545rpm (eq. NR).

The NR acquisition seems to be invalidated (value=0).

This INVALID NF-A failure is due to the free turbine overspeed which reached 545rpm (eq. NR) equivalent to approximately 140% of the nominal free turbine speed.

The gas generator rotation speed is recorded to a very high value of 105.3%NG.

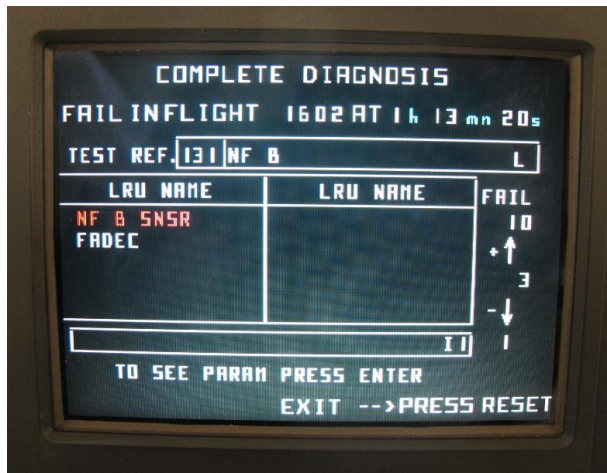
## “Maintenance” mode – “Failure” submode – Failure 3/10

**Failure code 131: NF-B**

This failure concerns the free turbine rotation speed sensor B validity.

It appeared on the left channel (L).

It was intermittent (I) at the flight duration of 1h13min20s for a total flight duration of 1h14min.

The associated parameters showed gas generator rotation speed 105.4%NG, Torque 87.8%TQ, Temperature 861°C T4 and free turbine rotation speed 545rpm (eq. NR).

Bit19 => Degraded operation  
 Bit20 => Failure without effect on control  
 Bit28 => Mixed mode

The NF-B failure is sent by the FADEC, however there are no FAIL 1 or 2 codes recorded declaring this failure. Moreover, the initial failure NG-A (failure 1) has disappeared while this is a non-reversible message.

The NF value 545rpm (eq. NR) seems to be the last valid NF value sent by the FADEC.

The loss of NF-B triggers the Bit 20 (failure without effect on control) which is consistent with a redundancy failure.

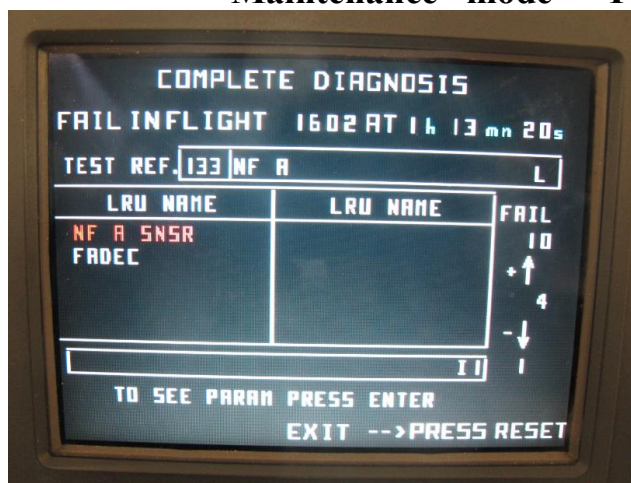
## “Maintenance” mode – “Failure” submode – Failure 4/10

**Failure code 133: NF-A**

This failure concerns the free turbine rotation speed sensor A validity.

It appeared on the left channel (L).

It was intermittent (I) at the flight duration of 1h13min20s for a total flight duration of 1h14min.

The associated parameters showed gas generator rotation speed 105.5%NG, Torque 87.8%TQ, Temperature 863°C T4 and free turbine rotation speed 545rpm (eq. NR).

Bit19 => Degraded operation  
 Bit20 => Failure without effect on control  
 Bit28 => Mixed mode

As for failure 3/10, the NF-A failure is sent by the FADEC, however there are no FAIL 1 or 2 codes recorded declaring this failure.

The NF value 545rpm (eq. NR) seems to be the last valid NF value sent by the FADEC.

The loss of NF-B triggers the Bit 20 (failure without effect on control) which is not consistent with a dual failure (NF-A and NF-B). A total control failure should have been triggered (the total failure is triggered on block 6/10 one second later).

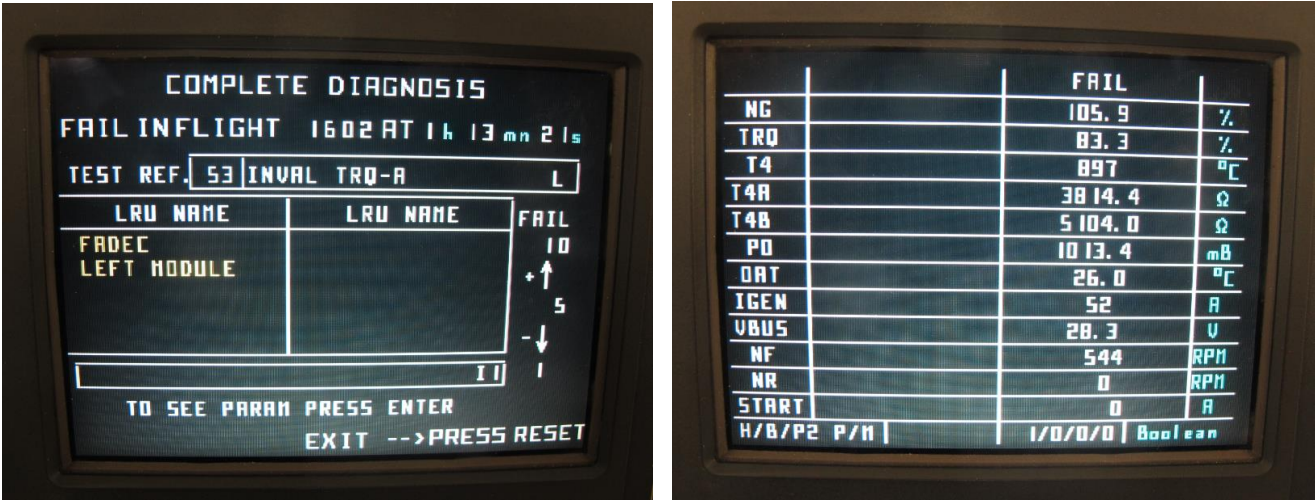
“Maintenance” mode – “Failure” submode – Failure 5/10

**Failure code 53: INVALID TRQ-A**

This failure concerns the torque sensor validity.  
It appeared on the left channel (L).  
It was intermittent (I) at the flight duration of 1h13min21s (3s after the first failure and 1s after the previous one) for a total flight duration of 1h14min.

The associated parameters showed gas generator rotation speed 105.9%NG, Torque 83.3%TQ, Temperature 897°C T4 and free turbine rotation speed 544rpm (eq. NR).  
The NR acquisition seems to be invalidated (value=0).

The torque acquisition seems to be invalid (raw value + conformation).

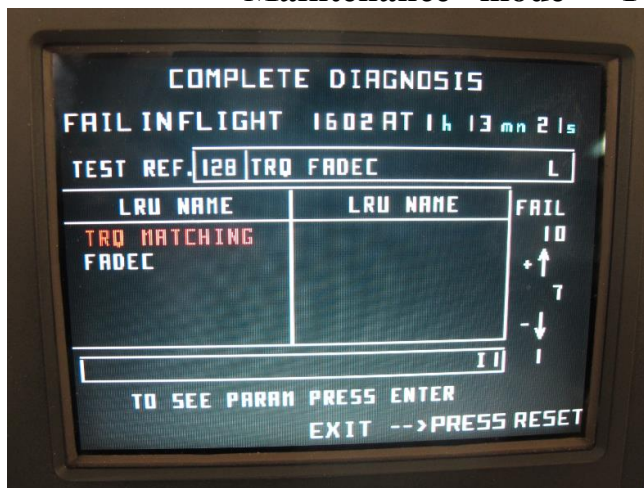
## “Maintenance” mode – “Failure” submode – Failure 7/10

**Failure code 128: TRQ FADEC**

This failure concerns the torque conformation validity.

It appeared on the left channel (L).

It was intermittent (I) at the flight duration of 1h13min21s for a total flight duration of 1h14min.

The associated parameters showed gas generator rotation speed 105.6%NG, Torque 55.7%TQ, Temperature 900°C T4 and free turbine rotation speed 544rpm (eq. NR).

Bit22 => Raw torque failure

Bit26 => Torque conformation failure after power

Bit23 => Total failure

Bit28 => Mixed mode

As for the failure 6/10, the torque acquisition seems to be invalid (raw value + conformation).

This failure is raised if the FADEC does not receive at least one input from the selector.

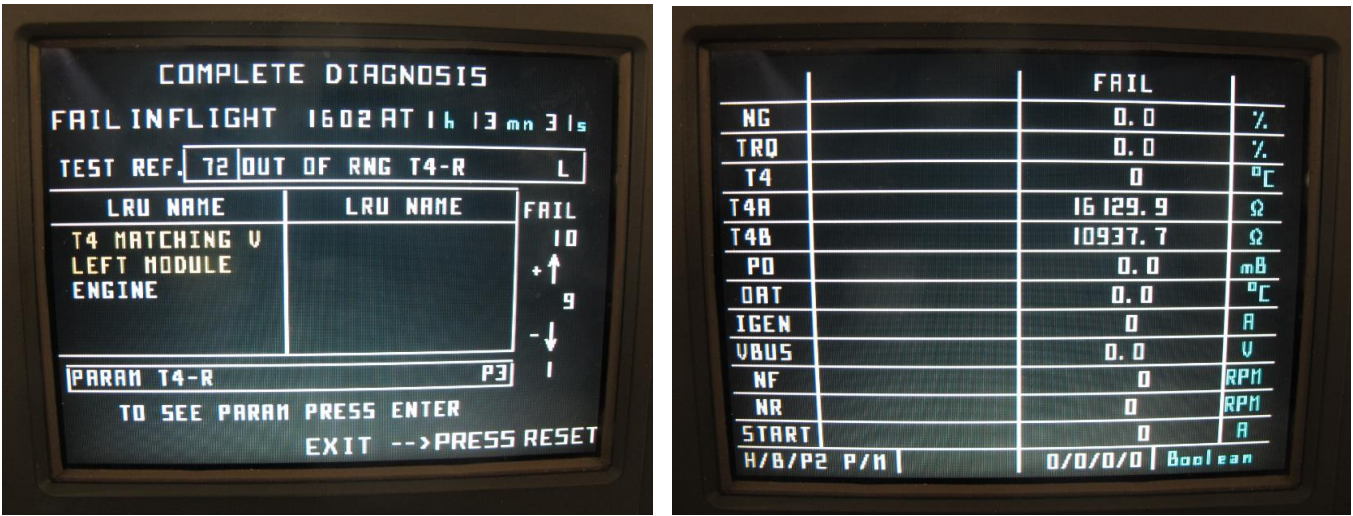
“Maintenance” mode – “Failure” submode – Failure 9/10

**Failure code 72: OUT OF RNG T4-R**

This failure concerns the T4 validity.  
It appeared on the left channel (L).  
It was intermittent (I) at the flight duration of 1h13min31s for a total flight duration of 1h14min.

Despite T4-A and T4-B, whole parameters recorded are null.  
T4-A and T4-B represent the resistivity of the thermocouple lines.  
This failure is most probably due to the aircraft power on without the FADEC installed: not relevant for the event understanding.

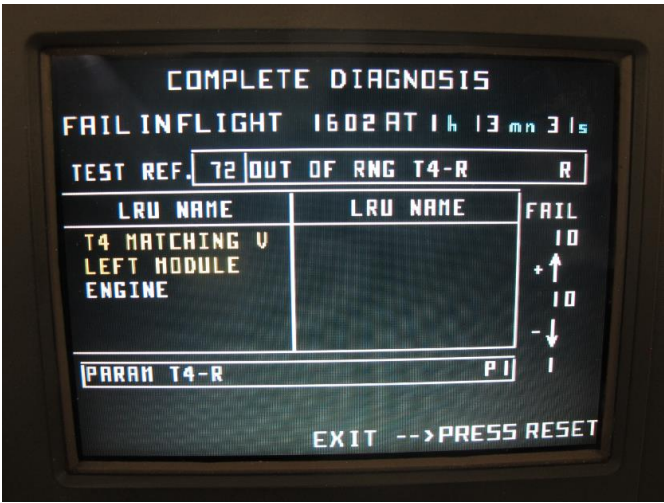
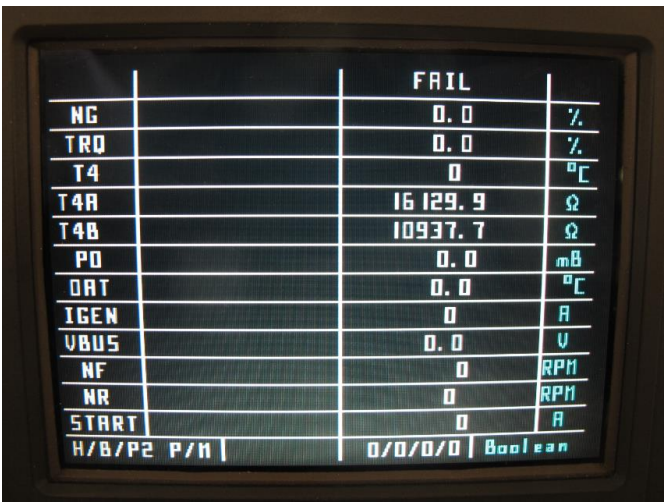
“Maintenance” mode – “Failure” submode – Failure 9/10

**Failure code 72: OUT OF RNG T4-R**

This failure concerns the T4 validity.  
It appeared on the left channel (R).  
It was intermittent (I) at the flight duration of 1h13min31s for a total flight duration of 1h14min.

Despite T4-A and T4-B, whole parameters recorded are null.  
As for the failure 9, this failure is not relevant for the event understanding.

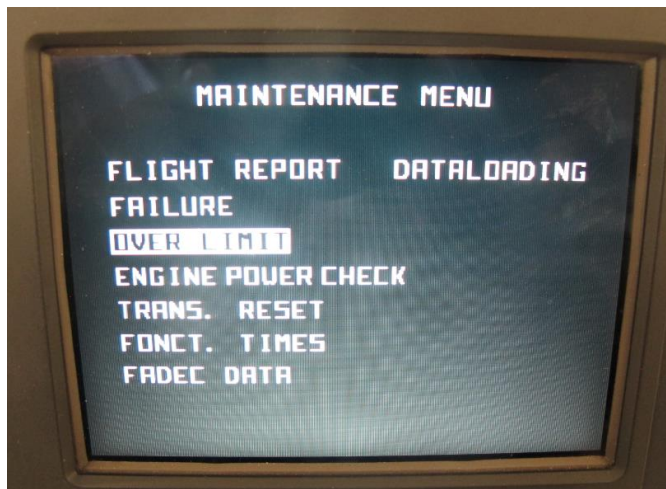
#### “Maintenance” mode – “Over Limit” submode

One over-limit appeared for the combustion chamber temperature with a maximum value reached during the flight phase of 987°C T4. The associated duration of 9s means corresponds to the time during which the T4 value exceeded 941°C.

A second over-limit appeared for the gas generator rotation speed with a maximum recorded value of 106.1% NG. The associated duration of 11s corresponds to the time during which the NG value exceeded 102.3%.

A third over-limit appeared for the free turbine rotation speed with a maximum recorded value of 543rpm NR. The associated duration of 4s corresponds to the time during which the NF value has been comprised between 120% and 150%.

Experience has shown that NF and T4 over-limits frequently appear after a blade shedding.

The very high value of NG may be due to an over-dosage of the fuel flow (possible mixed mode combined with a collective pitch decrease).

The last over-limit appeared for the main rotor rotation speed with a maximum value reached during the flight of 445rpm. This value is not fully representative with the maximum NF value recorded due to this standard of ASU card which limit the record to approximately 450rpm.

However, the VEMD records the five highest values (over 430 rpm) of the flight and those values are incremented each time that the main rotor rotation speed decreases to 426rpm. That means that the main rotor has probably reached two time values higher than 445rpm.

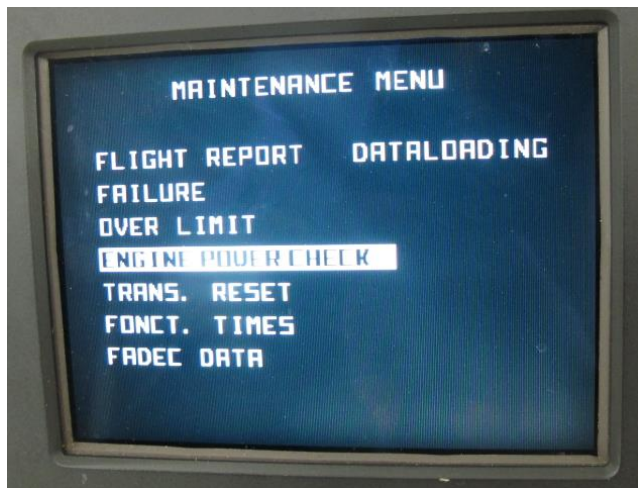
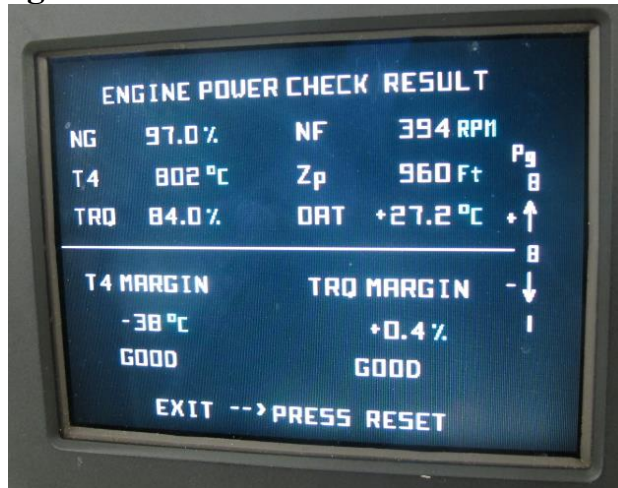
#### “Maintenance” mode – “Engine Power Check” submode

The ‘Engine Power Check Result’ submode has been opened  
The last engine power check result which is not dated was good.

As the Engine power check results are not dated, only the last result is relevant.

In case of bad engine power check result, the Safran HE troubleshooting manual recommends to perform an engine cleaning and then another engine power check. If the second result is always bad, dedicated maintenance card of Safran HE have to be applied.

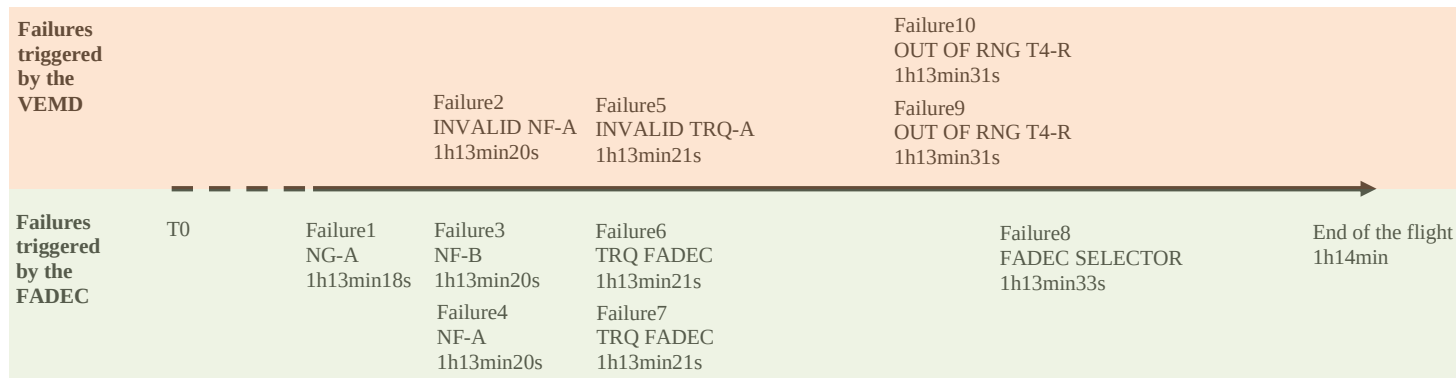
Failures and Over Limit were detected during this flight following this chronology:

When the first NG-A failure was recorded, the hexadecimal code indicates the mixed mode activation.

The following failures are most probably due to the free turbine overspeed.

When both NF failures are recorded (1h13min20s), the associated parameters showed gas generator rotation speed 105.9%Ng, Torque 83.3%TQ, T4 897°C and free turbine rotation speed recorded of 544rpm (eq. NR).

The very high value of NG may be due to an over-dosage of the fuel flow (possible mixed mode combined with a collective pitch decrease).

The T4 and NF over-limits are consistent with an engine blade shedding.

Failures 5 to 10 are not relevant for the event understanding.
