## Hydro-Mechanical Unit (HMU) and Assembly Valve examination Final report

Document ID: **BEA2017-0116\_tec05**  
 Date of occurrence: 21st February 2017  
 Place of occurrence: San Juan Airport (Puerto Rico)  
 Aircraft type: AEROSPATIALE - AS350 – B3  
 Registration number: **N413LP**  
 Equipment examined:

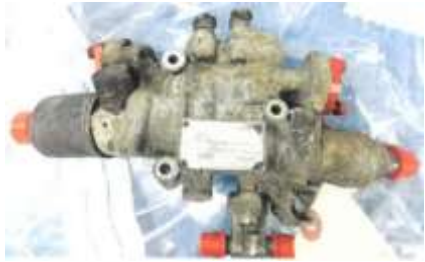
The HMU was found acceptable. A little discrepancy was found during the test: the stall margin protection was out of the limits fixed for new engines. This discrepancy was not significant and had no link with the reported event (engine overspeed).

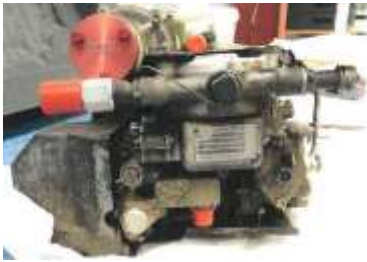
The assembly valve was found acceptable. Some slight leakages were found on the assembly valve, but without any effect on the functioning of the engine.
