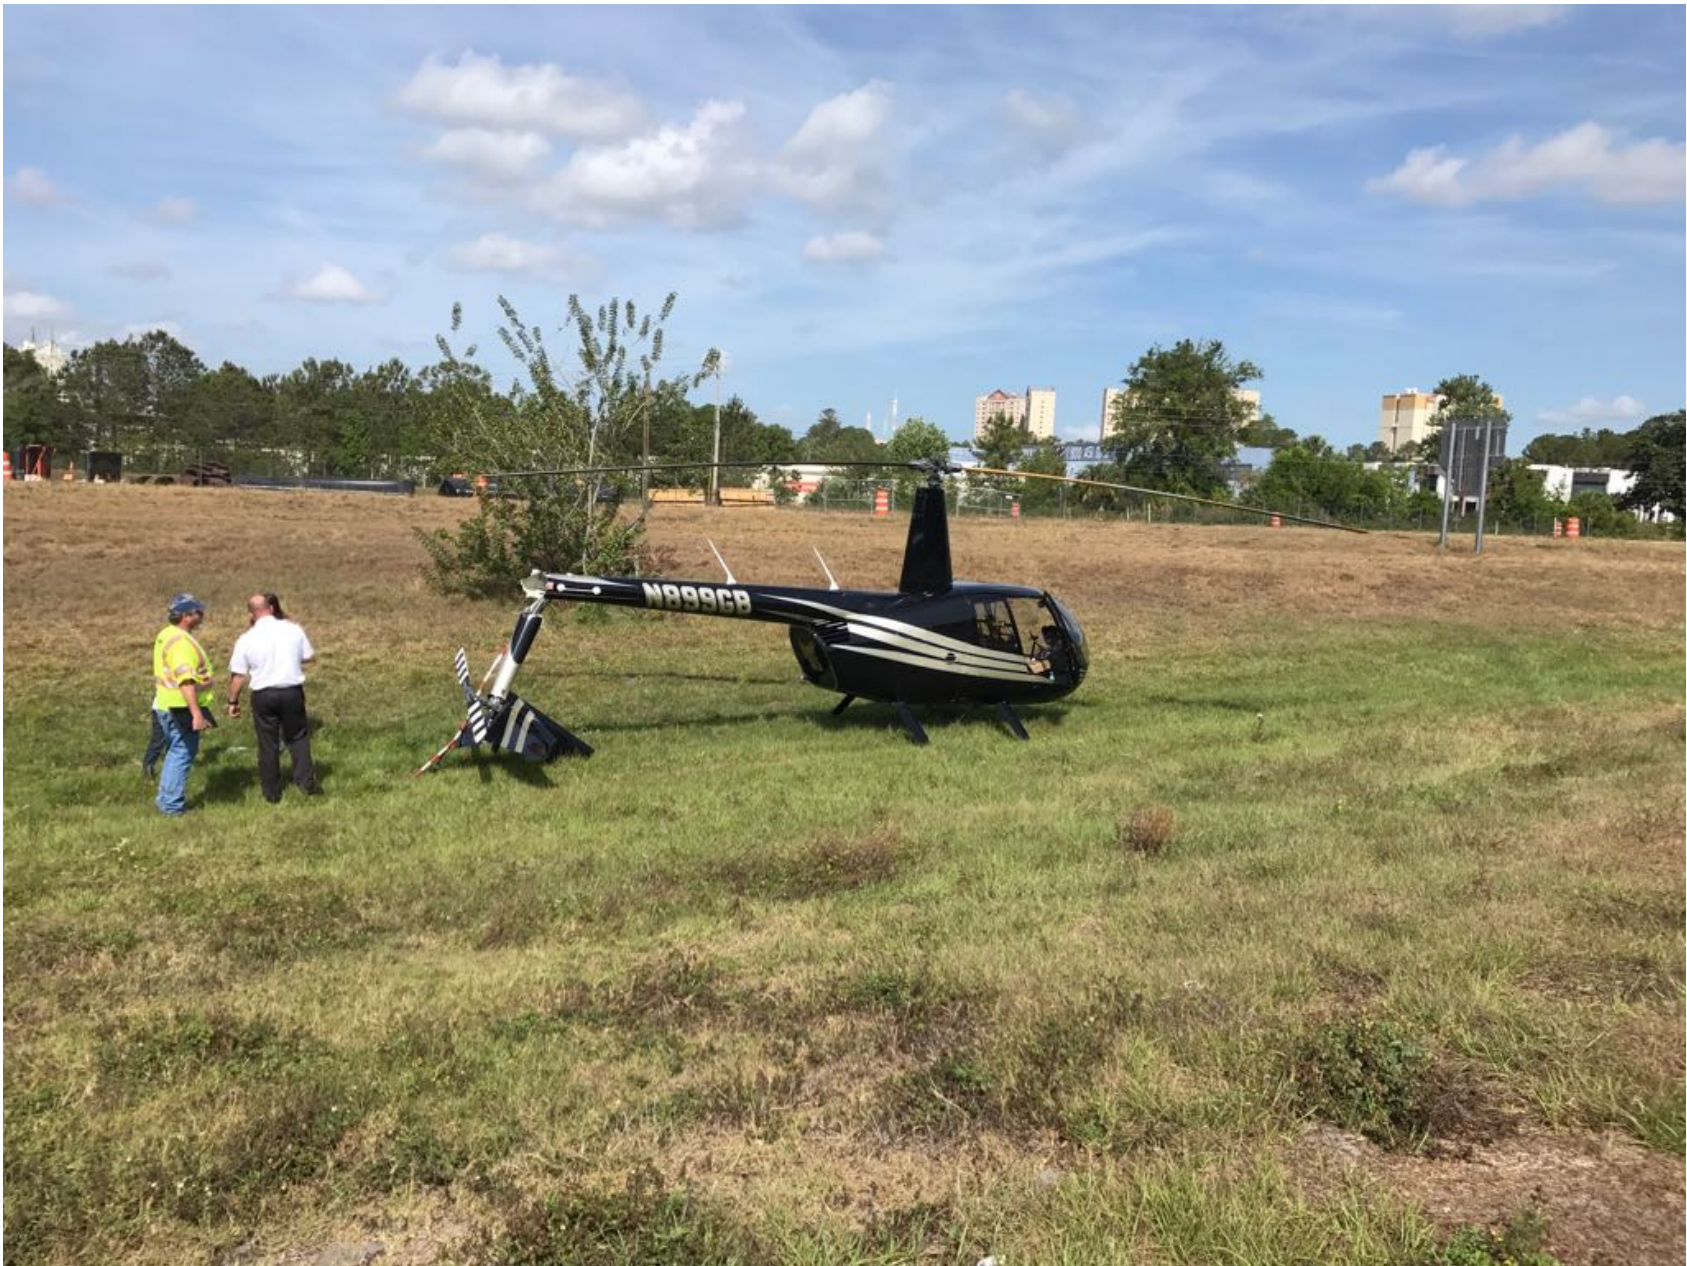
**Photo 1 – Digital Photograph Provided by Operator. View of the Helicopter at the Accident Site. Note the Partially attached Tailboom.**

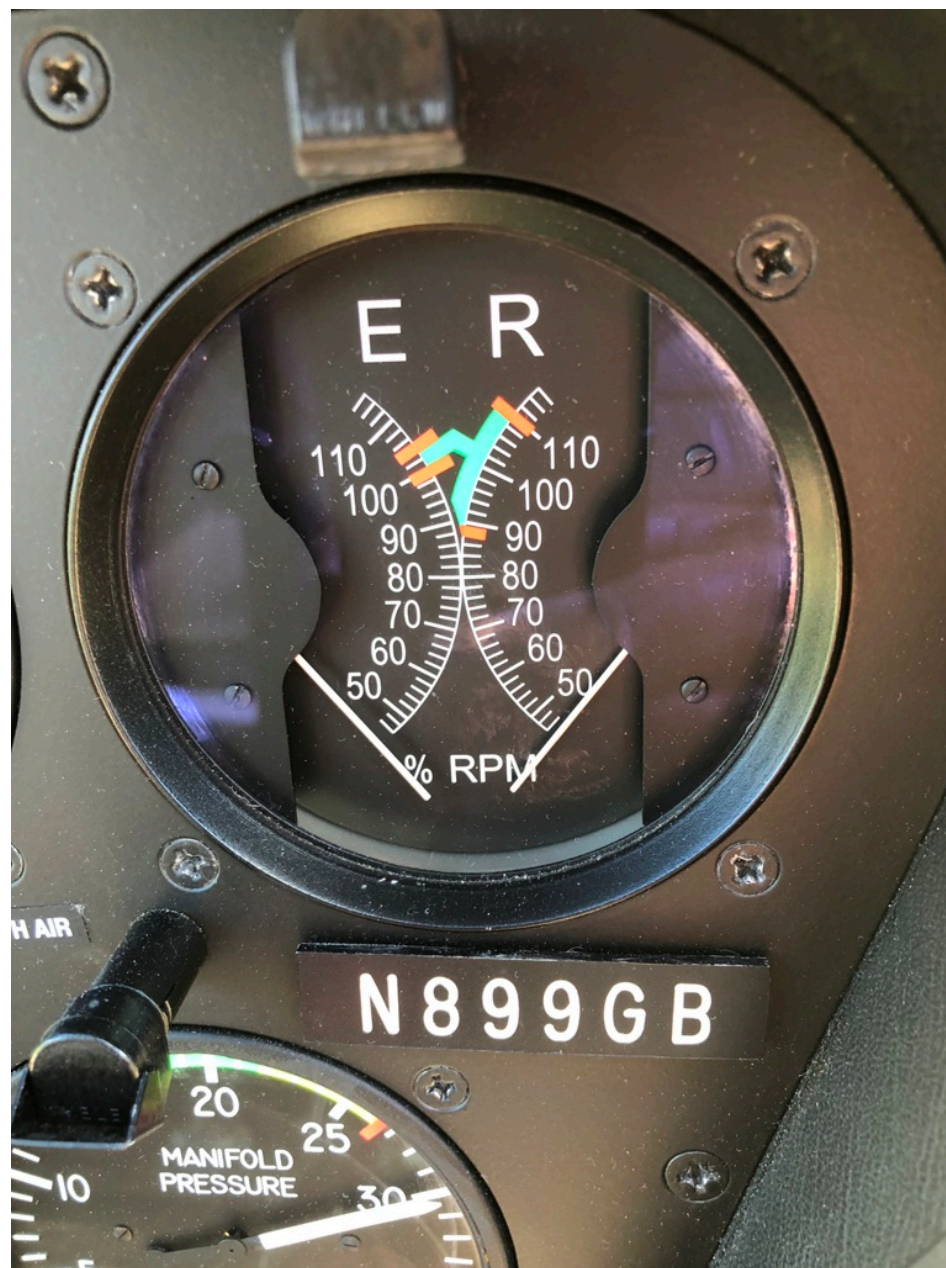
**Photo 2 - Digital Photograph Provided by Operator. View of the Dual Tachometer. Note the Lowest Numeric Marking of 50 on the Main Rotor.**

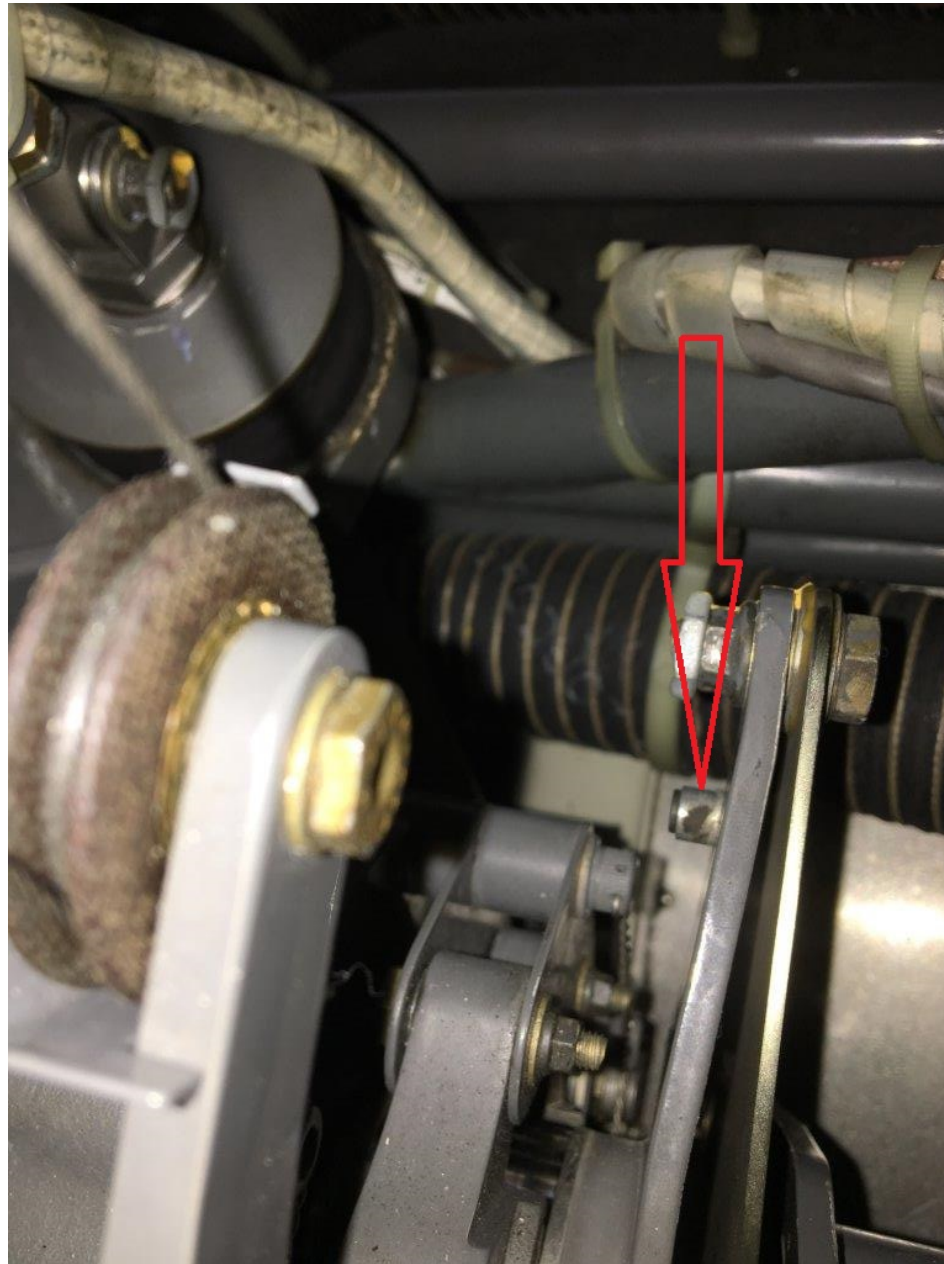
**Photo 3 – Digital Photograph Provided by FAA. Red Arrow Points to 1 Magnet Assembly Installed in C908-1 Yoke Assembly.**

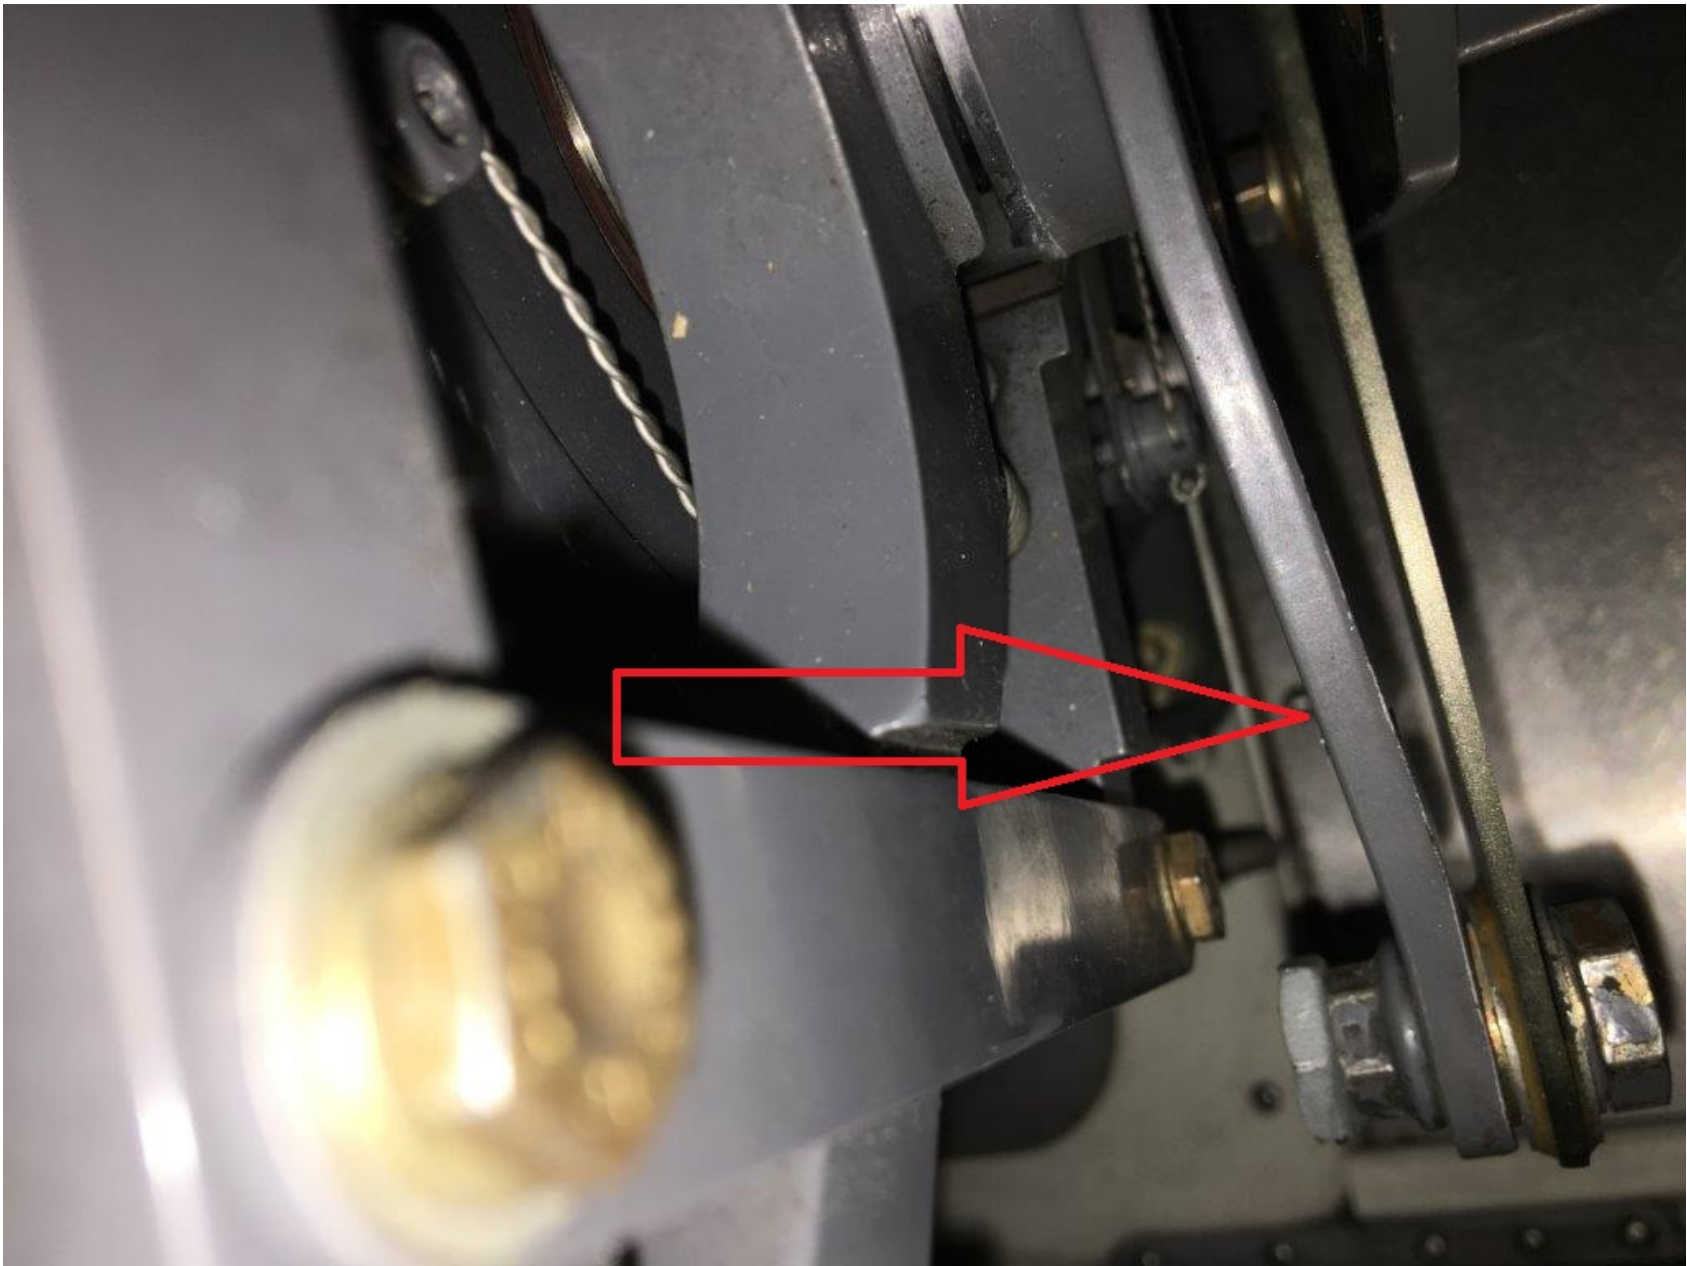
**Photo 4 - Digital Photograph Provided by FAA. Red Arrow Points to Area on C908-1 Yoke Assembly with Missing Magnet Assembly.**

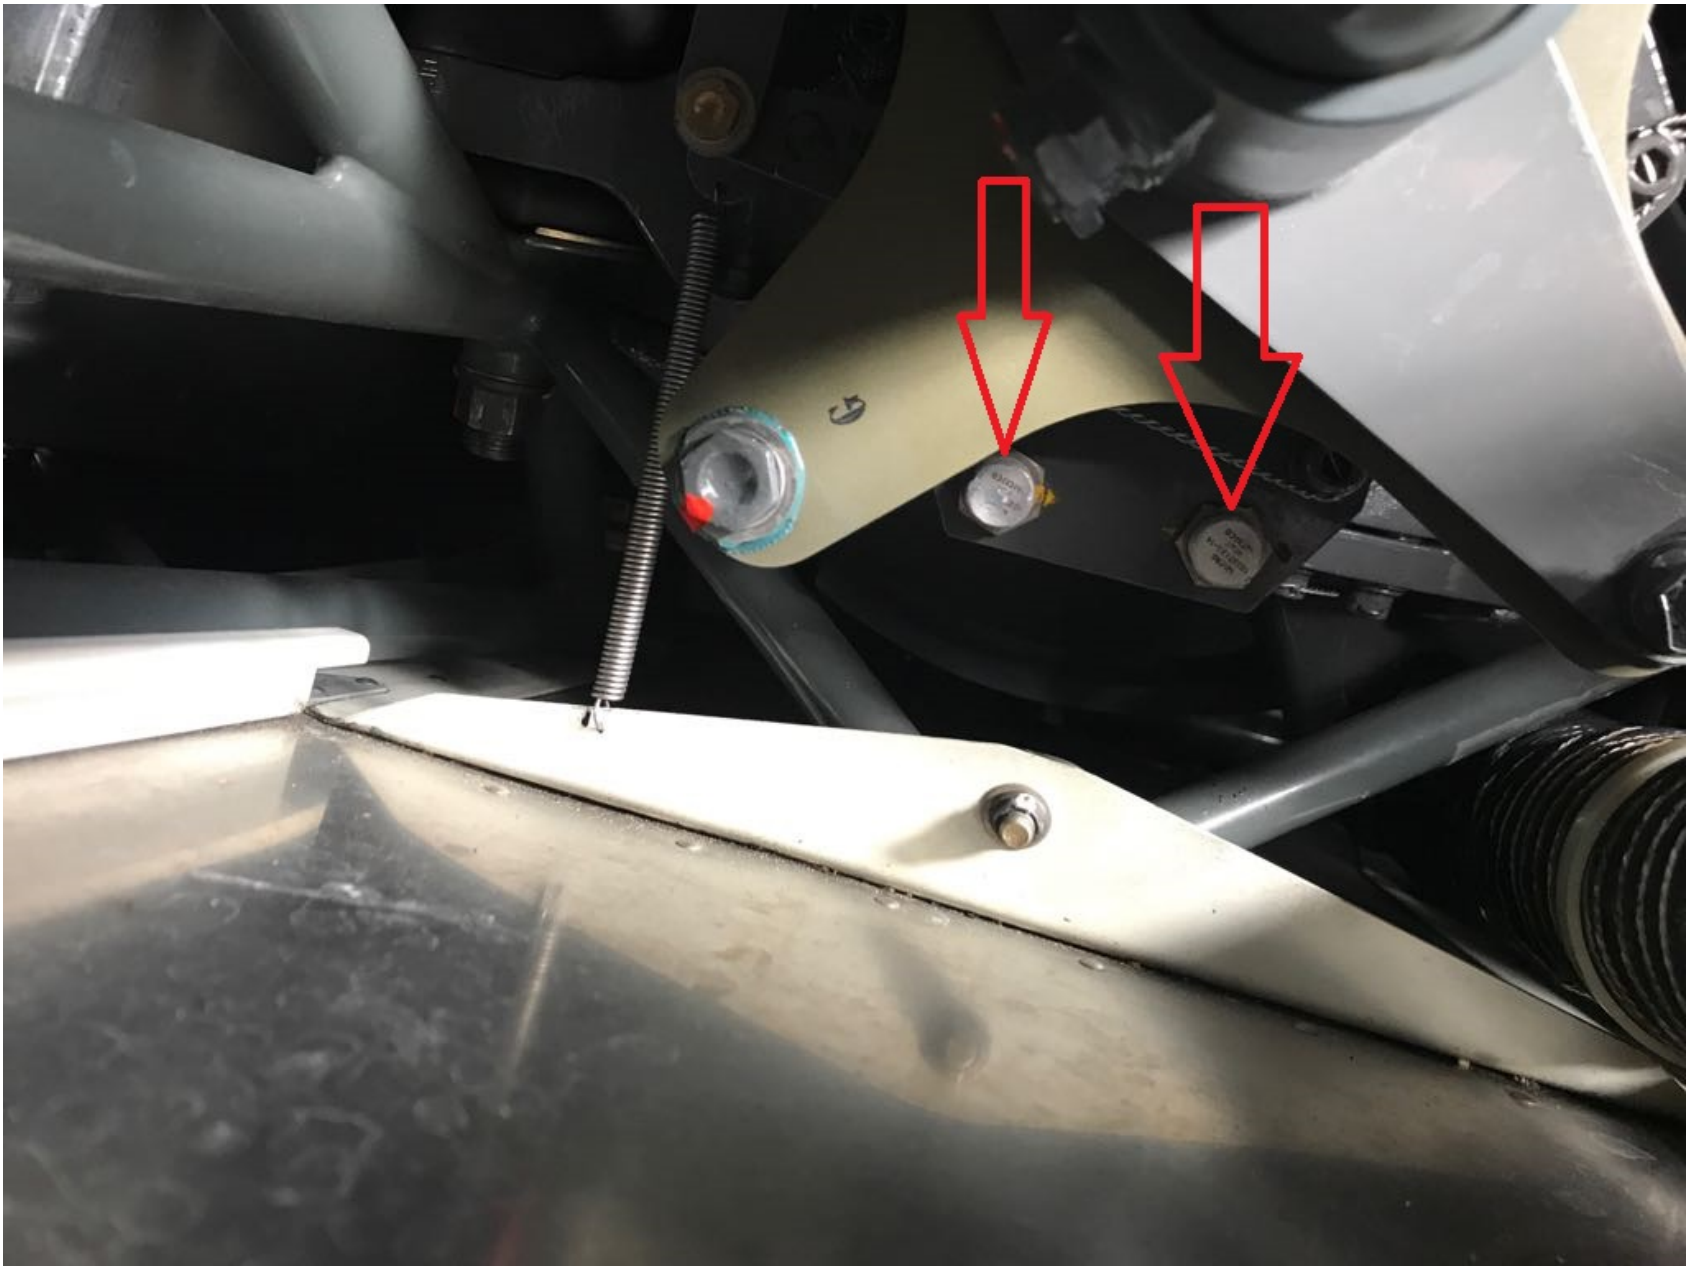
**Photo 5 - Digital Photograph Provided by Operator. Red Arrows Points to Both Main Rotor RPM Sender Assemblies.**

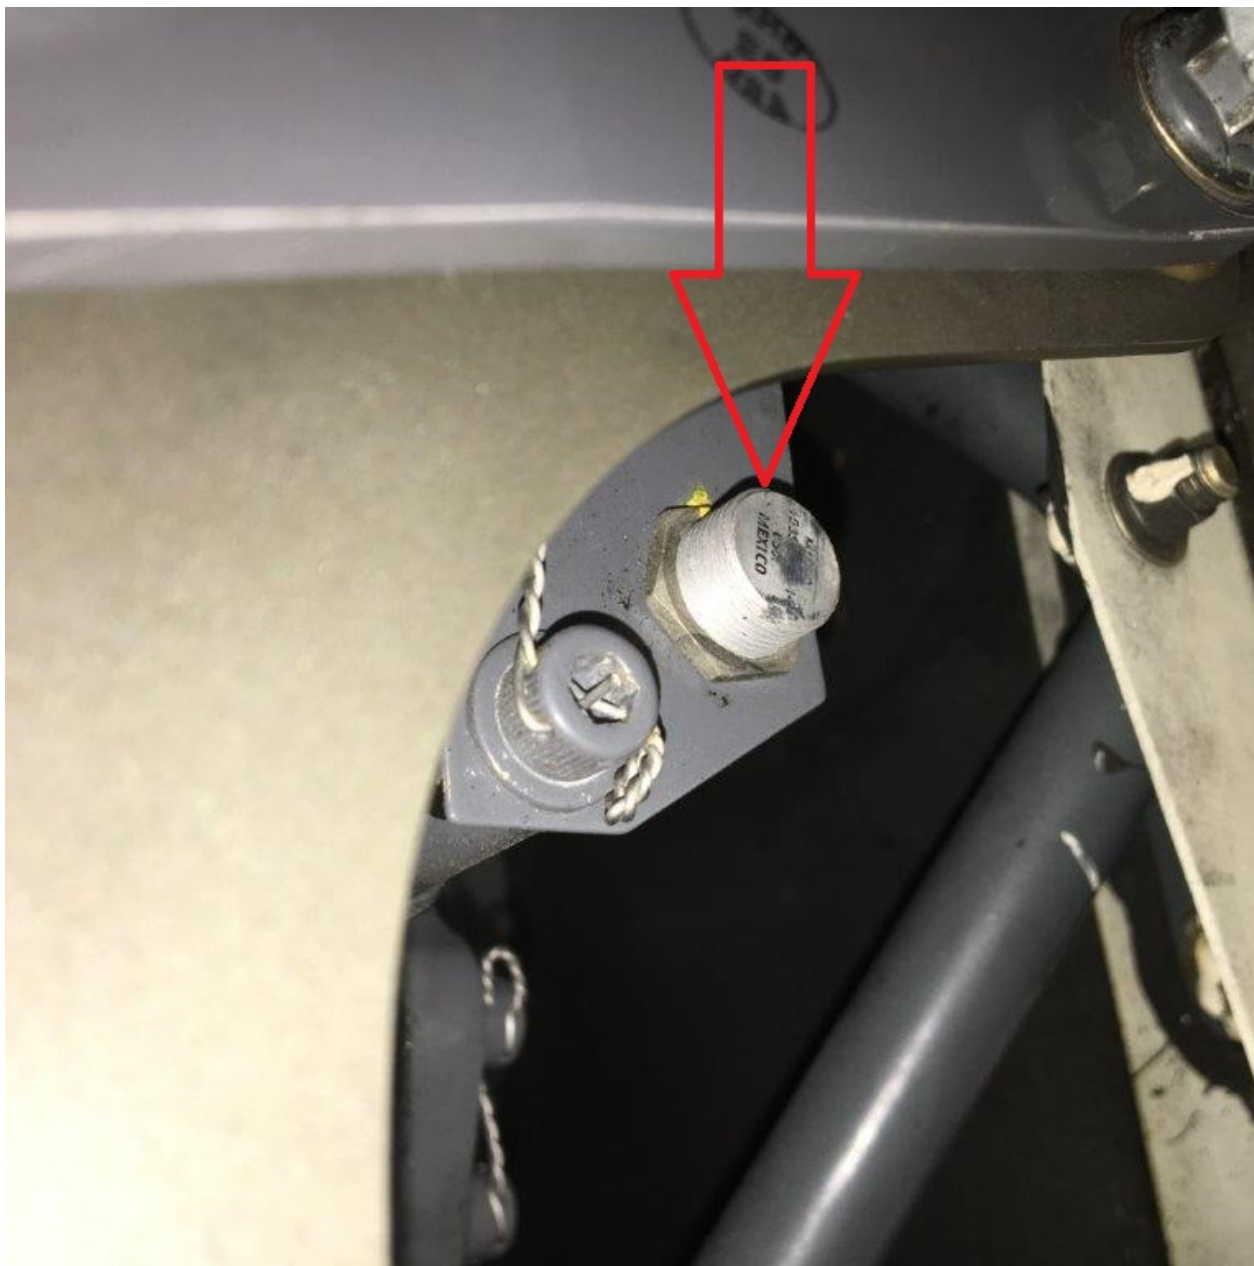
**Photo 6 - Digital Photograph Provided by FAA. Close-Up View. Red Arrow Points to 1 damaged Main Rotor RPM Sender Assembly.**
