# NATIONAL TRANSPORTATION SAFETY BOARD

## MATERIALS LABORATORY FACTUAL REPORT

Report No. 17-044

Place : Newton, North Carolina  
Date : April 27, 2017  
Vehicle : Robinson R44 II, N728CB  
NTSB No. : ERA17LA168  
Investigator : Bob Gretz, AS-ERA

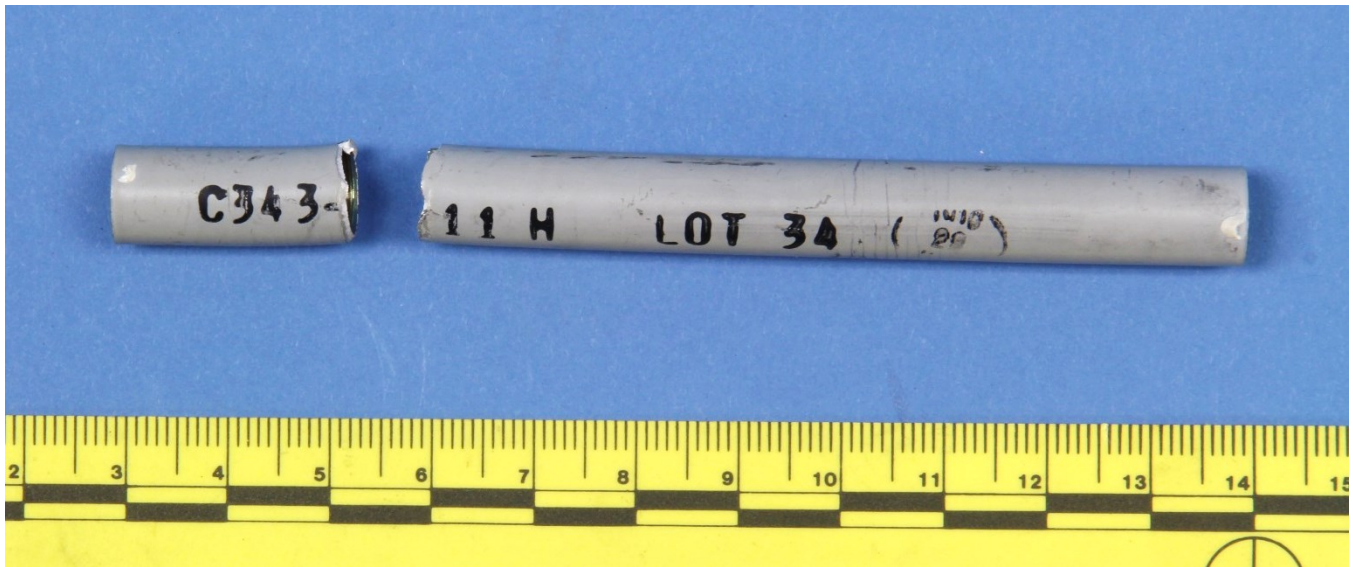
Figure 1 shows the fragments of the anti-torque pedal control tube, as received. The markings on the tube stated "C343 11H LOT 34". The tube had fractured perpendicular to the direction of the tube, approximately 0.90 inches from the end on the left of Figure 1. There was a slight outward bend of the short tube fragment near the fracture surface on one side.

Figure 1 – The fractured anti-torque pedal control tube halves, as received.

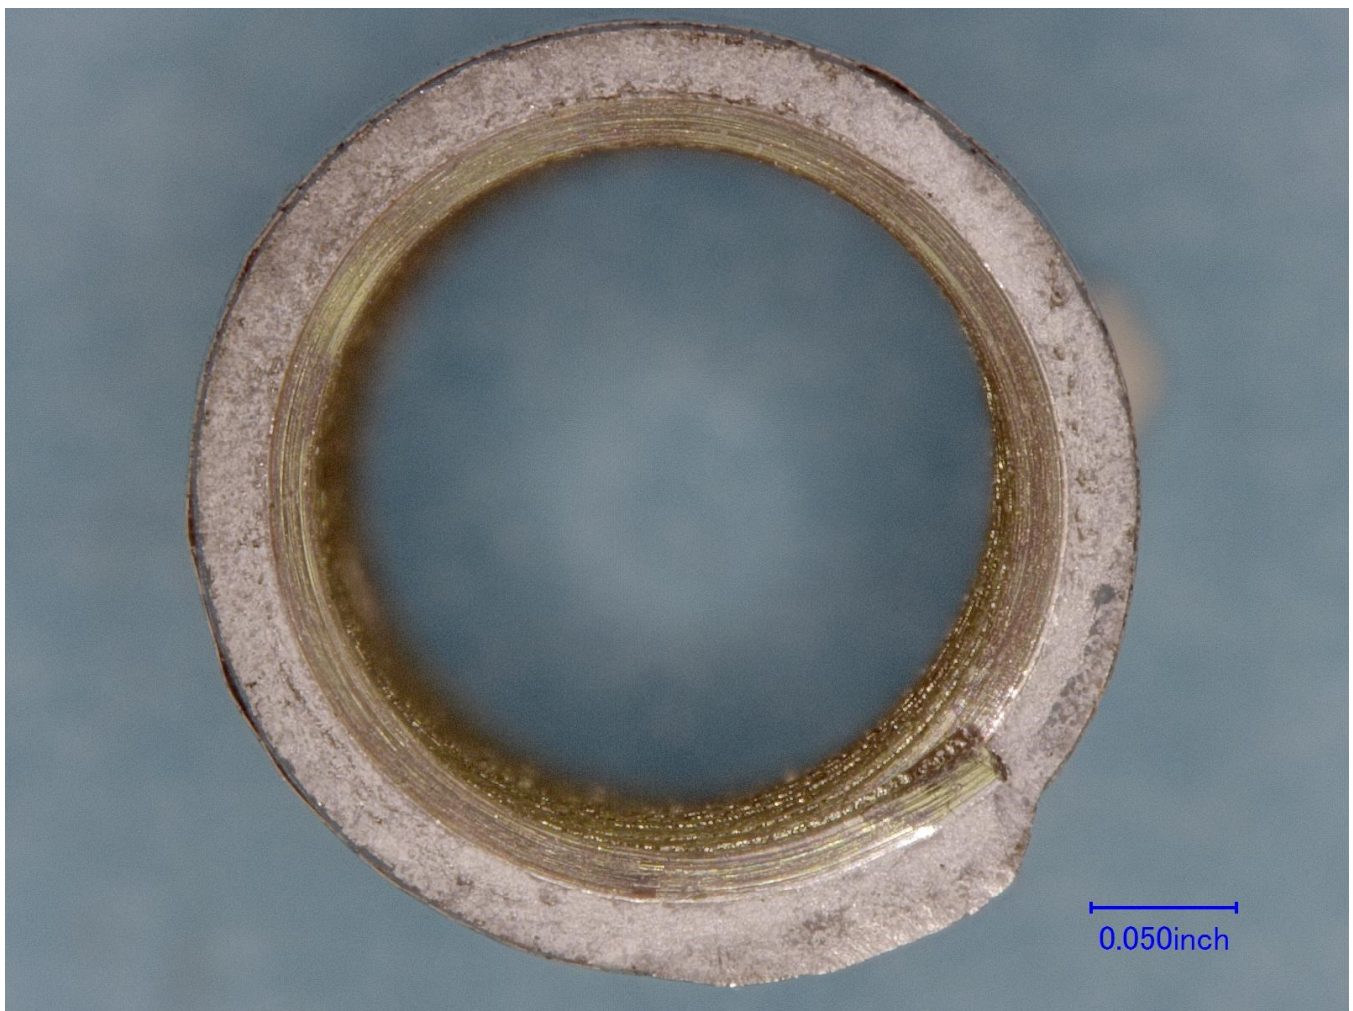
Figure 2 shows one of the mating fracture surfaces of the tube. The fracture surface exhibited a dull luster with a generally rough texture. A small step was present in the fracture surface, as shown in the lower right side of Figure 2.

Figure 2 – The fracture surface from the shorter fragment of the broken tube.

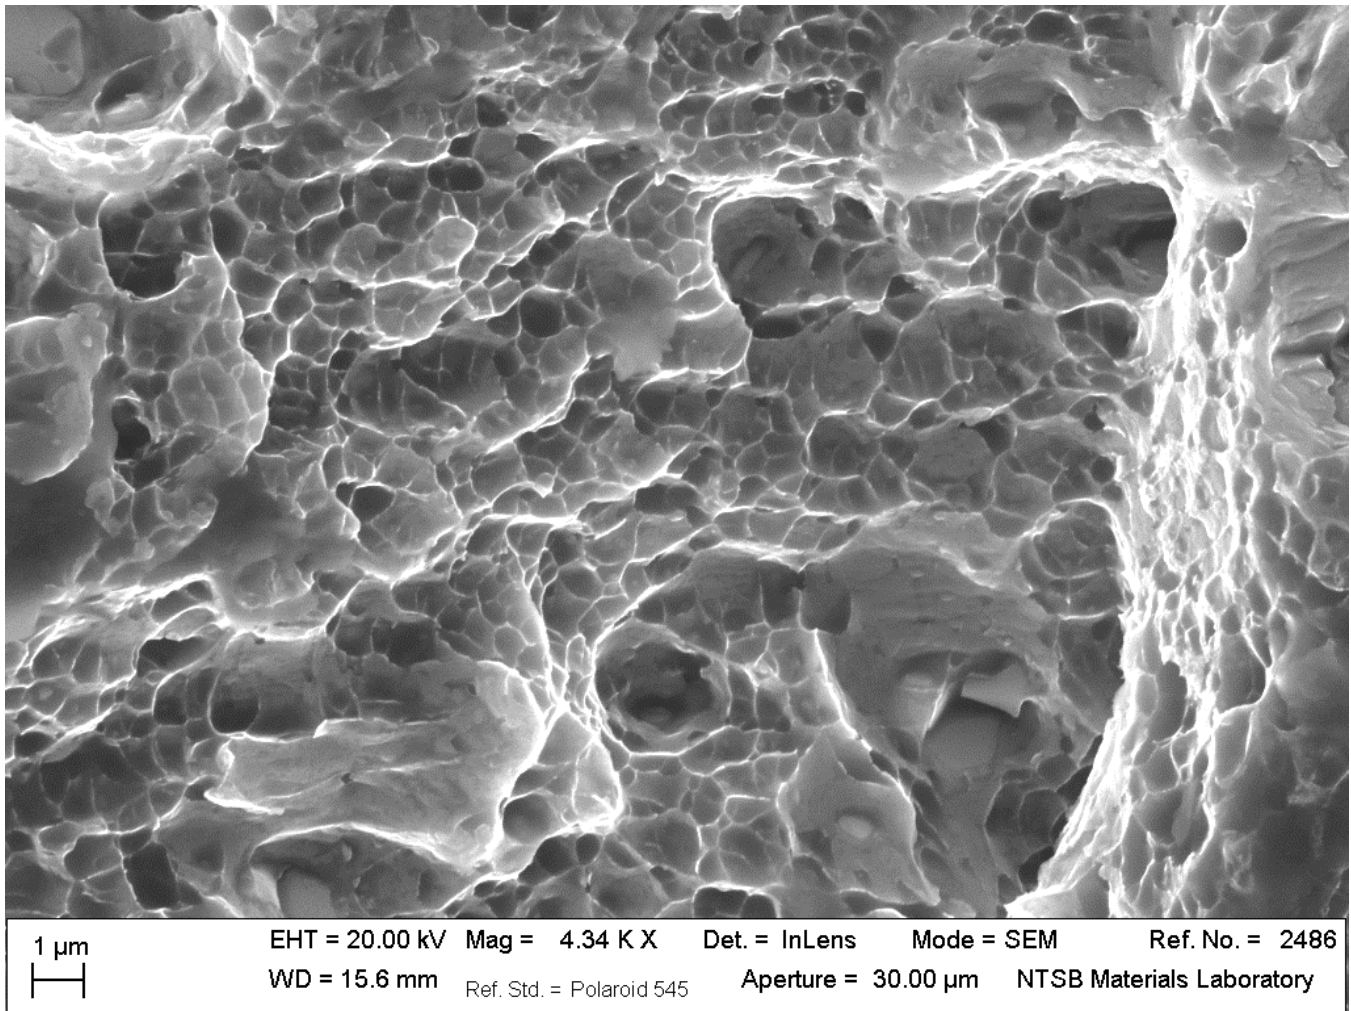
The fracture surface in Figure 2 was examined using a scanning electron microscope. As typified in Figure 3, the fracture surface exhibited dimple rupture, consistent with overstress failure. No indications of other failure modes were observed. The microscopic fracture features, as well as the macroscopic tube characteristics at and on the fracture surface, were all consistent with failure from overstress in torsion.

Figure 3 – Secondary electron micrograph of a typical area of the tube fracture surface, showing dimple rupture consistent with overstress failure.
