# NATIONAL TRANSPORTATION SAFETY BOARD

## MATERIALS LABORATORY FACTUAL REPORT

Report No. 18-012

Place : Homerville, Georgia  
Date : May 9, 2017  
Vehicle : Cessna 150M, N714DW  
NTSB No. : ERA17LA176  
Investigator : Todd Gunther, AS-ERA

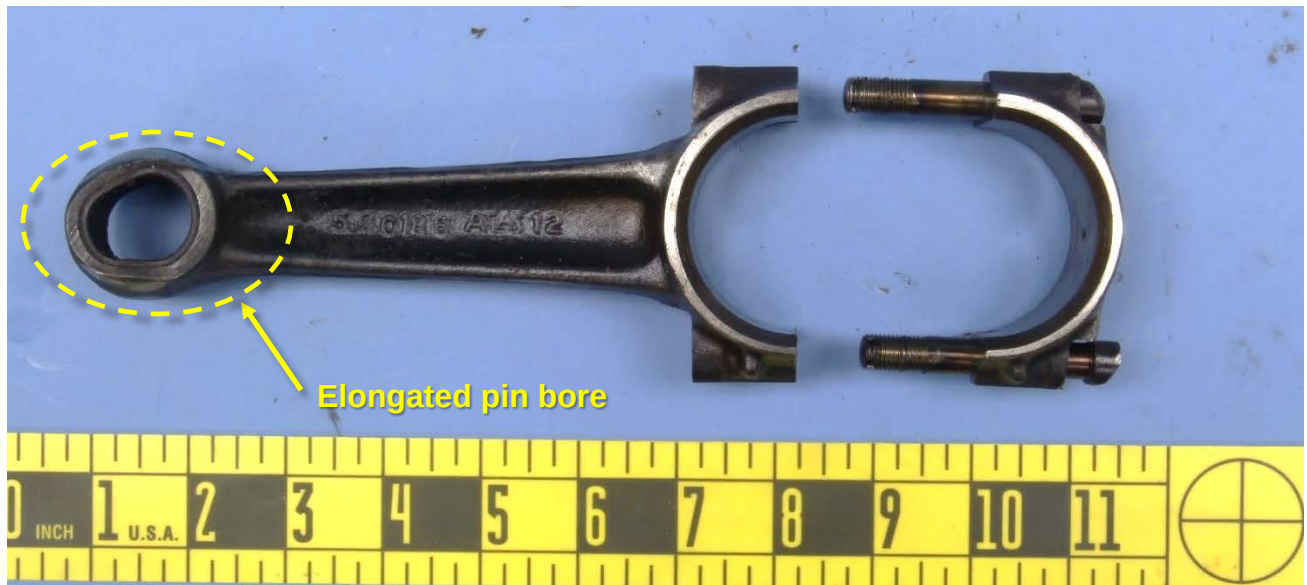
Figure 1 shows the pieces of the connecting rod, as received. The markings on the connecting rod stated, "5 6 0186 ATLAS 12". The connecting rod, cap, and bolts were all received intact, with no fractures. However, as shown in Figure 2, the rod body had been deflected along the web near the piston pin bore. The sides of the rod exhibited scraping or gouging damage (shown in the reflective areas of Figure 2).

The pin bore of the connecting rod had been deformed, consistent with elongation along the length of the rod. This is highlighted in Figure 1 and shown closer in Figure 3. As shown in Figure 3, this deformation was consistent with deformation toward the crankshaft (to the right in Figure 3). Minor rubbing marks were present of the side of the

Figure 1 – The pieces of the connecting rod, as received. The elongated pin side is highlighted on the left.

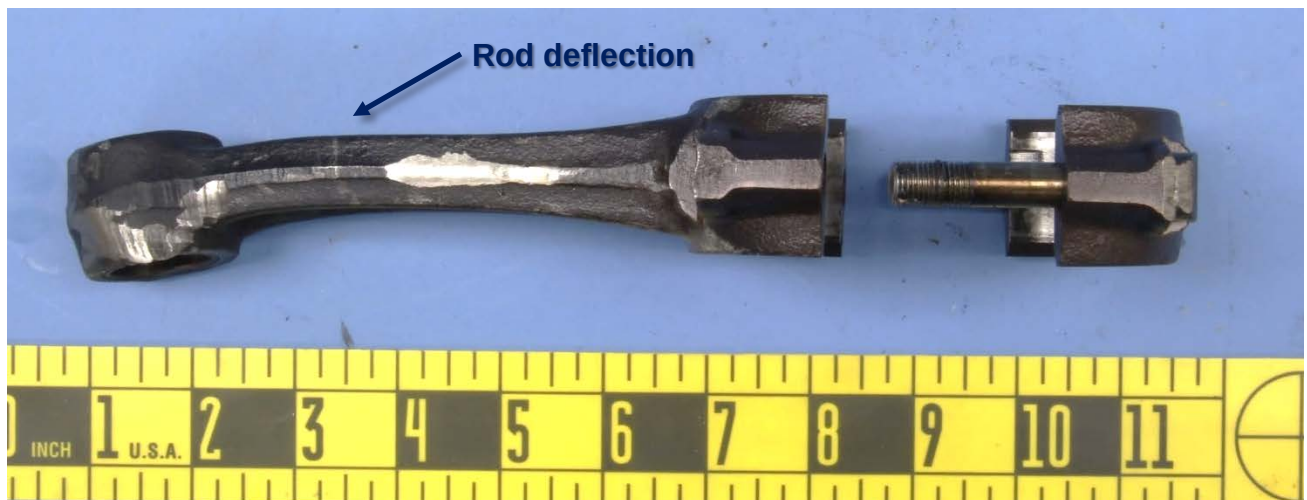
pin bore walls of the connecting rod (the web deflection in Figure 2 is towards the reader in Figures 1 and 3). The bushing inside the pin hole bore was relatively undamaged.

Figure 2 – The connecting rod pieces in Figure 1, shown from the side to demonstrate the deflection in the web.

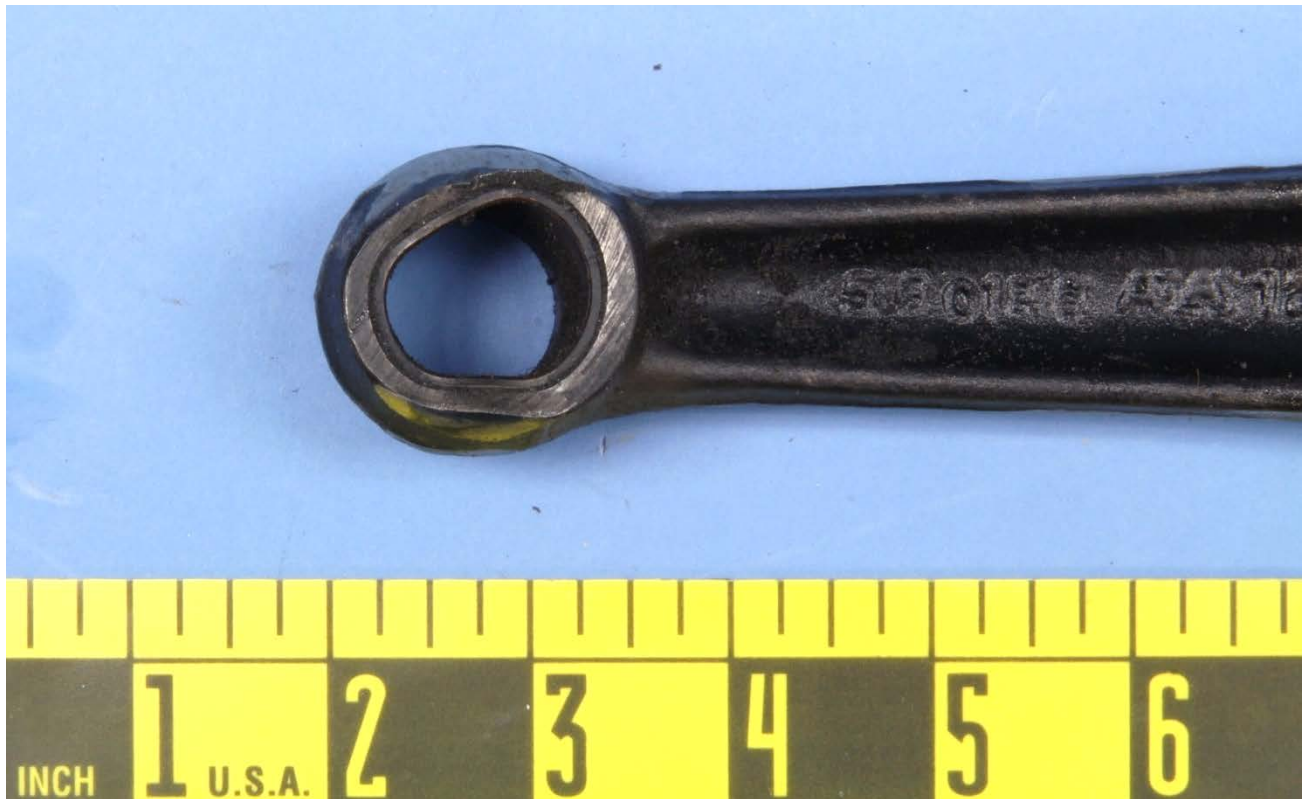
Figure 3 – A closer view of the elongated pin bore from Figure 1.

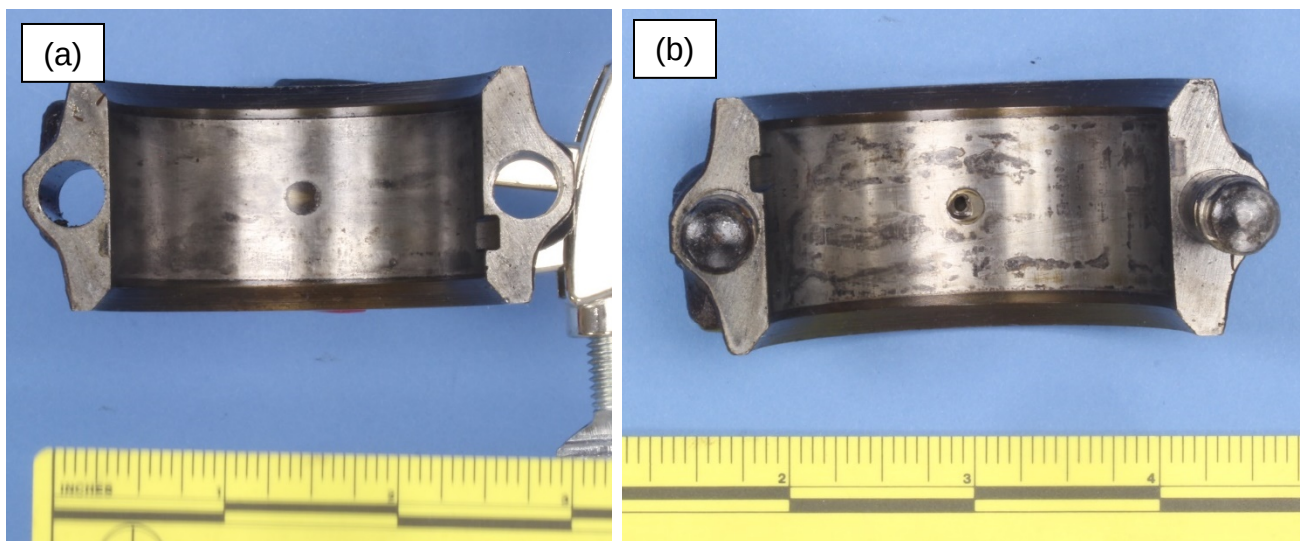
The crankshaft bearing surfaces are shown in Figures 4a and 4b. These surfaces were intact, exhibiting minimal wear marks. This wear was not severe enough to leave any indications consistent with deformation, gouging, or spalling.

Figure 4 – The bearing surfaces of the connecting rod assembly from (a) the rod side and (b) the cap side.

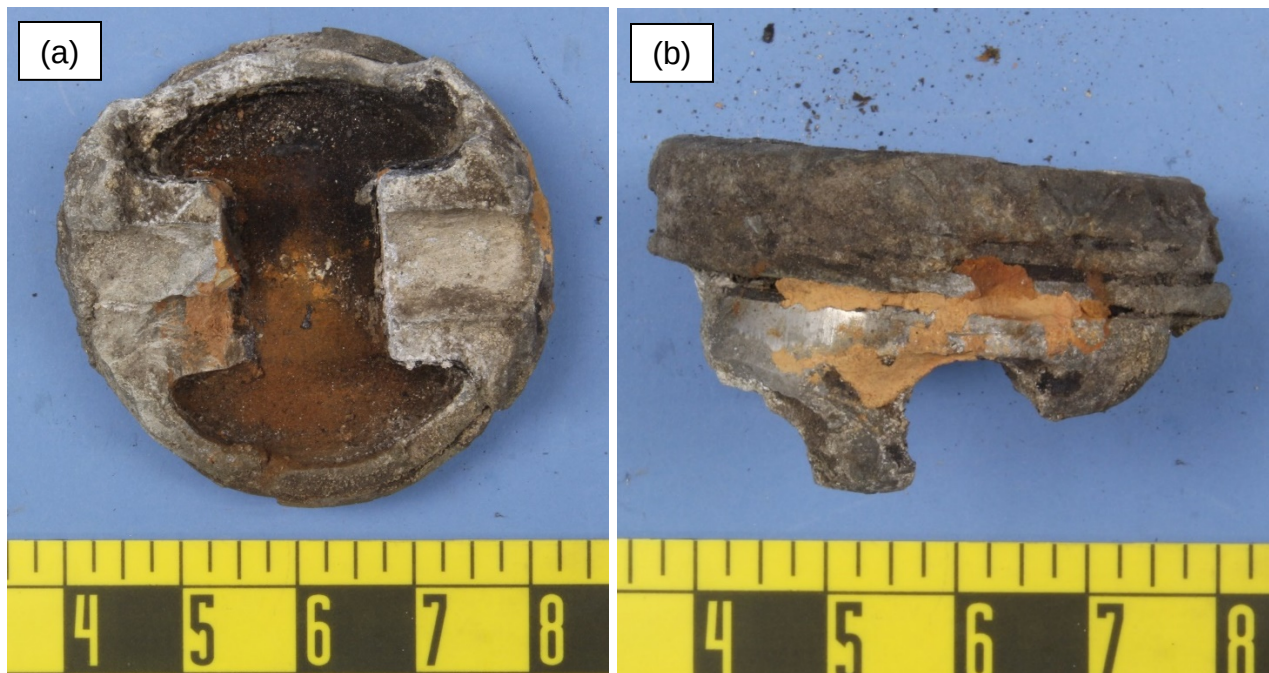
The piston is shown in Figure 5, as received. Much of the piston exhibited severe deformation and material loss. Figure 5b shows material consistent with caked on dirt or soil in the oil and guide ring notches. The fracture surfaces on the underside of the piston are shown in Figure 5a. These surfaces were heavily damaged due to post-fracture impact and corrosion damage. The still-present fracture features, such as faint river and chevron marks, were consistent with those of overstress fractures of reciprocating engine pistons. The pattern of features on these fracture surfaces was consistent with the fracture originating about the pin hole bore of the piston.

Figure 5 – The piston, as received, from (a) the underside and (b) the pin hole bore side.

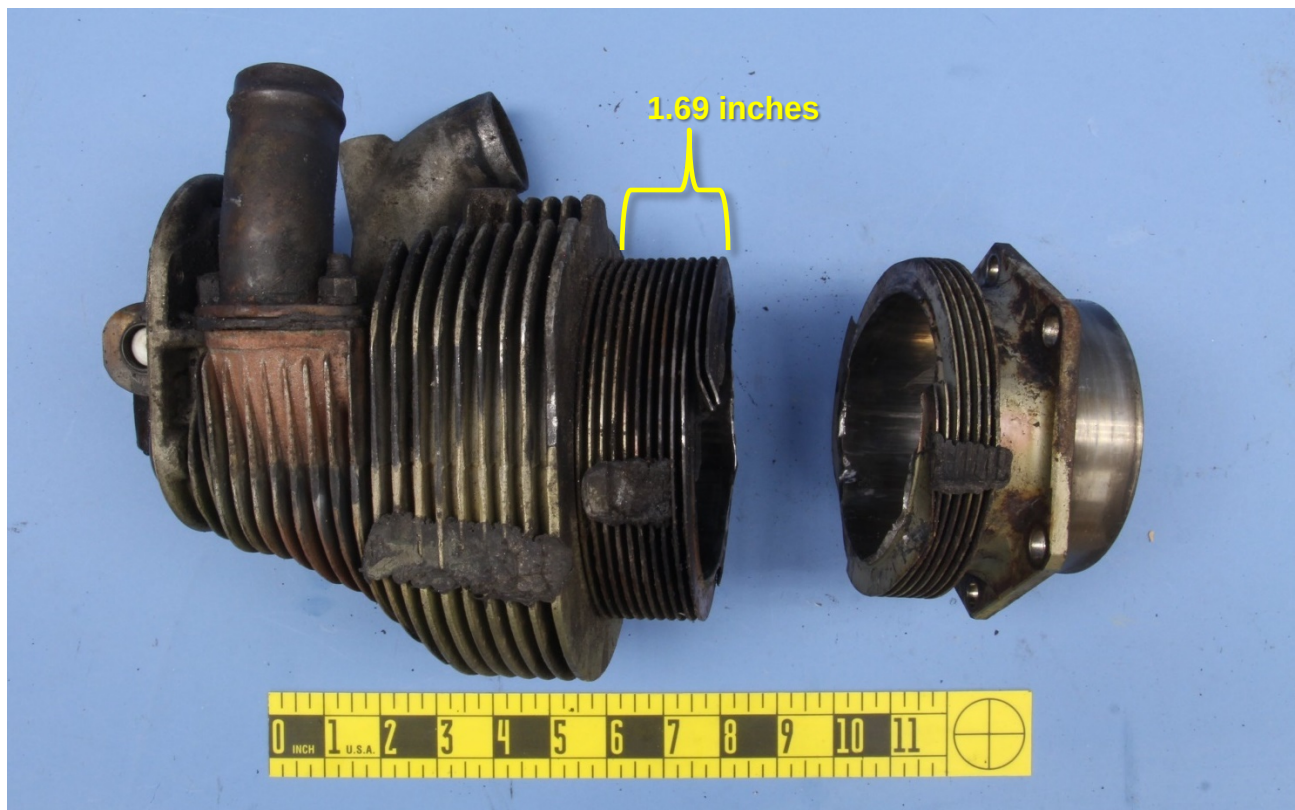
The cylinder assembly is shown in Figure 6, as received. The cylinder had fractured about the compression wall at the 10th cooling fin valley, when counted from the larger main body cooling fins of the cylinder head. This location was approximately 1.69 inches from the outboard, larger cooling fins (see Figure 6).

Figure 6 – The separated halves of the cylinder, as received.

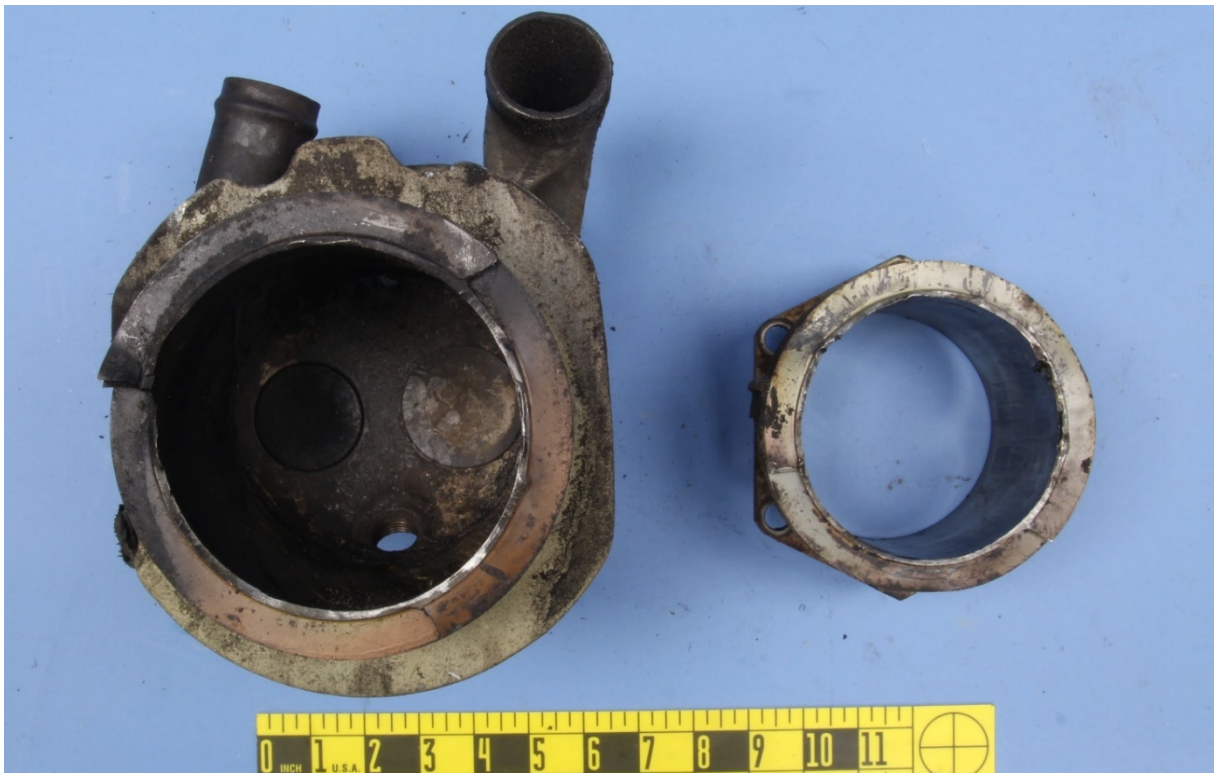
Figure 7 illustrates the halves of the cylinder positioned with the fracture surfaces facing the reader. The fracture was relatively flat and oriented normal to the direction of the piston actuation. The two cooling fins closest to the fracture exhibited bending and distortion. Several of the fin flange surfaces exhibited small circular features consistent with pitting.

The mating fracture surfaces are illustrated in Figure 7a and 7b. For the purposes of this report, the mating fractures are described as located on the head side and the piston, or open, side of the cylinder. Both fracture halves were relatively flat and exhibited a reflective luster. Much of the fracture surface had been damaged or entirely obliterated by post-fracture smearing or contact. Figure 8 shows a typical area of the fracture surface with little smearing damage. This damage was consistent with the visually apparent shiny, reflective luster of most of the fracture surfaces.

Figure 7 – The cylinder, as received, showing the mating fracture surfaces.

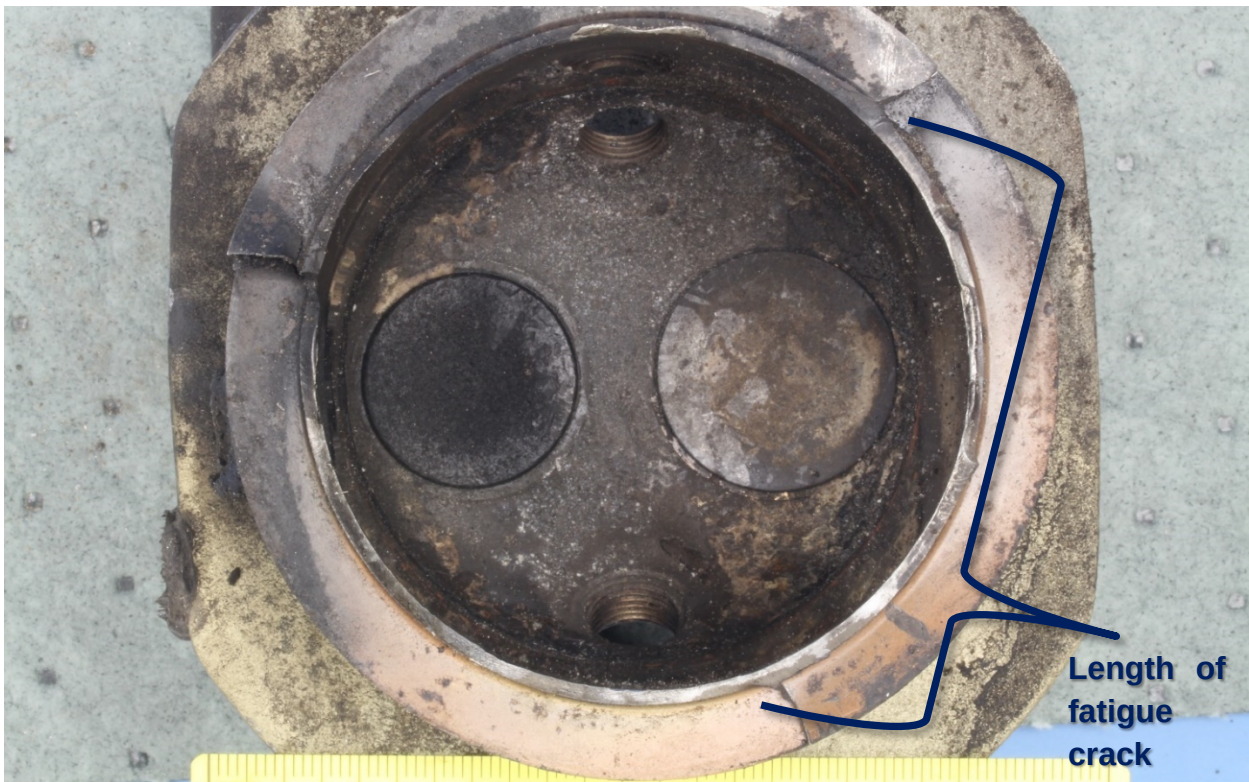
Closer examination of the head side fracture surface revealed that a portion exhibited crack arrest marks, consistent with progressive cracking that was later determined to be consistent with fatigue cracking (see Figure 8). The crack arrest features were present along approximately 30% of the fracture surface circumference (or approximately 110° of the circumference, which was approximately 3.8 inches long).

Figure 8 – The valve side of the cylinder, showing the fractured cylinder wall. The fatigue crack region is highlighted.

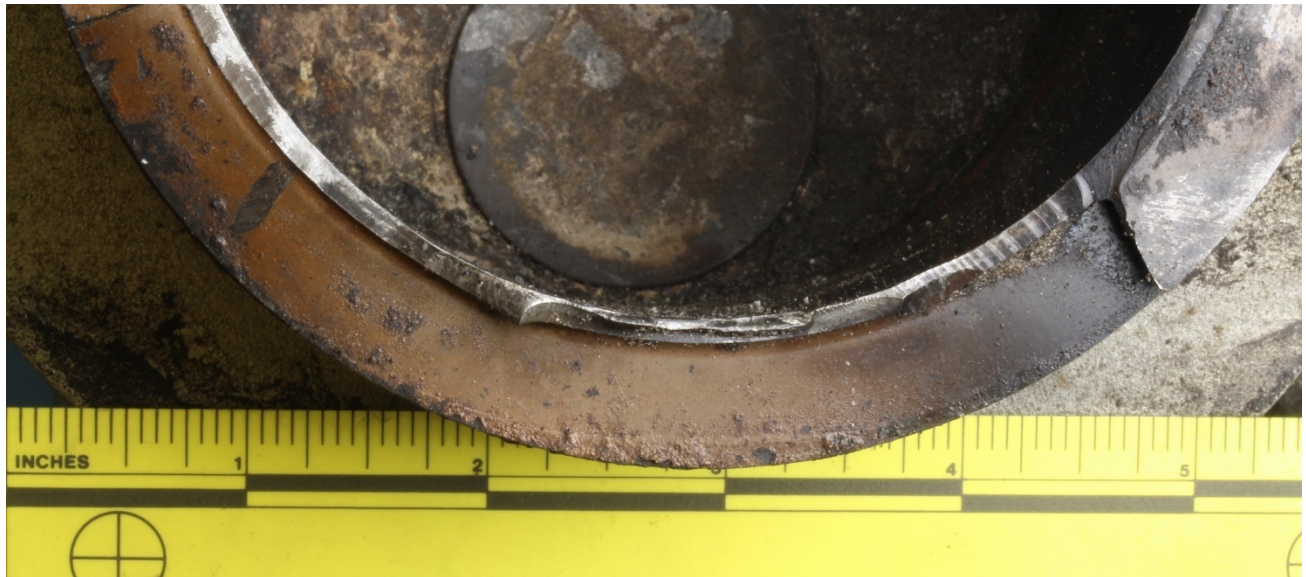
The crack arrest marks on both sides of the mating fracture surfaces propagated around the cylinder cross section from a singular point, highlighted in Figure 9 and Figure 10. As shown in Figure 6, the crack initiation site was located on the exterior surface of the cylinder fin valley. An initial thumbnail crack was present adjacent to the crack

Figure 9 – Closer view of the fatigue crack wall of the cylinder from the on the valve-side half.

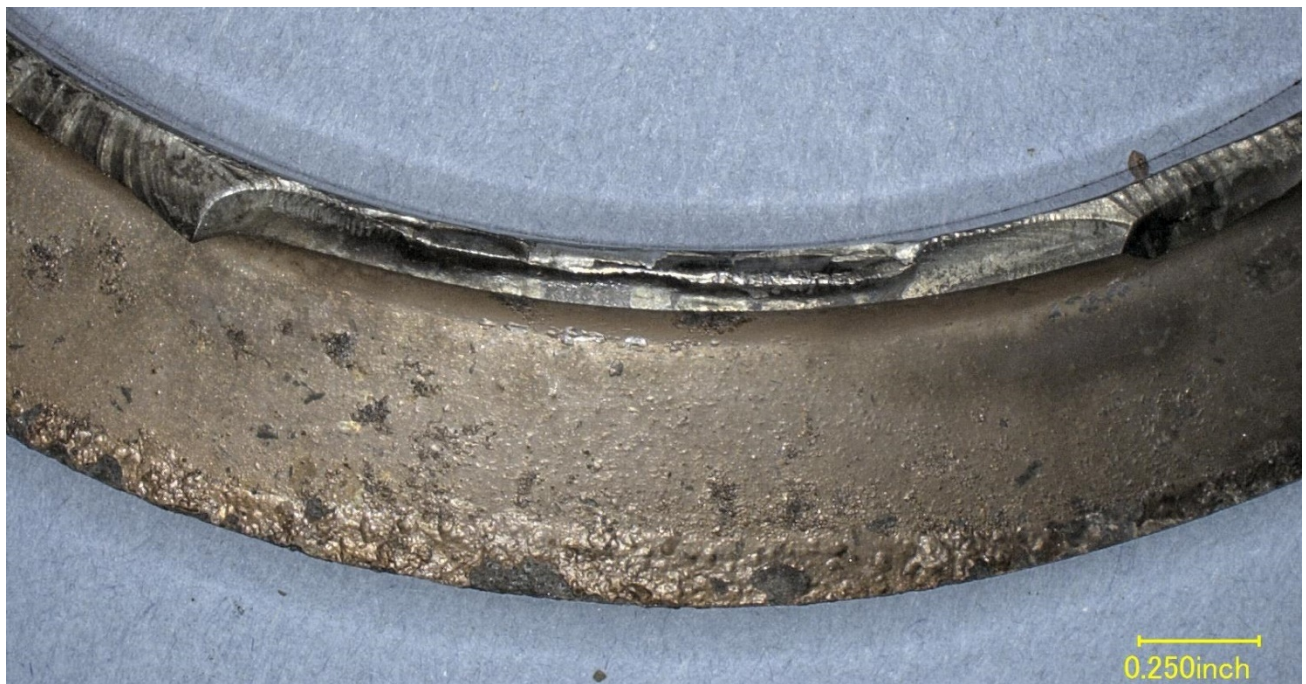
Figure 10 – Closer view of the initiation region of the cylinder fatigue crack, after sectioning and cleaning.

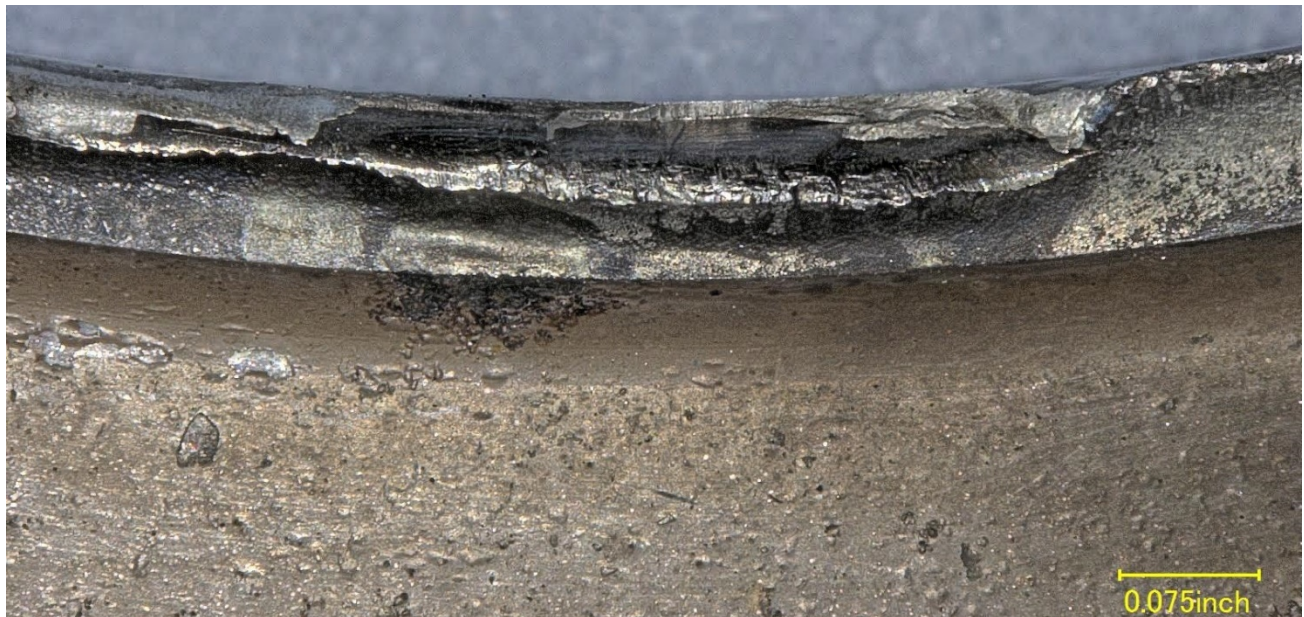
initiation site, with radial marks and crack arrest marks propagating outward (see Figure 11).

Figure 11 – Closer view of the initiation region from Figure 10.

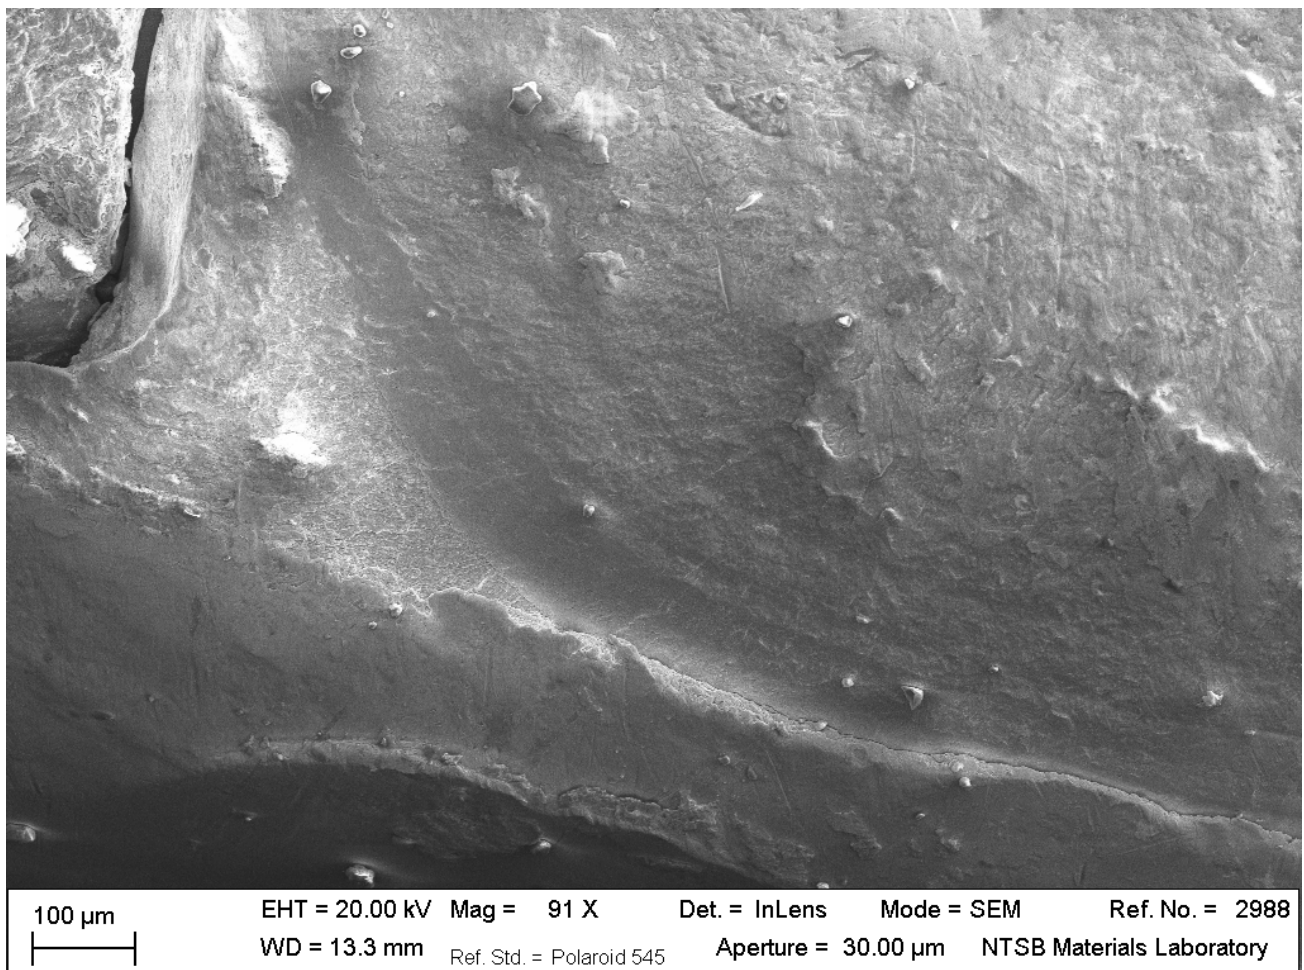
The cylinder fracture surfaces were examined using a scanning electron microscope (SEM). Figure 12 illustrates a typical area of undamaged fracture surface near the end of the progressive cracking area, showing crack arrest marks and radial lines, consistent with the crack propagation direction. Inside this region, fatigue striations were present, consistent with fatigue crack propagation (see Figure 13). Outside the fatigue crack, dimple rupture, consistent with subsequent overstress fracture, was observed (see Figure 14).

Figure 12 – Secondary electron (SE) micrograph of the end of the fatigue crack.

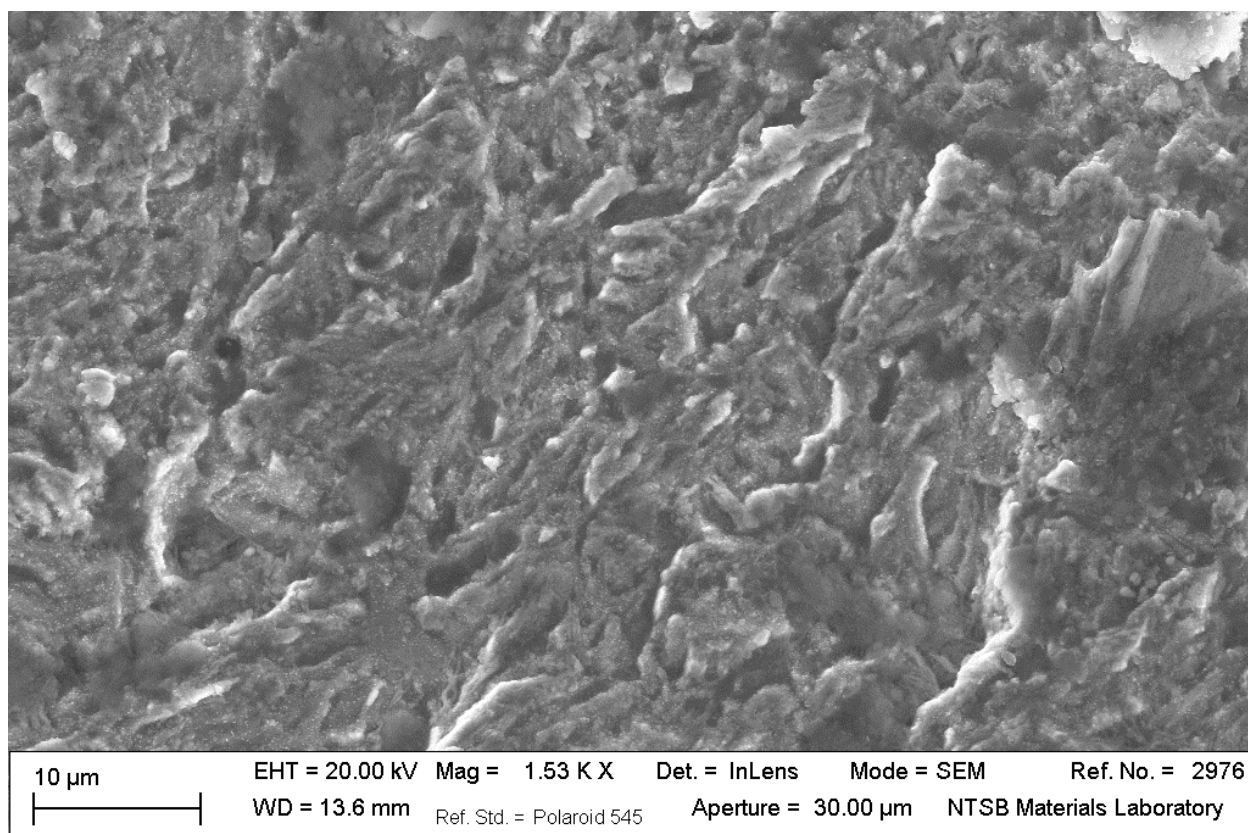
Figure 13 – SE micrograph of the fatigue region, showing striations.

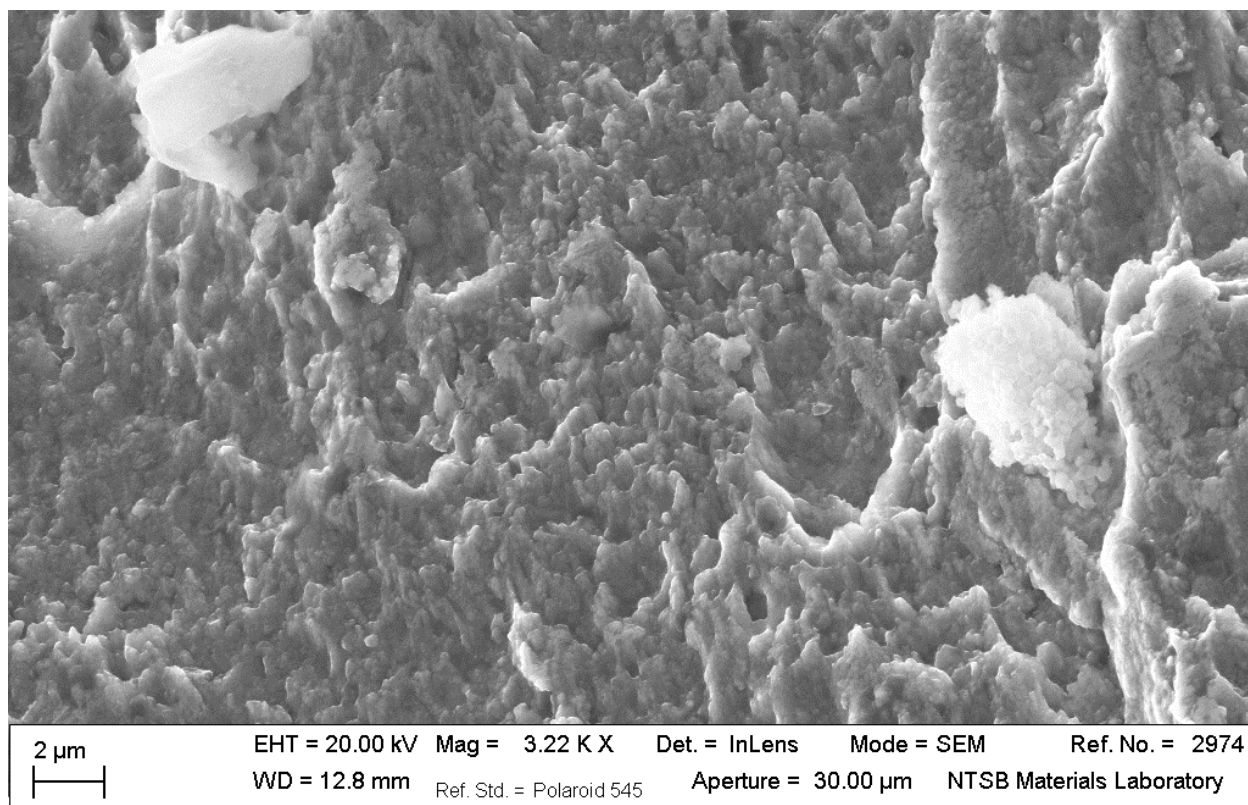
Figure 14 – SE micrograph of dimple rupture outside the fatigue region on the fracture.

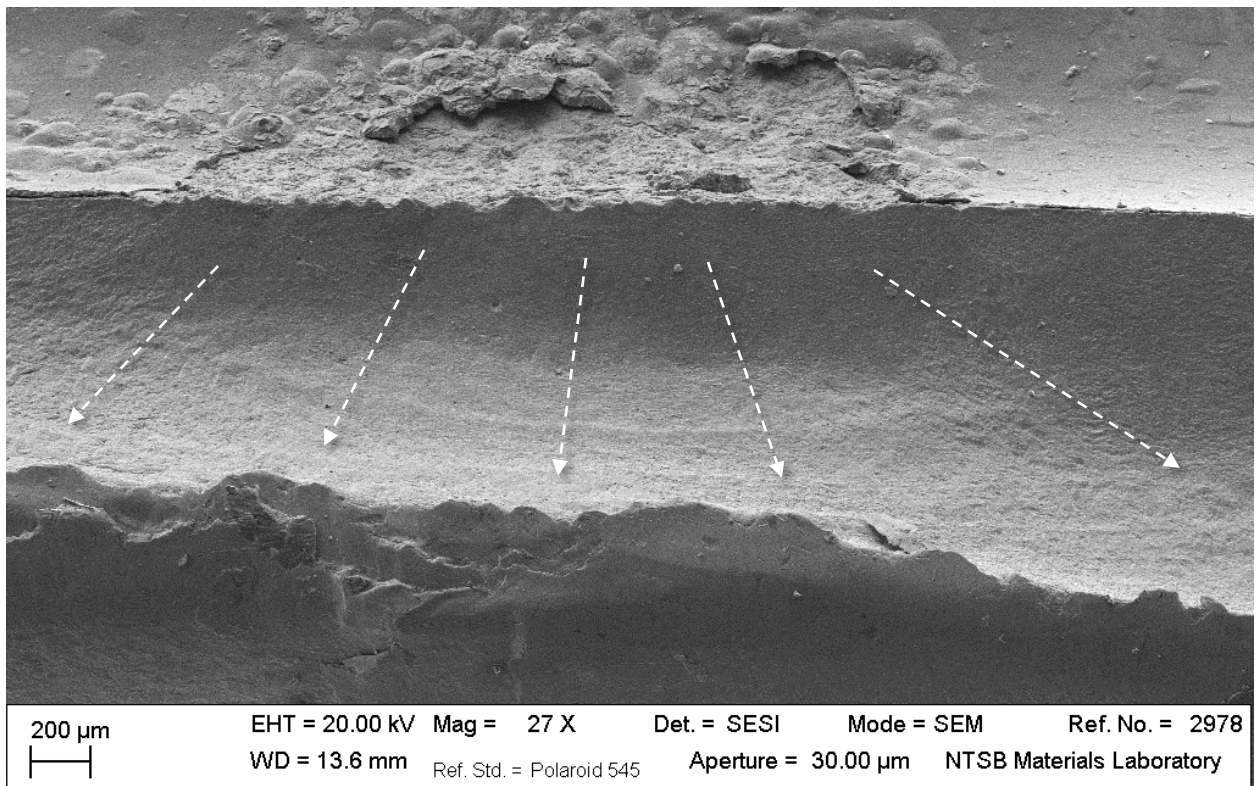
The crack initiation site on the head side of the fracture surface is illustrated in Figures 15 and 16. The crack initiation site was relatively undamaged, exhibiting fatigue striations towards the fin root valley. As shown in Figure 16, the fracture surface at the crack initiation site exhibited a faceted morphology, with pit-like depressions on the fin valley surface. These features were consistent with local corrosion and pitting.

Figure 15 – SE micrograph showing the fatigue crack initiation site.

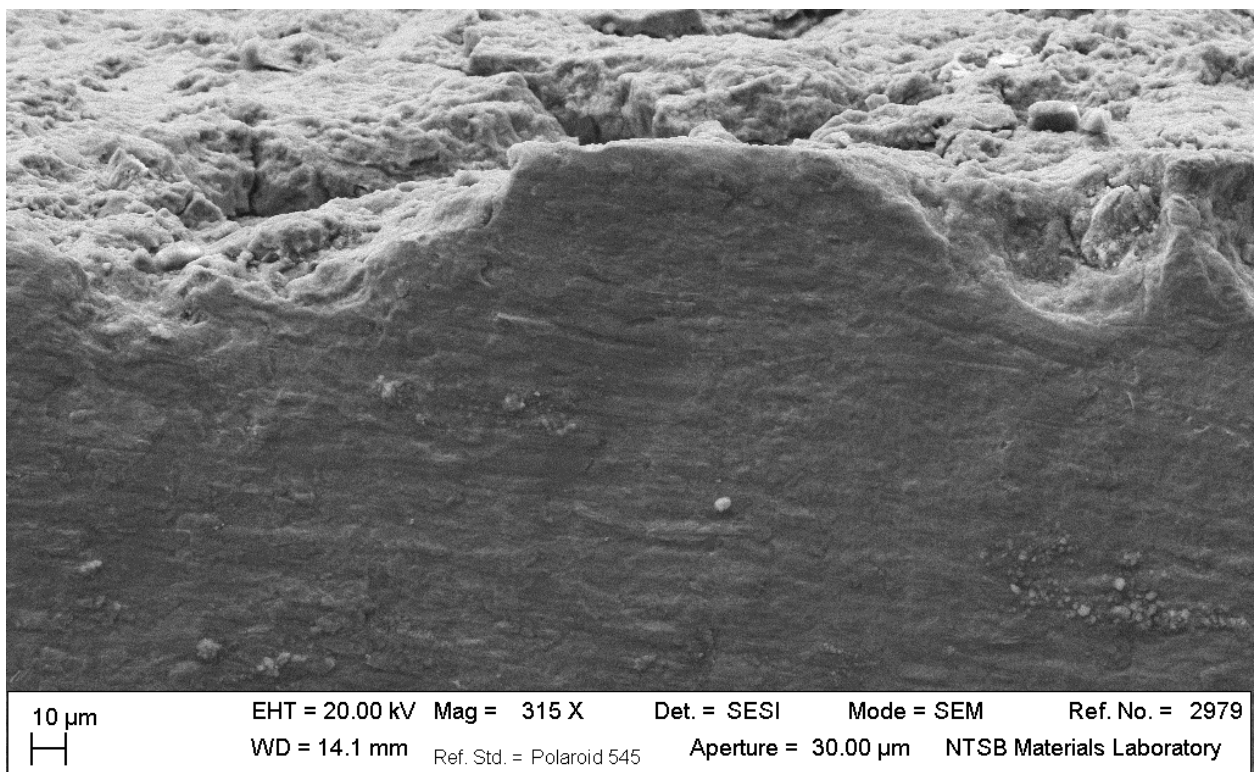
Figure 16 – SE micrograph of the fatigue crack initiation site, showing corrosion pits.

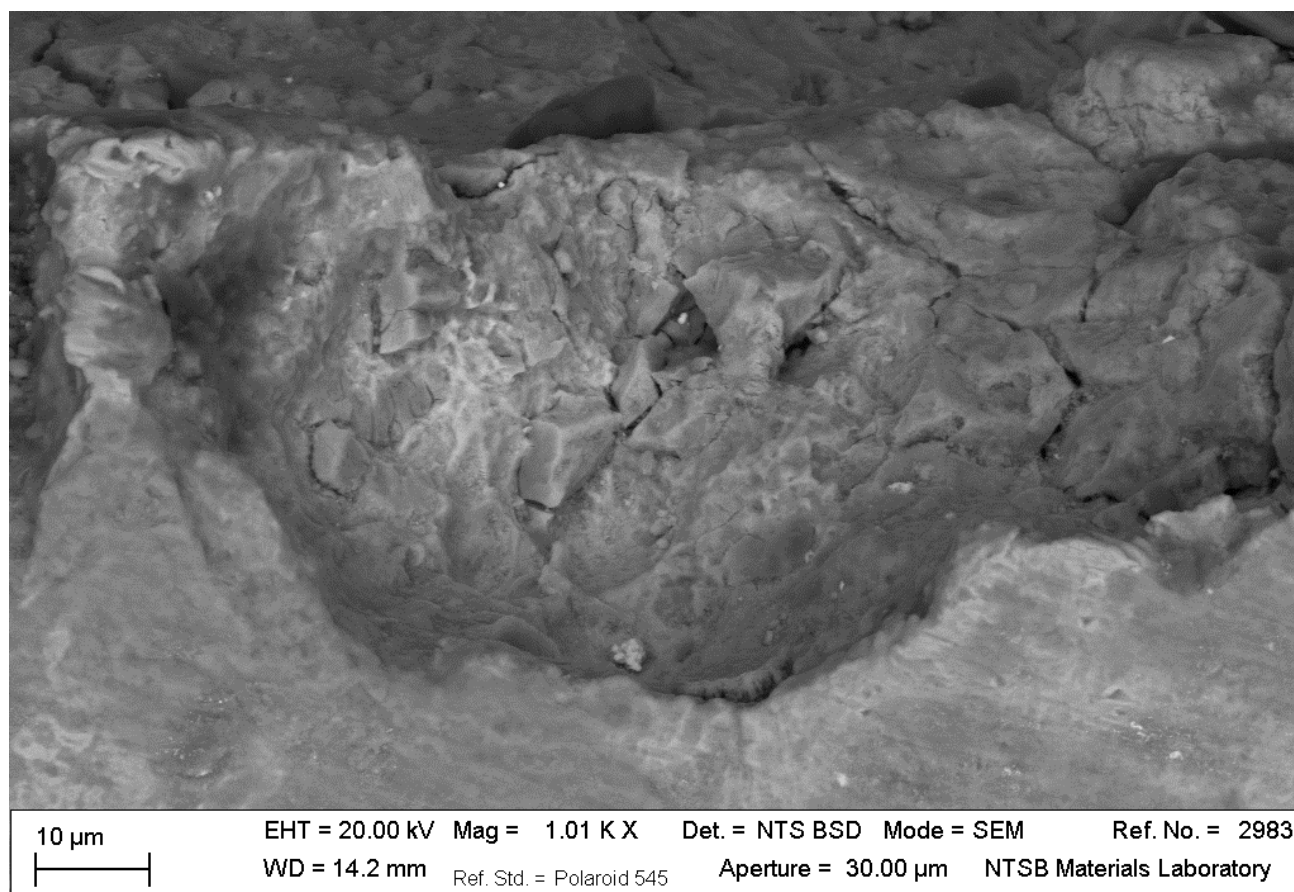
Multiple corrosion pits were present at the fatigue crack initiation site. The largest one is illustrated in Figure 17. The pit exhibited small facets consistent with local intergranular attack. The pit also exhibited local material loss, consistent with typical pitting corrosion. This and other pits contained non-conductive (non-metallic) compounds.

These compounds were inspected using energy dispersive x-ray spectroscopy (EDS). This examination the compounds to be consistent with an iron oxide, containing detectable levels of sodium, magnesium, phosphorus, potassium, sulfur, and calcium. These elements were not present in the bulk of the materials. Inspected using EDS, the chemical composition was found to be consistent with an alloy steel.

Figure 17 – Backscattered electron (BE) micrograph closeup of the corrosion pit at the fatigue crack initiation site.

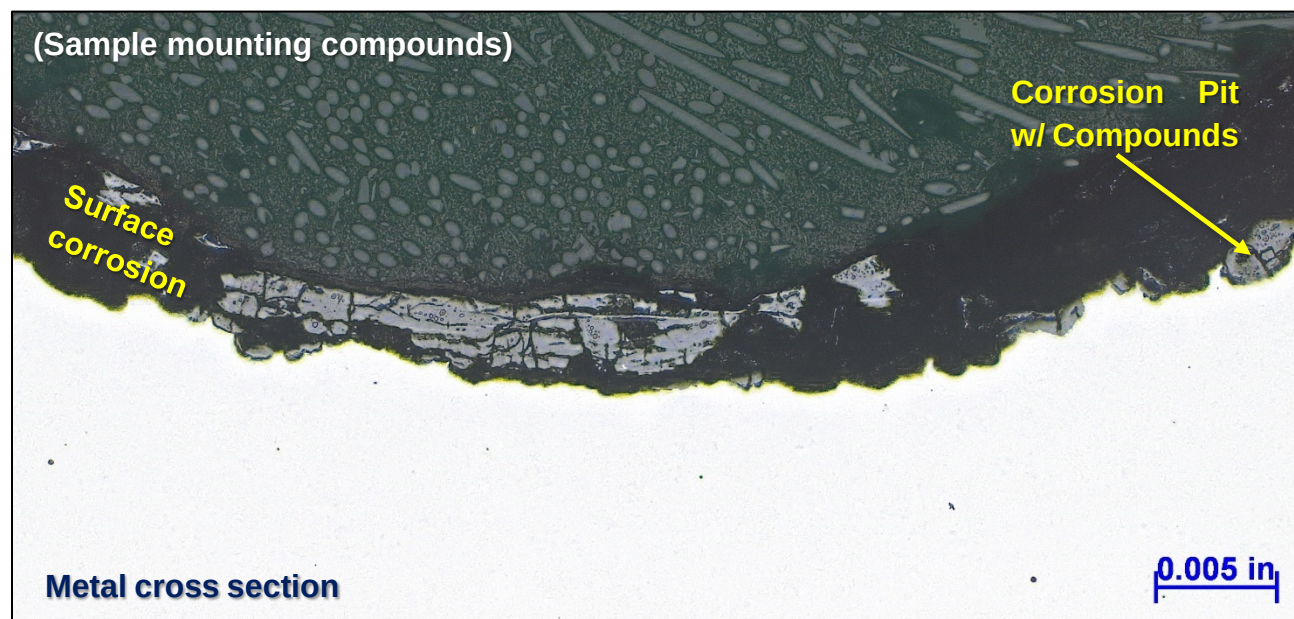
A portion of the cylinder and fins near the fracture surface was sectioned, mounted, and polished for metallographic examination. Of note were features present along the adjacent cooling fin valleys (see Figure 18). As shown in the figure, corrosion pits were present on the surface, with non-metallic compounds contained within. These corrosion pits were found on much of the surfaces examined in the cross-section (see Figure 19). The composition of these compounds, as examined using EDS, was consistent with that of the iron oxide compounds observed on the corrosion pits at the fatigue crack initiation site on the fracture surface.

Figure 18 – Bright field (BF) optical micrograph of a cross section of the cylidner wall, showing corrosion and pitting at a cooling fin root (~100X, as polished).

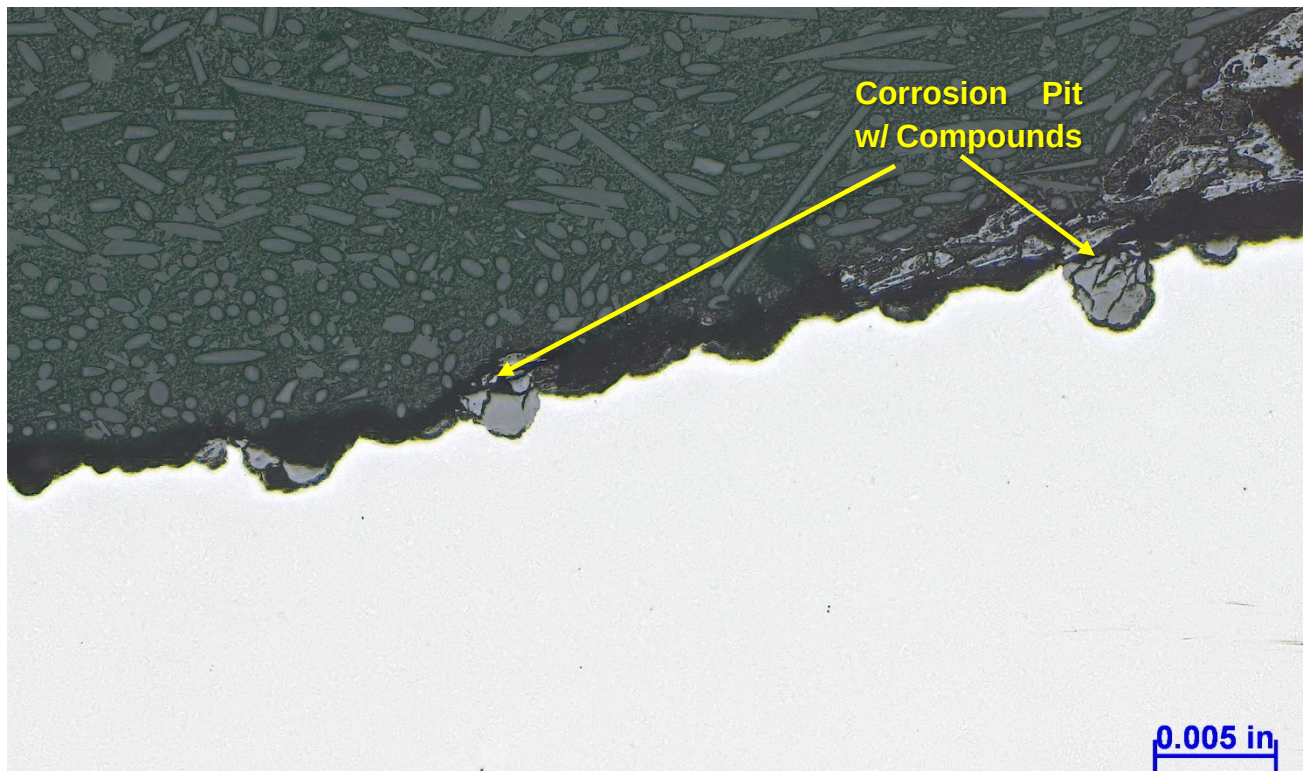
Figure 19 – BF optical micrograph of a cylinder wall cross-section showing corrosion pits along a fin (~100X, as polished).

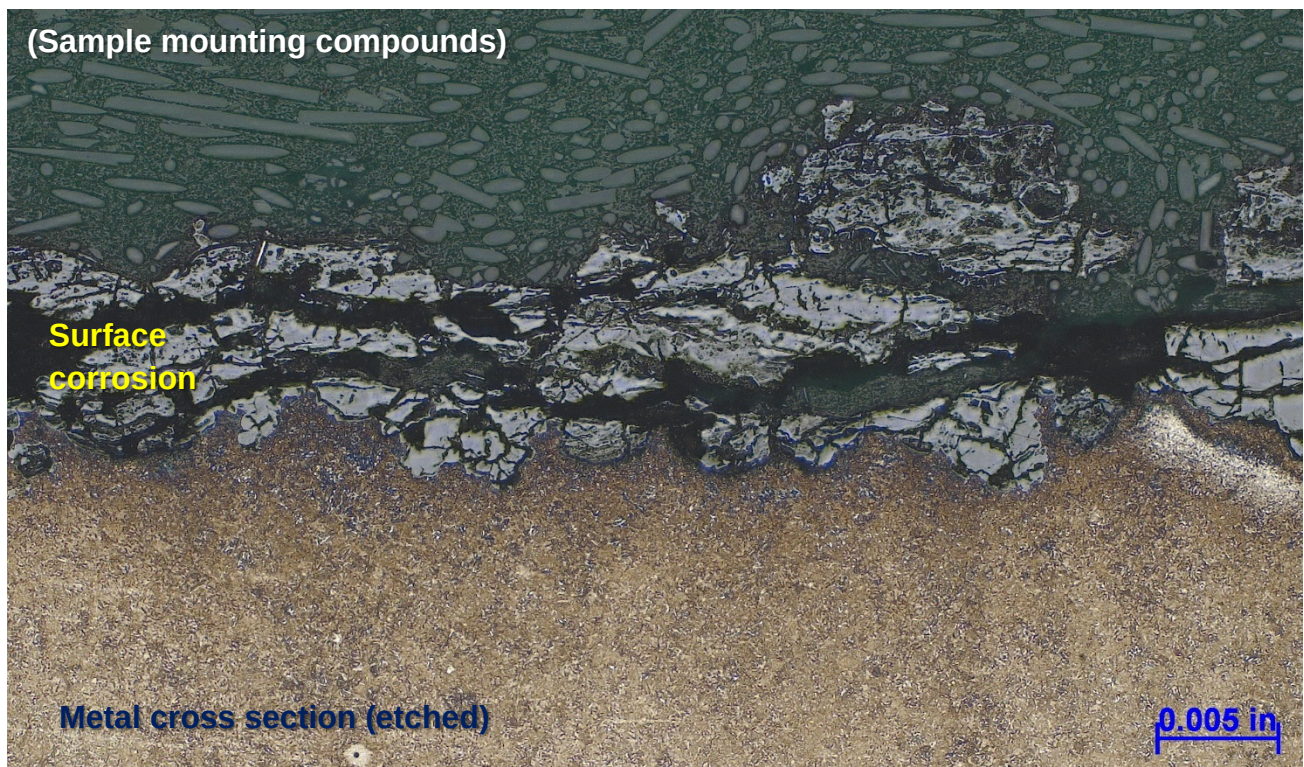
On much of the examined cross-section cylinder surfaces, surface corrosion up to 0.076 inches thick was observed (see Figures 20 through 22). This surface corrosion, more readily observable using SEM examination, was present at all the examined fin valleys, as exemplified in Figures 21 and 22. The chemical composition of these compounds was consistent with that of the corrosion pit compounds. As shown in Figure 22, this surface corrosion compound was cracked and discontinuous. The underlying interface with the base metal was tortuous in morphology, consistent with widespread pitting corrosion.

Figure 20 – BF optical micrograph highlighting surface corrosion and pitting on the cylinder (~100X, etched 2% Nital).

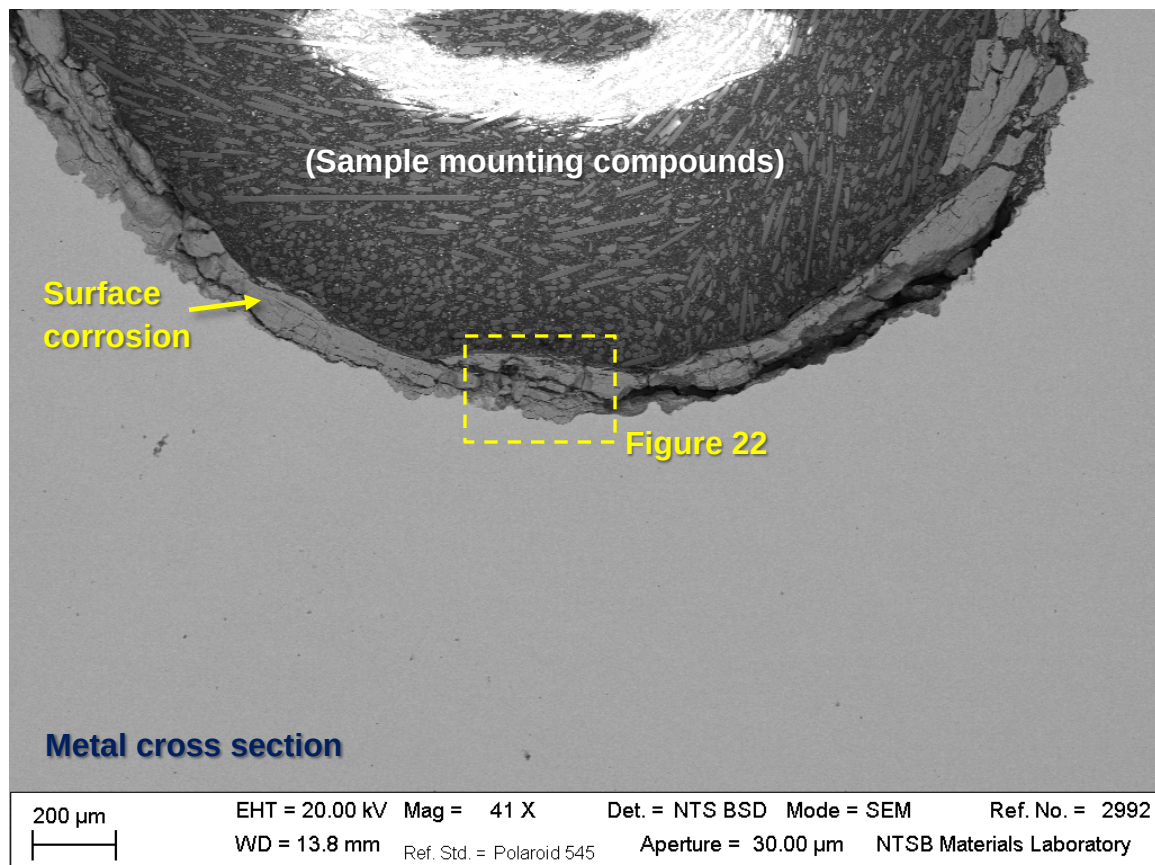
Figure 21 – BE micrograph showing corrosion and pitting at the cylinder fin root in Figure 18. The boxed area is highlighted in Figure 22.
