# NATIONAL TRANSPORTATION SAFETY BOARD

## MATERIALS LABORATORY FACTUAL REPORT

Report No. 18-012

Place : Homerville, Georgia  
Date : May 9, 2017  
Vehicle : Cessna 150M, N714DW  
NTSB No. : ERA17LA176  
Investigator : Todd Gunther, AS-ERA

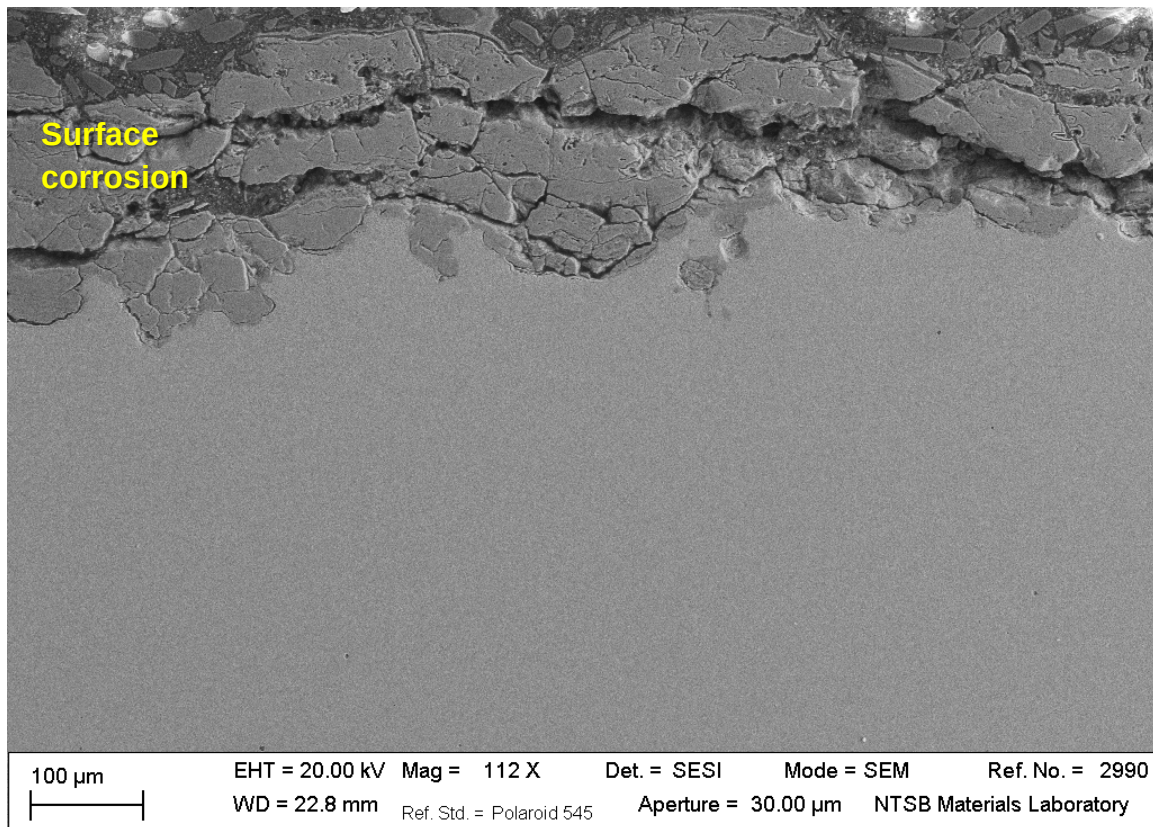
On much of the examined cross-section cylinder surfaces, surface corrosion up to 0.076 inches thick was observed (see Figures 20 through 22). This surface corrosion, more readily observable using SEM examination, was present at all the examined fin valleys, as exemplified in Figures 21 and 22. The chemical composition of these compounds was consistent with that of the corrosion pit compounds. As shown in Figure 22, this surface corrosion compound was cracked and discontinuous. The underlying interface with the base metal was tortuous in morphology, consistent with widespread pitting corrosion.

Figure 22 – BE micrograph showing a closer view of pitting and corrosion in Figure 21.

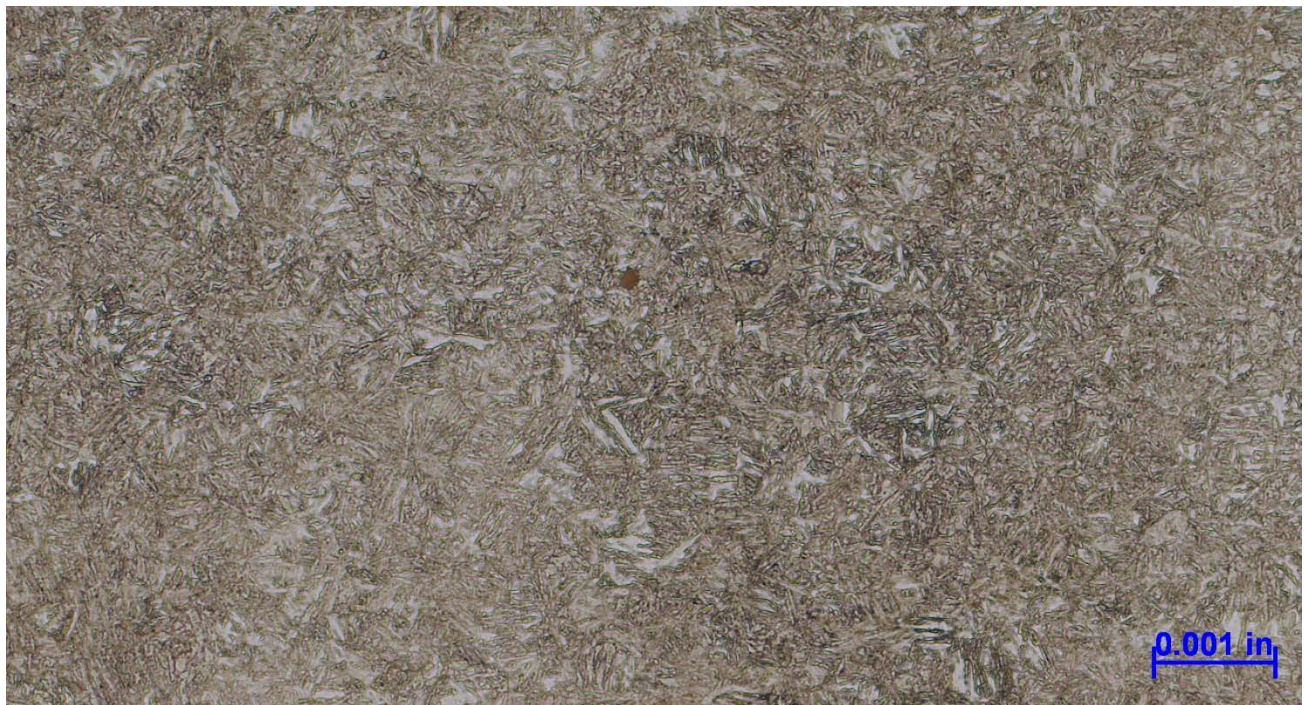
Examination of the cylinder microstructure found it to be consistent with tempered martensite and occasional manganese sulfide particles, typical for this material see Figure 23.

Figure 23 – BF optical micrograph showing the cylinder wall microstructure, consistent with tempered martensite (~500X, etched 2% Nital).
