**ERA17LA182**

**Stinson 108 – N9366K**

**NTSB ENGINE EXAMINATION REPORT**

**June 2, 2017**

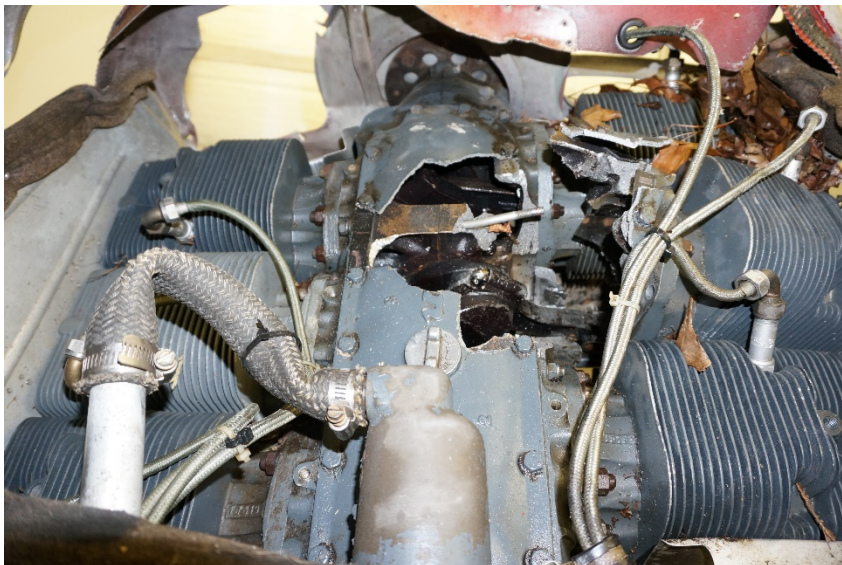
Picture 1. Top of Engine

The No. 4 cylinder was fracture separated from the crankcase and remained attached to the engine via the intake and exhaust manifolds.

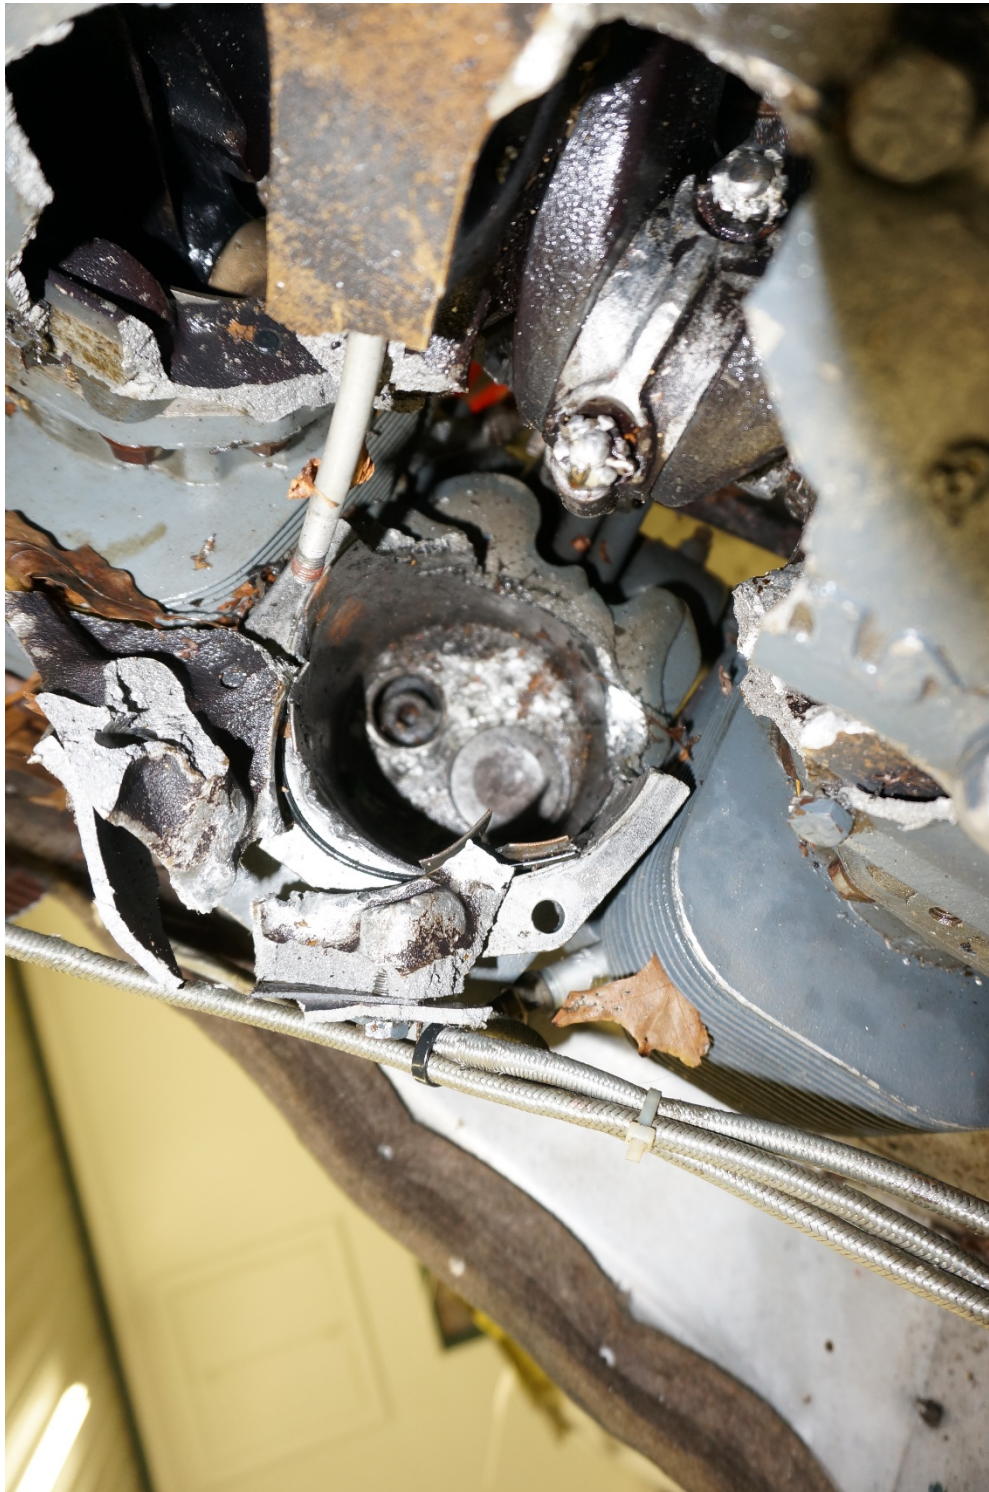
Picture 2. No. 4 Cylinder

The No. 4 piston was missing.

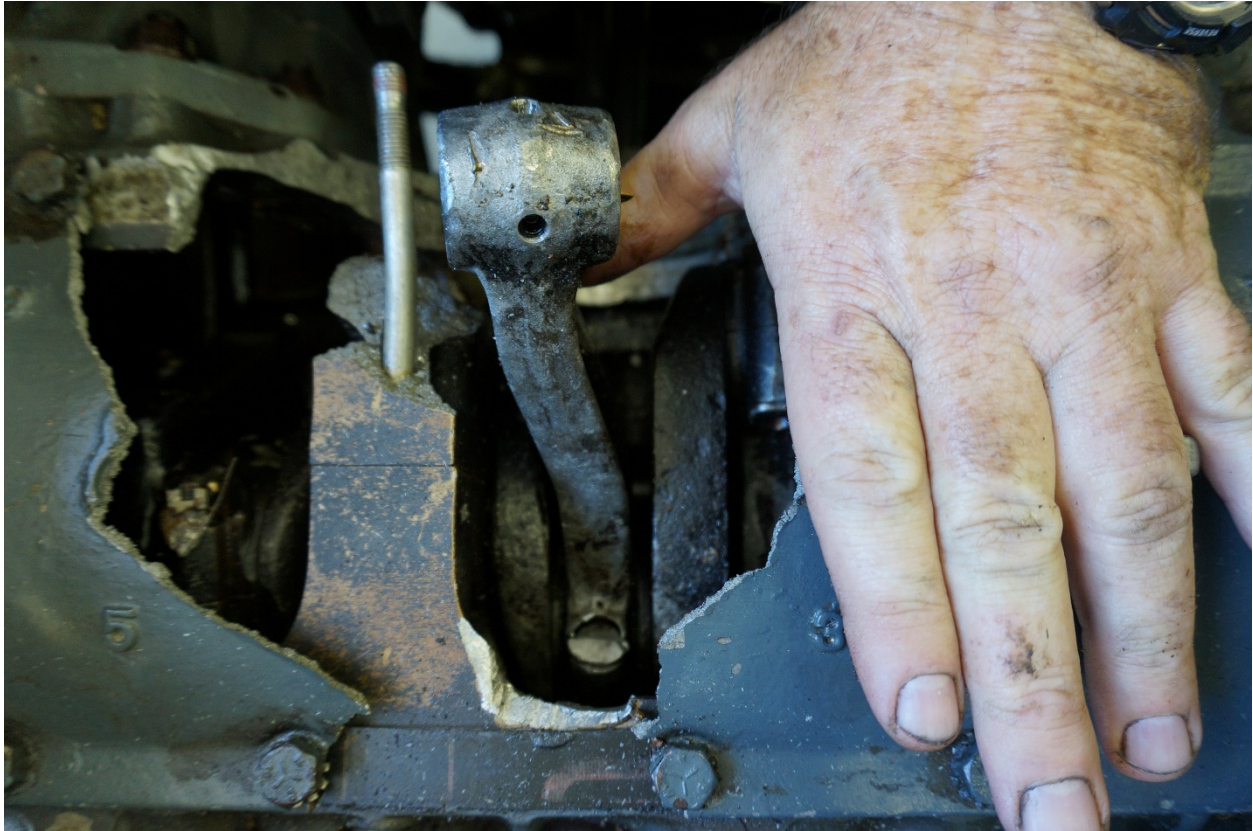
Picture 3. No. 4 Connecting Rod

The No. 4 connecting rod was bent, the wrist pin was missing, and damaged bearing material remained in the connecting rod piston end. The rod remained connected to the crankshaft.

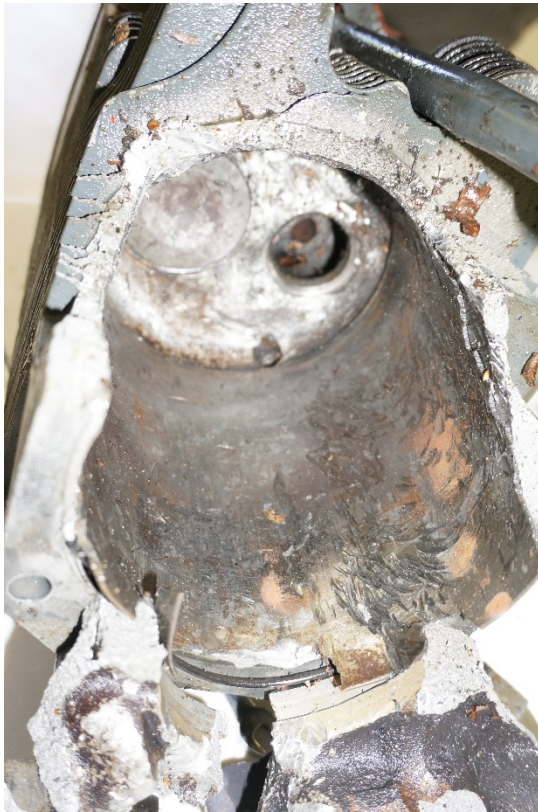
Picture 4. Internal View of No. 4 Cylinder

The No. 4 cylinder was fractured and a large portion was missing. The exhaust valve face was missing. The cylinder wall contained dozens of semi-circular gouges consistent with the diameter of the exhaust valve.

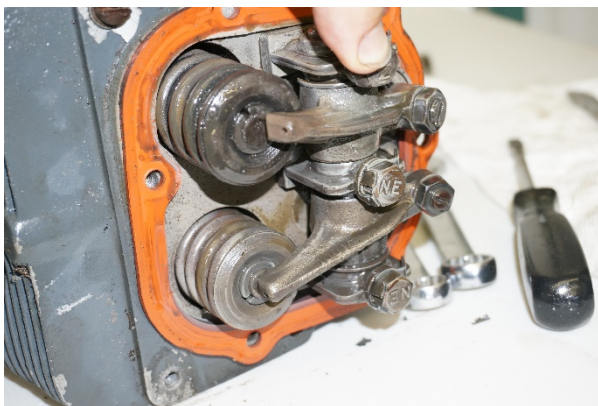
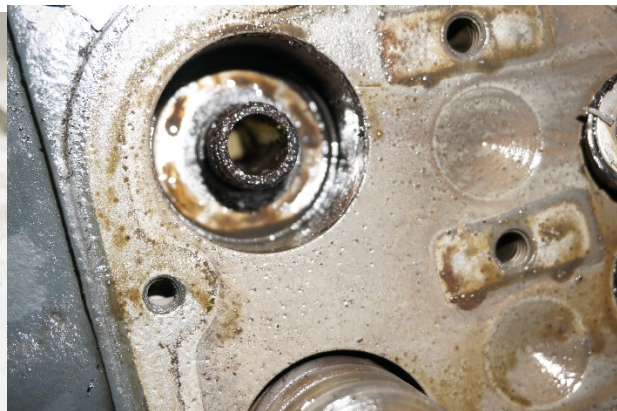
Picture 5. View of No. 4 Valve assembly and exhaust guide

The No. 4 exhaust valve stem was fractured. The valve guide and the area near the tip and spring retainer contained carbon deposits. The clearance between the stem and guide appeared excessive.

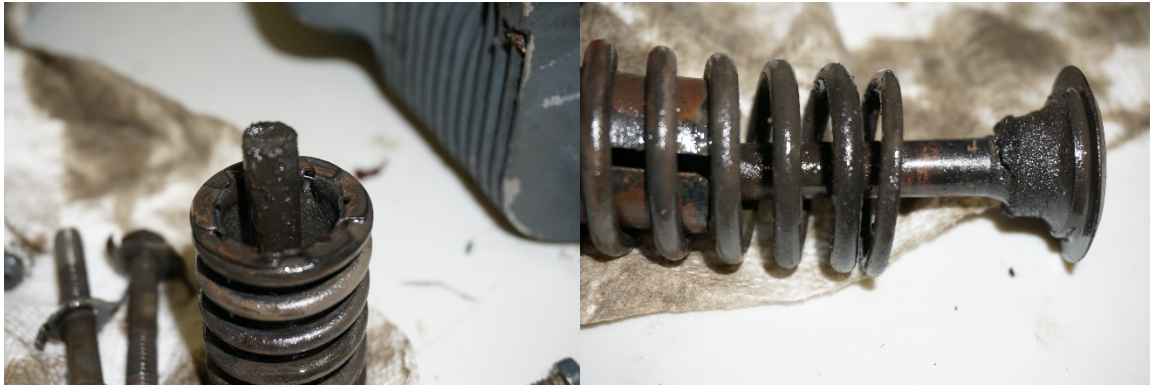
Picture 6. No. 4 Exhaust valve fractured stem and tip end

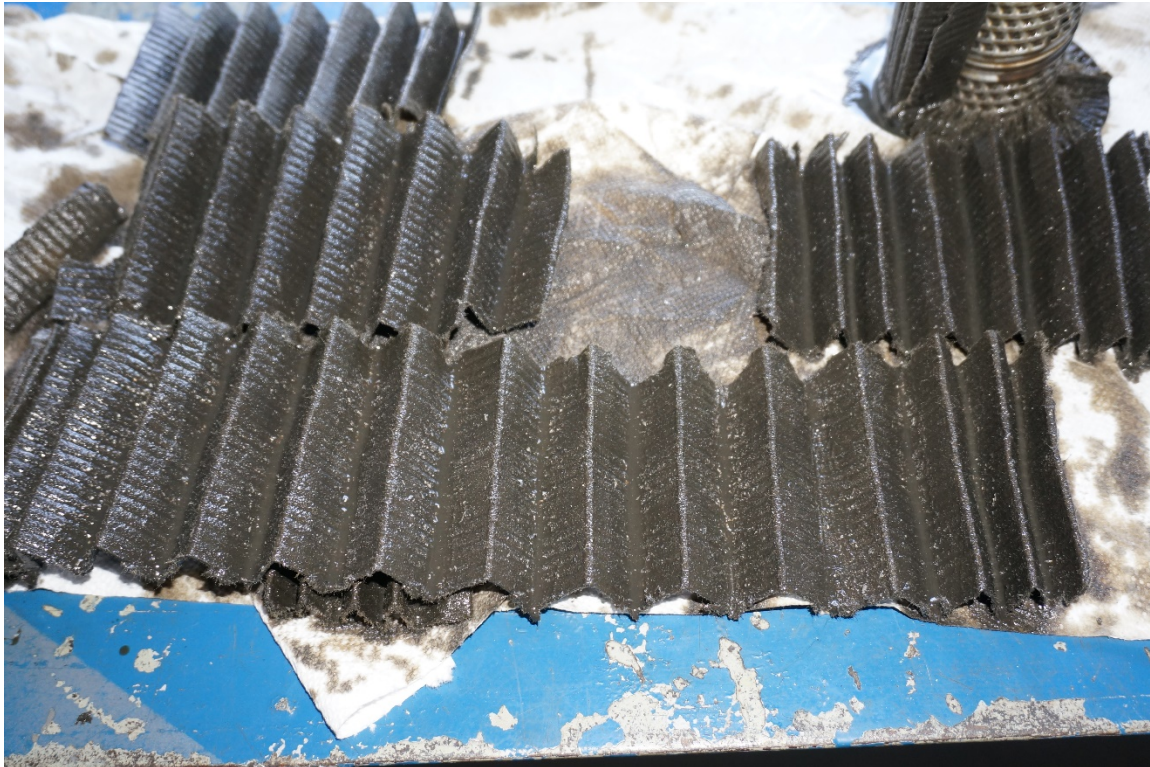
Picture 7. Oil Filter Element

The oil filter was cut open and the paper element examined. The element contained granular metallic debris about the size of sand grains.

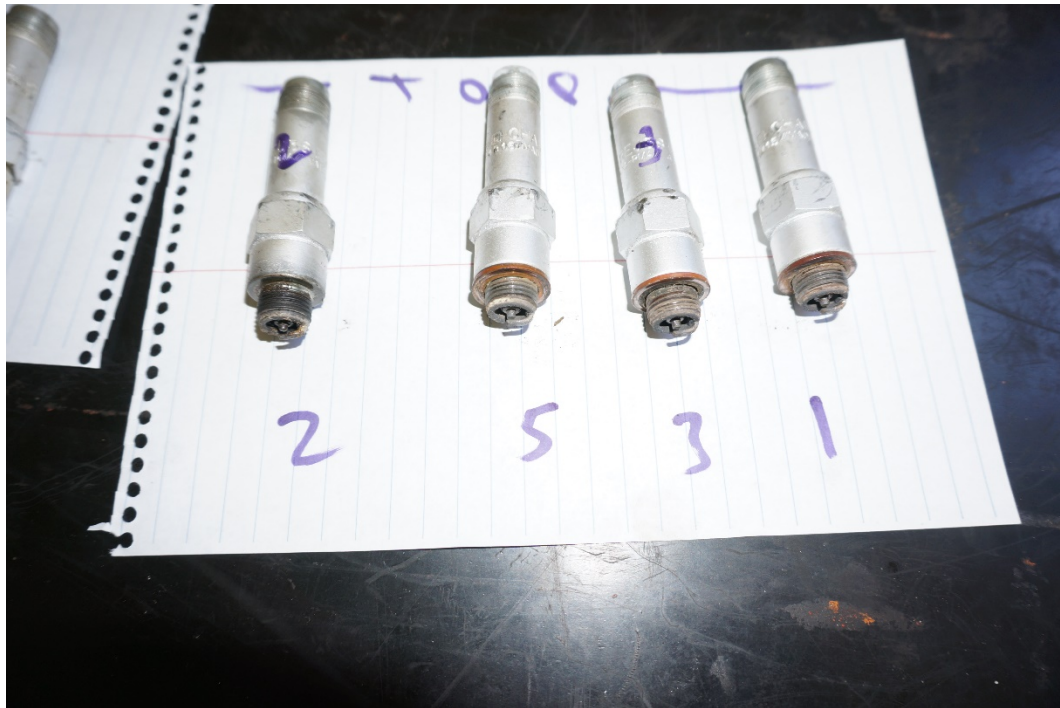
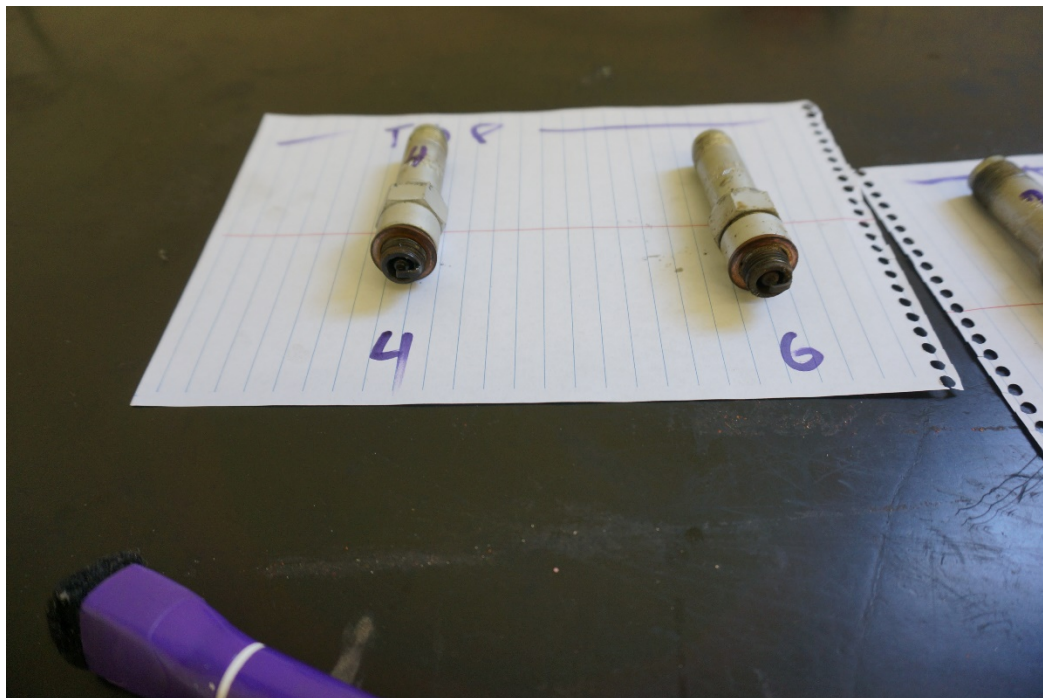
Picture 8. View of All Top Spark Plugs

The top spark plugs were removed from the engine. The Nos. 1, 3, 5, and 6 spark plugs were slightly sooted. The No. 2 electrode exhibited corrosion. The No. 4 spark plug was oil soaked.
