# NATIONAL TRANSPORTATION SAFETY BOARD

## MATERIALS LABORATORY FACTUAL REPORT

Report No. 18-066

Place : West Creek, New Jersey  
Date : May 15, 2017  
Vehicle : Stinson 108-2, N9366K  
NTSB No. : ERA17LA182  
Investigator : Heidi Kemner, AS-ERA

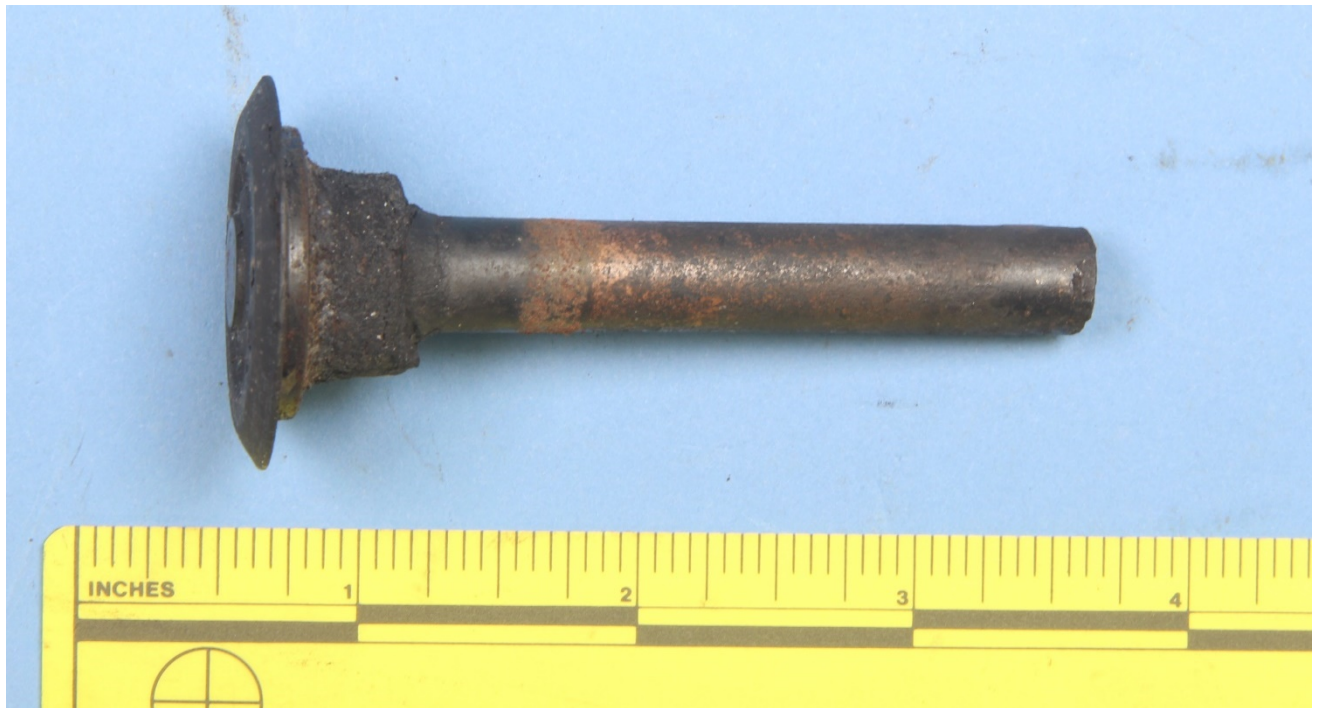
Figure 1 shows a remnant of an exhaust valve from the engine, as received. Figure 2 shows the fractured exhaust valve assembly from the side with the fracture surface and from the retainer side, as received. In the as-received condition, the retainer and retainer keepers were still in place on the end of the valve stem. Underneath the retainer was a cylindrical area of dark-colored viscous material (Figure 3). This material was consistent with residue or contamination that built up during service in the cylinder valve bore.

Figure 1 – The remnant of the exhaust valve, still affixed to the retainer, as received.

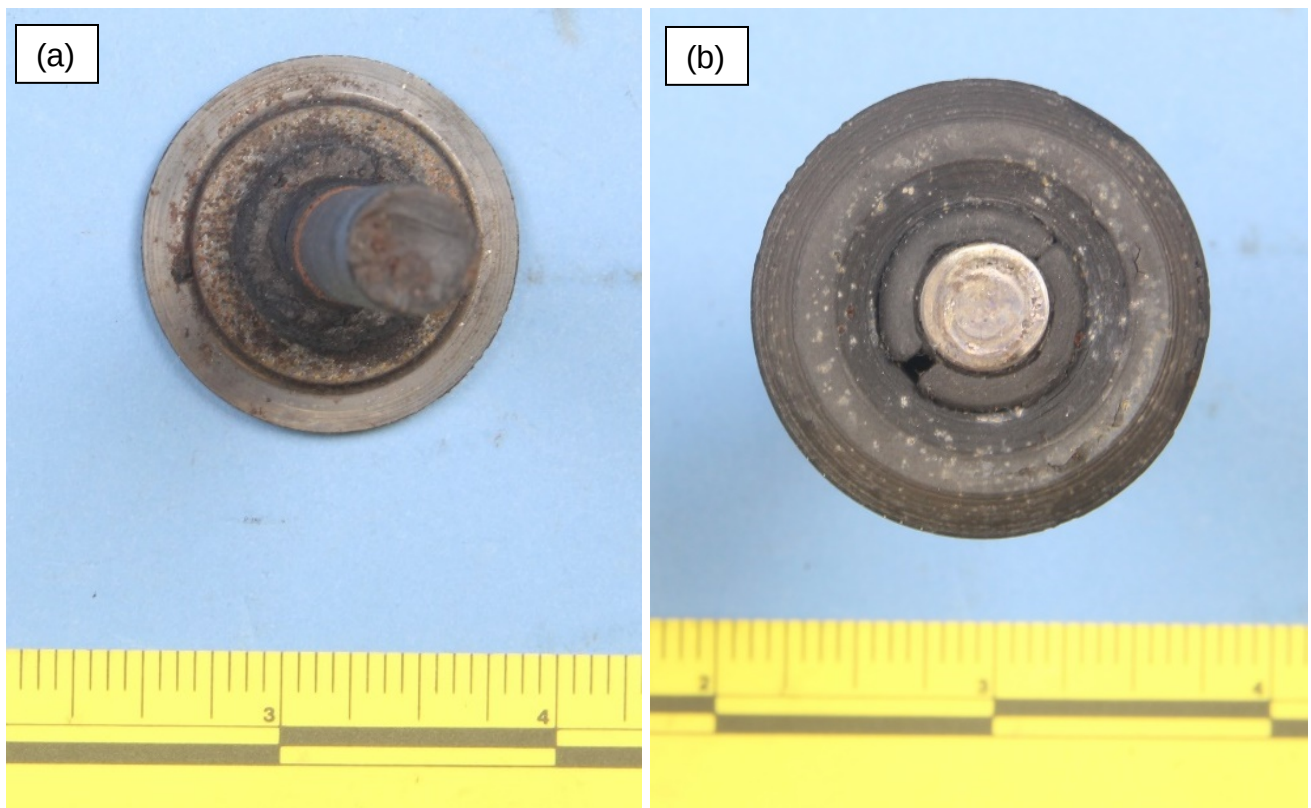
Figure 2 – The fractured valve assembly viewed from (a) the stem fracture surface and (b) the top rocker face with the retainer and keepers still attached, as received.

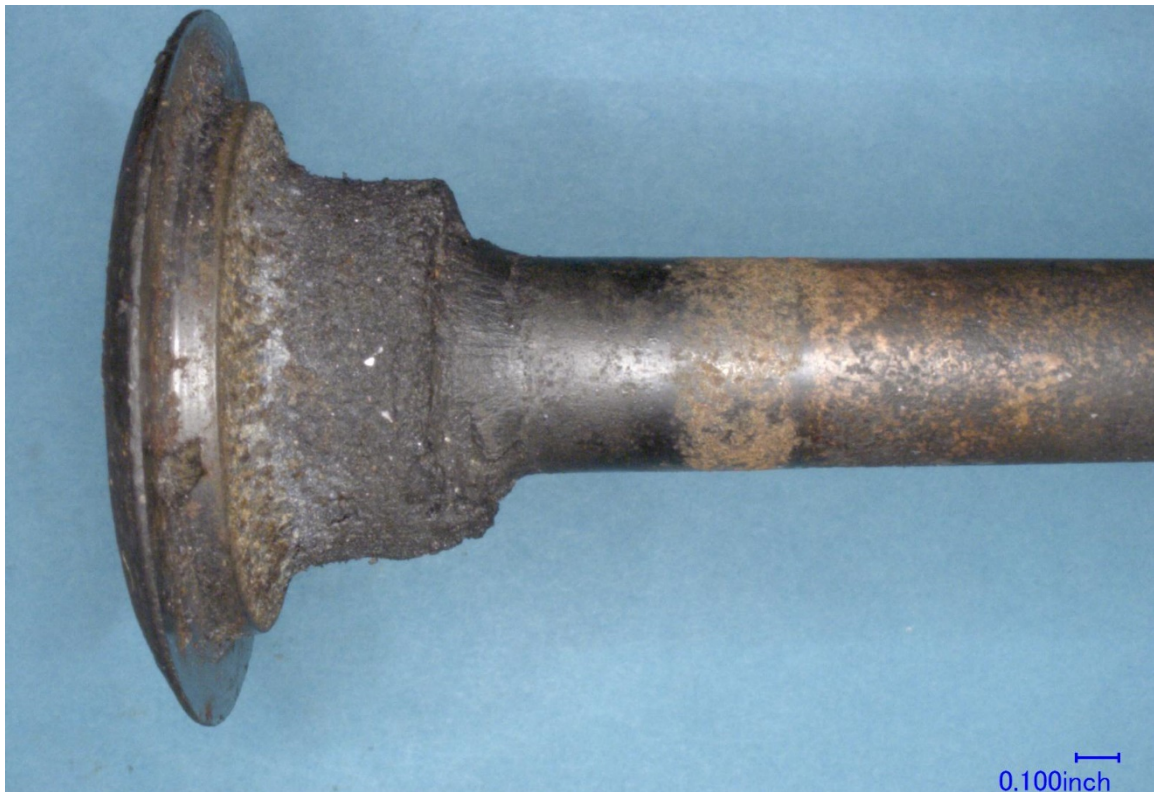
Figure 3 – The underside of the retainer on the exhaust valve, showing contamination buildup.

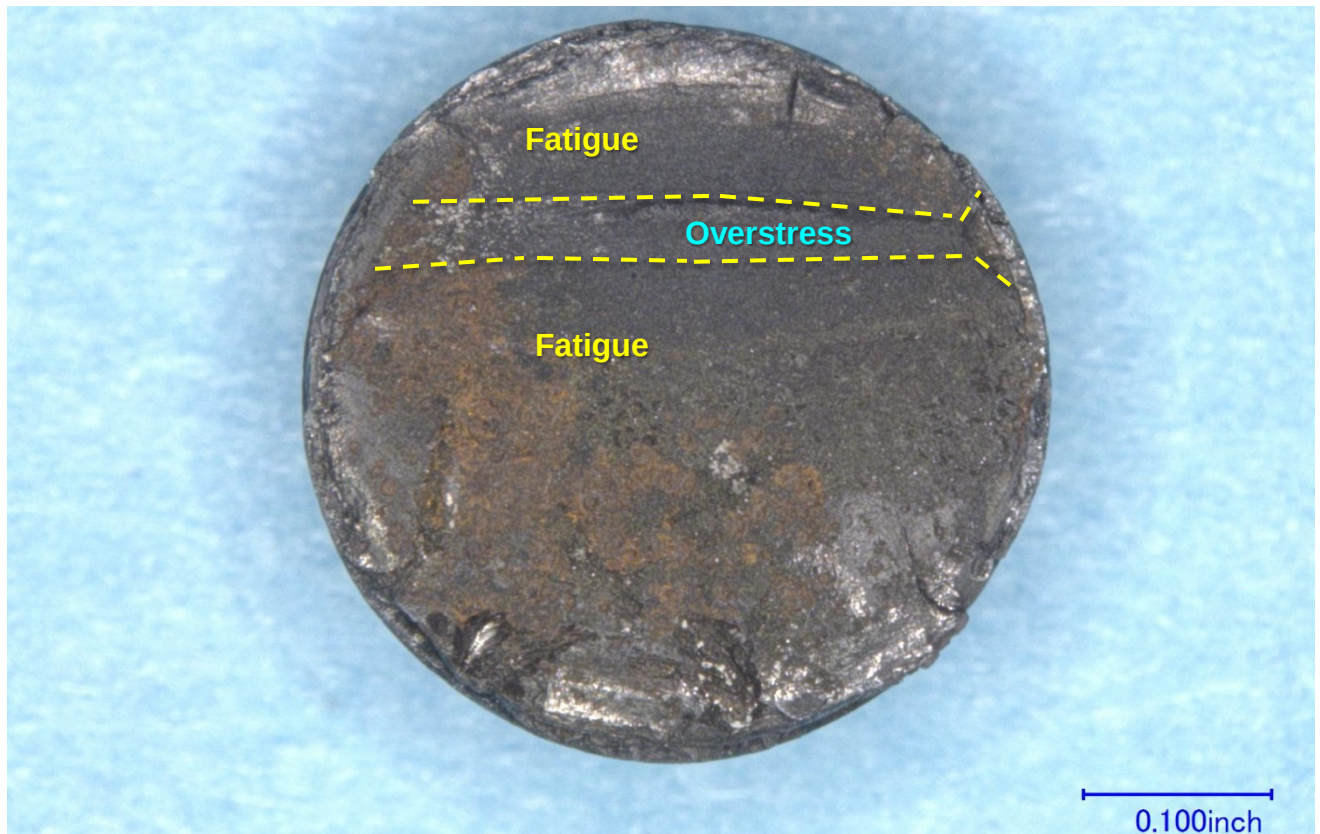
fracture surface is shown after sectioning in Figure 4. The fracture surface exhibited a general dull dark color, consistent with high temperature oxidation post-fracture. This oxidation obscured many of the underlying fracture features, although some areas that were relatively less damaged exhibited features that could be examined. There was no indication of local gross plastic deformation on the stem adjacent to the fracture surface. The stem thickness was measured in multiple places along the stem as 0.388 inches.

As annotated in Figure 4, the fracture surface exhibited features consistent with multiple fracture modes. The majority of the fracture surface exhibited features consistent with crack arrest marks having progressed from the outside of the valve stem inward. A thin strip of the fracture surface exhibiting rougher features was present between the areas exhibiting crack arrest marks (see Figure 5).

Figure 4 – View of the stem fracture surface after sectioning.

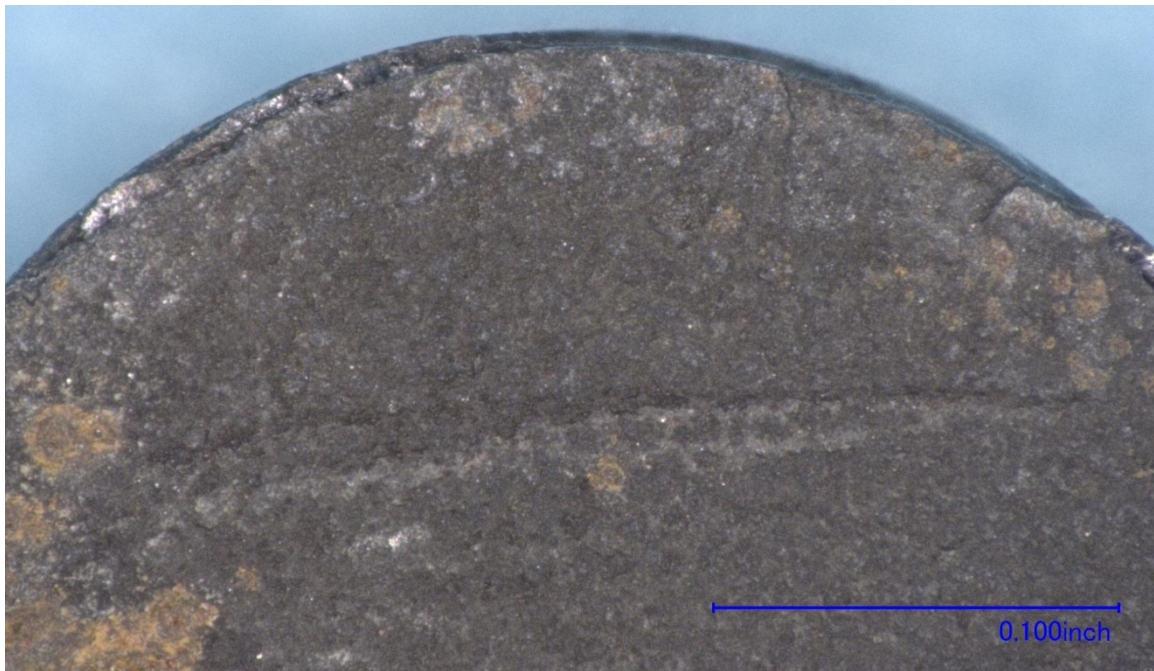
Figure 5 – Closer view of the portion of the fracture surface opposite Figure 5a, showing the middle ridge area on the fracture surface.

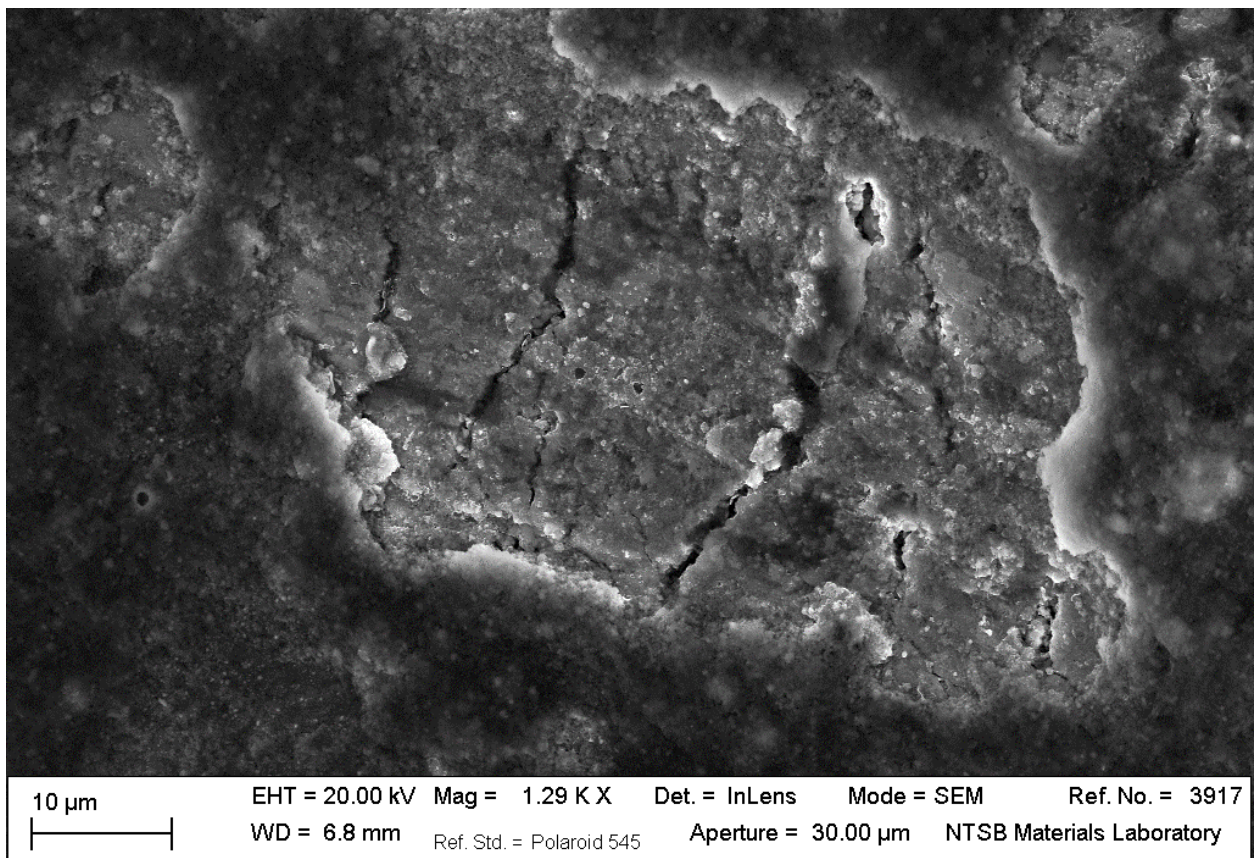
Figure 6 shows a typical area in where the outer oxide had been removed. The underlying surface exhibited fatigue striations, consistent with fatigue crack propagation. The nature of these striations was consistent with crack propagation inward from the outer surface. The features in the center strip on the fracture surface exhibited dimple rupture, consistent with tensile overstress, as typified in Figure 7. All of these fracture features were consistent with fracture of the exhaust valve stem by reverse bending fatigue crack propagation. When the fatigue cracks had propagated deep enough, the remaining middle cross section of the valve succumbed to tensile overstress.

Figure 6 – Secondary electron (SE) micrograph of corroded fatigue striations where the outer oxide spalled.

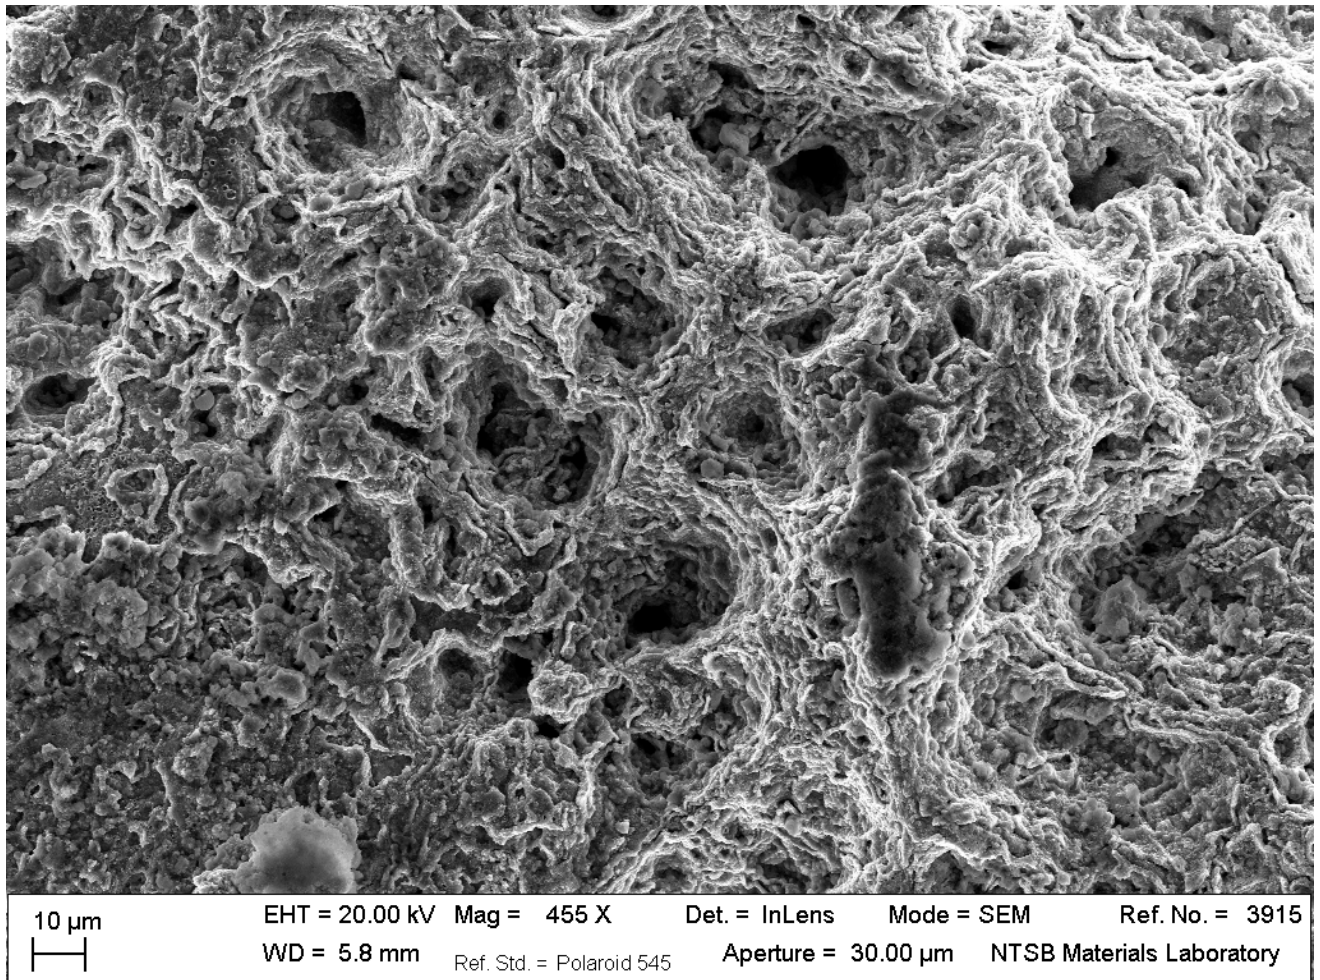
Figure 7 – SE micrograph showing oxidized dimple rupture features on the center strip portion of the fracture surface.

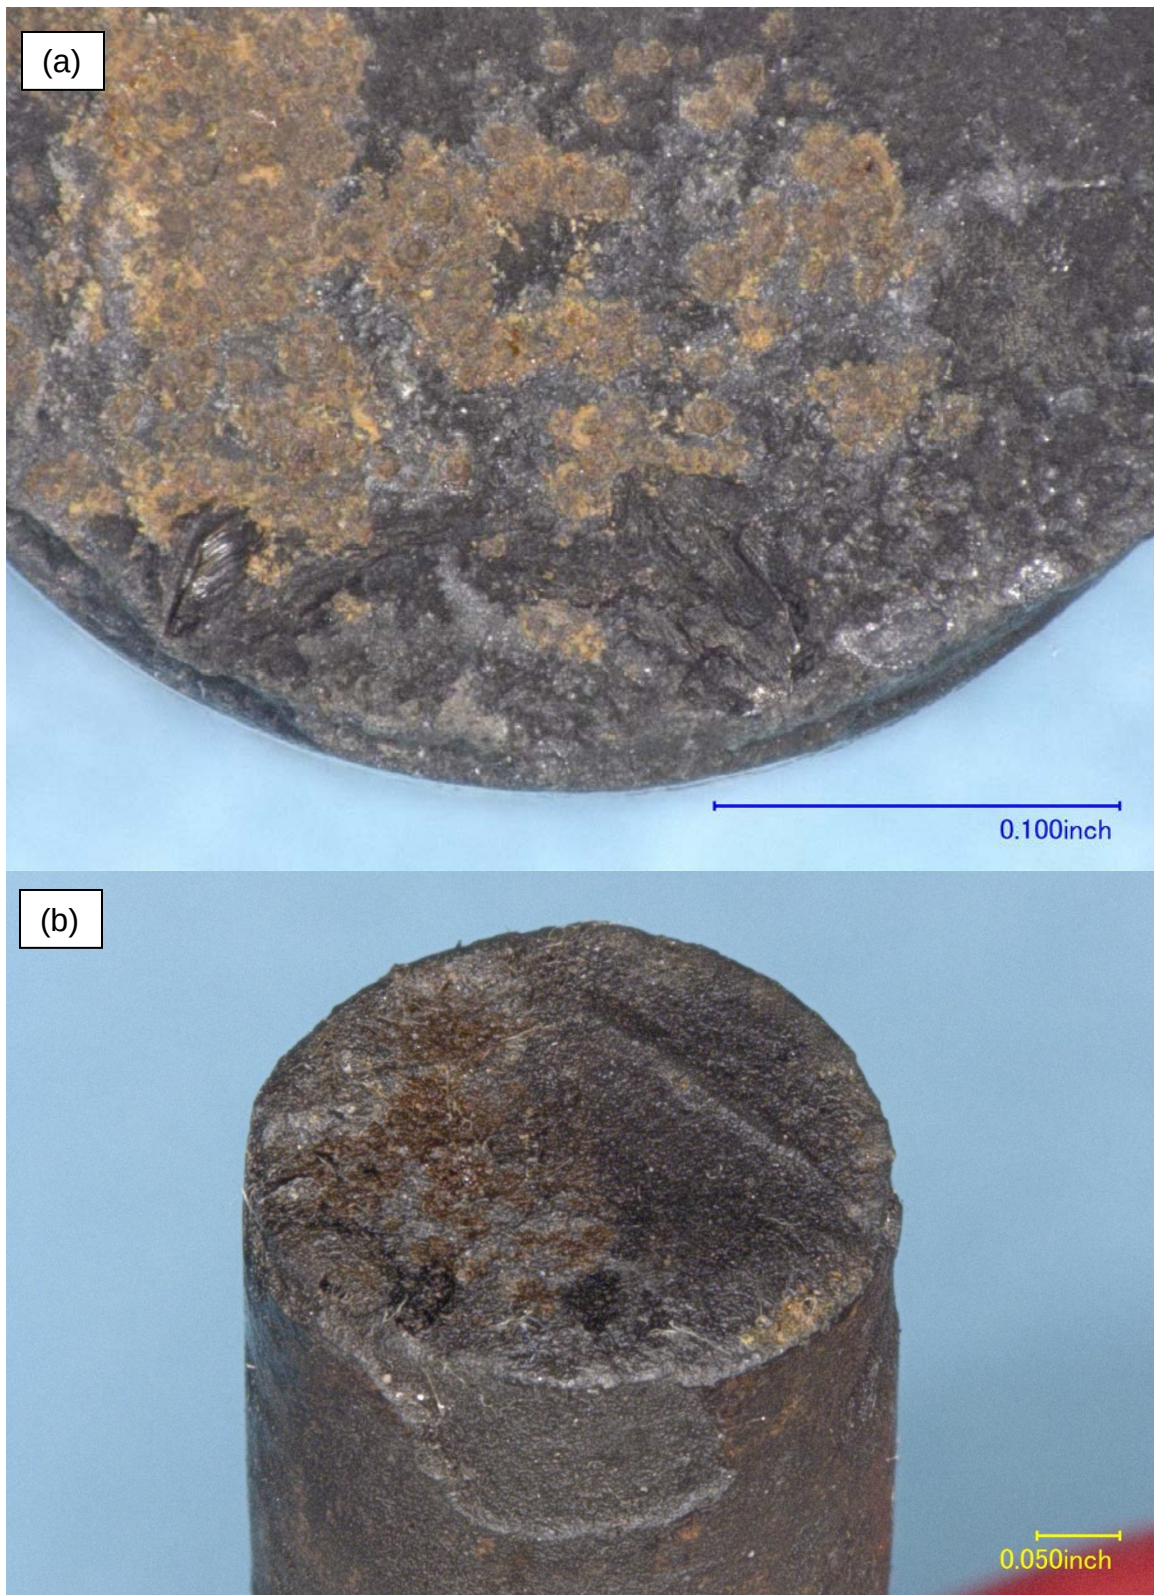
Distinctive features on the edges of the fracture surface indicative of fatigue crack initiation sites could not be ascertained due to the extensive corrosion and damage around the periphery. Figure 8 illustrates a typical area of this damage. Smearing, consistent with post-fracture contact was present. In addition, portions of the outer surface of the stem near the fracture surface had spalled off (Figure 8b). Some of this edge material was examined in the SEM, as shown in Figure 9. The outer layer of the valve stem surface exhibited a faceted fracture surface, exhibiting a porous interior. These features were consistent with brittle fracture of an outer oxide layer.

Figure 8 – The area consistent with the fatigue crack initiation site(s) viewed from (a) the fracture surface and (b) the side, showing outer material loss.

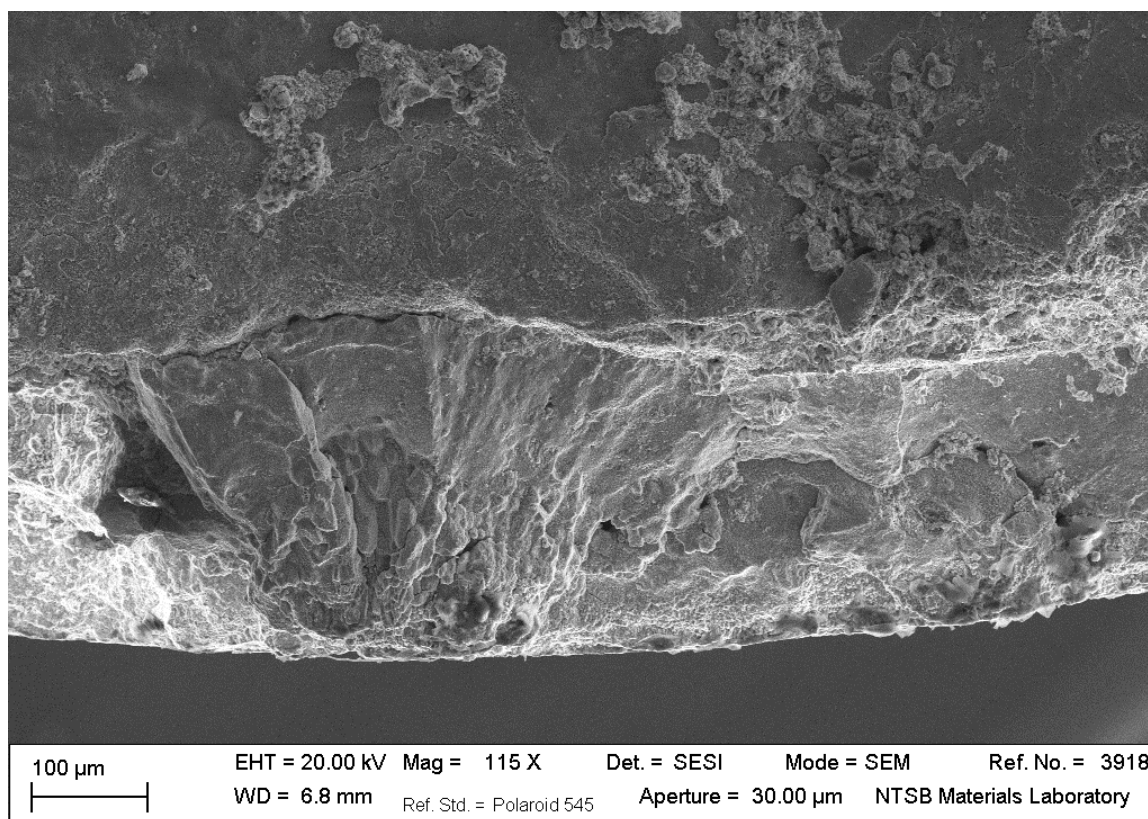
Figure 9 – SE micrograph showing the edge of the fracture surface, with fractured corrosion product.

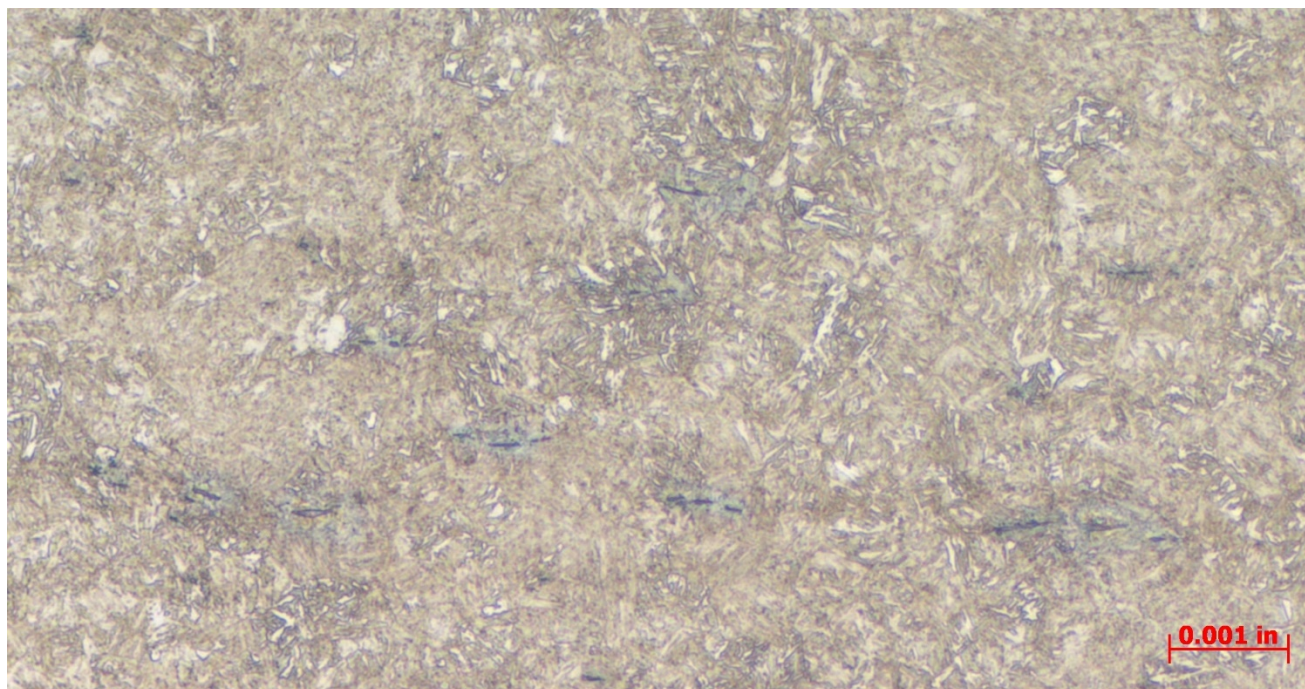
Transverse and longitudinal cross sections of the valve stem were mounted, polished, and etched. Figure 10 shows a typical portion of the stem microstructure. The microstructure consisted of ferrite and tempered martensite, along with second phase stringers in the longitudinal direction, consistent with manganese sulfide (MnS). This microstructure was consistent with those typical of alloy steels. The composition was examined using energy dispersive x-ray spectroscopy (EDS). The composition was found to be consistent with an alloy steel.

Figure 10 – Bright field (BF) optical micrograph showing a typical area of the valve stem microstructure (longitudinal cross-section), showing a tempered martensite microstructure with MnS stringers (~500X, etched 2% Nital).

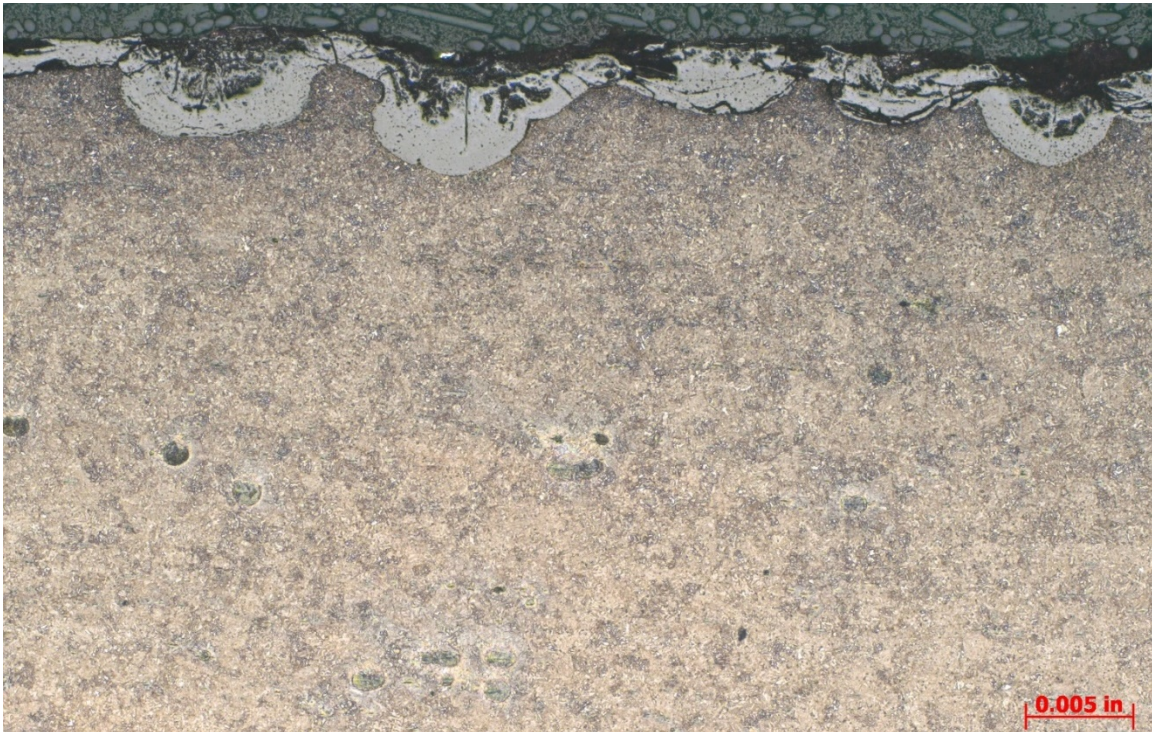
The surface of the valve stem was examined in both longitudinal (Figure 11) and transverse (Figure 12) cross section. In all cases, the surface of the stem exhibited an 0.003 to 0.005 inch thick, undulating surface layer of non-metallic material. This surface oxide exhibited cracks that were oriented in random directions, including 90° to the valve stem longitudinal direction. When examined using EDS, the material was found to be consistent with iron oxide. In addition, high levels of lead (Pb) and bromine (Br) were present. These elements were consistent with constituents in combustion compounds derived from the tetraethyl lead additives added to avgas aviation fuel.

Figure 11 – BF micrograph of a longitudinal cross section of the valve stem surface, showing undulated corrosion product (~100X, 2% Nital).

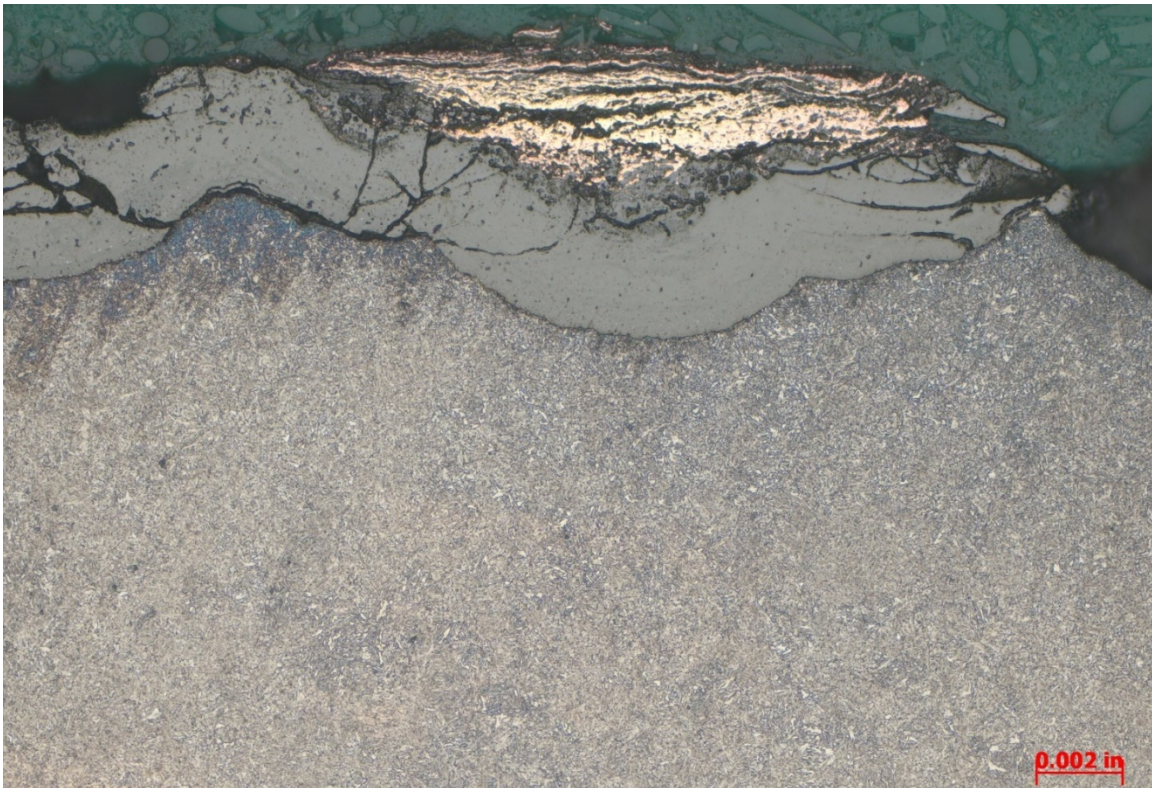
Figure 12 – BF micrograph of a transverse cross section of the valve stem near the fracture surface, showing surface oxidation (~200X, 2% Nital).
