**ERA17LA185**

**West Chester, Pennsylvania**

**Cessna 182S – N378ES**

**NTSB ENGINE EXAMINATION REPORT**

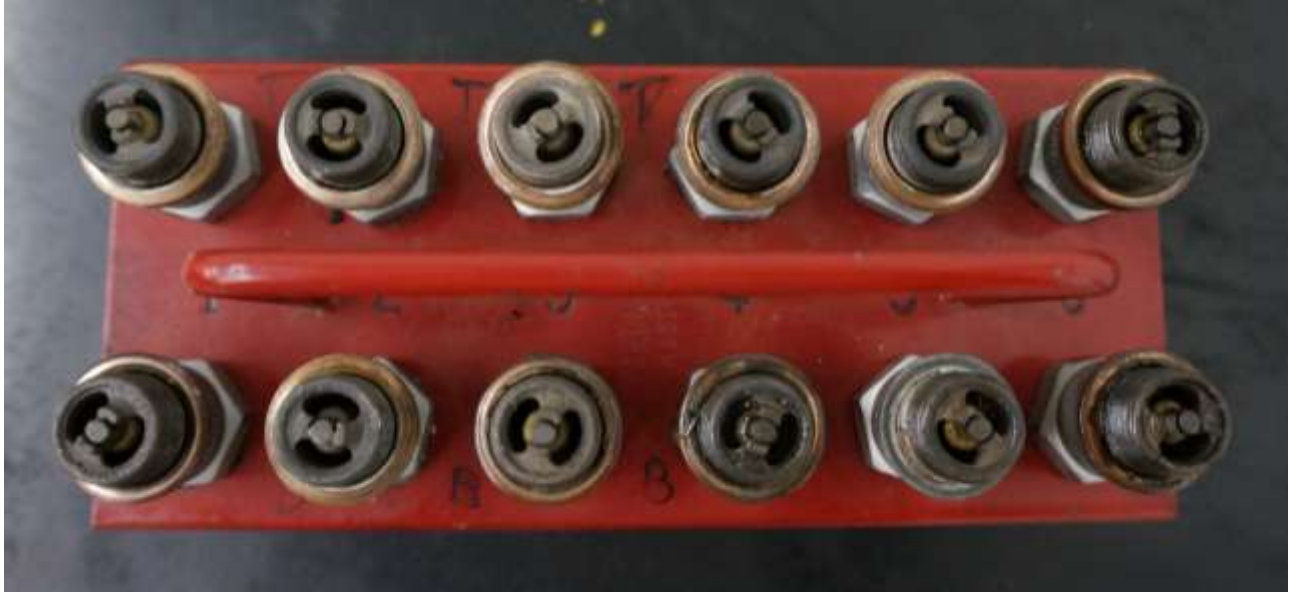
Picture 2. View of All Spark Plugs

All spark plugs were removed from the engine. The spark plugs were massive electrode type plugs. The No. 4 bottom spark plug and No. 6 top and bottom plugs were oil soaked.

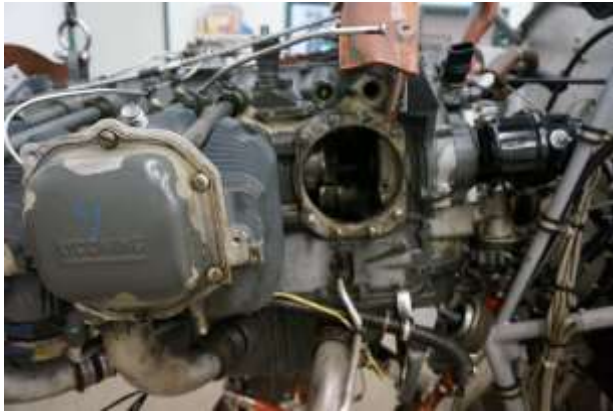
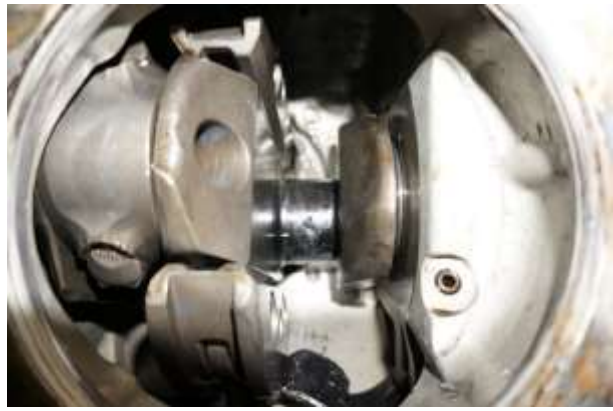
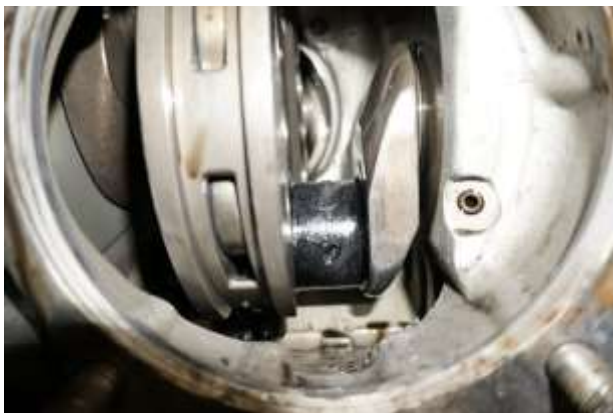
Picture 3. No. 6 Crankshaft Journal

Cylinder No. 6 was removed from the engine case. The No. 6 crankshaft connecting rod journal was discolored, smeared, and contained gouges, consistent with thermal damage.

The examination revealed that the No. 6 connecting rod and bearing exhibited lubrication and heat distress. In addition, the crankcase contained about  $\frac{1}{4}$  quart of oil. An on-site inspection by the FAA revealed that oil was streaking along the bottom of the airplane fuselage.

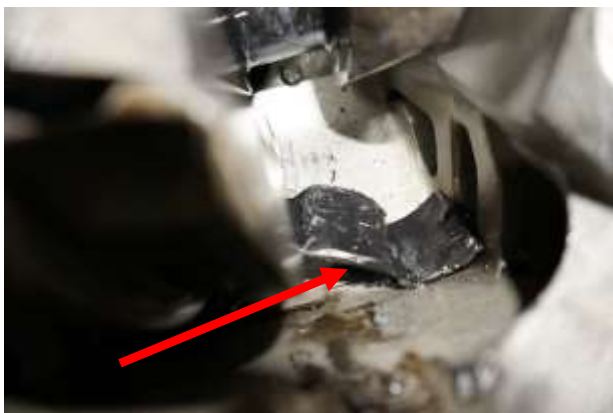
Picture 4. Bearing Material

Remnants of connecting rod bearing material were found loose inside the crankcase.

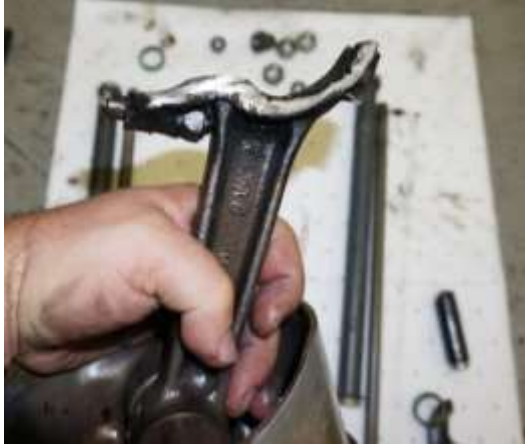
Picture 5. Connecting Rod and Cap

The crankshaft end of the connecting rod was spread open, discolored, and damaged. The rod end cap was separated from the rod, deformed, discolored and damaged. Both were consistent with thermal damage.

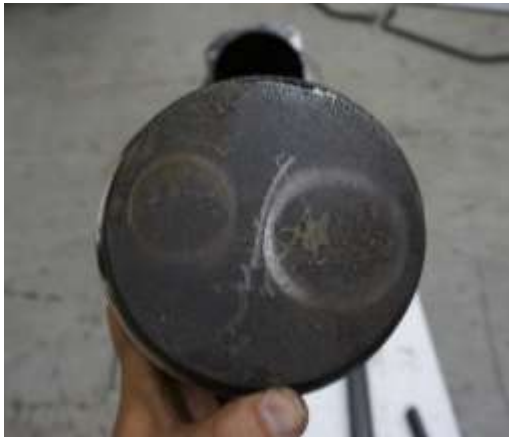
Picture 6. Piston Top

The piston top had impact marks consisting with contact from both valves.

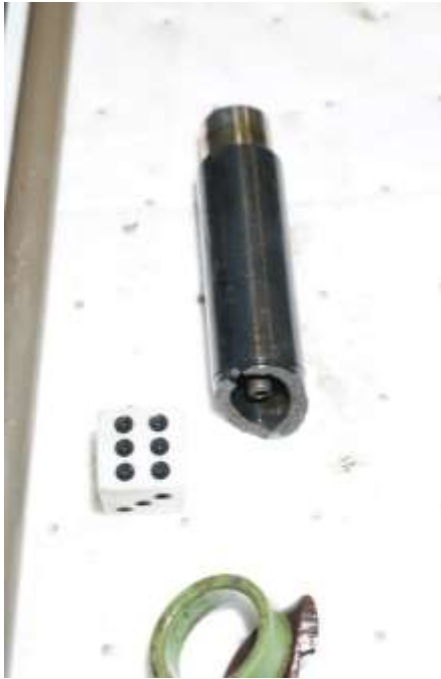
Picture 7. Fractured Exhaust Valve Lifter

The exhausted valve hydraulic lifter was fractured circumferentially.

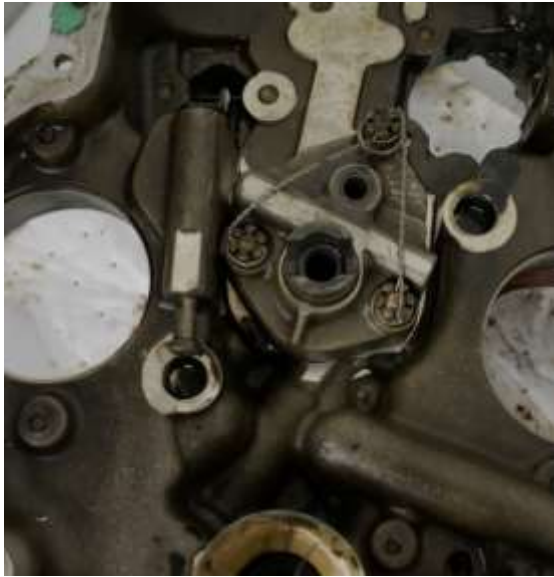
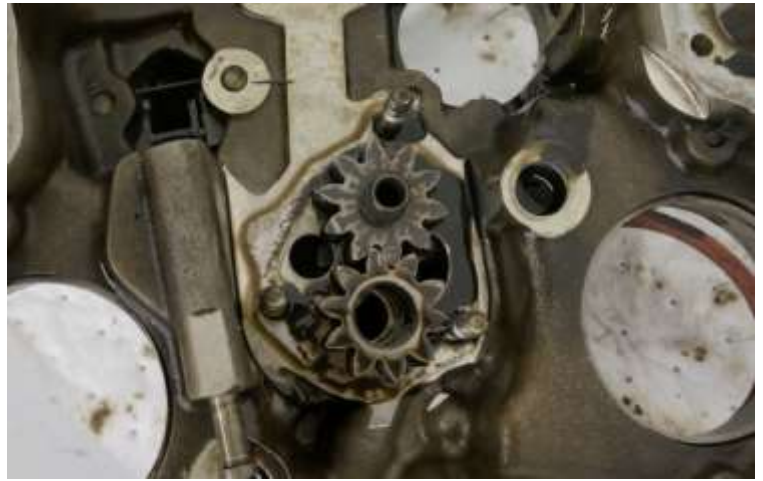
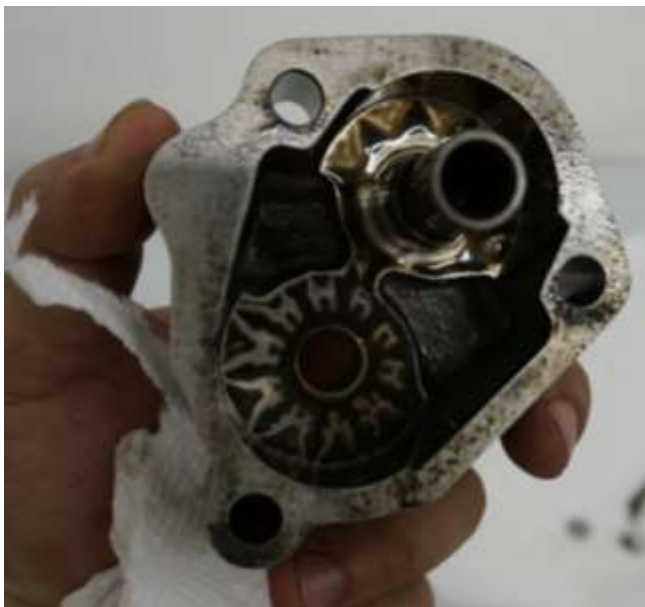
Picture 8. Oil Pump

The engine oil pump was removed. The safety wire on the housing bolts was intact. The housing cover was removed. The drive coupling, gears, and housing were intact with no damage noted. The shaft turned freely by hand. was removed from the engine. An unmeasured amount of oil and metal particles were noted inside the oil sump
