# NATIONAL TRANSPORTATION SAFETY BOARD

## MATERIALS LABORATORY FACTUAL REPORT

Report No. 18-009

Place : Suffolk, New York  
Date : June 12, 2017  
Vehicle : Cessna 172M, N13306  
NTSB No. : ERA17LA203  
Investigator : Heidi Kemner, ASI-ERA

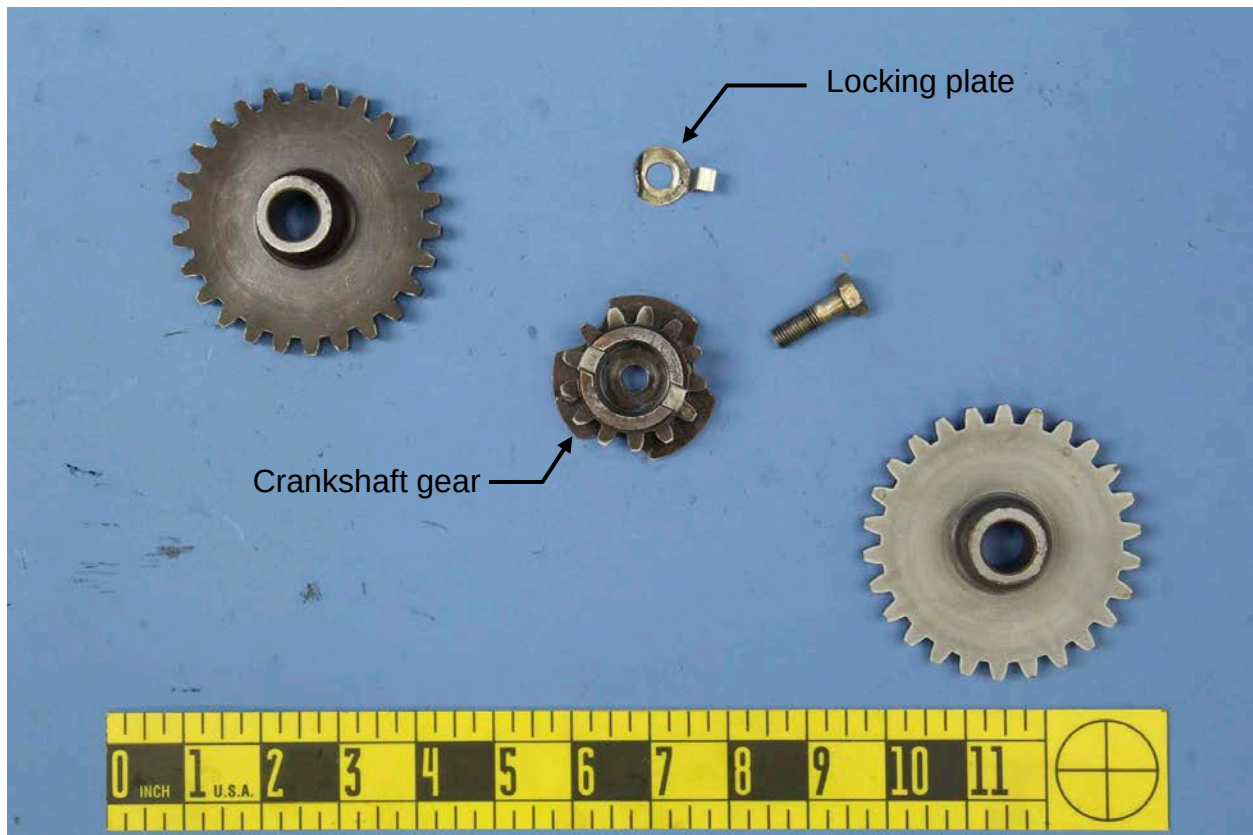
A crankshaft gear from a Lycoming O-320-series engine was submitted to the NTSB Materials Laboratory for examination along with two accessory gears, the locking bolt, and lockplate, as shown in figure 1. In normal operation, the crankshaft gear sits inside a counterbore recess at the aft end of the crankshaft. The rotational alignment of the gear with respect to the crankshaft is set by an alignment dowel that is press fit into the crankshaft counterbore recess. A machined hole in the crankshaft gear pilot flange accepts the alignment dowel and sets the rotational alignment of the gear with respect to the crankshaft. In the as-received condition, the alignment dowel had fractured, with one half retained with the crankshaft (not shown) and the other half retained in the pilot flange hole, as indicated in figures 2a and 2b.

**Figure 1:** The crankshaft gear, two accessory gears, bolt, and locking plate, as received by the lab.

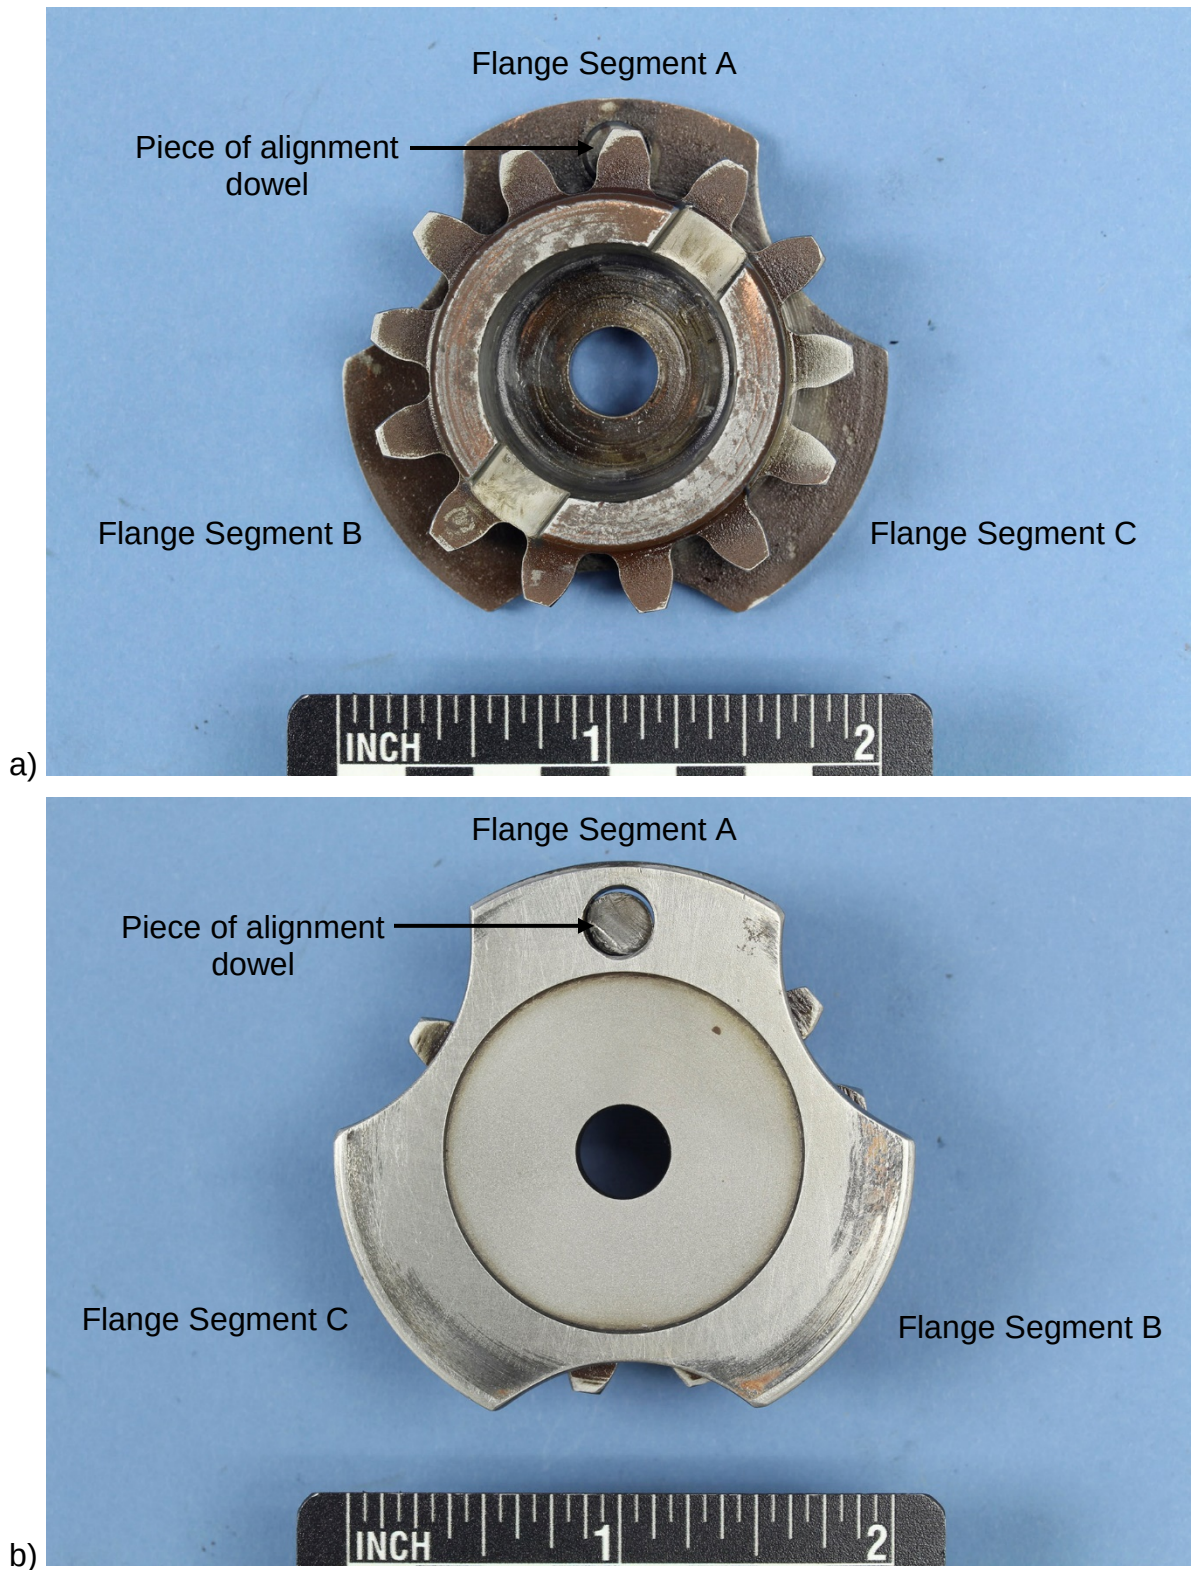
**Figure 2:** Images of the crankshaft gear: a) Outward-facing view of the gear and b) view of the counterbore face of the gear. For convenience the three flange segments are labelled A through C.

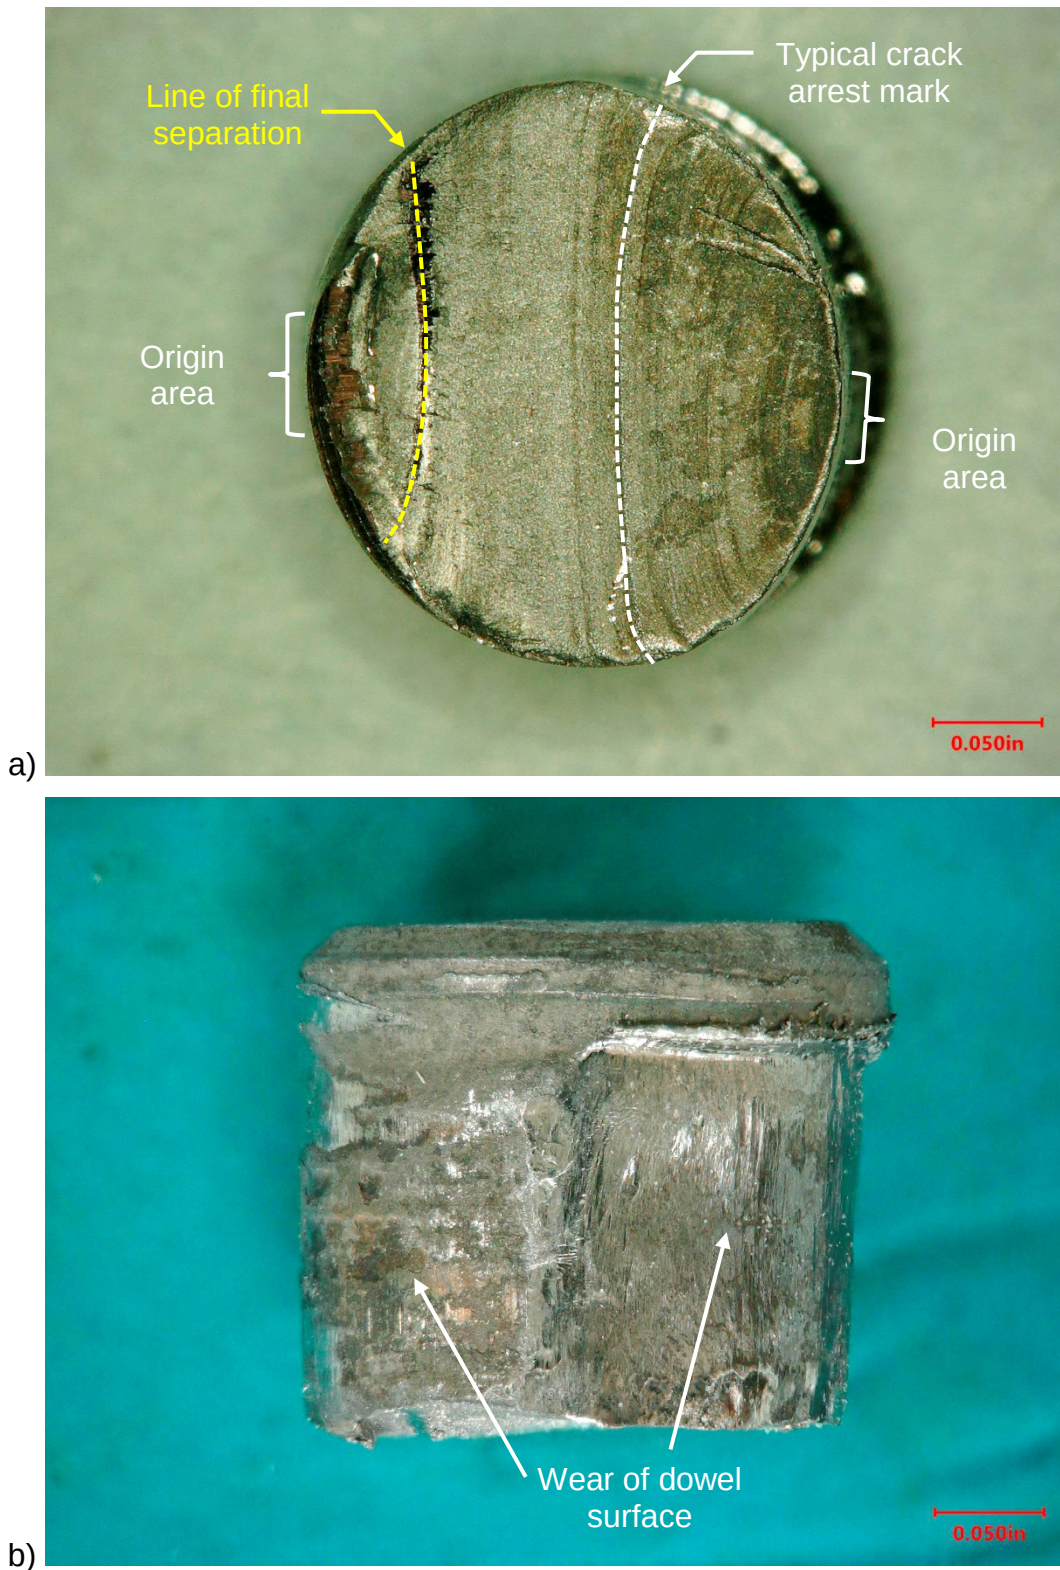
The piece of the alignment dowel was extracted from the hole with a punch and the fracture surface cleaned using standard laboratory procedures. The fracture surface, as shown in figure 3a, exhibited a flat appearance with multiple curved crack arrest marks progressing across the fracture. Multiple crack origin areas were observed on approximately opposite sides of the fracture. The crack from the origin area on the right of figure 3a covered approximately 80% of the fracture surface while the crack from the origin area on the left side of the figure covered approximately 20% of the fracture. The two cracks met along a line of final separation as indicated in figure 3a. The dowel surface exhibited wear marks, as indicated in figure 3b. On one side of the dowel, the wear had removed approximately 0.015 inch of material while the wear mark on the other side was

comparatively superficial. Taken together, the features were consistent with a fatigue fracture of the alignment dowel that initially progressed under unidirectional bending and transitioned to reverse bending.

**Figure 3:** a) Image of the fracture surface on the piece of alignment dowel and b) side view of the piece showing wear of the dowel surface.

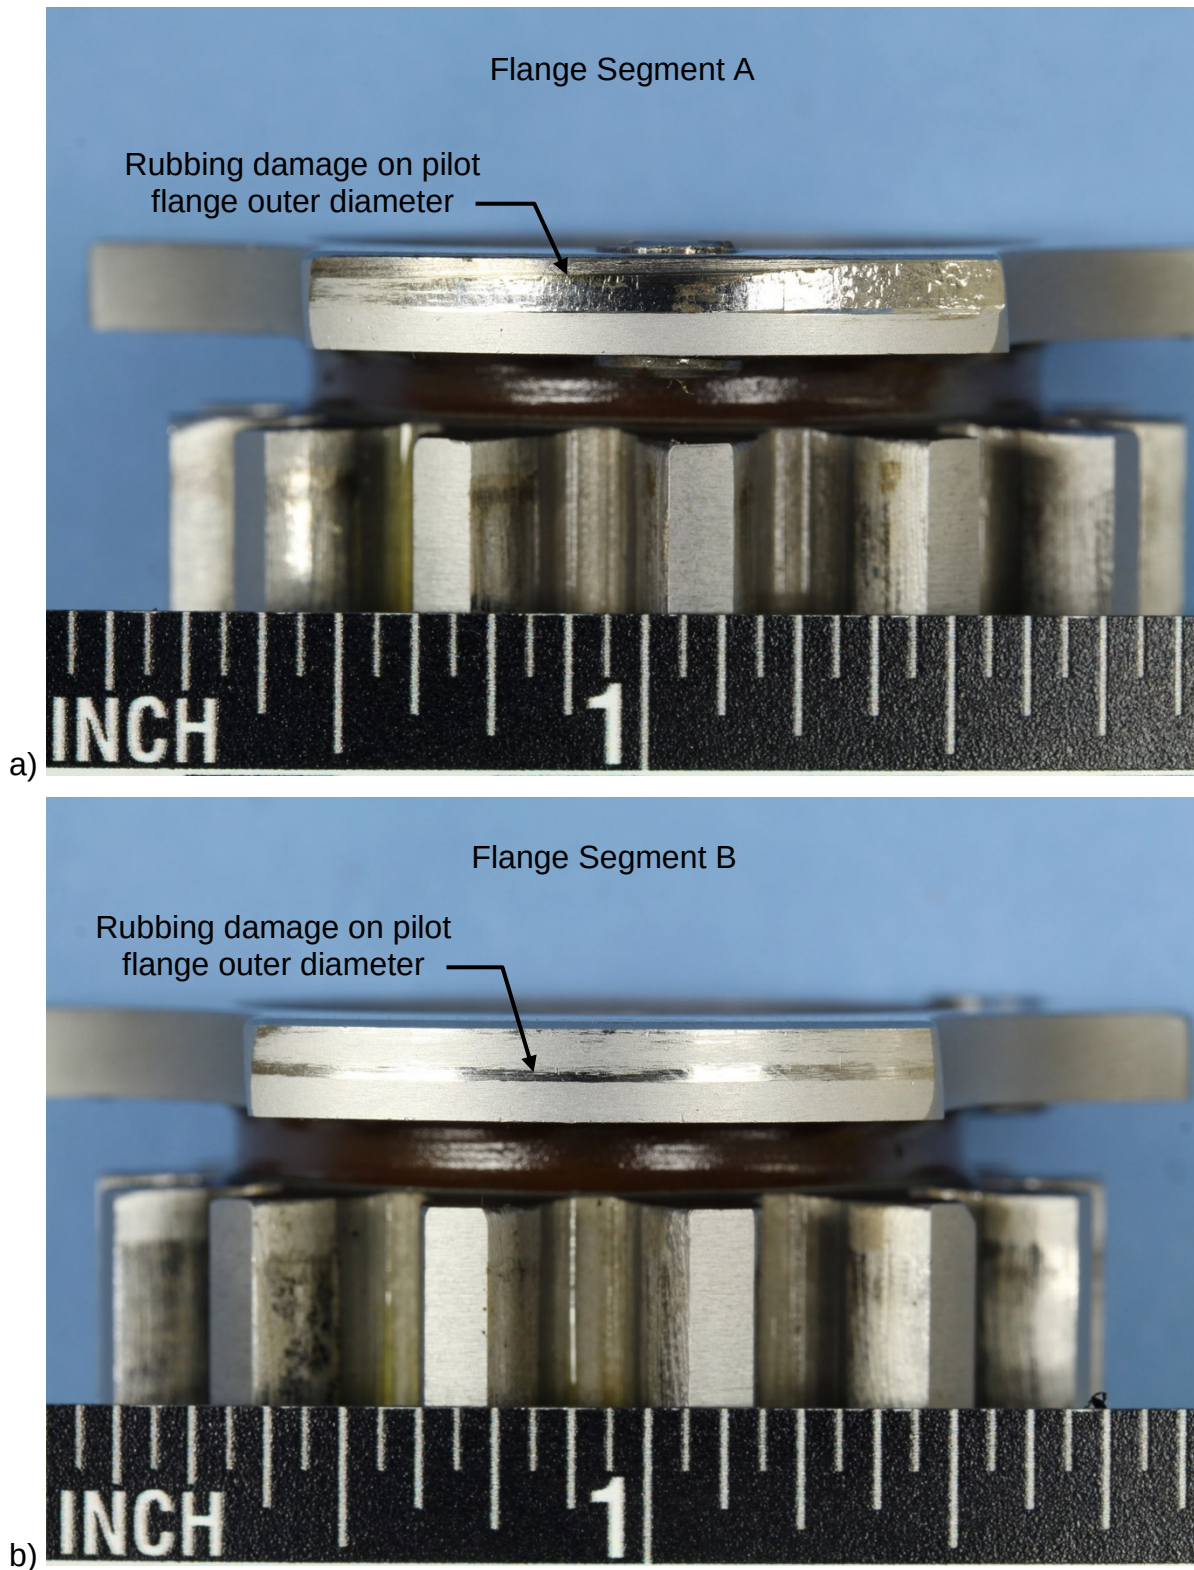
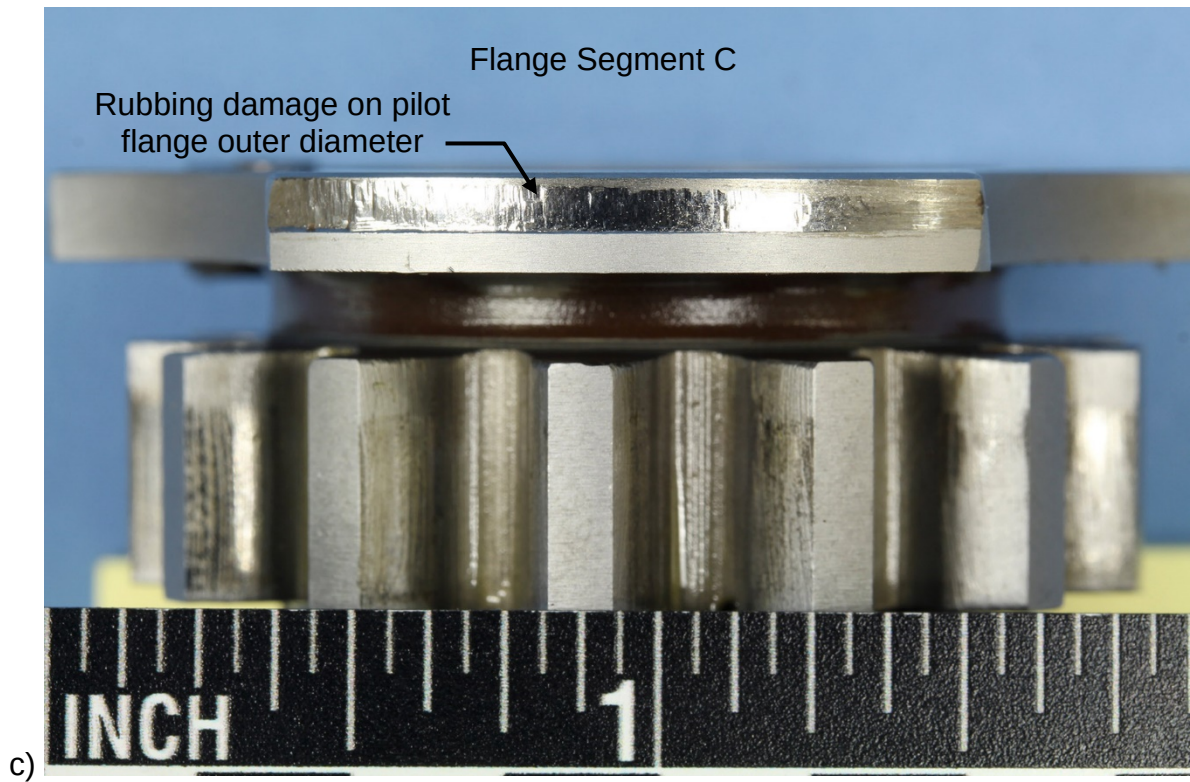
The pilot flange outer diameter exhibited rubbing damage along its interface with the crankshaft counterbore recess, as indicated in figures 4a through 4c for the three flange segments. The segments were labelled A, B, and C for convenience and are labelled in figure 2 as well. Rub marks were also seen on the counterbore face of the pilot flange segments, as seen in figures 5a through 5c, and at the interface between the lockplate and the gear, as shown in figures 6a and 6b. The tab on the locking plate was bent, but the bend was not aligned with the locking tab's plastic hinge, as indicated in figure 6b.

**Figure 4:** Images of rubbing damage to the pilot flange outer diameter: a) Segment A; b) Segment B.

Figure 4 (cont.): c) Segment C.

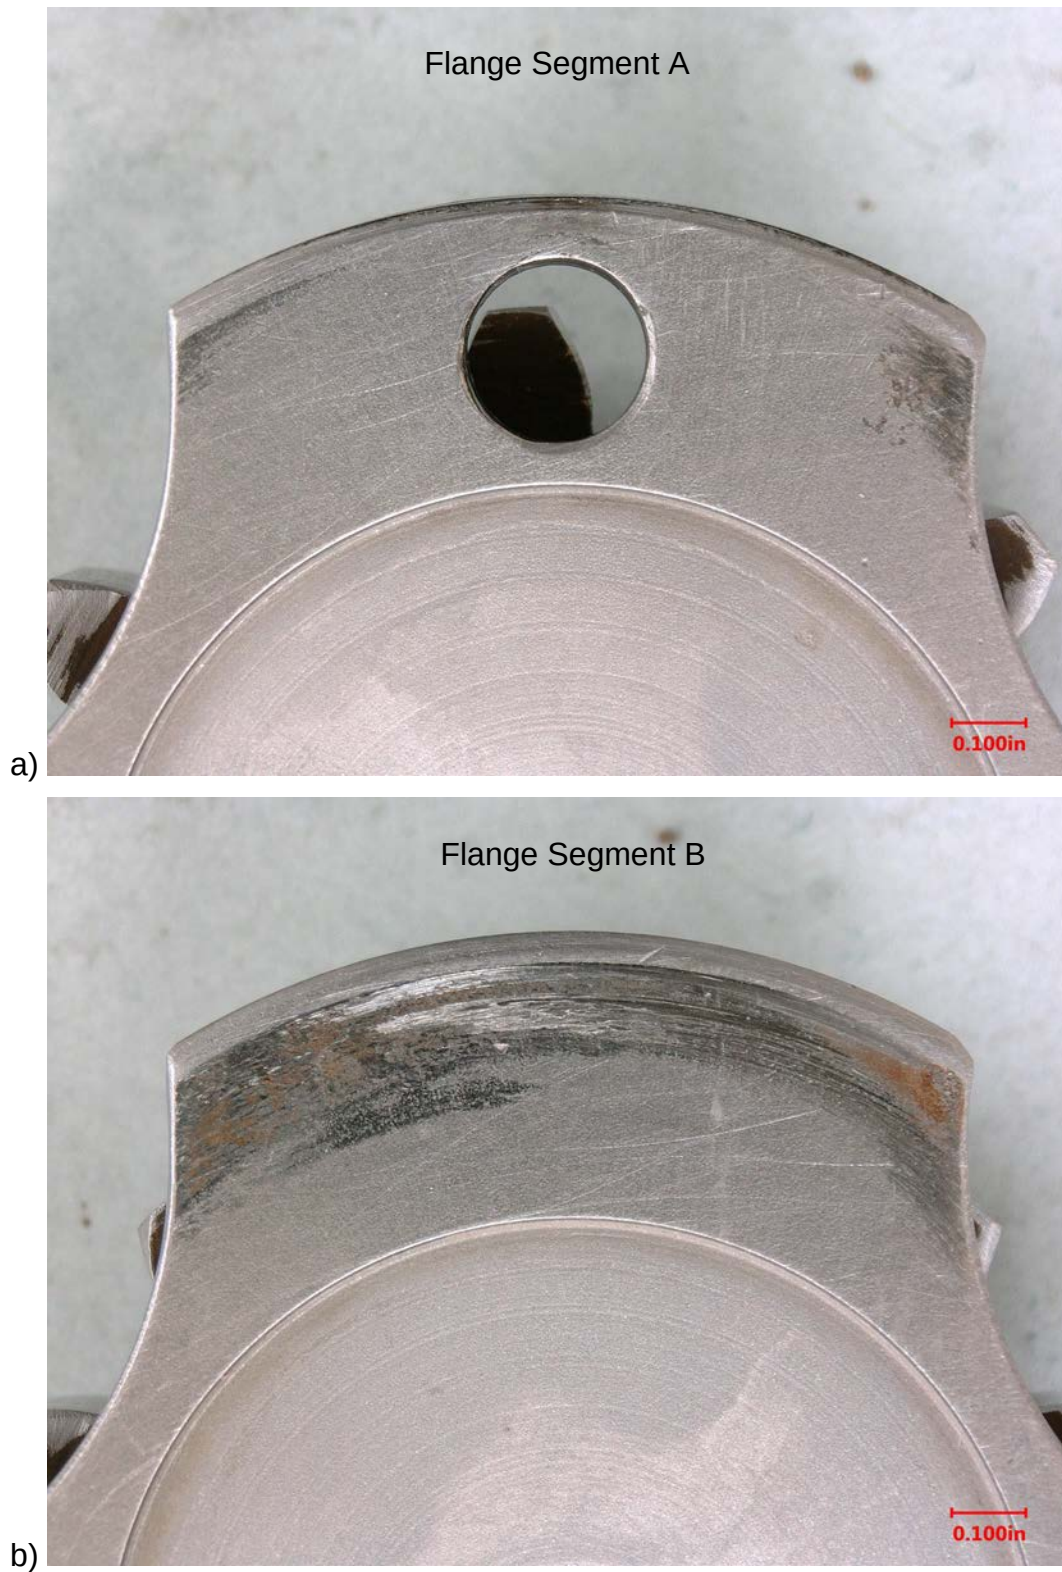
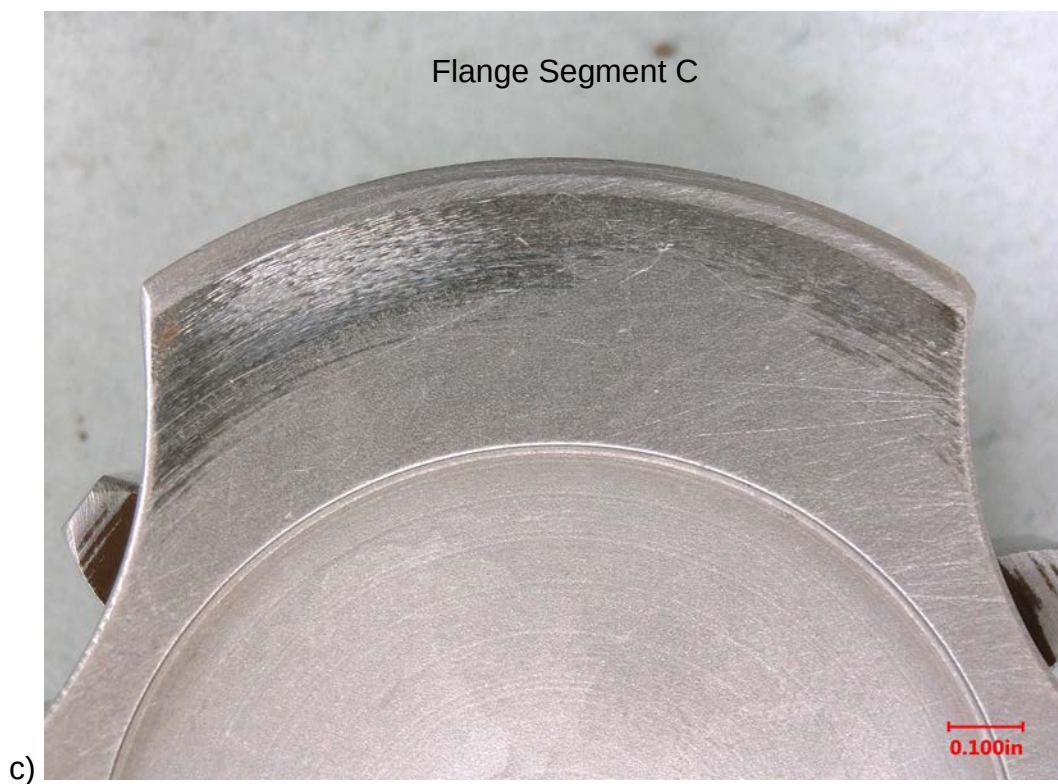
**Figure 5:** Images of rubbing marks on the counterbore face of the pilot flange: a) Segment A; b) Segment B;

**Figure 5 (cont.): c) Segment C.**

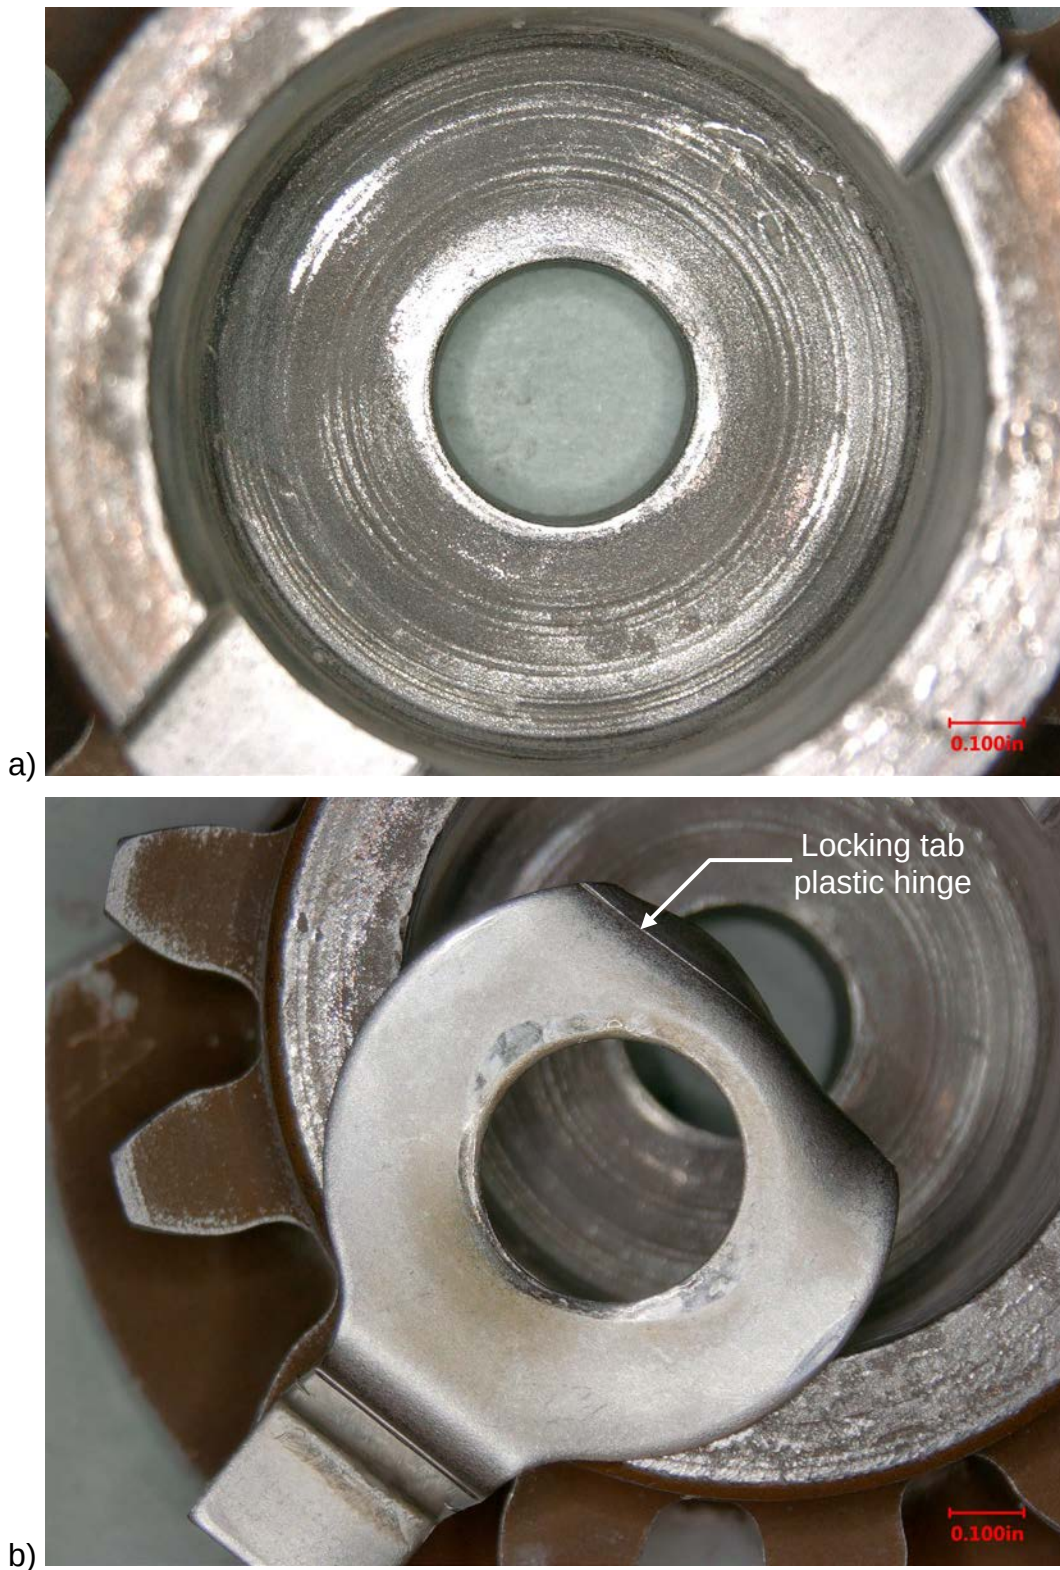
**Figure 6:** Rubbing marks at the interface between the locking plate and the crankshaft gear: a) gear-side of interface; b) locking plate side of interface.
