# SERVICE BULLETIN

Service Bulletin No. 475C  
(Supersedes Service Bulletin No. 475B)  
Engineering Aspects are  
FAA Approved

SUBJECT: Crankshaft Gear Modification and Assembly Procedures

MODELS AFFECTED: All Lycoming direct drive piston aircraft engines (including VO-360 and IVO-360; excepting O-320-H, O-360-E, LO-360-E, TO-360-E, LTO-360-E, and TIO-541 series engines).

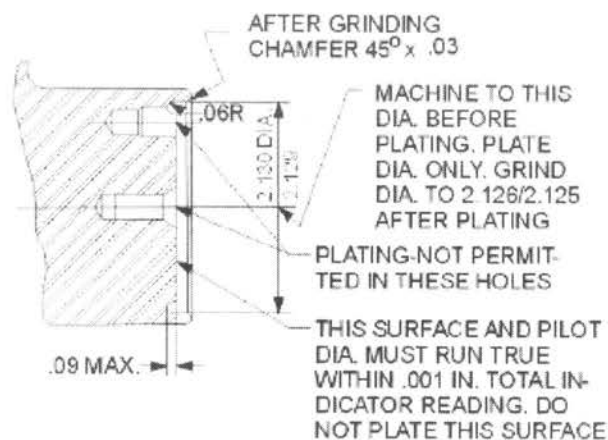
Figure 1. Details for Repairing Pilot Diameter of Crankshaft

3. Check the pilot diameter of the counterbore on the end of the crankshaft for size and evidence of damage. This diameter should not exceed 2.1262 inches when measured at any location. If found to be oversize, the crankshaft may be repaired as described in the following steps. Do not attempt to reuse a crankshaft with an oversize pilot diameter.

- a. After removing the dowel, machine the pilot diameter in the end of the crankshaft to 2.129/2.130 inch as shown in the illustration. See Figure 1. Also, cut the .09 deep x .06R undercut as shown.

- b. Chrome or nickel plate the surface of the pilot diameter with a firmly bonded deposit that is free of pin holes, blisters and any other imperfections that could impair the function of the parts.

- c. After plating, stress relieve the shaft by baking at 390° to 410°F for 3 to 5 hours.
  - d. Grind the plated pilot diameter surface to 2.125/2.126 inch. Note that the diameter must run true with rear main journal within .001 inch total indicator reading.

- e. Chamfer edge of pilot diameter  $45^\circ \times .03$  as shown in Figure 1.
4. If the dowel has been removed, check the condition of the dowel hole in the crankshaft. If out of round or oversize, ream as required for installation of an oversize dowel. Available oversize dowels and the corresponding size for reamed holes are shown in Table 1.
5. Install a new dowel in the crankshaft as shown in Figures 2 and 3. Insure that the correct dowel is installed.

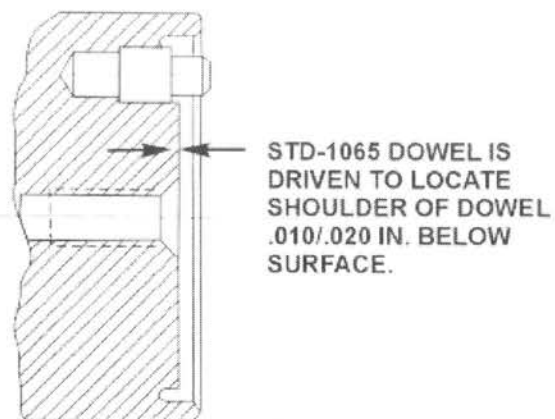
Figure 2. Section Thru End of Crankshaft Showing Driven Height of STD-1065 Dowel

2. Check the condition of the dowel in the end of the crankshaft. It should be perfectly smooth with no indication of nicks or deformation. If it is out of round, it should be removed and replaced with a new one. Replacement instructions are in paragraph 4. If dowel condition is acceptable, insure that it is installed as shown in Figure 2 or 3.

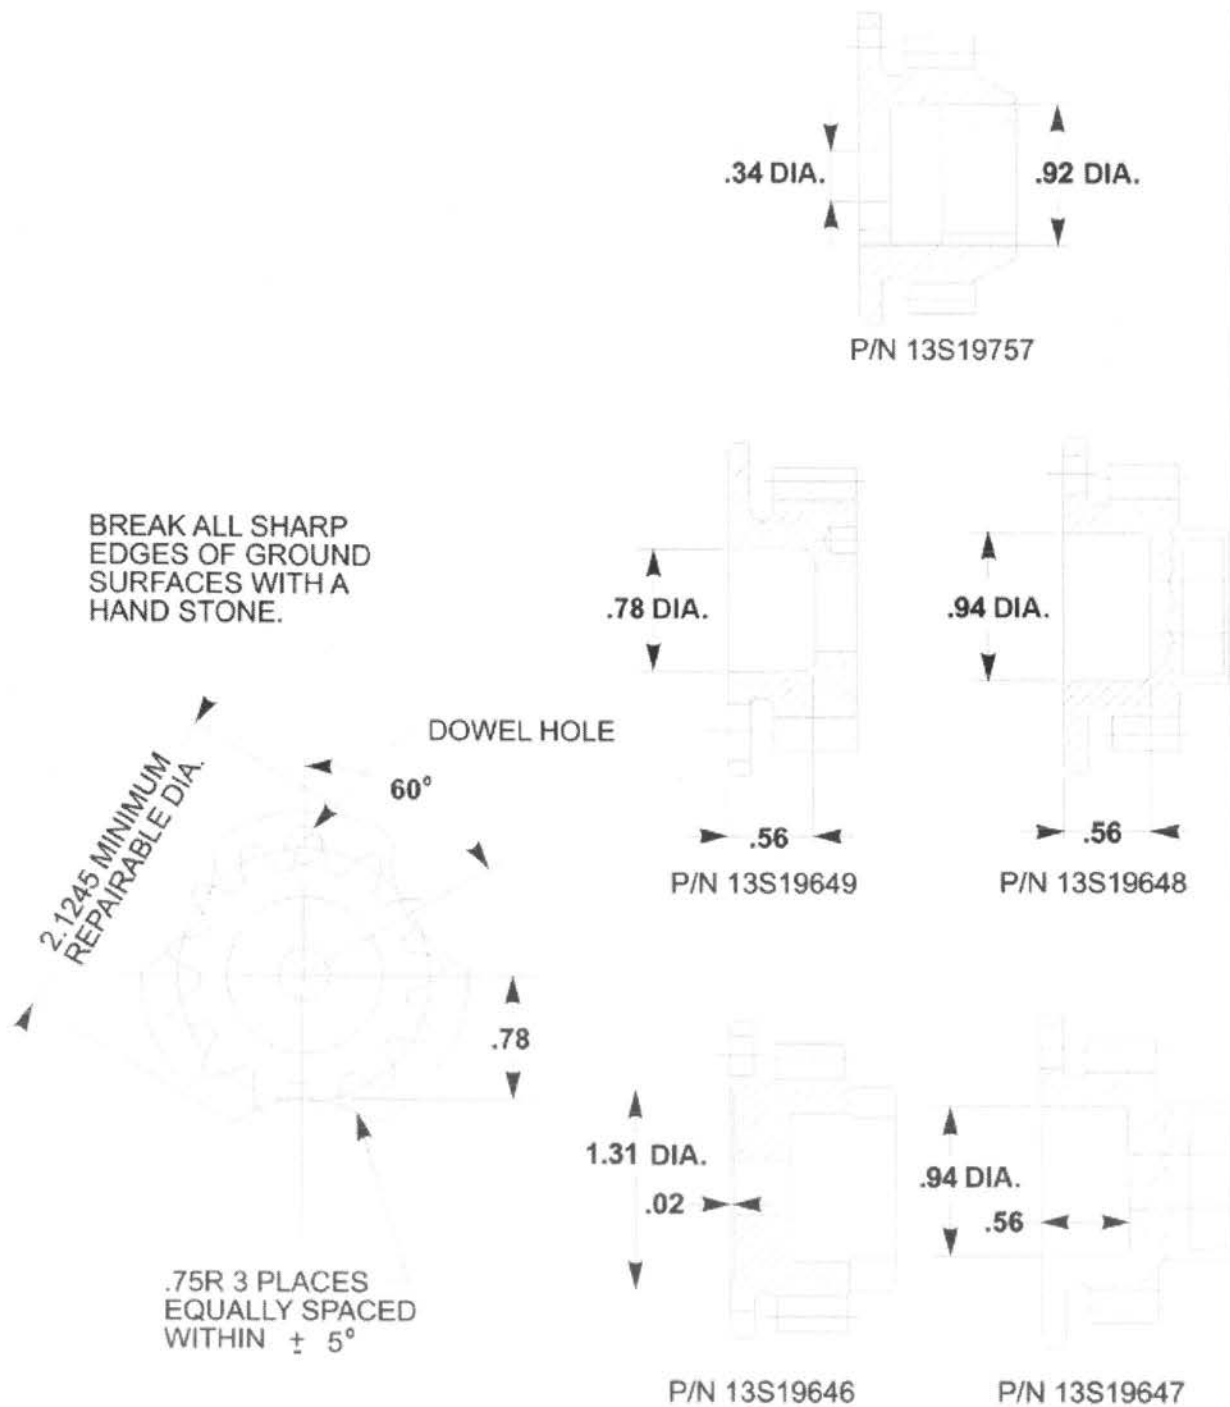
Figure 5. Details for Rework of Crankshaft Gears to Current Configuration

CRANKSHAFT GEARS FOR APPLICABLE ENGINES ARE NOW MANUFACTURED WITH THREE 3/4 INCH RADIUS SCALLOPS CUT INTO THE O.D. OF THE PILOT FLANGE AND A COUNTERBORE ON THE BACK SIDE OF THE GEAR. THESE ENLARGED SCALLOPS HAVE BEEN ADDED TO ALLOW INSPECTION OF THE GEAR AND CRANKSHAFT ASSEMBLY. SERVICEABLE GEARS MUST BE MODIFIED AS SHOWN IN FIGURE 5. PRIOR TO BEING REASSEMBLED ON THE CRANKSHAFT, OR A NEW GEAR THAT HAS BEEN MANUFACTURED TO THIS CONFIGURATION MUST BE INSTALLED. BEFORE MODIFYING THE GEAR, MEASURE THE DIAMETER OF THE PILOT FLANGE. IF IT IS LESS THAN 2.1245 INCH, IT SHOULD NOT BE RESUED. THE ORIGINAL 2.1250/2.1255 DIMENSION OF THE CRANKSHAFT GEAR MUST BE RESTORED WITH A FLASH COPPER PLATE OF UP TO .0005 INCH MAX.

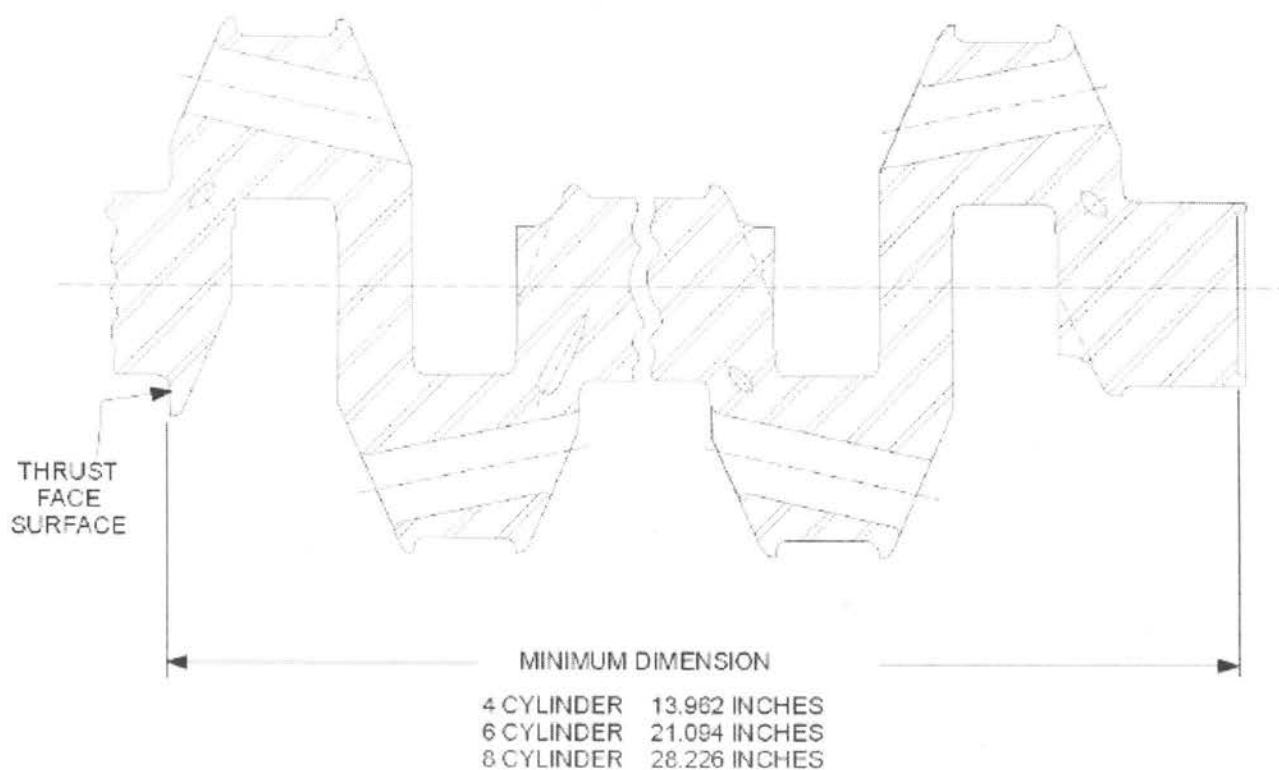
Figure 7. Minimum Dimension of Crankshaft

THE CRANKSHAFT COUNTERBORED GEAR MOUNTING FACE SHOULD BE CHECKED FOR DAMAGE. IF THE SURFACE REQUIRES REPAIR OTHER THAN SPECIFIED IN "CAUTION" ON PAGE 1, THE CRANKSHAFT SHOULD FIRST BE MEASURED AS SHOWN IN FIGURE 7. IF THE CRANKSHAFT MEASURES MORE THAN THE MINIMUM DIMENSION SHOWN IN FIGURE 7, THE SURFACE MAY BE REWORKED DOWN TO THE DIMENSIONS SHOWN. (DO NOT PLATE THIS SURFACE.) THE SURFACE MUST BE TRUE WITHIN .001 IN. TOTAL INDICATOR READING TO REAR MAIN BEARING AND THE SURFACE FINISH MUST BE HELD TO 45 TO 90 MICROINCHES.

INSURE MINIMUM DIMENSION IS MEASURED BETWEEN THRUST FACE SURFACE AND PILOT.
