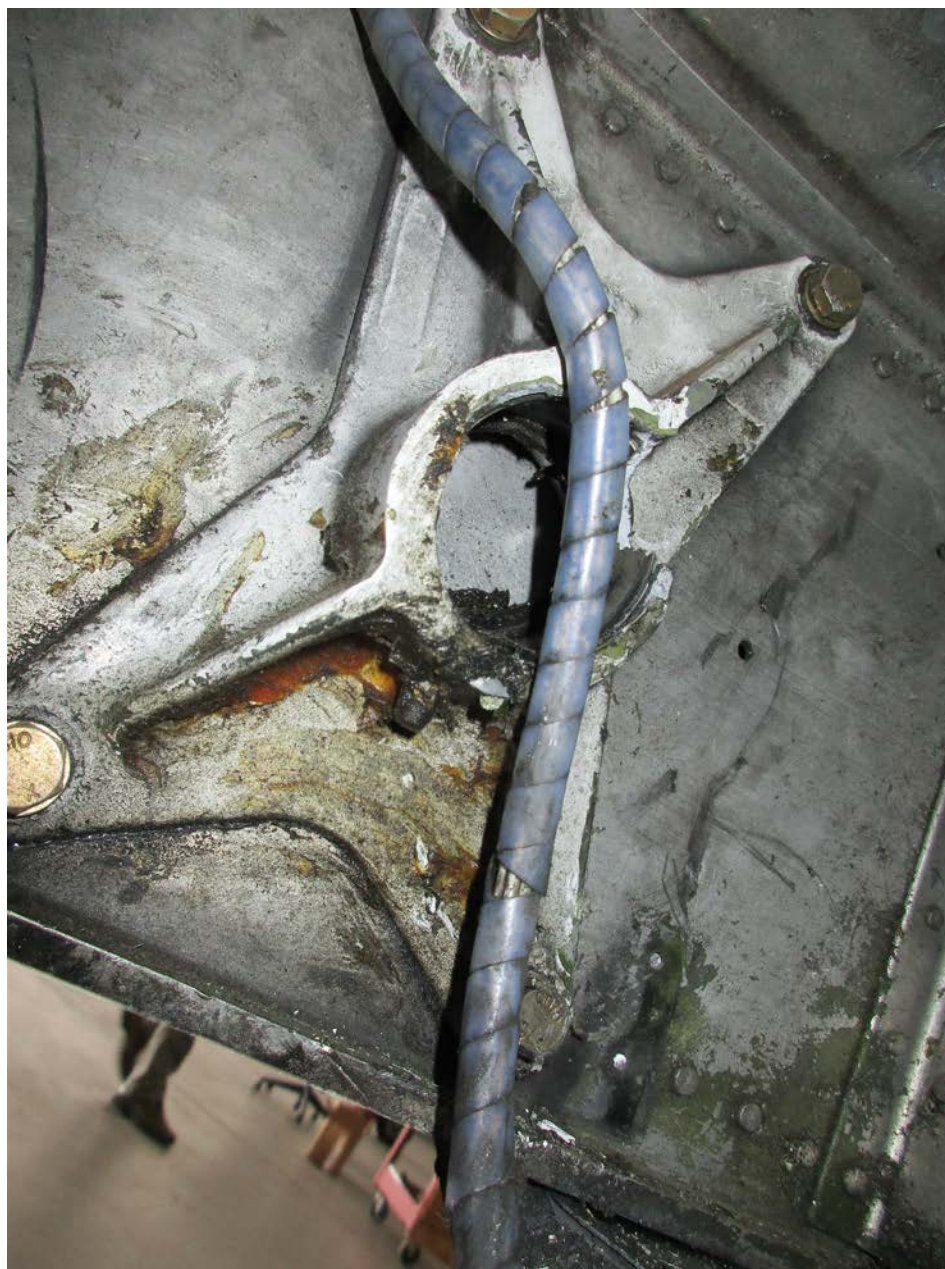
**Photo 1 – View of fractured right main landing gear trunnion**

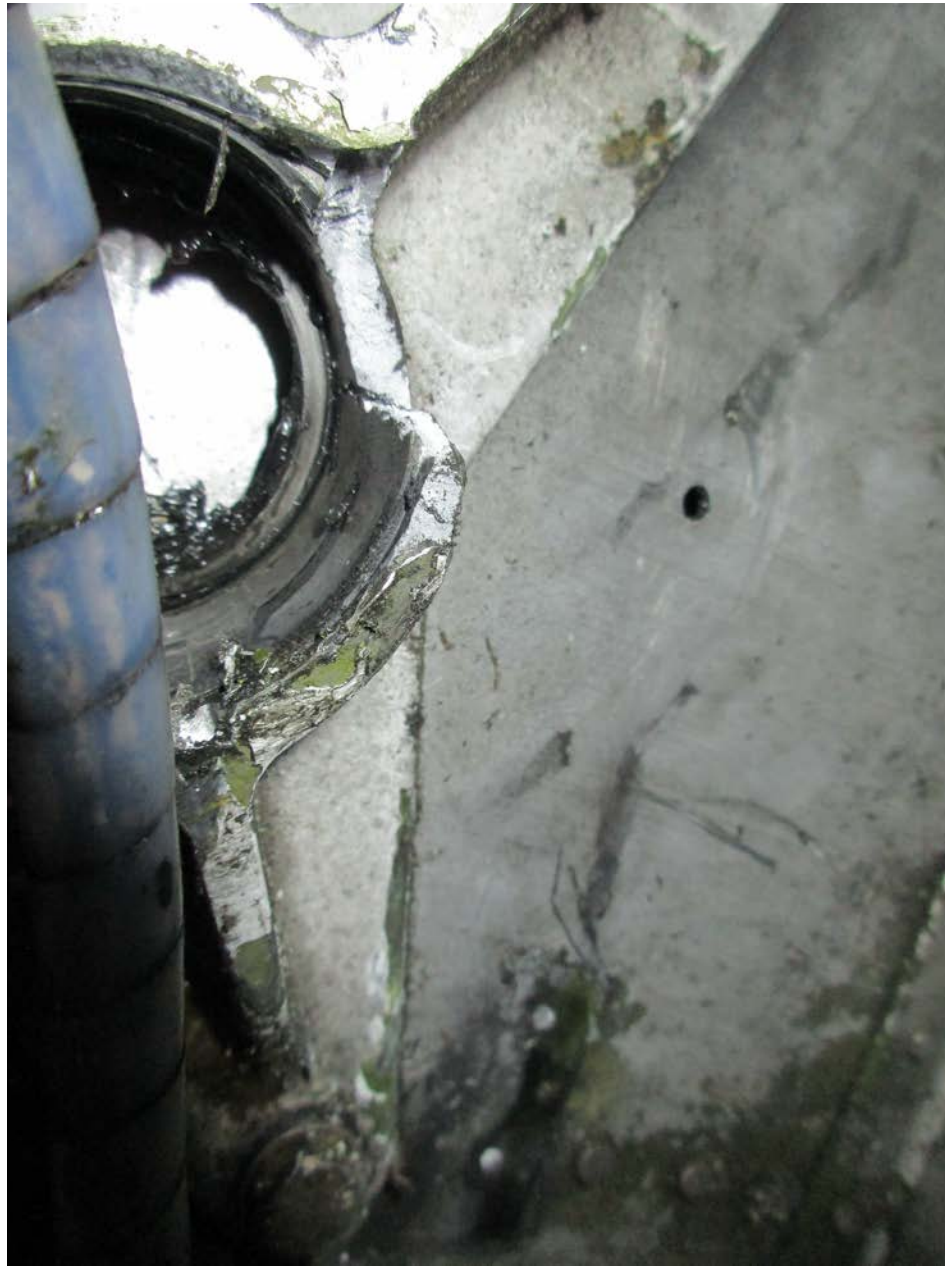
**Photo 2 – View of top of the fracture surface of the trunnion**

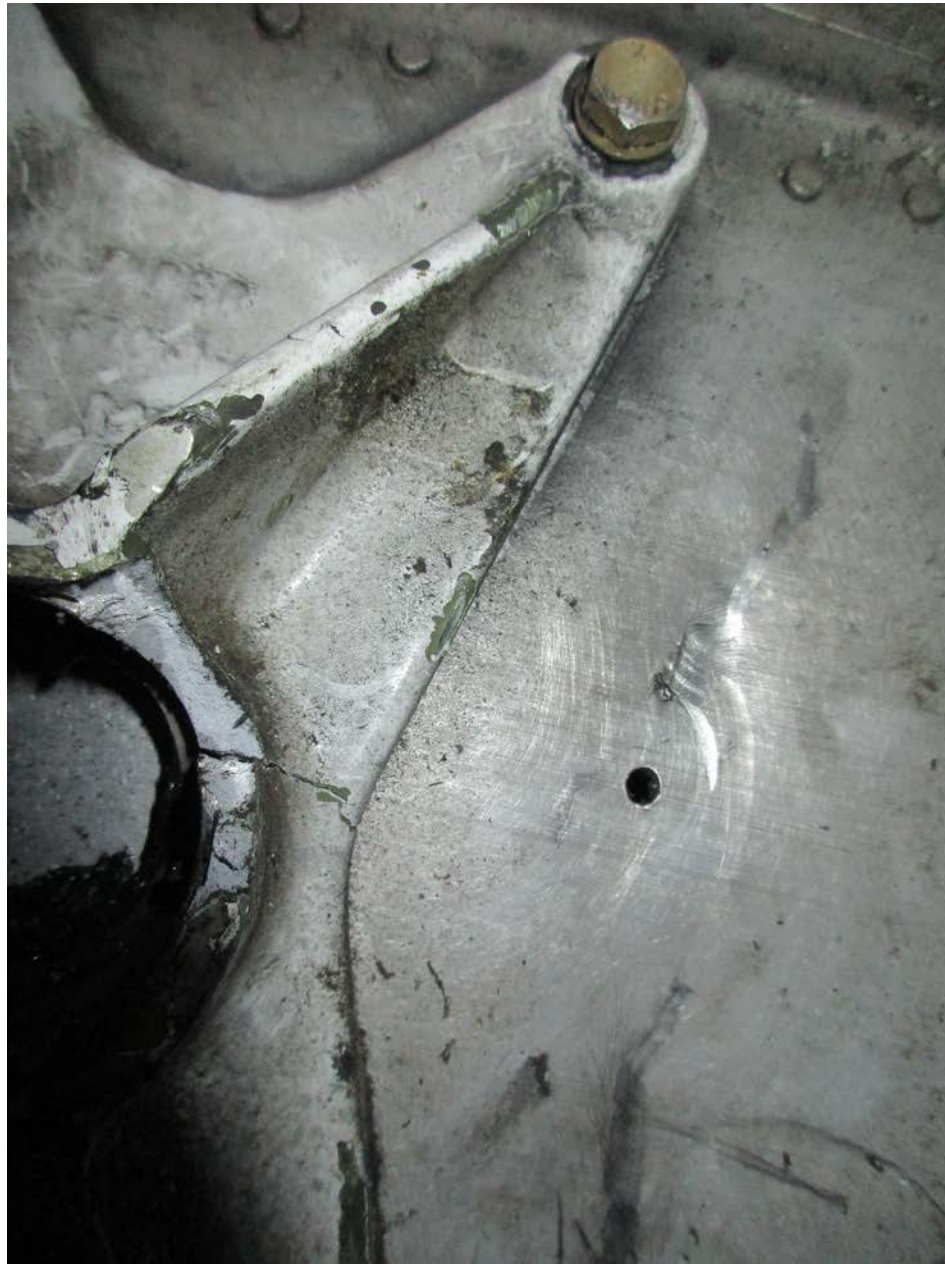
**Photo 3 – Close up of fracture surface of trunnion**
