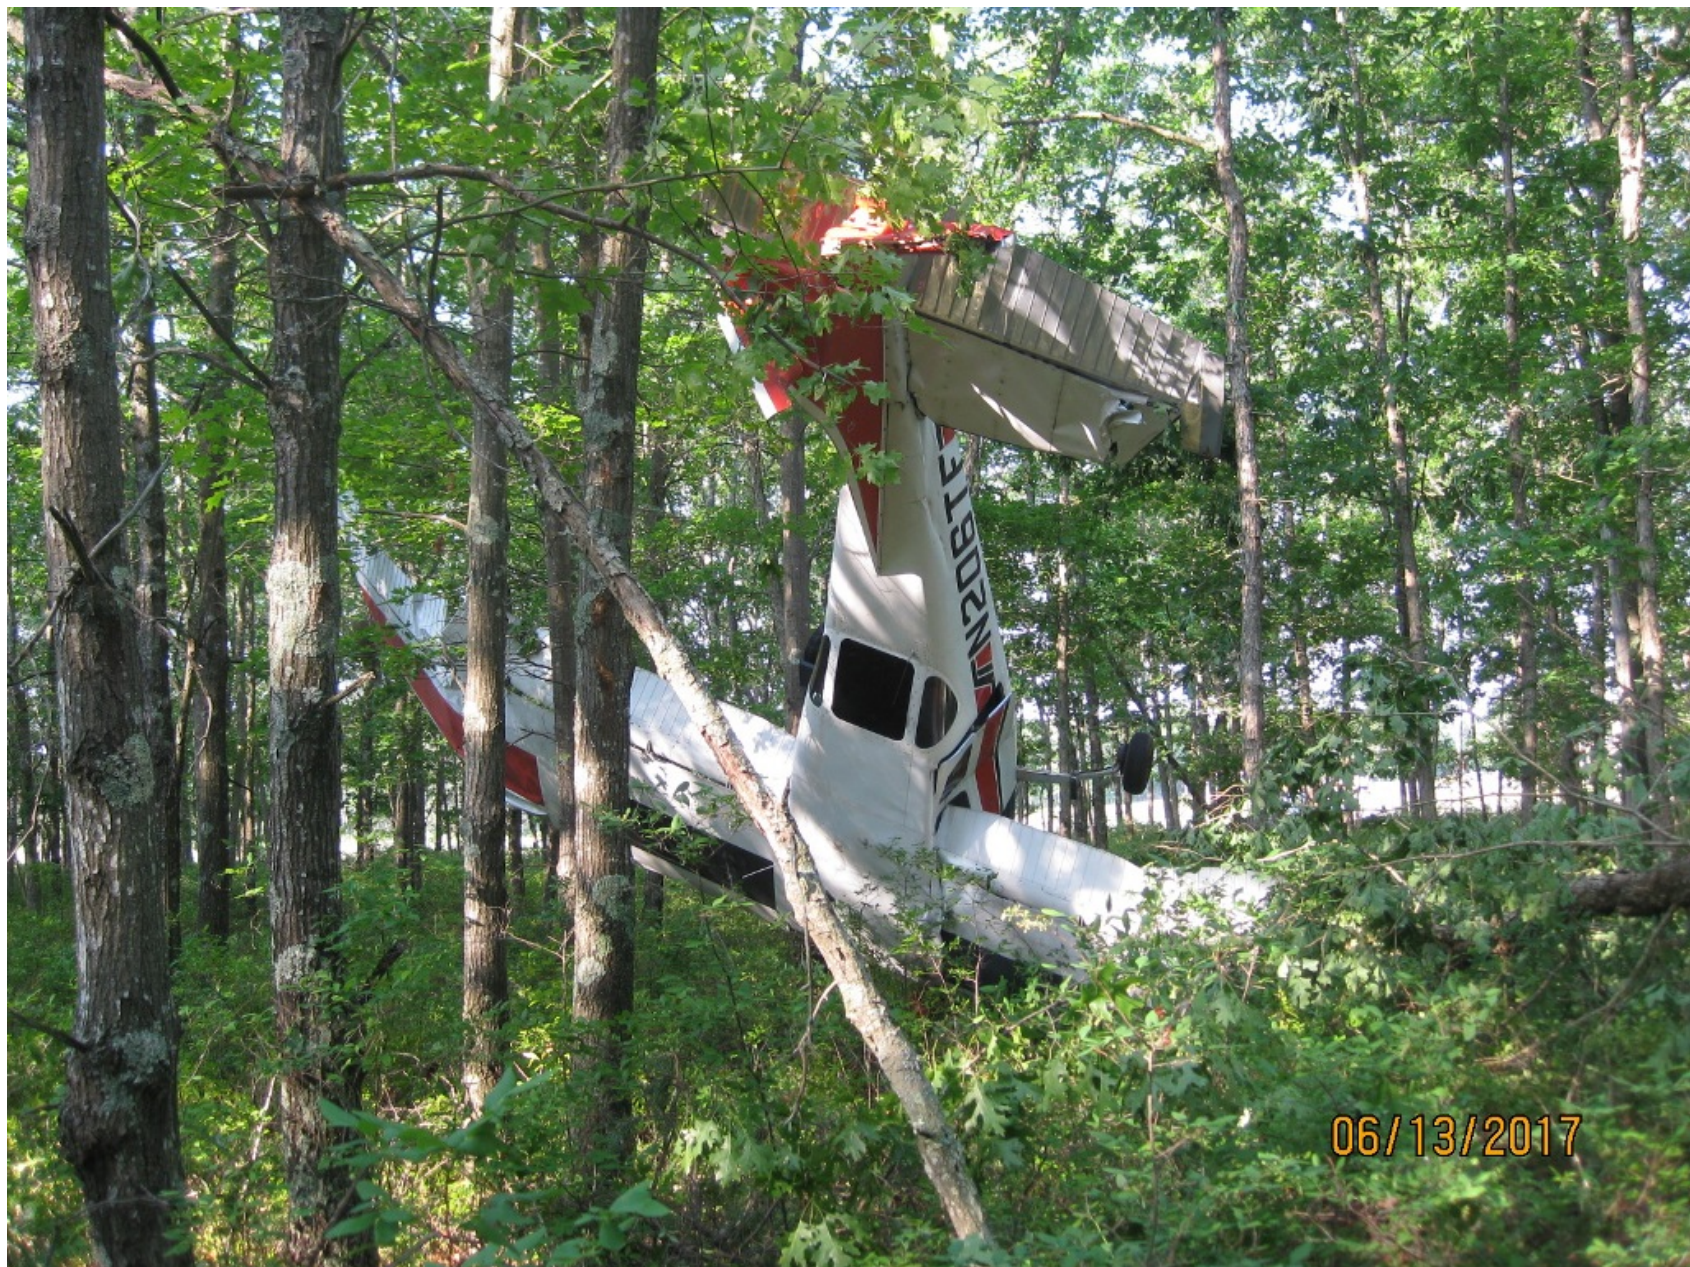
**Photo 1 – FAA Digital Photograph. View of the Inverted Airplane at the Accident Site.**

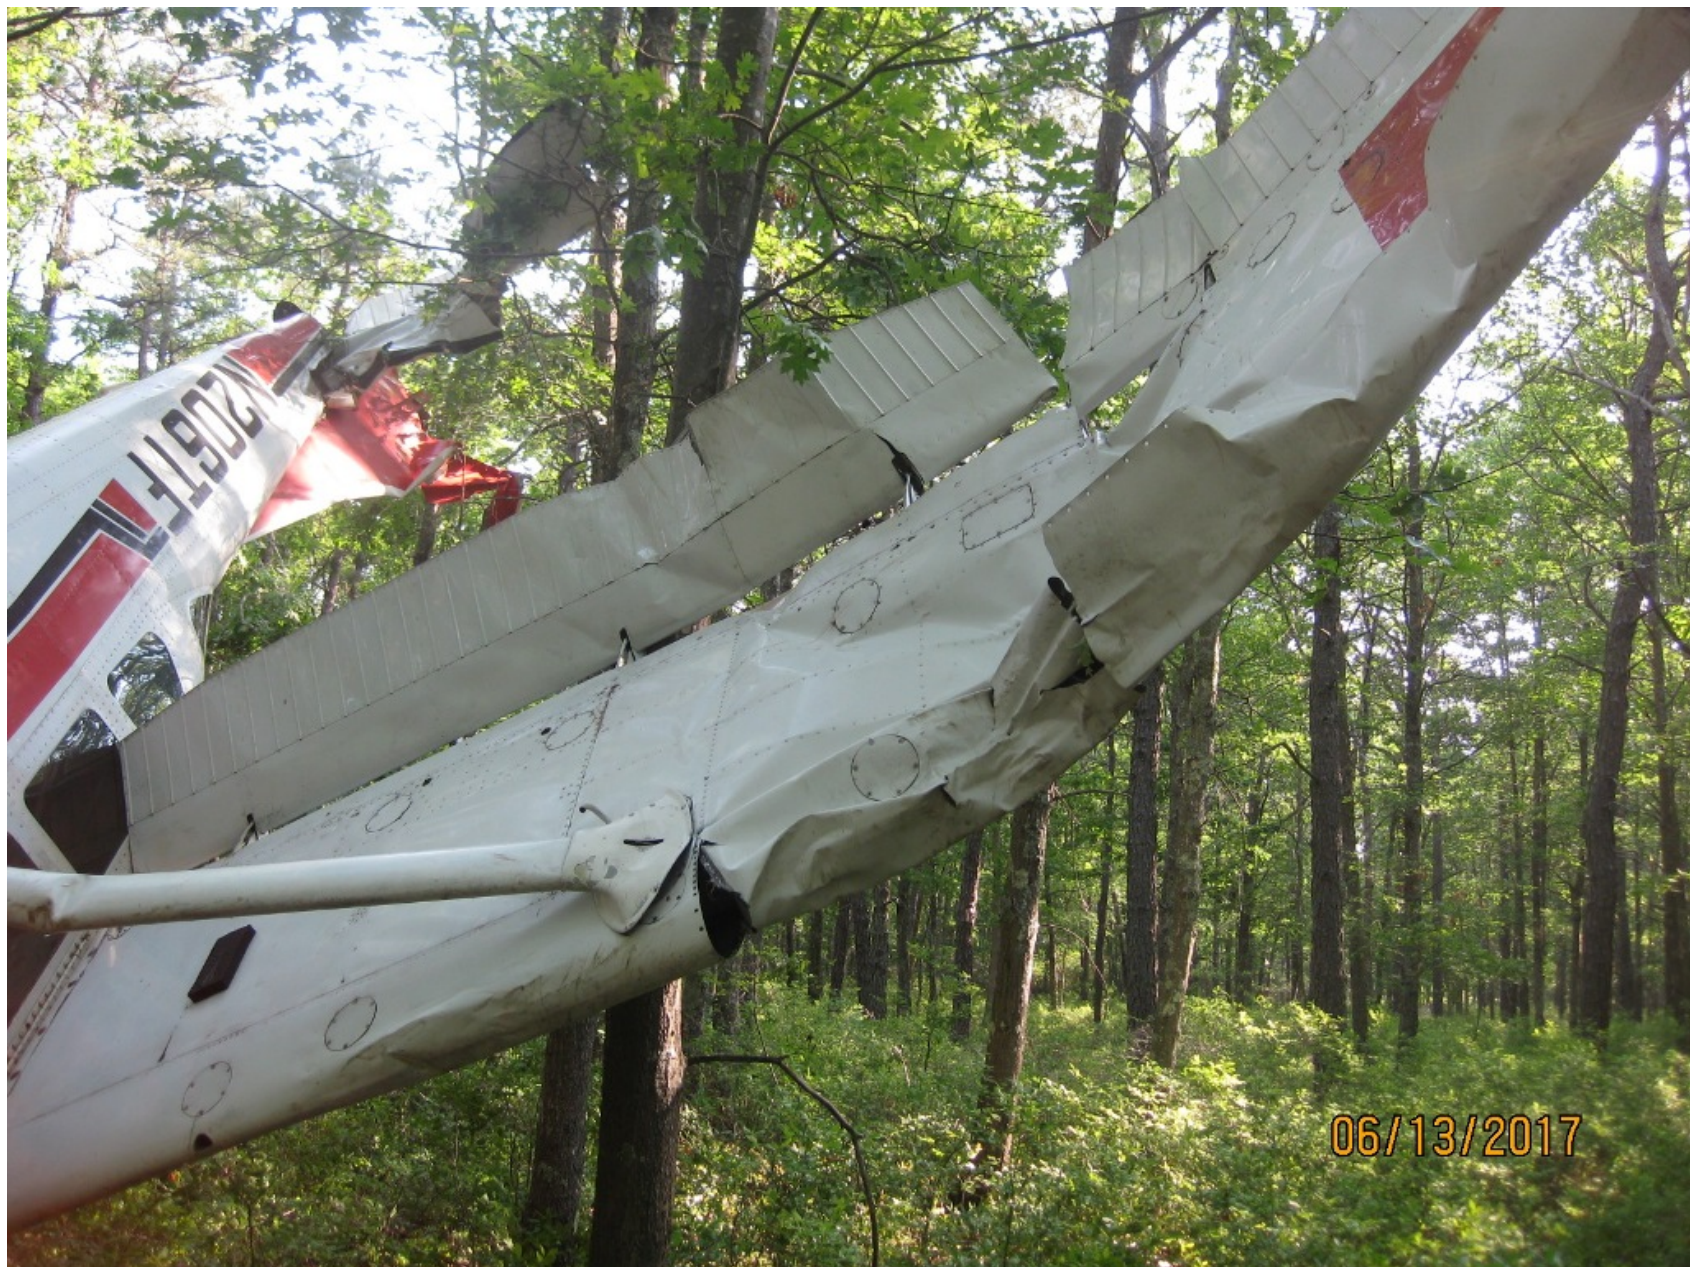
**Photo 2 - FAA Digital Photograph. View of the Lower Surface of the Right Wing**

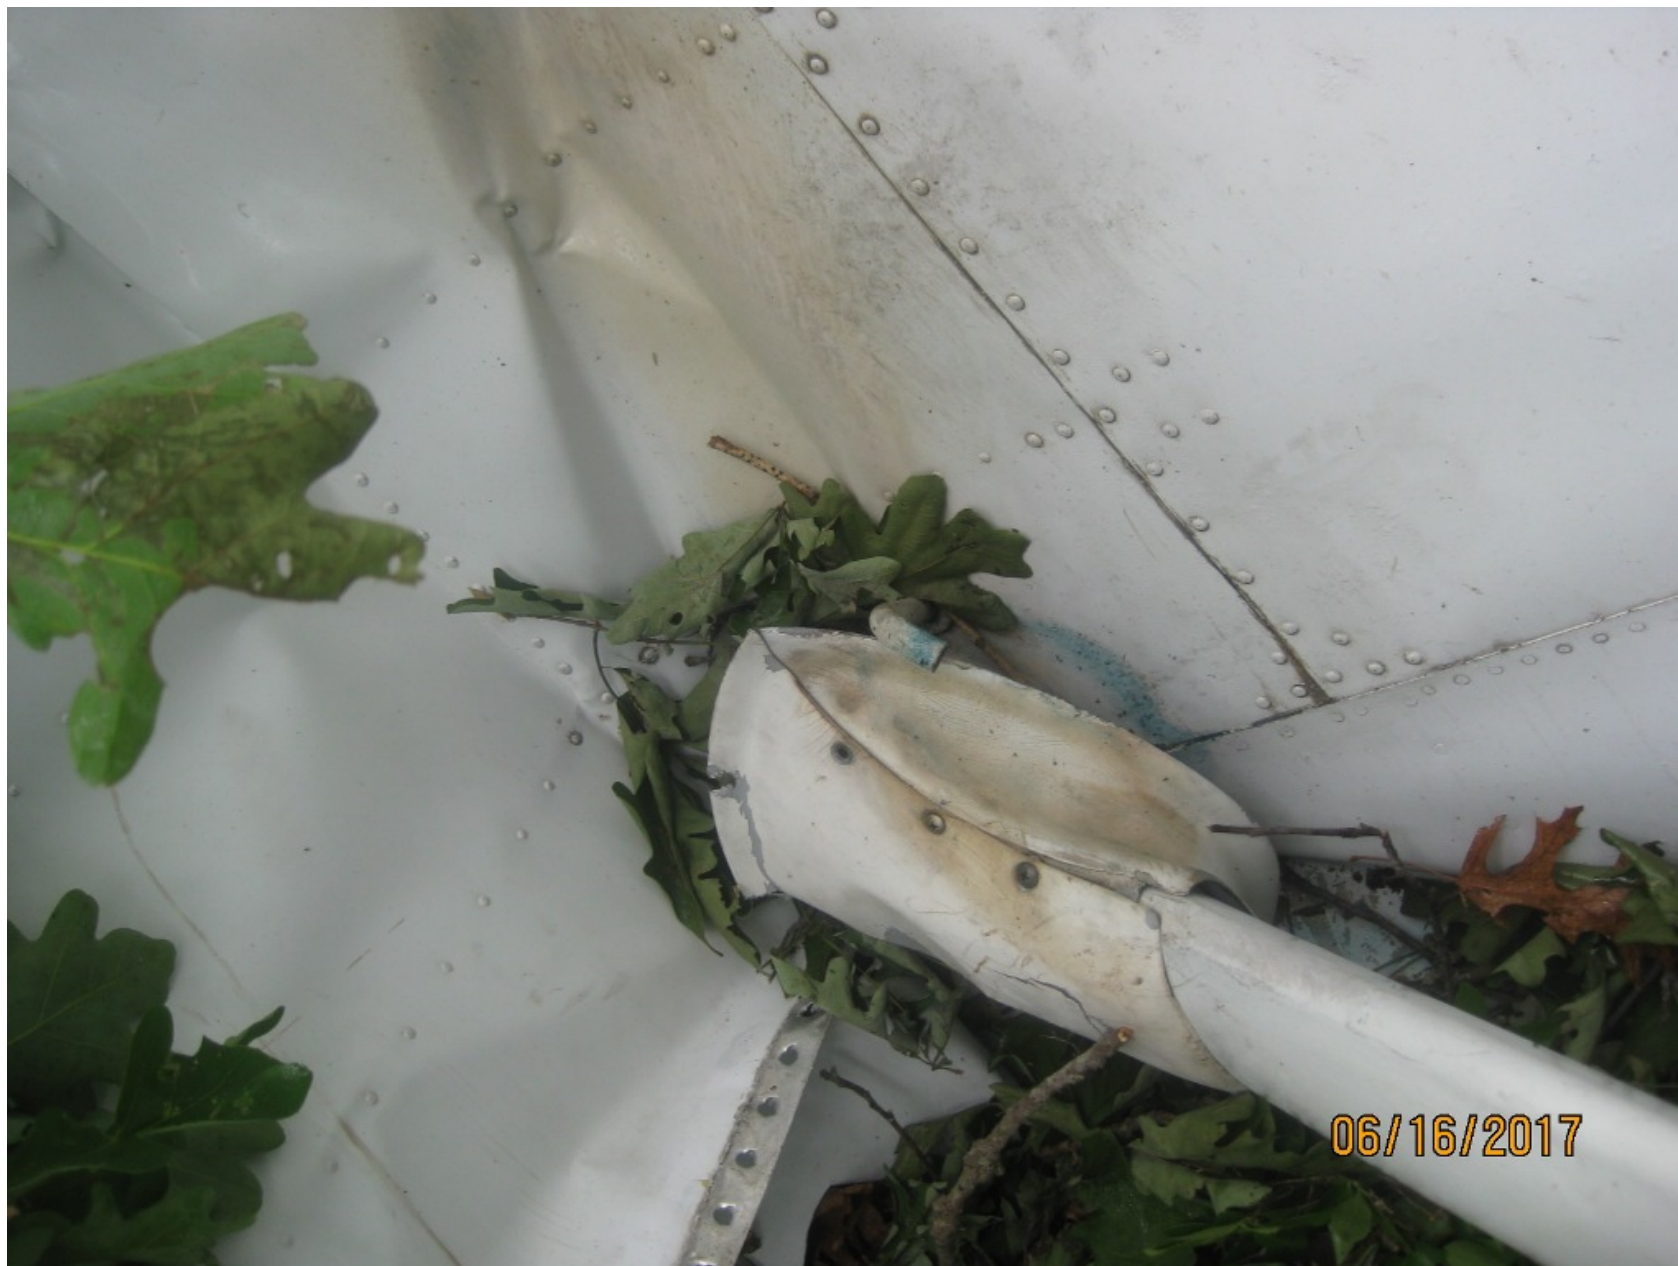
**Photo 3 - FAA Digital Photograph. View of Portion of the Lower Surface of the Left Wing. Note the blue Stain at the Fuel Vent Line and on Lower Wing Skin near Fuel Vent Line.**

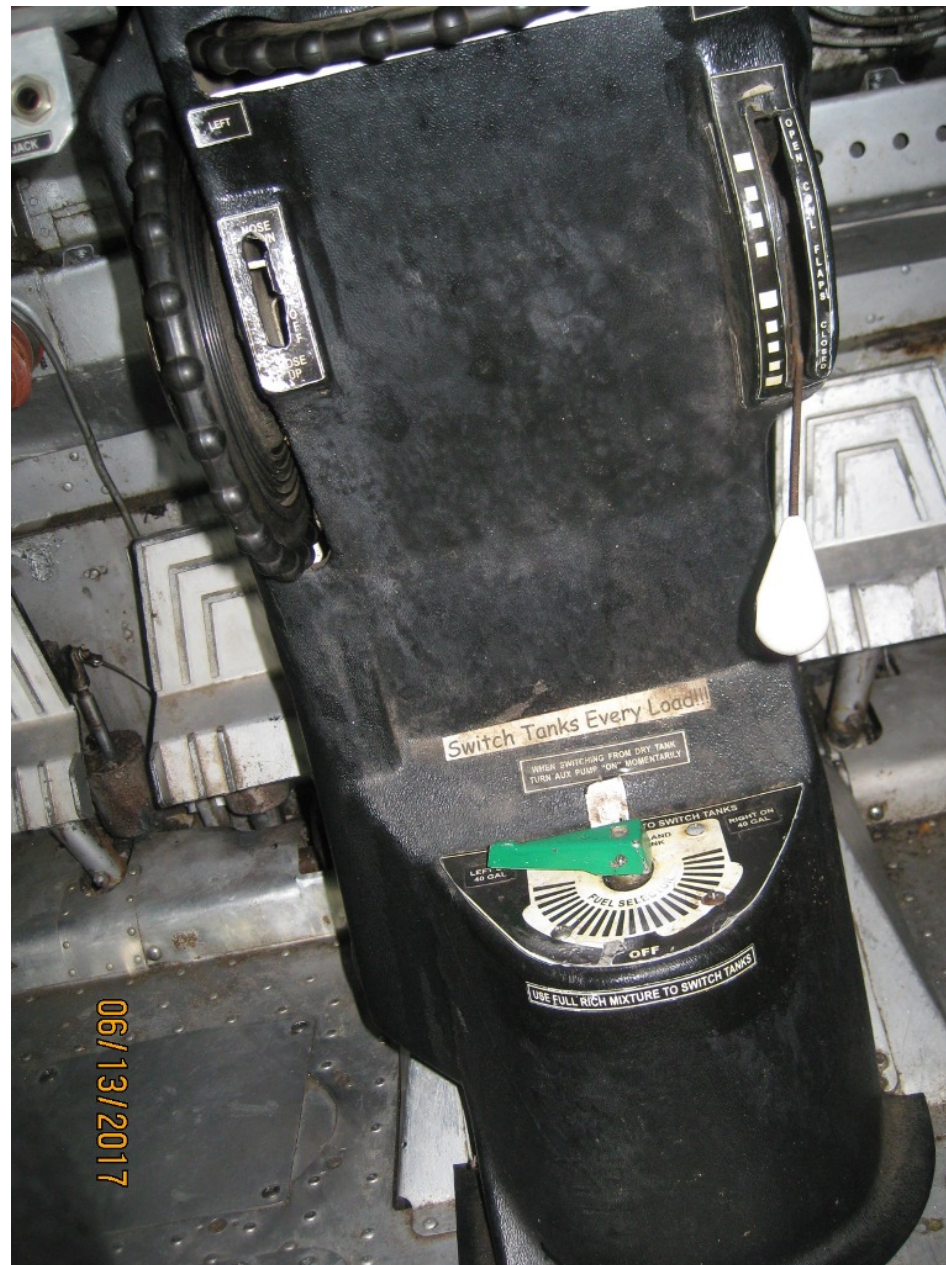
**Photo 4 - FAA Digital Photograph. View of the As-Found Position of the Fuel Selector Valve.**

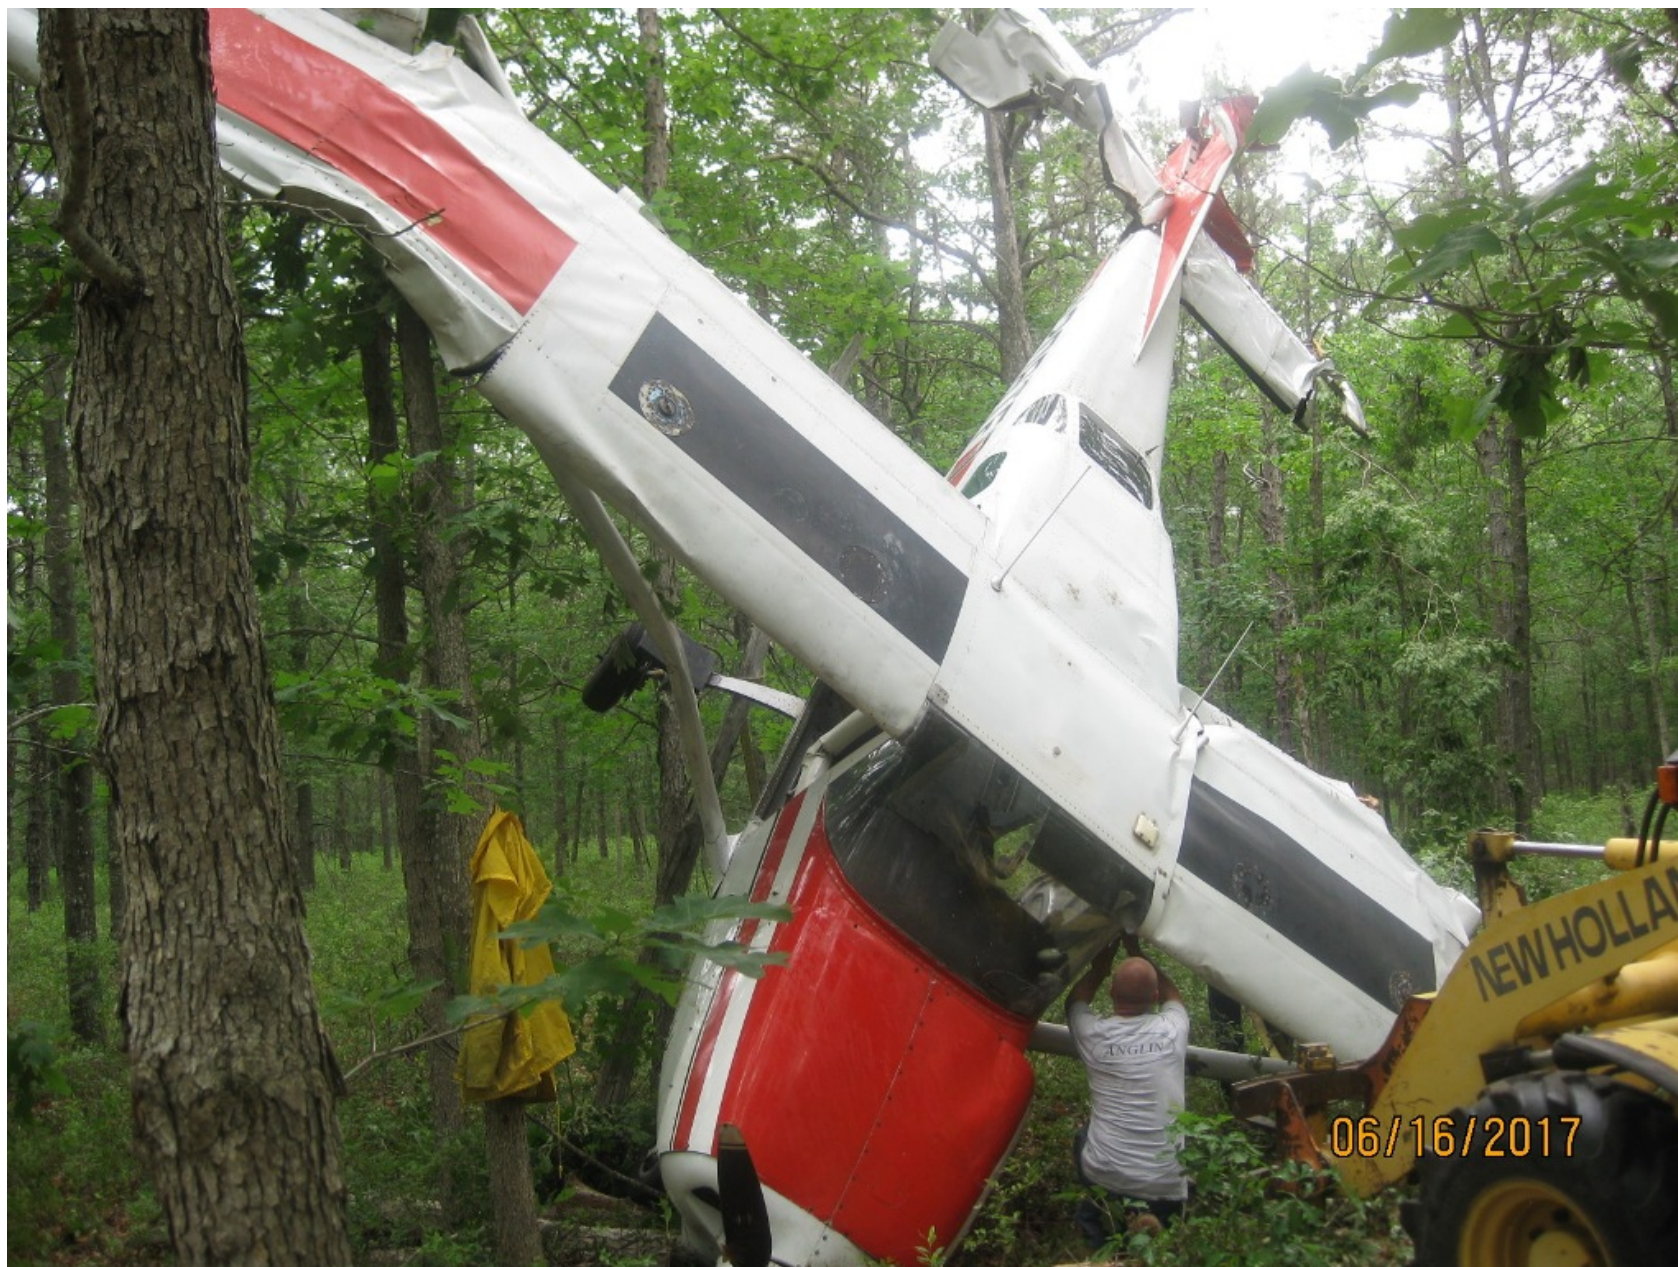
**Photo 5 - FAA Digital Photograph. View of the Upper Inboard Portion of Both Wings During the Process of Uprighting the Airplane.**

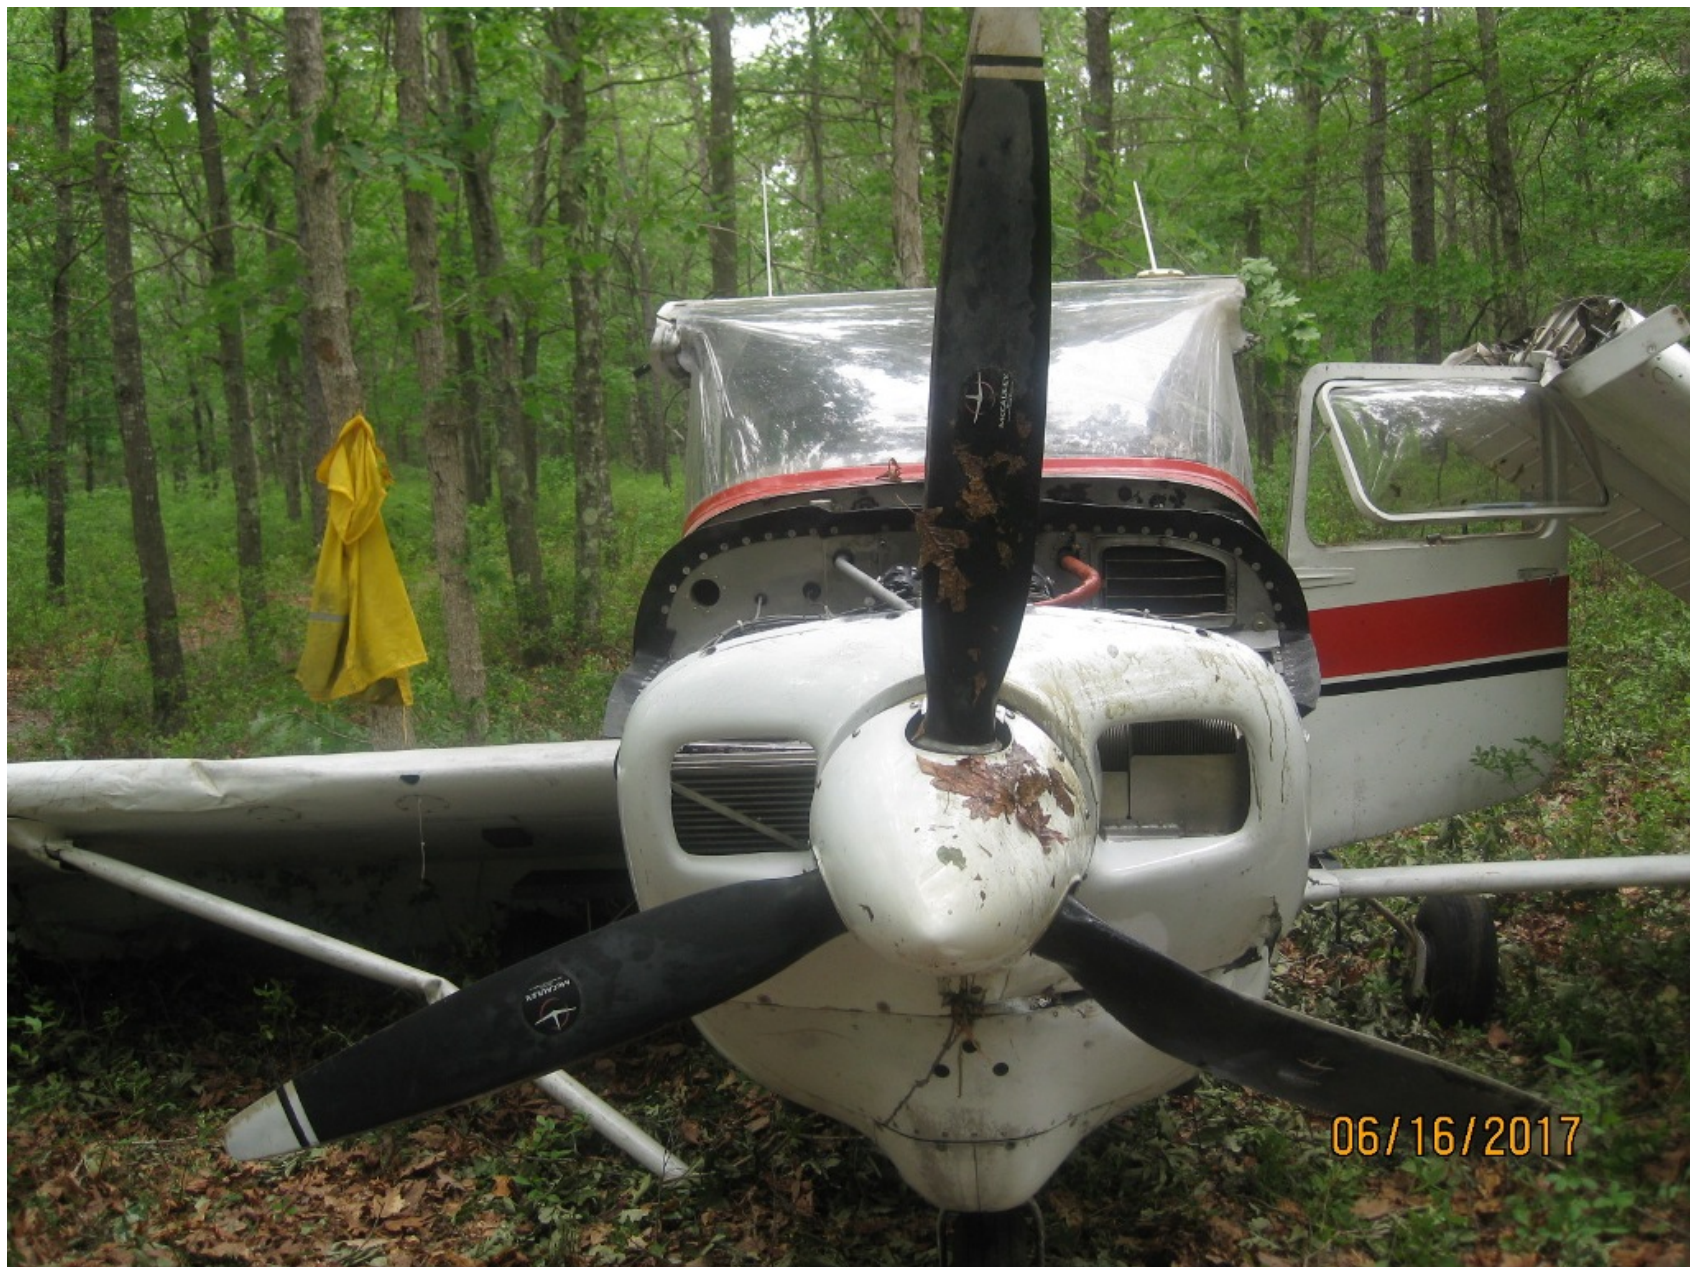
**Photo 6 - FAA Digital Photograph. View of the Propeller.**

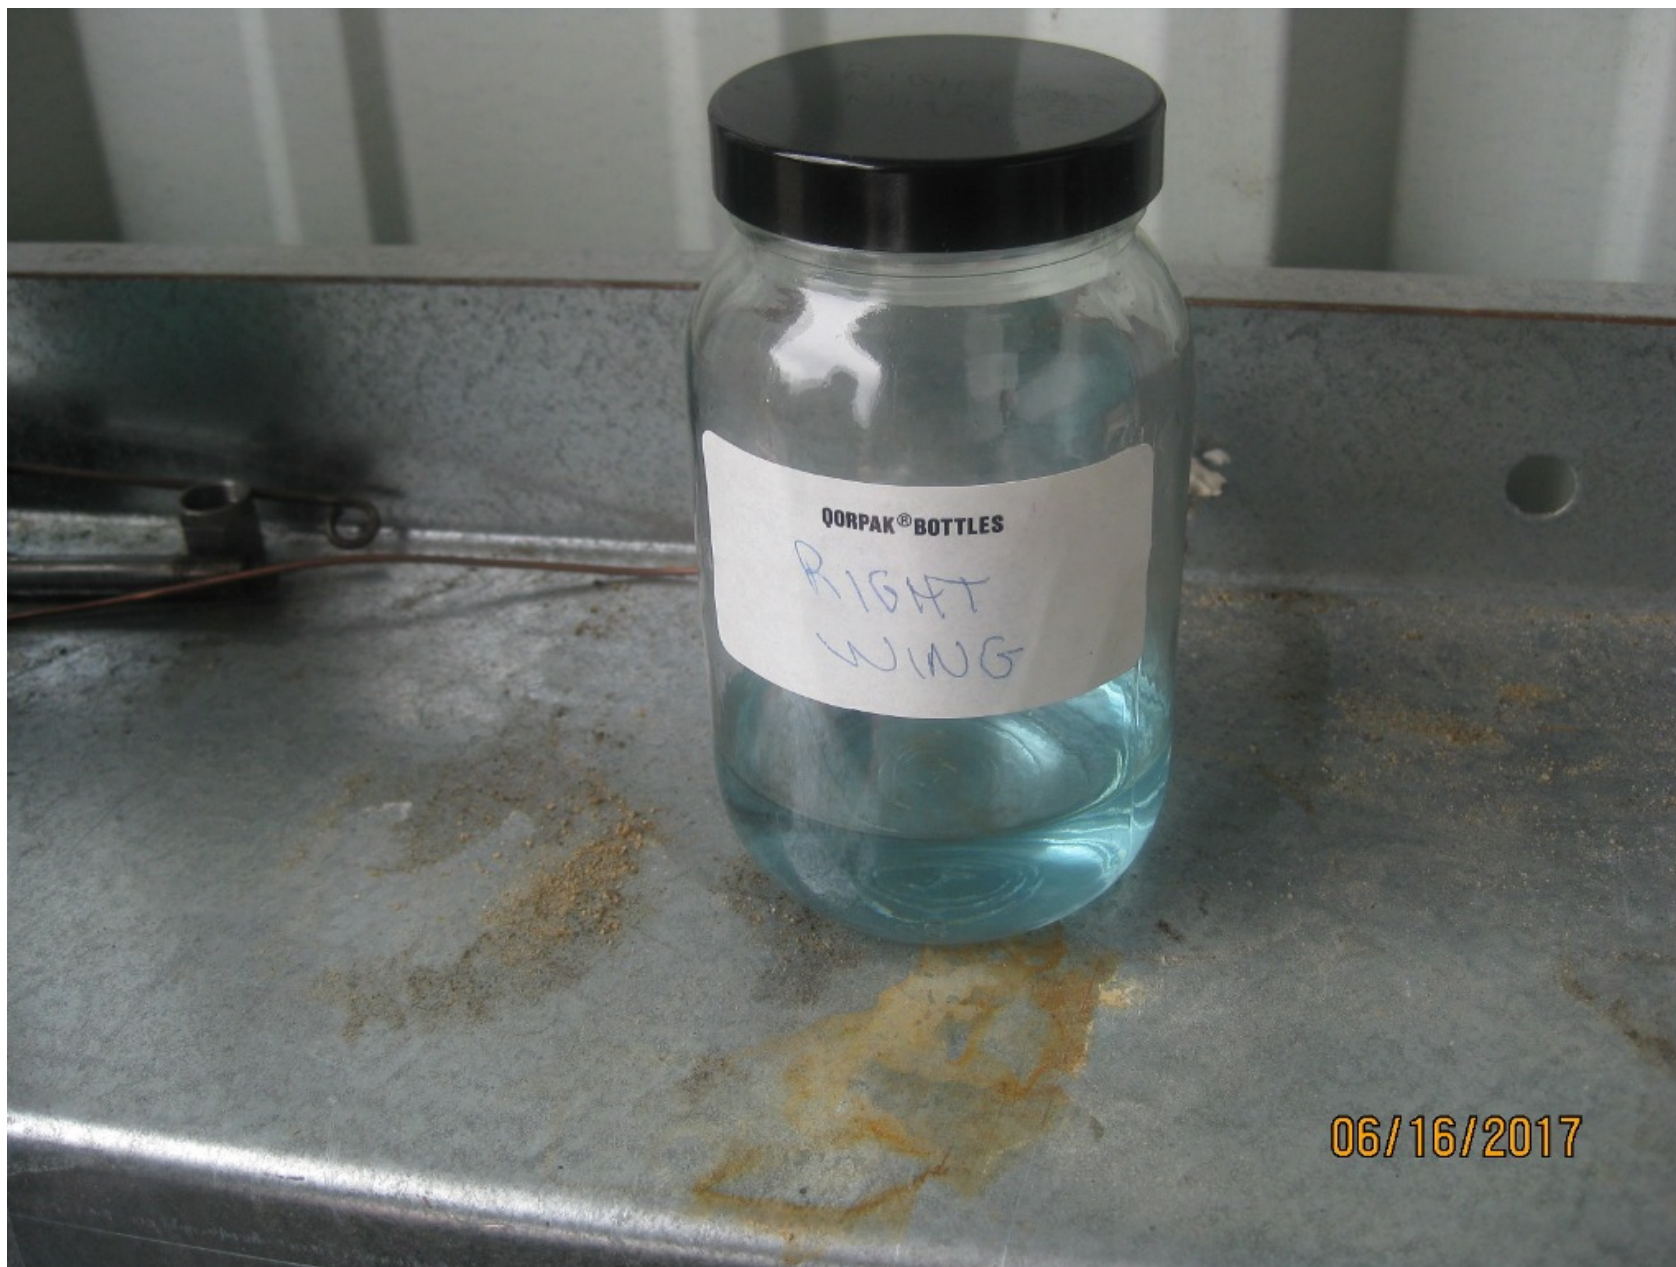
**Photo 7 - FAA Digital Photograph. View Depicting the Approximately 6 ounces of Fuel Drained from the Un-breached Right Fuel Tank.**

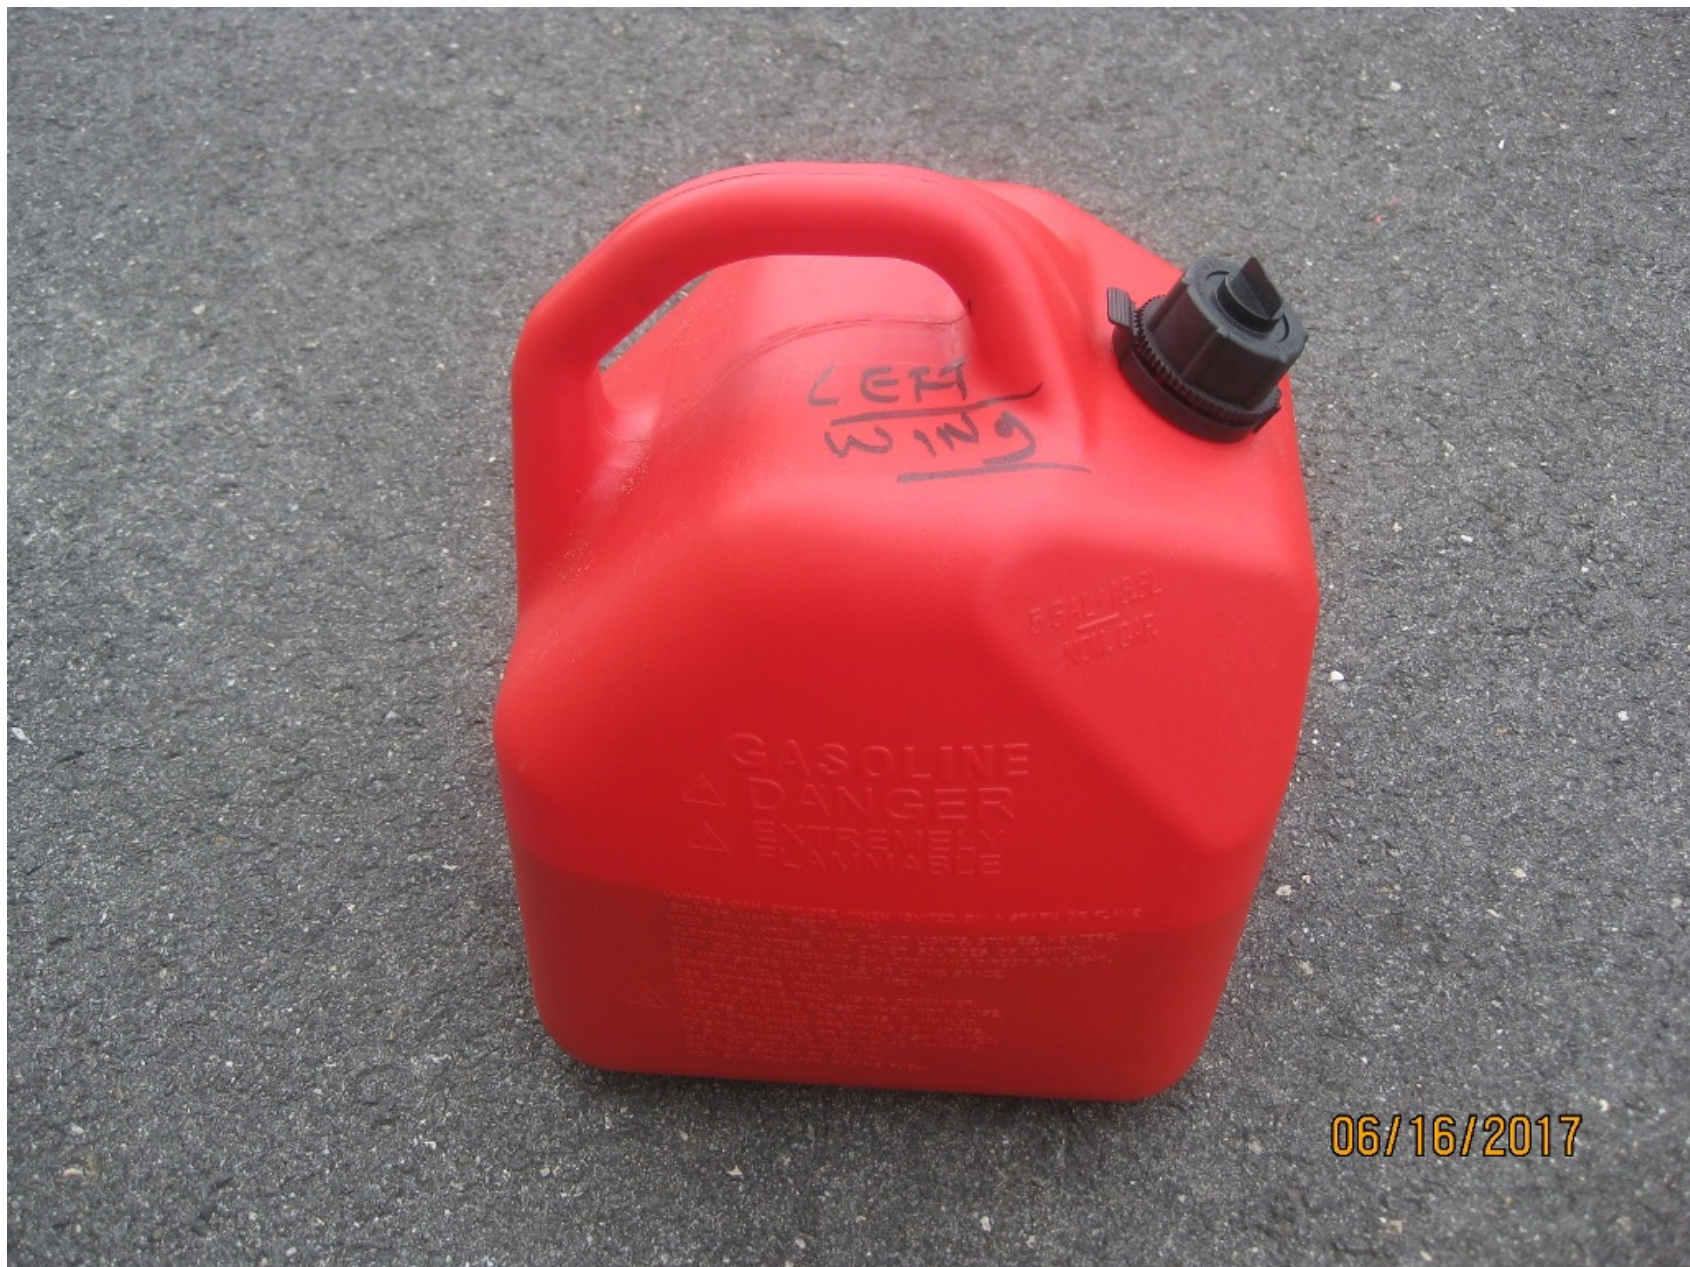
**Photo 8 - FAA Digital Photograph. View Depicting the Approximately 2.5 gallons of Fuel Drained from the breached Left Fuel Tank**
