# Continental Motors

## ENGINE EXAMINATION REPORT

| ENGINE MODEL | O-170-3 |
| FILE NUMBER | 16-696 |

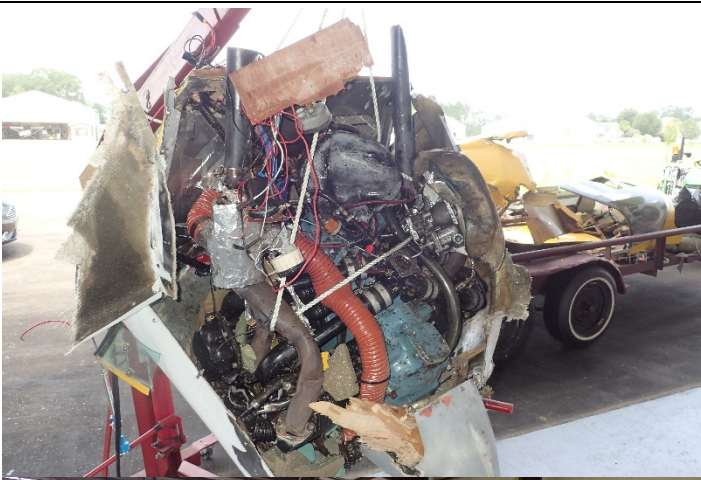
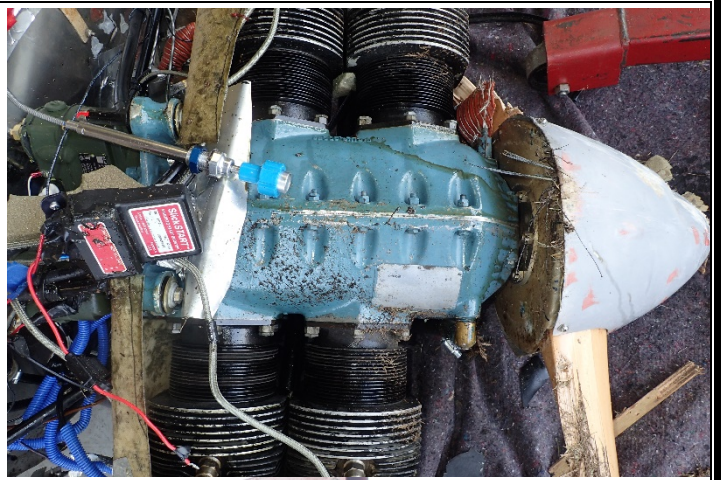
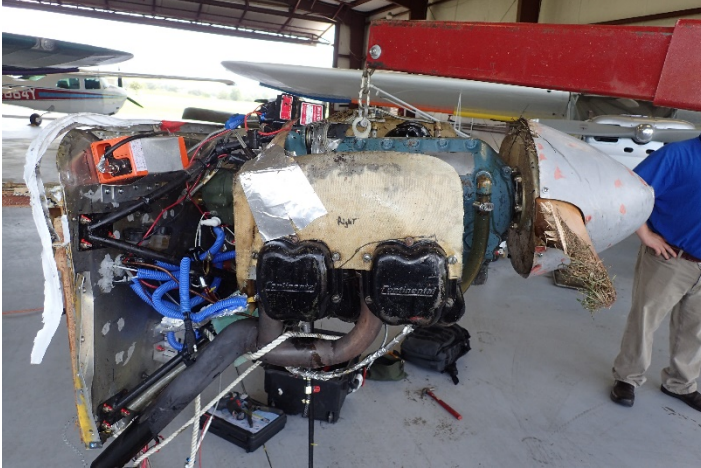
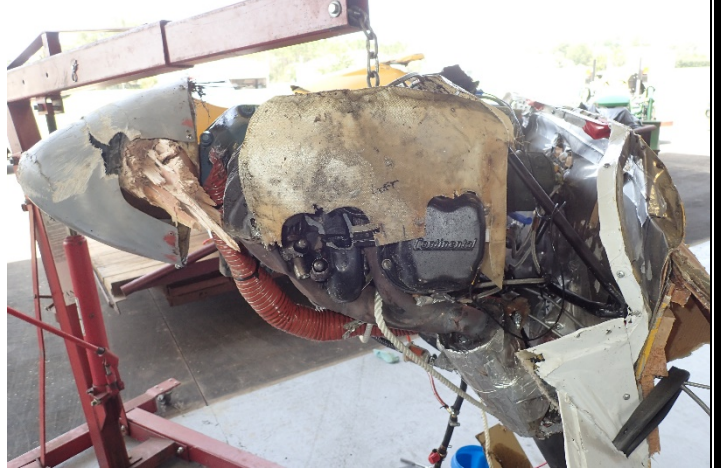
The engine remained attached to the firewall through the engine mounts, cables, wires, and hoses. The engine displayed impact damage signatures with the most damage occurring to the bottom and to the left side of the engine. The two blade, fixed pitch, wooden propeller hub remained attached to the crankshaft; both propeller blades had shattered. The crankcase remained intact and displayed minor impact damage signatures. All four cylinders remained attached to their cylinder bays and displayed varying amounts of impact damage; the #4 cylinder displayed the most impact damage signatures.

The carburetor displayed a significant amount of impact damage. The carburetor had broken free from the induction system and the air box was crushed. The carburetor inlet fuel line had broken free from the carburetor.

Both of the magnetos remained attached to their installation points. The left magneto displayed impact damage signatures to the distributor portion of the magneto. The right magneto was undamaged. The ignition harness displayed impact damage signatures with the bottom ignition harness displaying the most impact damage. All of the spark plugs remained installed in their cylinders and displayed varying amounts of impact damage signatures with the bottom spark plugs displaying the most impact damage.

The induction system displayed impact damage signatures with the most damage occurring to the #4 cylinder induction riser and to the carburetor mounting flange. The exhaust system remained attached to the engine and displayed impact damage signatures with the left side exhaust risers displaying the most impact damage.

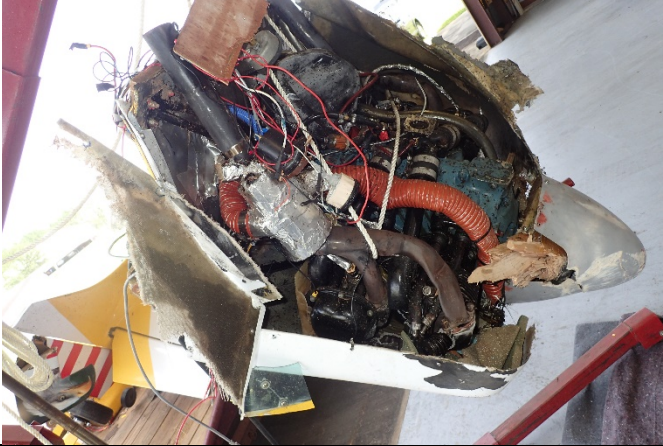
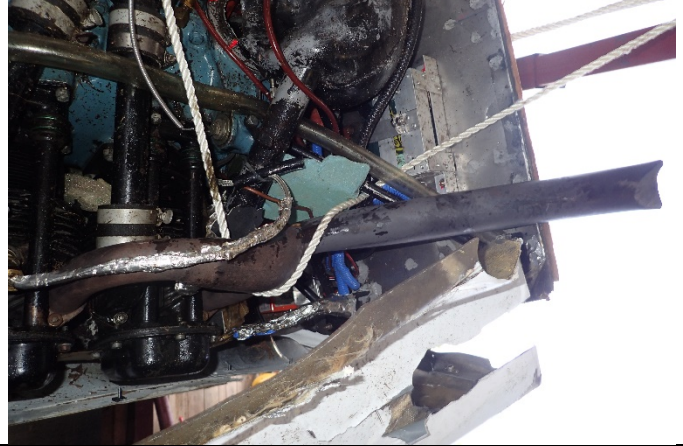
#### EXHAUST SYSTEM

**Condition:** The exhaust system remained attached to the engine and displayed impact damage signatures. The left side exhaust system displayed the most impact damage. There were no anomalies noted with the exhaust system.

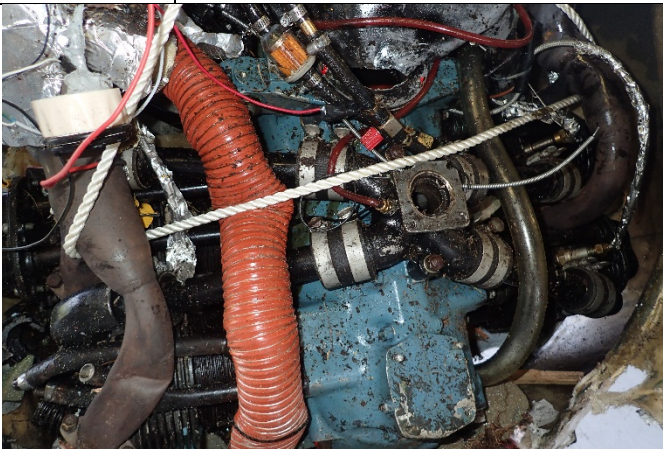
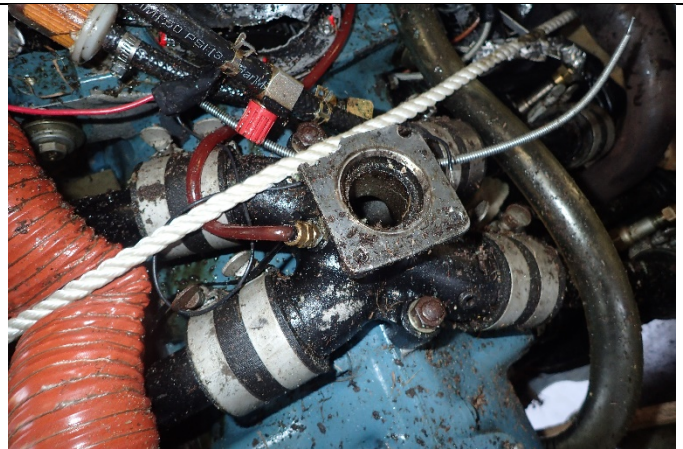
#### INDUCTION SYSTEM

**Condition:** The induction system displayed impact damage signatures with the #4 cylinder exhaust riser and the carburetor mounting flange displaying the most impact damage. There were no signs of induction leaks noted with the induction system. There were no anomalies noted.

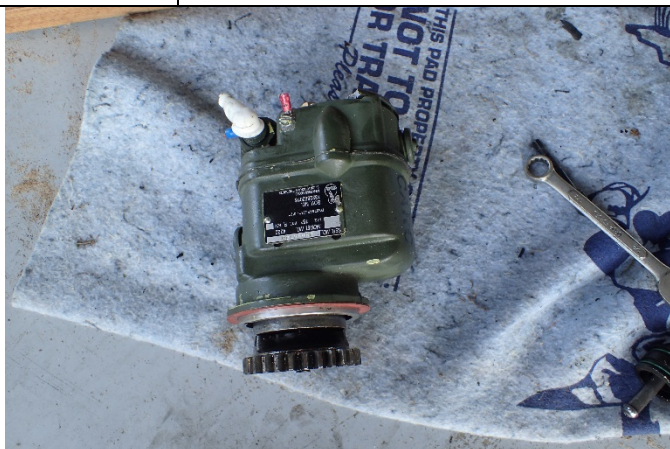
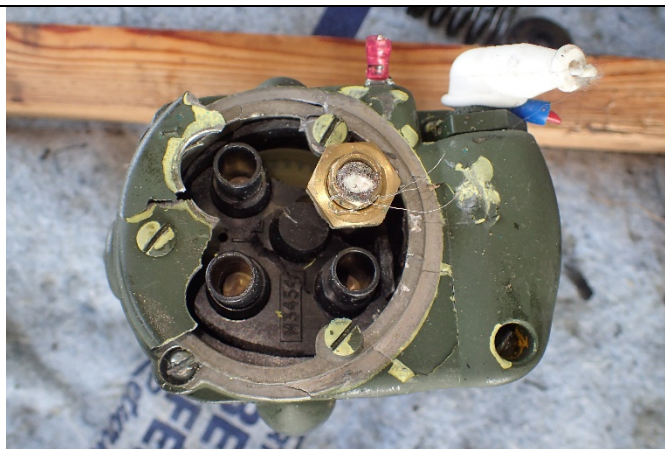
## LEFT MAGNETO

The magneto remained attached to its installation point and displayed impact damage signatures to the distributor section of the magneto. During crankshaft rotation it was noted that the magneto would only produce a spark on one of the posts. The magneto was removed and visually inspected; it was noted that the distributor was impact damaged and the distributor gear was displaced. There were no pre-impact damage anomalies noted.

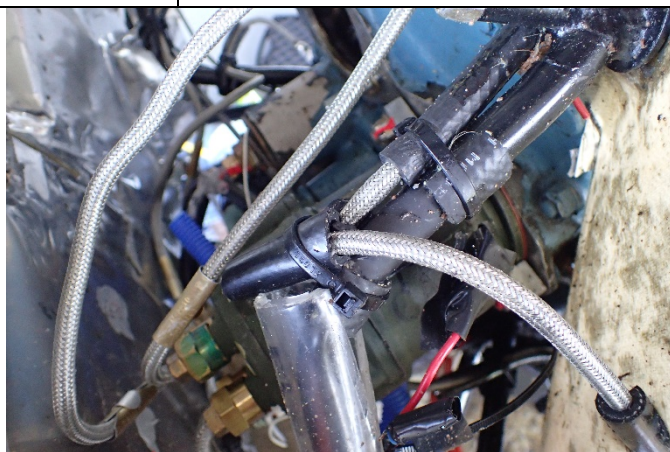
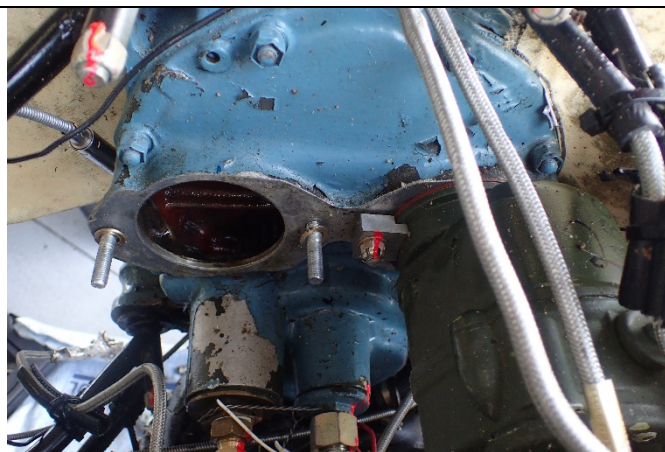
## RIGHT MAGNETO

The right magneto remained attached to its installation point and was undamaged. During crankshaft rotation, it was noted that the magneto was capable of producing a spark to all of the ignition lead ends and was in the correct firing order. There were no anomalies noted.

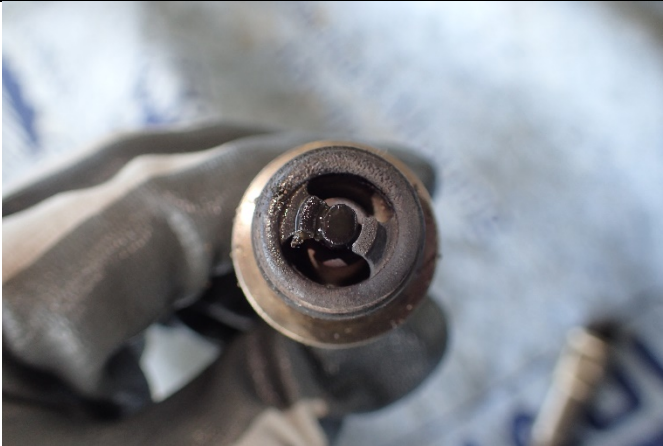
#1 Top Spark Plug

The spark plugs remained secured in their cylinders and displayed varying amount of impact damage with the bottom spark plugs displaying the most impact damage. The top spark plugs were removed and visually inspected. The spark plug electrodes displayed normal operating and wear signatures. The bottom spark plugs were inspected using a lighted borescope. The bottom spark plugs displayed normal operating and wear signatures; the bottom #4 spark plug insulator was broken which was consistent with impact damage. It was noted that the top #2 spark plug was a different manufacture and had a different heat range.

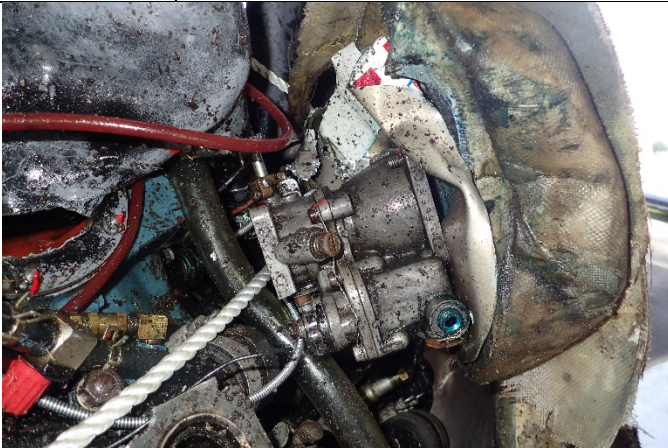
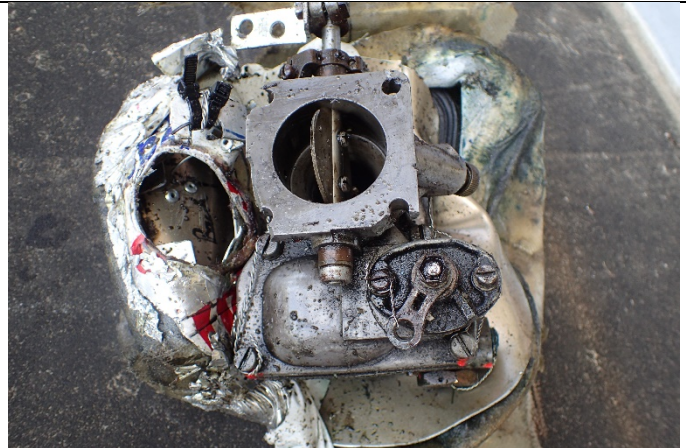
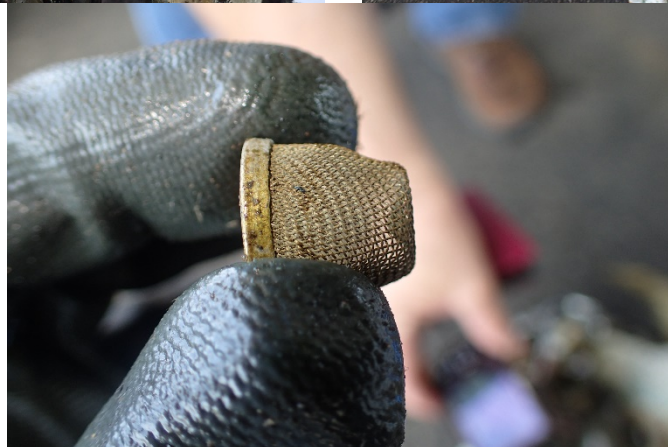
### CARBURETOR

The throttle control arm was found loose on the throttle control shaft; however, due to the design of the control arm and shaft it could not be determined if this was a result of impact damage or occurred prior to the accident. There were no further anomalies noted that would have prevented normal operation or production of rated horsepower.

The carburetor had broken free from its installation point and displayed impact damage signatures. The throttle control cable remained attached to the control arm. The carburetor was removed from the airframe and visually inspected. It was noted that the control arm was loose on the control shaft and the investigators were able to pull the control arm off the control shaft without having to loosen the control arm clamp. Due to the impact damage to the carburetor and the design of the arm and shaft the investigators could not determine whether it became loose as a result of the accident or occurred prior to impact. The carburetor was disassembled and the internal components were visually inspected. The internal components displayed normal operating signatures and the fuel inlet filter was clear of contaminants.

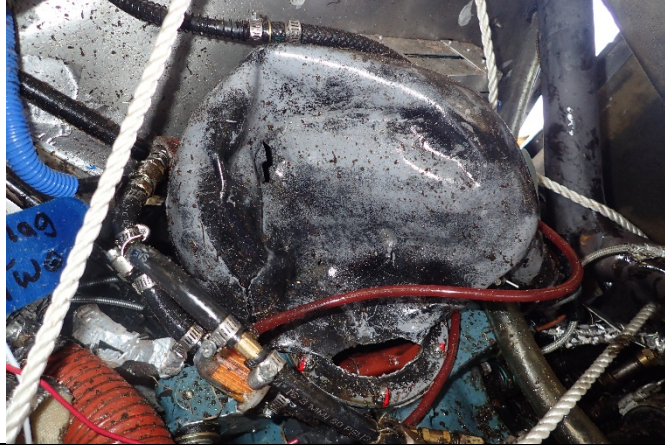
#### OIL SUMP

Condition: The oil sump displayed a significant amount of impact damage and was breached. When the engine was turned right side up a significant amount of oil leaked out from the breached oil sump. There were no anomalies noted.

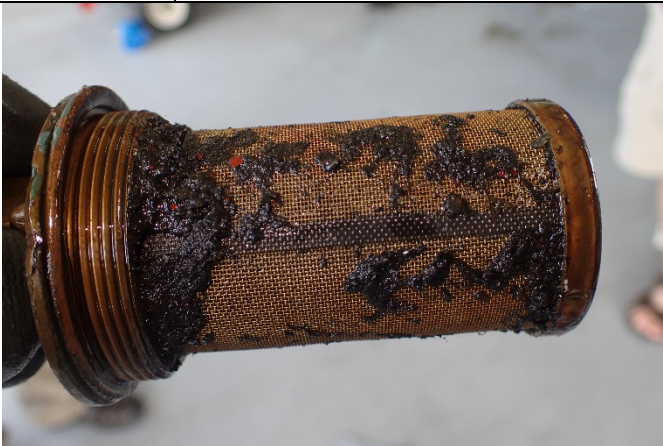
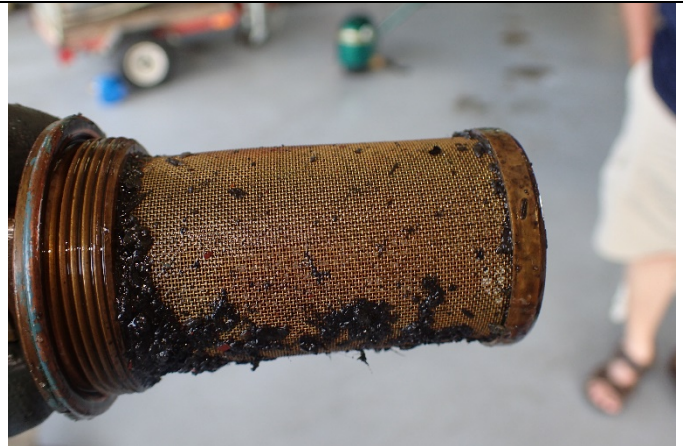
#### OIL SCREEN

Condition: The oil screen remained secured in its installation point and was undamaged. The oil screen was removed and visually inspected. There was a significant amount of carbon noted within the screen. There were no further anomalies noted with the oil screen inspection.

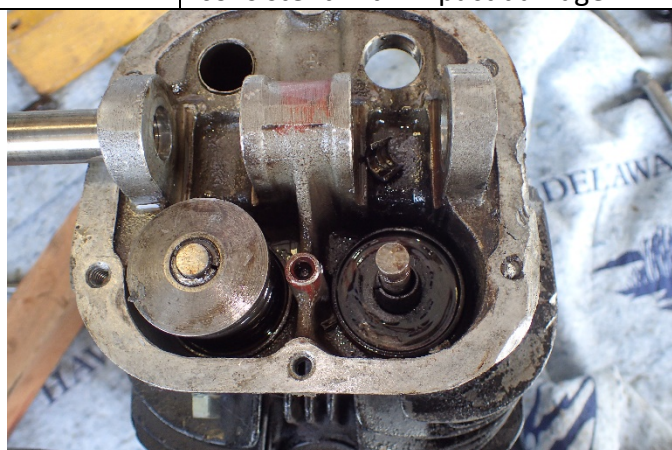
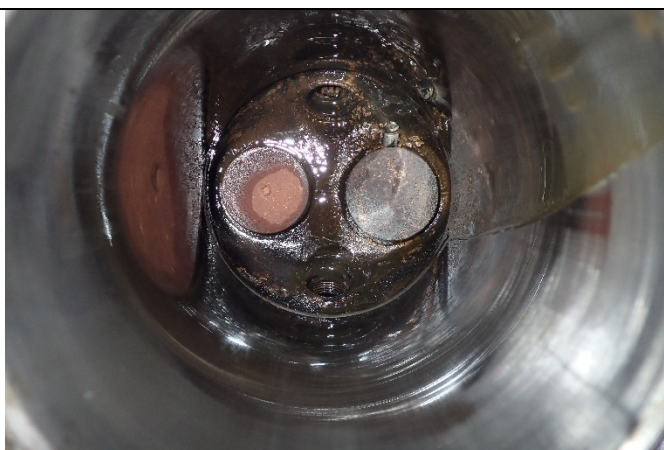
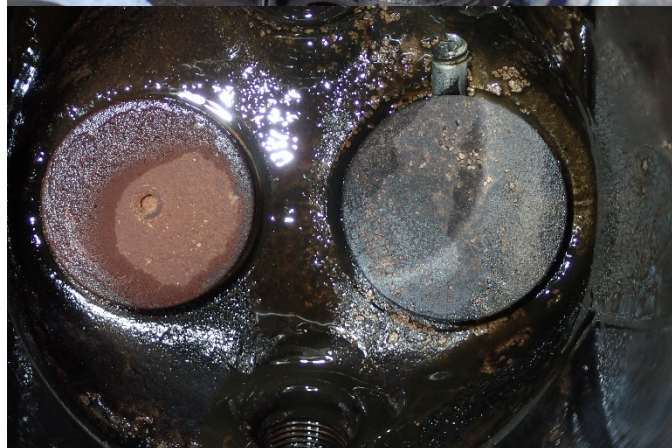
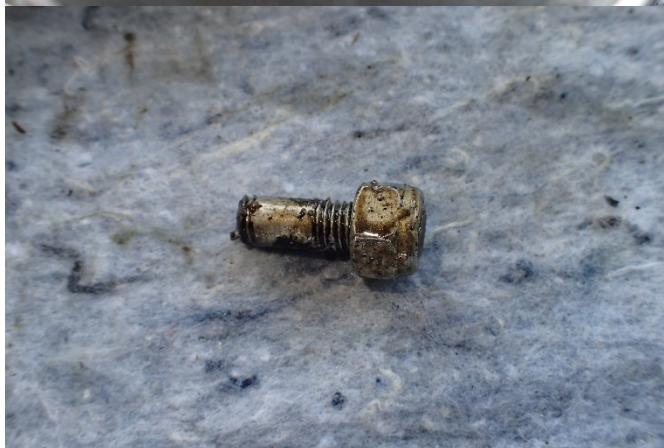
CYLINDER #2

The cylinder remained attached to its cylinder bay and displayed impact damage signatures to the cylinder head. The internal portion of the cylinder was inspected using a lighted borescope. The piston face and cylinder bore displayed normal operating and combustion signatures. The inspection of the valves revealed a foreign object was underneath the intake valve and the exhaust valve was stuck in the open position. The cylinder was removed and the foreign object was removed from the intake valve; it was determined that the object was one of the mounting studs for the carburetor that had broken free during impact. The exhaust rocker arm was removed and it was noted that it was impinged in its installation point which was consistent with the impact damage to the cylinder. The exhaust valve was removed and it was noted to be bent which was consistent with impact damage.

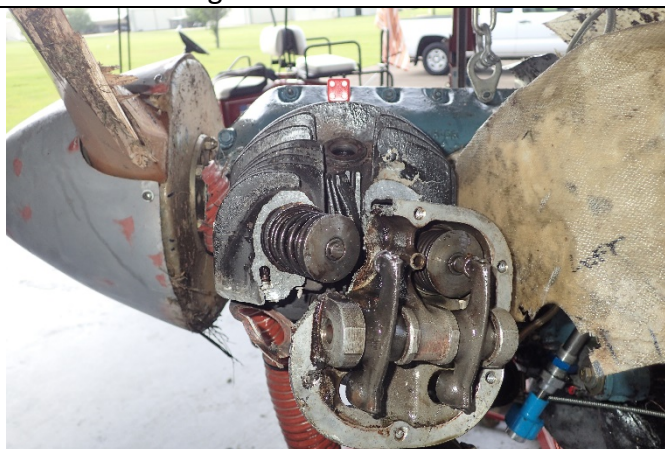
## CYLINDER #4

The cylinder remained attached to its cylinder bay and displayed a significant amount of impact damage to the cylinder head. A large portion of the cylinder head had broken free from the rest of the cylinder and both of the valves were bent. The internal portion of the cylinder was inspected using a lighted borescope. The piston face and cylinder bore displayed normal operating and combustion signatures. The valves heads were displaced from their seats which was consistent with impact damage. Both of the valve heads displayed normal combustion signatures. The overhead components (valves, springs, rocker arms, and push rods) displayed impact damage signatures, normal operating signatures and lubrication signatures.

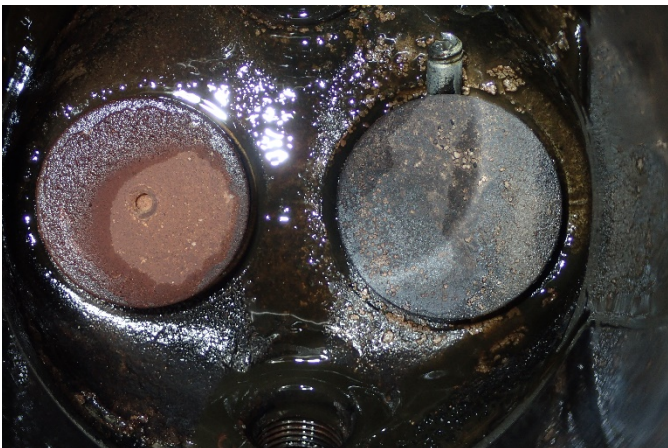
The #2 cylinder exhaust valve was found stuck in the open position. The exhaust valve was removed and it was found to be bent which was consistent with impact damage. The #2 intake valve had a foreign object under the valve; after the cylinder was removed it was determined the object was a stud that had broken free from the carburetor mounting flange during the accident sequence. The #4 valves displayed impact damage signatures and were bent and the valve heads were displaced from their seats. All of the valve heads displayed normal combustion signatures and the #1 and #3 valves operated normally during crankshaft rotation.

#2 Intake and Exhaust Valves with Debris

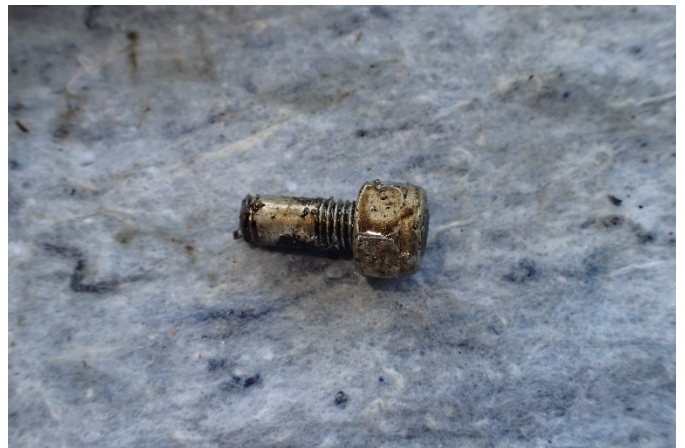
Bolt and nut found between the #2 intake valve head and seat

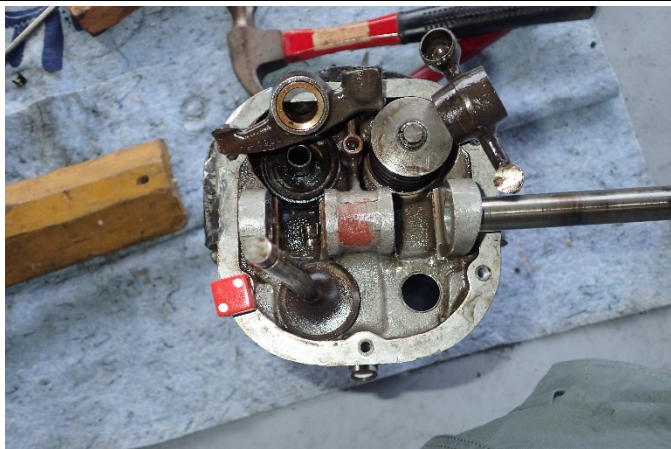
#2 Rocker Arms after Removal

The #2 exhaust rocker arm was noted to be impinged in its installation point which was consistent with impact damage to the cylinder. The rocker arms displayed normal operating and lubrication signatures.

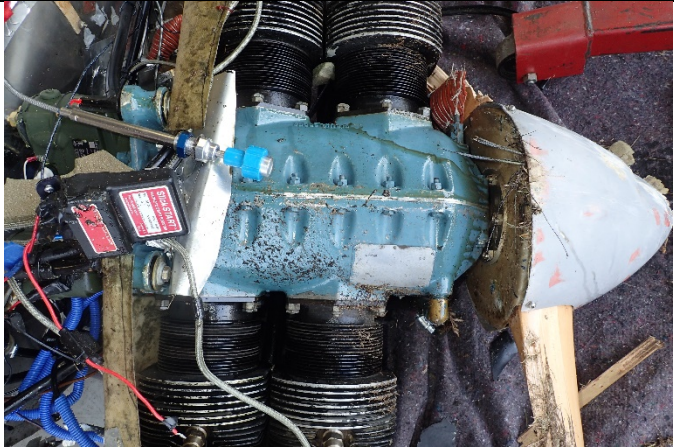
**CRANKCASE ASSEMBLY**

| Condition: | The crankcase remained intact and displayed minor impact damage signatures. There were no anomalies noted with the crankcase. | | | |

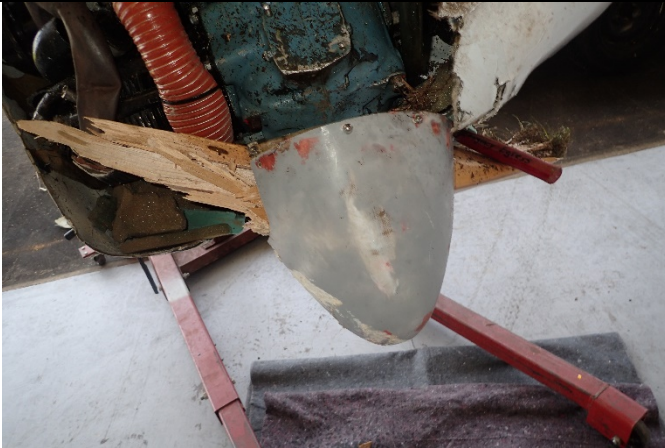
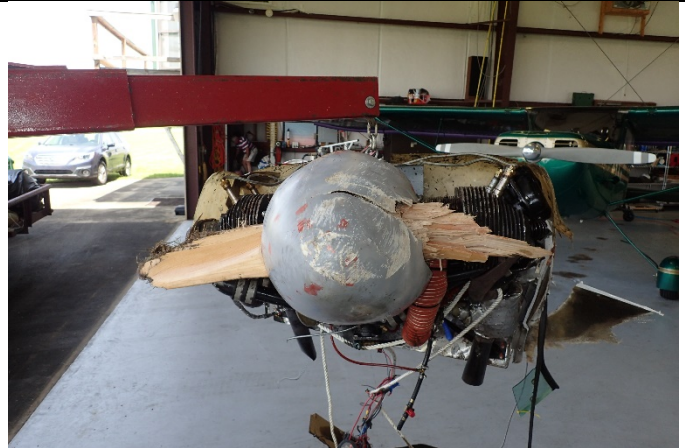
#### PROPELLER

The two blade, fixed pitch, wooden propeller remained attached to the propeller flange and displayed impact damage to both propeller blades. Both of the propeller blades had shattered into multiple pieces.
