**NATIONAL TRANSPORTATION SAFETY BOARD**  
Vehicle Recorder Division  
Washington, DC 20594

## **Witness and Onboard Video**

**Specialist's Factual Report**  
**By Bill Tuccio, Ph.D.**

| NTSB Number: | ERA17LA227 |

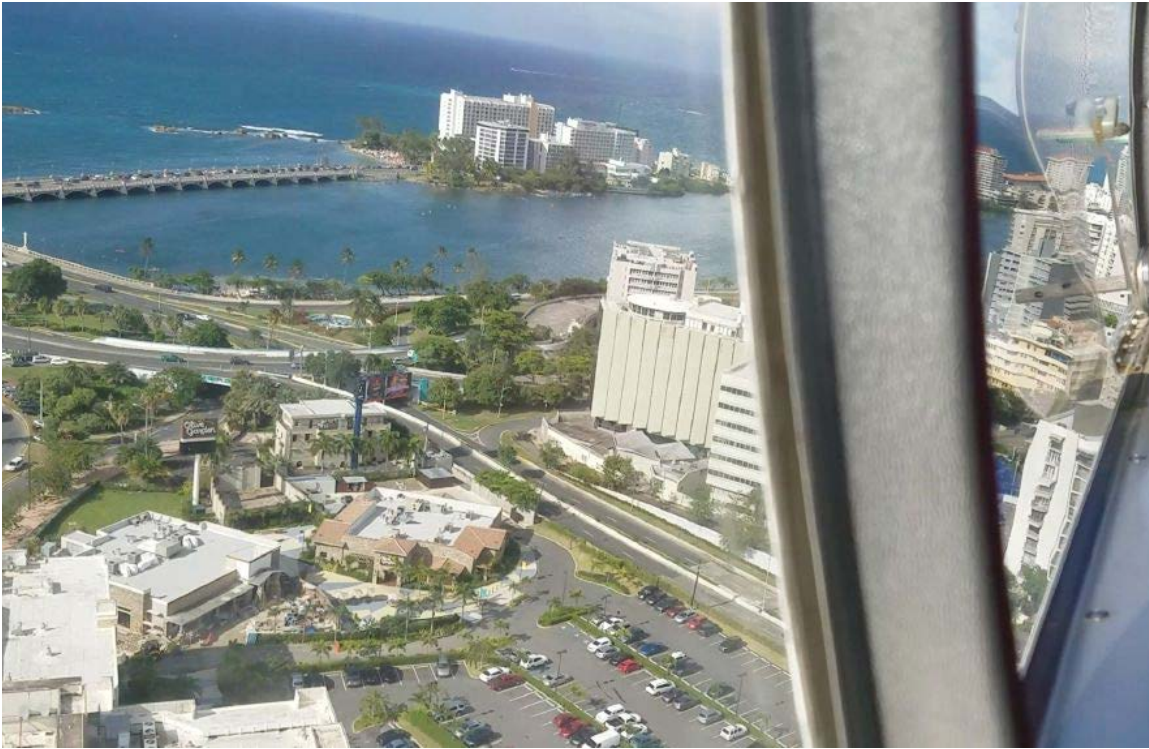
Figure 3 shows the aircraft left bank angle at 00:01:32.2, which had increased from 00:01:30.8. The right side of the image is cropped to eliminate a view of the interior occupants.

Figure 3. Image at 00:01:32.2 onboard video elapsed time.

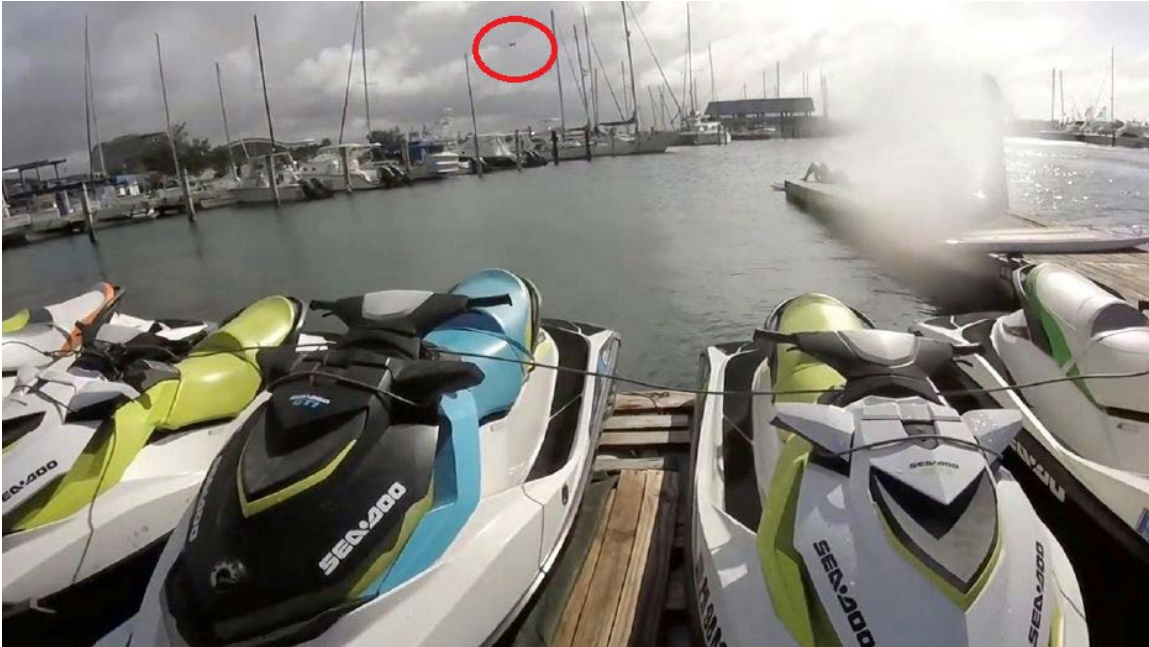
At 00:00:15.3, the accident airplane was visible in the video (see figure 4), flying level in roll (climb/descent/pitch was not discernable), and the airplane's engine noise was faintly recorded.

Figure 4. Witness video at 00:00:15.3 (annotated).

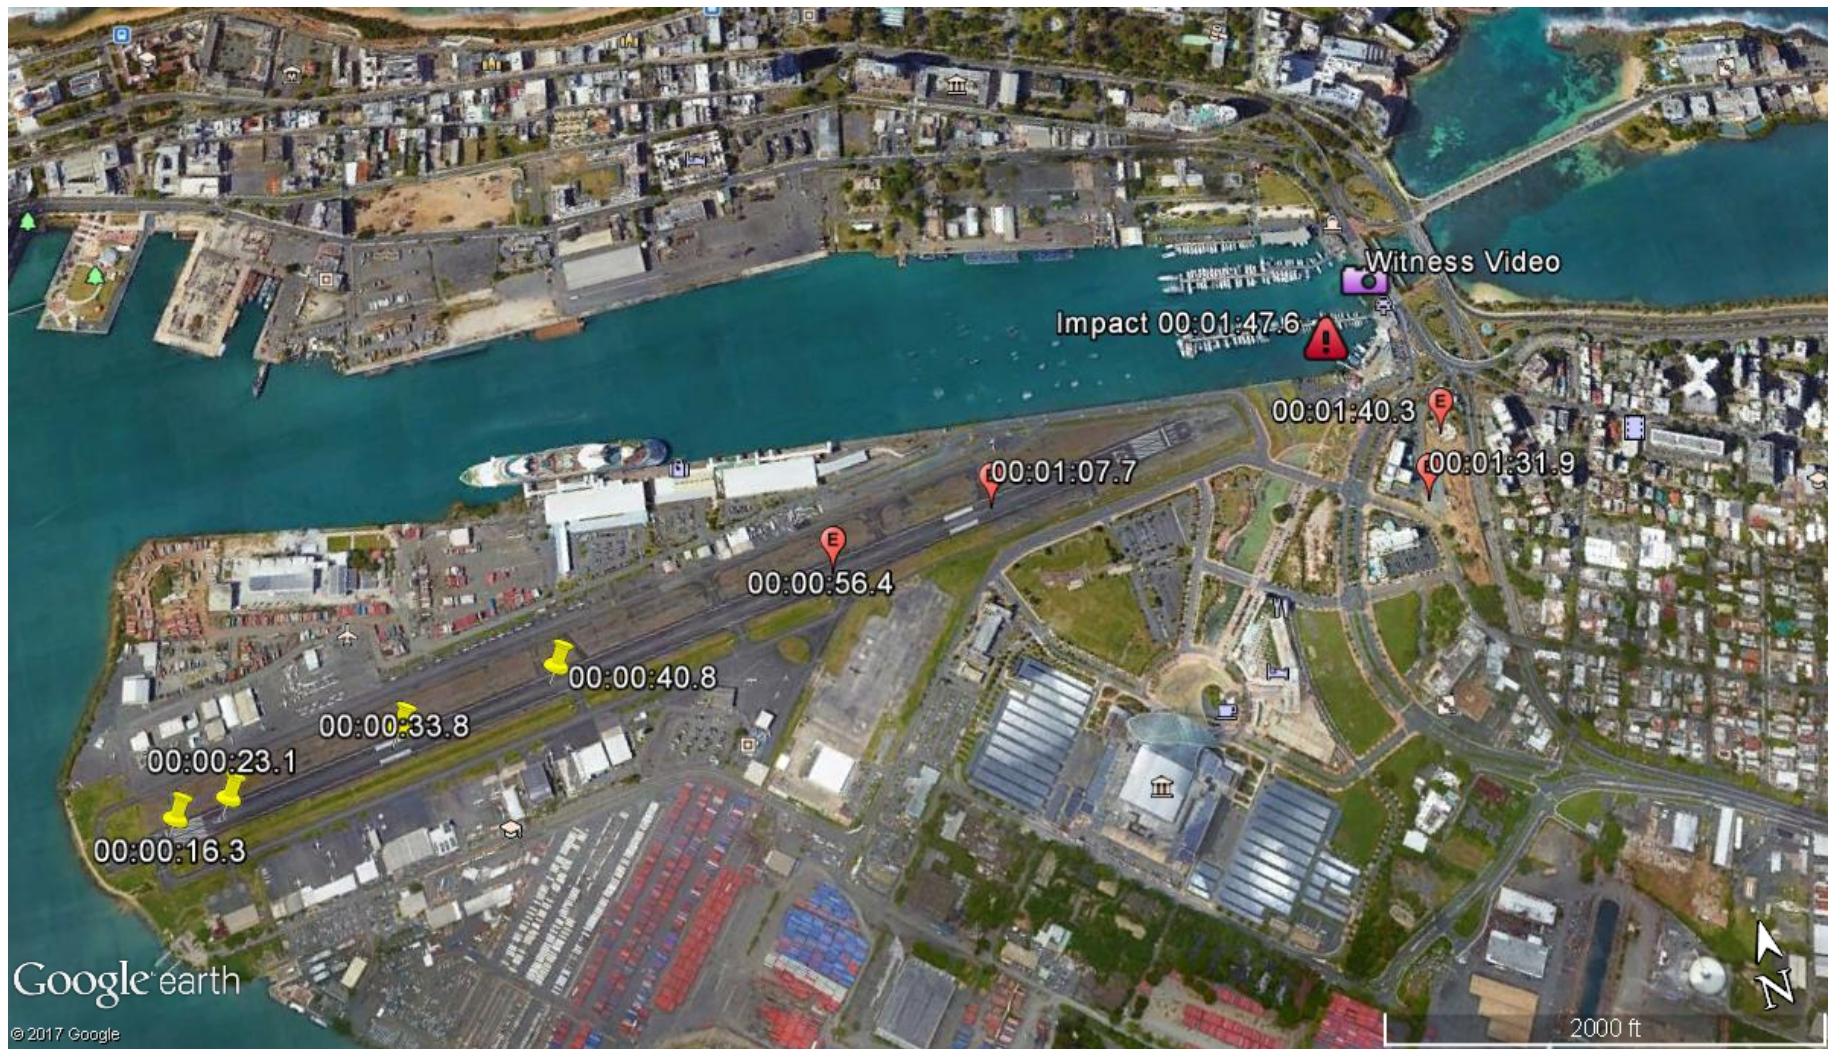
Figure A-1 shows points along the aircraft path, in onboard video elapsed time, produced in Google Earth. The yellow pin markers (📌), show precise measures of aircraft position; the red “e” markers (📍) show approximate positions; and the remaining markers show the approximate location of the witness video and impact point.

Figure A-1. Aircraft trajectory points in onboard video elapsed time.
