**Photo 1 – FAA Digital Photograph. View of the Airplane near the Accident Site**

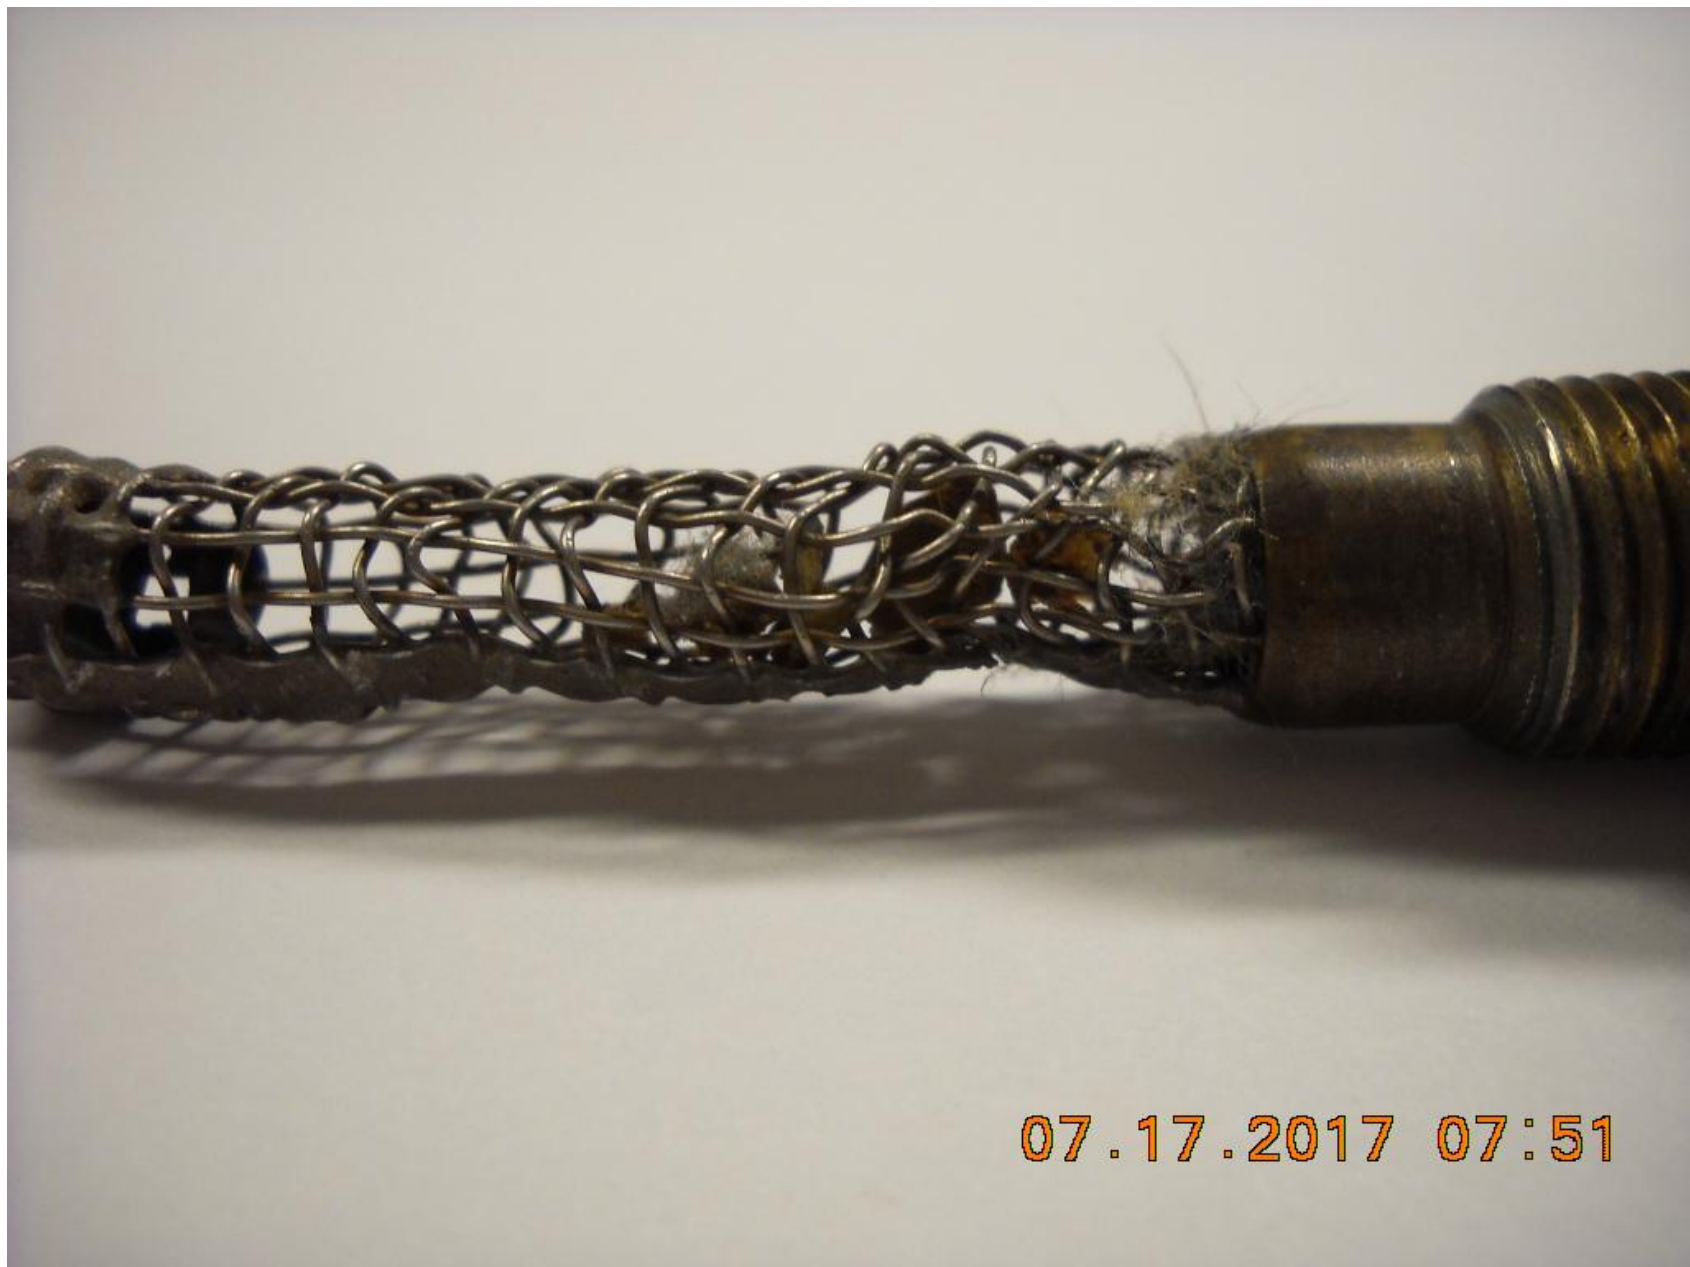
**Photo 2 - FAA Digital Photograph. View of the Exterior of the Right Fuel Tank Strainer**

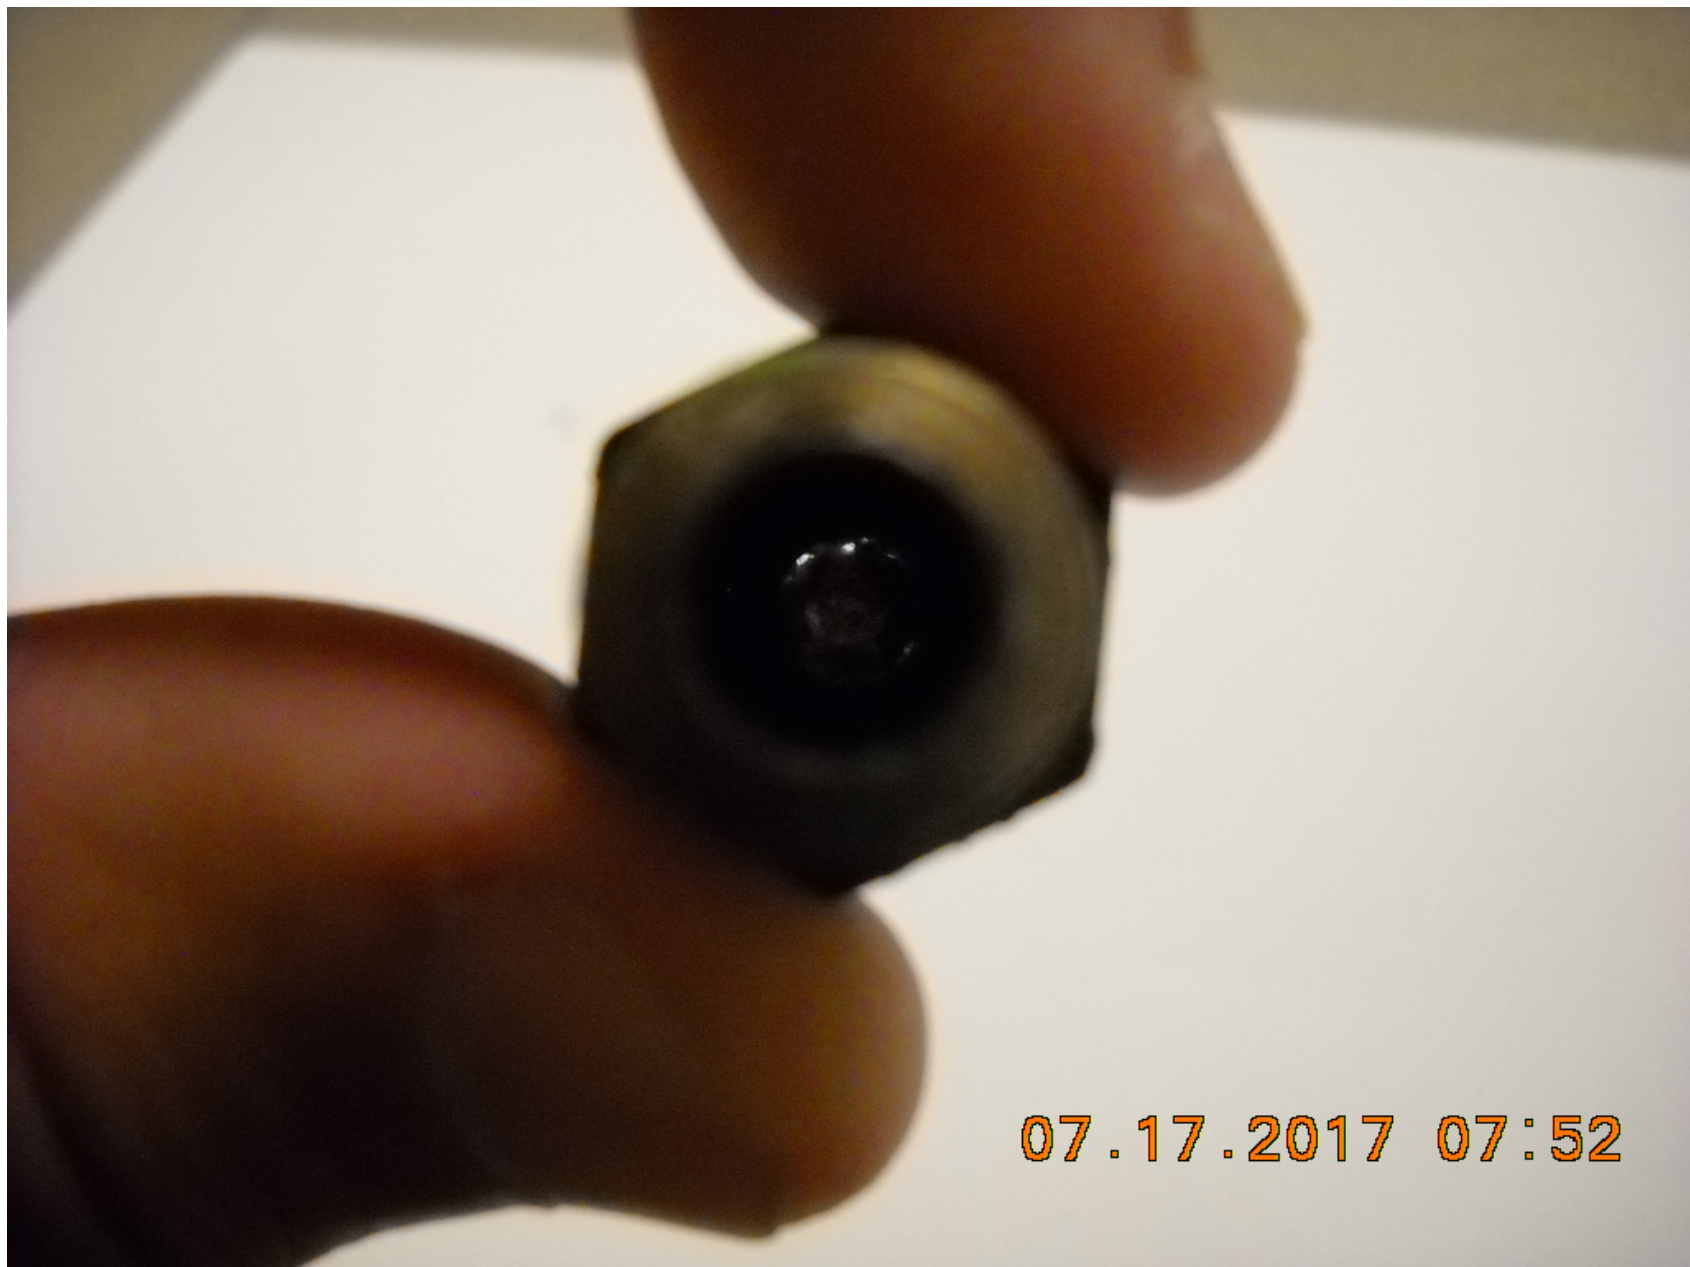
**Photo 3 - FAA Digital Photograph. View of the near complete blockage of the Right Fuel Tank Strainer**

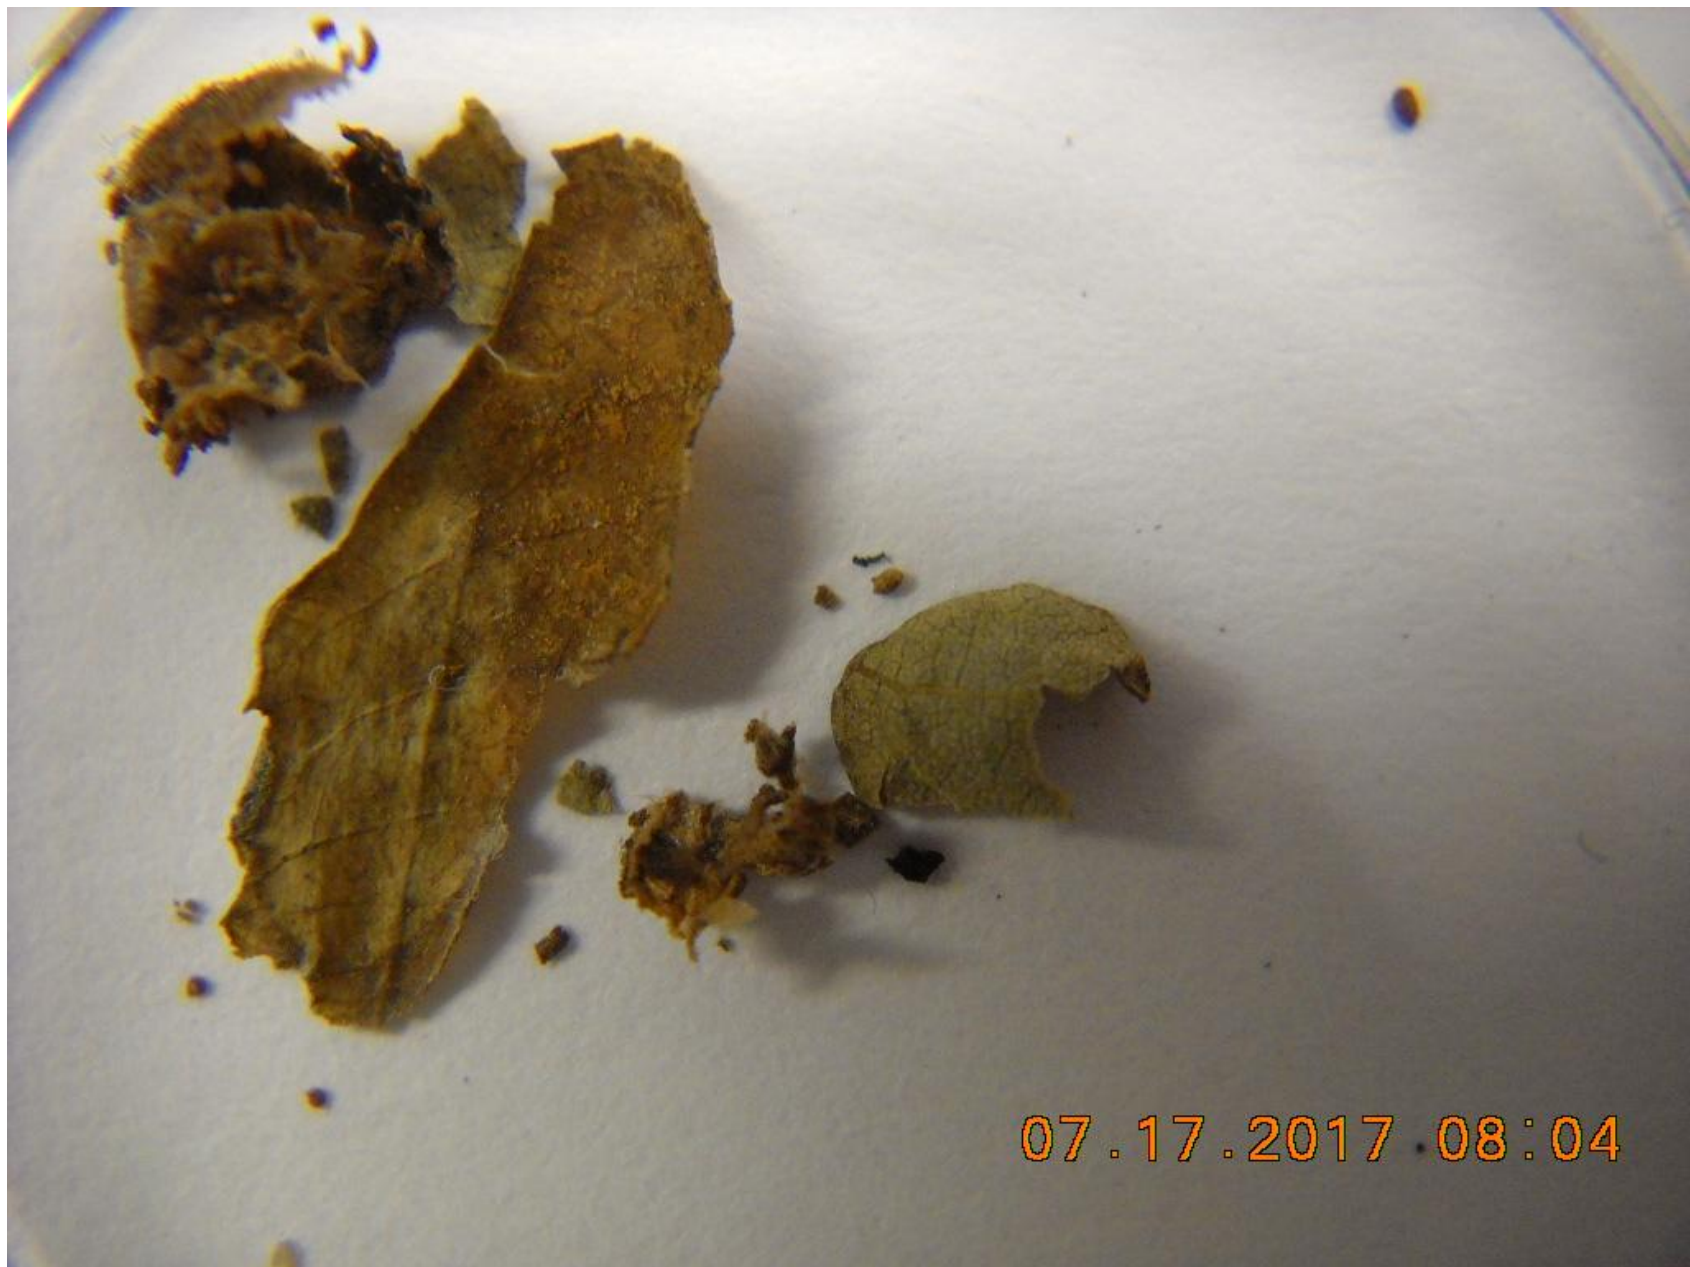
**Photo 4 - FAA Digital Photograph. View of the organic material removed from Right Fuel Tank Strainer**
