# NATIONAL TRANSPORTATION SAFETY BOARD

## MATERIALS LABORATORY FACTUAL REPORT

Report No. 17-084

Place : Myrtle Beach, South Carolina  
Date : July 24, 2017  
Vehicle : Robinson R44, N828RD  
NTSB No. : ERA17LA257  
Investigator : Timothy W. Monville, AS-ERA

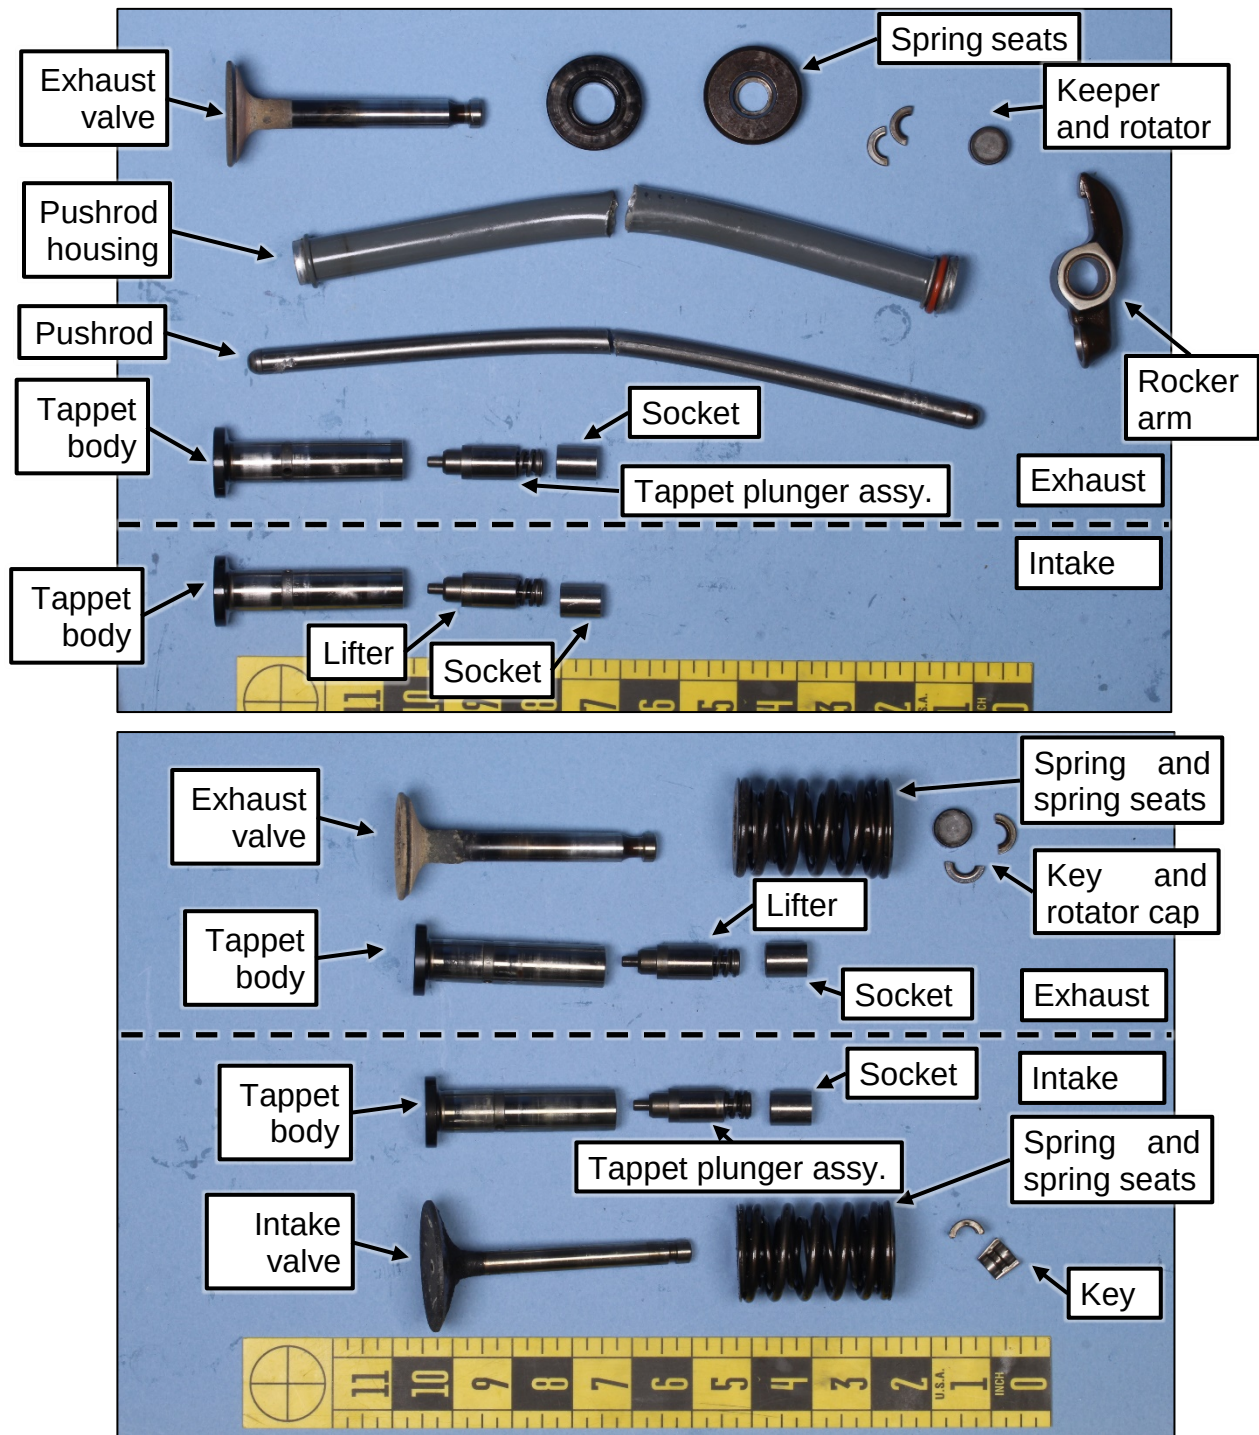
An overall view of the submitted valve train components from the numbers 4 and 5 cylinders are shown in figure 1. Components from both cylinders included the intake and exhaust tappet bodies, plunger assemblies, and sockets and the exhaust valves, rotator caps, keys, and spring seats from both cylinders. The rocker arm, pushrod, and pushrod housing were also included from the number 5 cylinder, and the valve springs, intake valve, and intake key were included from the number 4 cylinder.

The number 5 exhaust pushrod was bent and fractured as shown in figure 1. Fracture features on the pushrod pieces were obliterated by post-fracture contact between the mating fractures. The rocker arm and socket ends of the pushrod are shown in figure 5. Gouges consistent with contact damage with the edge of the rocker arm seat and with the edge of the cylinder flange were observed on the side of the pushrod at the rocker arm end as indicated in figure 5. The contact damage closest to the end of the pushrod was located in line with the inner radius of the bend. The wear pattern at the socket end of the pushrod was angled relative to the longitudinal axis of the pushrod. The wear pattern was consistent with the pushrod axis angled relative to the socket axis, and the orientation of the angle was consistent with the orientation of the bend in the pushrod.

The pushrod housing was fractured near the middle of its length as shown in figure 1. Rough fracture features with adjacent deformation of the housing wall was consistent with fracture due to overstress loads. Rub marks consistent with contact with the pushrod were observed on the interior of the pushrod housing. The inboard end of the pushrod housing where it was inserted in the crankcase is shown in figure 6. Arrows in figure 6 indicate areas of impact damage with missing material at the end of the pushrod housing. The position and geometry of the damage was consistent with contact with the edge of the tappet socket, also shown in figure 6. Corresponding contact marks and material transfer were observed on the edge of the socket.

Figure 1. Overall view of the submitted valve train components from the number 5 cylinder (upper image) and the number 4 cylinder (lower image).

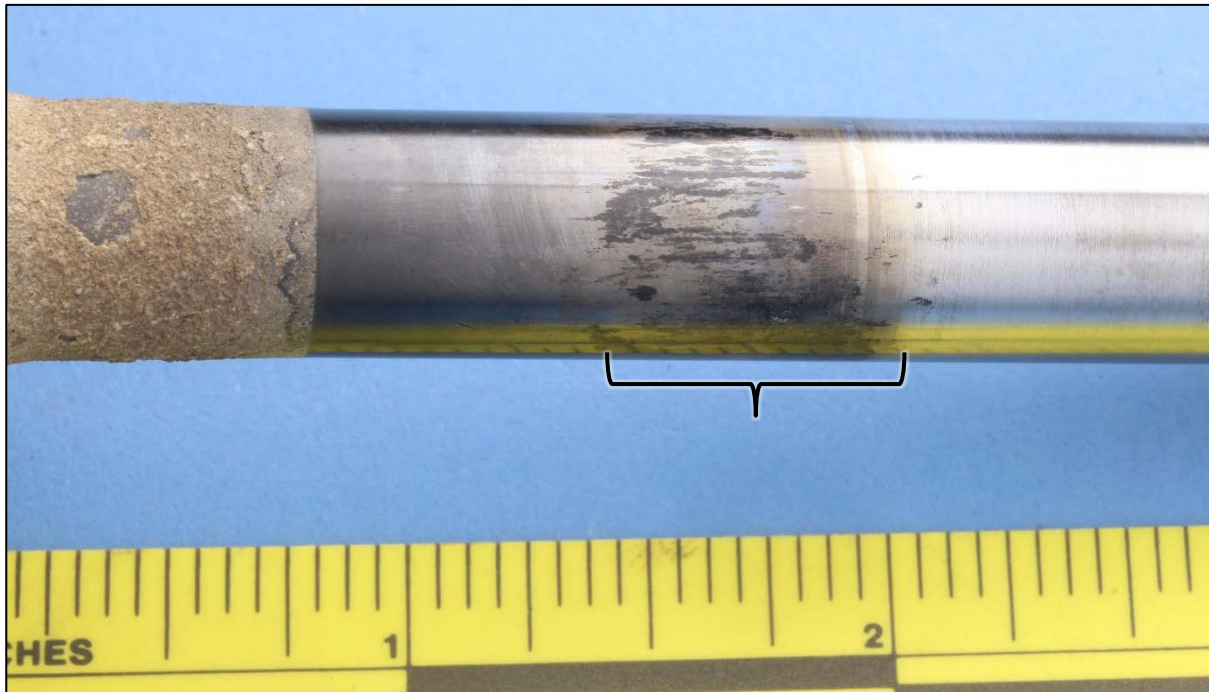
The head of the number 5 exhaust valve was covered with tan-colored deposits up to the position corresponding to the end of the valve guide as can be seen at the left side of the image in figure 2. The valve seat contact area was free of deposits and had a uniform contact pattern with no evidence of excessive impact. The area next to the tan-colored deposits on the valve stem was tinted black and brown. Around the circumference, the number 5 exhaust valve stem had black streaks generally oriented in the longitudinal direction near the upper end of the tinted region as indicated with a bracket in figure 2. No evidence of galling was observed on the stem, and no change in surface roughness was detected by rubbing a fingernail across the black streaks. Curved impact marks were observed on the face of the valve tip as indicated with arrows in figure 3. The shapes of the impact marks were consistent with multiple impacts with the edge of the displaced rotator cap.

Figure 2. Number 5 exhaust valve stem. A bracket indicates an area with glazed black streaks on the surface.

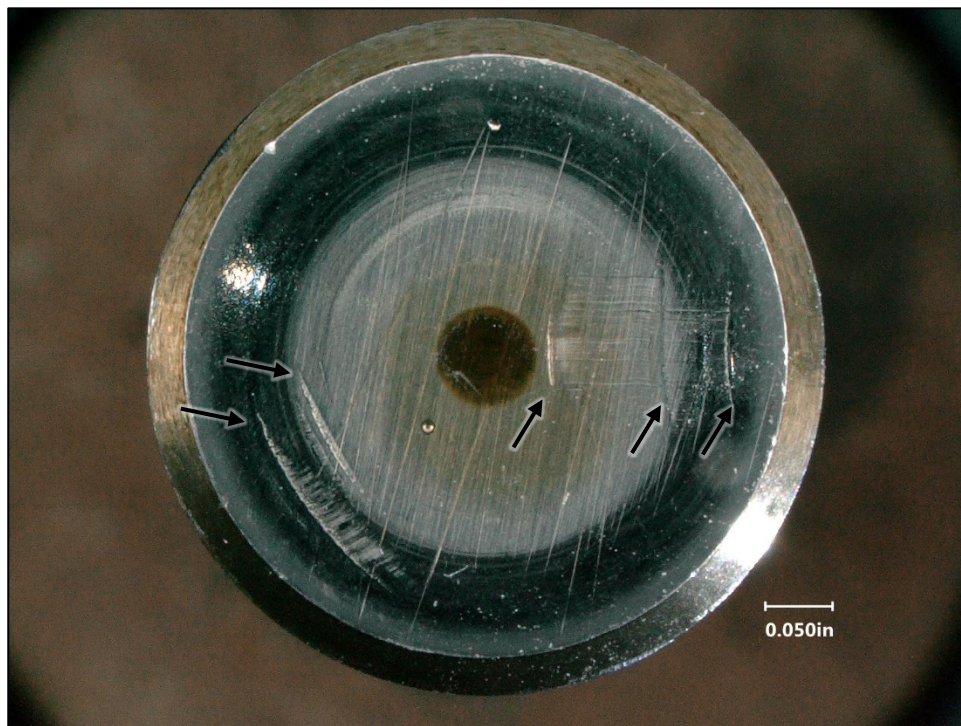
Figure 3. Number 5 exhaust valve tip. Arrows indicate arc-shaped impacts consistent with contact with the rotator cap edge.

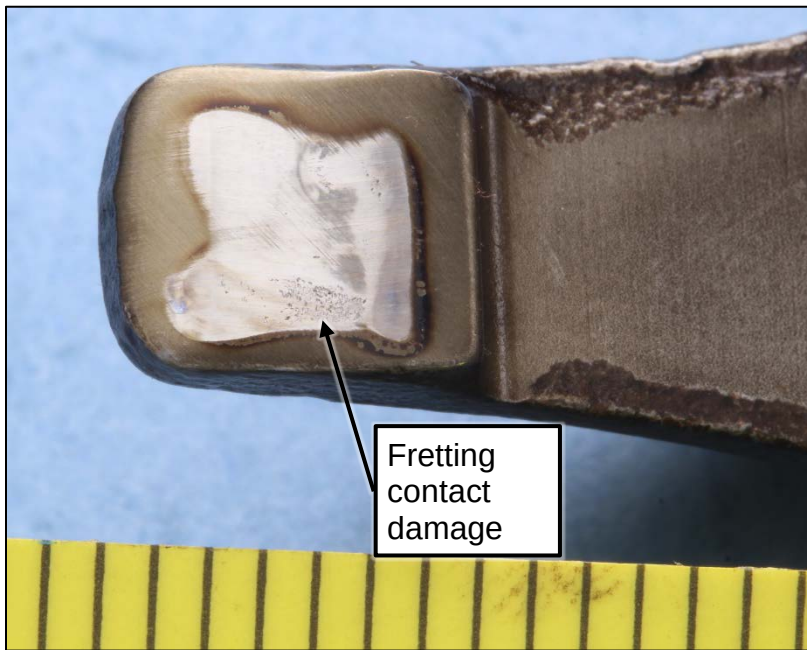
The valve contact pad on the number 5 exhaust rocker arm is shown in figure 4. An area of pitting consistent with fretting contact damage was observed at the edge of the shiny contact area on the pad as indicated in figure 4.

Figure 4. Number 5 exhaust rocker arm pad.

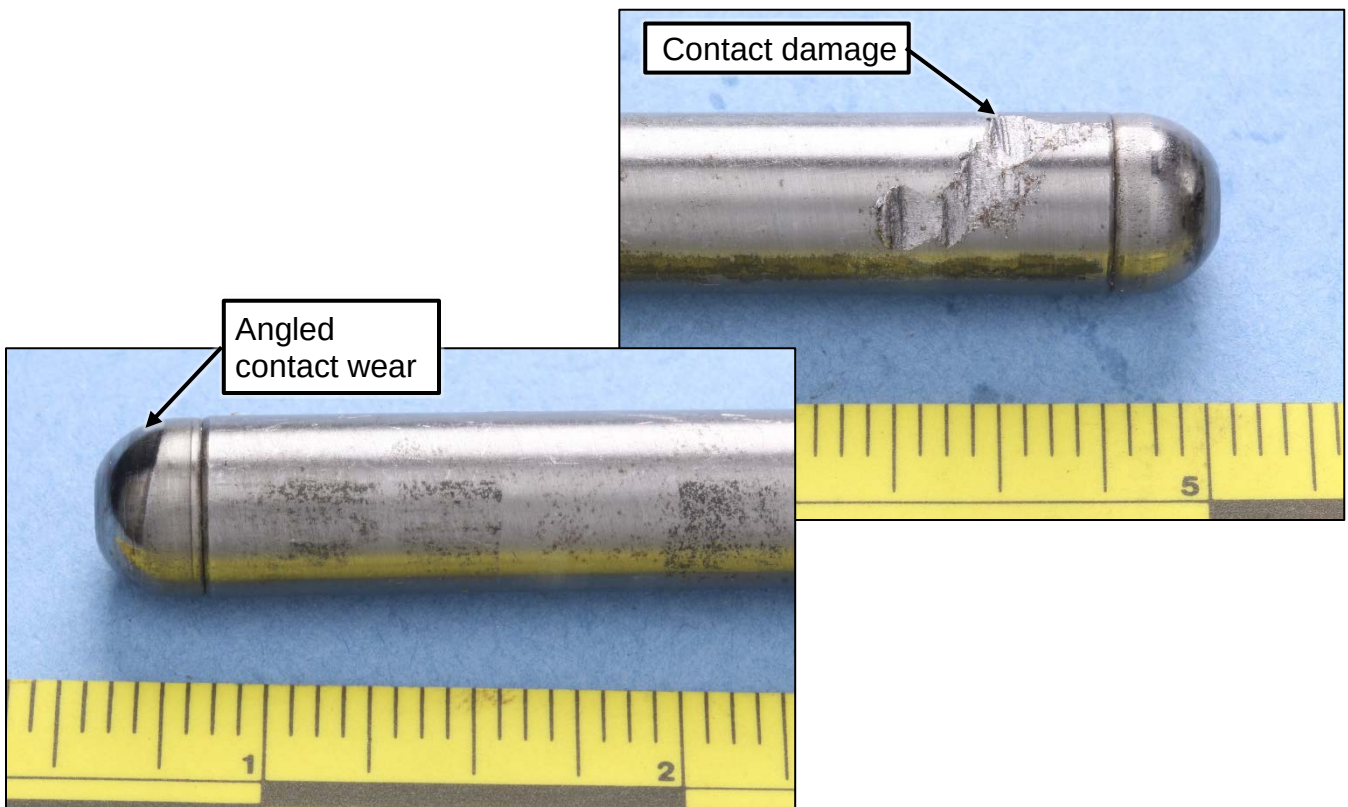
Figure 5. Rocker end (upper image) and tappet end (lower image) of the number 5 exhaust push rod. Contact damage and angled contact wear patterns are indicated.

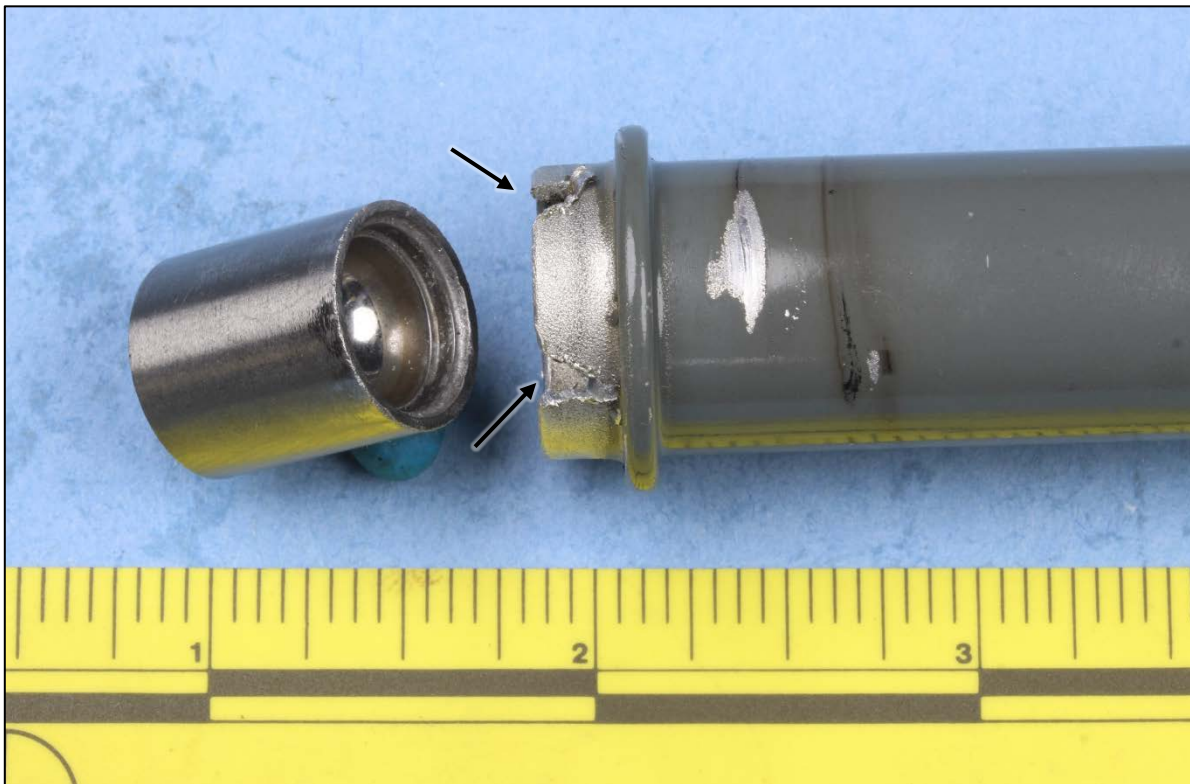
Figure 6. Number 5 exhaust tappet socket and crankcase end of the pushrod housing. Arrows point to contact damage to the pushrod housing corresponding to contact with edges of the tappet socket.
