# NATIONAL TRANSPORTATION SAFETY BOARD

## MATERIALS LABORATORY FACTUAL REPORT

Report No. 17-093

Place : Wurtsboro, NY  
Date : 8/27/2017  
Vehicle : Cessna 305  
NTSB No. : ERA17LA298  
Investigator : Heidi Kemner

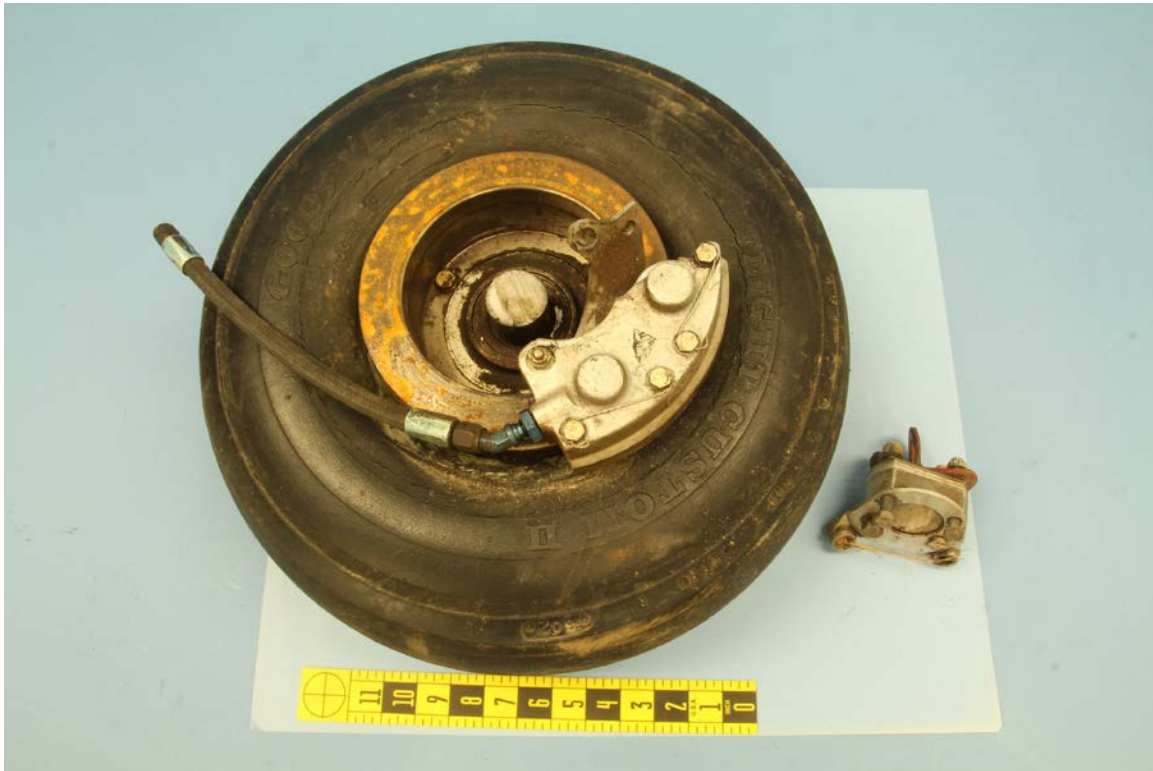
Left main landing gear axle assembly and wheel (figure 1)

Figure 1: Left main landing gear wheel and axle assembly as received.

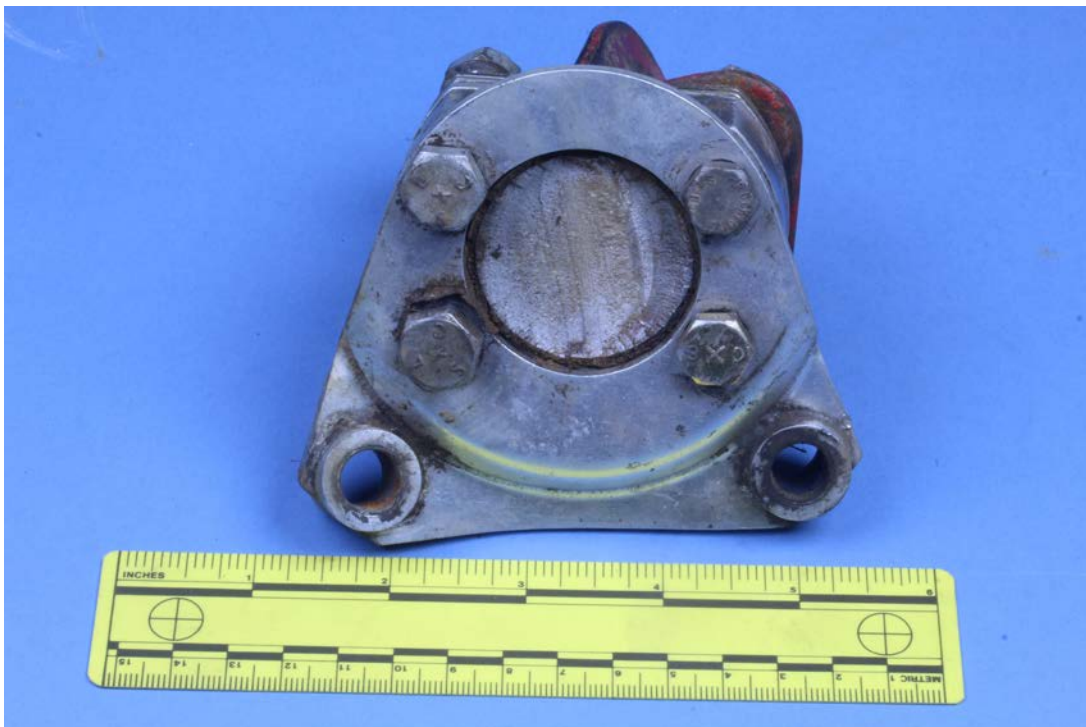
The axle of the left main landing gear assembly was fractured near the end that would have been attached to the landing gear strut (figure 2). Examination of the fracture surface using a stereo microscope revealed fracture features consistent with a fatigue fracture (figure 3). There were two opposing fatigue regions on the fracture surface separated by an overstress region (figure 4). Fatigue region #1 had a shiny appearance consistent with re contact of the fracture surfaces. Fatigue region #2 exhibited a more matte appearance and covered a larger area than region #1.

Figure 2: Portion of fractured axle shaft.

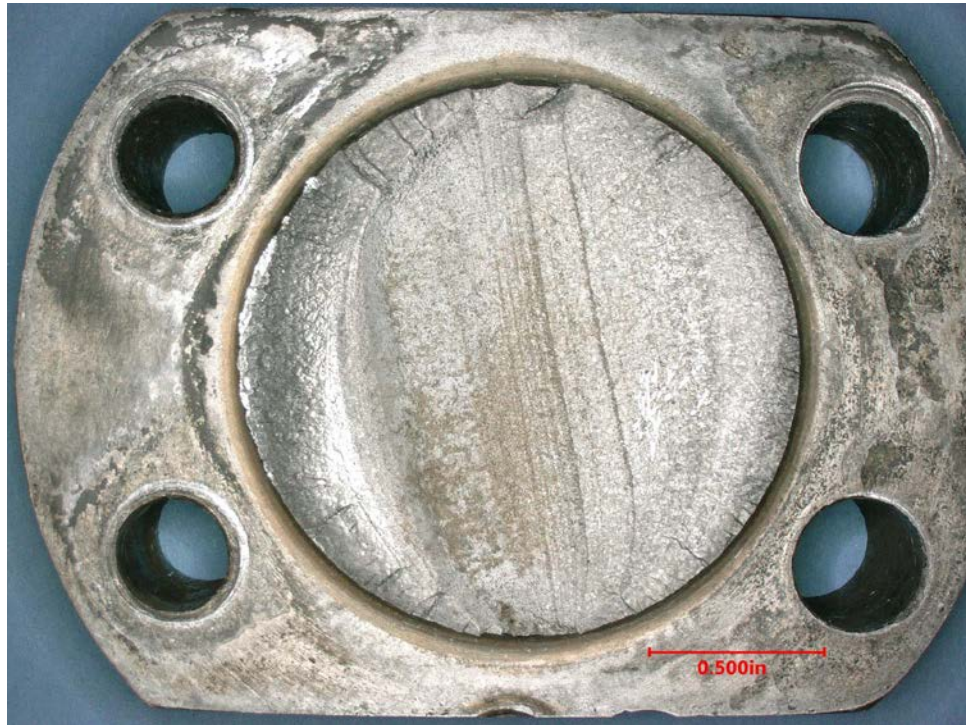
Figure 3: Axle shaft fracture surface exhibiting ratchet marks on the periphery and crack arrest fronts towards the middle.

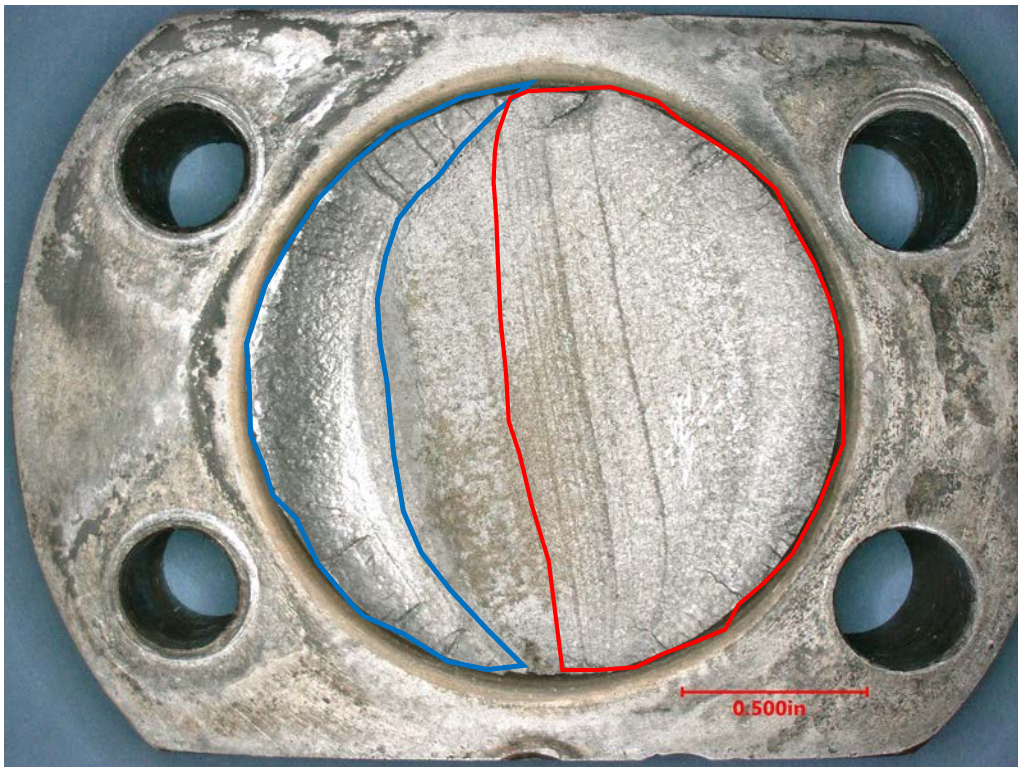
Figure 4: Approximate boundaries of fatigue regions #1 (blue) and #2 (red) separated by overstress region.
