**Subject:** ERA17LA312 - Lyndonville, VT - Materials Laboratory Examination  
**Date:** Thursday, October 5, 2017 10:24:02 AM  
**Attachments:** [IMG\\_9950.jpg](#)  
[IMG\\_9951.jpg](#)

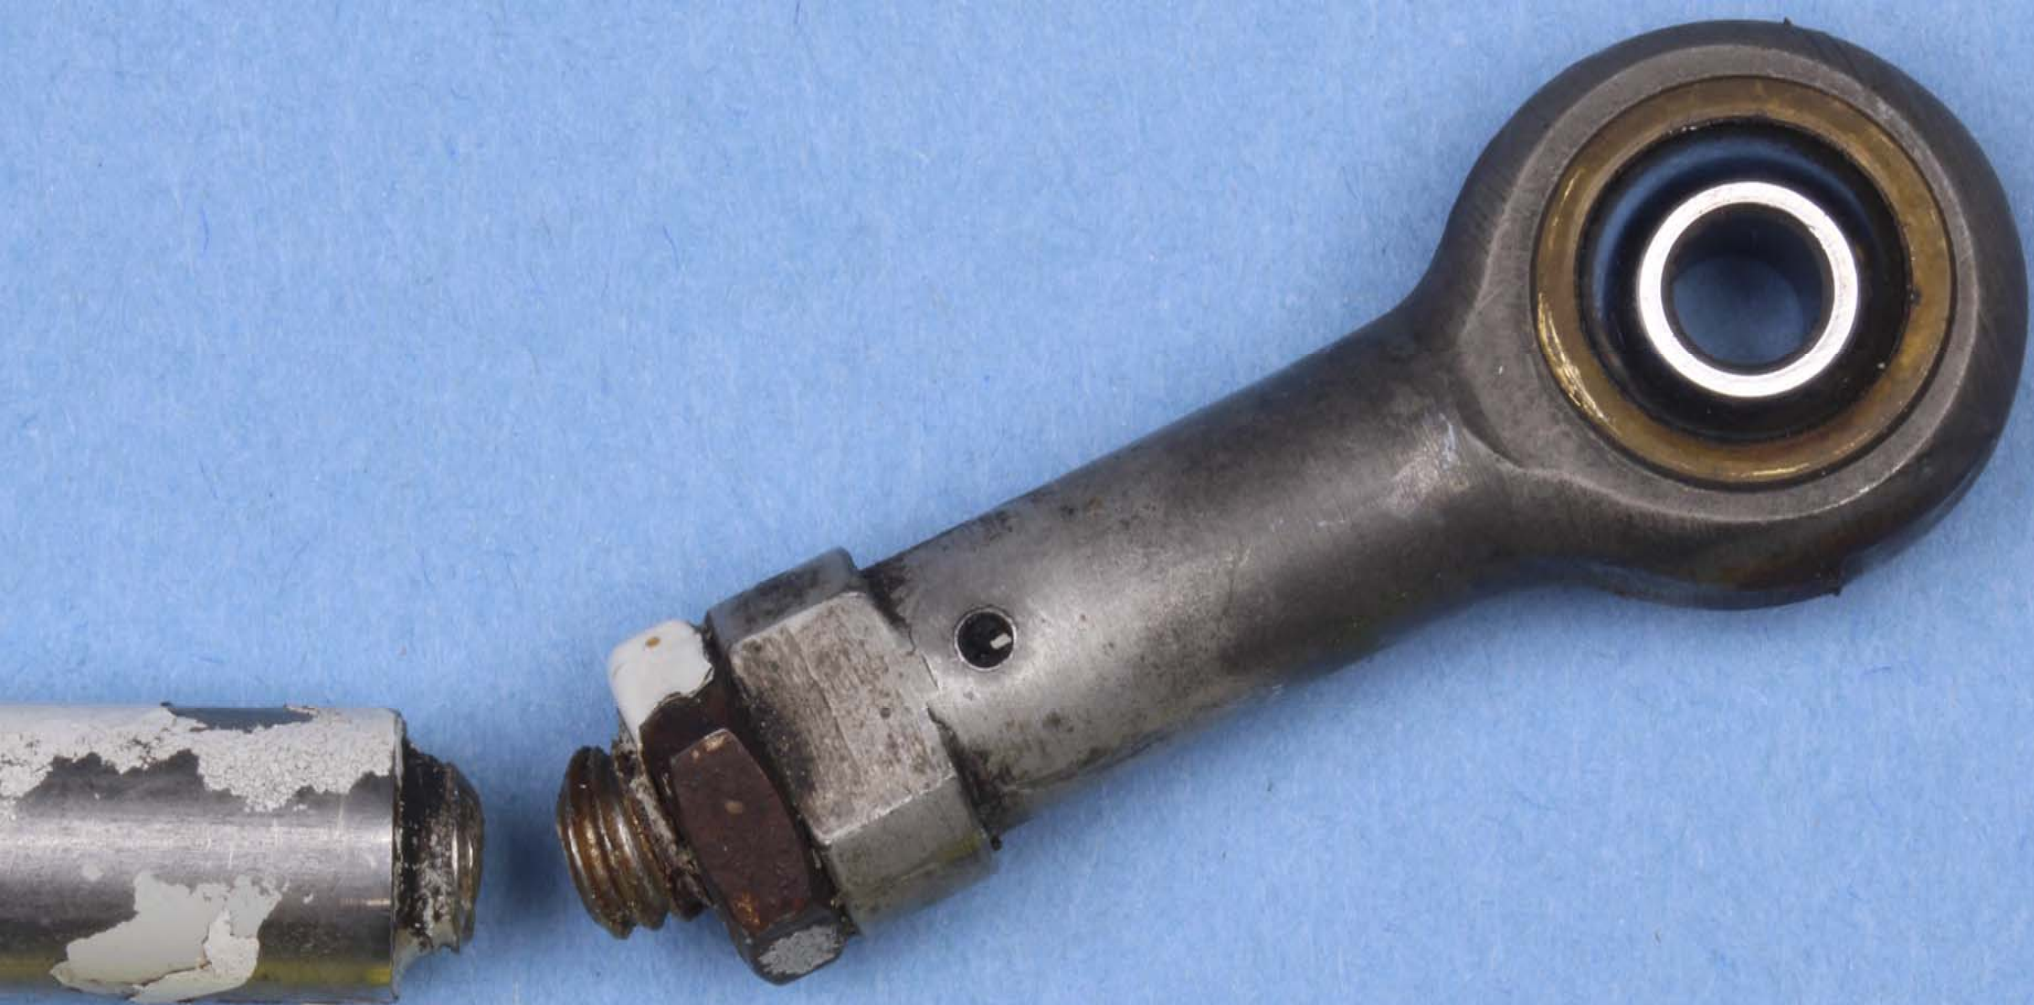
Photographs of the aileron control push/pull tube as received are attached. The end fitting was fractured in the threaded shank, and deformation of the shank adjacent to the fracture was consistent with ductile overstress fracture under bending loads. The mating fracture surfaces had rough, matte gray fracture features across most of the surface and had a small area at the compression side of the fracture that appeared reflective consistent with smeared contact features. All fracture features were consistent with ductile overstress fracture under bending loads. No evidence of a preexisting crack was observed.
