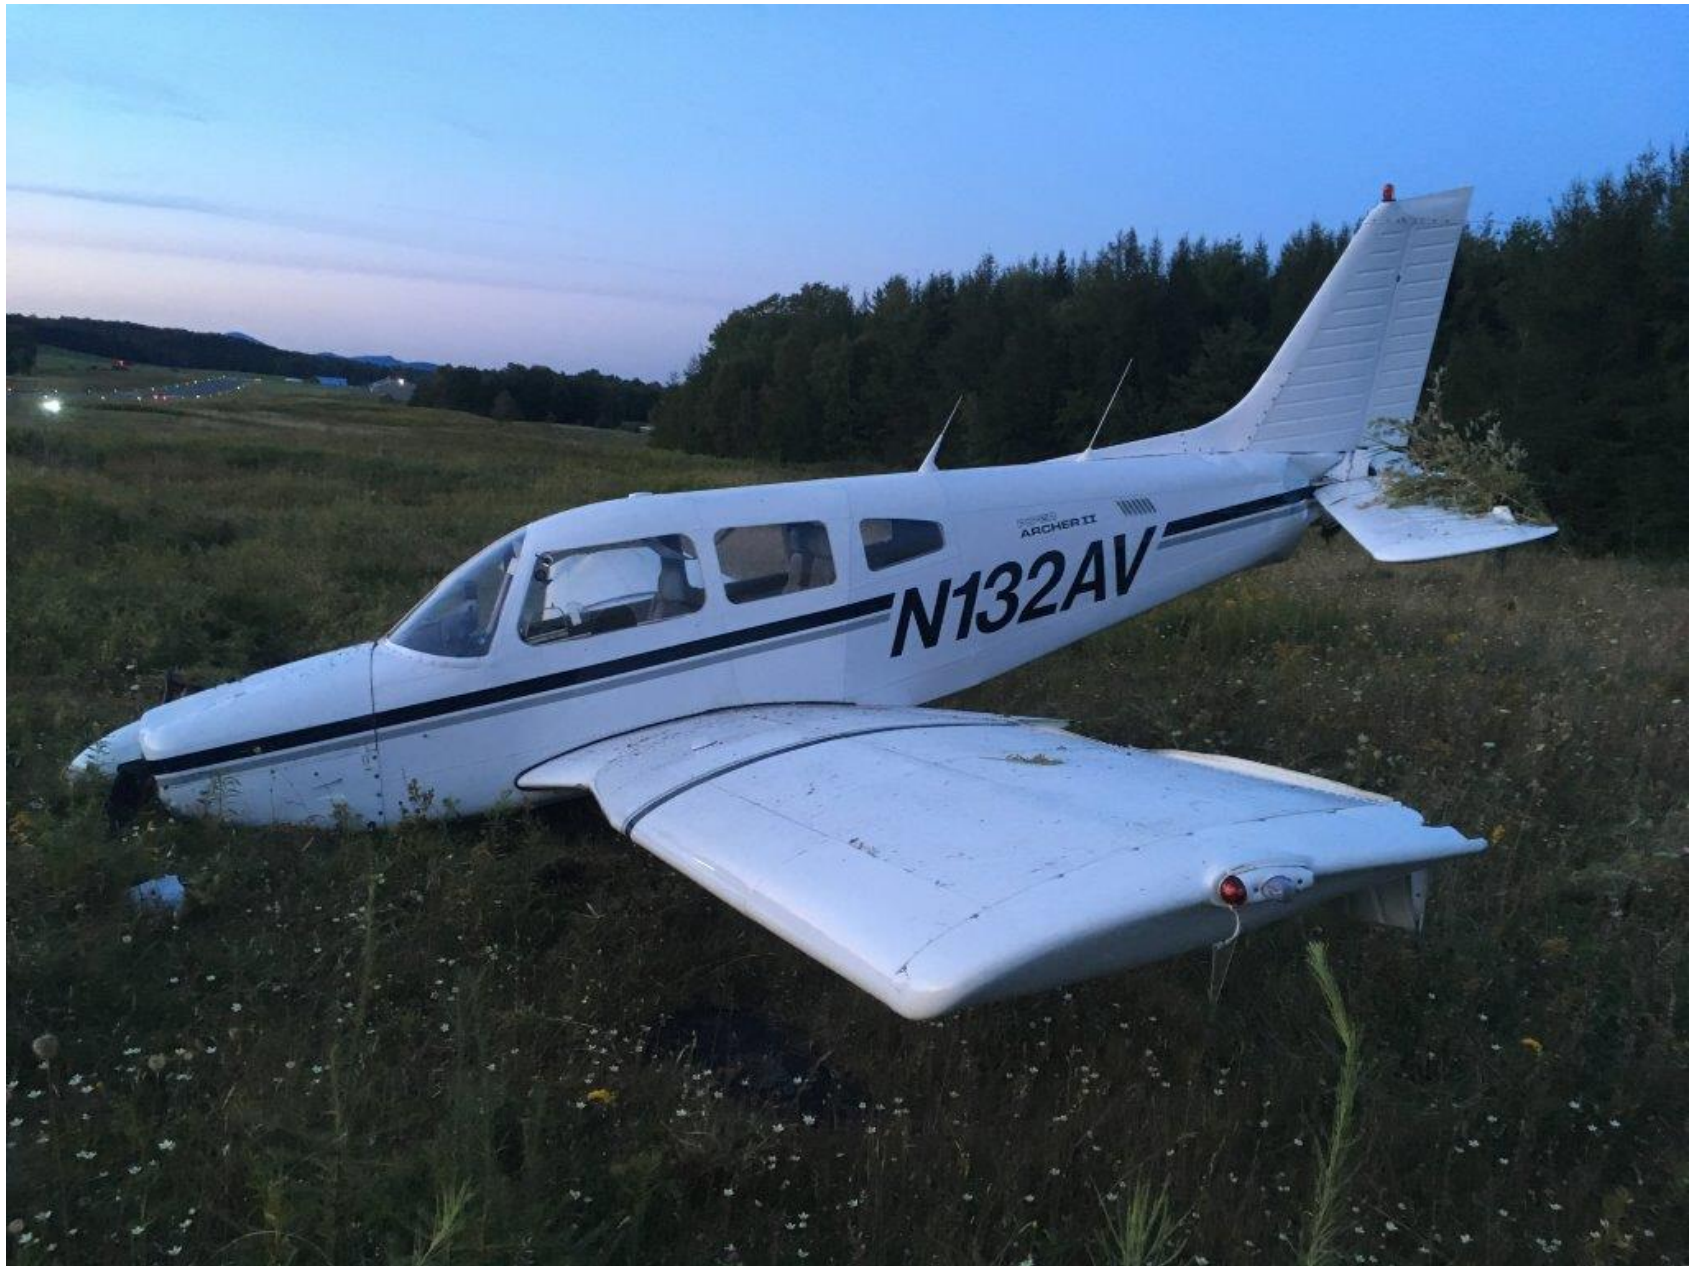
**Photo 1 – View of Airplane as Found as Viewed Facing Departure Runway (State of Vermont)**

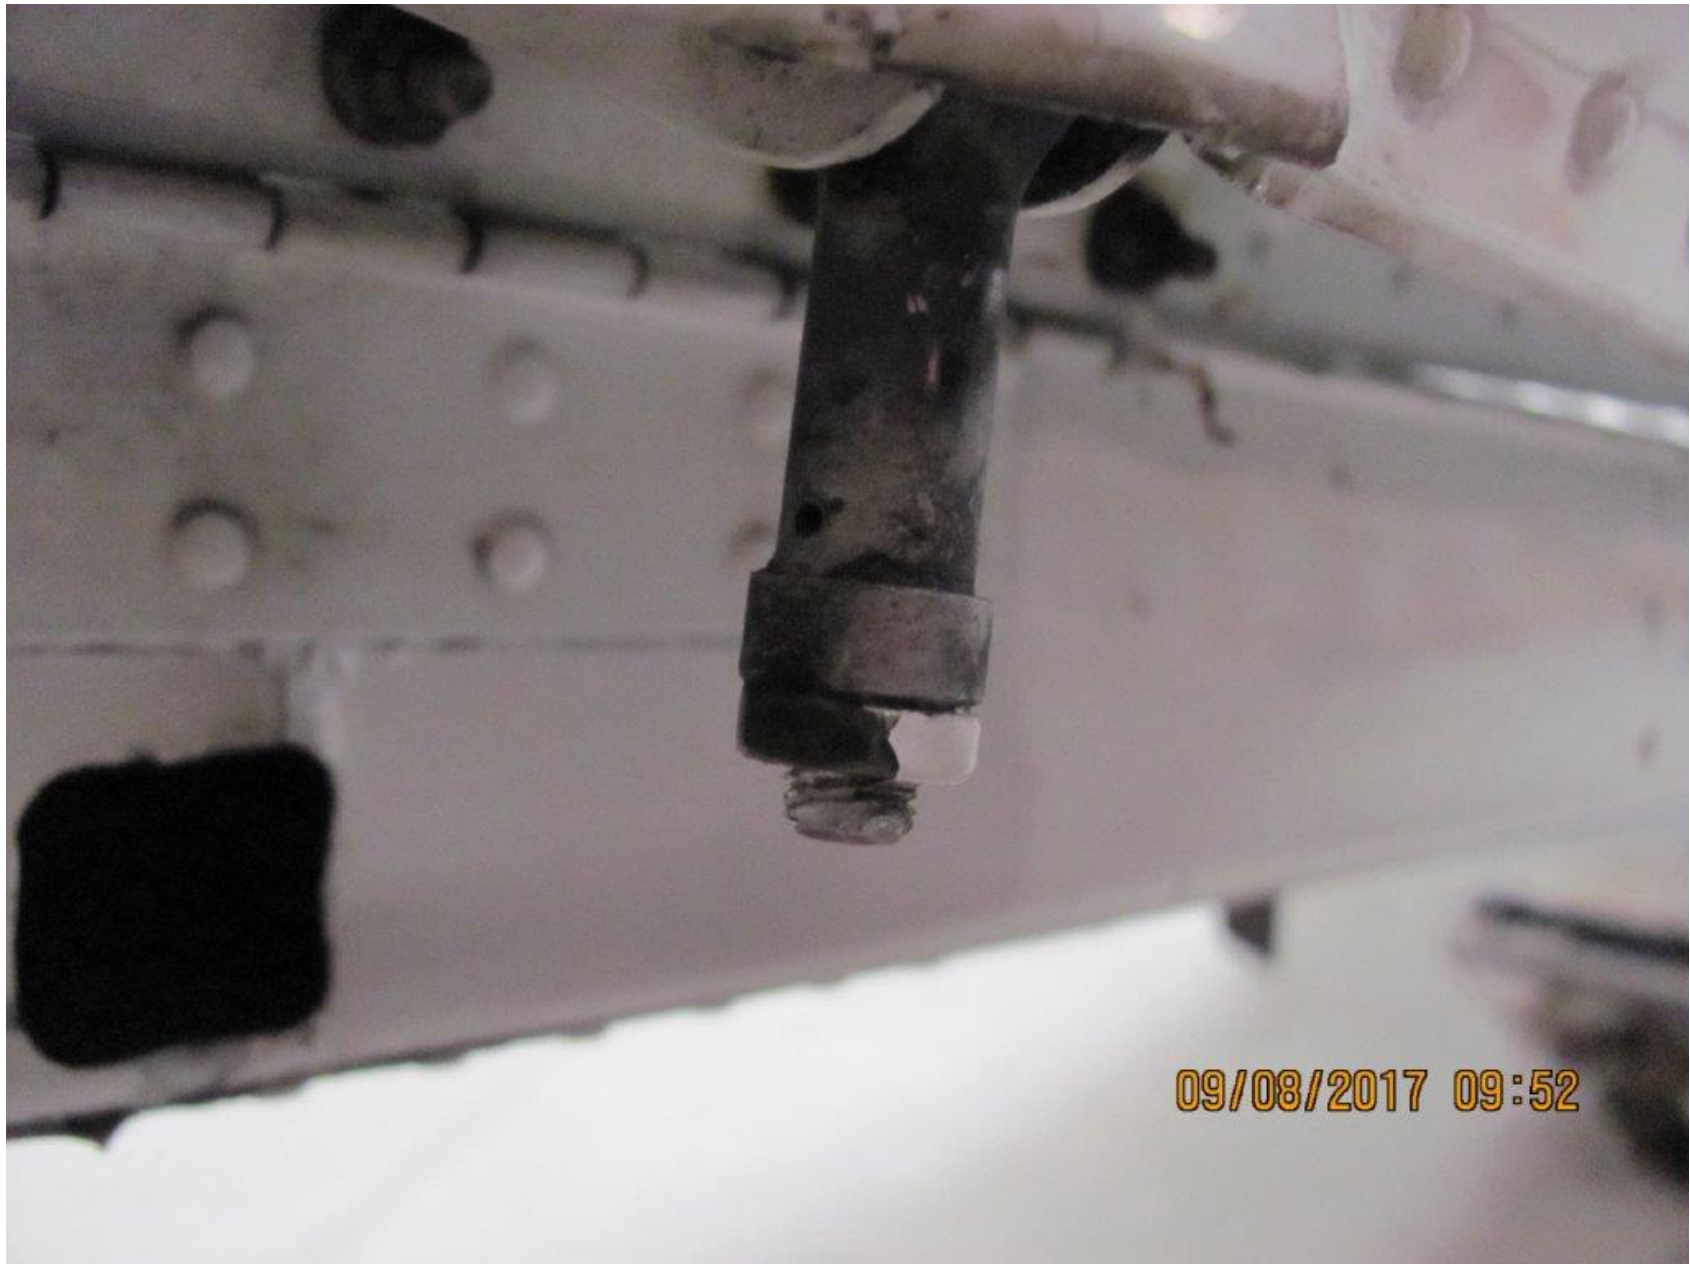
**Photo 2 – View of Fractured Aileron Control Rod (State of Vermont)**

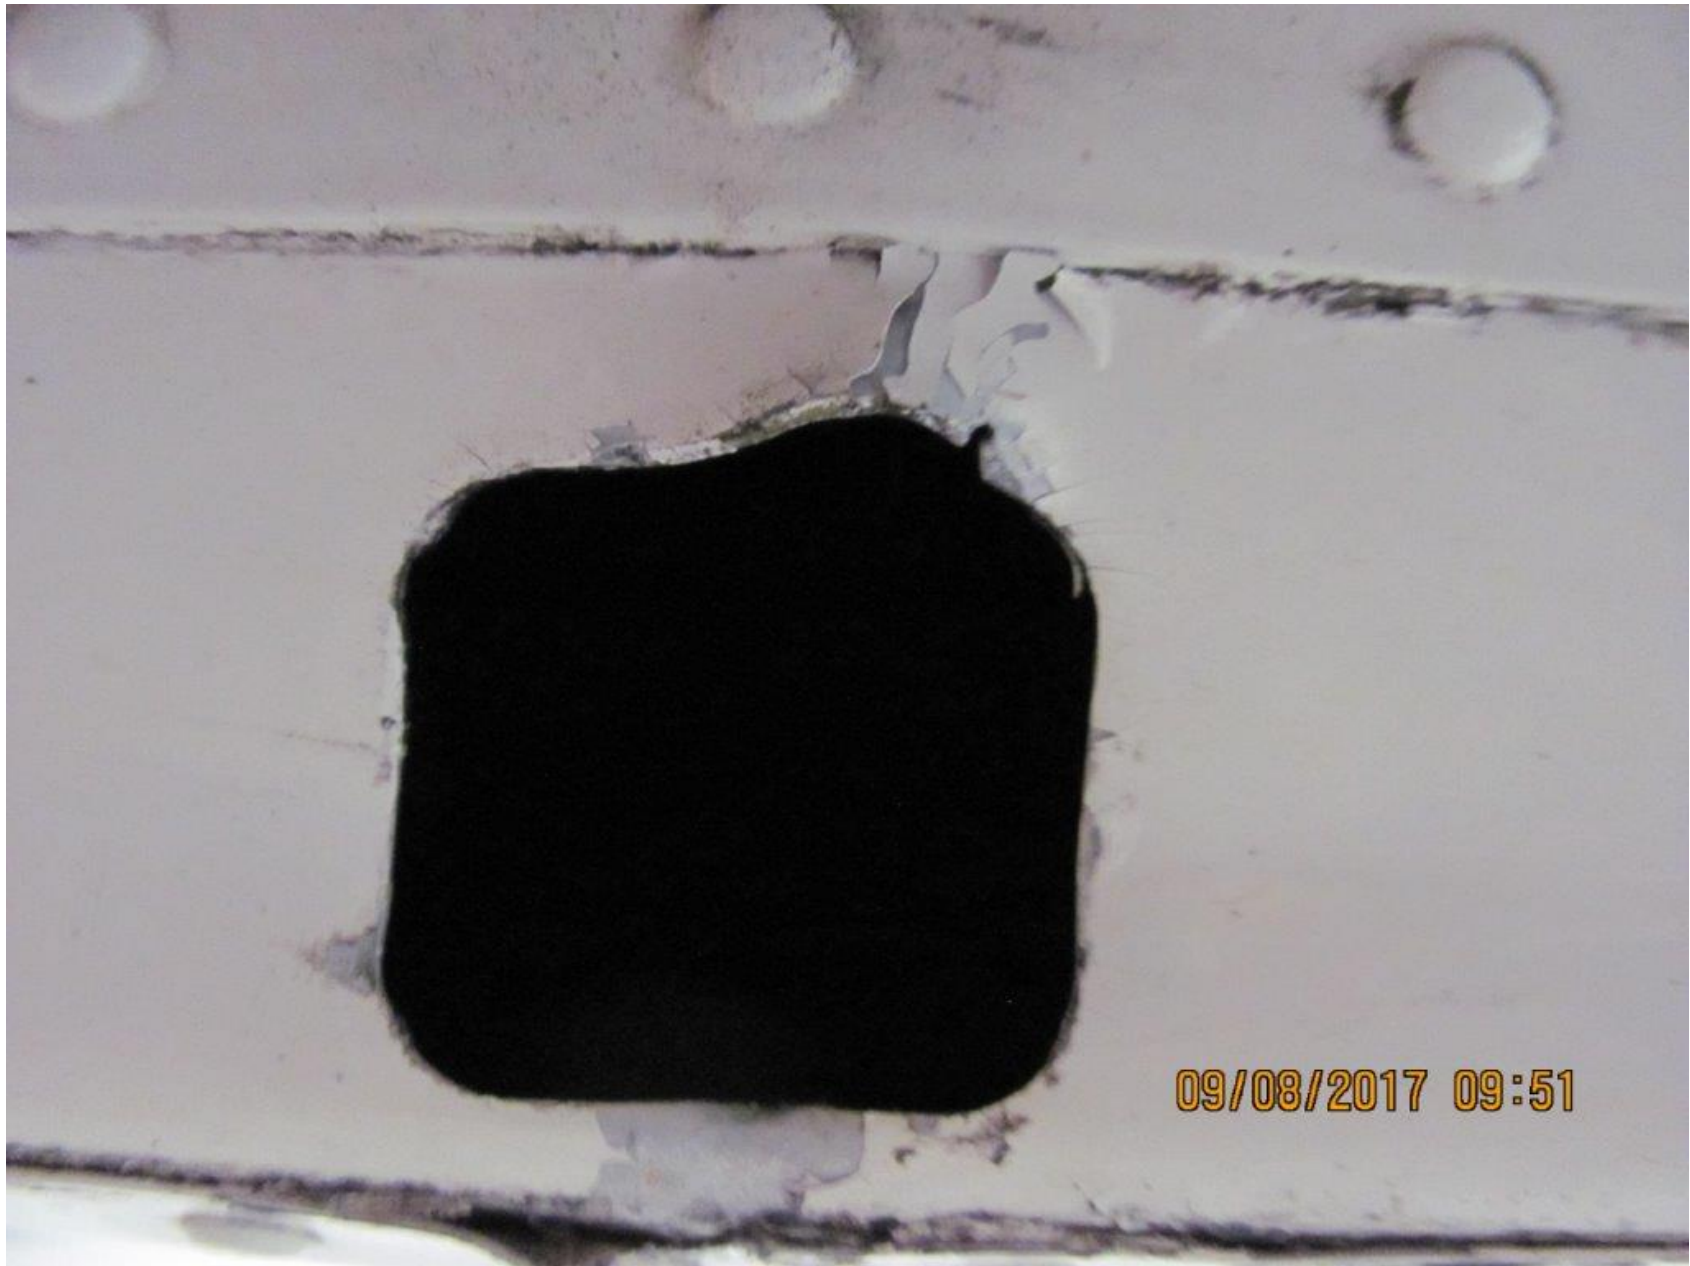
**Photo 3 – View of Deformed/Fractured Aileron Control Rod Pass-Thru Hole (State of Vermont)**
