# NATIONAL TRANSPORTATION SAFETY BOARD

## MATERIALS LABORATORY FACTUAL REPORT

Report No. 19-005

Place : Union City, Tennessee  
Date : September 15, 2017  
Vehicle : Air Tractor AT-502, N4531K  
NTSB No. : ERA17LA326  
Investigator : Brian Rayner, AS-ERA

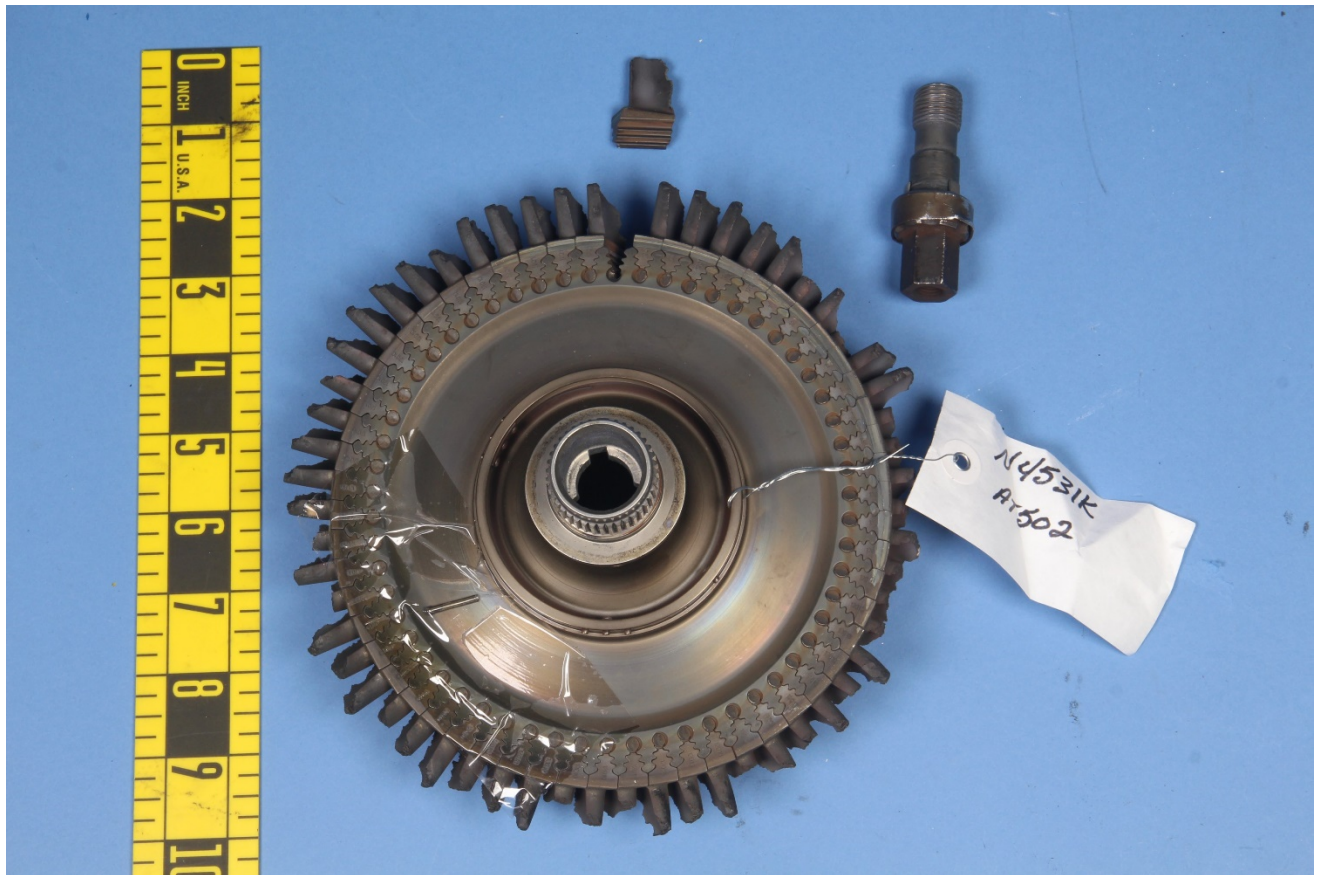
Figure 1 shows the engine components received by the Materials Laboratory. These included the compressor turbine wheel, with 57 affixed but fractured turbine blades, and a single unattached blade with its pin. As shown in Figure 2, the unattached blade had been in place in the empty slot in the turbine wheel. A pin at that position was submitted separately and had been detached from the wheel. The remainder of the fractured blades from the views shown in Figure 2 were documented and are recorded in Appendix A.

Figure 1 – The turbine wheel, loose blade, pin, and position nut, as received.

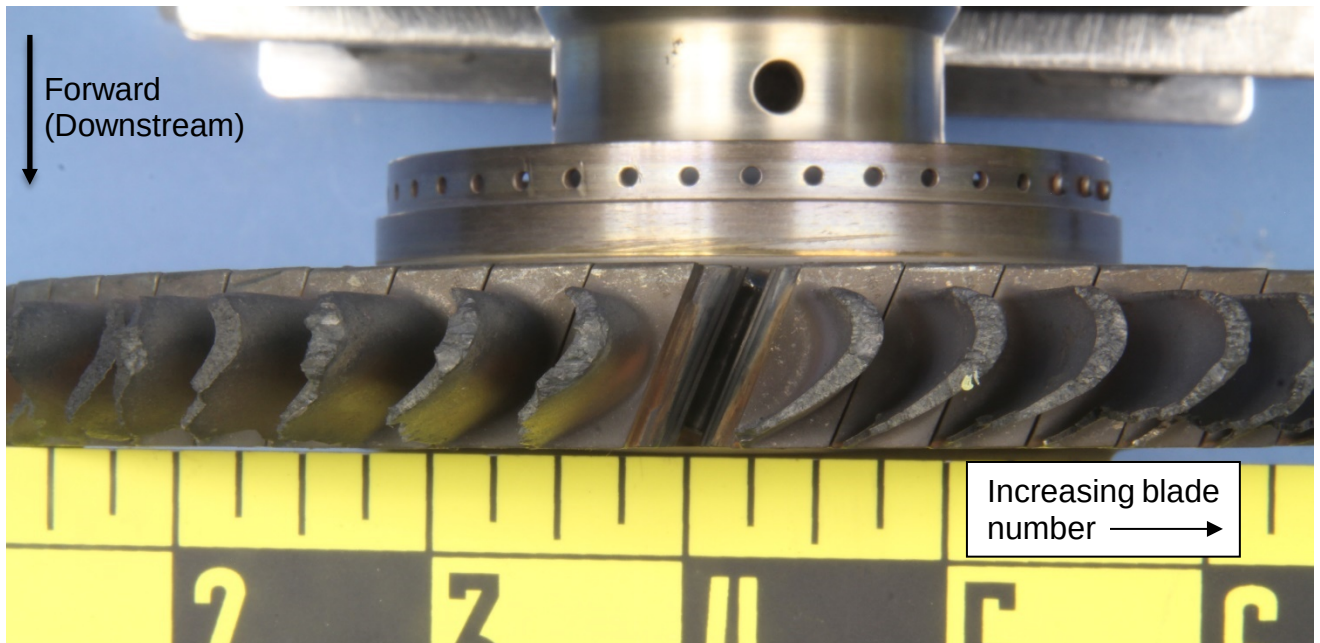
Figure 2 – View of the slot on the turbine wheel where the missing blade was located.

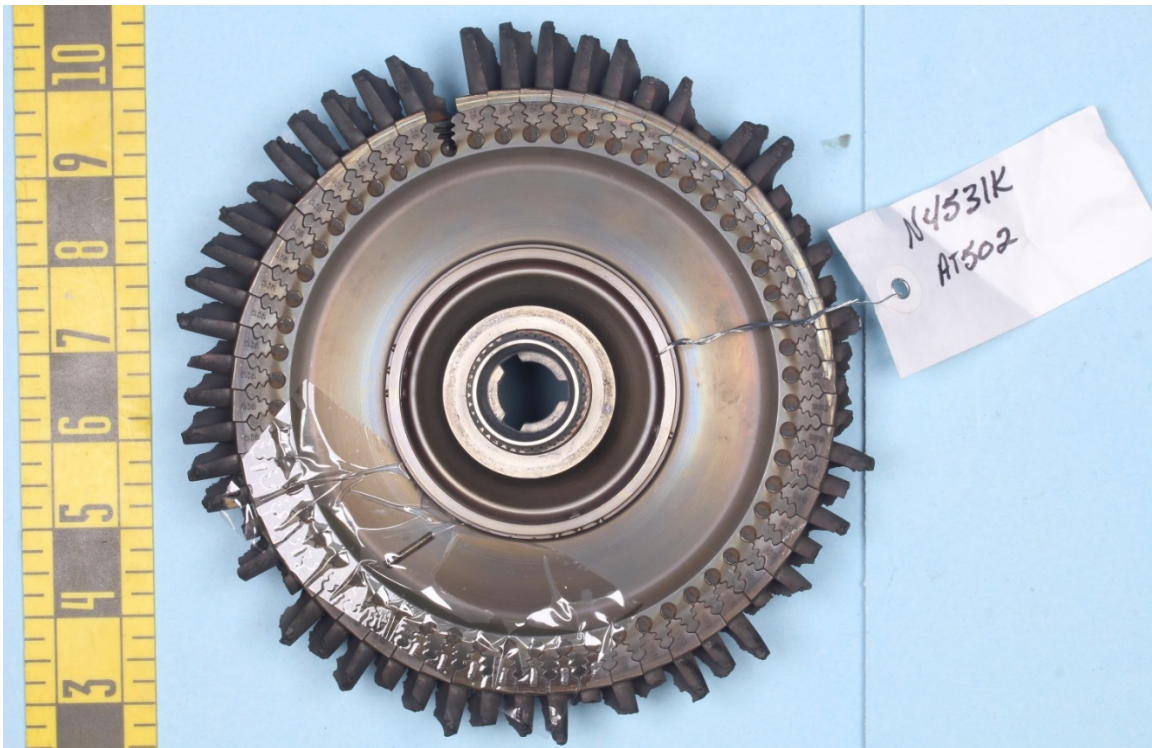
Figure 3 and Figure 4 show the faces of the compressor turbine wheel from the upstream and downstream side (aft and forward), respectively. The removed pin from the empty blade slot had been taped to the lower left side of the wheel. After this initial documentation, the blades remaining in-place were all removed using a mallet and flat chisel.

Figure 3 – The upstream or aft face of the turbine wheel with broken blades, as received. The removed pin from the empty blade slot had been taped to the lower left side of the wheel.

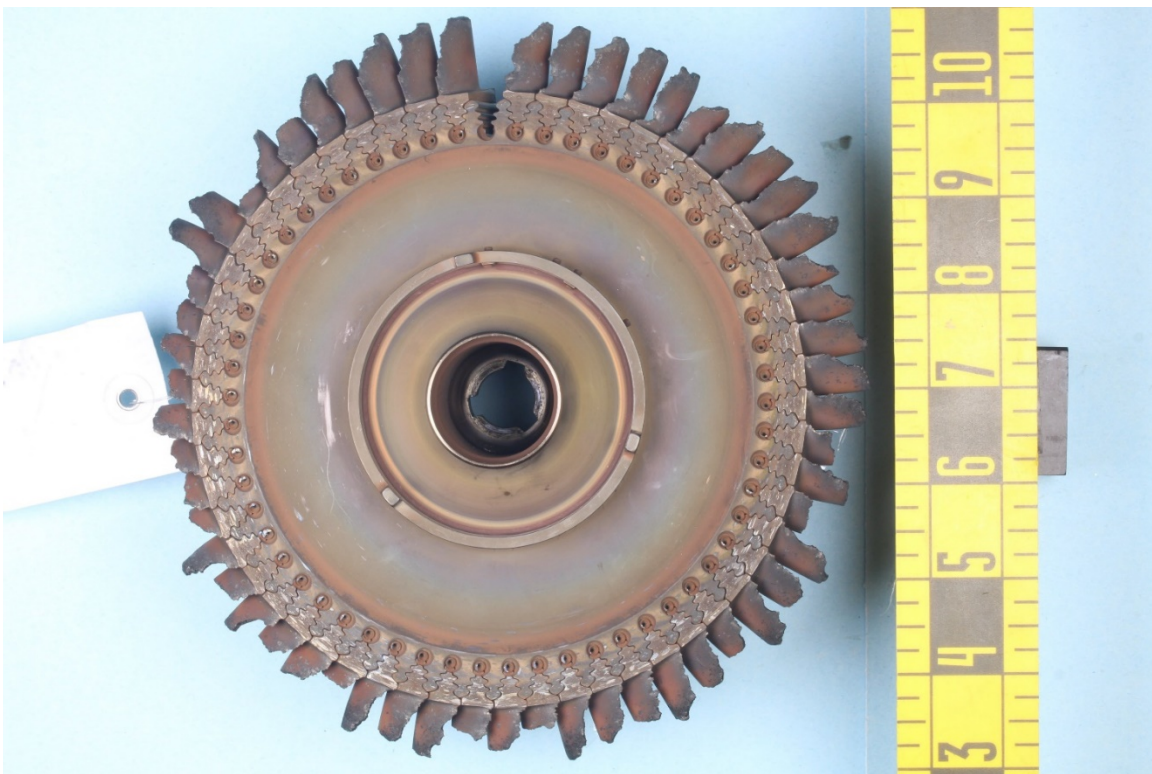
Figure 4 – The downstream or forward face of the turbine wheel with broken blades, as received.

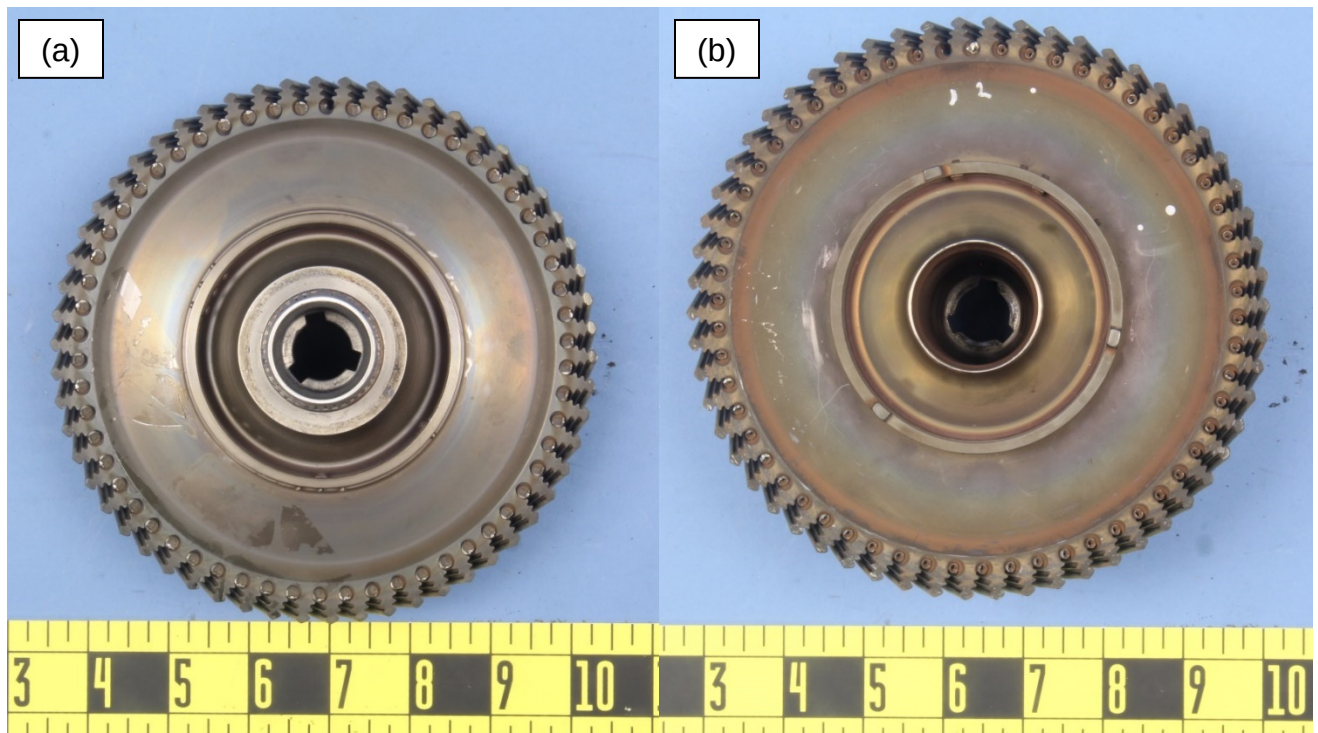
Figure 5 shows the compressor turbine wheel from the upstream and downstream faces after removal of the blades. Figure 6 shows the slots with the pins in place, after removal of the blades. Overall, the wheel did not exhibit any indications of damage consistent with impacts, plastic deformation, or excessive wear. The dovetail slot for Blade 1 did not exhibit any indications of fretting, wear, or chatter marks. There were some shiny rub marks on some of the other dovetail slots, but it could not be determined whether these were the result of removing the blades. There was an overall reddish surface compound layer, particularly on the downstream side (Figure 5b). This was consistent with oxidation from combustion gasses, typical of the those experienced in the turbine sections of the turboprop engines.

Figure 5 – The turbine wheel after removal of the blades, viewed from the (a) upstream and (b) downstream faces.

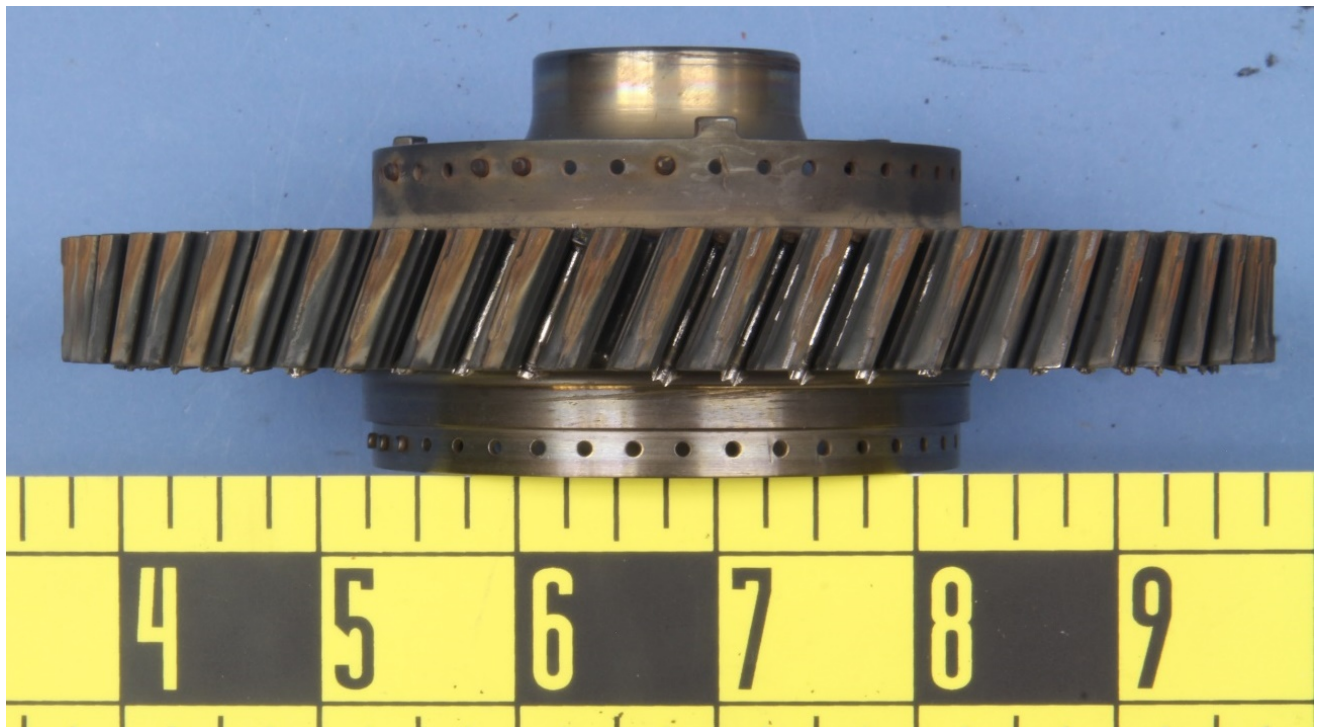
Figure 6 – Some of the slots of the turbine wheel, after removing the blades.

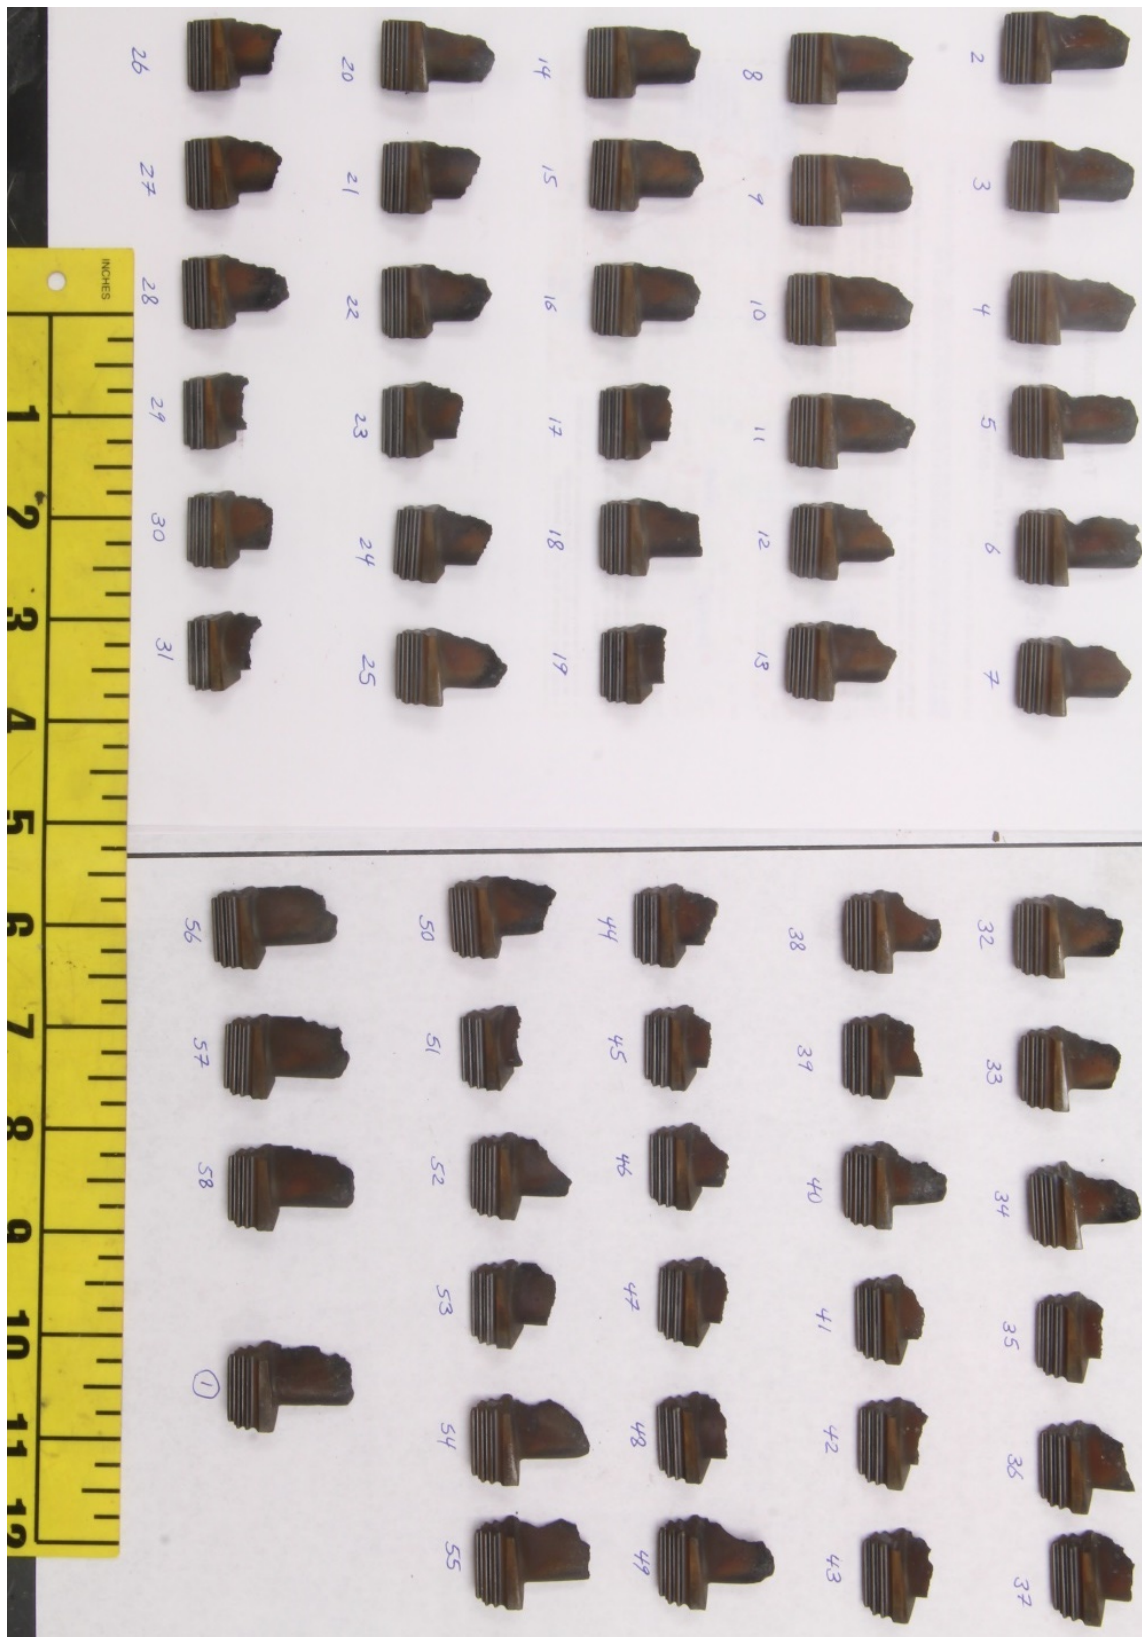
Figure 7 shows the turbine blades, after removal, along with the unattached blade, viewed from the concave side. The free blade submitted separately was labeled Blade 1 for the purposes of this report. The other blades were labeled 2 through 58. These blades were numbered sequentially, increasing in number as rotated counterclockwise (opposite of normal rotation), as labeled in Figure 2. A more comprehensive series of images of all the removed blades, from both the concave and convex sides, is detailed in Appendix B.

Figure 7 – The blades removed from the turbine wheel, labeled 2 through 58, along with Blade 1, viewed from the convex sides.

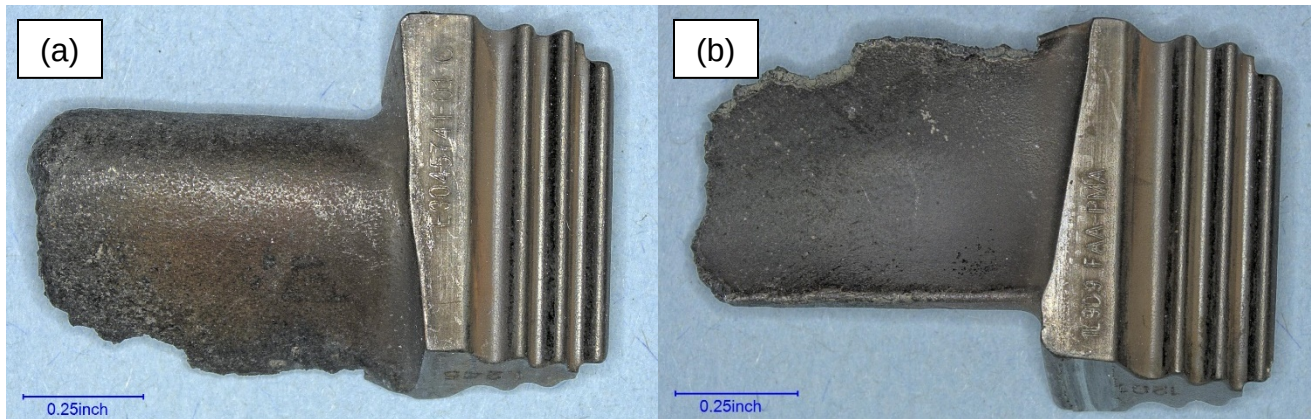
Figure 8 shows the convex and concave sides of Blade 1. Figure 9 shows a view of the fracture surface. The blade fracture surface was oriented parallel to the platform, with a rough fracture surface. The leading edge of the blade was deformed but was still intact. The trailing edge of the blade was missing chunks of material, consistent with impact with other components or objects.

Figure 8 – The blade submitted loose, labeled Blade 1, viewed from the (a) convex and (b) concave side.

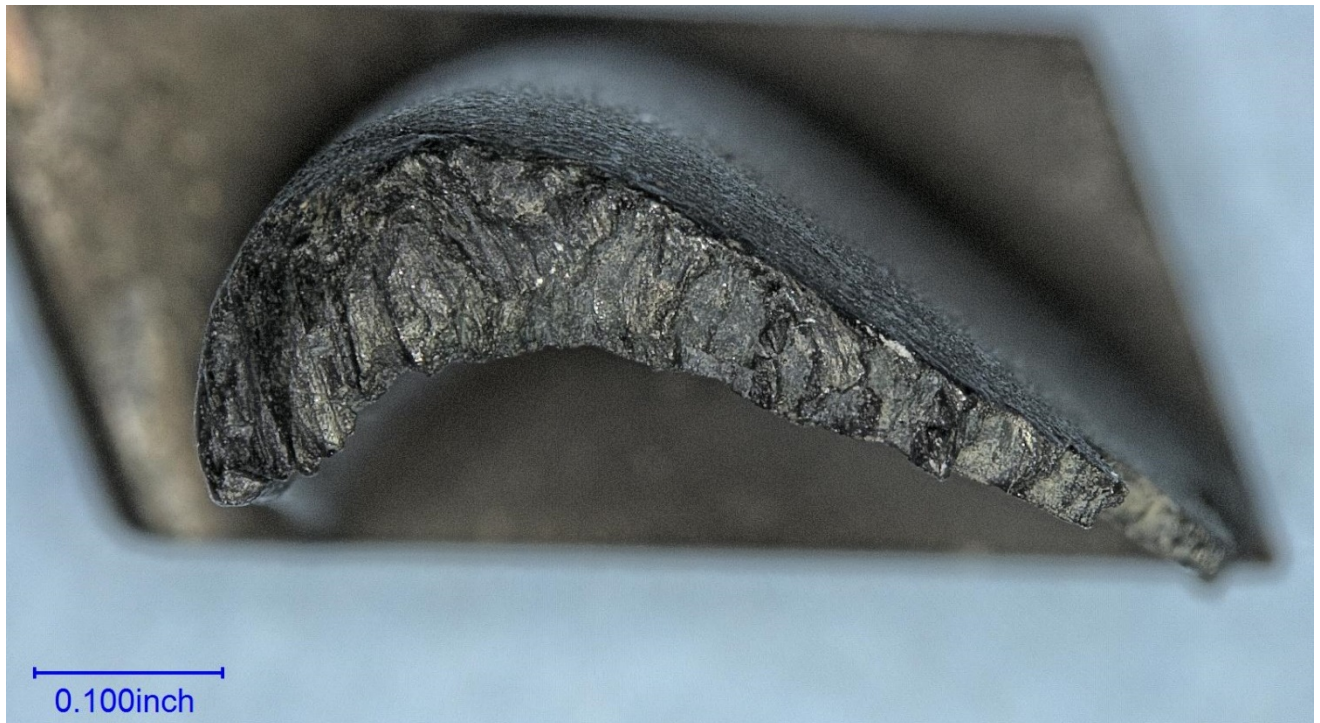
Figure 9 – The fracture surface of Blade 1.

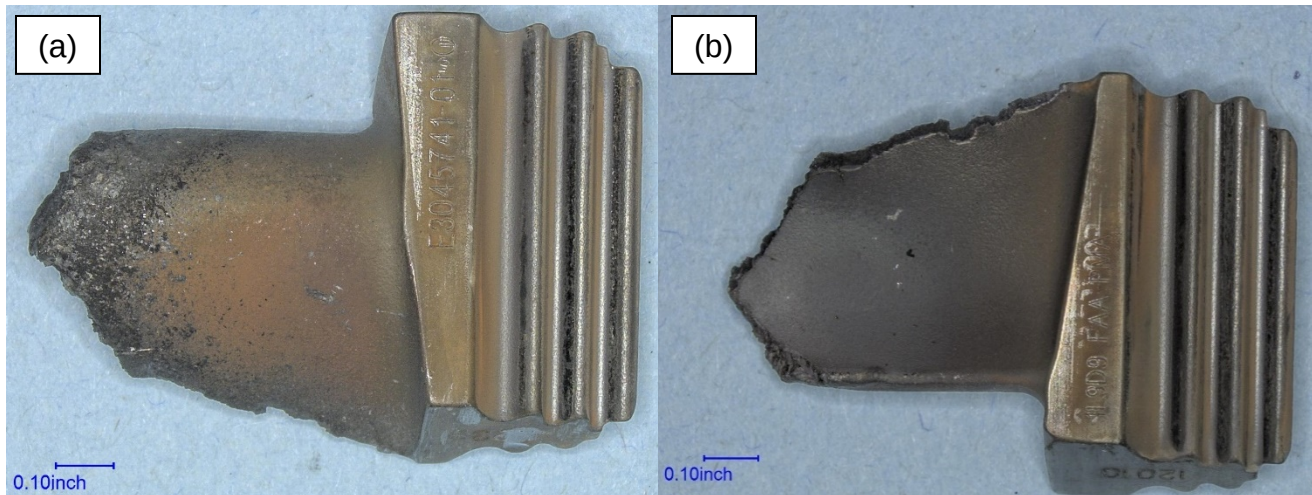
Figure 10 shows the convex and concave sides of Blade 25. Figure 11 shows a view of the fracture surface. The fracture surface of this blade was generally V-shaped with respect to its orientation to the platform. The leading edge of the blade exhibited small impact marks, whereas much of the trailing edge was missing. The convex surface of the blade exhibited material loss at the fracture surface. This loss was such that 0.1 to 0.2 inches of the fracture surface on the convex side were missing. This damage is shown in Figure 10a, indicated by the removal of the outermost orange-colored oxide layer.

Figure 10 – Blade 25 viewed from the (a) convex and (b) concave side.

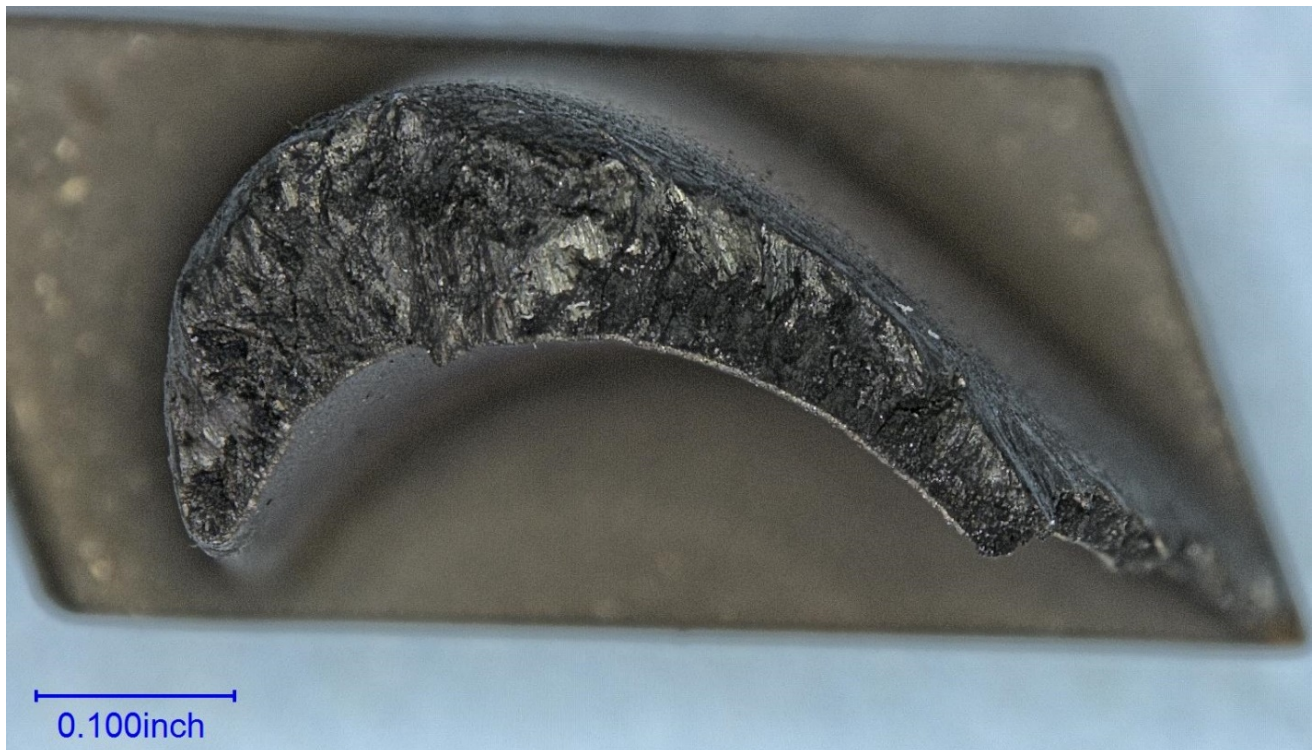
Figure 11 – The fracture surface of Blade 25.

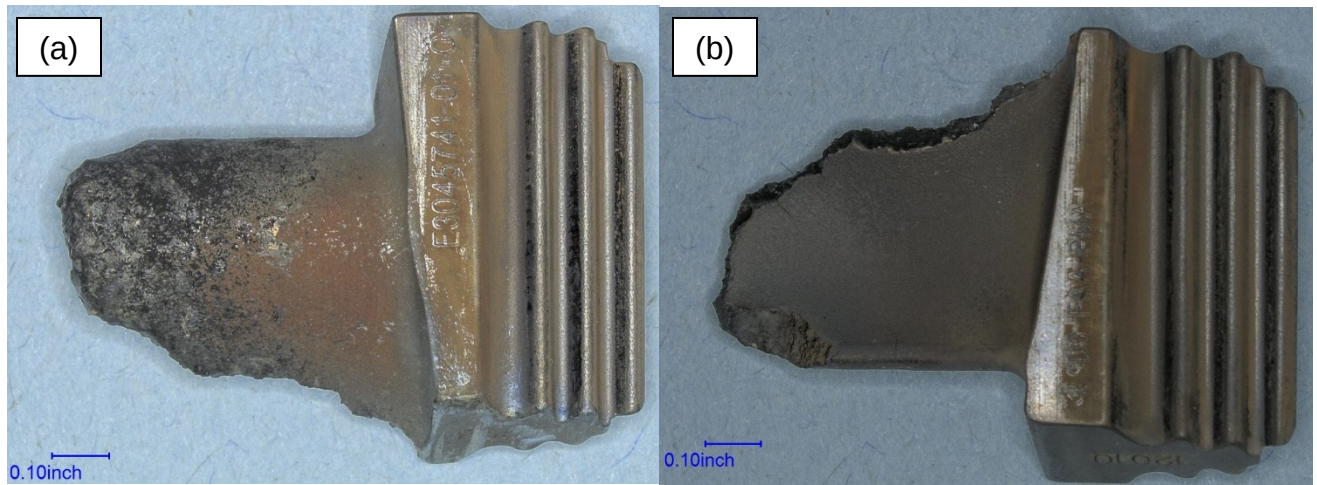
Figure 12 shows the convex and concave sides of Blade 34. Figure 13 shows a view of the fracture surface. Similar to Blade 25, the fracture surface of this blade was

Figure 12 – Blade 34 viewed from the (a) convex and (b) concave side.

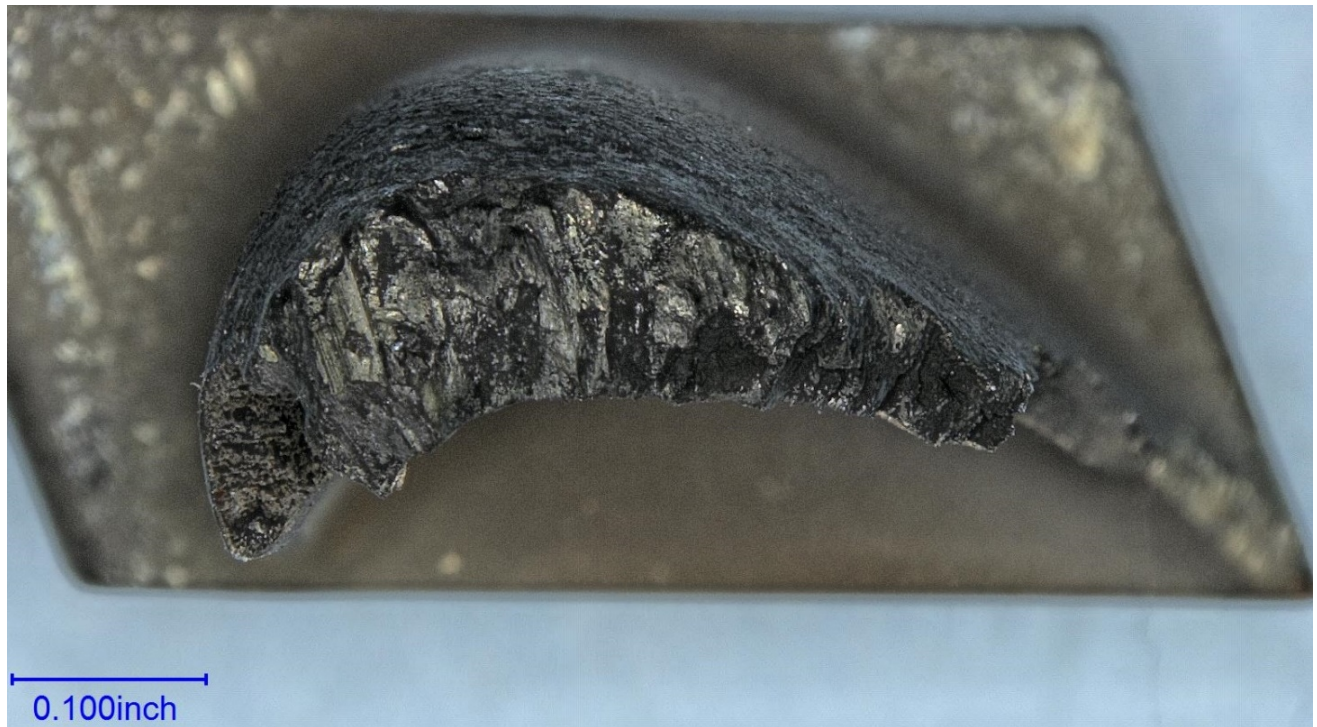
generally V-shaped, although more rounded. The blade material closest to the fracture surface exhibited significant plastic deformation consistent with thinning or necking (see Figure 13). Portions of both the leading and trailing edges were missing, consistent with impact with other objects at high speed. The blade exhibited material loss of 0.1 to 0.2 inches of the convex side of the fracture surface, similar to that observed on Blade 25.

Figure 13 – The fracture surface of Blade 34.

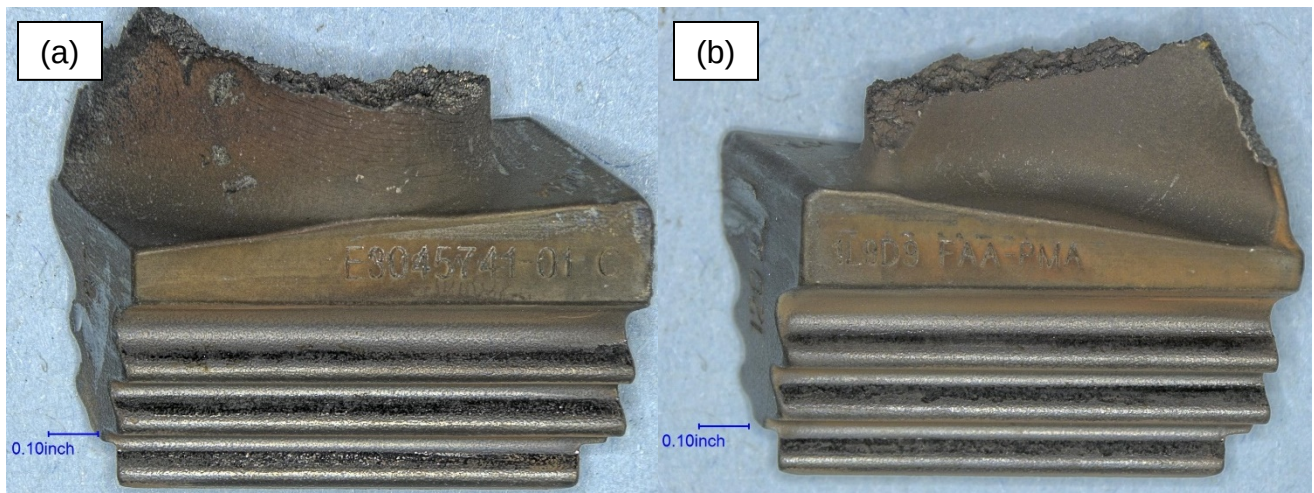
Figure 14 shows the convex and concave sides of Blade 42. Figure 15 shows a view of the fracture surface. On this component, most of the blade airfoil was missing, with only 0.186 inches of blade material remaining above the platform. The fracture surface of this blade was rough and tortuous, with no smoothing or severe necking at or near the fracture surface. .

Figure 14 – Blade 42 viewed from the (a) convex and (b) concave side.

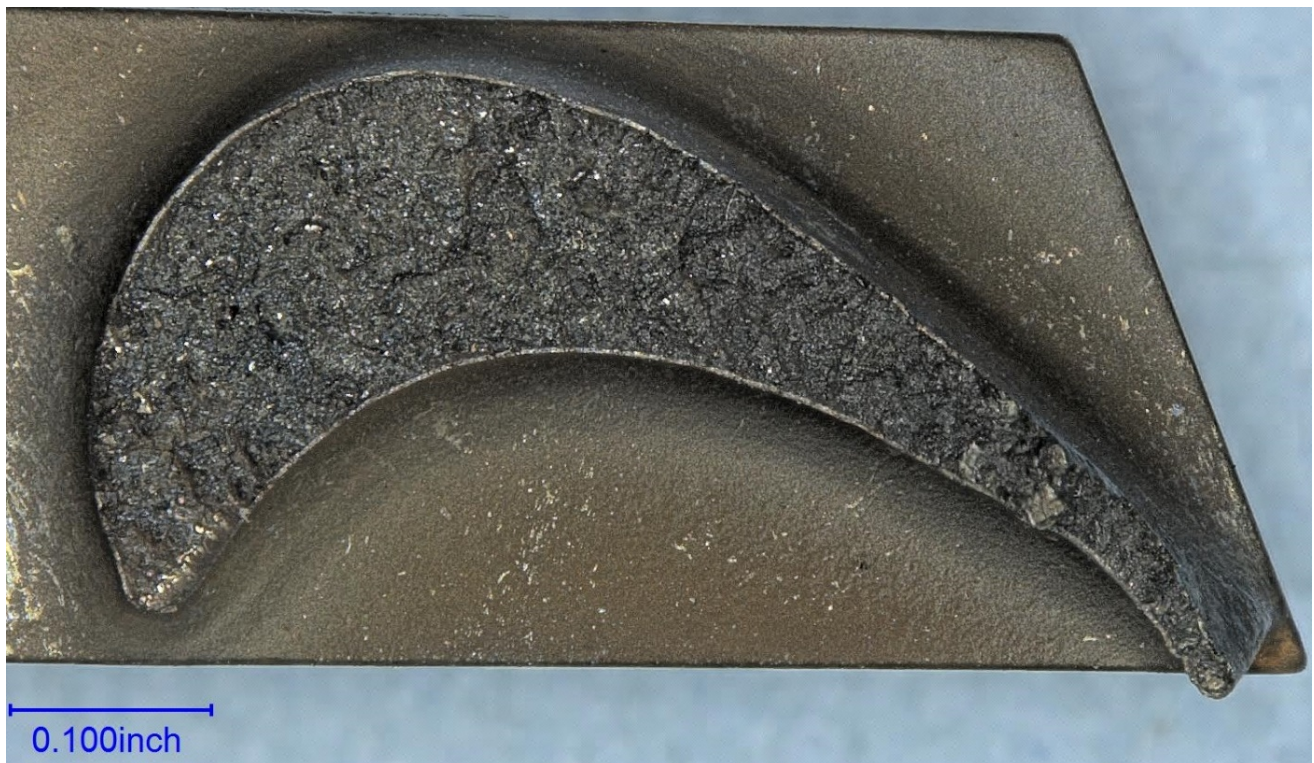
Figure 15 – The fracture surface of Blade 42.

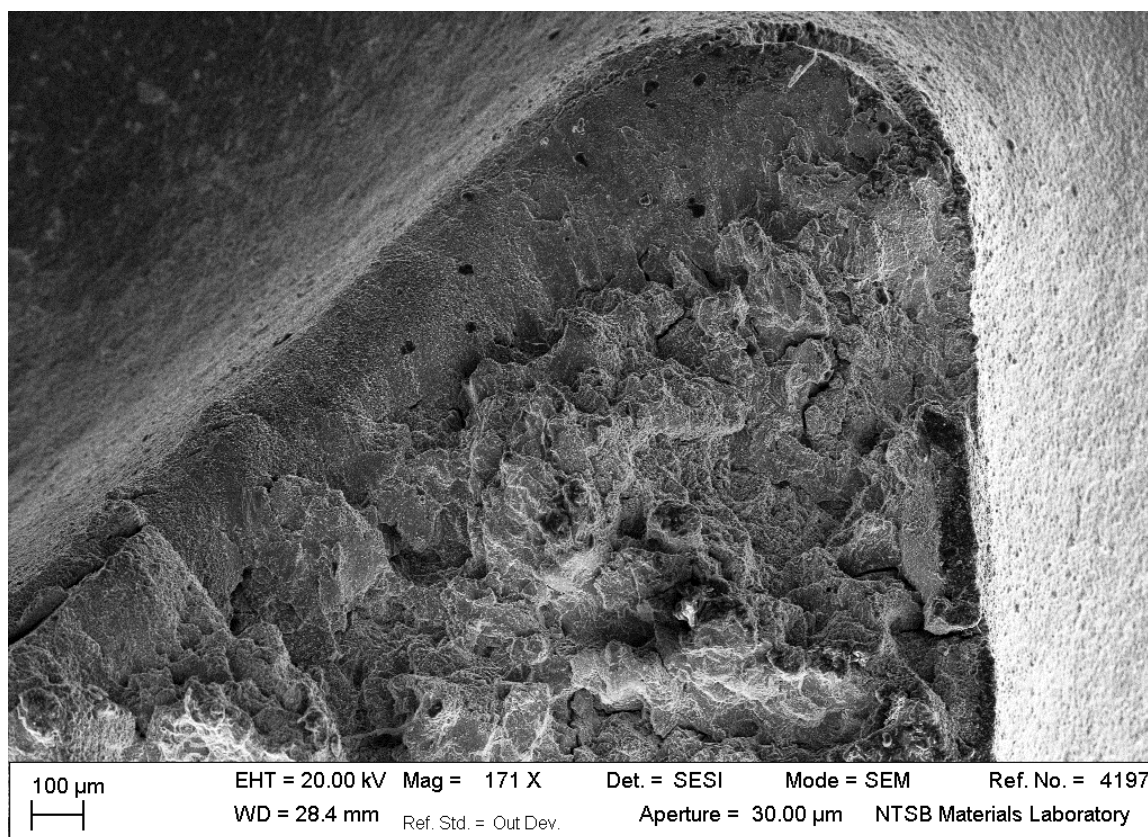
The fracture surfaces of the above blades were examined using a scanning electron microscope (SEM). Figure 16 through Figure 19 show micrographs of selected areas of the Blade 25 fracture surface. This fracture surface was highlighted as this blade was considered one of the more damaged in the set based on initial visual examination but exhibited fracture features that had not been excessively oxidized, eroded, or damaged. Figure 16 shows the leading edge of the Blade 25 fracture surface. The edges of the fracture surface exhibited smearing, consistent with post fracture damage. This smearing exhibited localized rounding and plastic deformation, consistent with fracture at elevated temperatures.

Figure 16 – Secondary electron (SE) micrograph of the leading edge of the Blade 25 fracture surface.

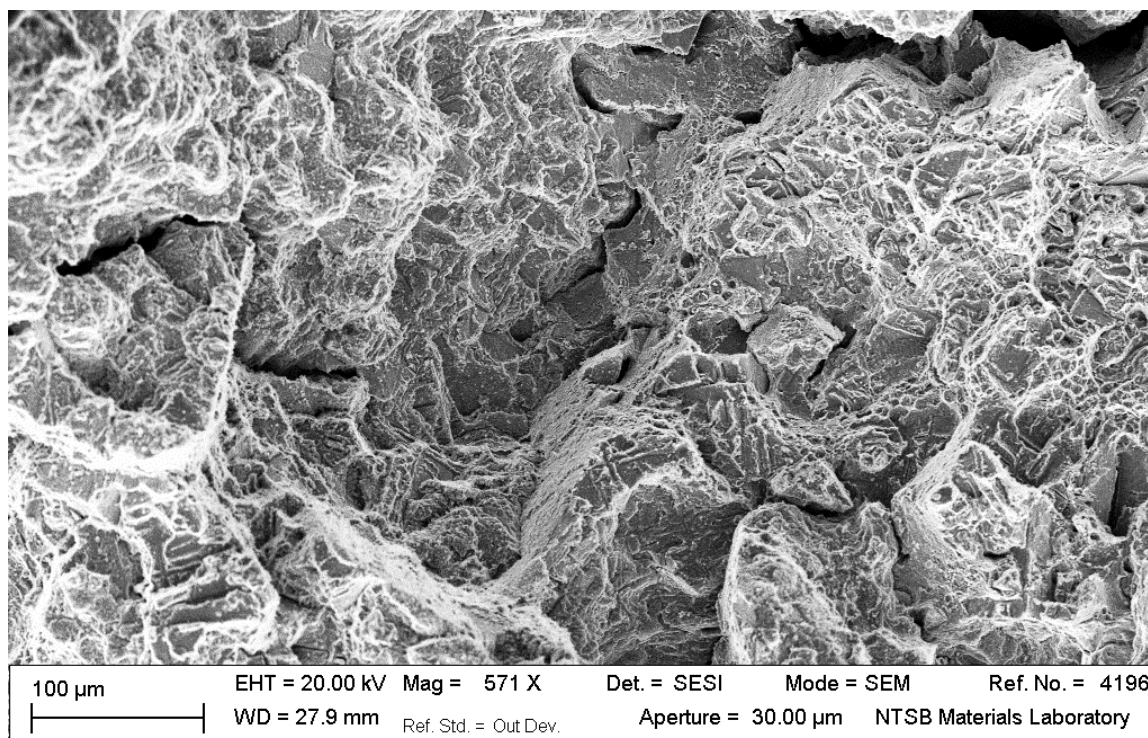
Closer views of notable features in the fracture surface of Blade 25 are illustrated in Figure 17 through Figure 19. As shown in Figure 17, the fracture surface was generally varied in roughness and elevation. Figure 18 displays areas of tearing of the fracture surface. This tearing was consistent with rupture along grain boundaries in the blade, as typified by flat faceted features on the fracture surface. Other portions of the fracture surface exhibited features consistent with dimple rupture (lower right in Figure 18). Also noted on this fracture surface was separation along the dendrite/interdendritic interface, as typified in Figure 19. These fracture features were consistent with fracture at elevated temperatures.

Figure 17 – SE micrograph showing a closer view of fracture features on the Blade 25.

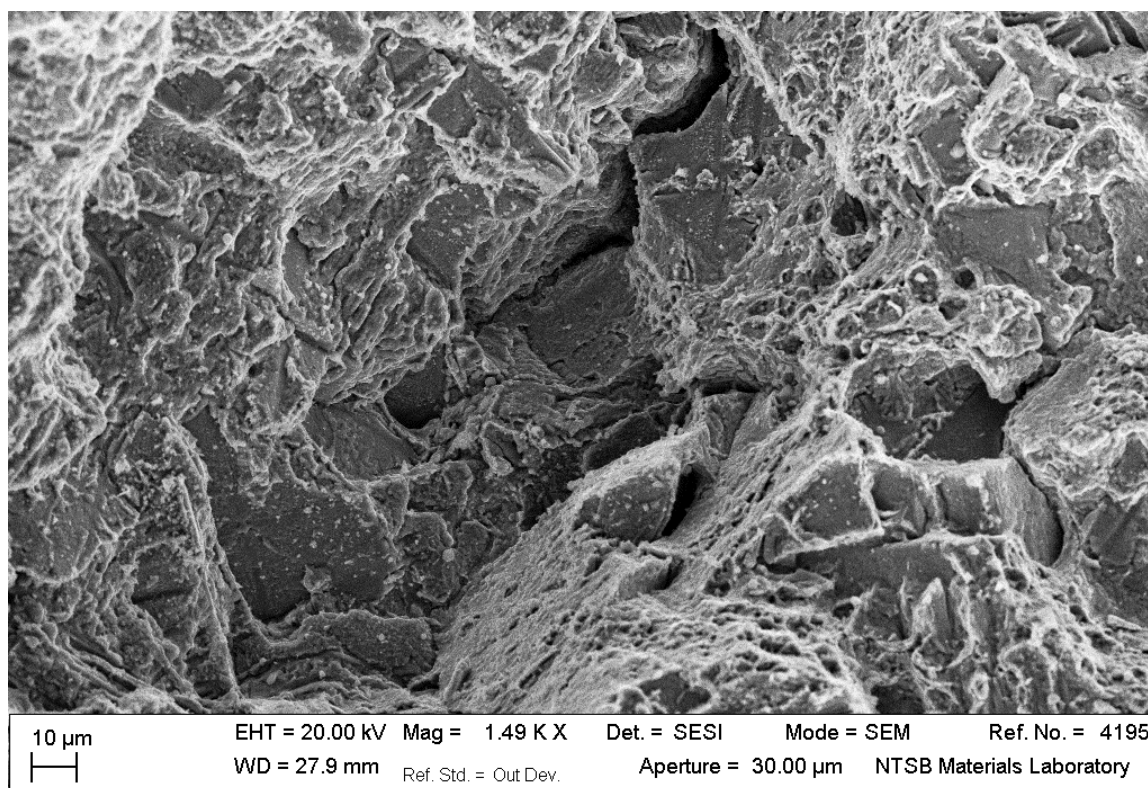
Figure 18 – SE micrograph of intergranular fissures on the Blade 25 fracture surface.

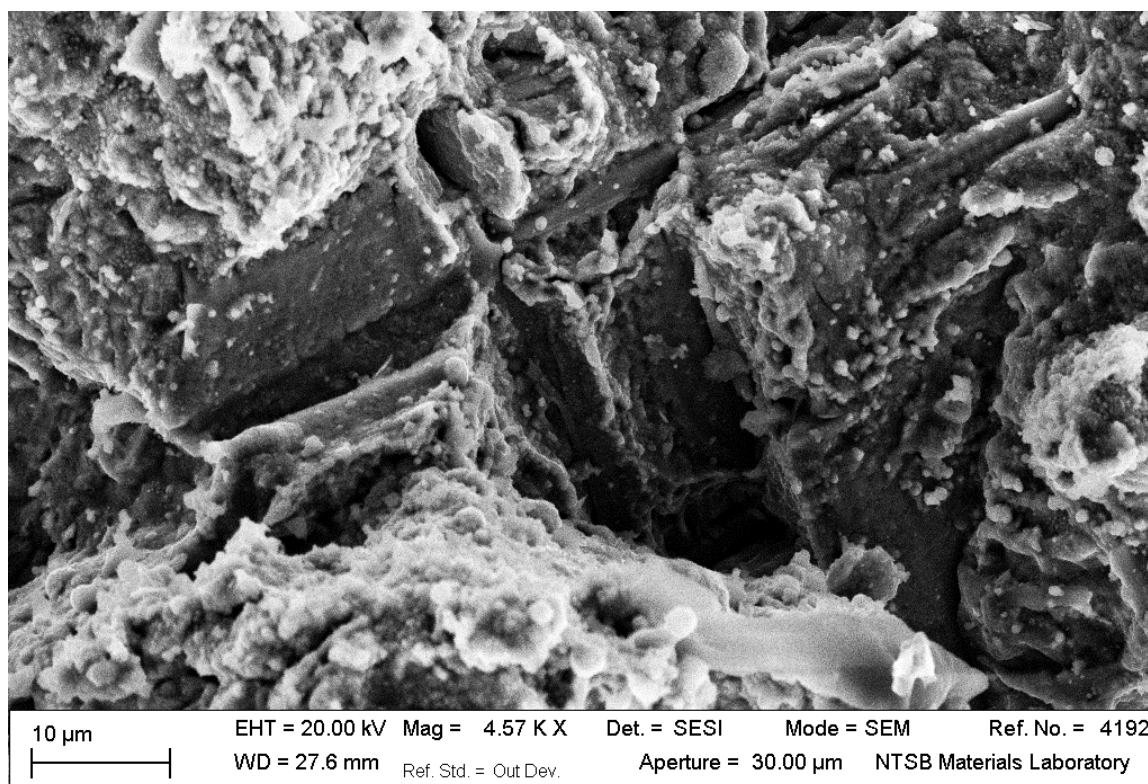
Figure 19 – SE micrograph showing tearing between the dendrites and interdendritic material on the Blade 25 fracture surface.

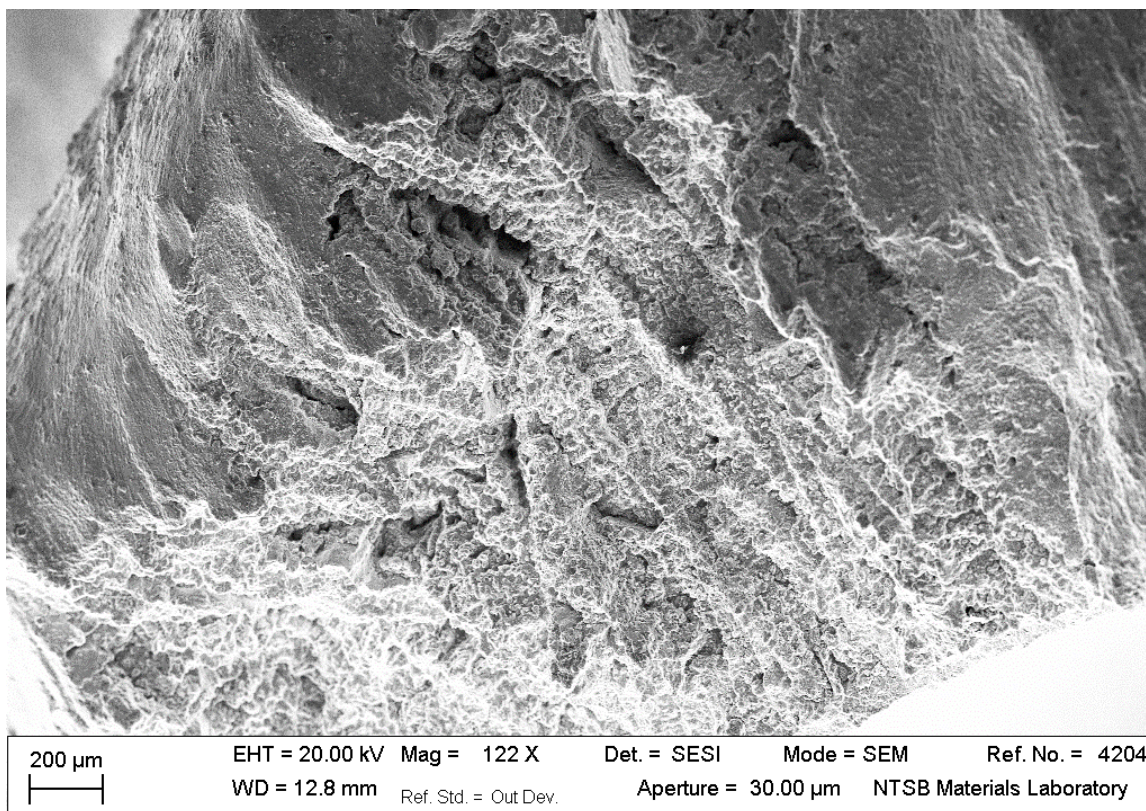
In comparison, selected fractographs from the fracture surface of Blade 42 are illustrated in Figure 20 through Figure 23. This blade exhibited the least amount of blade material remaining above the platform. Figure 20 shows a view of the undamaged portions of the fracture surface near the leading edge. The portions closest to the convex surface on the leading edge exhibited smearing and rounding, consistent with post-fracture secondary damage at elevated temperature exposure.

Figure 20 – SE micrograph of the leading-edge portion of the Blade 42 fracture surface.

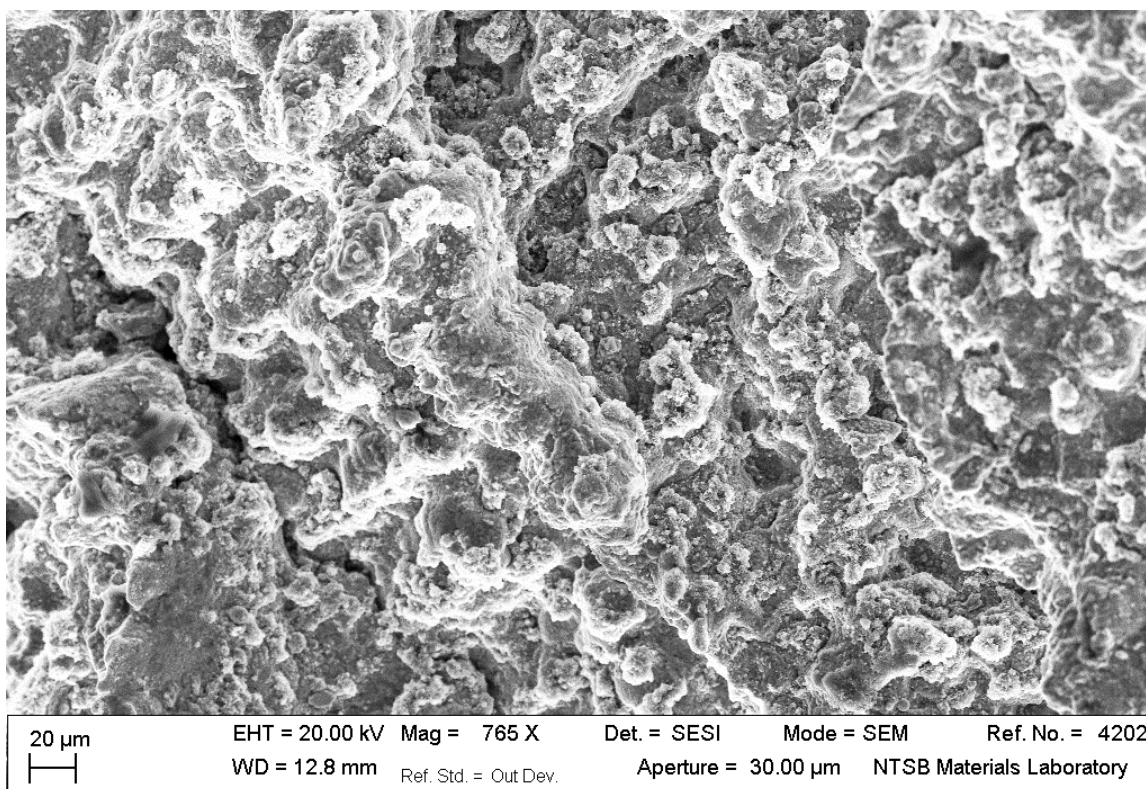
Figure 21 shows the dendritic nature of the fracture surface morphology consistently observed on Blade 42. While this fracture surface did exhibit some surface oxidation (consistent with exposure to engine temperatures after fracture), the underlying fracture features could be more readily discerned using a SEM. As shown in Figure 22 and Figure 23, the fracture surface exhibited features consistent with fine ( $< 1\ \mu\text{m}$ ) dimple rupture. In comparison, the dimple rupture features on the Blade 25 fracture surface were on the order of  $10\ \mu\text{m}$  in size.

Figure 21 – SE micrograph showing a closer view of the Blade 42 fracture surface.
