# NATIONAL TRANSPORTATION SAFETY BOARD

## MATERIALS LABORATORY FACTUAL REPORT

Report No. 19-005

Place : Union City, Tennessee  
Date : September 15, 2017  
Vehicle : Air Tractor AT-502, N4531K  
NTSB No. : ERA17LA326  
Investigator : Brian Rayner, AS-ERA

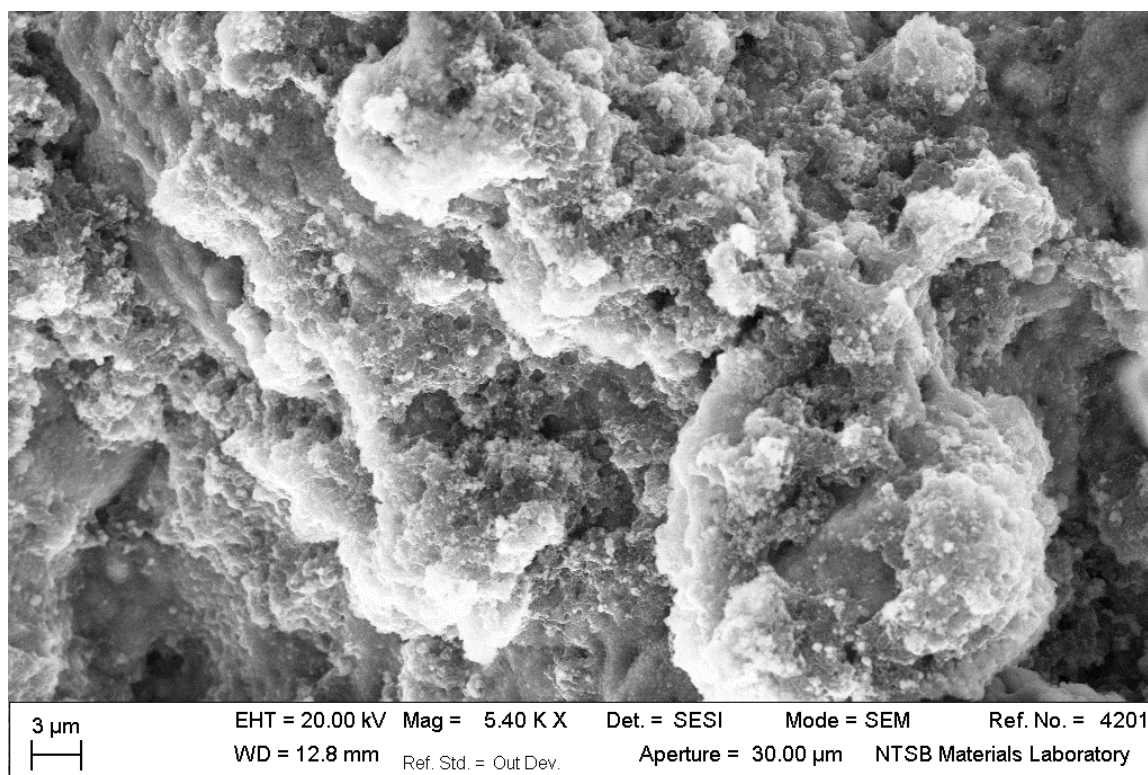
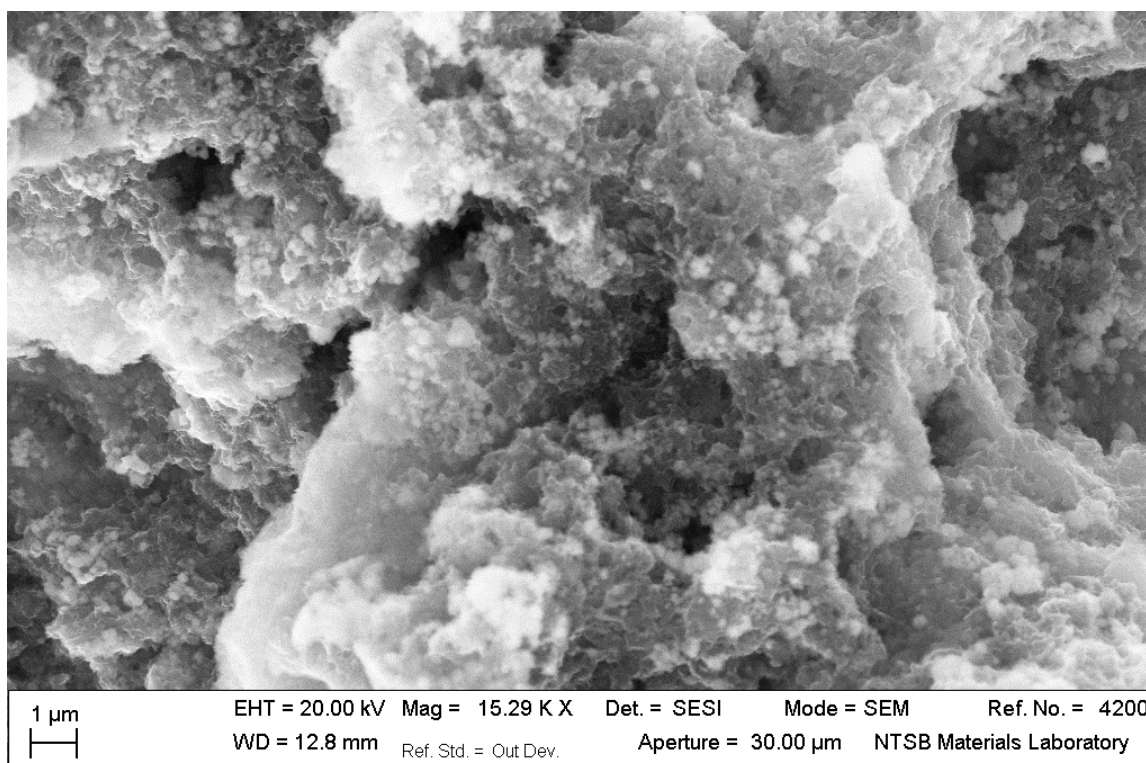
Figure 21 shows the dendritic nature of the fracture surface morphology consistently observed on Blade 42. While this fracture surface did exhibit some surface oxidation (consistent with exposure to engine temperatures after fracture), the underlying fracture features could be more readily discerned using a SEM. As shown in Figure 22 and Figure 23, the fracture surface exhibited features consistent with fine ( $< 1\ \mu\text{m}$ ) dimple rupture. In comparison, the dimple rupture features on the Blade 25 fracture surface were on the order of  $10\ \mu\text{m}$  in size.

Figure 22 – SE micrograph of a magnified view of the Blade 42 fracture surface in Figure 21, showing dimple rupture.

Figure 23 – SE micrograph of a closer view of the dimple rupture on the Blade 42 fracture surface in Figure 22.

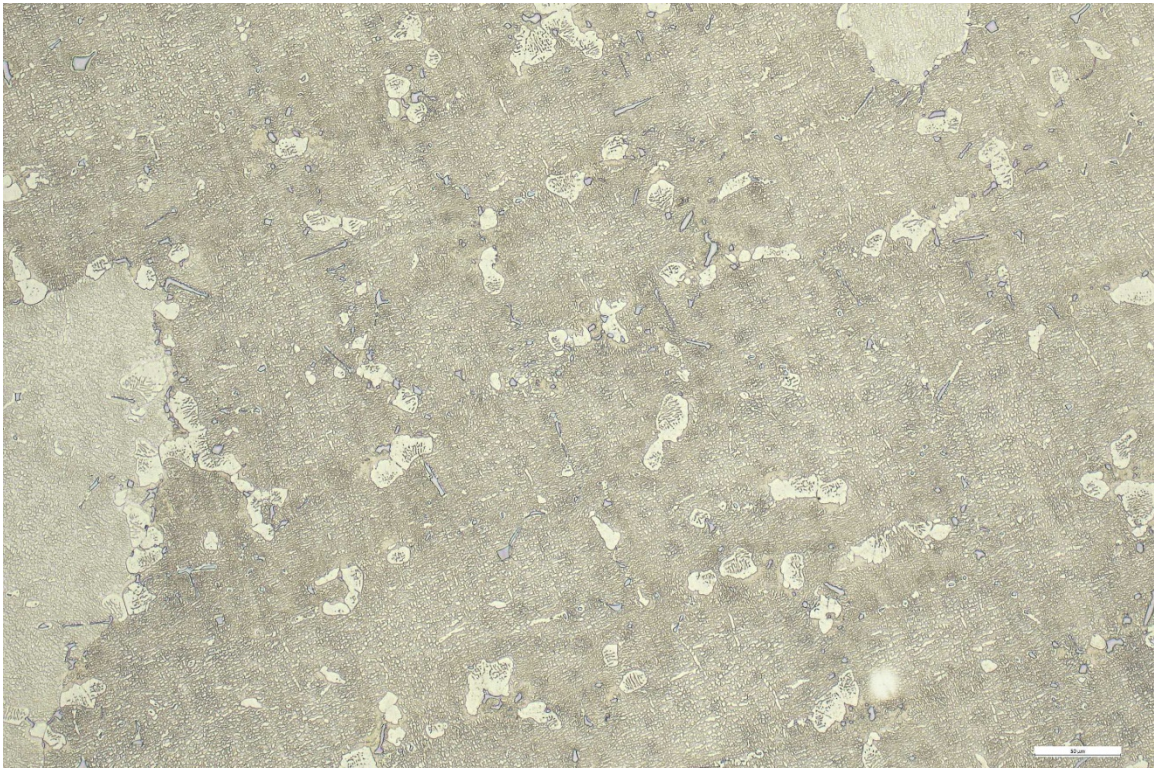
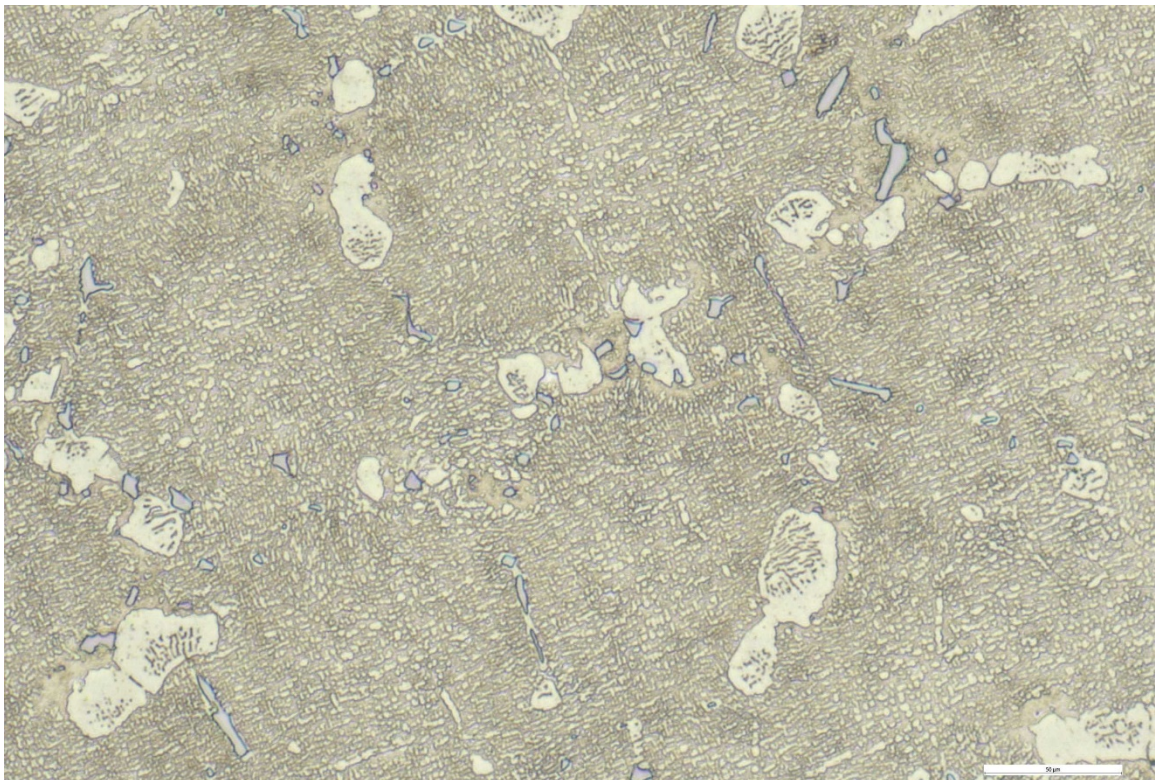
Figure 24 through Figure 28 show the micrographs from Blade 1. Figure 24 and Figure 25 show typical areas of the blade microstructure below the platform. This microstructure was consistent with those typical for nickel-base superalloys, exhibiting a general matrix of nickel rich  $\gamma$  phase and semi-cuboidal  $\gamma'$  ( $\text{Ni}_3\text{Al}$ ) phase, with "fan-shaped" lighter-colored globules of eutectic  $\gamma'$  and blocky carbides. The microstructure also showed a dendritic structure, typical of cast alloys. Equiaxed grain boundaries, consistent with a conventionally cast blade material, were also observed.

Figure 24 – Bright field (BF) micrograph of the Blade 1 dovetail microstructure (~200X, etched Marble's Reagent).

Figure 25 – Bright field (BF) micrograph of the Blade 1 dovetail microstructure (~500X, etched Marble's Reagent).

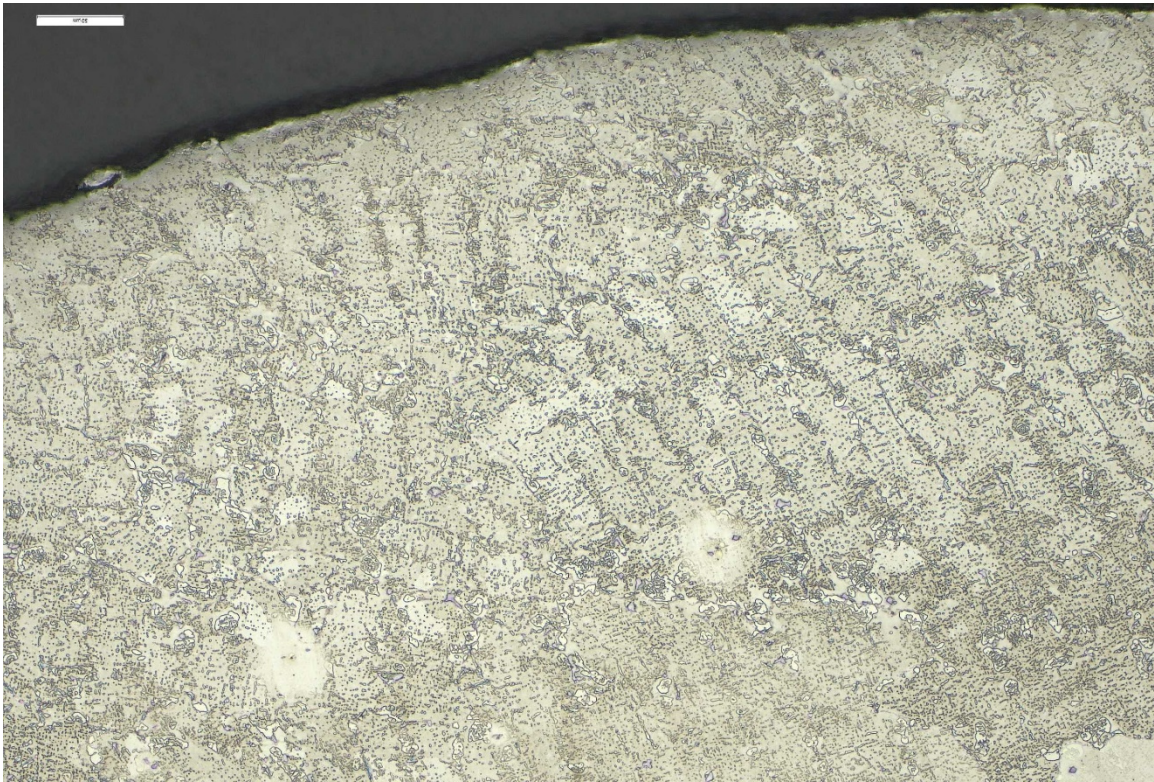
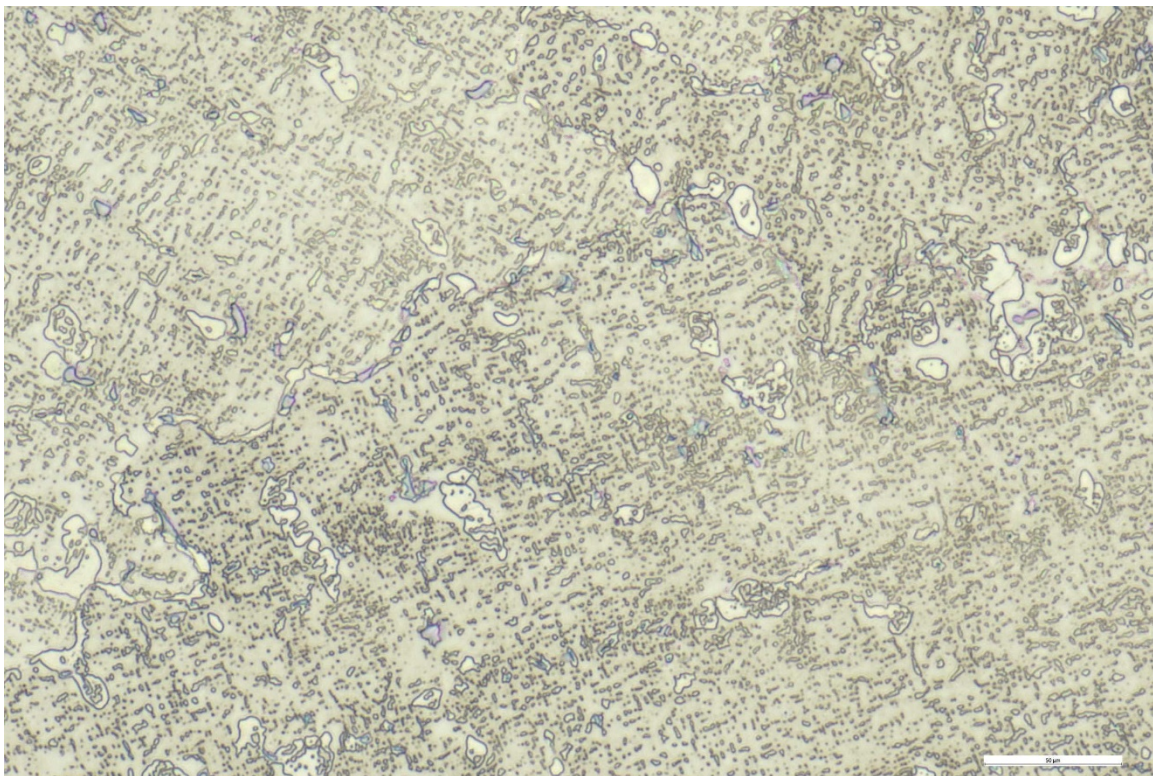
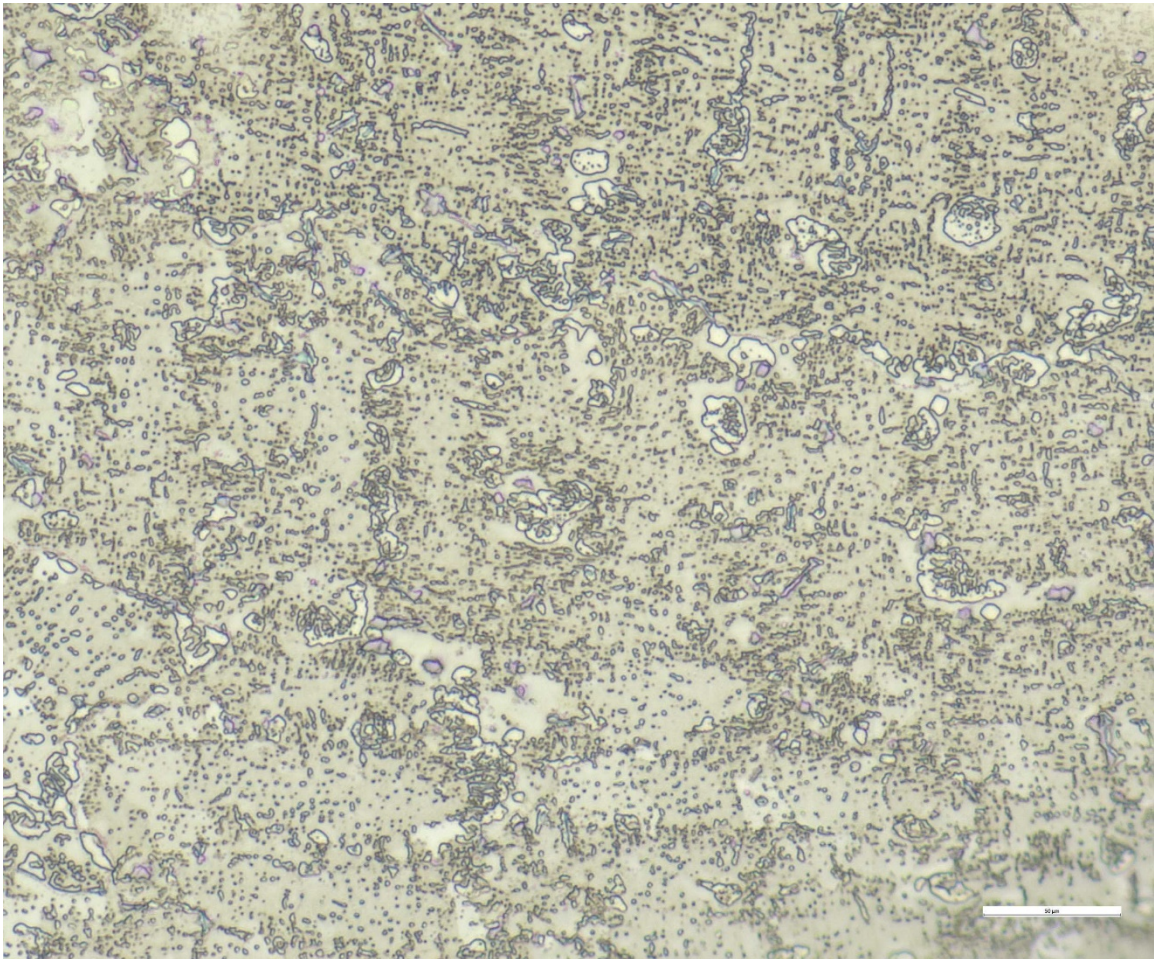
Figure 26 through Figure 28 show the microstructure near the Blade 1 fracture surface. This microstructure shows some rounding and shape change in the eutectic  $\gamma'$  phases. In addition, some resolutioning of the  $\gamma'$  was found in the microstructure near the blade fracture surface.

Figure 26 – Bright field (BF) micrograph of the microstructure in a cross section of Blade 1 fracture surface (~200X, etched Marble's Reagent).

Figure 27 – Bright field (BF) micrograph of the microstructure near the Blade 1 fracture surface (~500X, etched Marble's Reagent).

Figure 28 – Bright field (BF) micrograph of the microstructure near the Blade 1 fracture surface (~500X, etched Marble's Reagent).

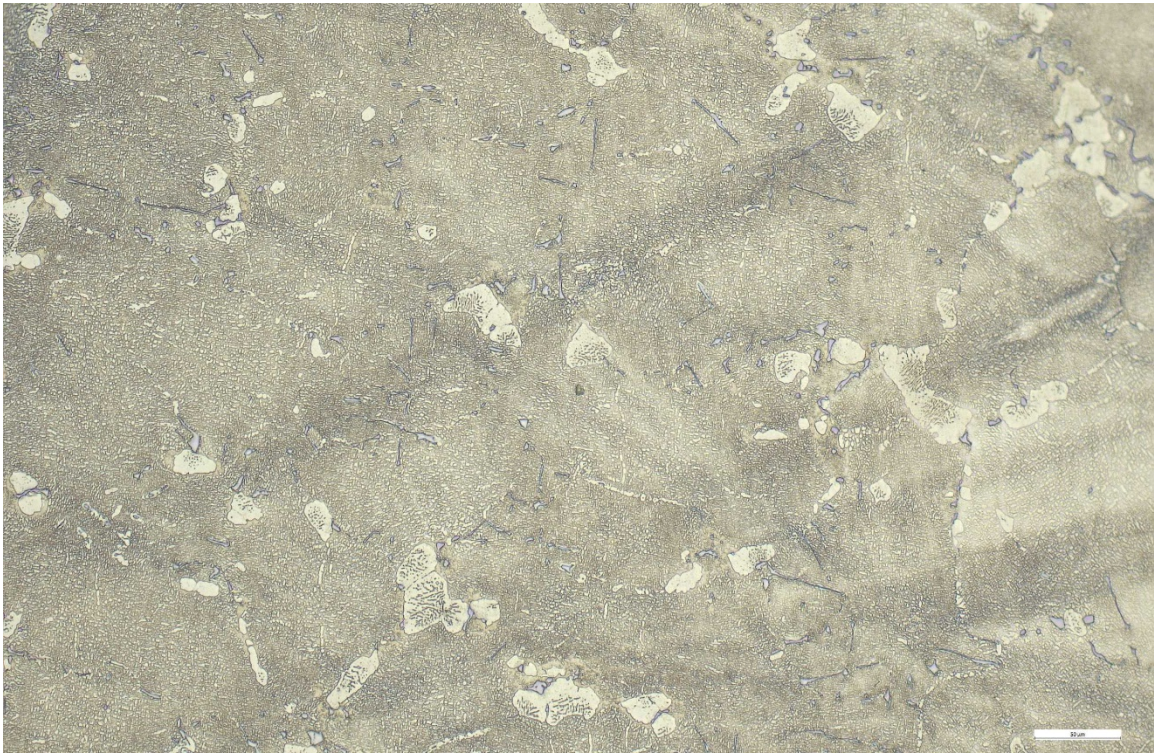
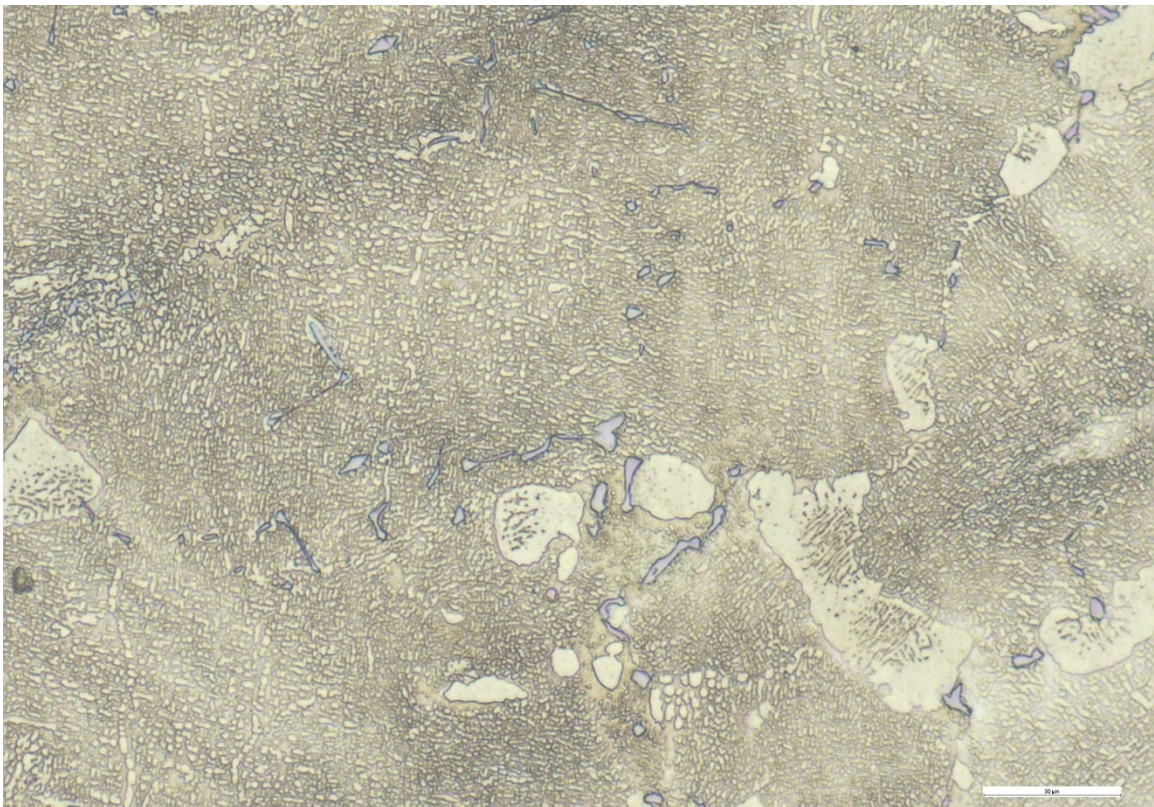
Figure 29 and Figure 30 show typical areas of the microstructure in the dovetail section below the platform of Blade 25. The microstructure was consistent with that in the dovetail of Blade 1. Figure 31 and Figure 32 show the Blade 25 microstructure at the fracture surface. As evident from the figures, the material below the fracture surface exhibited subsurface cracks. These cracks were located along grain boundaries that intersected the fracture surface. The grain boundary cracks often also exhibited oxidation and voids along the grain boundaries.

Figure 29 – Bright field (BF) micrograph of the microstructure in the Blade 25 dovetail (~200X, etched Marble's Reagent).

Figure 30 – Bright field (BF) micrograph of the microstructure in the Blade 25 dovetail (~500X, etched Marble's Reagent).

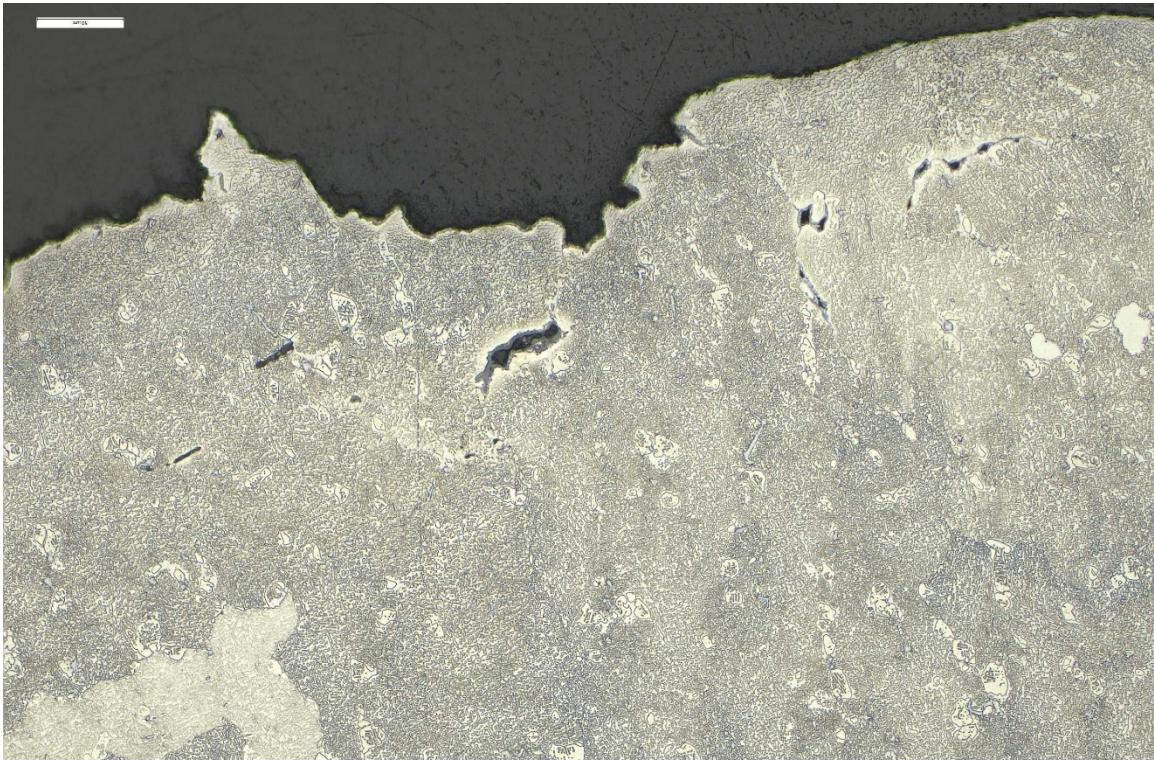
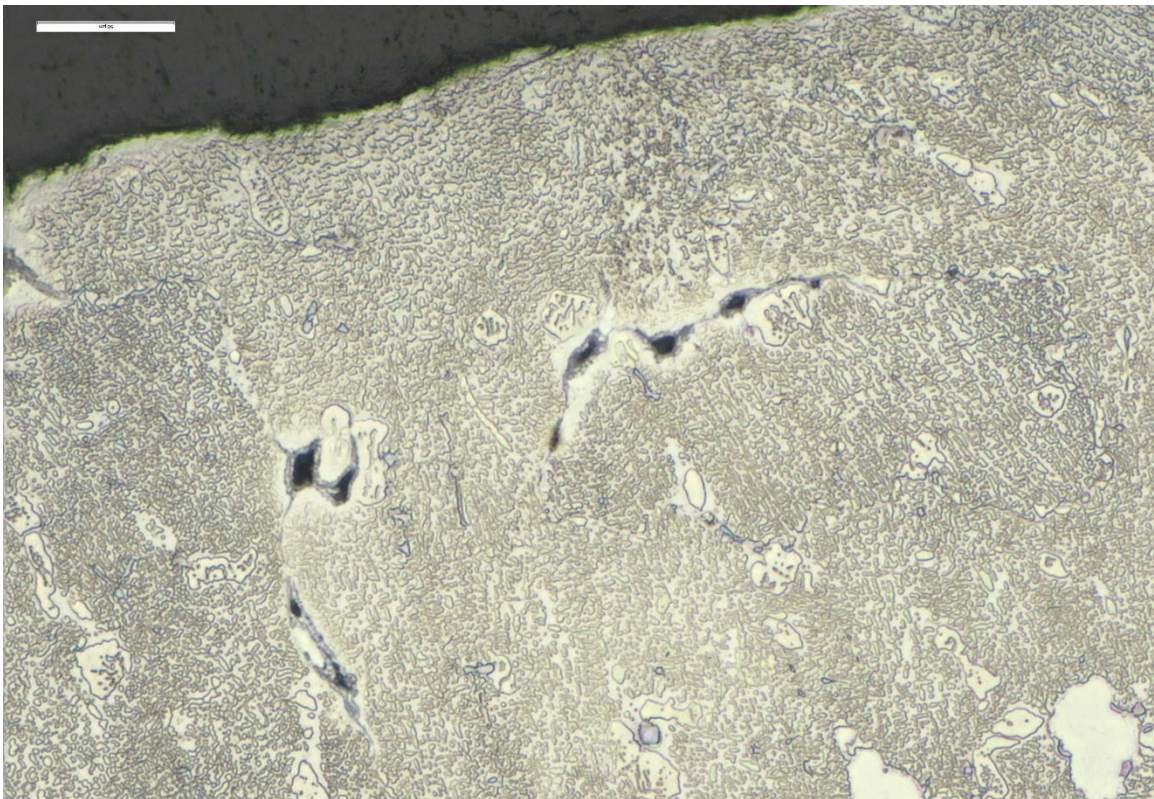
The microstructure near the Blade 25 fracture exhibited resolutioning of the  $\gamma'$ , but it was more pronounced than that observed near the fracture surface of Blade 1. In addition, much of the  $\gamma'$  exhibited rafting (or coalescence), which was consistent with a morphology change at high temperatures under stress. The microstructure was inspected using a SEM. Figure 33 shows the resolutioning and rafting of the  $\gamma'$ , along with the shape change of the eutectic  $\gamma'$ . This can be contrasted with the  $\gamma'$  morphology in the dovetail of the same blade, shown in Figure 34. In the dovetail, the  $\gamma'$  exhibited the semicuboidal shape, rather than a more rounded shape. The dovetail microstructure also contained smaller tertiary  $\gamma'$  phases in the  $\gamma$ -Ni matrix.

Figure 31 – Bright field (BF) micrograph of the microstructure at a cross section through the Blade 25 fracture surface (~200X, etched Marble's Reagent).

Figure 32 – Bright field (BF) micrograph of the microstructure at a cross section through the Blade 25 fracture surface (~500X, etched Marble's Reagent).

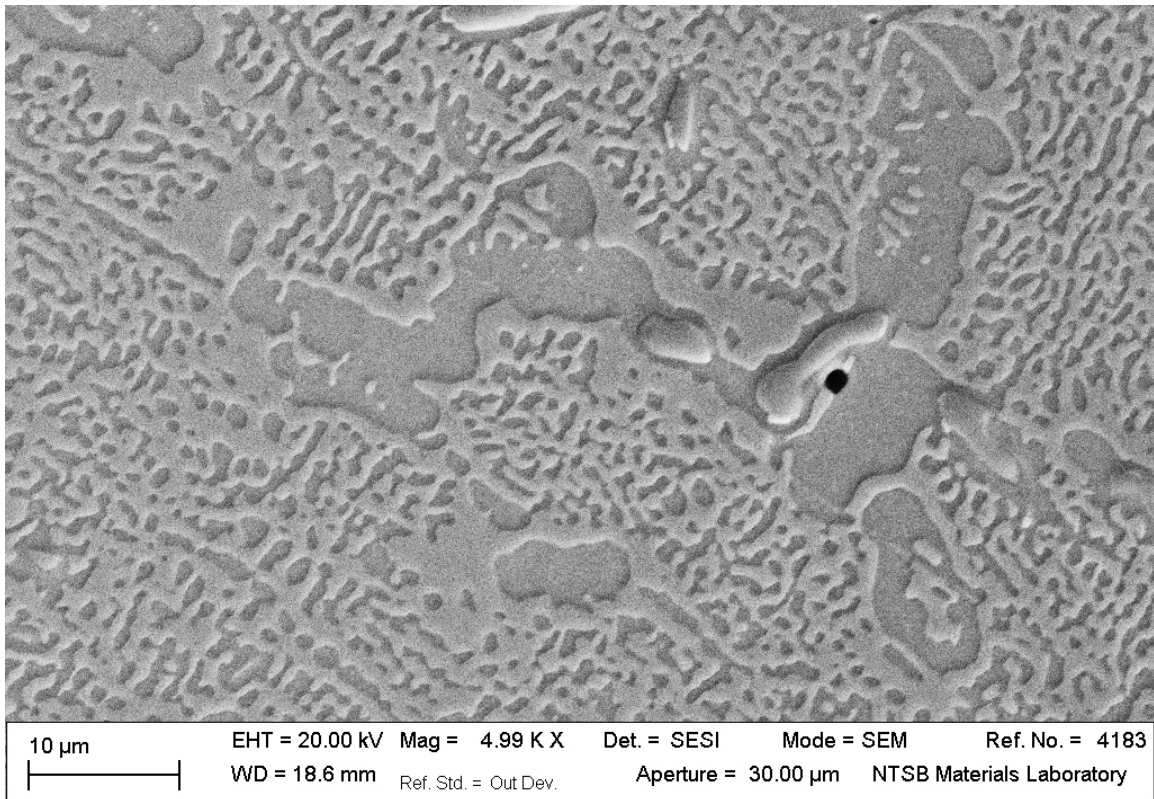
Figure 33 – SE micrograph of the microstructure of Blade 25 near the fracture surface (etched Marble's Reagent).

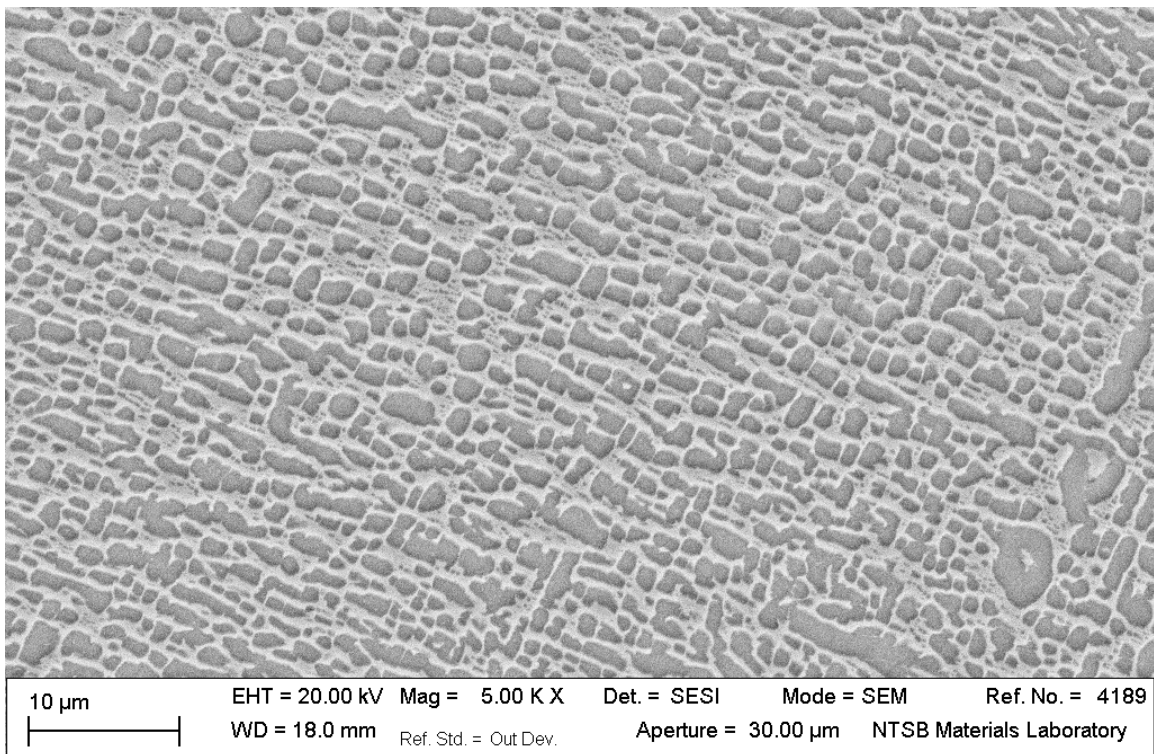
Figure 34 – SE micrograph of the microstructure of Blade 25 in the dovetail (etched Marble's Reagent).

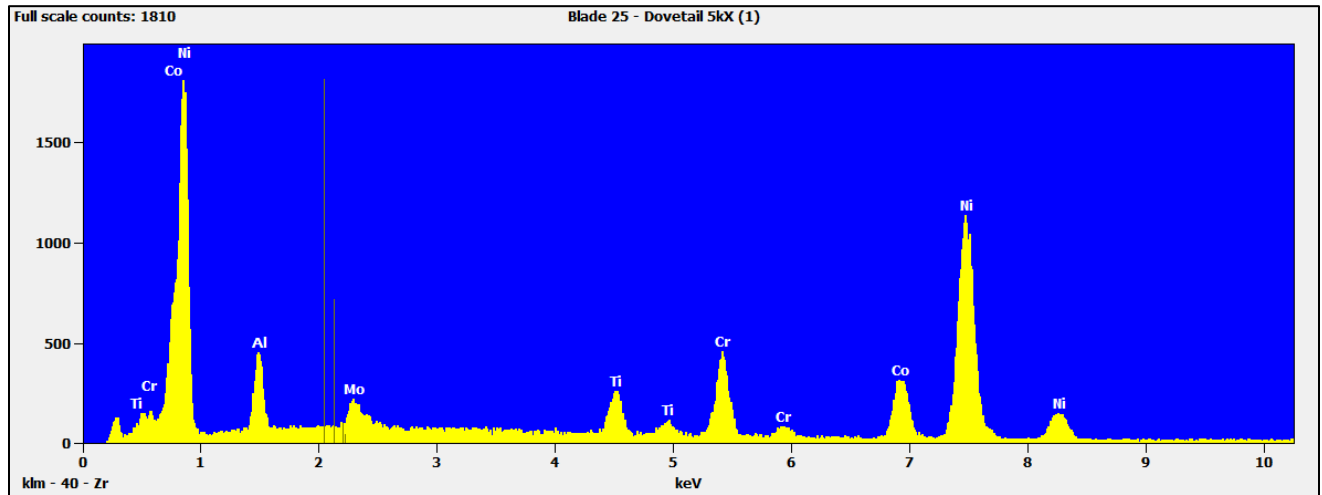
The chemical composition of the Blade 25 dovetail was inspected using energy dispersive X-ray spectroscopy (EDS). A typical spectrum is illustrated in Figure 35. The composition was consistent with Inconel 100 (IN 100). The subsurface grain boundary oxidation, shown in Figure 36, was inspected using EDS. The oxide material exhibited higher levels of Ti, Cr, and O, with minor amounts of Al, C, and Ni. The coating of Blade 34 was more adherent than that of Blade 25, and was inspected using EDS. This coating

Figure 35 – Typical EDS spectrum from the dovetail of Blade 25.

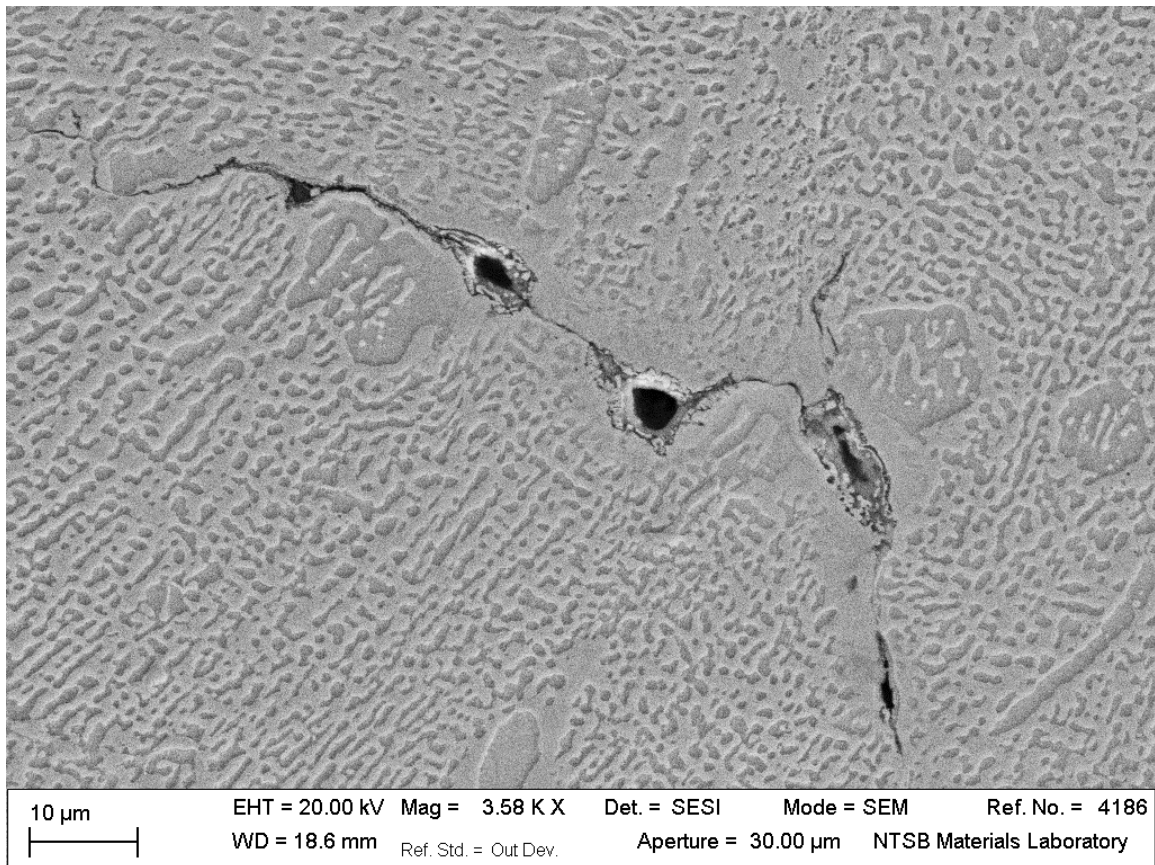
Figure 36 – SE micrograph of a subsurface crack near the Blade 25 fracture surface, showing oxide along the crack.

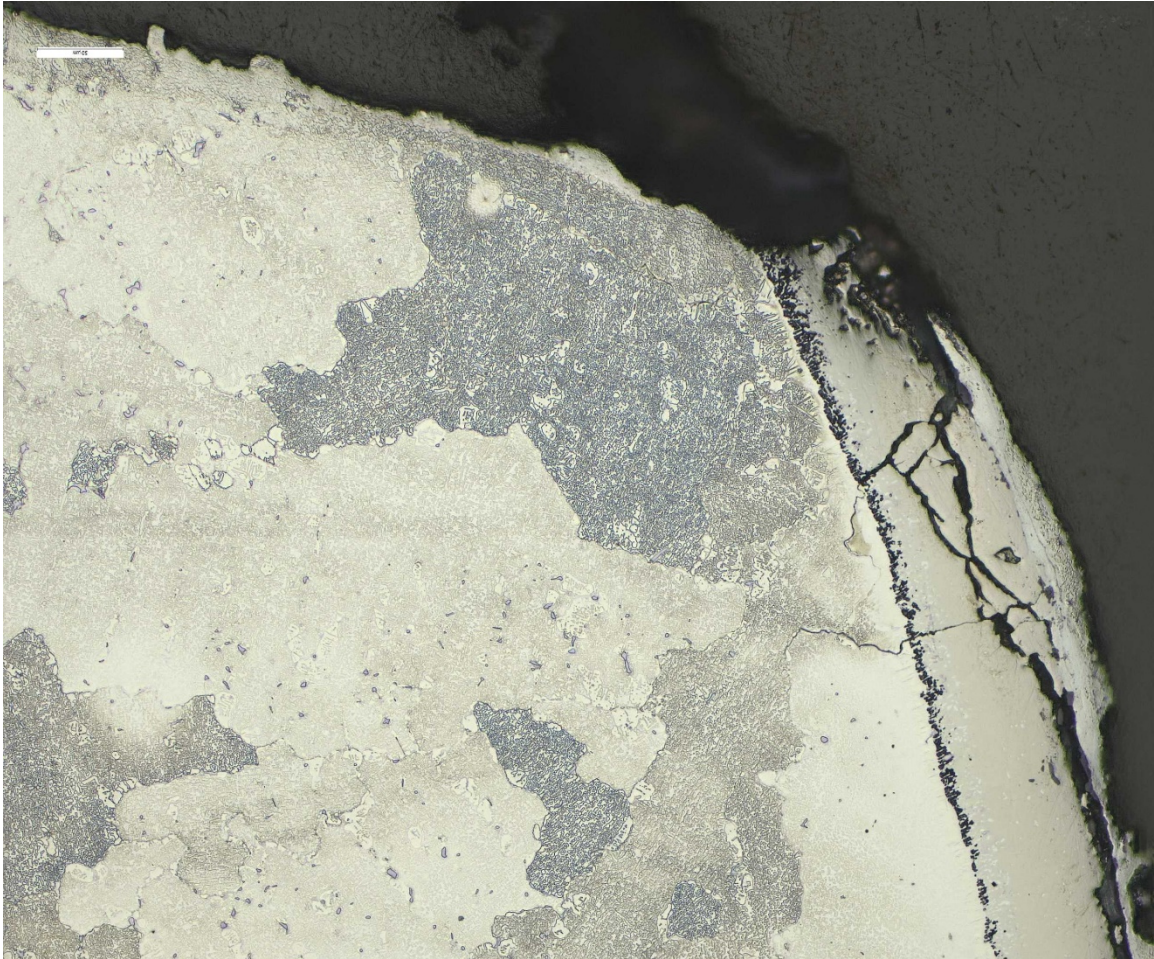
was consistent with a platinum aluminide coating, typical of those commonly applied to some turbine blades. The coating in the case shown in Figure 37 exhibited cracking, particularly near the blade fracture surface.

Figure 37 – BF micrograph of the microstructure through a cross section of the fracture surface of Blade 34, with part of the cracked coating (~200X, etched Marble's Reagent).

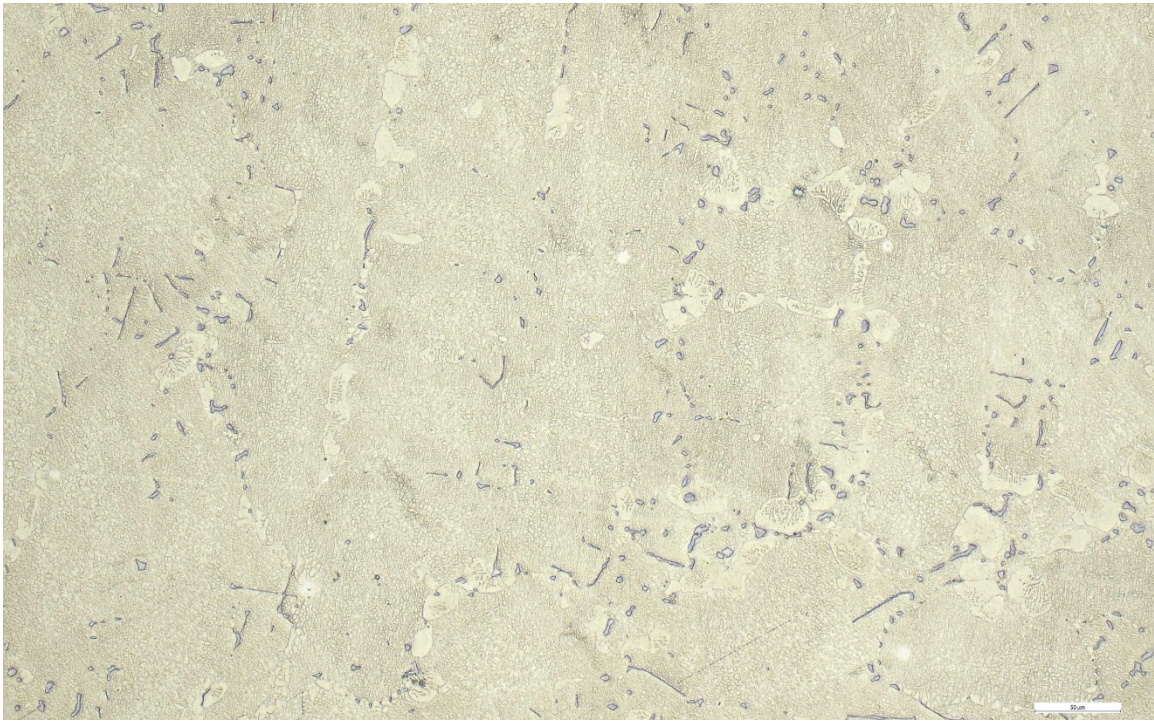
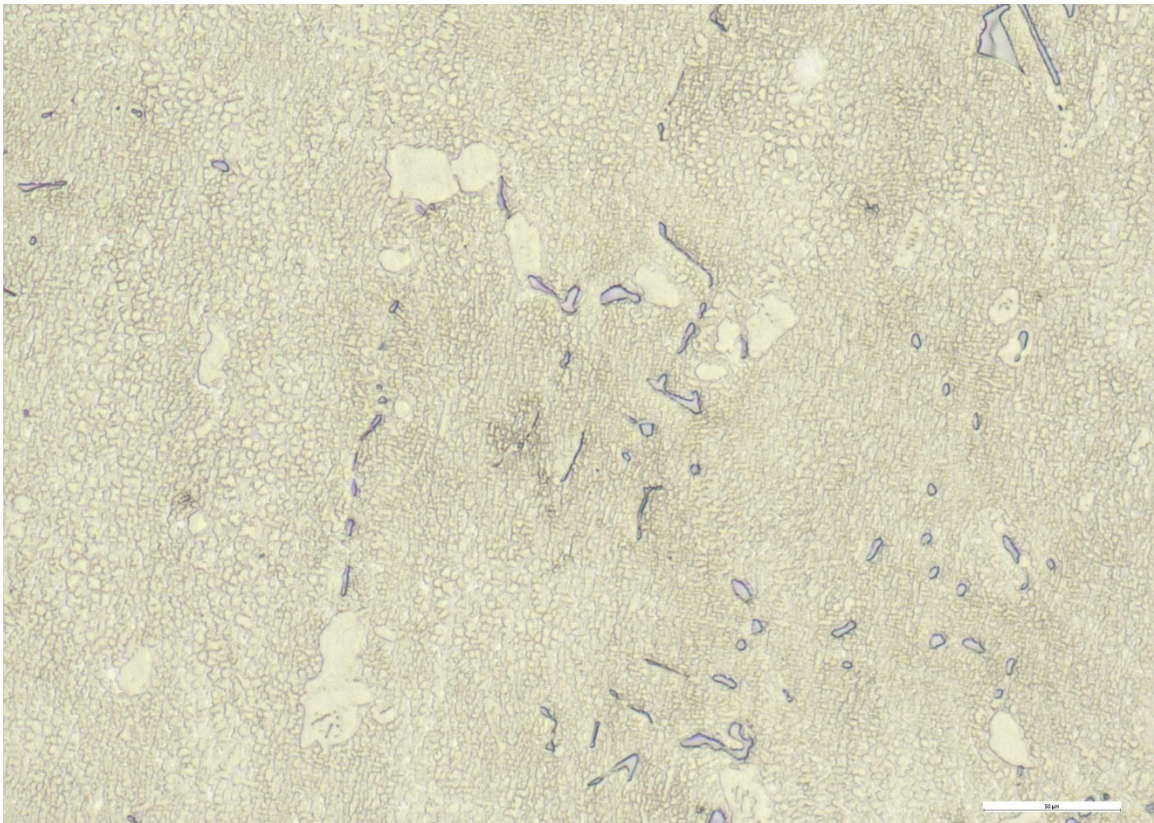
Figure 38 and Figure 39 show the microstructure of Blade 42. This microstructure was consistent with those observed in all of the examined dovetails of the three other blades. The fracture surface of the blade is shown in Figure 40. This fracture surface exhibited a more tortuous fracture surface than the other three blades. There were some noted grain boundary fractures, but these exhibited a parallel tearing morphology rather than cracking along the grain boundaries with intergranular oxidation. The microstructure near the fracture surface of Blade 42 is shown in Figure 41. There was some rafting of the  $\gamma'$ . However, no discernible resolutioning of the  $\gamma'$  was found. These features, along with the features observed on the fracture surface of this blade, were consistent with fracture from overstress under elevated temperatures at this location.

Figure 38 – BF micrograph of the microstructure in the Blade 42 dovetail (~200X, etched Marble's Reagent).

Figure 39 – BF micrograph of the microstructure in the Blade 42 dovetail (~500X, etched Marble's Reagent).

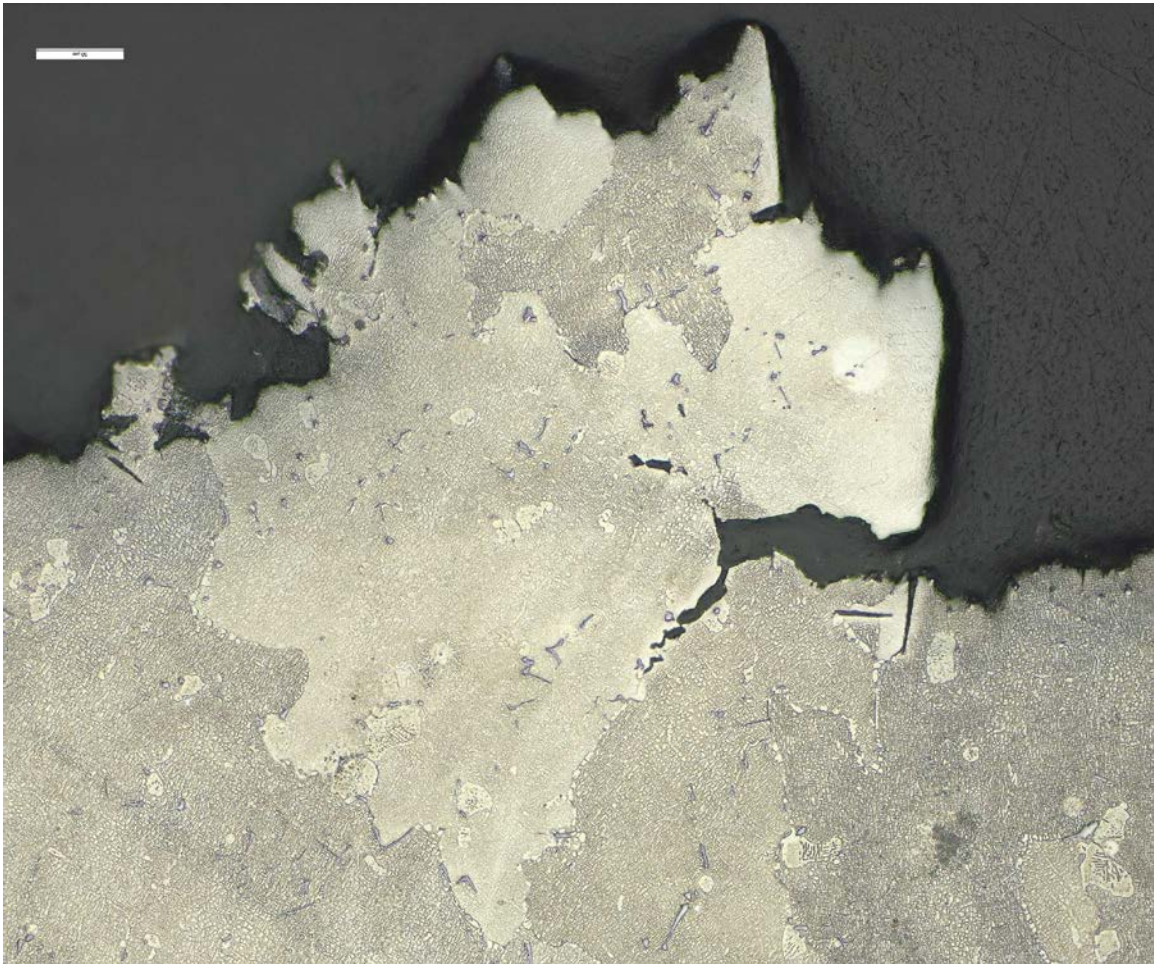
Figure 40 – BF micrograph of the microstructure through a cross section of the fracture surface of Blade 42 (~500X, etched Marble's Reagent).

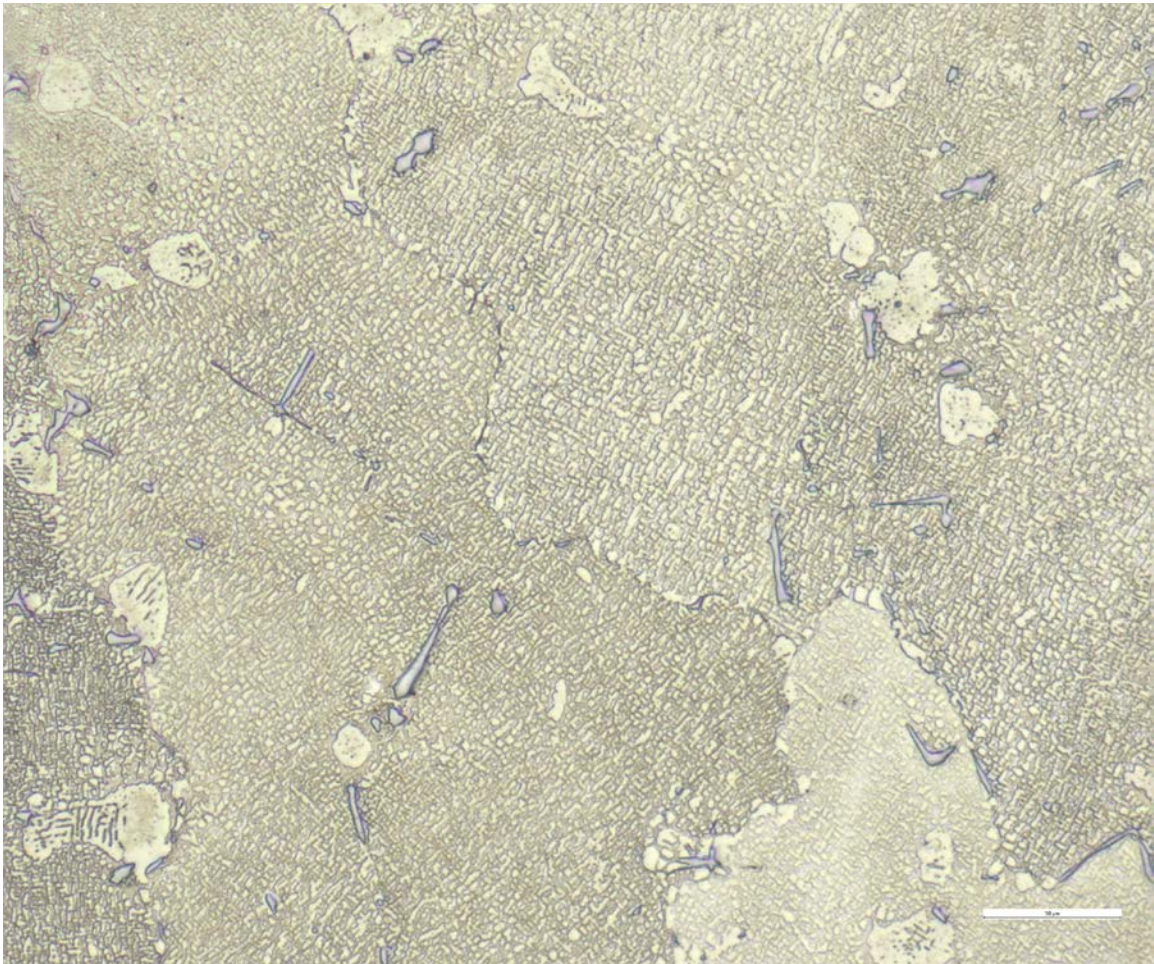
Figure 41 – BF micrograph of the microstructure near the fracture surface of Blade 34, with part of the cracked coating (~500X, etched Marble's Reagent).
